Rehabilitation of East Lynn Lake Bridge, WV

Hota GangaRao and Ruifeng Liang

West Virginia University Constructed Facilities Center and CICI

Overview of East Lynn Lake Bridge, WV - Steel H-pile Rehab with Composites Project

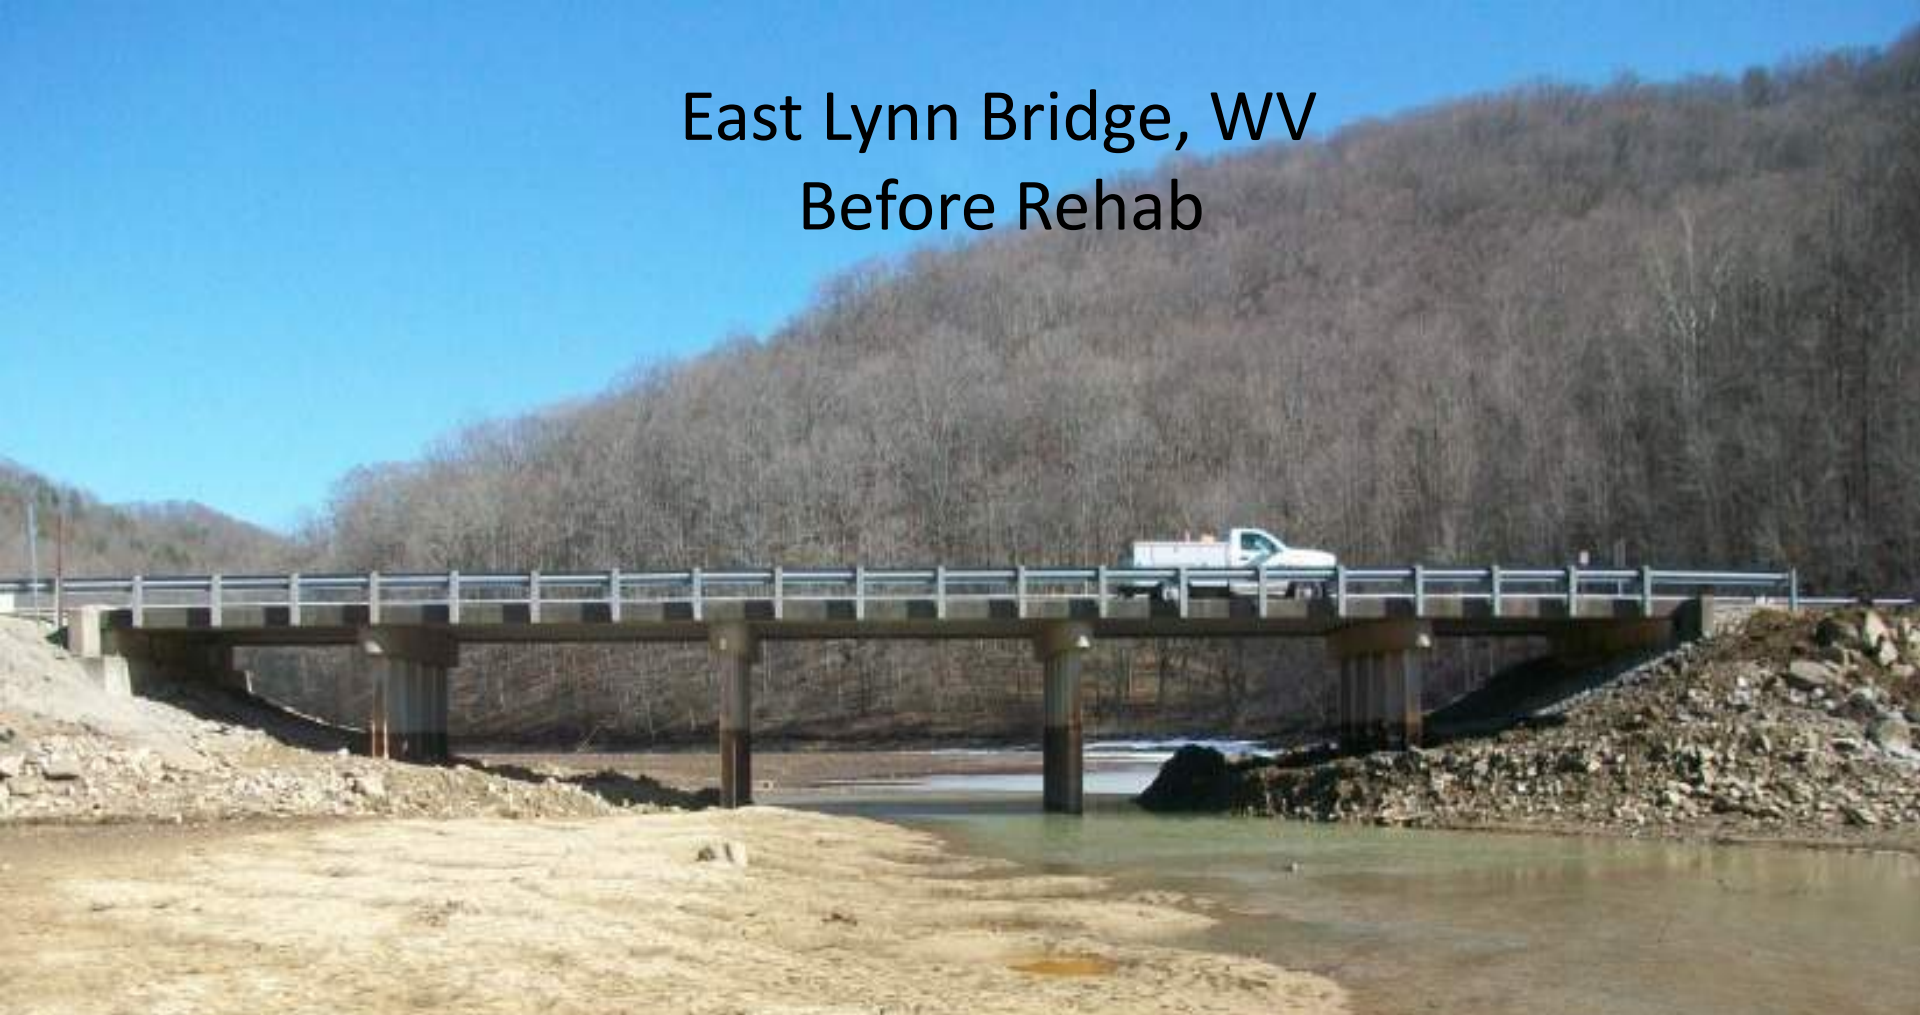
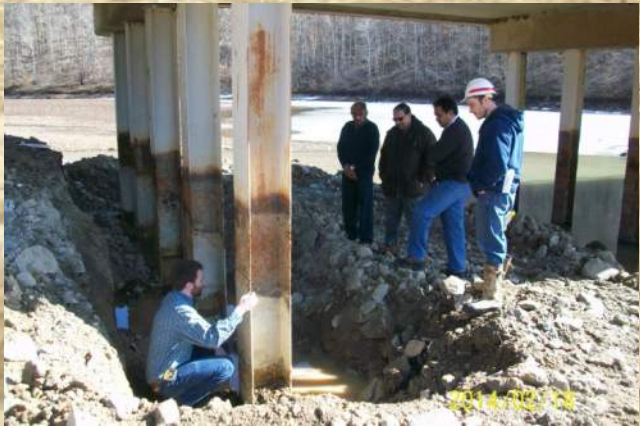
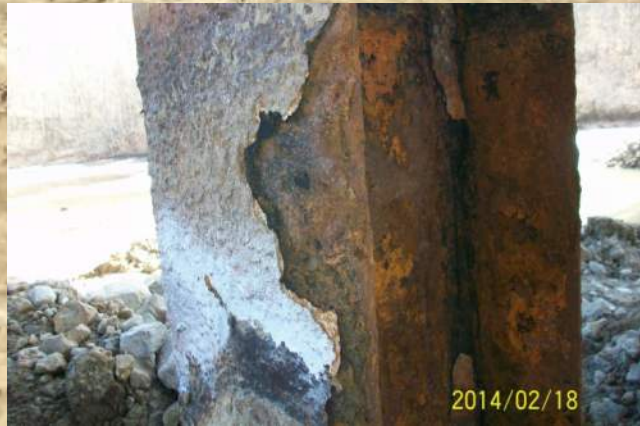
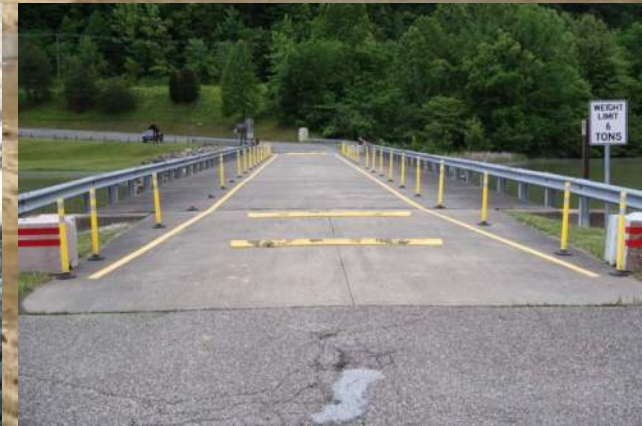
East Lynn Bridge, WV Before Rehab

Corrosion of H-piles resulted in section loss up to **50%**, load rating of **6 tons**, speed reduction to 10 MPH, and one lane closure.

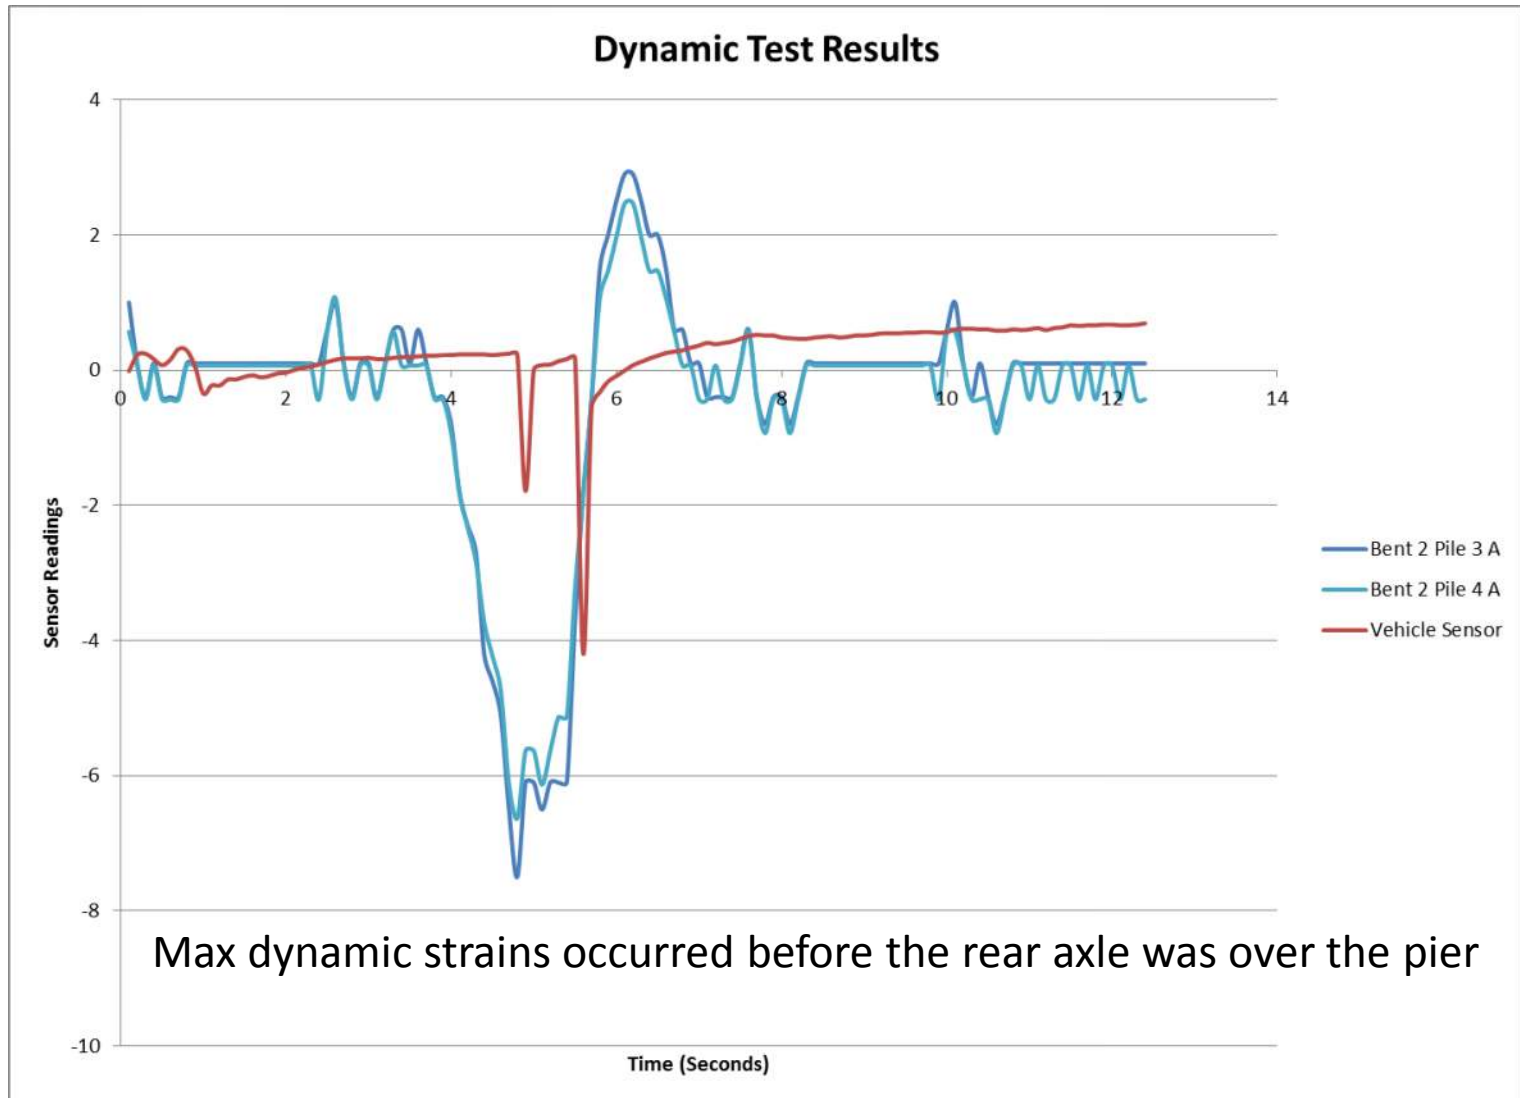
Sensor Readings as a Function of Time during a Dynamic Load Test

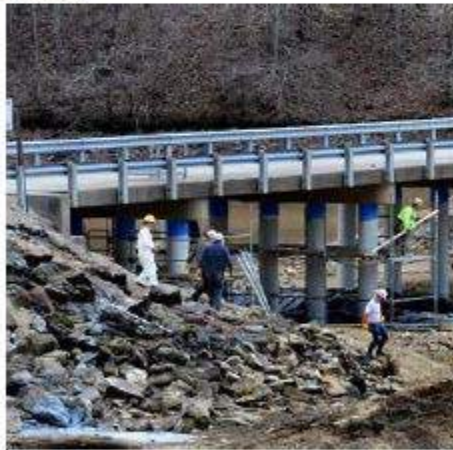
West Virginia University engineering students remove scaffolding f Lynn Lake after its piers were fixed with a WVU-designed repair p

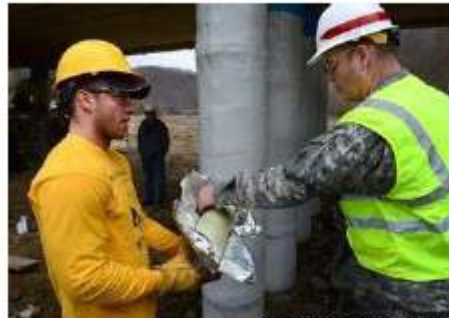
Huntington District Corps of Engineers Col. Leon F. Parrott looks at a roll of composite wrap used on the bridge piers and being held by engineering grad student Luis Pama.
