## **2018 STIC Incentive Project 12 Month Report - BFRP-RC Standardization**

**Fed Project No: STIC-0004-00A; FPID 443377-1**

This is the second report for the Basalt Fiber-Reinforced Polymer (BFRP) Bar Standardization for Reinforced Concrete (RC) with the FHWA allocation memorandum dated March 1, 2018. This report covers a slightly extended period from November 2018 until May 2019, since there were a number of key work products completed in April/May 2019.

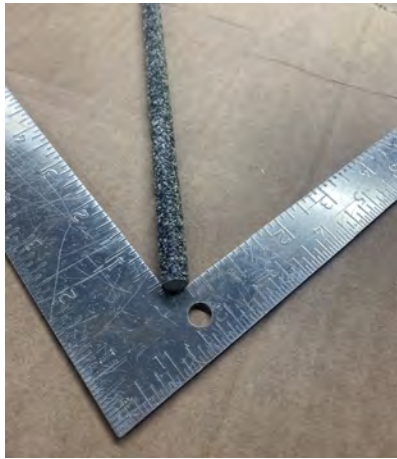
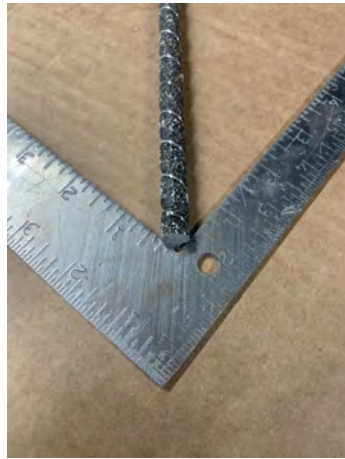
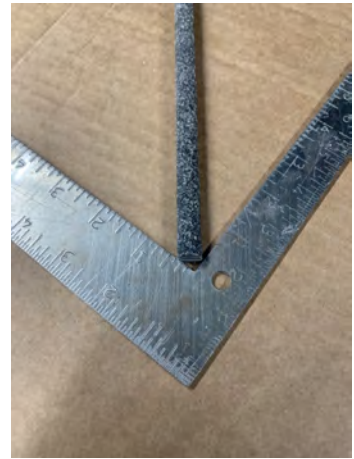
Figure 1.1: Sample pictures of tested BFRP #3 Rebars

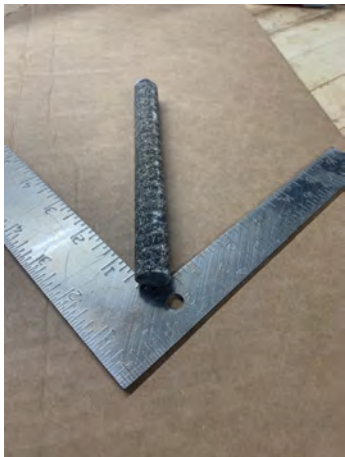
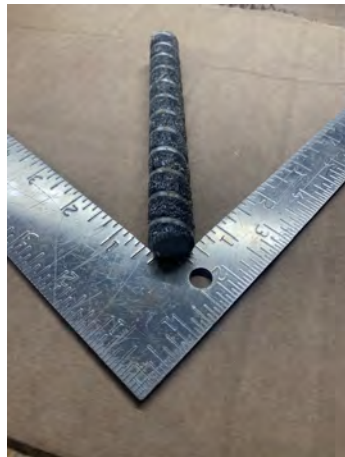
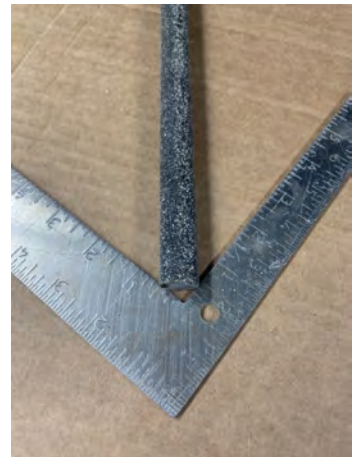
Figure 1.2: Sample pictures of tested BFRP #5 Rebars

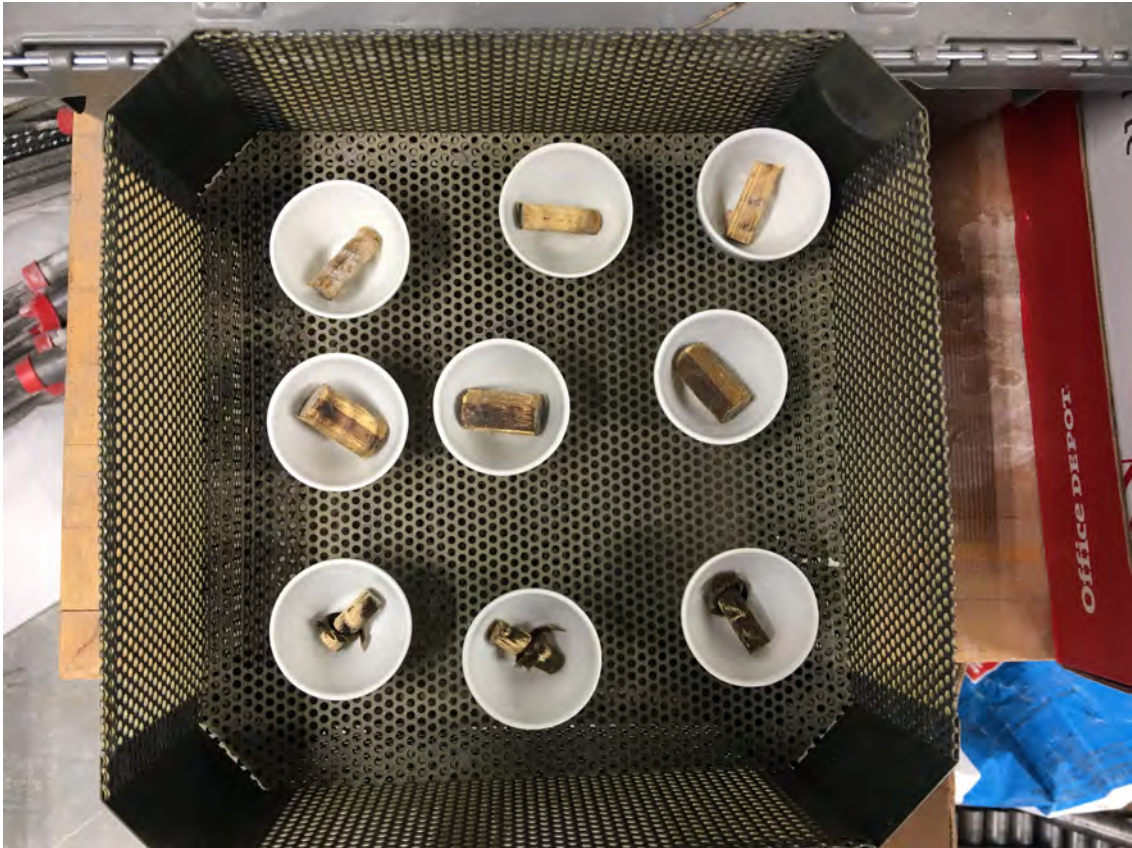
Figure 3.2: Fiber content specimen of GP HP # 3, 5 after test

appearance of the rebars after the test were similar for all rebar types.

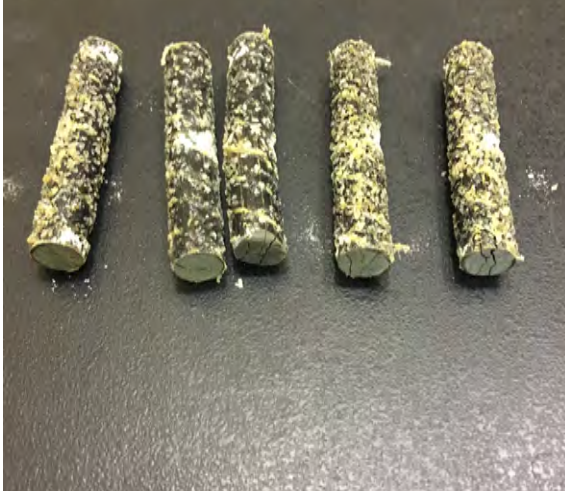
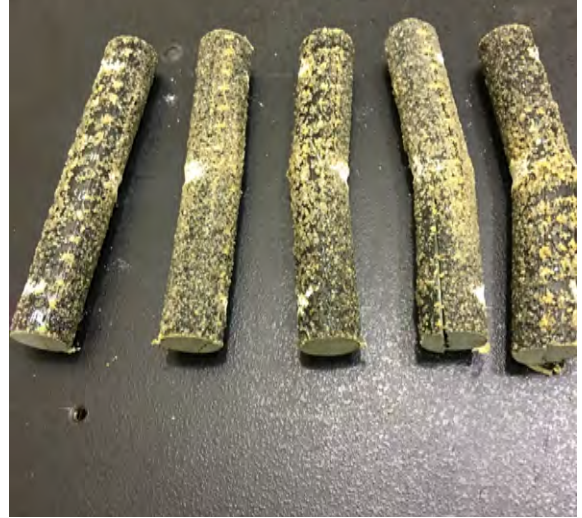
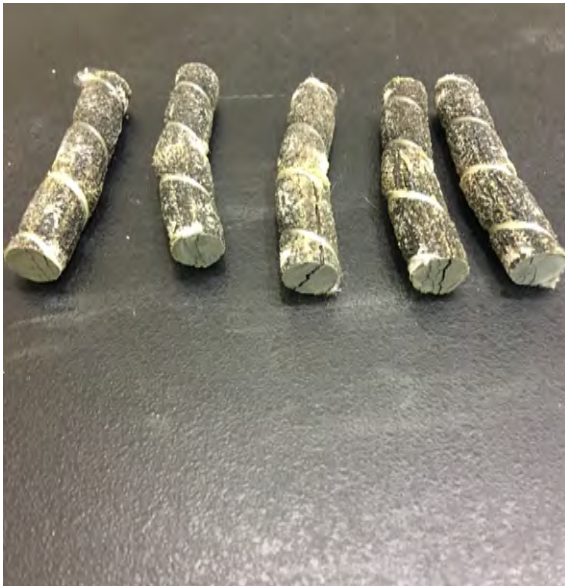
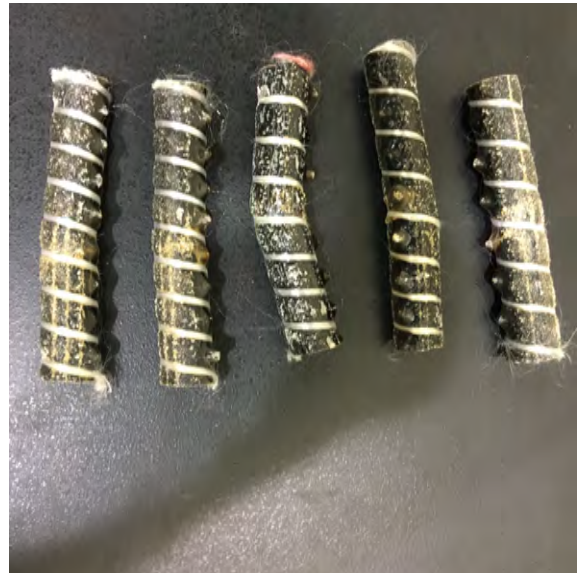
Figure 3.10 shows the failed BFRP specimen after completion of the horizontal shear test.

Figure 3.10: Failure pattern for tested rebar after horizontal shear test

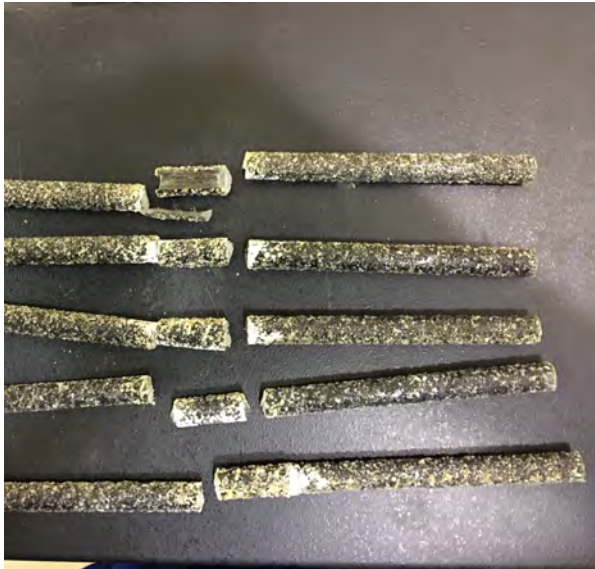
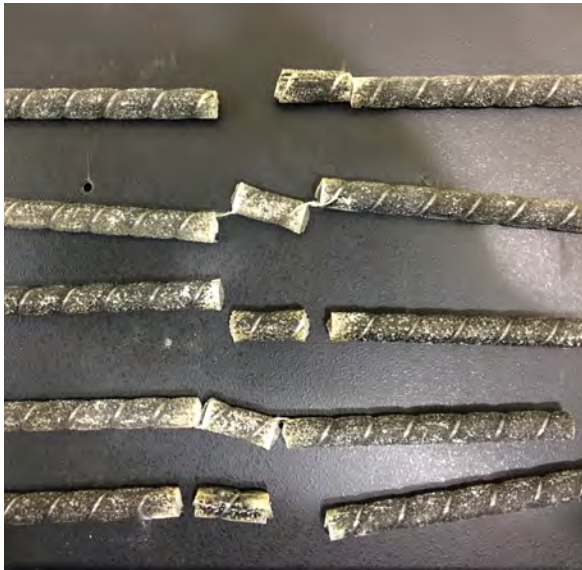
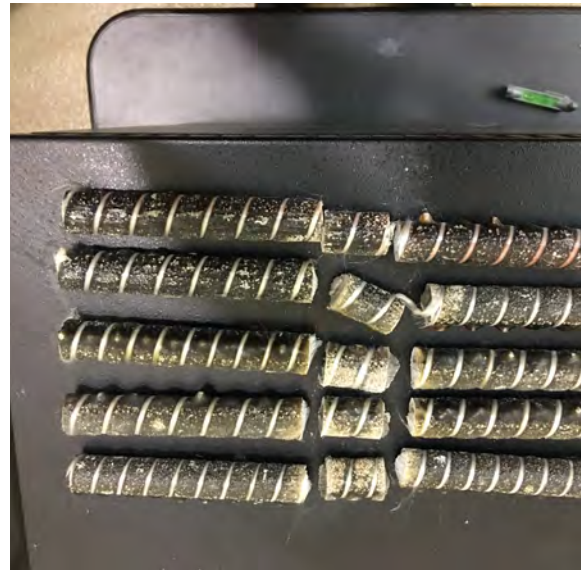
The Figure 3.17 in this section shows the pictures of failed BFRP specimen due to transverse shear load.

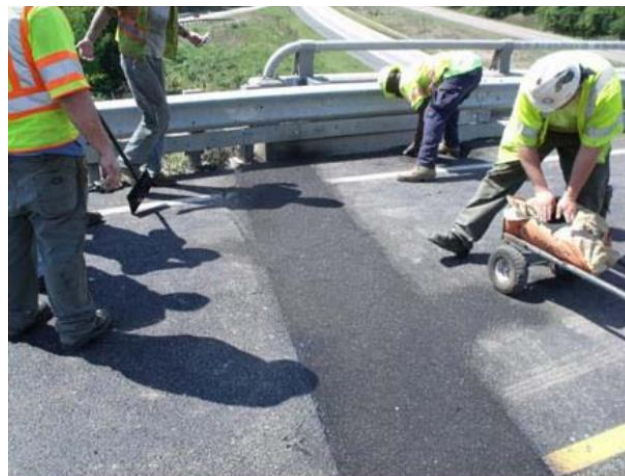
**Fig. 10: Asphalt Plug Joints**

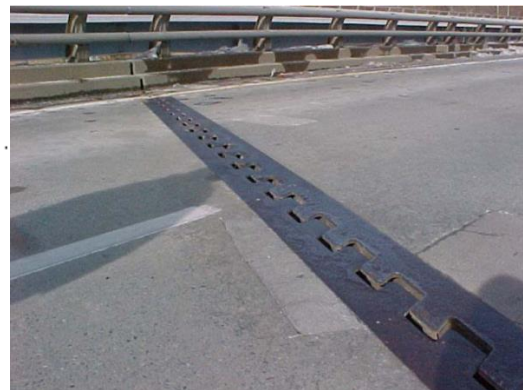
**Fig. 12: Finger Joints**
