TRB ANNUAL MEETING, (WASHINGTON DC.) JANUARY, 2019

Bakers Haulover Cut Bridge: Seawall- Bulkhead Rehabilitation and New GFRP-RC Solutions

Steven Nolan, P.E. (FDOT State Structures Design Office)

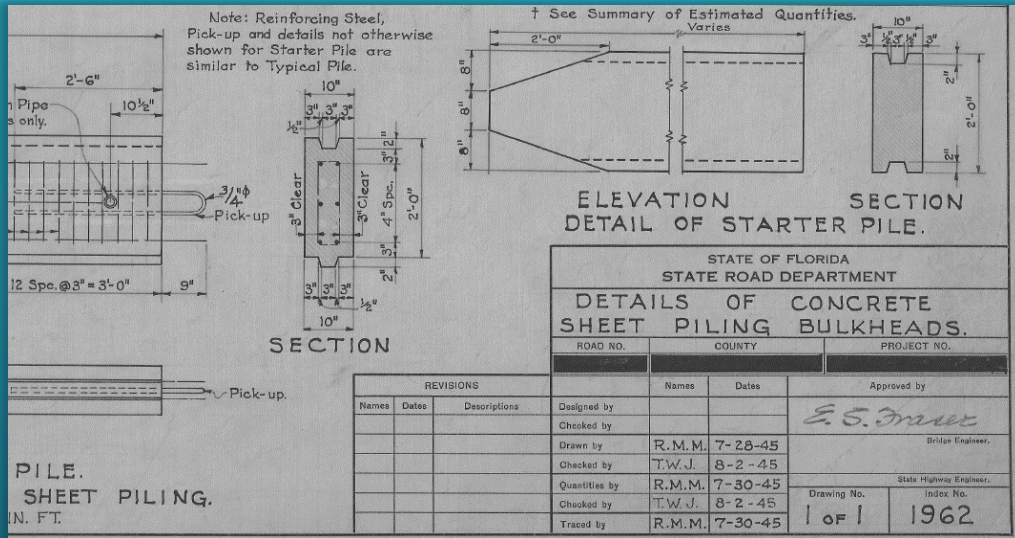
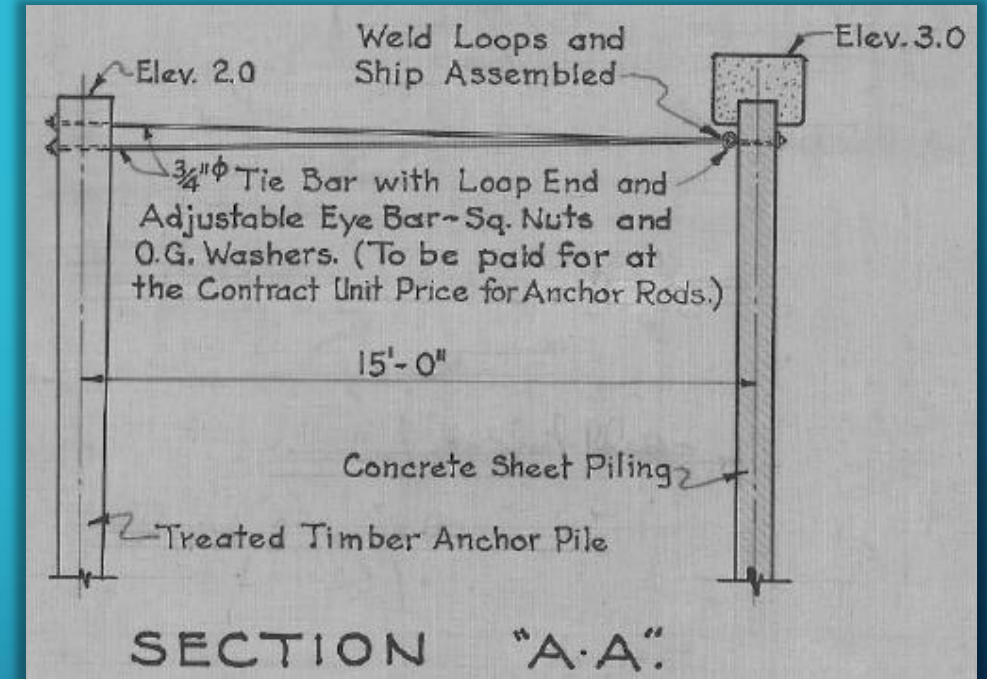
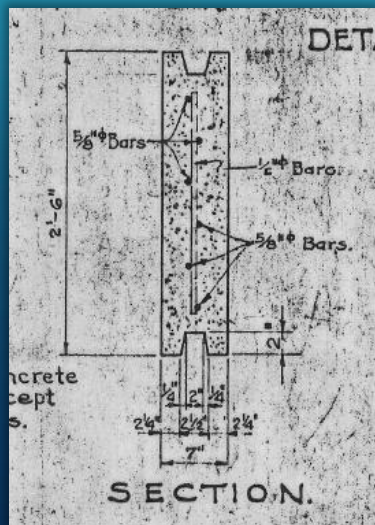
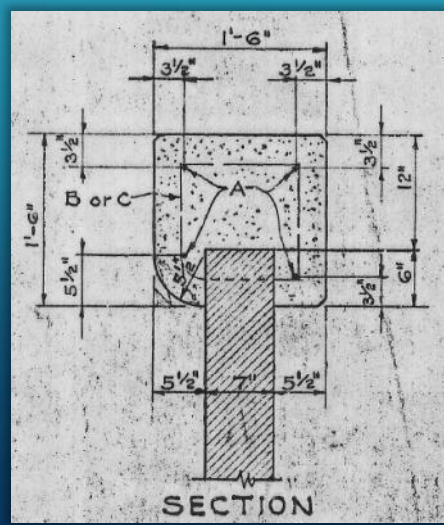
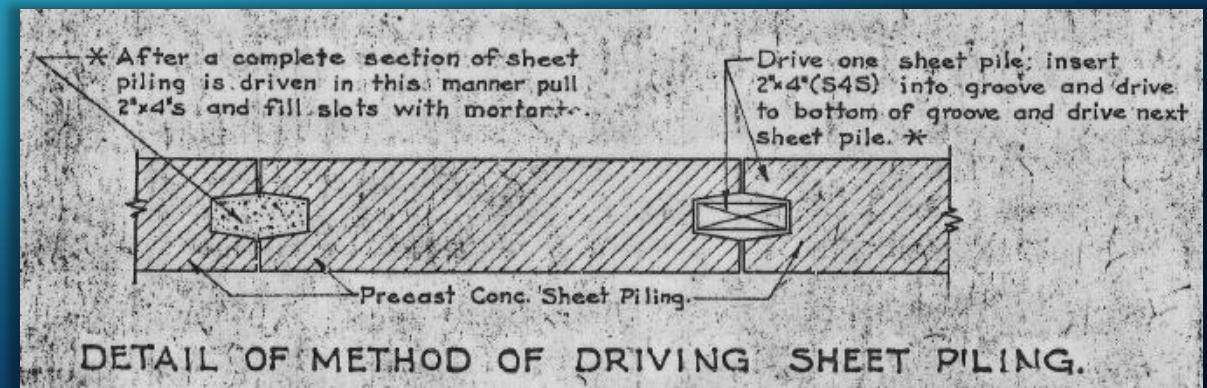
Reinforced Concrete: since 1920's

Images from 1945 (Index 1962) & 1946 (Index 2039) Standards.
Florida State Road Dept. (FDOT)

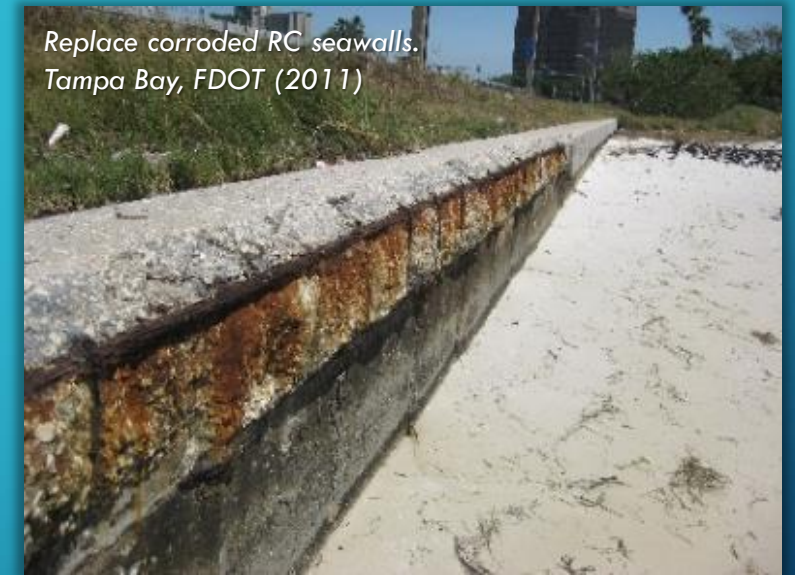
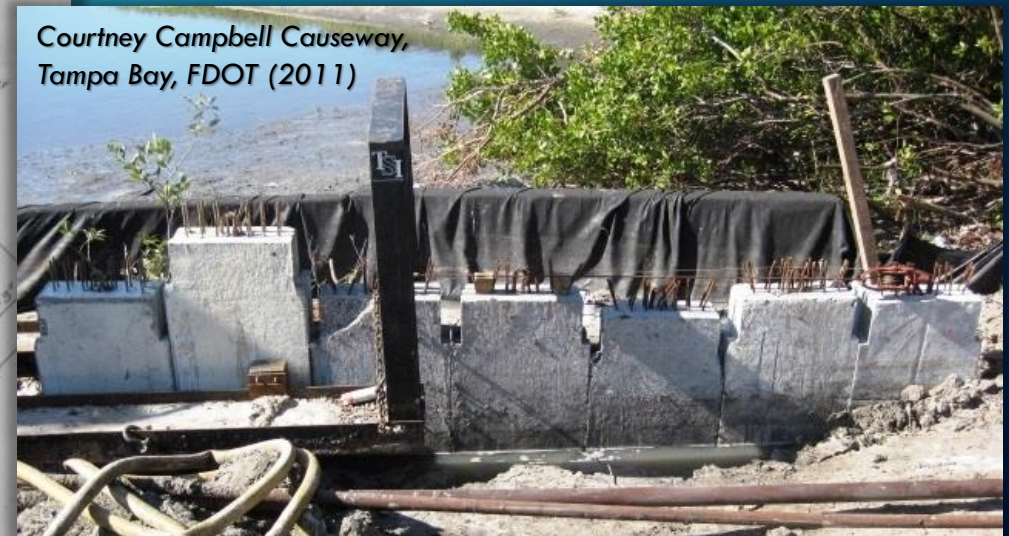
Prestressed Concrete:

- Soldier Piles in the 1950's
- Sheet Piles in the 1970's ...better,

...but still Reinforced Concrete CIP cap!

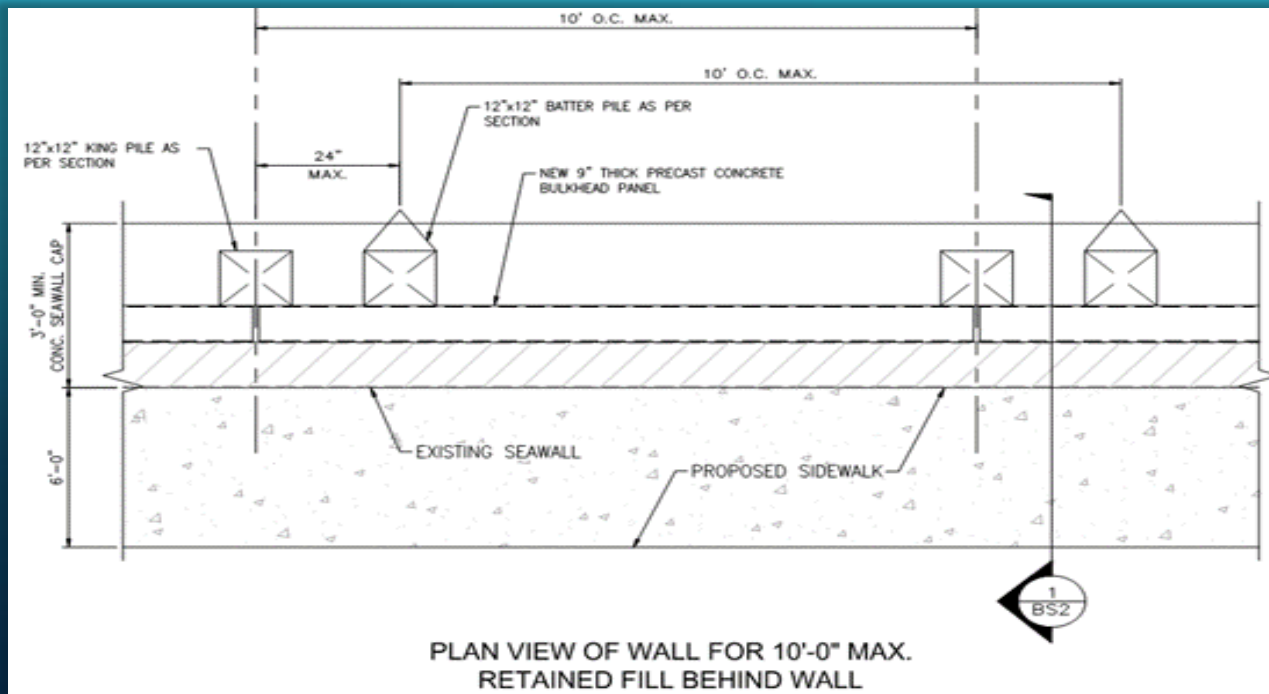
Prestressed Concrete (Miami-Dade):

- Soldier Piles in the 1950's & 60's
- Still using RC panels in between...

...similar durability challenges

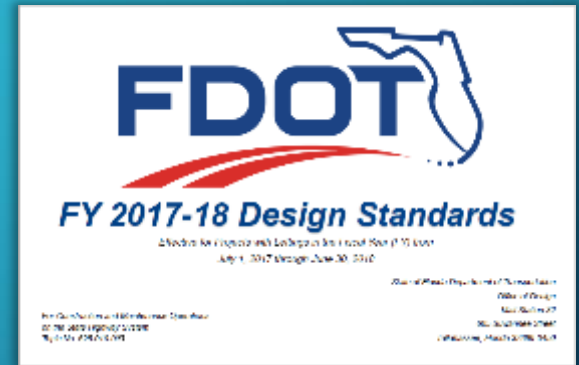
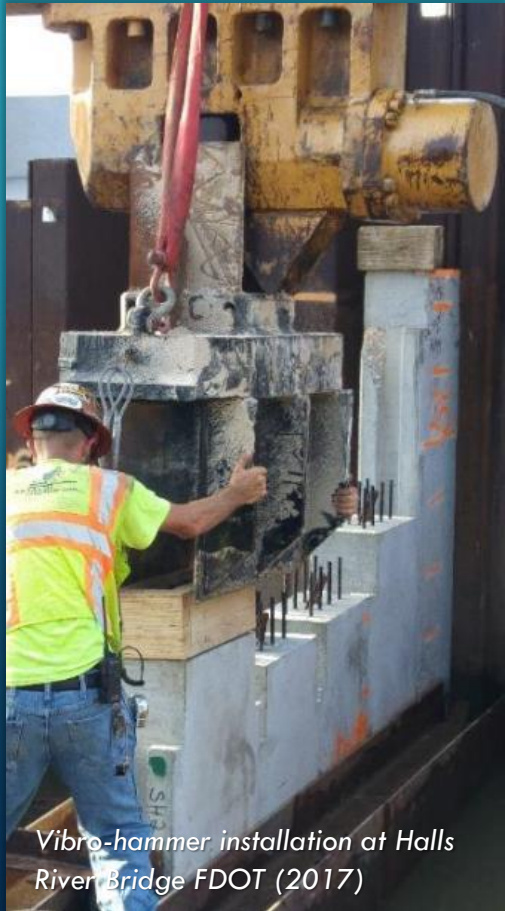
Vibro-hammer installation at Halls River Bridge FDOT (2017)

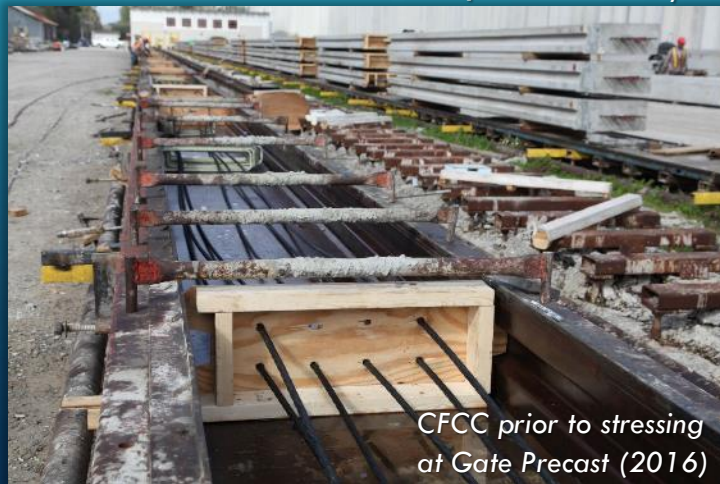
CFCC prior to stressing at Gate Precast (2016)

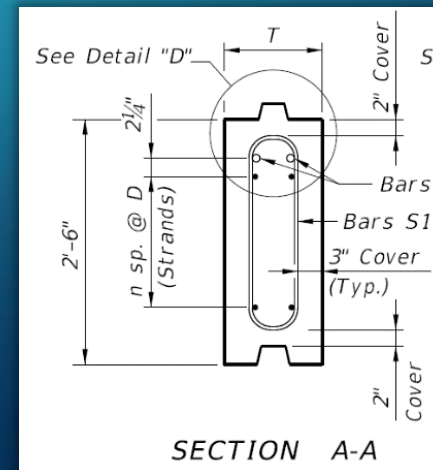
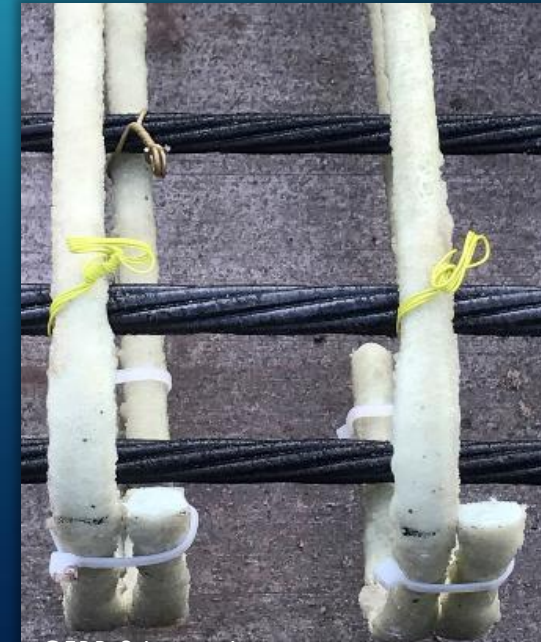
GFRP Stirrups ties to CFRP strands (2016)

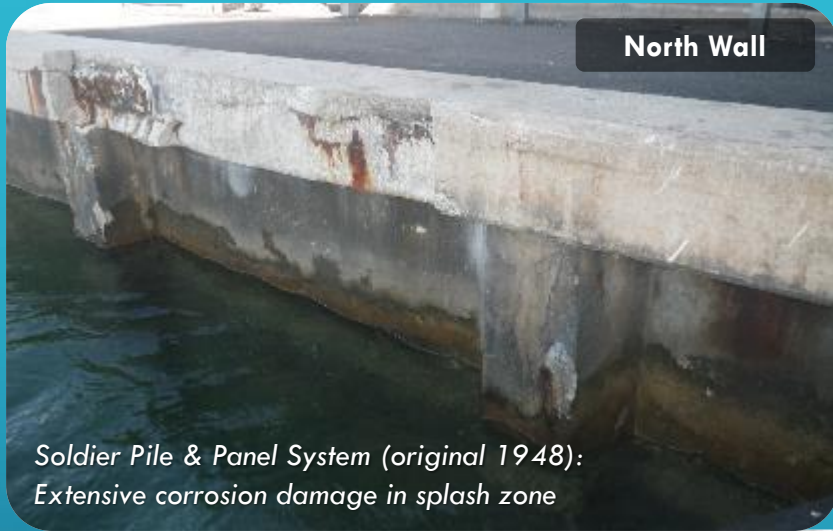
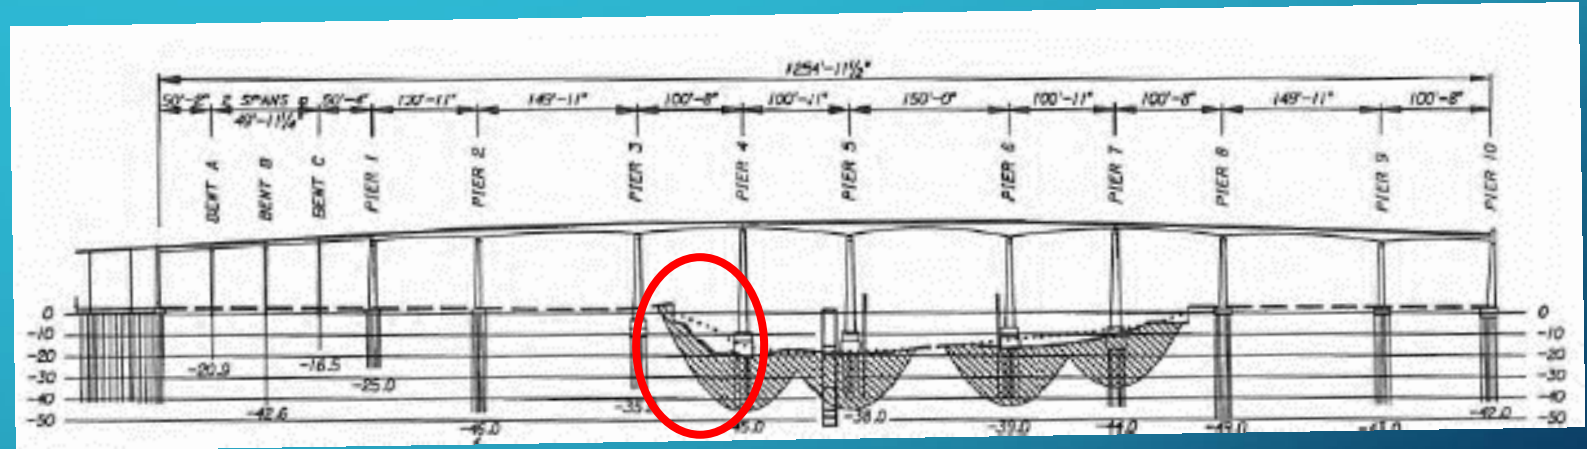
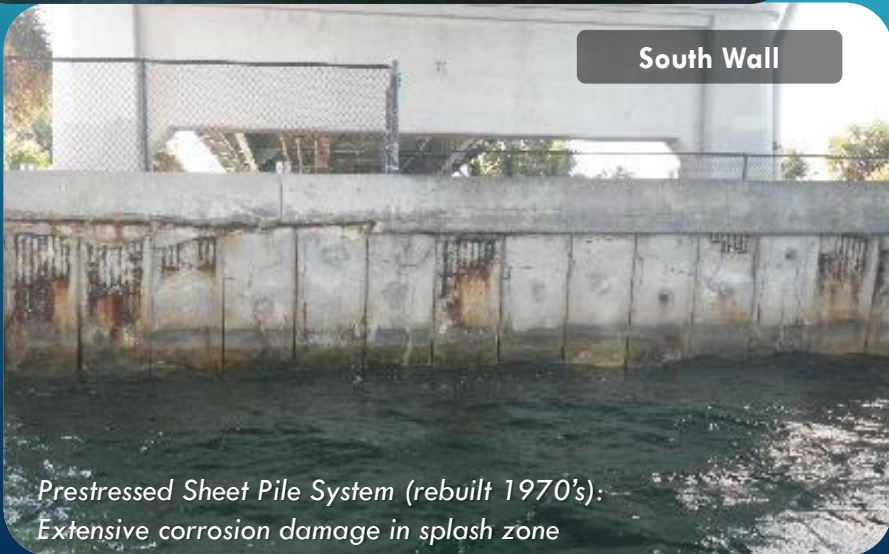
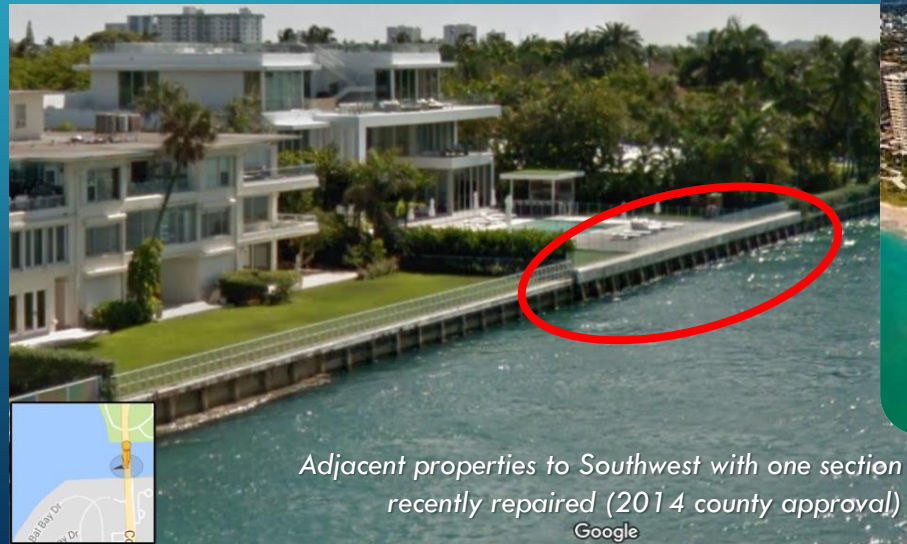
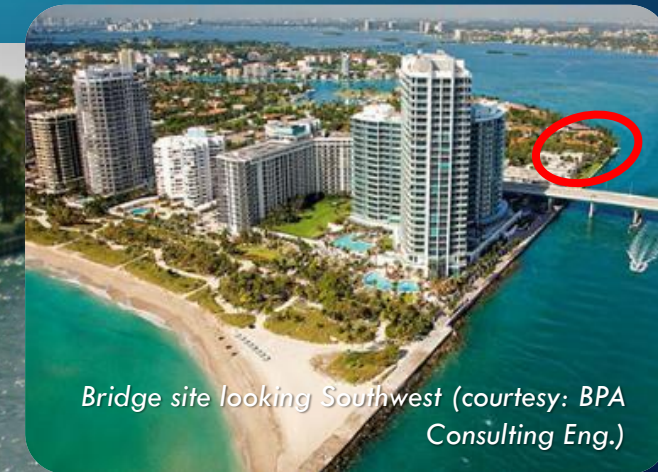
Pile & Panel (north wall) Prestressed Sheet Pile (south wall):

...both in severely corroded condition

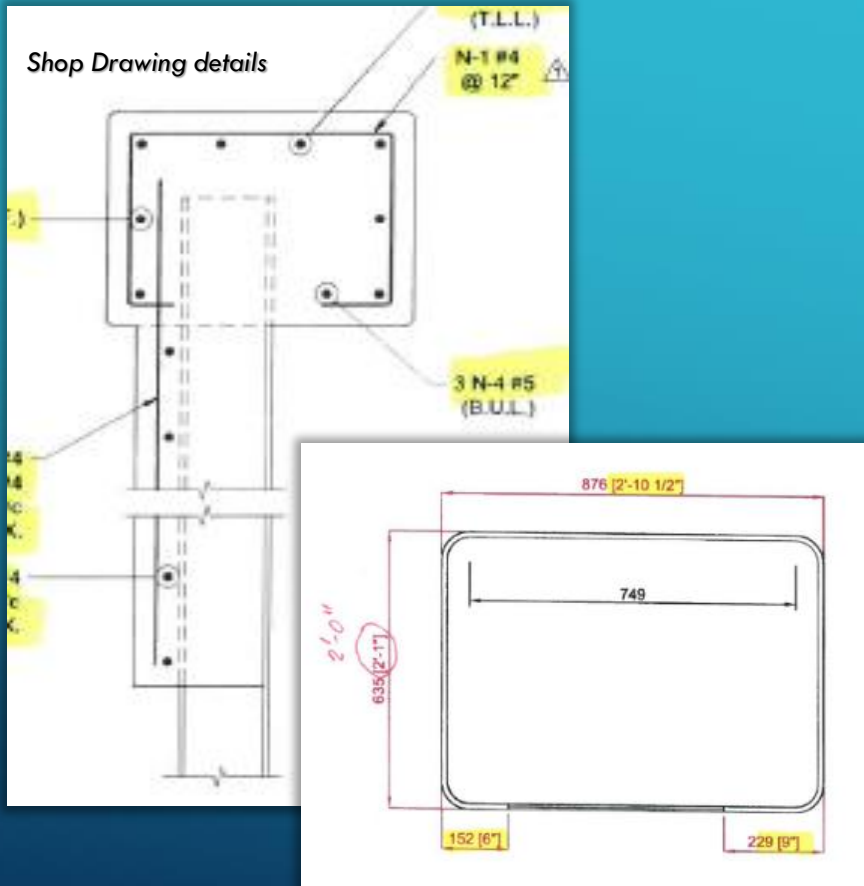
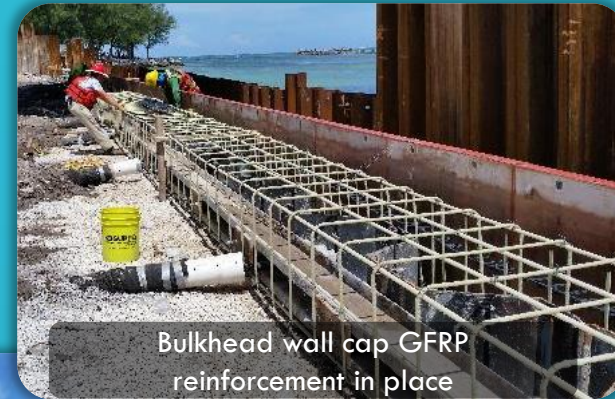
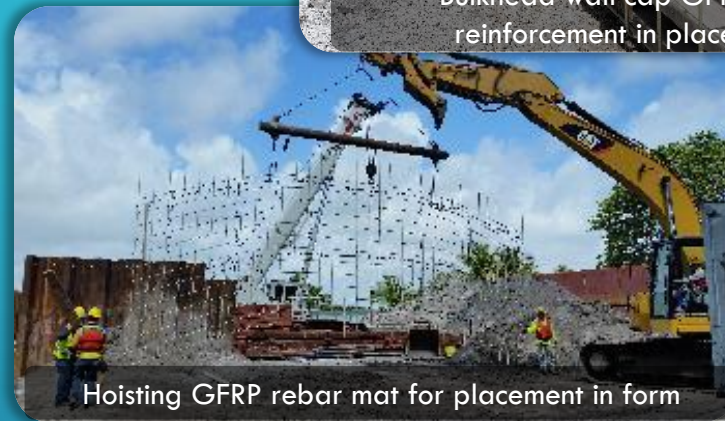
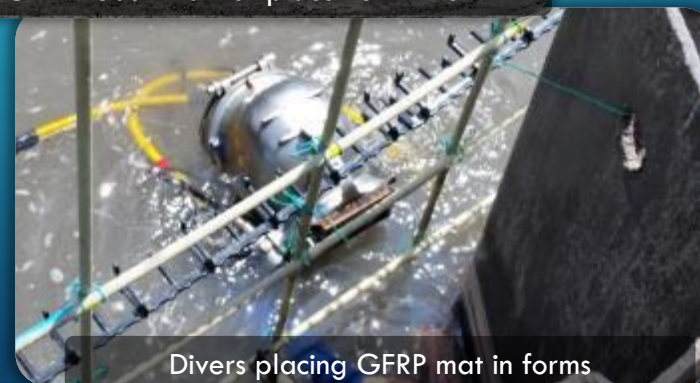
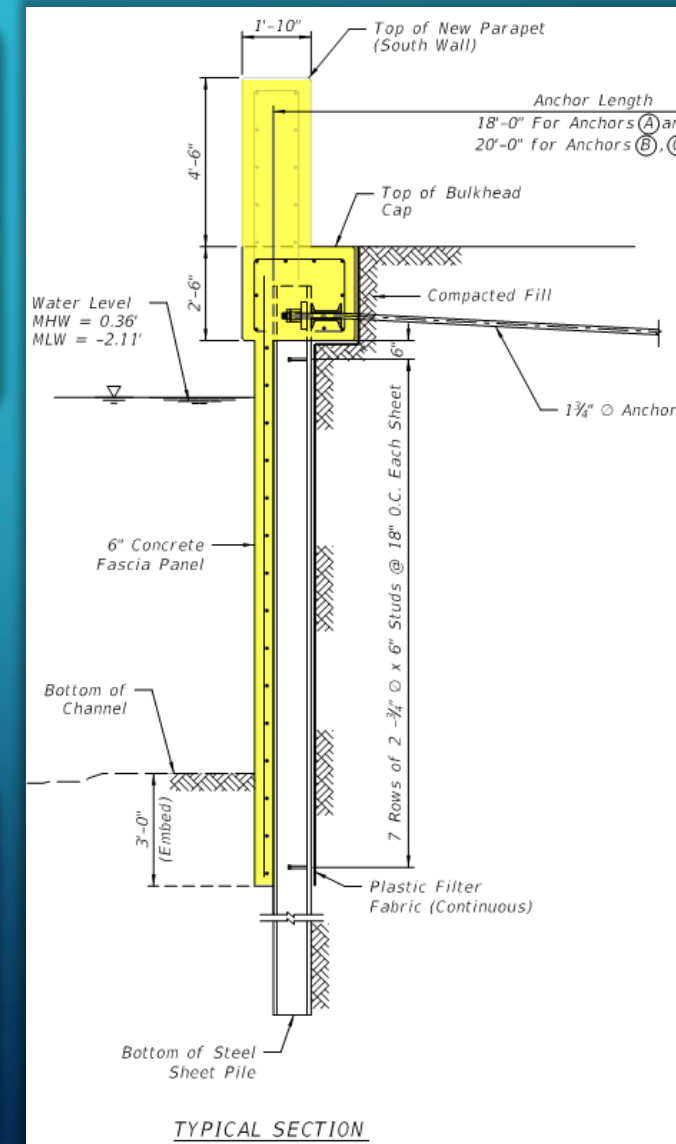
Selected Alternative: ...Steel Sheet Piles with GFRP-RC fascia

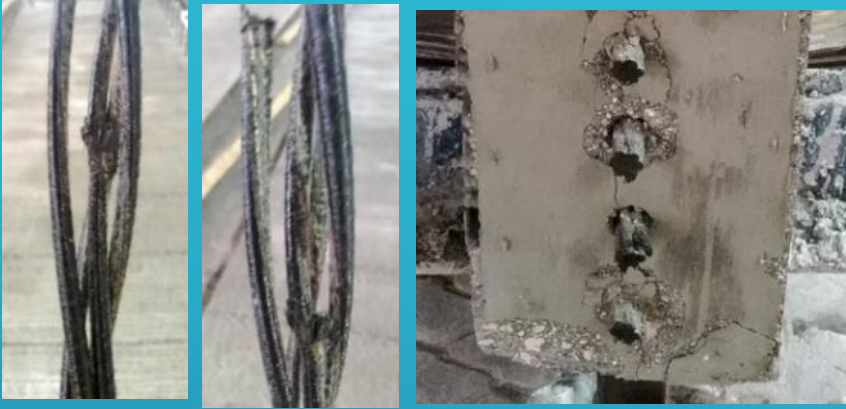
(a) & (b) CFRP strand failed during tensioning;
(c) cracking following strands release.

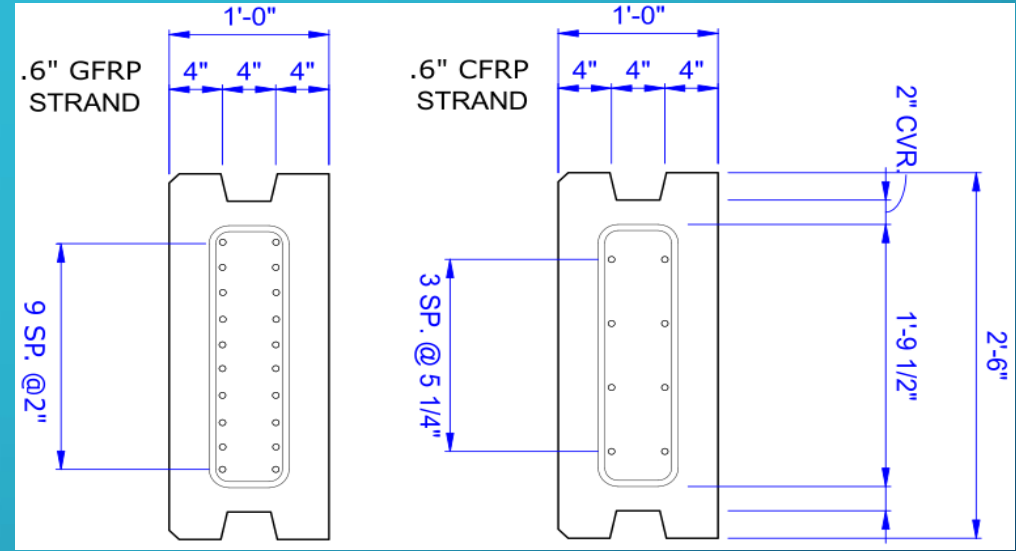
(a) GFRP-PC sheet pile concept (b) CFRP-PC sheet pile design for Halls River Bridge

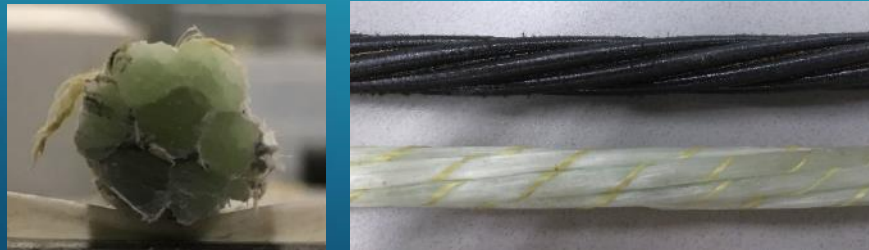
(a) GFRP strand prototype cross section;
(b) compared to a CFRP alternative.

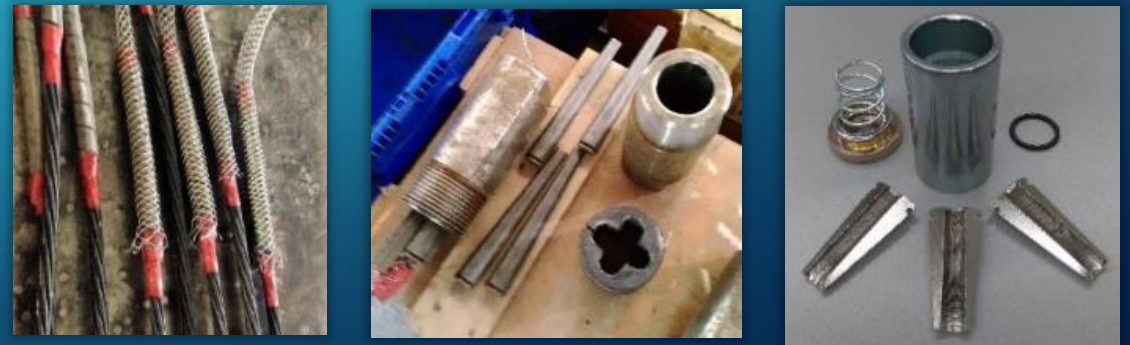
(a) & (b) Tensioning apparatus for CFRP; versus (c) standard steel HSCS chucks, for GFRP.

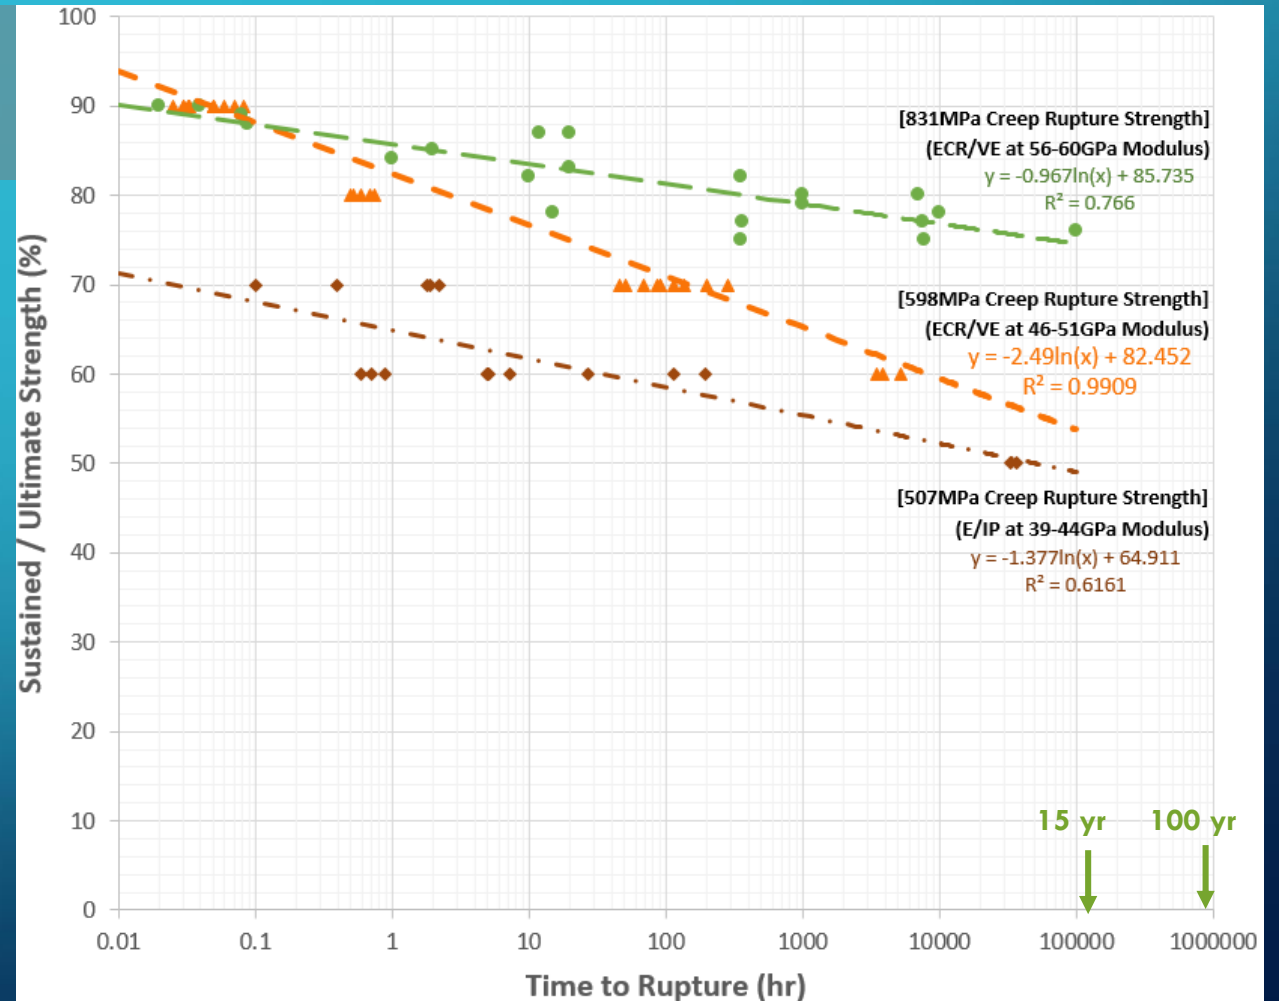
ACI 440.3R B.8 GFRP Creep Rupture Accelerated Testing

1. ACI 440.1R limits the allowable sustained stress for traditional GFRP;
2. Creep rupture limit recently improved $C_C = 0.2$ to 0.3 in AASHTO BDGS-2;
3. ASTM D7957 GFRP rebar of ECR glass fiber in vinyl ester shows improved creep rupture limit.

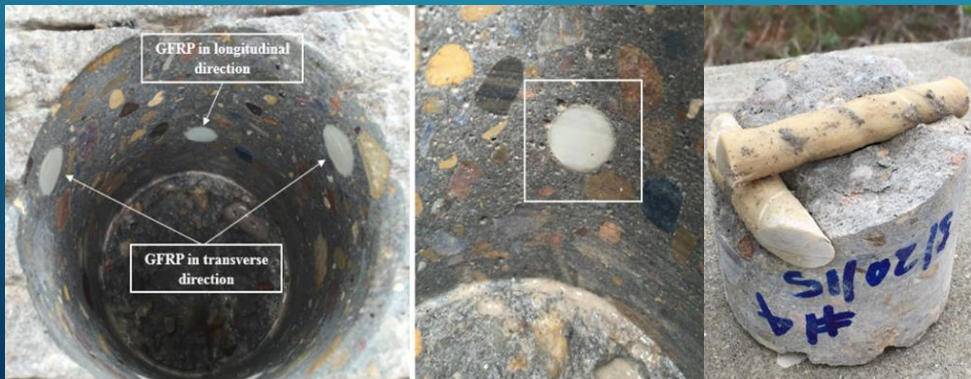
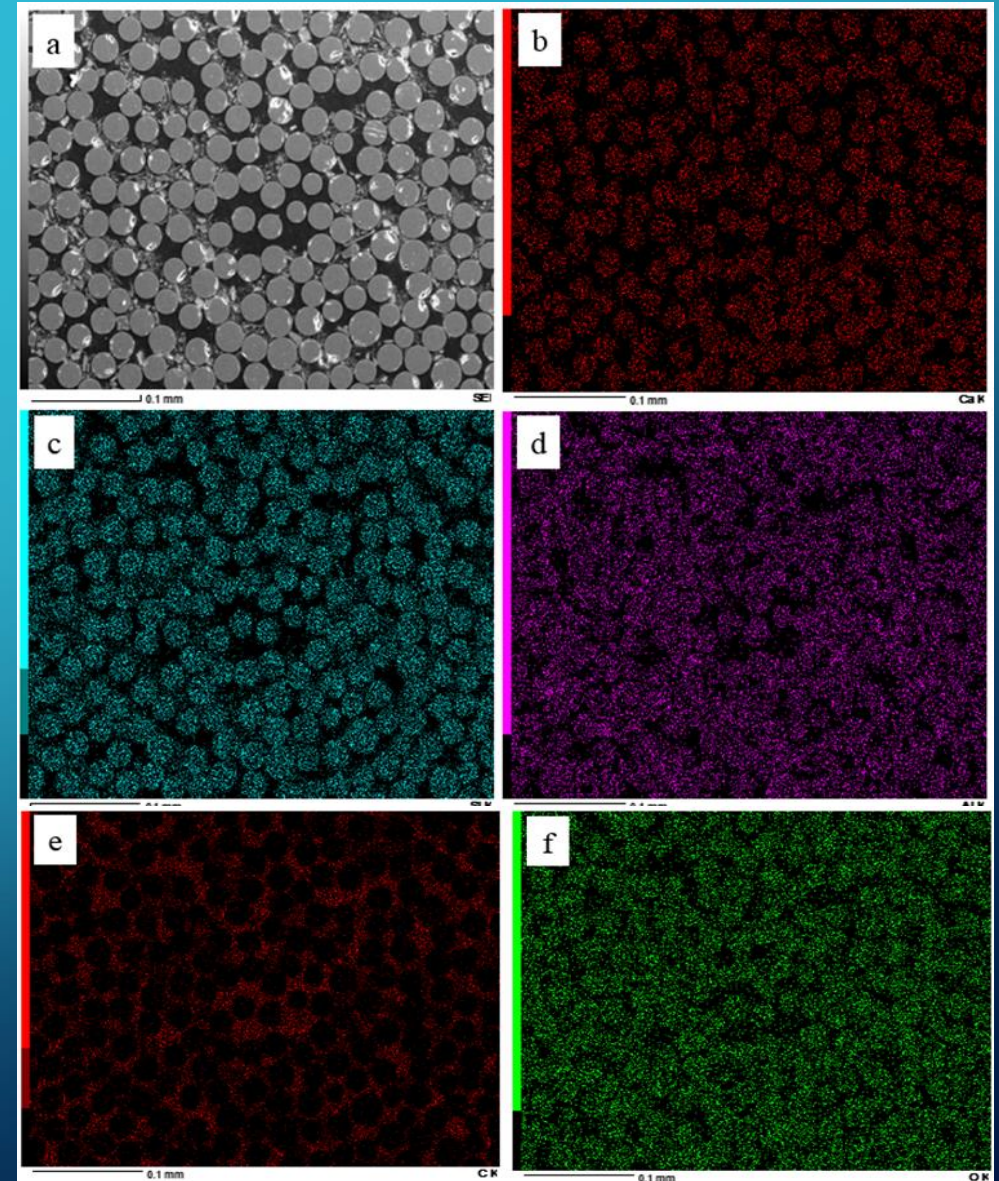
Bridge Core Extraction of 15+ Year GFRP Rebar Samples

1. Negligible impact in mechanical properties and chemical composition of GFRP fiber and matrix SEM/EDX (300x image fiber, Ca, Si, Al, C, O)
2. GFRP rebar durability in corrosive environments better than predicted by accelerated test methods $0.85 C_E$

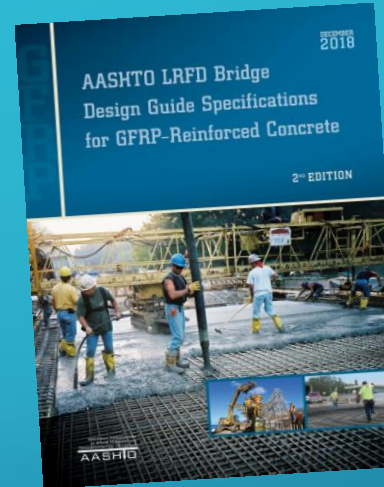
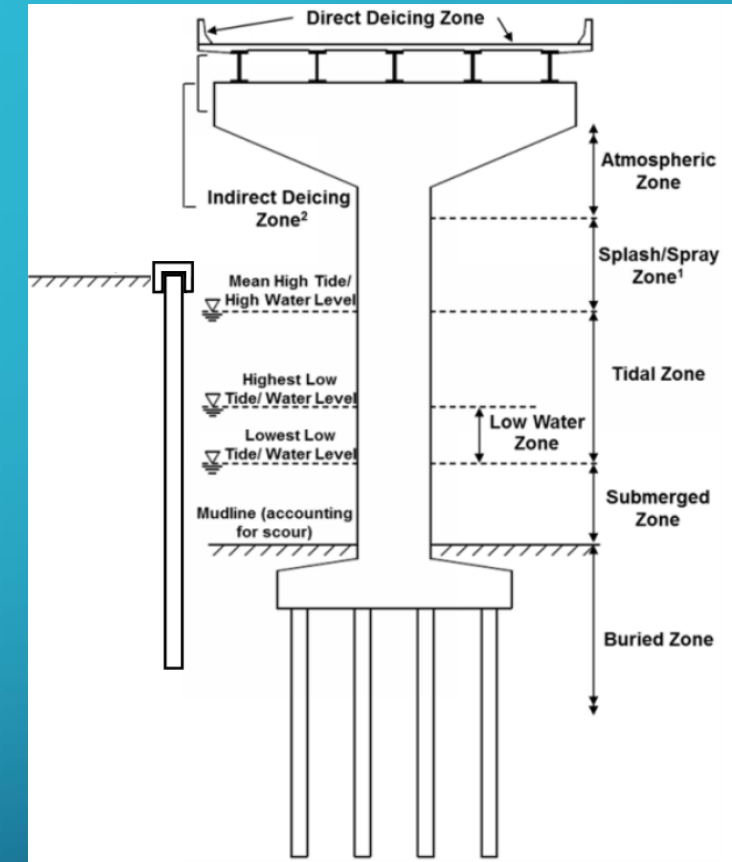
Micro-Exposure Zones proposed under NCHRP Project 12-108 for Service Life Design
