Bakers Haulover Cut Bulkhead Rehabilitation

SR A1A/Collins Avenue over Haulover Cut Bridge
Rehabilitation

Bridge Number: 870071

FPID #: 433378-1

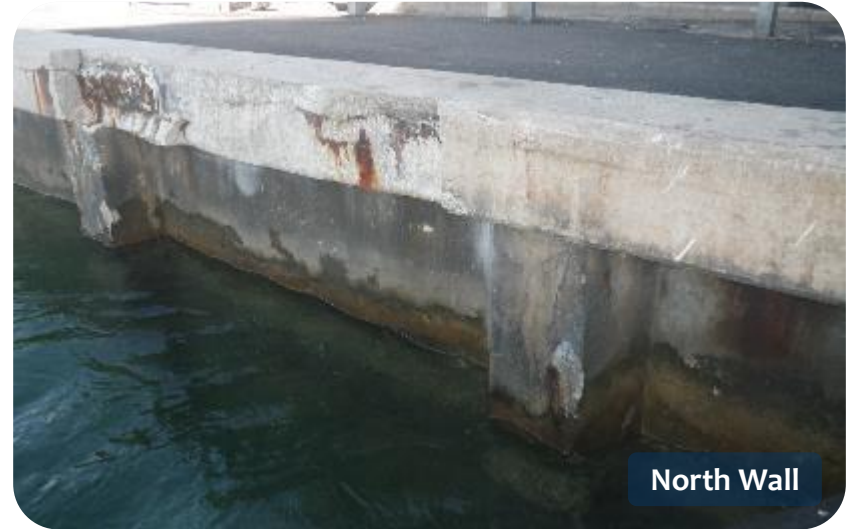
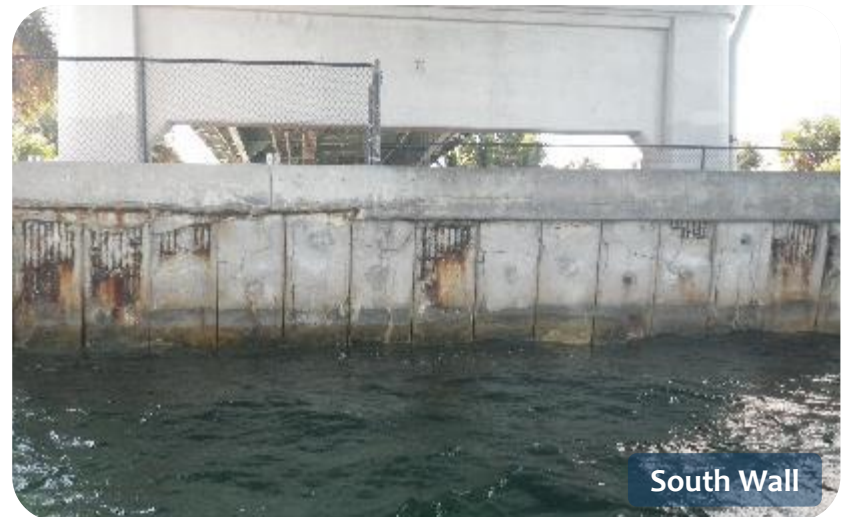
Existing Wall Conditions & Project Purpose:

- North wall built during 1948 construction
- South wall re-built using precast prestressed concrete sheet piles
- Both walls exhibited extensive reinforcement corrosion and are in poor condition

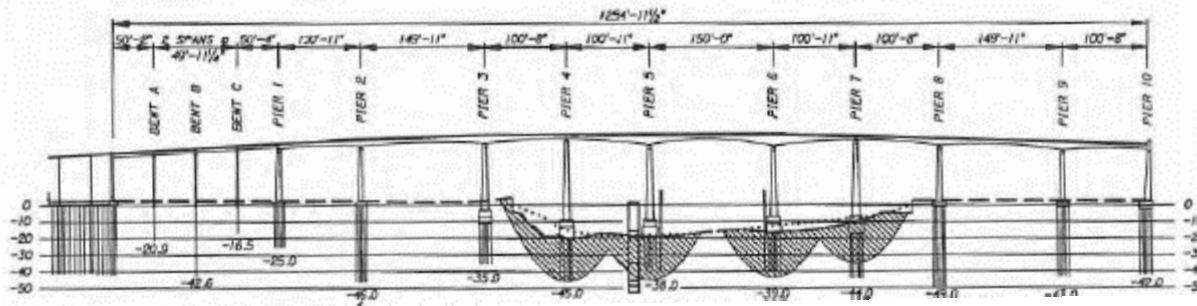
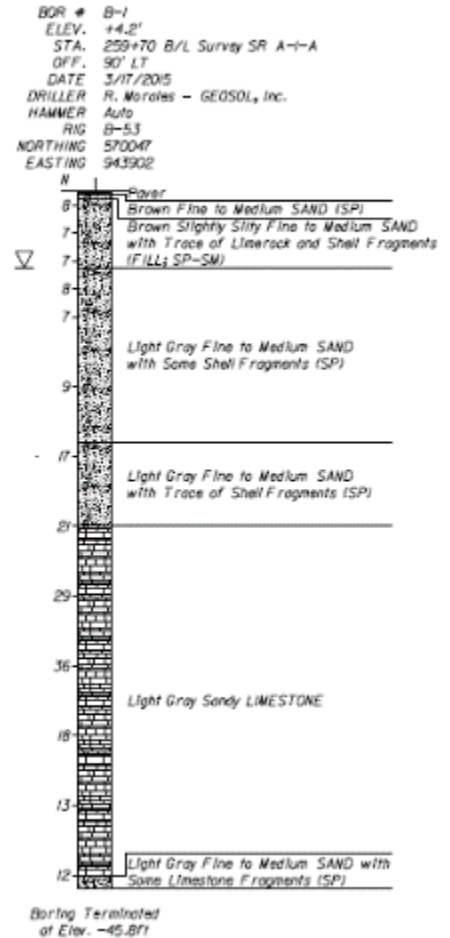
Design Challenges:

- 8' Scour Criteria
- High water velocity in inlet from tide fluctuation

Geotechnical Conditions:

- Weathered limestone rock above minimum tip elevation

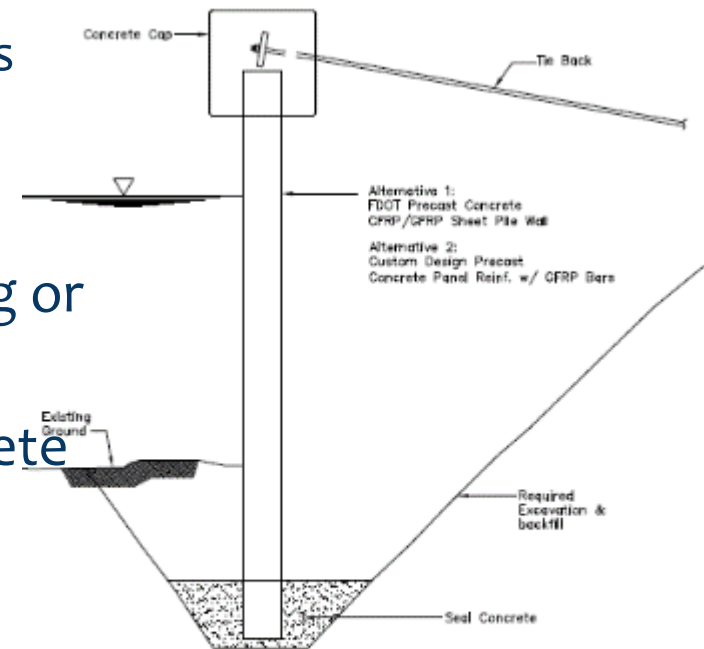
SECTION

Wall Study Alternatives:

- Precast Concrete GFRP Sheet Piles
- Custom Precast Concrete GFRP Panels
- Scour criteria required minimum tip penetration of 17-20 ft.
- Limestone rock layer precluded driving or jetting concrete sheet piles
- Depth of excavation for placing concrete panels was not feasible
- Excavation also lead to environmental permitting concerns

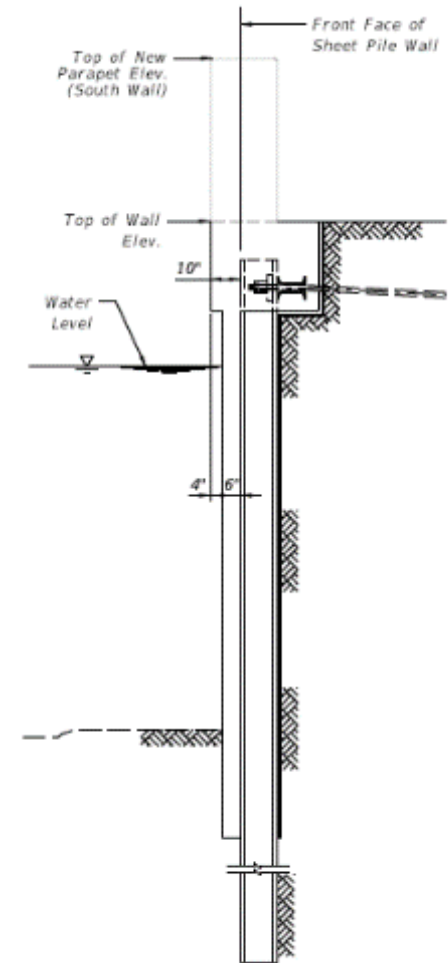
TYPICAL SECTION

Selected Alternative:

- Steel Sheet Piles with Concrete Fascia Panel reinforced with GFRP
- Facilitated driving to minimum tip without excavation
- Facilitated environmental permits
- Concrete fascia panel reinforced with GFRP provided extra layer of corrosion protection to steel sheet piles
- Concrete fascia panels blended well with existing adjacent concrete panel walls

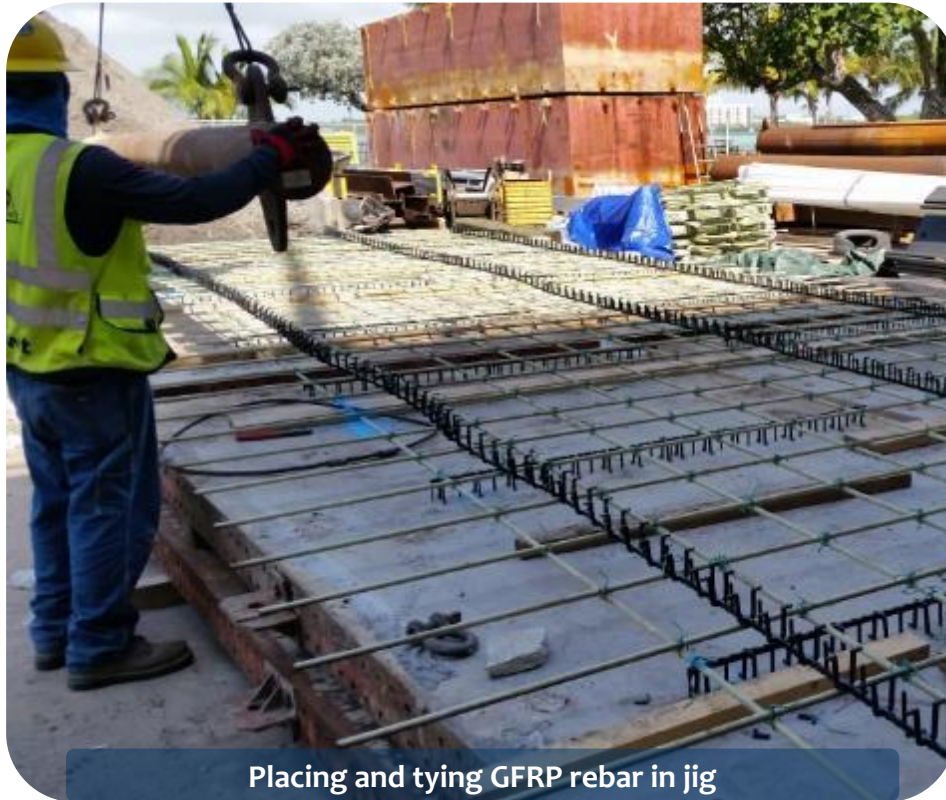
Placing and tying GFRP rebar in jig

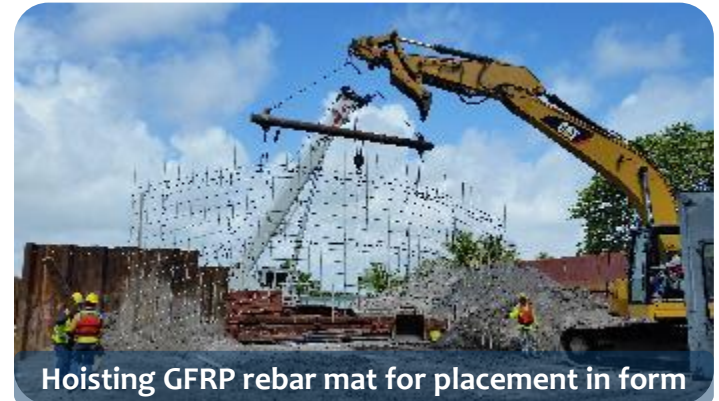
Hoisting GFRP rebar mat for placement in form

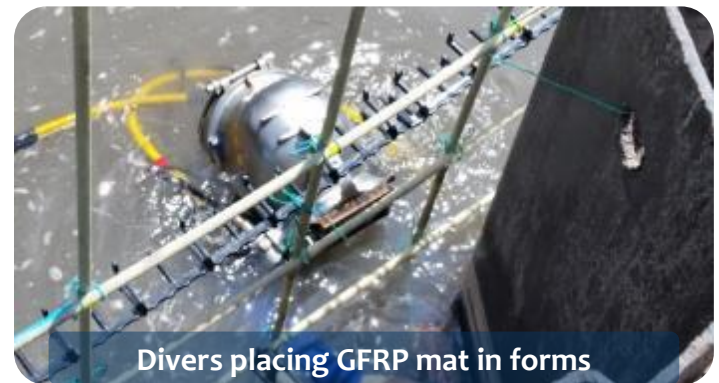
Divers placing GFRP mat in forms

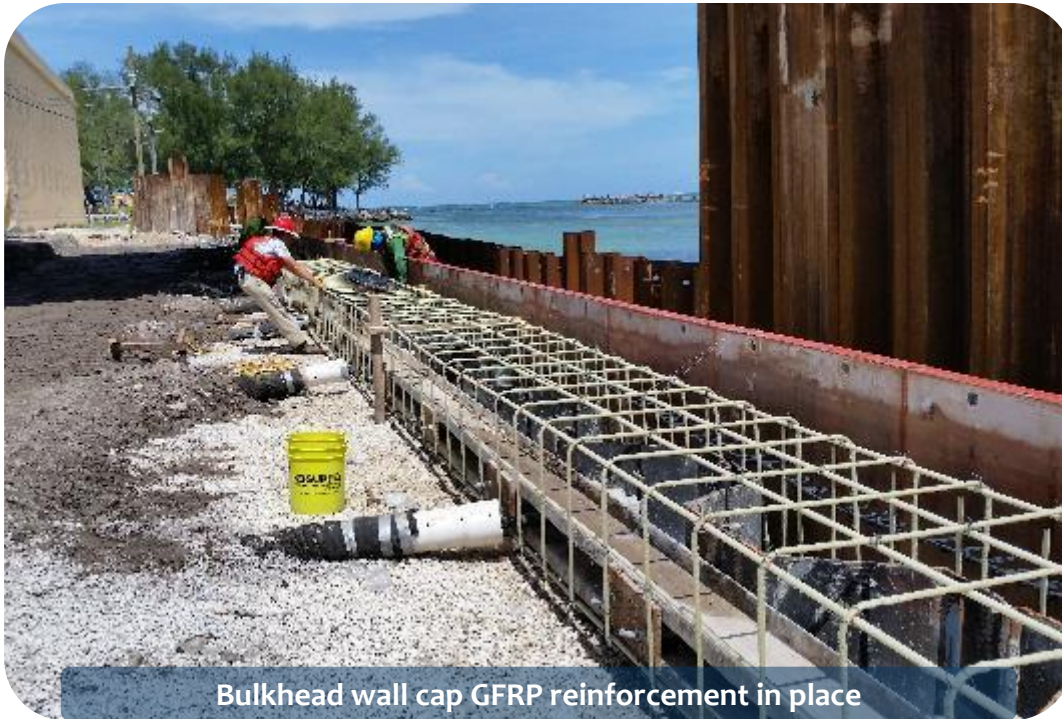
Bulkhead wall cap GFRP reinforcement in place

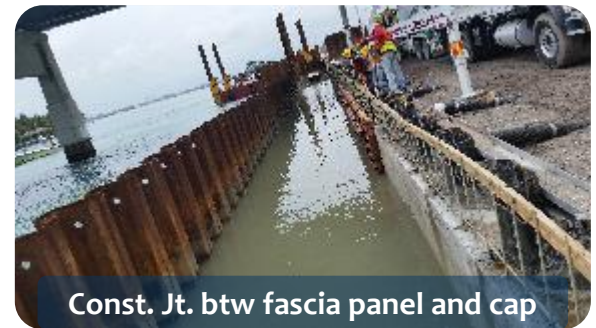
Const. Jt. btw fascia panel and cap

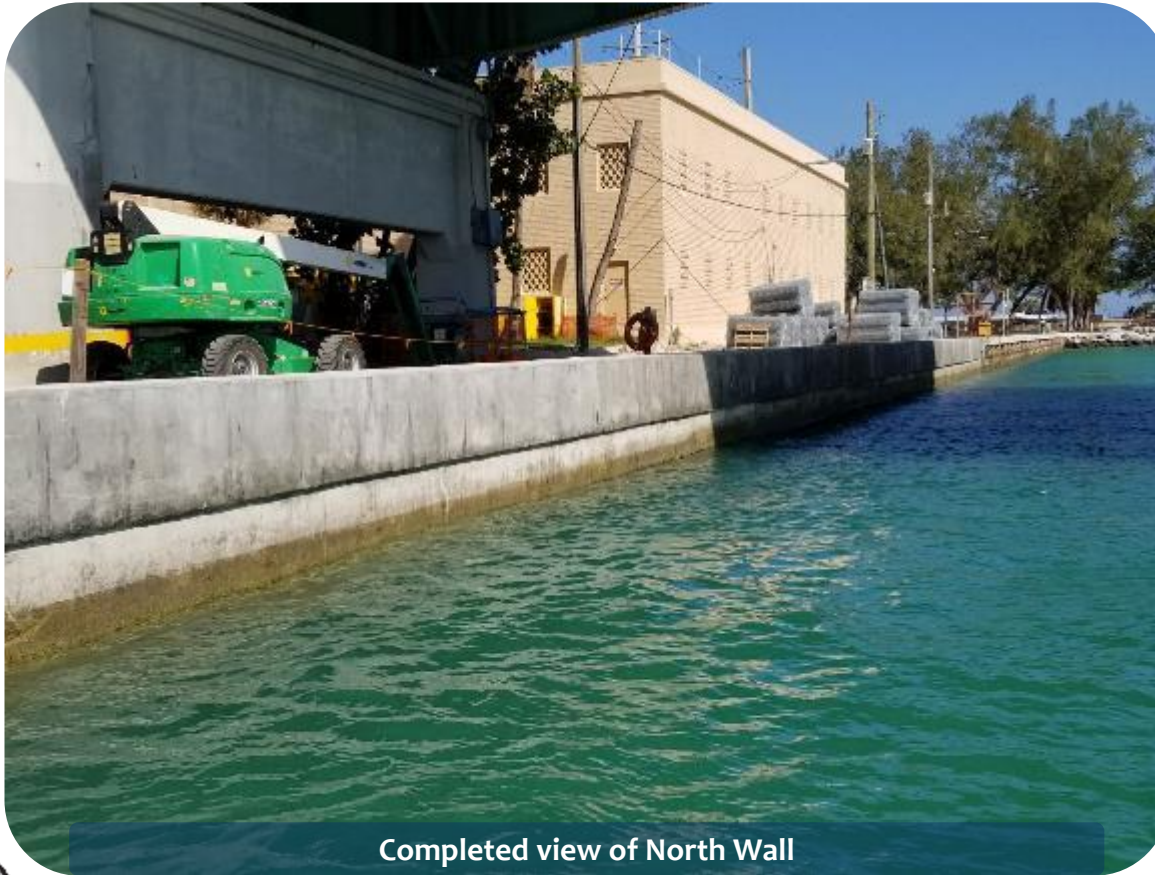
Completed view of North Wall
