# Long Spans with Transportable Precast Prestressed Girders

**Final Report**

**December 2013**

Florida Department of Transportation (FDOT)

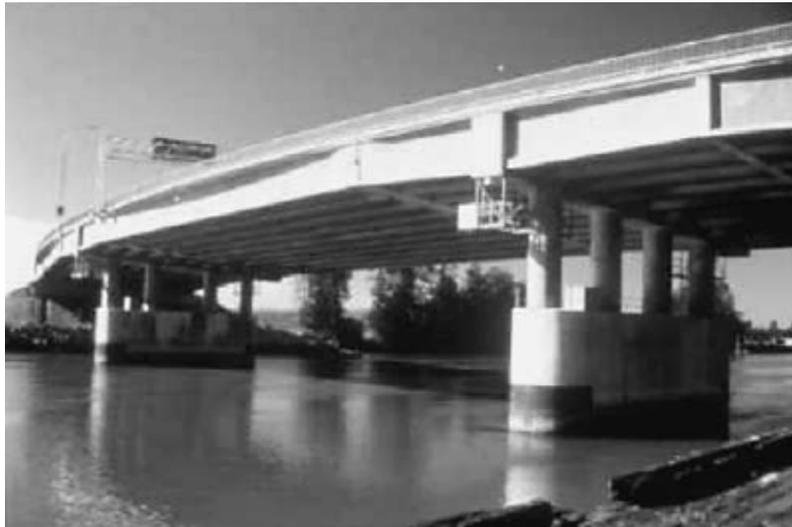
Figure 2–Curved roadway constructed with spliced girders (Abdel-Karim and Tadros 1992b)

One significant benefit of spliced long-span precast concrete girders is their ability to accommodate curved alignments (Figure 2). When a curve in the roadway is required, the splice location can be situated in order to provide a point of curvature between short segment lengths (PCI 2004). Similarly, spliced segments can be arranged such that the placement of the piers avoids obstacles on the ground, such as railroad tracks, utilities or other roadways (Castrodale and White 2004). Because the designer has more flexibility when specifying span lengths and locations of piers, spliced construction allows the placement of piers and spans as necessary for the geometry of the road (Weigel et al. 2003; PCI 2004).

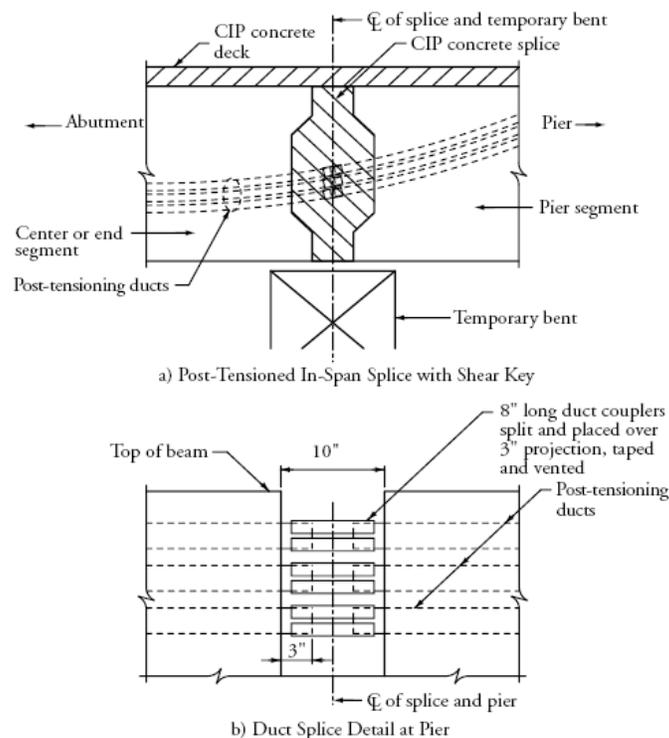
Figure 4—Post-tensioned CIP splice (PCI 2004)

Several issues must be considered when employing a post-tensioned cast-in-place splice. Frequently, standard I-girder sections must be modified to provide enough space for the PT duct, longitudinal reinforcement, shear stirrups, and code-mandated concrete cover; Florida bulb-tees with modified webs are commonly used in precast, prestressed spliced I-girder spans (Abdel-Karim and Tadros 1992; Ronald 2001). Accurate alignment of the PT duct is important to reduce the prestress losses caused by friction. Rotation of the ends must be controlled by design to limit camber. Care must be taken not to damage the post-tensioning duct during erection; a damaged PT duct cannot be properly grouted. Without fully grouted tendons, the splice may incur additional prestress losses due to friction and may have reduced durability over its lifespan (FDOT 2004). Furthermore, care must be taken to completely seal the coupling zone and PT duct to prevent leakage of the post-tensioning grout and corrosion of the reinforcing steel (PCI 2004; FDOT 2004).

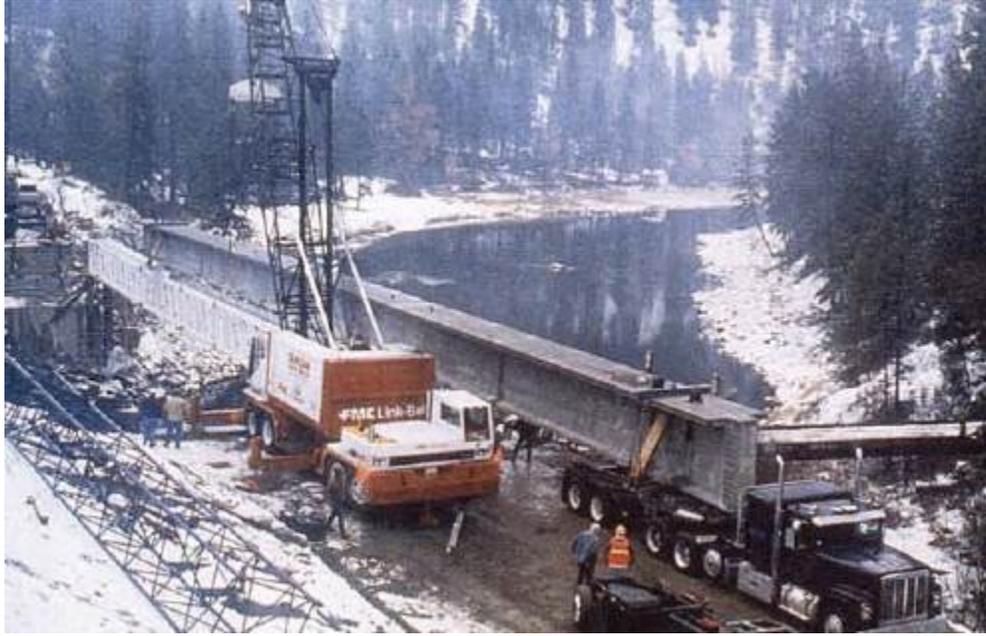
Figure 9—Launching assembled girder using trolley (Nicholls and Prussack 1997)

If the weight of an assembled girder is excessive, or if site conditions do not allow the girder to be lifted, the entire girder assembly may be loading onto a rolling trolley and moved laterally into place along a rail on an adjacent temporary structure. After sliding the girder onto the temporary support, two cranes, one on each end of the span, can then place the girder over the supports. An example of this procedure, as done during the construction of Rock Cut Bridge, is shown in Figure 9 (Nicholls and Prussack 1997; Joint PCI-PTI Committee 1982). For more details, see Nicholls and Prussack, 1997.

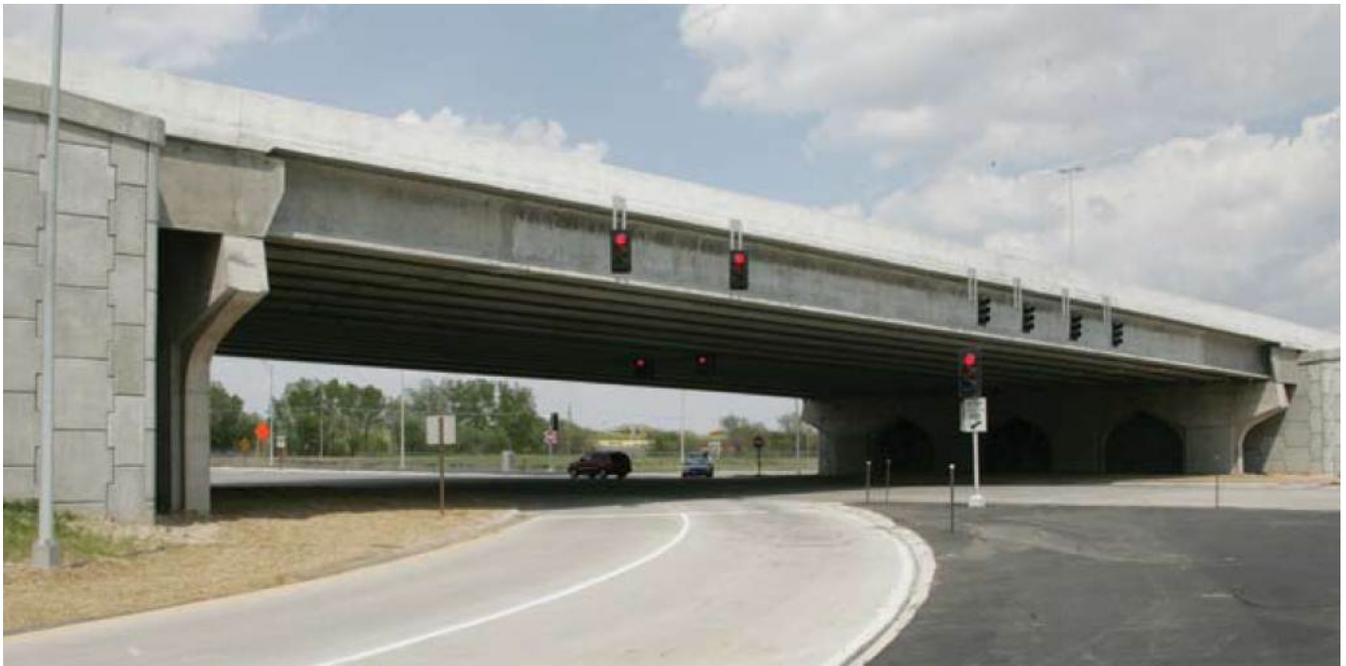
Figure 12–204th Street Bridge (Jaber et al. 2006)

The design of the 204<sup>th</sup> Street Bridge (Figure 12) is the closest example of the system type targeted by this research. The simple-span single point interchange, as described by Jaber et al. (2006), consisted of 14 girder lines constructed as two structures (for each lane of traffic). Two short end segments were bridged together with a long center segment to span a total of 207 ft.

Splicing of the segments was completed mid-air, using temporary towers to provide support at the joint. The authors describe as one of the most challenging design aspects the determination of the girder elevations at the splice locations so as to provide a smooth riding surface and to prevent sag in the girder-soffit profile. Screw jacks were used to refine the girder elevation as required. The precast concrete girders were spliced together with a cast-in-place joint, aligning the post-tensioning ducts running through each segment. After the closure pour reached the specified strength, the assembled precast girder system was post-tensioned along its entire length. (Jaber et al. 2006).

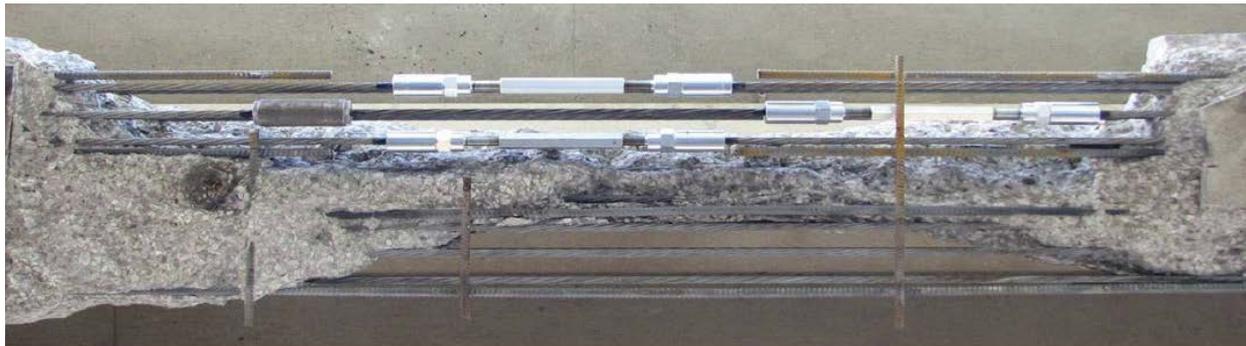
Figure 15–Repair of severed strand using a coupler (Ministry of Transportation of Ontario 2011)

used to repair bridges in several states. No problems have been reported post-repair (Waheed et al. 2005; Johnson 2011). Figure 15 shows a damaged girder in Ontario that was rehabilitated with couplers (Ministry of Transportation of Ontario 2011).

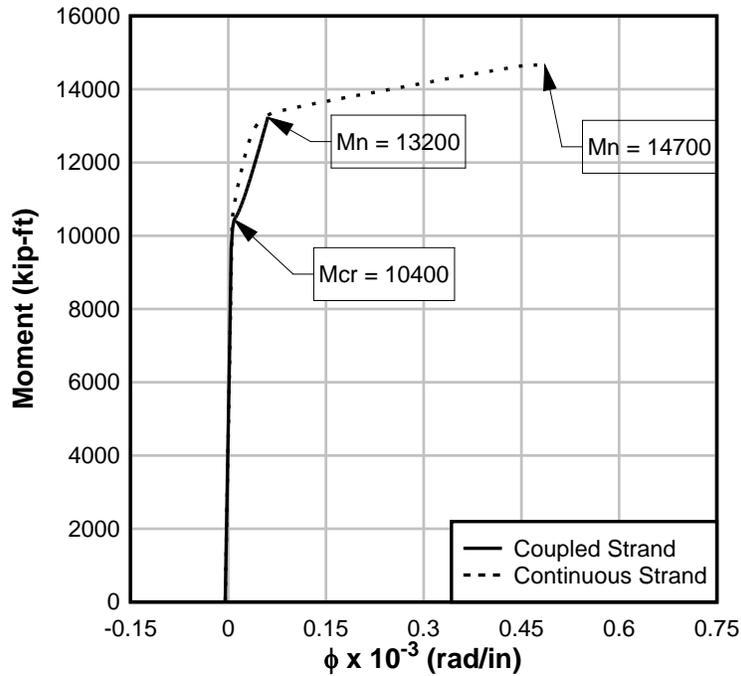
Figure 21–Moment-curvature of FIB96: continuous strand vs. coupled strand

Another important aspect of the splice design that is not explicitly covered in the AASHTO-LRFD is the flexural ductility of the section. Because the strands will be mechanically coupled at the beam splice, the flexural ductility of the section at that location will depend on the stiffness and seating movement of the strand couplers. To evaluate the ductility the beam splice, moment-curvature analysis was conducted considering the effect of the strand couplers on ductility. The coupler stress-strain model (established with testing reported in Chapter 4) was utilized to assess the cross-section with 31 strands coupled using a 0.6-in. dia. coupler (Figure 21). The Ramberg-Osgood model was used to analyze the cross-section as if the strands were continuous across the splice, without any coupling device (Collins and Mitchell 1991).

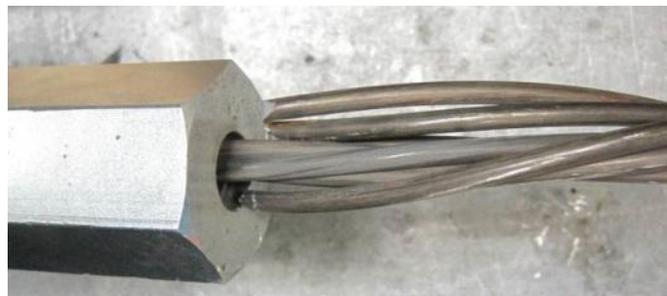
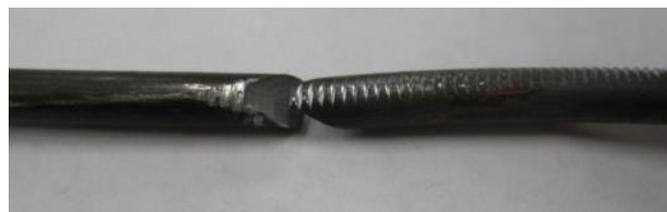
Figure 25–Rupture of strand in 0.6-in. dia. coupler

Two tension tests were conducted on the 0.6-in. dia. couplers to be used in the proposed splice design. The first test was performed at the FDOT State Materials Office (Figure 24). In this test, the coupler was used to splice two lengths of 0.6-in. dia. 270 ksi lo-lax prestressing strand. One end of each strand was prepared with white glue and fine sand prior to the test, in accordance with ASTM A1061; the sand-prepared end was gripped by the wedge grips of the test machine (ASTM A1061 2009). Load was applied at a displacement-controlled rate of approximately 0.2 in./min. The test ended when the strand ruptured near the top wedge of the coupler device (Figure 25(a)) at an applied tensile load of 53.6 kip, or 91% of the strand's specified ultimate strength. At rupture, the prestressing strand stress was 247 ksi; though near the proportional limit of lo-lax strand, the stress-strain plot of the coupled device shows that the prestressing strand did not exceed this point, and did not begin to yield prior to rupture. The strand ruptured at notches caused by the wedges (Figure 25(b)).

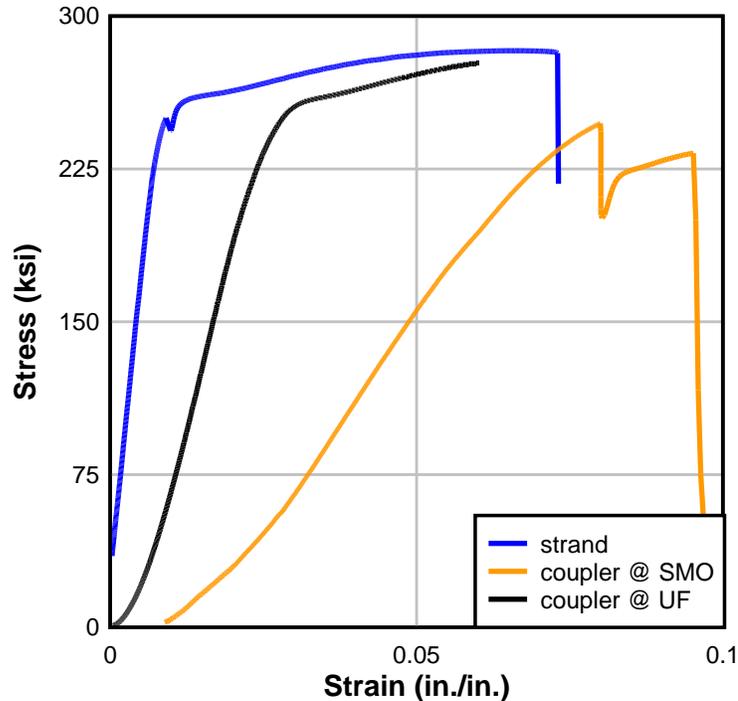
Figure 27—Comparison of 0.6-in. dia. coupler and strand behavior

Figure 27 shows the stress-strain plot for the two tensile tests of the coupler with strand. Also shown is the stress-strain plot for just the strand (uncoupled), tested per ASTM A1061 (2009).

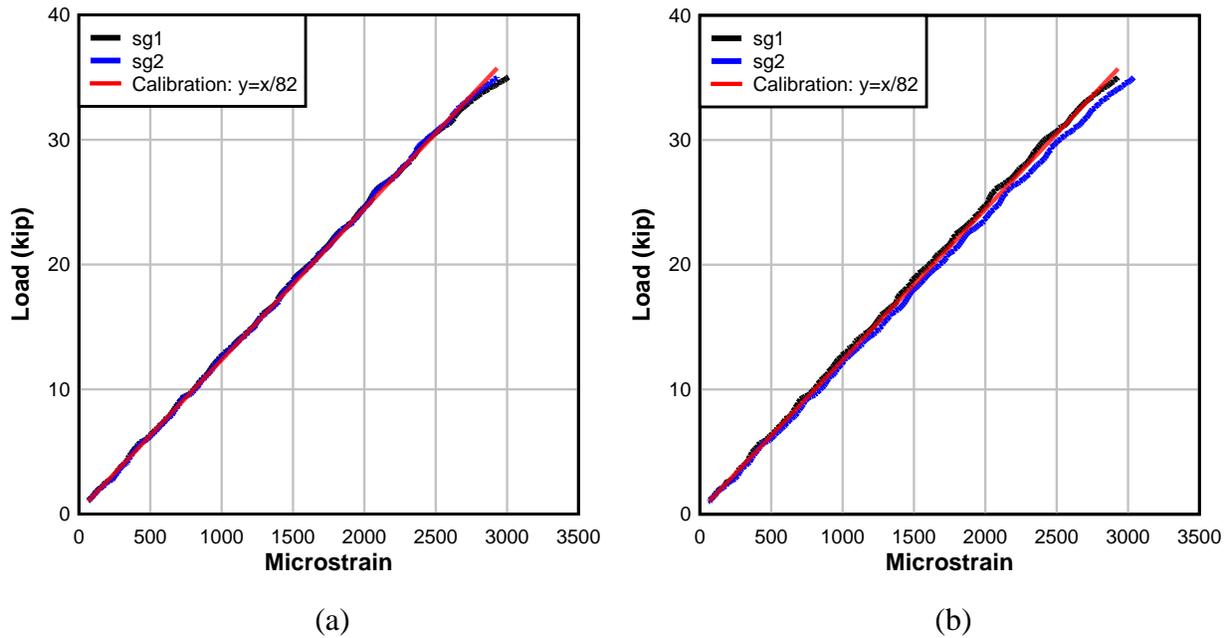
Figure 30–Coupler strain gage calibration (a) specimen 1 and (b) specimen 2

indicate that the coupler was behaving linear-elastically at the tested load range. Also shown in the plot is the approximate linear curve-fit used to relate the coupler strain to an applied tensile load. This relationship was used in later data analysis to relate measured strain in the coupler to strand load.

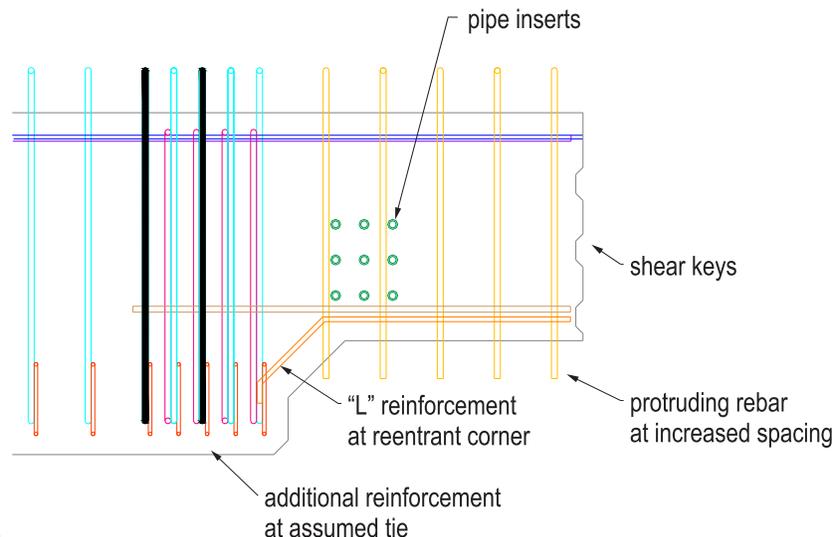
Figure 33–Detailing considerations

Special detailing was included the segments to be spliced to accommodate personnel during the splice assembly, to prevent cracking, and to provide additional strength capacity. Special detailing for the joint area included shear keys, additional rebar around the notched area of the bonded segment, and special stirrups. Additionally, the geometry of the splice area was also considered. This section covers these detailing considerations. Figure 33 shows the key detailing considerations of the joint area.

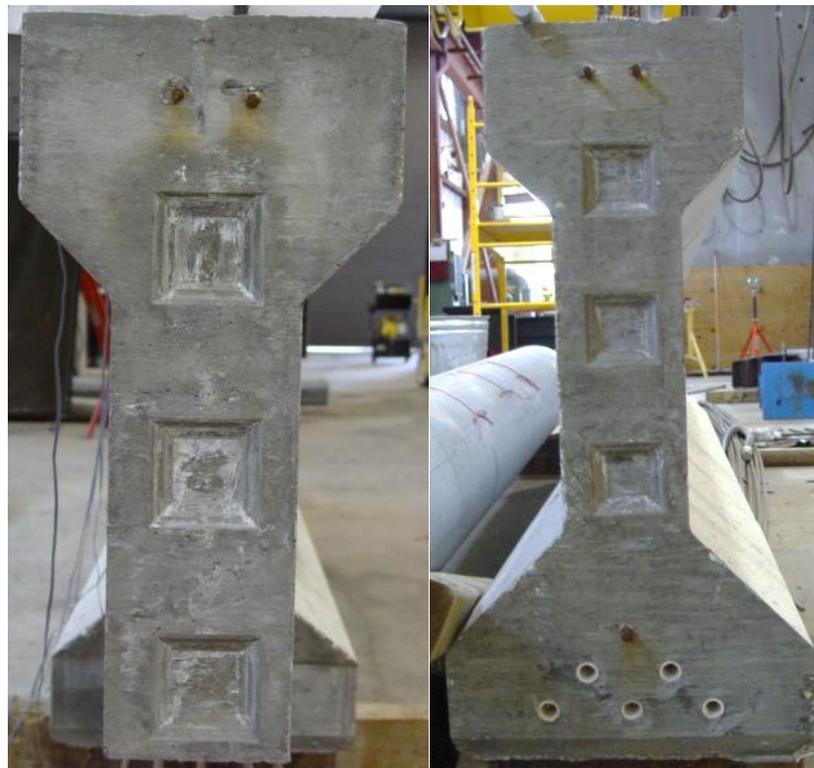
Figure 35–Shear keys in test specimen

Shear keys were detailed on the to be spliced ends of both the bonded and unbonded segments, to provide mechanical interlock to increase the shear capacity of the interface between the precast concrete and the closure pour concrete. The shear keys are shown in Figure 35. Design recommendations are provided by AASHTO-LRFD (2007) regarding the geometry of shear keys; these recommendations are dependent on the size of the aggregate and the width of the web and were considered for the determination of the shear key dimensions (Figure 11). Dimensions are given in Appendix D–Precast Fabrication Drawings.

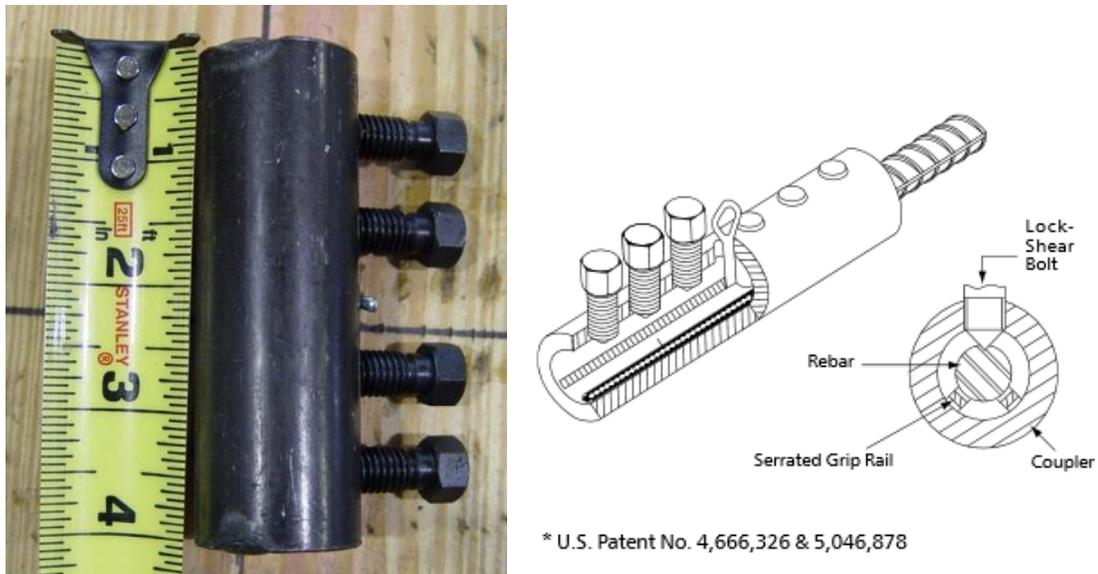
Figure 36–Rebar coupler

The selected rebar coupler is a commercially available product which does not require preparation of the rebar. It mechanically connects two pieces of rebar, using a series of screws to engage each rebar piece. Serrated guide rails within the coupler provide additional mechanical grip. A cotter pin serves to set the length of each rebar within the coupler. The rebar coupler is shown in Figure 36.

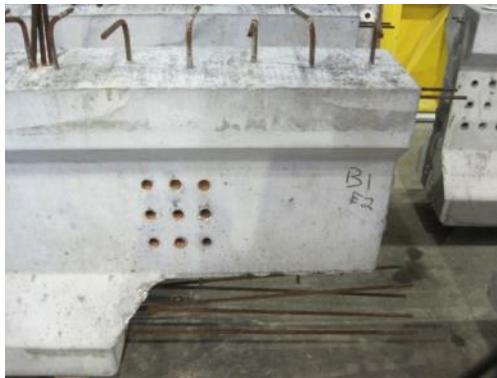
Prestressing strand protruding from the bonded segment was detailed to extend into the coped area approximately 26 in., in order to ensure adequate length for later strand splicing. The strand was protected during the precasting and storage by the wooden block-out.

Figure 37–Protruding strand

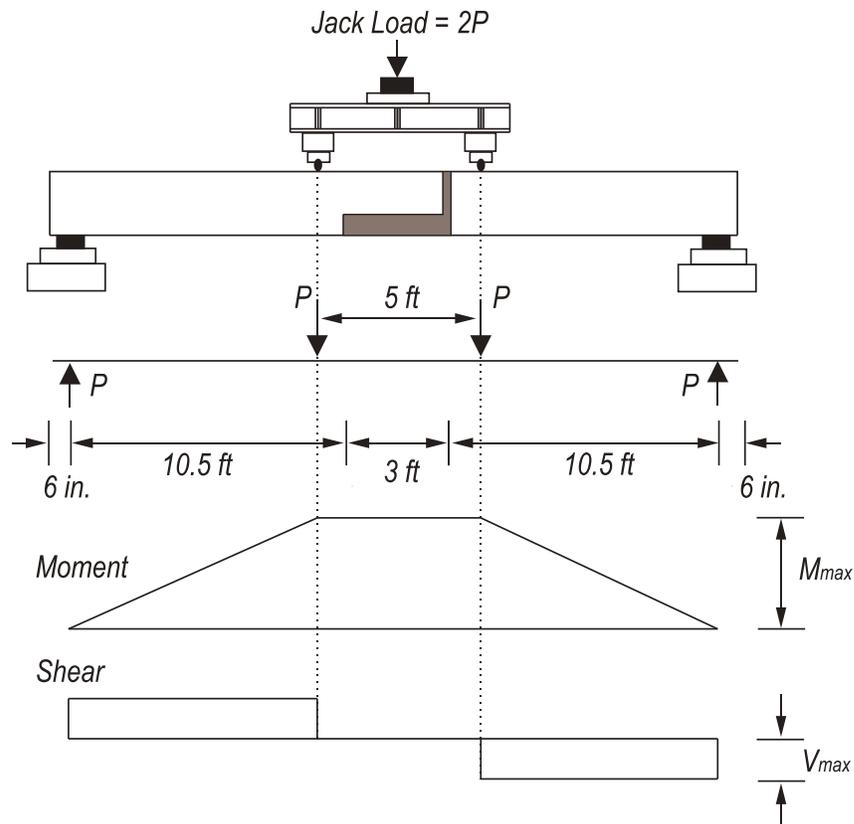
Figure 38–Flexure test set-up

A four-point bending set-up, with the splice region encompassed in the constant moment region, was chosen to investigate the flexural behavior of the test specimen. The 5-ft distance between the load points was selected to encompass the entire splice region. The general flexural test set-up is shown in Figure 38.

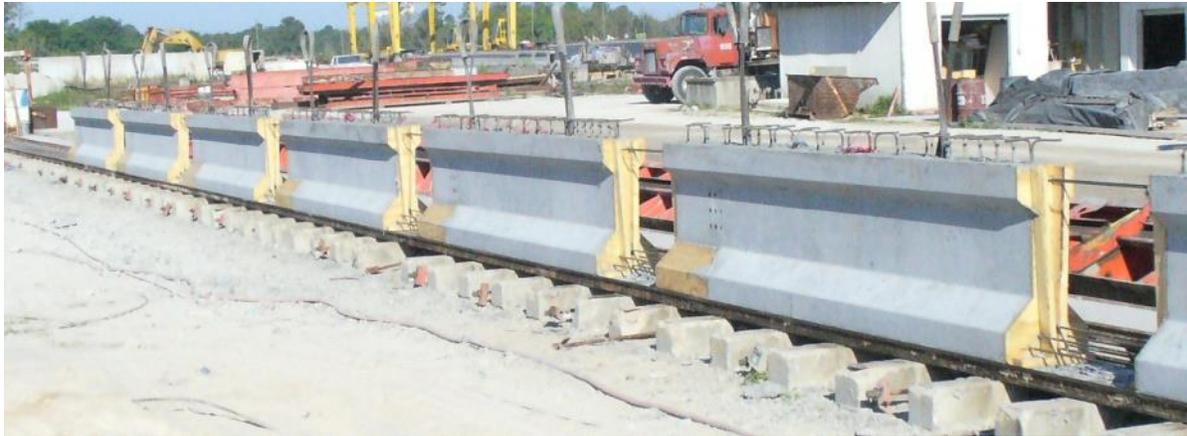
Figure 43–Bed layout

To reduce the likelihood of strand recoil during detensioning, segments for the first pour were arranged in the bed as shown in Figure 43; segments were located close to one another, but away from the abutments.

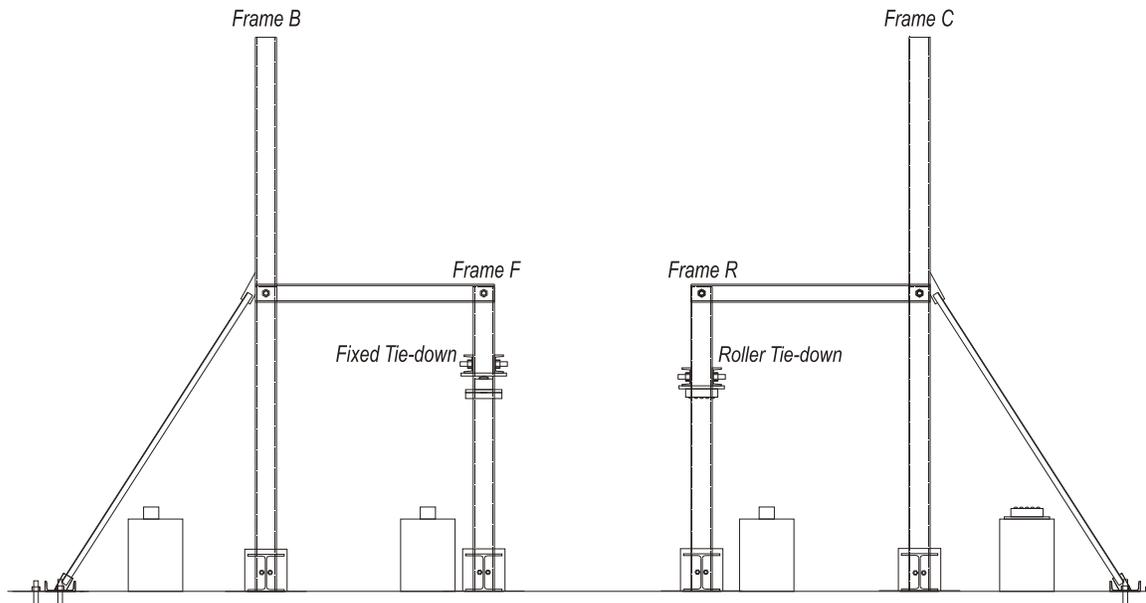
Figure 46–Elevation of assembly frames

Pushing the segments apart with hydraulic jacks placed eccentric to the strand centroid created an internal moment. This internal moment caused uplift that was resisted by the structural steel frames and tie-down connections shown in Figure 46. Four steel frames were positioned and bolted to the strong-floor using 1.5-in. diameter threaded rod. Two interior frames were used as tie-downs, resisting the uplift force during the stressing procedure. All four frames were designed to resist beam roll-over and to guide the longitudinal movement of the rolling segment during stressing. Tie-down connections were positioned and welded onto their respective frames. The fixed tie-down connection was constructed of steel plate with a load button receiver welded to a pair of channels bolted to Frame F. The roller tie-down connection was constructed by welding a Hilman roller to a steel plate, which was then welded to a pair of channels bolted to Frame R. To ensure smooth translation of the rolling beam, the Hilman roller was leveled prior to welding it to the frame.

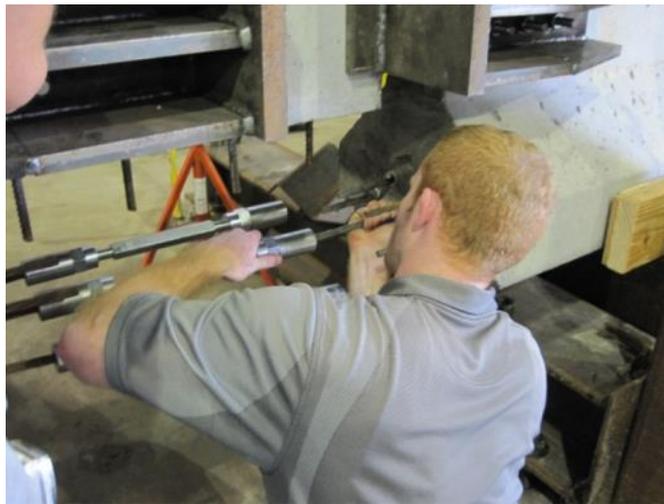
Figure 48–Coupler installation on unbonded strand

the strand protruding from the bonded segment. Engagement of the wedges in the coupler was checked by hand. Couplers were then attached to the strand protruding from the unbonded segment (Figure 48). Engagement of the coupler wedges was again checked by hand. At this point, the coupled strands were not taut in the closure pour region and occasionally appeared to bend across the closure pour length (Figure 49). Next, rebar couplers were attached to the rebar protruding into the notch. The couplers were used to attach the bottom hook of the stirrups in the splice region (Figure 50).

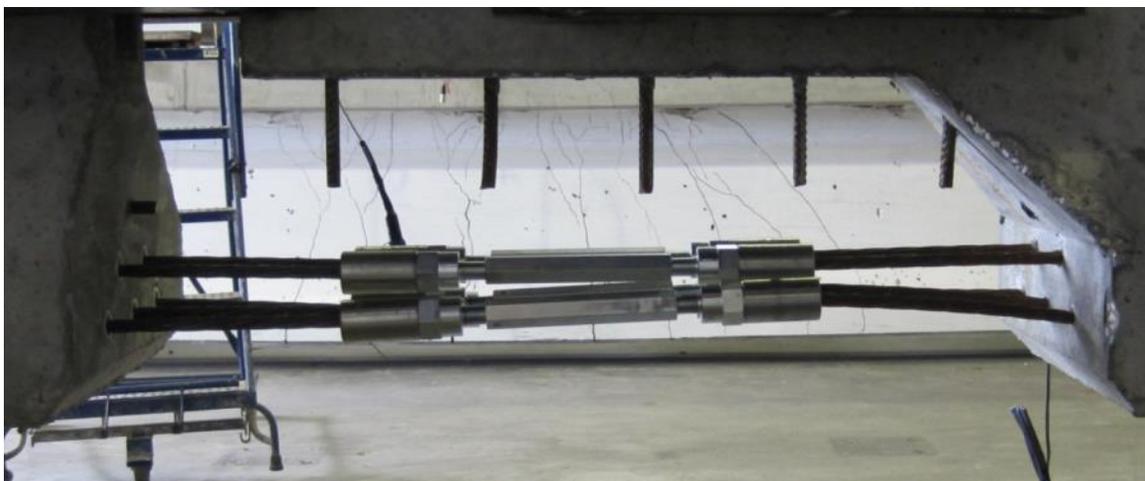
Figure 49–Coupled strand prior to prestressing

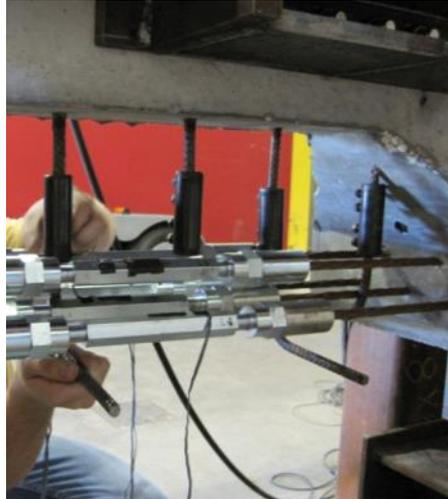
Figure 50–Coupled stirrups

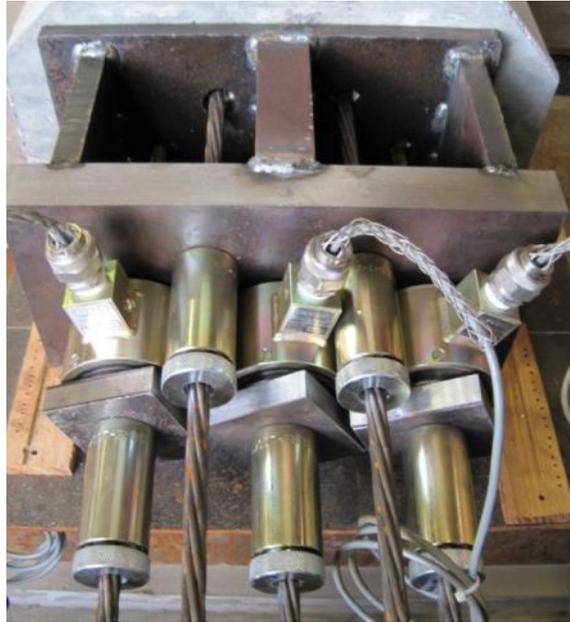
The detensioning chair (Figure 52) was then threaded onto the protruding strand from the unbonded segment. The chair was shimmed to the proper height and leveled to provide clear passage of the prestressing strand through each hole. Chucks, load cells, and anchor plates were then installed.

Figure 52–Detensioning chair, chucks, and load cells on the unbonded segment

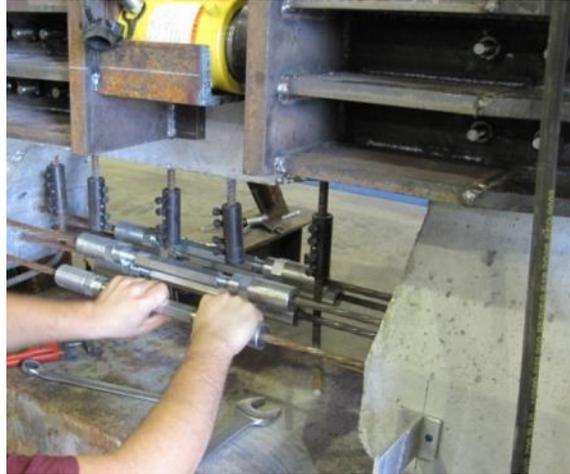
Prestressing strand couplers were then tightened to hold the detensioning chair against the unbonded segment (Figure 53.). One person was required to adjust each turnbuckle in the closure pour until the coupled strand was taut while the second person monitored and adjusted the alignment of the detensioning chair, the load cells and the prestressing chucks. Proper positioning of the hardware included clear, unrestrained passage of the prestressing strand through the detensioning chair and the load cells; unobstructed placement of each prestressing chuck relative to one another; and flush seating of the detensioning chair on the end of the beam.

Figure 53–Tightening the turnbuckles to seat detensioning chair

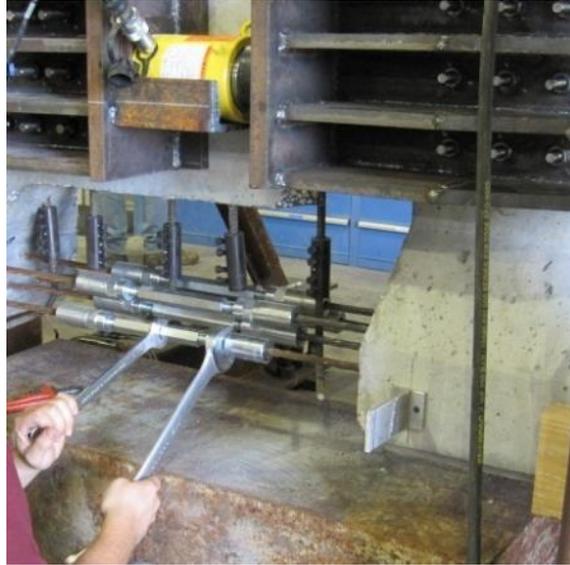
With unbonded strands secured with chucks at both ends, an initial load was put into each strand to straighten the prestressing strand across the closure gap, and to provide an “even” starting point for later stressing. This was done by adjusting the turnbuckles on each coupler, alignment of the detensioning chair was monitored to ensure that the protruding strand passed clear through the detensioning chair and the load cells without obstruction. In addition, the load cell and coupler strain gage output were monitored. Alignment of the load cells was monitored to ensure that they were bearing evenly on the detensioning chair and the prestressing chucks. Approximately 1 kip of load was achieved in each strand, or approximately 100 microstrain per coupler. Equalization of the force in each strand was an iterative process, requiring several adjustments to each turnbuckle, as each adjustment affected the force in the nearby strands.

Figure 54–Tightening the turnbuckles

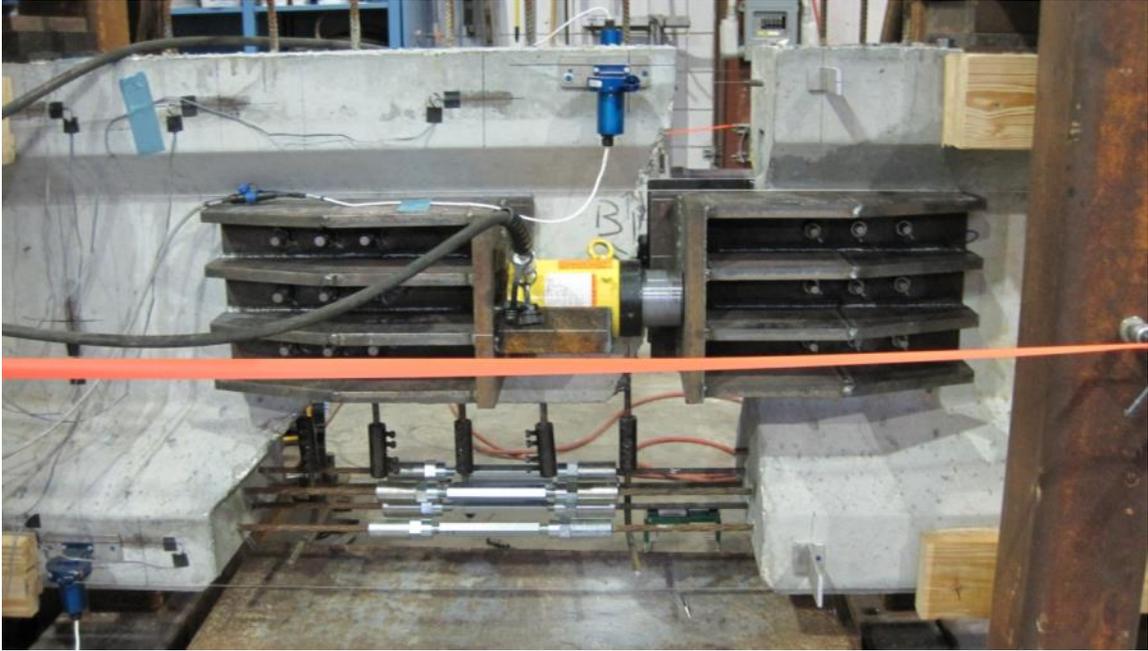
Figure 55–Splice stressed with lock-nuts engaged

At 5600 psi, the lock-nuts on both actuators were hand-tightened. In cases where the string-pots at the bottom of the closure indicated 1-in. of displacement prior to achieving 5600 psi in the prestressing jacks, the procedure was halted and the lock-nuts were tightened early. In cases where the gap opening between the segments and the load cell readings were both low, jacking was continued until the jack pressure reached 6100 psi. The hydraulic pressure was then simultaneously and slowly released from the jacks.

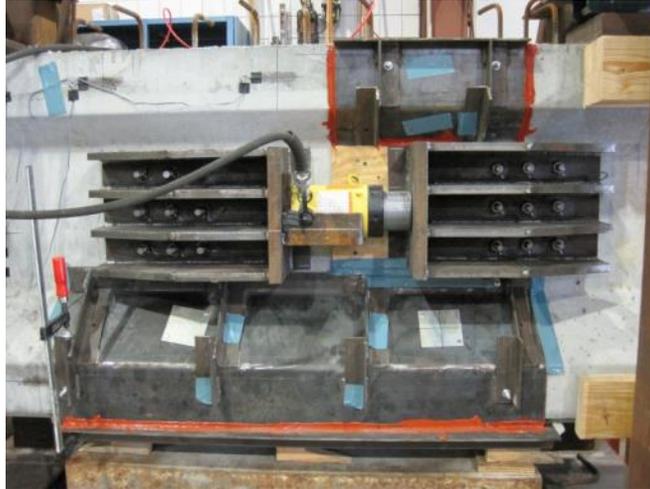
Formwork for the closure pour was then attached to the beam segments (Figure 56). The closure pour formwork consisted of two forms for the top flange, two forms for the bottom flange, a long form for the bottom of the beam and small pieces of plywood for the region between the actuators. Side forms were attached to the precast beam using expansion anchors and concrete screws. The bottom form was wedged into place, supported underneath by a steel support block. Seams were caulked and/or duct taped with foam backer rod to prevent leakage during the pour (Figure 57).

Figure 56–Closure formwork in place

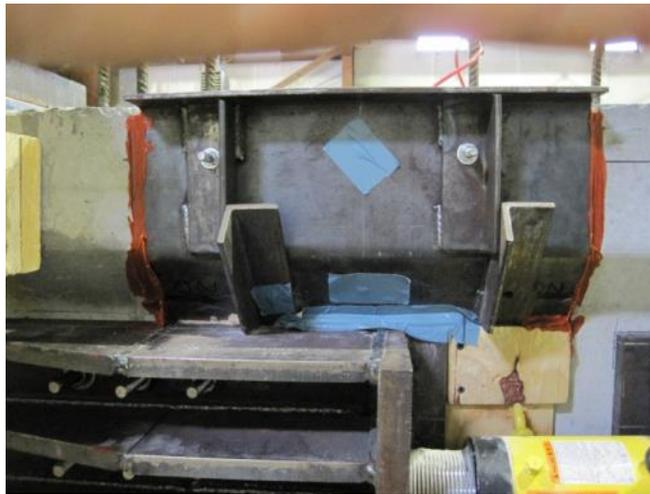
Figure 57–Seams sealed

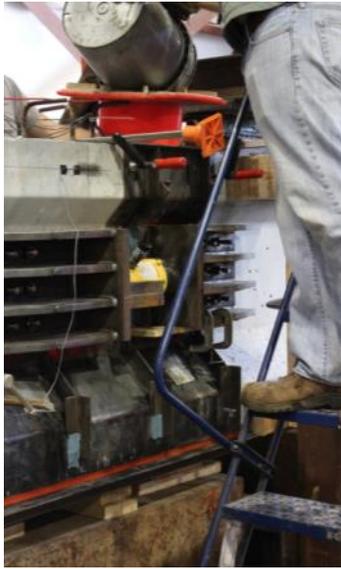
Concrete was lifted using 5-gal. buckets and tremied into the closure with the aid of a plastic traffic cone (Figure 58). The cone was wedged deeply into the form at the start of the pour, and as the concrete level rose, the cone was slowly extracted to mitigate segregation of the mix and void formation.

Figure 58–Pouring the closure

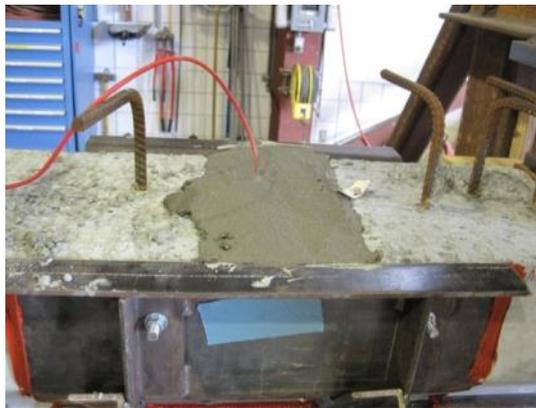
A hand-held vibrator was used to vibrate the accessible parts of the pour; however, limited vibration of the closure concrete was possible due to hardware congestion and the placement of instrumentation.

Figure 59–Top of finished closure pour

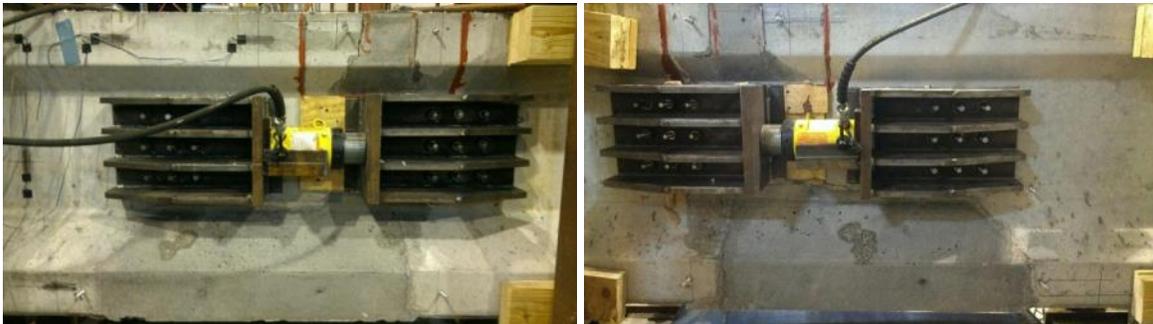
Figure 60–Formwork removed (Specimen X1 shown)

small amount of tension is introduced into the joint). The formwork was then removed from the splice region (Figure 60).

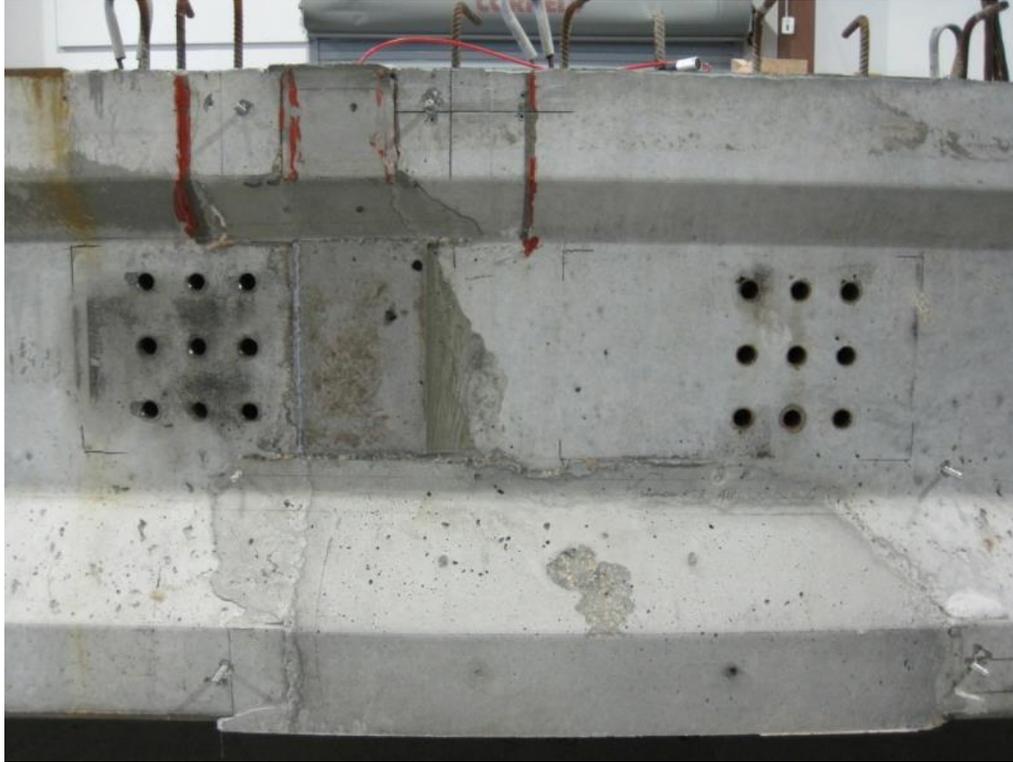
Figure 61–Splice complete

Tie-down forces were then released. A jack was placed under the beam as near to the support under the bonded segment as possible. The inner support points (wooden supports) were removed to reduce restraint. The jack under the bonded segment was pressurized until the neoprene pad under the beam could be removed. Pressure was then released, which lowered the beam end sufficiently to remove tie-down forces at frames F and R. The stressing brackets were removed, and the assembled beam was removed from the assembly frames, completing the splice procedure.

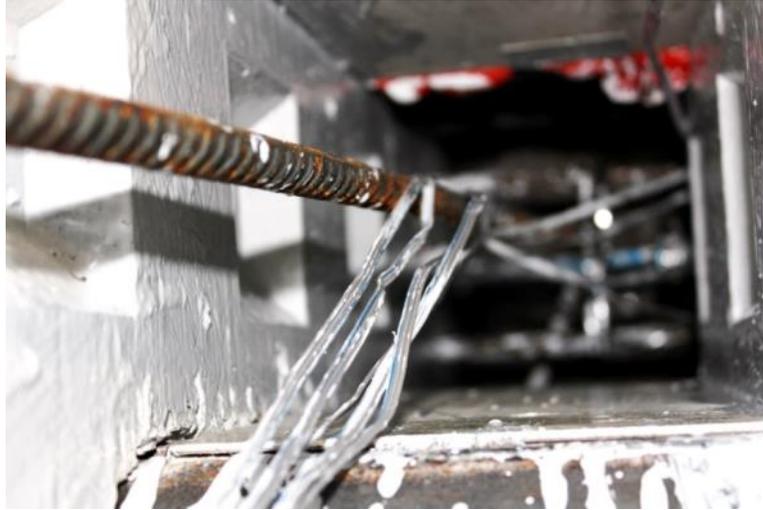
Figure 64 shows view of the epoxy application. Approximately 10 minutes prior to the arrival of the closure pour concrete, the epoxy was mixed and applied to the joint. The epoxy was applied from above and below the beam, using a bristle paintbrush. Care was taken to cover the entire surface area with a generous coat. Following the application of the epoxy, the closure was poured; the pour was completed within one hour of epoxy application.

Figure 64–Epoxy in closure pour

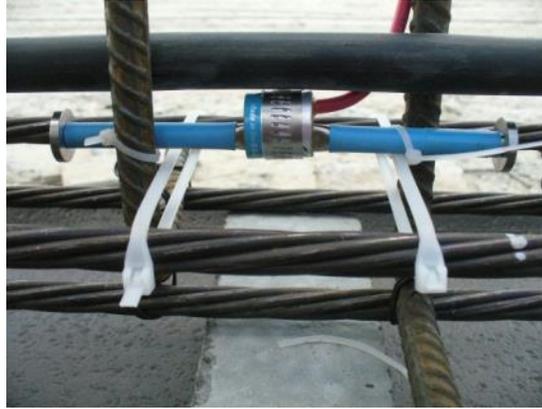
During the splice assembly in the laboratory, a gage was installed near the midspan of the full spliced beam length prior to the closure pour. In all cases, the VWSG was installed at the approximate height of the strand pattern centroid. The locations of the VWSGs are shown in Figure 66. To ensure each VWSG remained at the set height, cable ties were used to attach the VWSG to the prestressing strand as shown in Figure 67.

Figure 67–VWSG installation near centroid of strand pattern

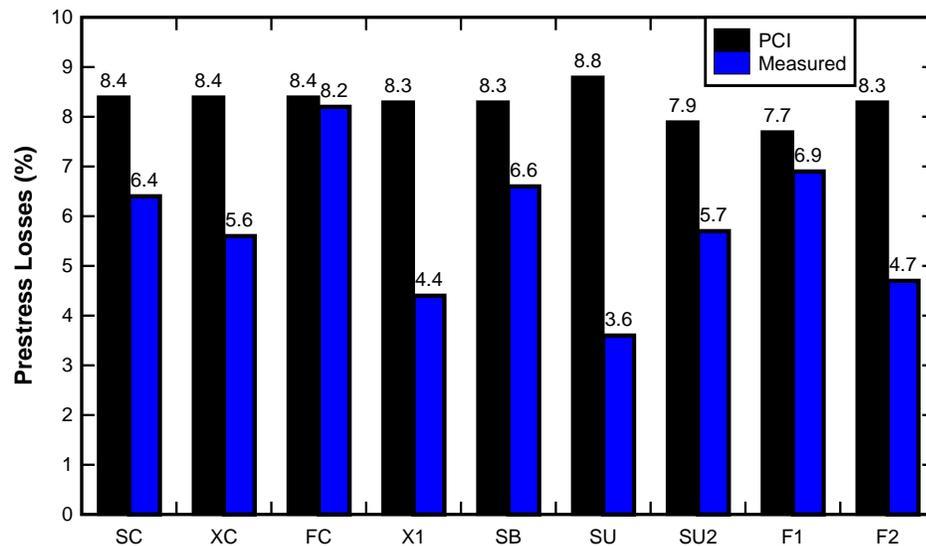
Figure 82–Measured prestress losses vs. PCI

Specimen	Elastic losses (ksi)	Long-term losses (ksi)	Total prestress loss (ksi)	Total prestress loss (%)
SC	3.8	10.2	14.0	8.4
XC	3.8	10.2	14.0	8.4
FC	3.8	10.2	14.0	8.4
X1	3.7	9.7	13.5	8.3
SB	3.7	9.6	13.3	8.3
SU	4.1	11.4	15.5	8.8
SU2	3.3	8.3	11.7	7.9
F1	3.1	7.5	10.6	7.7
F2	3.8	10	13.7	8.3

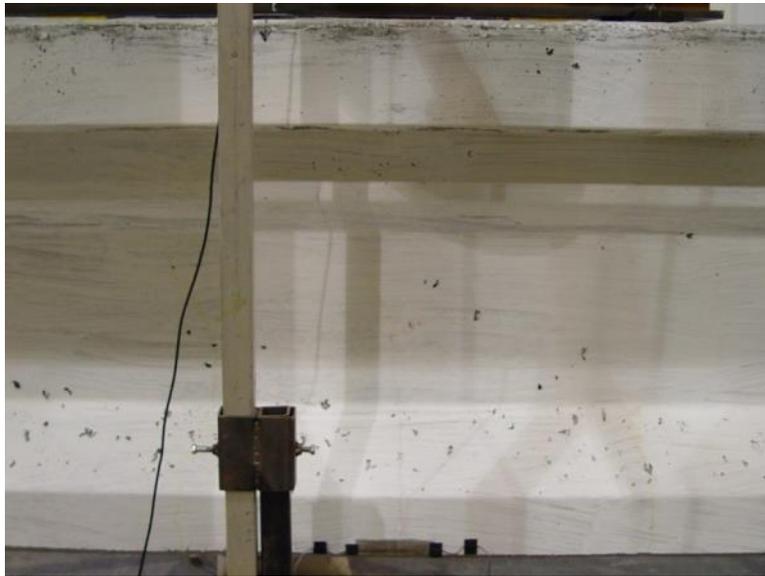
Figure 83–Decompression strain gages

indicating that the pre-compression caused by the prestress force had been overcome. This method has been described by Pessiki et al. (1996).

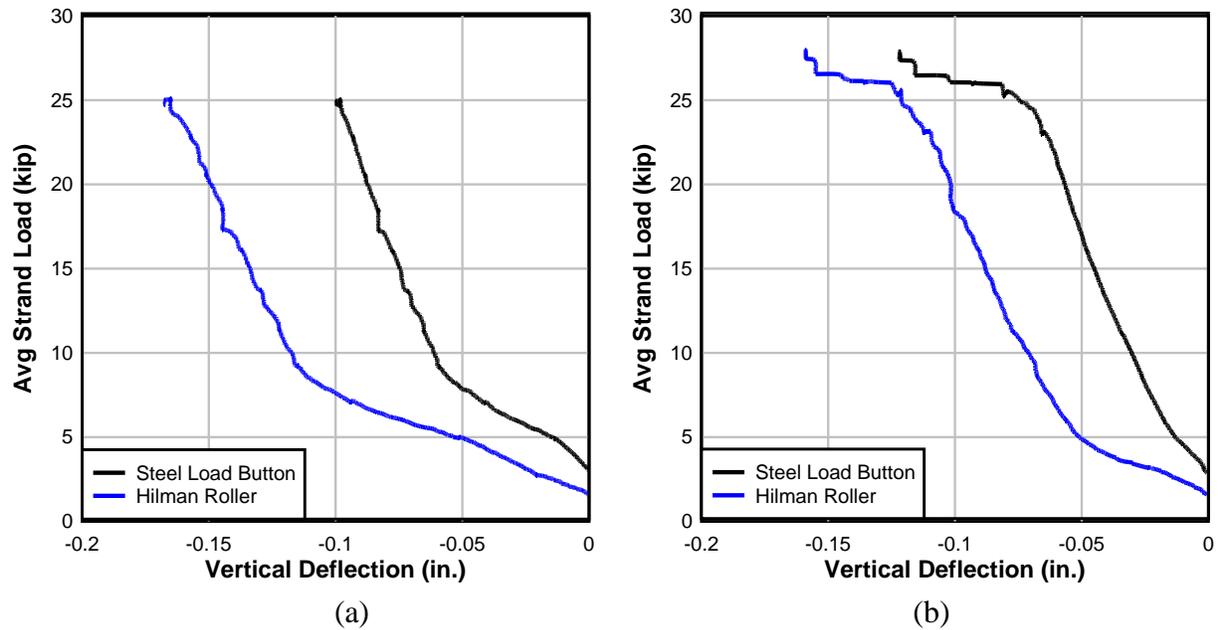
Figure 89–Tie-down deflections: (a) SB and (b) SU

The magnitude of these vertical movements was affected by the conditions at each restraint. In each case, the roller tie-down—which consisted of a steel Hilman roller displaced upward more than the fixed tie down—which consisted of a neoprene pad and a load cell. An example is shown in Figure 89. The slackness of the rollers in the roller tie-down allowed more vertical movement than the neoprene of the fixed tie-down.

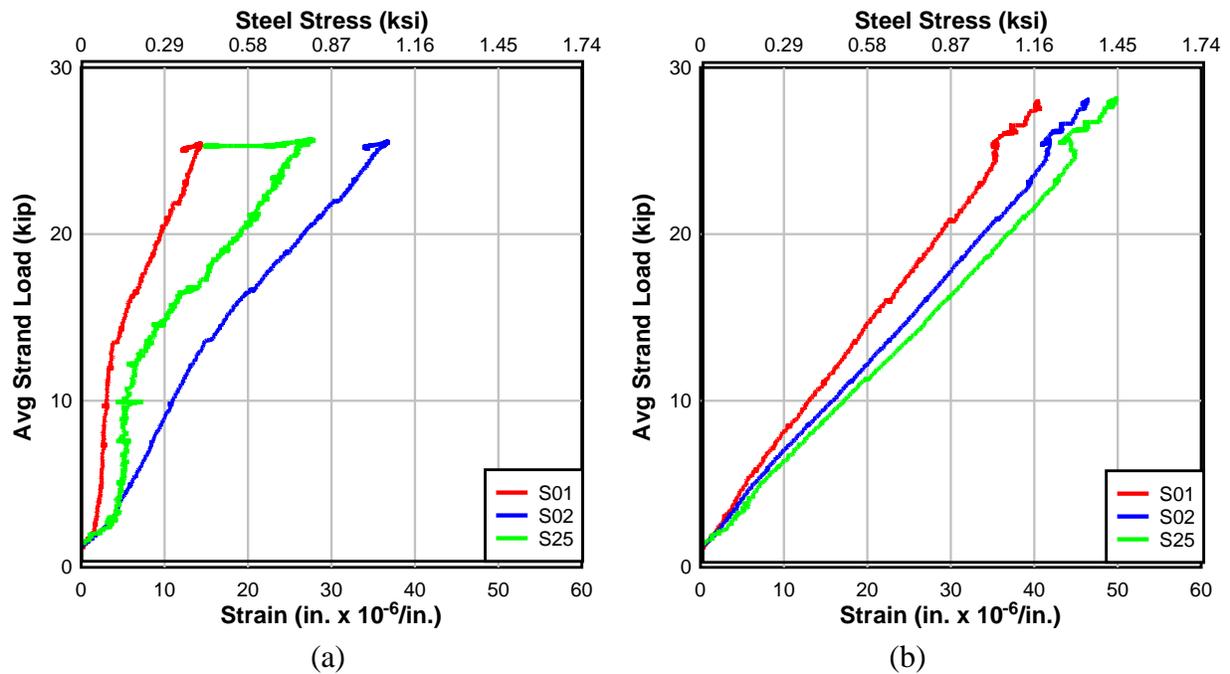
Figure 92–Tie strain (a) X1 and (b) SU

Two stirrups were instrumented with strain gages (S01 and S02) and placed within the precast segments during construction as described in Section 7.1. An external strain gage (S25) was also placed on the concrete surface of the precast segments prior to the splice assembly procedure at the same location along the beam length. This gage was used to verify the readings of the stirrup gages and to check the assumption of perfect bond between the rebar and the precast concrete. Based on the perfect bond assumption, the strain measured in the concrete should be approximately equivalent to the strain in the ties. Figure 92 shows the measured strain for the three strain gages versus the average strand load for the stressing of specimens X1 and SU. The gage locations are shown in Figure 68.
