# Long Spans with Transportable Precast Prestressed Girders

**Final Report**

**December 2013**

Florida Department of Transportation (FDOT)

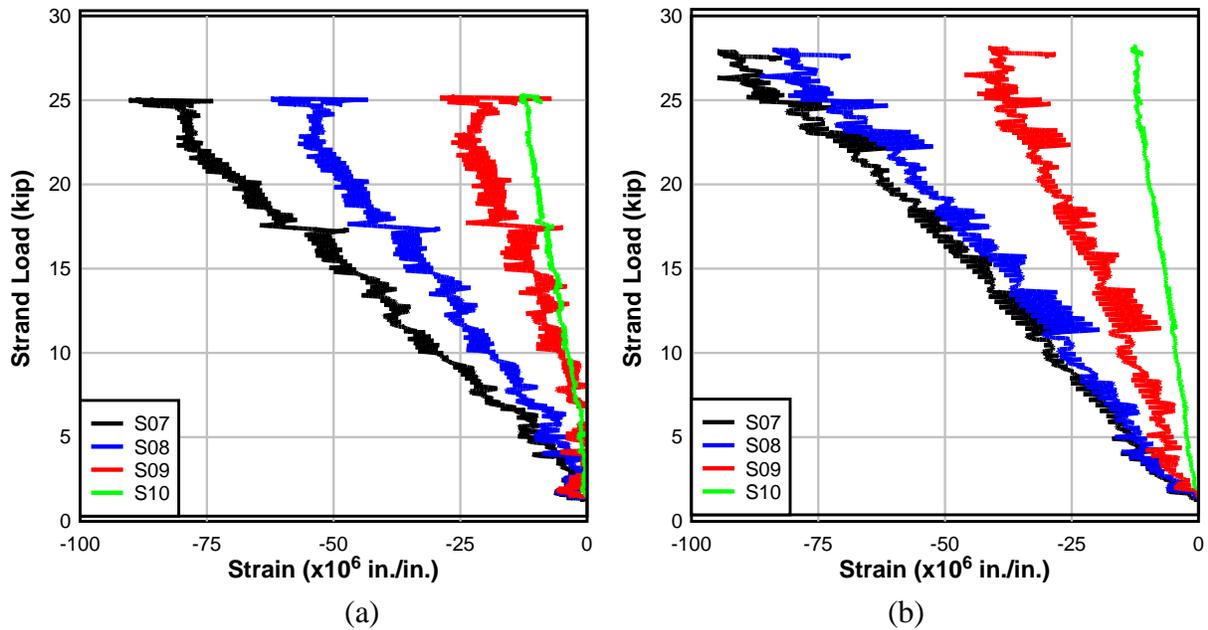
Figure 93–Strain in top flange for (a) SB (b) SU

Figure 93 shows a plot of the strain measured by gages along the beam top flange versus the average strand load. Also shown in the figure are the gage locations and the assumed strut-and-tie model. This field of strain gages was placed to approximately determine the node location of the compressive strut, i.e., the location of the compressive strut node nearest the tie-down. Because the angle of the strut is assumed and unknown, these measurements were taken to simply visualize the region affected by the compressive strut introduced during the stressing procedure.

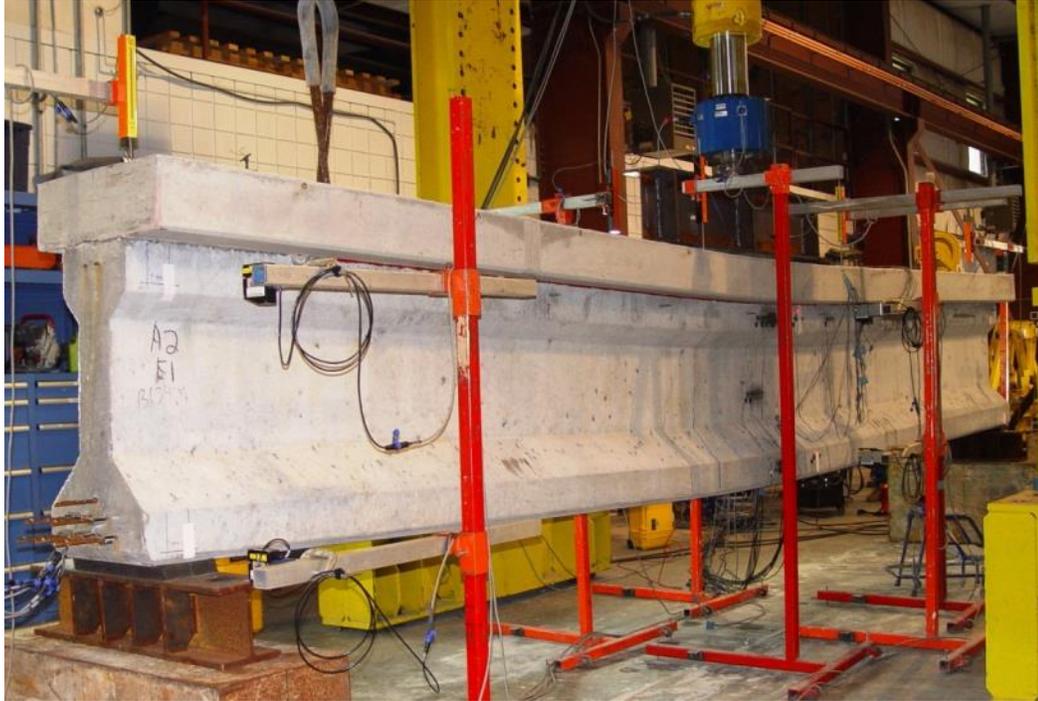
Figure 97–XC: Permanent set

As XC was loaded beyond cracking, sudden minor load decreases occurred periodically until the midspan deflection reached just less than 1 in. These decreases indicated flexural crack formation and were confirmed with audible cracking sounds and visual observations. Although the peak load had not been reached, the test was terminated at a deflection of approximately 4 in. (maximum load of 158 kip) to avoid damage to instrumentation. After the applied load was removed from the beam, a permanent set of 2.38 in. was measured at midspan (Figure 97).

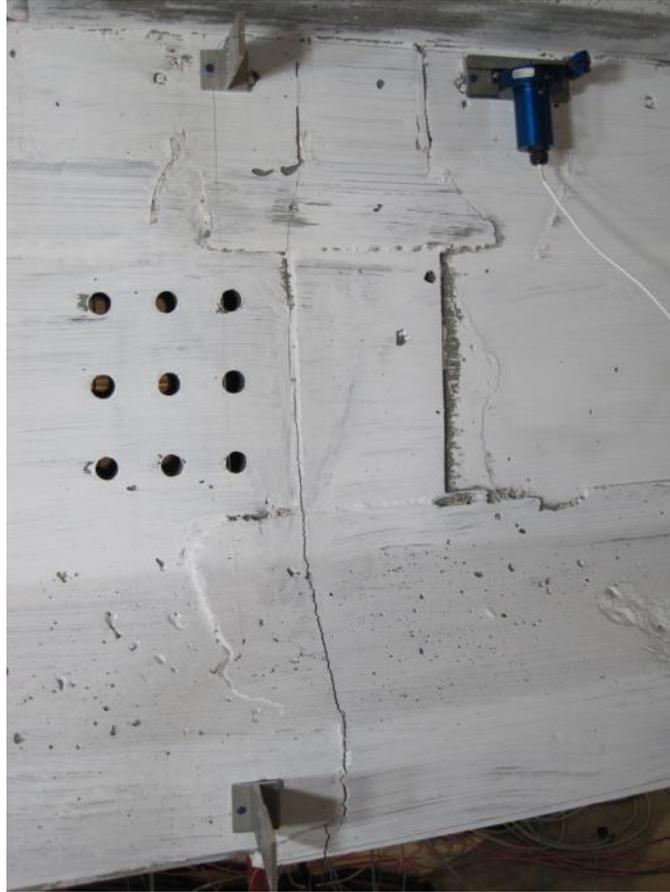
Figure 101-X1: Vertical crack at interface

At 68 kip, a single crack was visually observed at the vertical interface of the unbonded precast and the closure pour (Figure 101). Note that this was the only crack at this load; other inconsistencies in the white-wash seen in the figure are from incomplete white-wash application or rough surfaces of the concrete. Prior to 68 kip, only superficial cracks where the closure pour overlapped the precast concrete were noted (Figure 102).

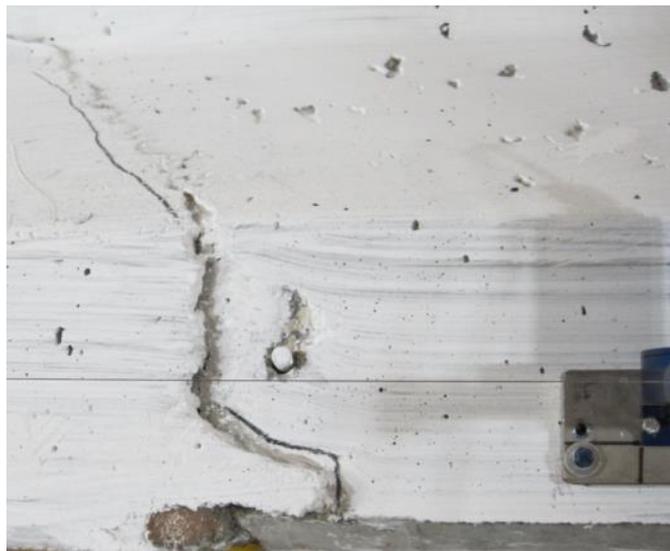
Figure 102-X1: Superficial cracks at overlap

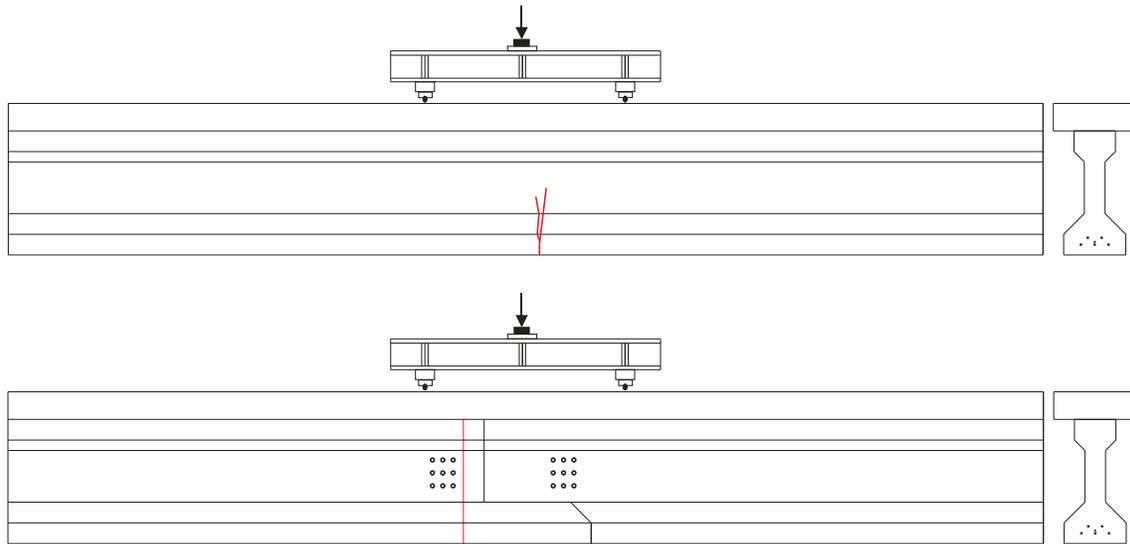
Figure 107–XC vs. X1: first crack

precompression of the beam and the modulus of rupture of the concrete; in the case of XC, the beam cracks when the bottom fiber stress is approximately  $4\sqrt{f'_c}$  (psi). At the cracking moment, a flexural crack developed midway between the load points. X1's first crack, however, occurred at the vertical face of the closure pour (Figure 107).

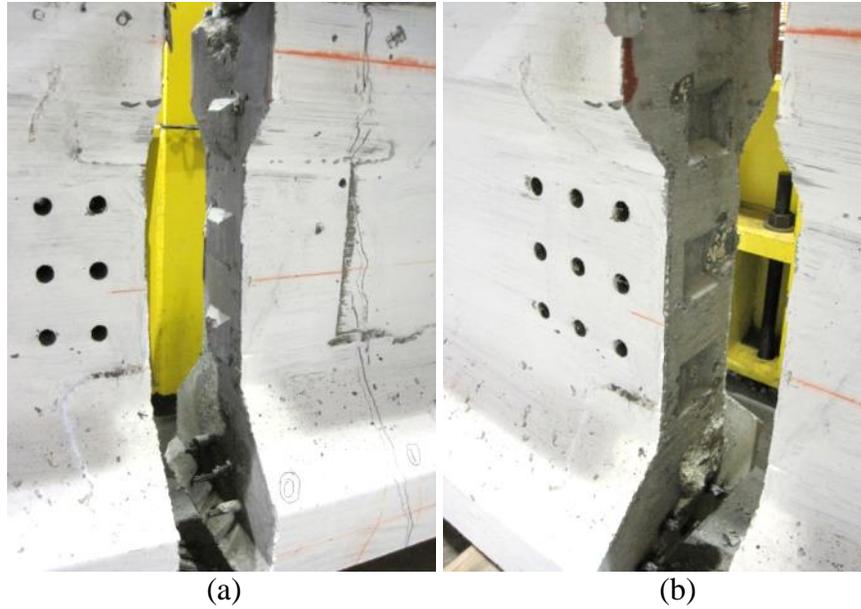
Figure 108–Dry joint interface post-demolition, looking at (a) the closure pour, (b) the precast

It can also be observed from Figure 108 that the shear keys exhibited little damage, indicating that the keys had sufficient strength to transfer shear across the interface.

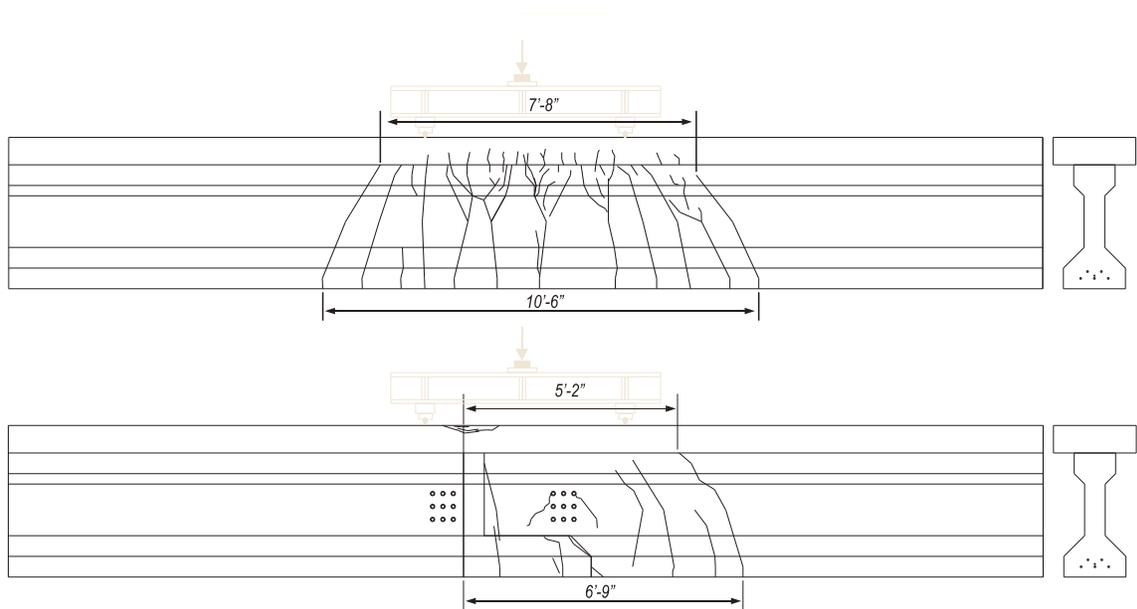
Figure 109–XC vs. X1: final cracking patterns

As loading progressed, XC cracks were noted to be uniformly distributed between the load points, which is typical of bonded prestressed beam behavior (Figure 109). Conversely, X1 behaved more like an unbonded, prestressed beam: the crack pattern focused around a single crack at the end of the unbonded length with some flexural cracks in the bonded segment.

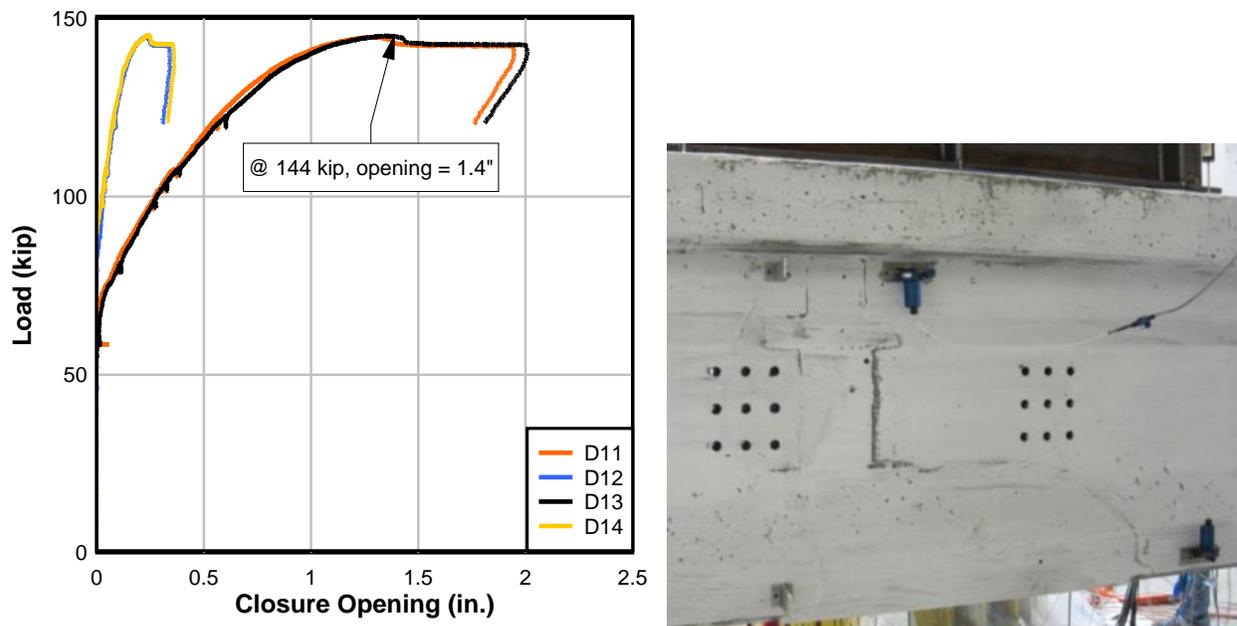
Figure 110–X1: String-pots across closure

Figure 110 shows the displacement measured across the closure pour at the top and bottom of the precast section. Gages D11 and D13 measured the opening at mid-height of the bottom flange; gages D12 and D14 measured opening near the top of the top flange.

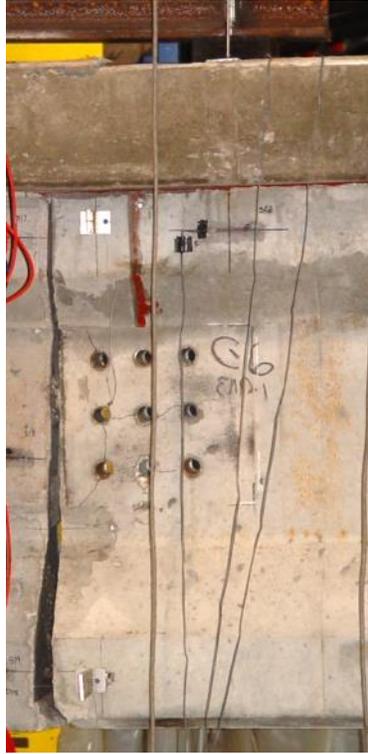
At the maximum load, the four cracks contained in the interface opened a combined amount of approximately 1.4 in. at the mid-height of the bottom flange. As shown in Figure 111, most of the crack opening occurred at the joint.

Figure 111-X1: Opening at joint during test

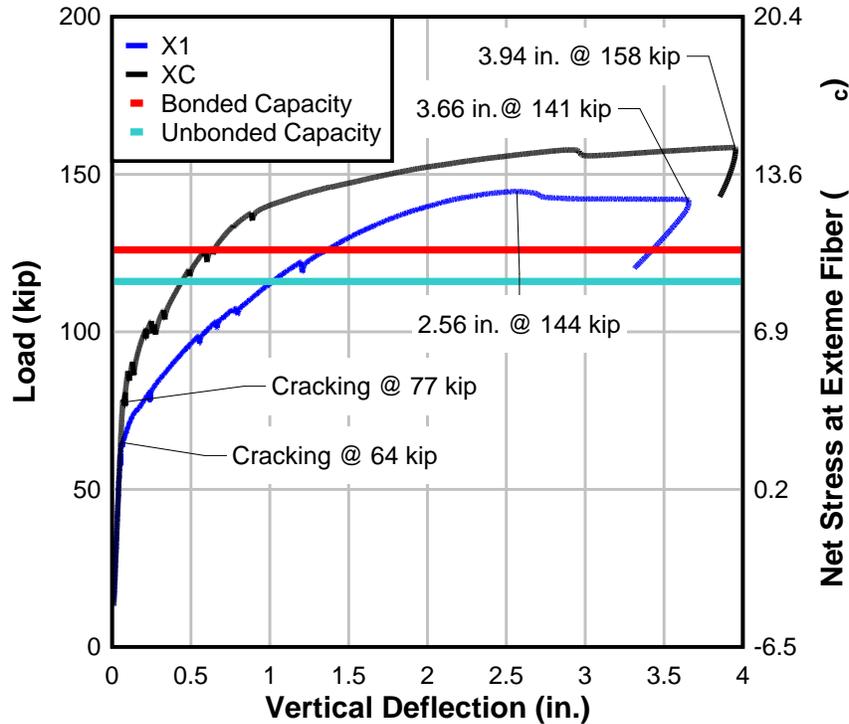
Figure 113–Flexural strength: XC and X1

The computed flexural strength is compared to their respective load-displacement plots in Figure 113. The strength was computed in accordance with AASHTO-LRFD using specified materials of 4.5 ksi deck concrete and 270 ksi prestressing steel. The predicted bonded moment capacity at 0.003 concrete compressive strain was 631 kip-ft, which corresponds to an applied load of 123 kip. For both XC and X1, the peak load exceeded the predicted design strength of a bonded prestressed member. Considering the cracking behavior and failure mode of the spliced specimen X1, the AASHTO-LRFD capacity was also calculated assuming the steel strands were unbonded. The calculated moment strength, assuming all five strands were unbonded, was 589 kip-ft, which corresponded to an applied load of 114 kip. X1 exceeded the anticipated capacity of an unbonded section.

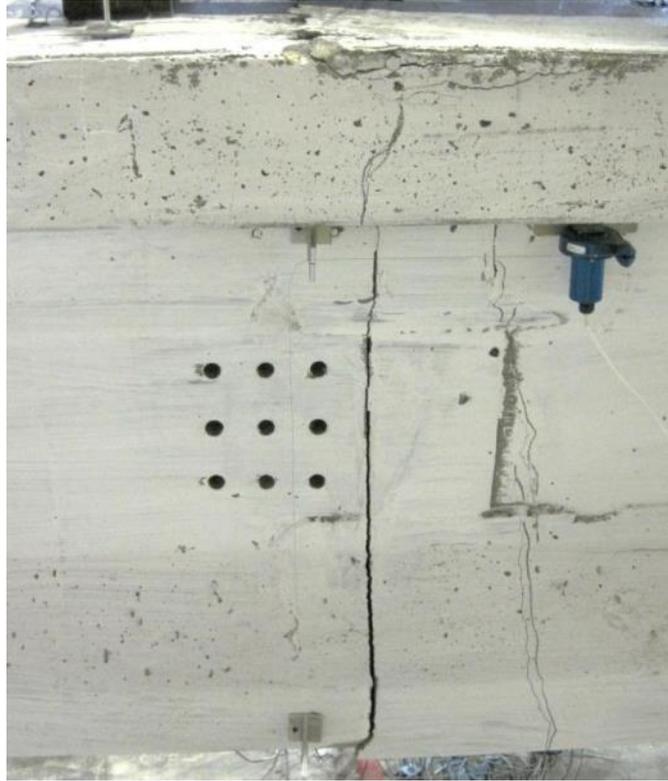
Figure 114—Damage to X1 following testing with spalled concrete in compression zone and wide, permanent crack

At the maximum applied load of 145 kip, the beam continued to deflect without resisting additional load. The midspan deflection at the maximum applied load was approximately 2.6 in. with a permanent set 0.75 in. upon load removal. X1 exhibited a tension-controlled flexural failure as the deck concrete crushed (Figure 114).

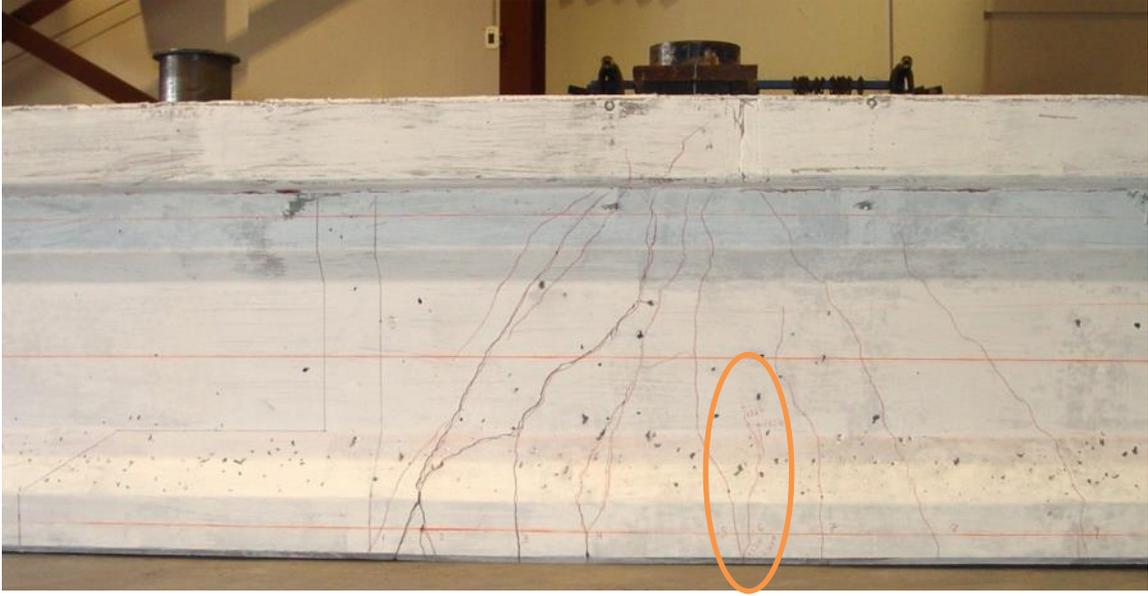
Figure 117-SC: Crack pattern

The first visible crack was a flexural crack which occurred at 128 kip. It formed approximately under the load point (Figure 117). While SC is a homogenous precast specimen, the location of what would be the closure pour in a spliced beam has been sketched onto the beam to provide a reference for discussion.

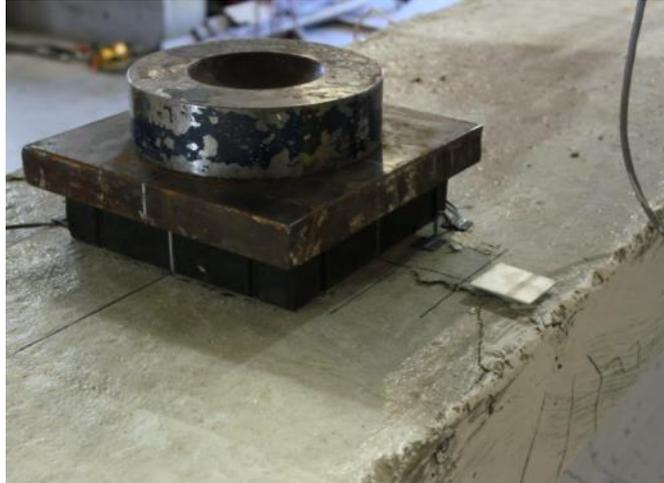
The peak load was approximately 217 kip when the deck failed in compression under the load point (Figure 122); a maximum deflection of 1.5 in. occurred at the load point at the ultimate load.

Figure 122–SB: Deck at failure

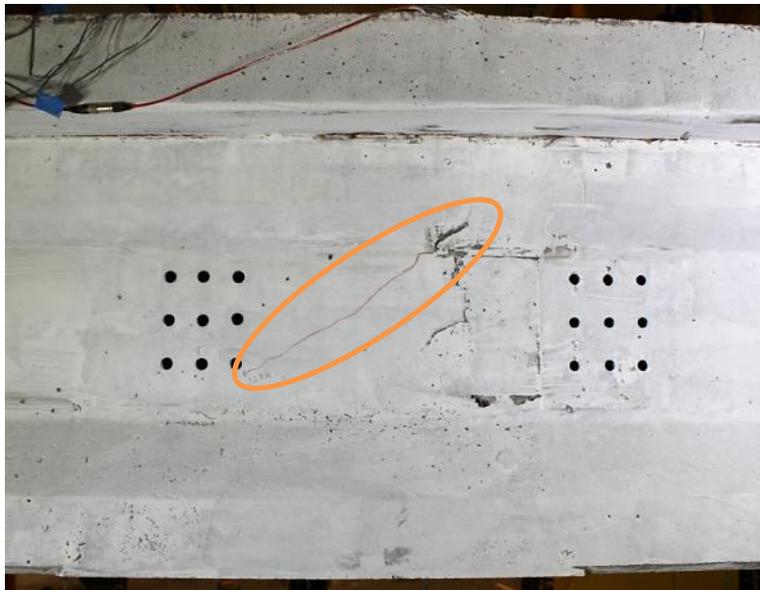
Figure 129–SU2: First crack

The first visible crack was a web-shear crack which formed in the precast concrete near the joint (Figure 129). At the cracking load, the crack affected only the precast concrete, halting at the closure pour.

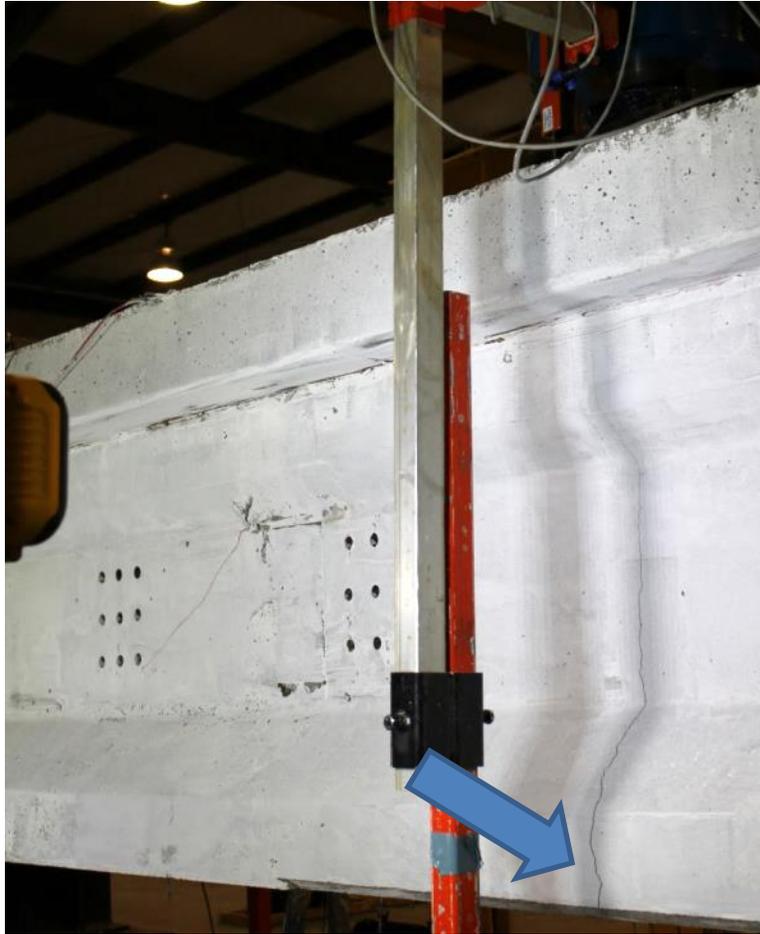
As additional load was applied, SU2 exhibited reduced—but nearly equal- stiffness, until approximately 149 kip. At 149 kip, a major load decrease of approximately 18 kip occurred when a flexural crack formed directly under the load point (Figure 130).

Figure 130–SU2: Flexural crack at 149 kip

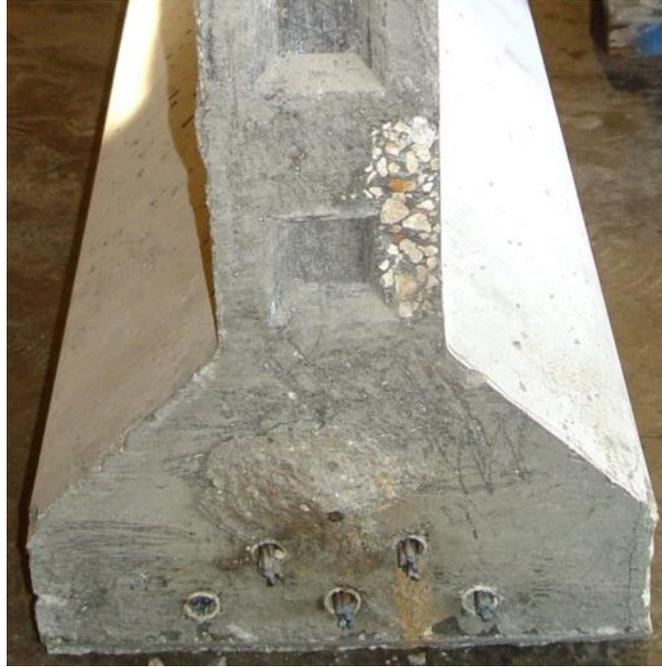
Figure 142–Post-test: End view of unbonded segment

Based on the delay between the vertical crack formation and the gain in the strand load, it can be surmised that the crack at the interface did not expose the prestressing strand immediately. Inspection of the closure pour concrete after demolition of the specimen shows some bonding between the closure pour concrete and the precast concrete around the single bonded strand at this location (Figure 142). The bonding in this area may have slowed the exposure of the prestressing strand until approximately 139 kip, when Figure 141 indicates that the prestressing strand began to pick up load.

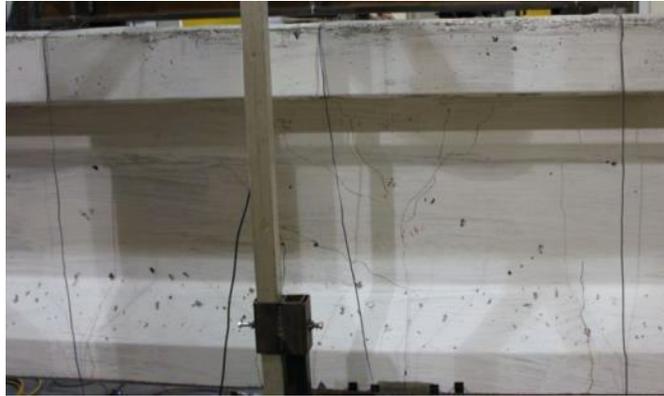
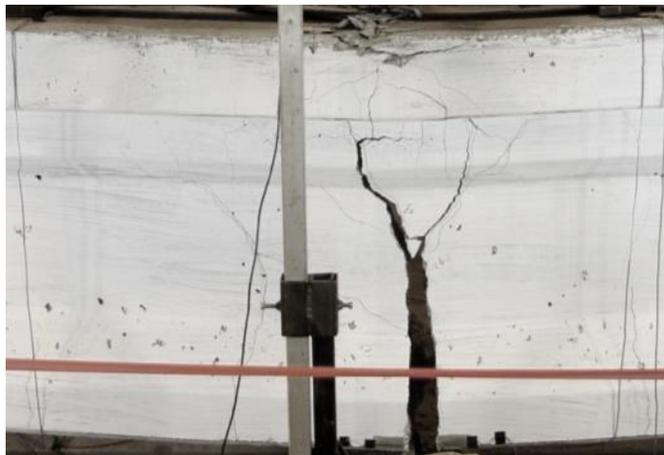
Figure 151–FC crack progression at (a) no load; (b) ultimate (c) second loading

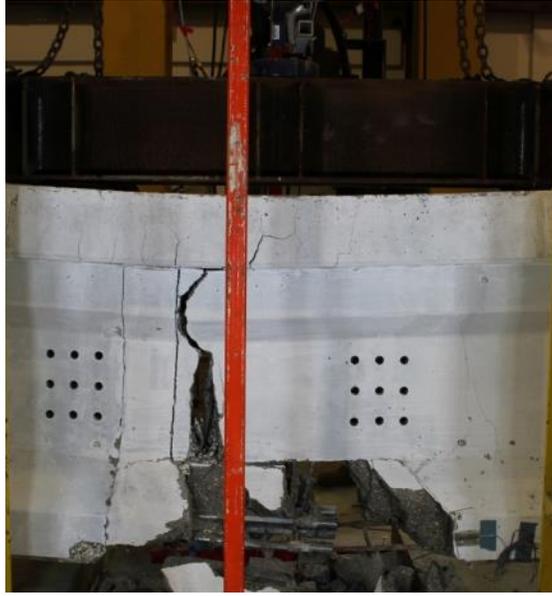
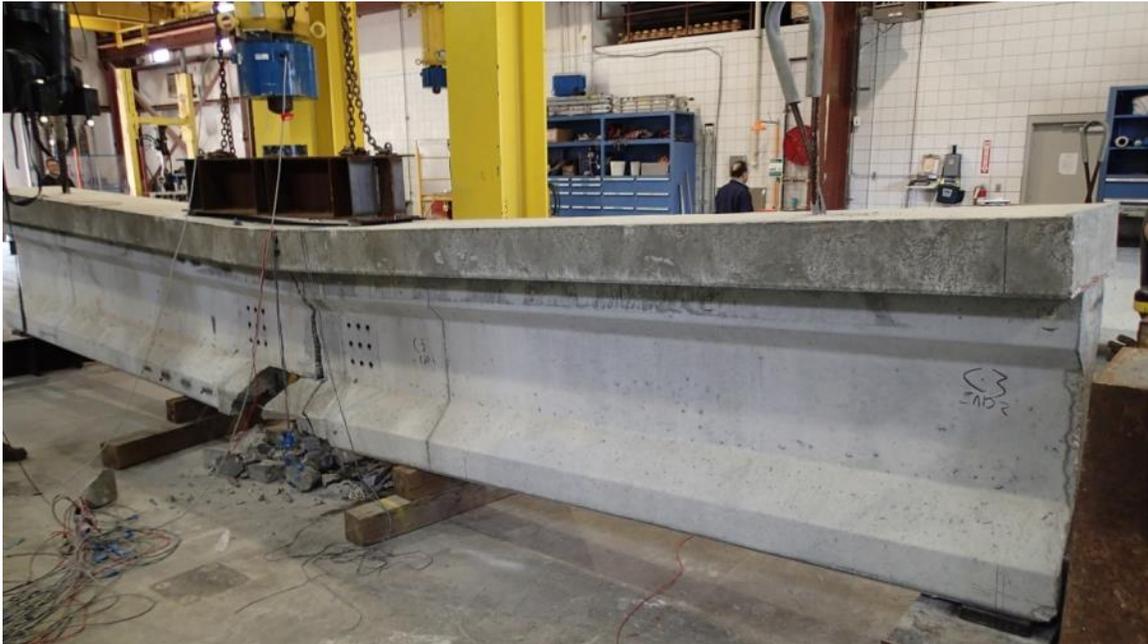
Figure 163–F1: Post-failure

Fracture of the strand predicated compression failure in the deck. The maximum measured compressive strain in the constant moment region of the deck was approximately 0.0016 (Figure 164).

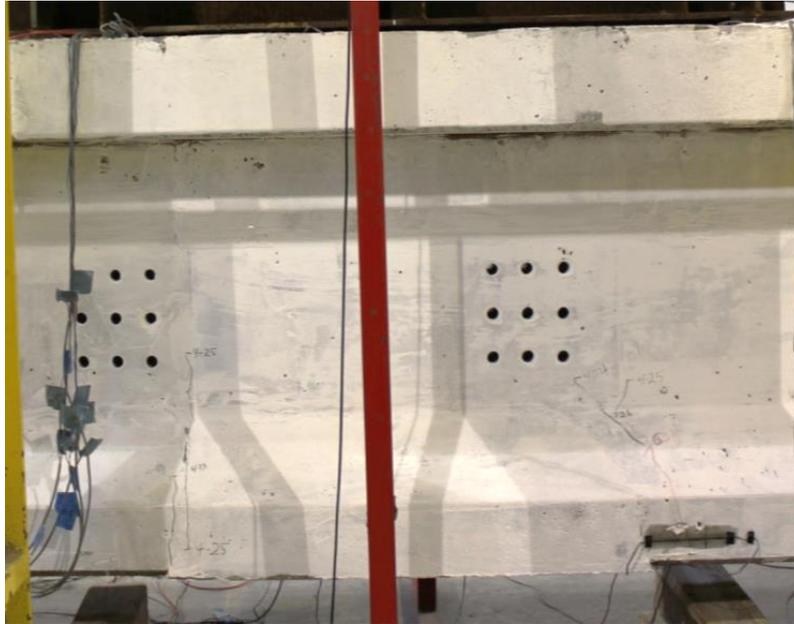
The specimen was inspected throughout the 2 million cycles for crack propagation. Cracks were observed to grow, and new cracks formed. Most notably, an opening of the vertical interface of the closure pour was observed at approximately 1.7 million cycles. The cracks were marked as they propagated and can be seen in Figure 173.

Figure 173–F2: Cracking after 2 million cycles

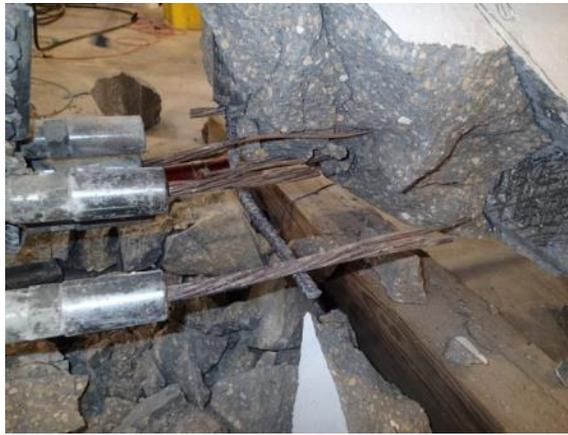
improperly seated (Figure 187). All but one wire of the other top row strand remained engaged by the coupler; this strand ruptured at the notch crack. The bottom row of strands ruptured at the crack location (Figure 186).

Figure 186-F1: Post-failure

The location of the primary crack affected the strand rupture and ductility at ultimate. In the ultimate load test of F1, the crack at the notch interface became the location of strand rupture at ultimate load. In post-failure inspection of F1, it was observed that a single top row strand had slipped completely from the wedge. Post-failure inspection revealed that the wedge had

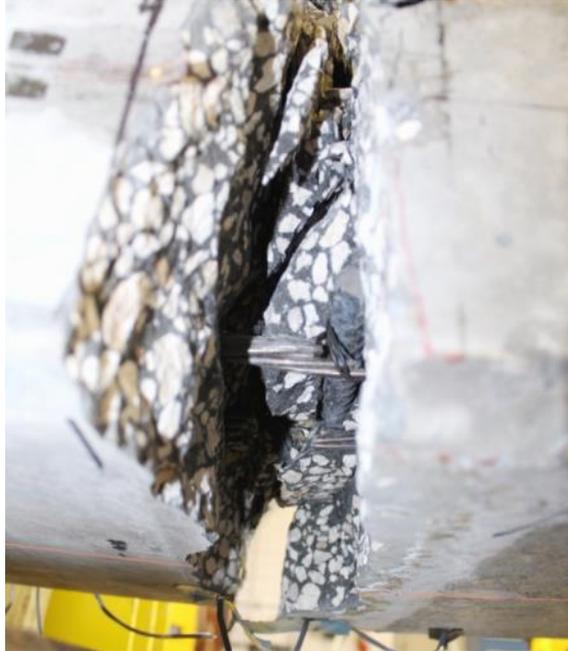
Figure 188-F2: Post-failure

F2's strand ruptured at the primary crack location shown in Figure 167, approximately 14 in. away from a Grabb-it face. The ruptured strands are seen in Figure 188. It can be observed in the picture that the strand rupture has occurred at a rebar location; inspection of the strand found evidence of fretting between the rebar and the bottom row prestressing strand initiated the fatigue wear at this location (Figure 189).

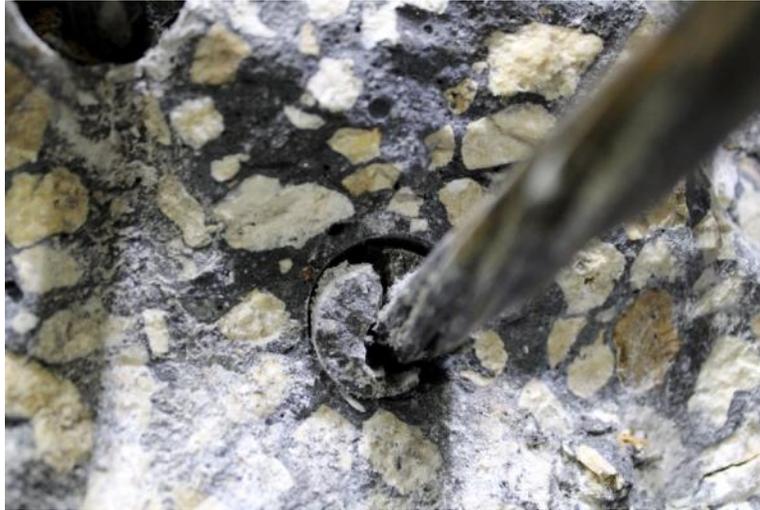
Figure 193–F2: Concrete intruding into unbonded length

- Observed evidence of intrusion of the closure pour concrete into the unbonded segment’s PVC sheathing. This indicates that the self-consolidating concrete used in the closure

pour was sufficiently flowable to penetrate and potentially affect the behavior of the unbonded length.

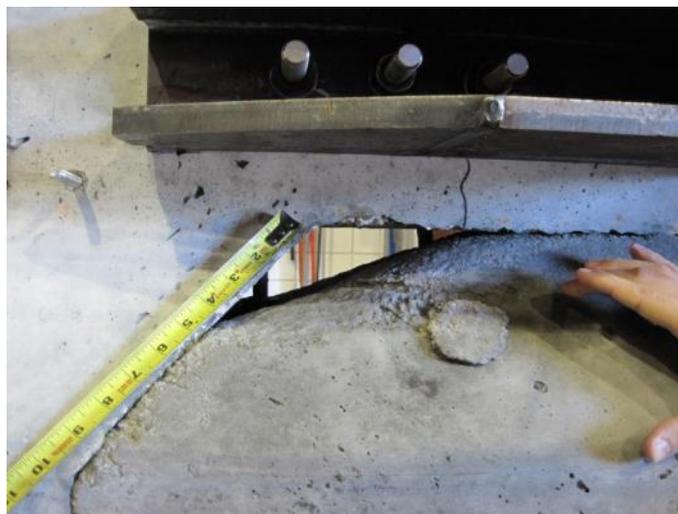
Figure 194–SB: Void at reentrant corner

- Self-consolidating concrete worked well, with enough flowability to form a voidless pour, so long as the form sides were vibrated using a hand-held vibrator. In one splice assembly (SB), hand-held vibrators were not used, resulting in a void at the reentrant corner of the splice region (Figure 194). The void was repaired prior to testing.

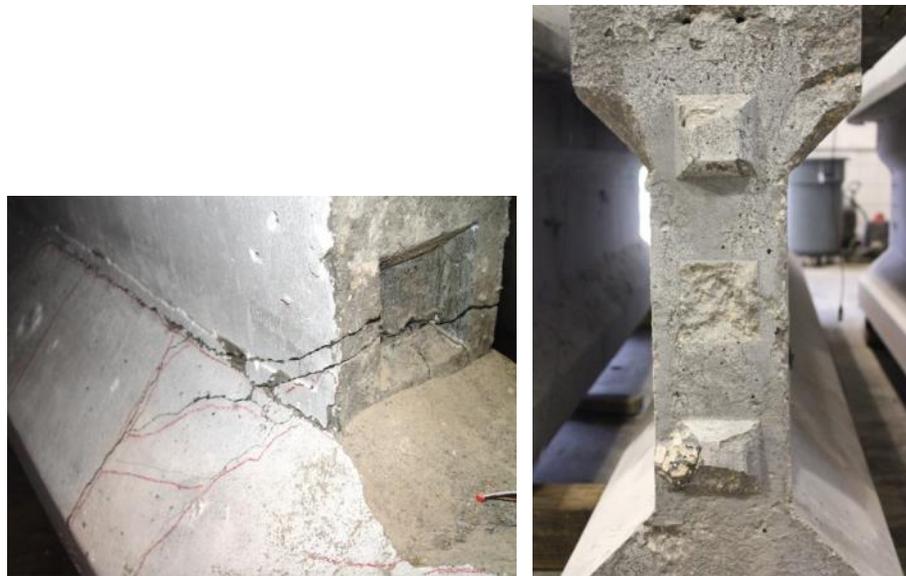
Figure 195–Shear keys (a) SU and (b) SU2

- Shear keys were observed to be effective when the specimen was tested in a high V/M ratio set-up with the unbonded length under the load point (both tests SU and SU2).

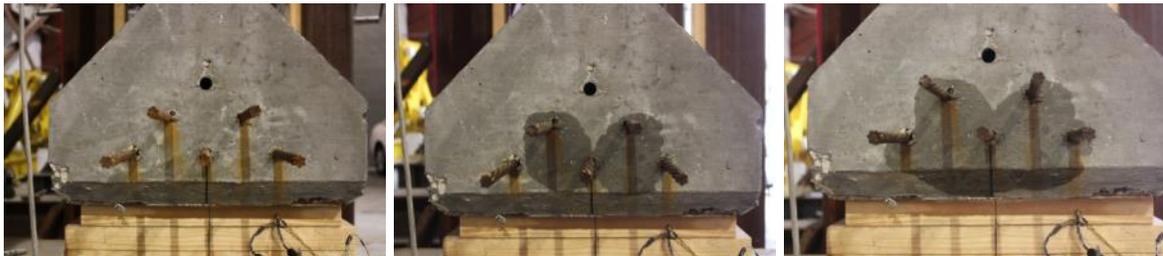
Figure 196–SU: (a) Prior (b) 35 minutes (c) 40 minutes

- Water transmission was observed along the bonded length of strand approximately ten minutes after the completion of the closure pour. Water was observed to wick the entire bonded length (approximately 13.5 ft) of every strand. Figure 196 shows the end of the bonded precast segment prior to the pour, at 35 minutes, and at 45 minutes after the pour of SU.

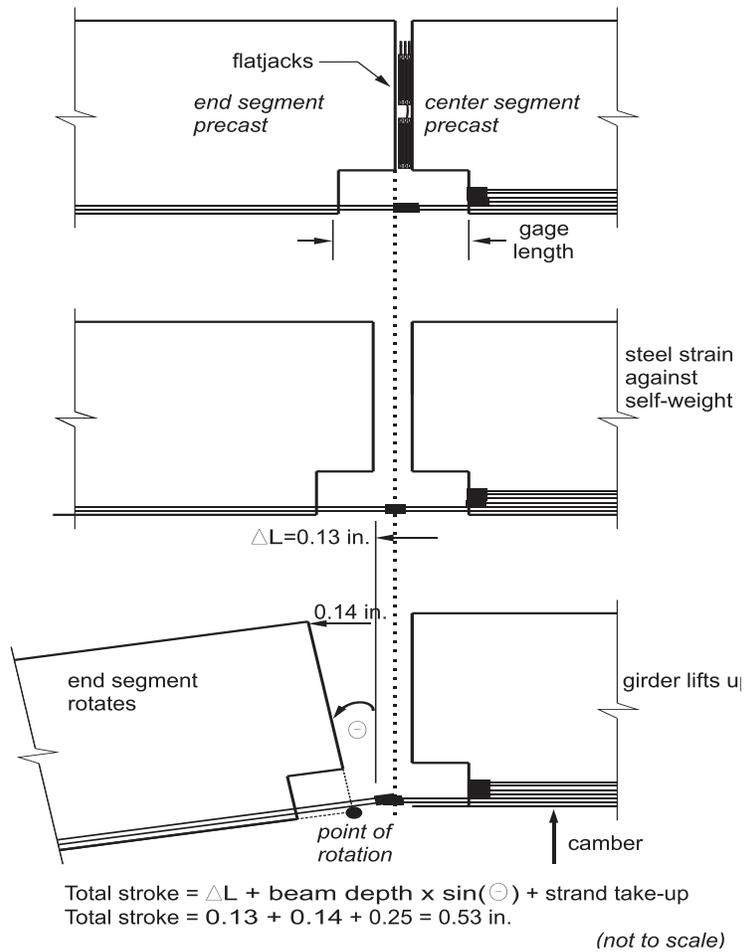
Figure 207–Hinging (and attendant camber) caused by inflation of flatjack. Rotation angle is exaggerated to illustrate mechanism.
