Final Report

March 2013

END REGION DETAILING OF PRETENSIONED CONCRETE BRIDGE GIRDERS

Sponsor:
Florida Department of Transportation (FDOT)
Sam Fallaha, P.E. – Project Manager

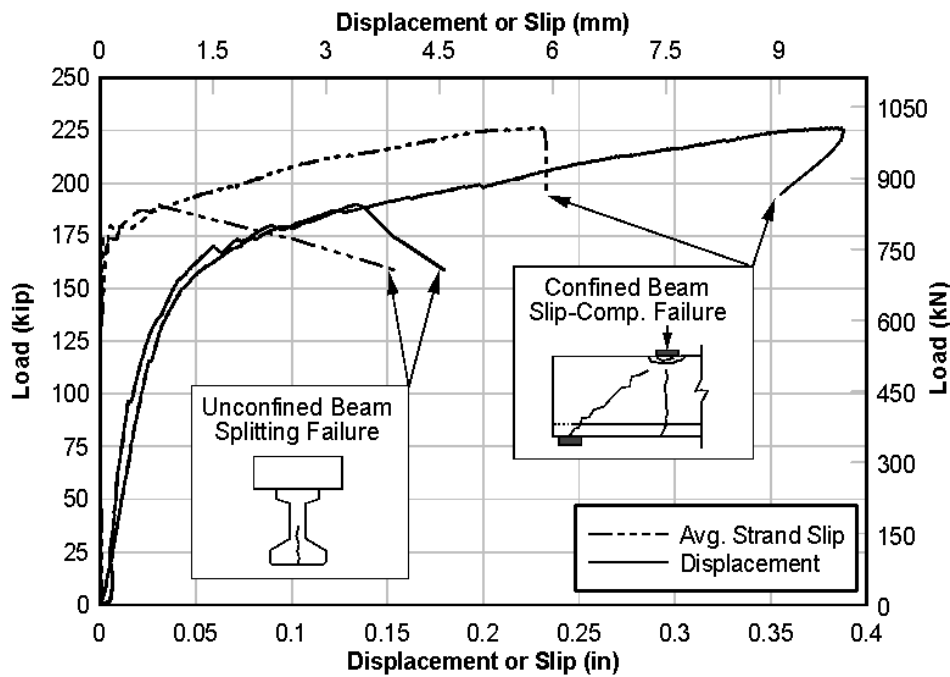
Figure 8–Load vs. displacement and strand slip

initiating strand slip. Strand slip was gradual at first, but increased when the load reached approximately 175 kip (779 kN). Slip and displacement characteristics of the confined and unconfined ends remained similar up to a load of 190 kip (846 kN), at which point the unconfined specimen failed in a splitting mode. Splitting failures were characterized by formation of splitting cracks at the end of the beam above the support, accompanied by sudden strand slip and an almost instantaneous loss of capacity.

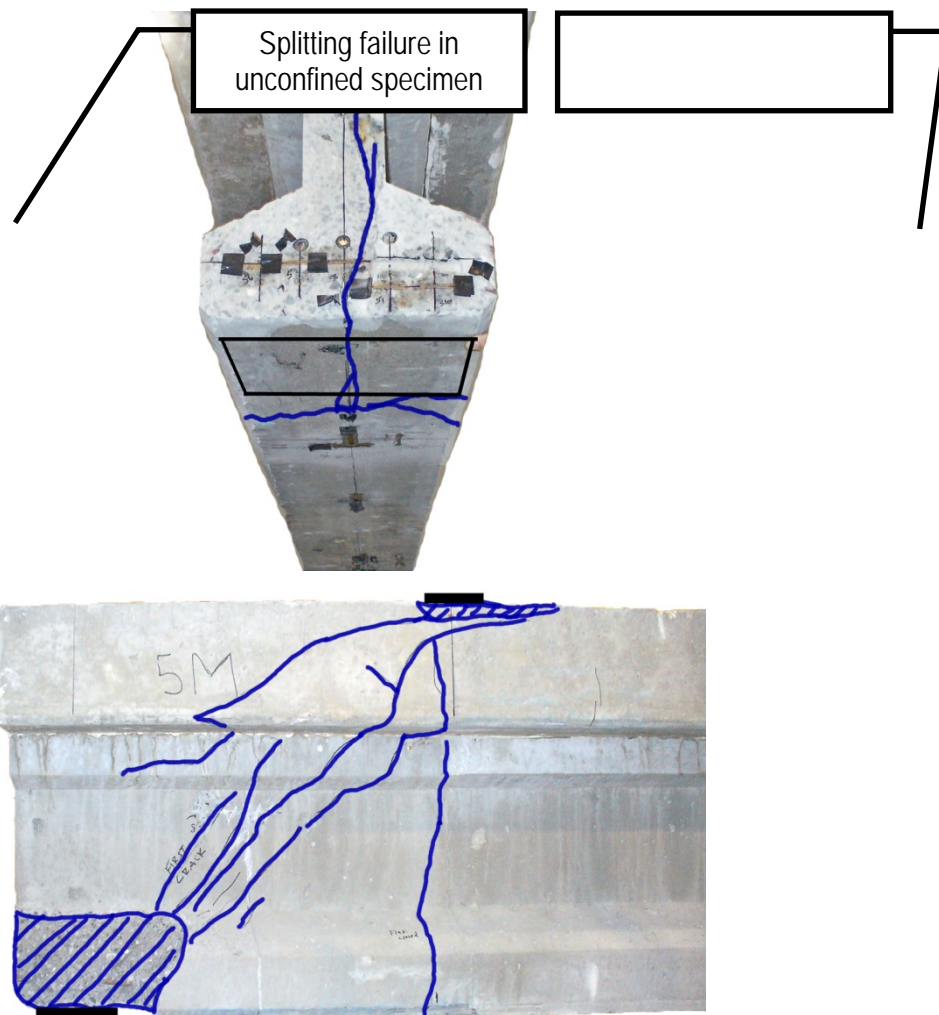
Figure 9–Failure of unconfined (left) and confined (right) specimens

For the confined end, load continued to increase until failure occurred at a load of 226 kip (1006 kN). The continued load increase, however, was accompanied by further strand slip indicating that the remaining development length provided sufficient anchorage to maintain stability of the mechanism. As the strands slipped, the diagonal crack opened further, reducing the concrete area available to resist the compression in the top of the section. Capacity was reached when the concrete below the load point was crushed due to the excessive rotation that was allowed, in part, by strand slip. Indeed most of the rotation occurred about the inclined crack, which shortened the available strand development length. Strands in the confined end slipped 0.23 in. (5.8 mm) at failure. Enhanced photographs of the failed test specimens are shown in Figure 9.

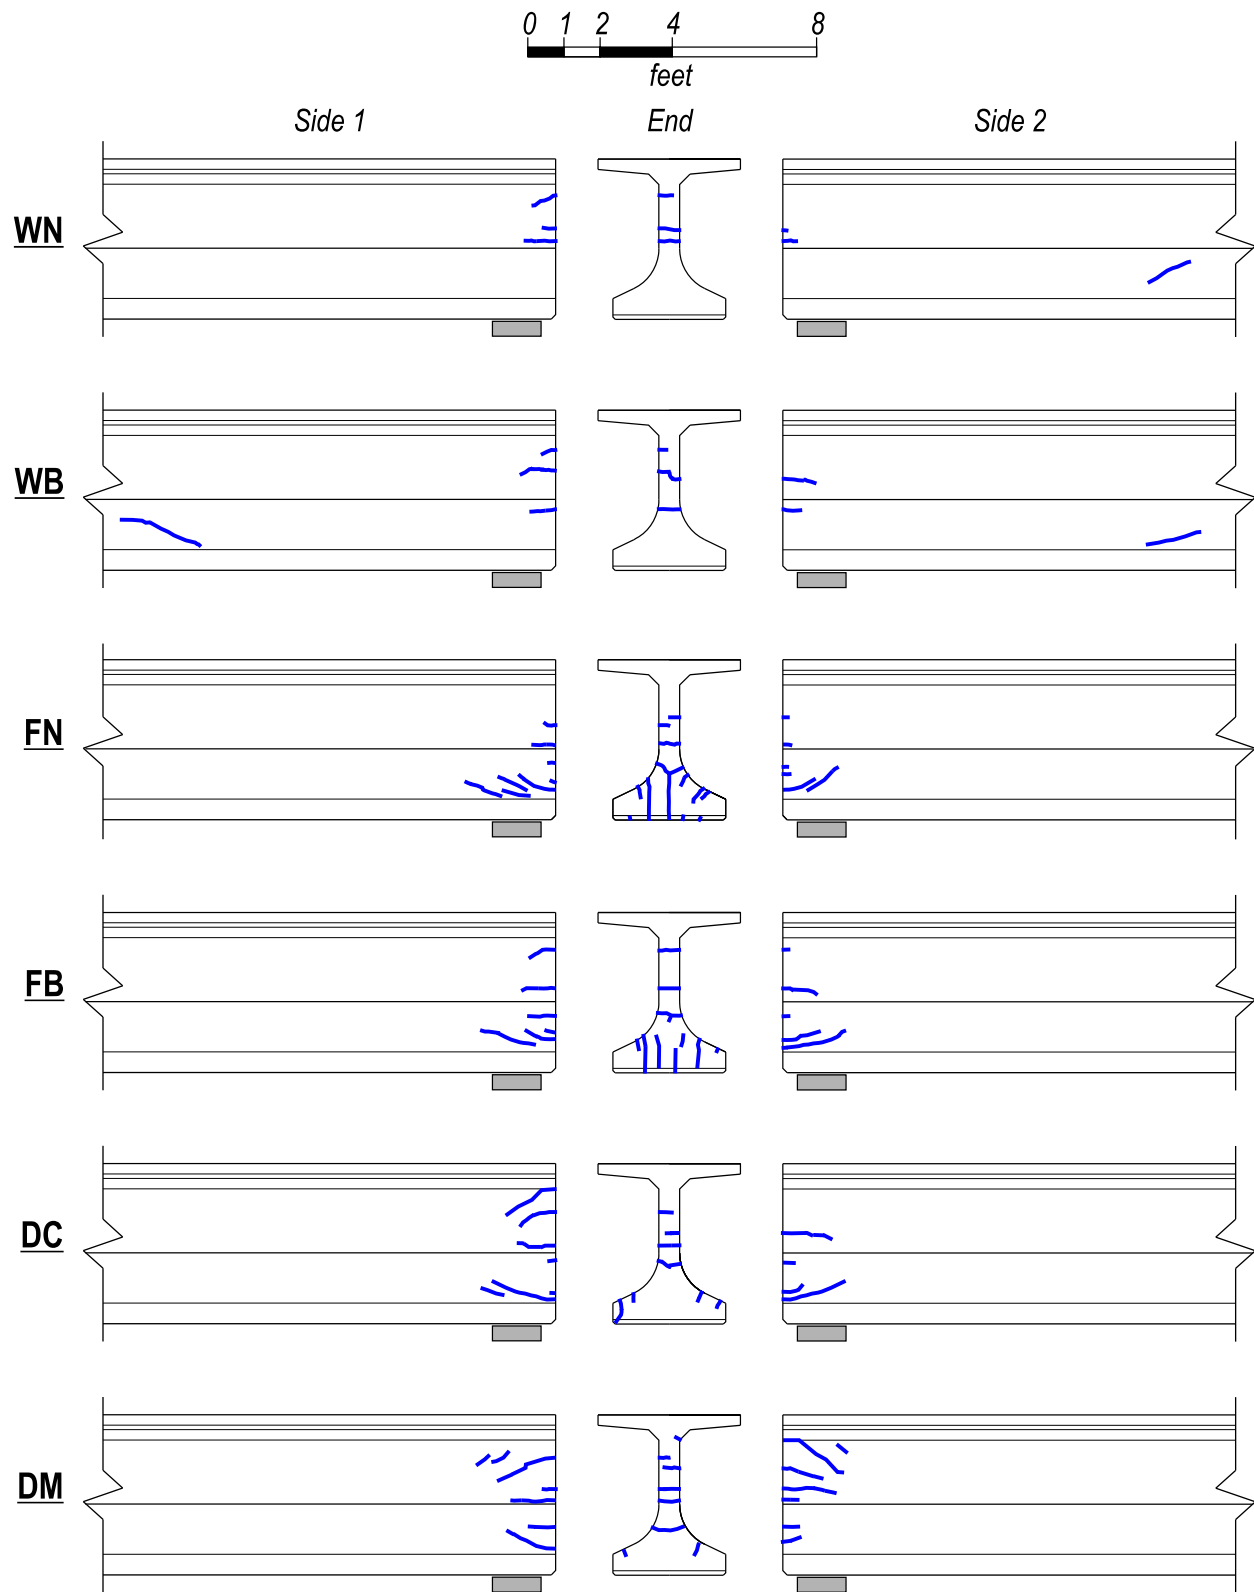
Figure 24–Girders W, F, & D web and flange splitting cracks

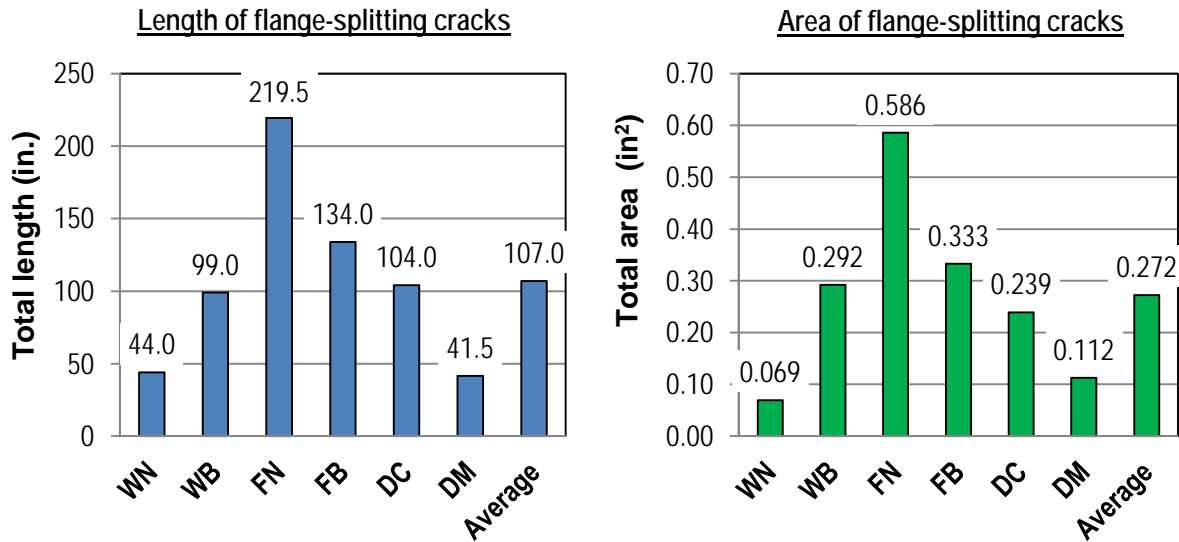
Figure 25–Flange splitting cracks girders W, F, and D

Each of the specimens listed in Figure 25 had the same Class of concrete, were fabricated at the same time, and were fabricated using the same procedures. Strand patterns, bearing plates, and confinement reinforcement varied among specimens. The most severe cracking, in terms of total length and area, occurred in specimens FB and FN. Severity of cracking in these specimens is attributed to the strand pattern. All of the fully bonded prestressing strands in these specimens were located in the outer portion of the flange. As discussed in the previous section, prestressing located in the outer portions of the flange caused transverse tension in the bottom flange. This transverse tension is culpable in the cracks observed in specimens FB and FN.

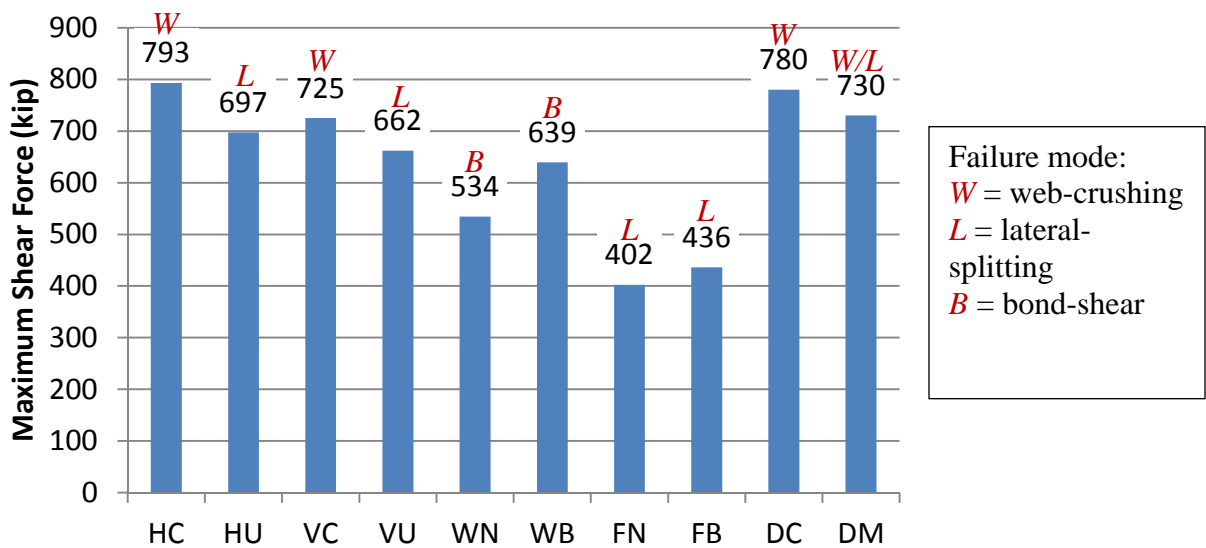
Figure 27–FIB-54 Peak shear forces

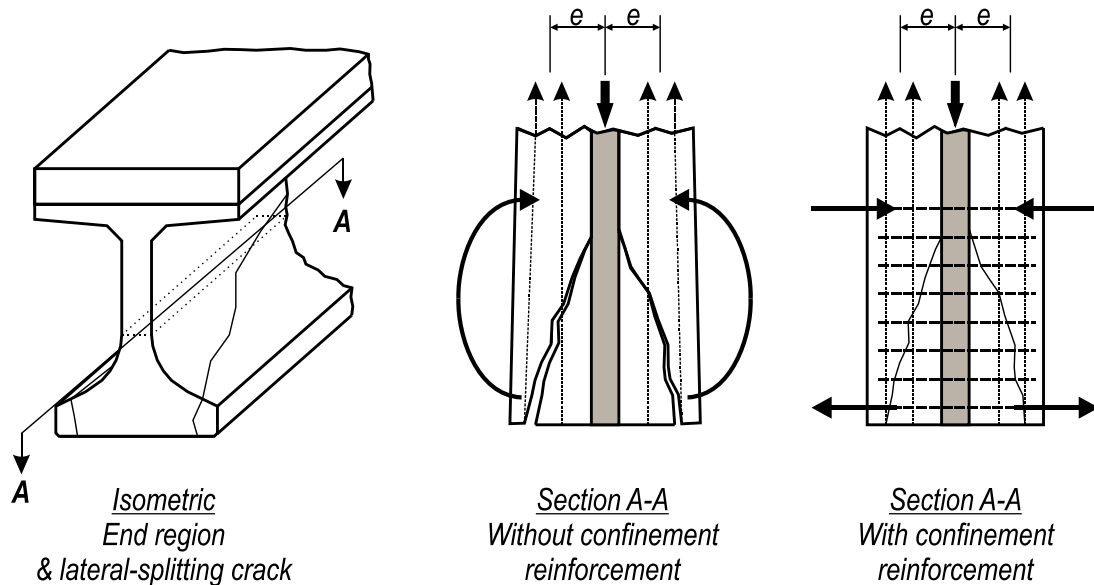
Figure 28–Lateral-splitting failure mechanics

Lateral-splitting and bond-shear failures are considered “premature” failure modes because they occur prior to a girder reaching the desired web-crushing capacity. ACI 318 and AASHTO LRFD provisions for shear design both consider web-crushing failure. In the test program, lateral-splitting failures occurred in specimens lacking confinement reinforcement and in specimens with all fully bonded prestressing strands placed in the outer portions of the bottom flange. Bond-shear failure was observed in specimens with the smallest quantity of fully bonded strands.

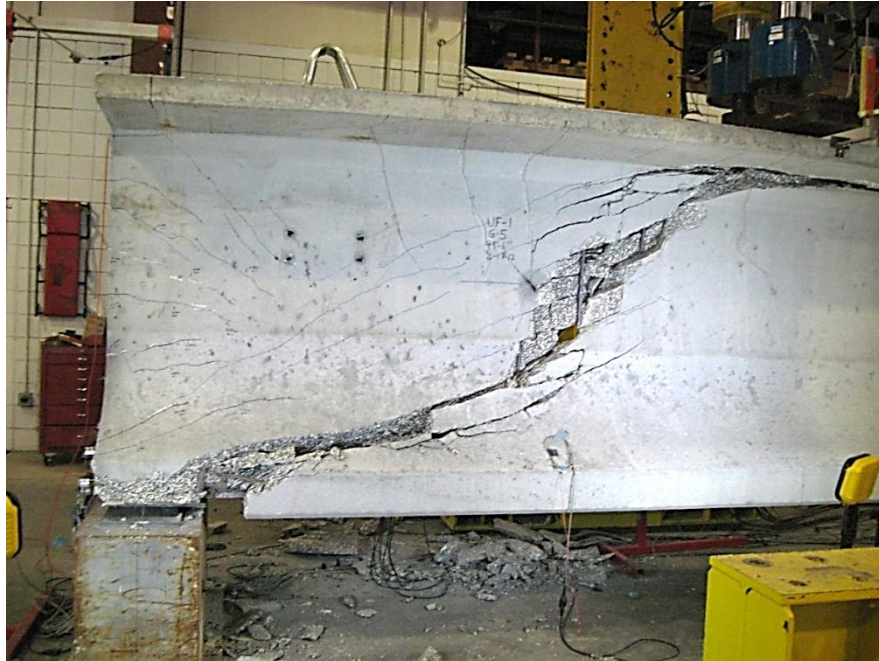
Figure 40–Specimen CT after load tests

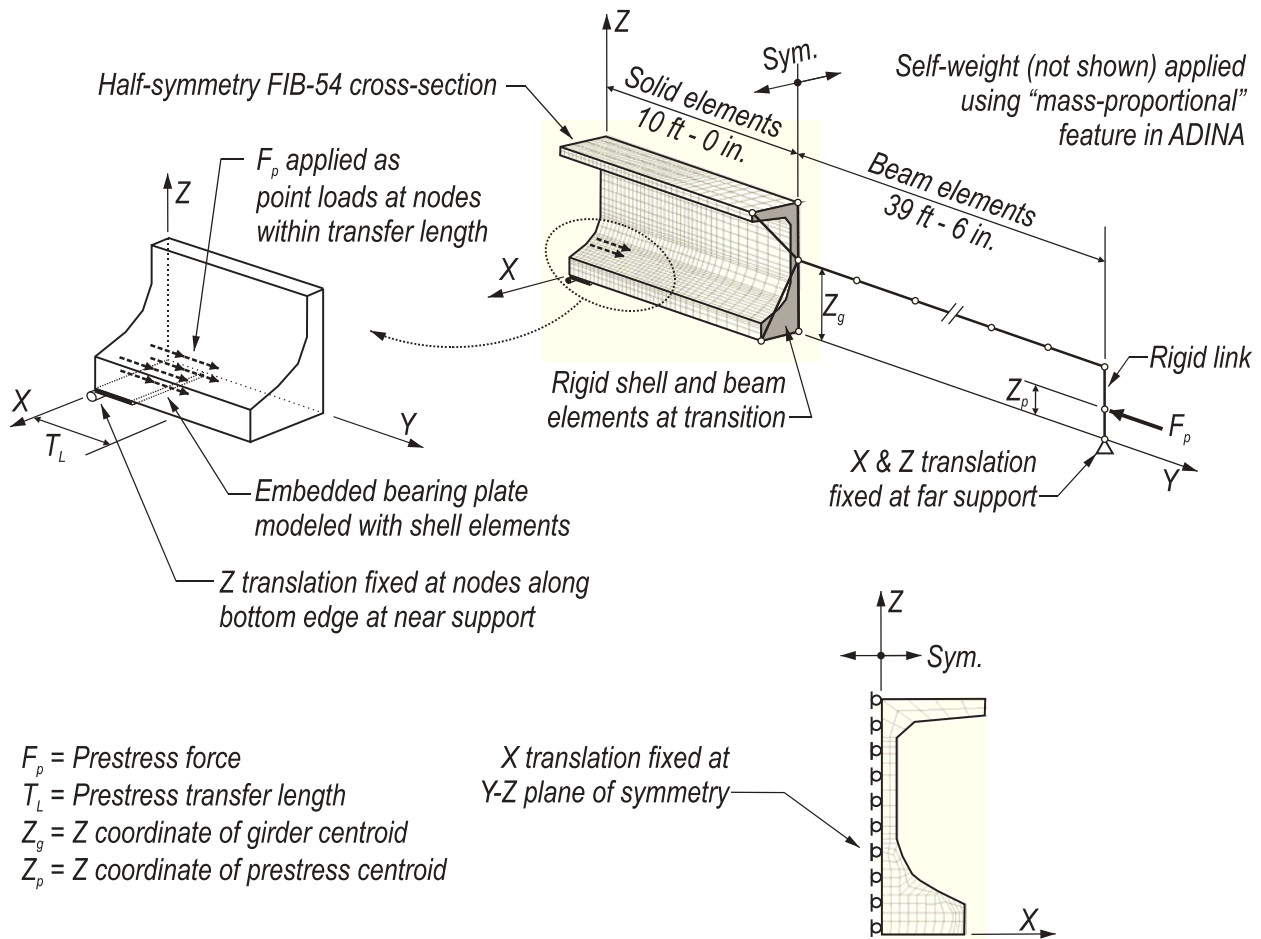
Figure 42–FE model details

One critical feature of the model was that prestressing forces were applied sequentially as occurs in physical girders during prestress transfer. To match the transfer process used in the experimental programs, prestressing forces were applied from the outside-in. In this manner the stress and strain state of the end region could be evaluated at different stages of the prestress transfer process. Self-weight was applied using the ‘mass proportional’ load feature of ADINA.

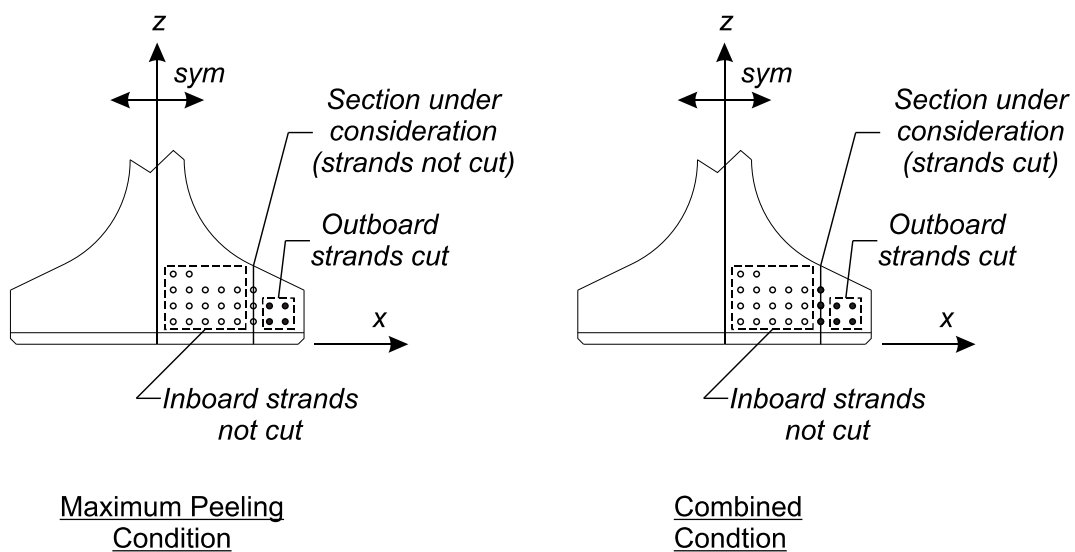
Figure 54–Strand release conditions

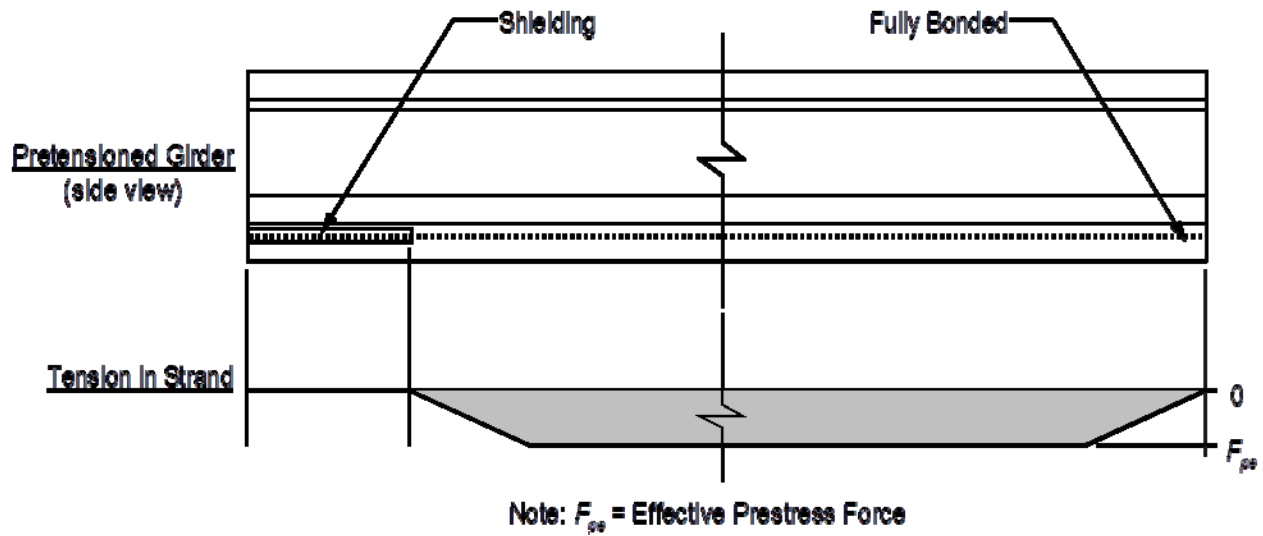
Figure 7–Strand debonding (shielding)

Strand debonding (shielding). Stress in pretensioned concrete girders can be controlled by selectively preventing force transfer between strands and concrete. To prevent force transfer, strands are debonded (also called shielding), at the ends of the beam. Debonding is accomplished by placing a sleeve over the strand to prevent bond with the concrete. Debonding moves the transfer length of shielded strands away from the girder end (Figure 7).

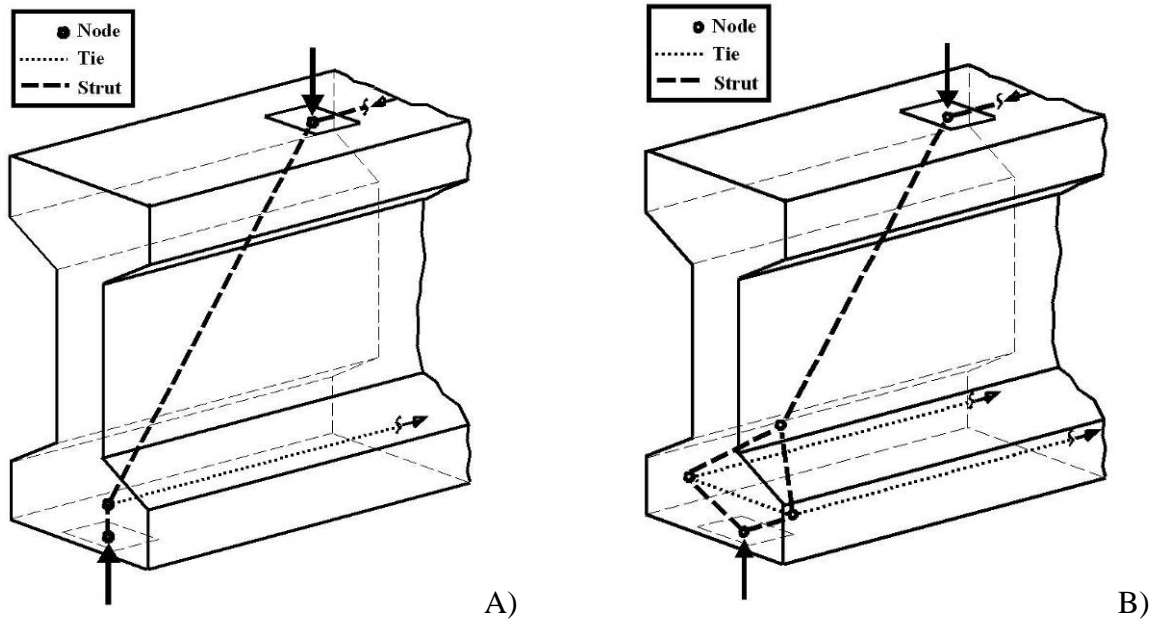
Figure 13–End region strut and tie models A) with fully bonded strands below web and B) debonded strands concentrated below web.

were the only strands able to act as ties (Figure 13b). This resulted in a disruption of the node at the support point. Because of the offset between the strut in the web and the two ties (fully bonded strands) in the bottom flange, secondary struts formed to transfer the load laterally to the nodes at the ties. Additional secondary struts were essential between the support and the nodes at the ties to complete the load path to the support. Both pairs of secondary struts induced horizontal components that acted transverse to the beam.

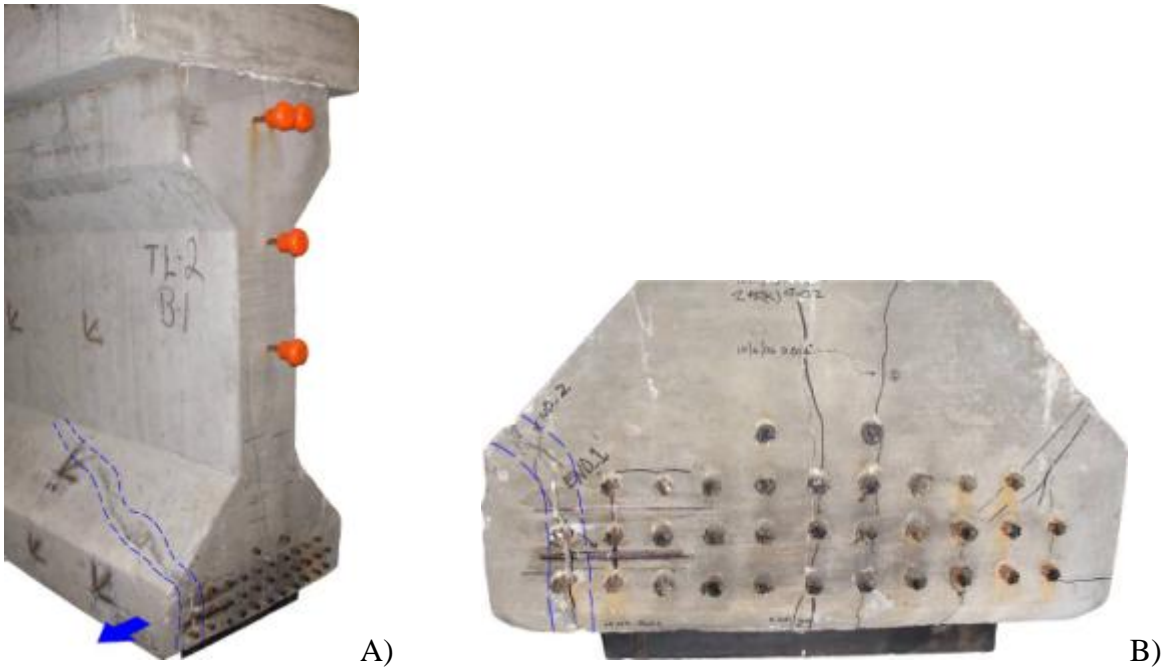
Figure 14–Flange cracking in girder with debonded strands concentrated below web A) side view and B) end view.

Test beams had no reinforcement (such as confinement reinforcement) to support the transverse force, and edges of the bottom flange peeled or split away at failure (Figure 14). The authors speculate that “[confinement] reinforcement might have held the bulb together after cracking.”

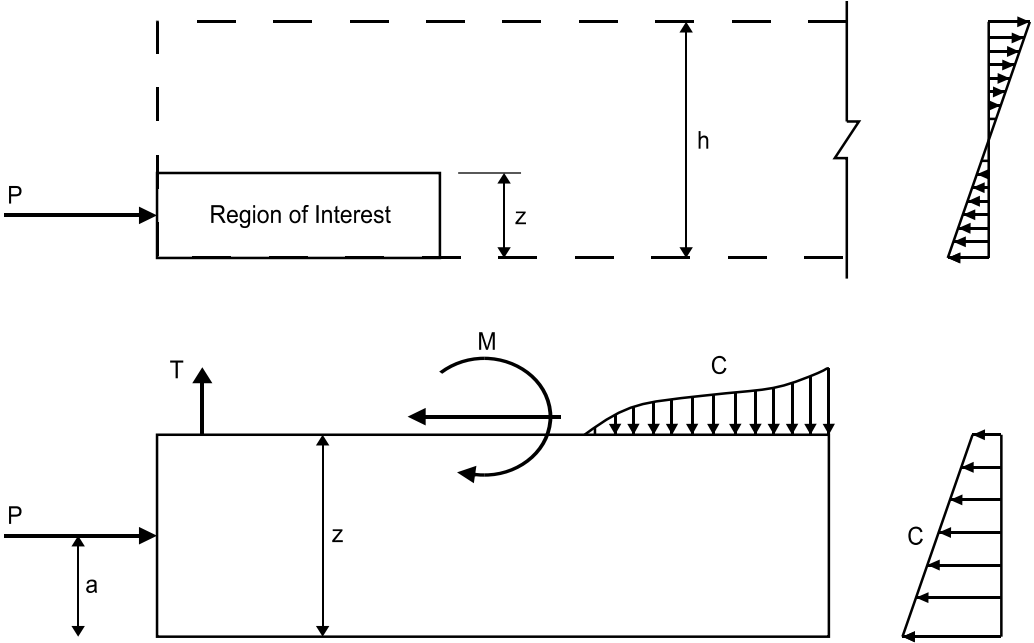
Figure 19–Free-body diagram based on Gergely-Sozen model (after Gergely et al. 1963)

Inelastic analysis was employed by Gergely et al. (1963) to produce the Gergely-Sozen model. Their approach assumed an initially cracked cross section and was based on equilibrium of the end region. The Gergely-Sozen model gives a conceptual framework for describing the formation of tensile forces in the web (Figure 19).

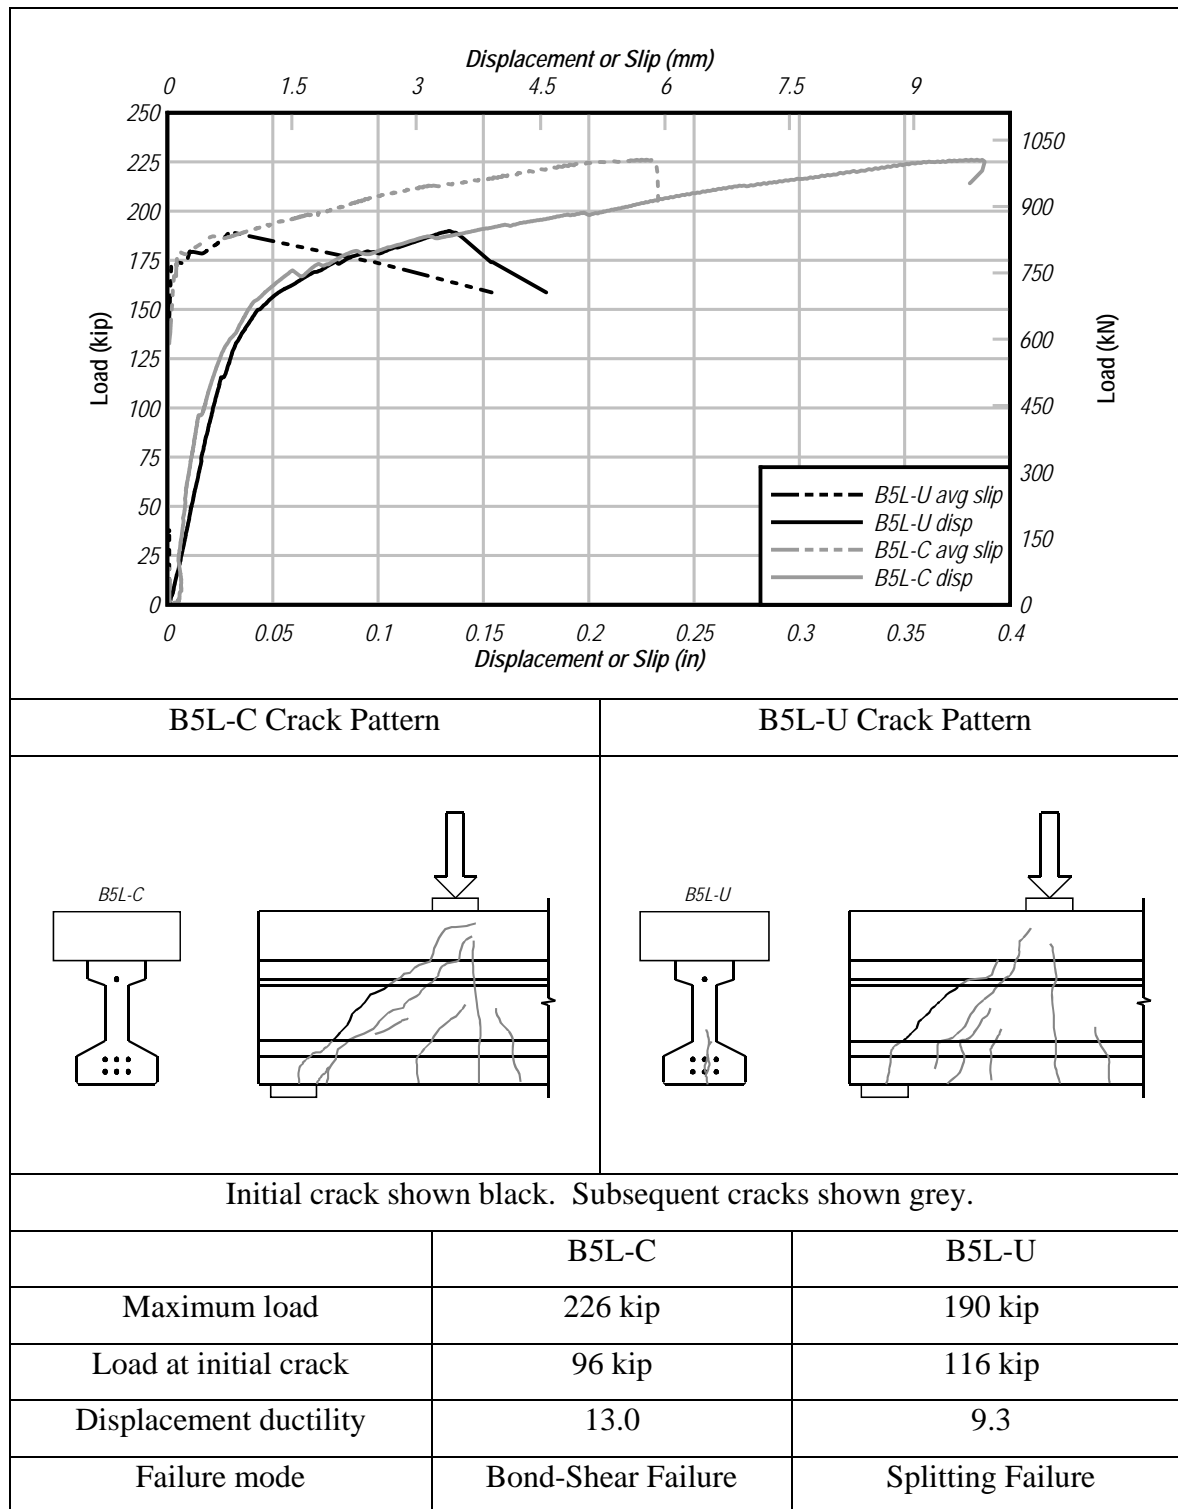
Figure 21–Summary of results for B5L-C and B5L-U

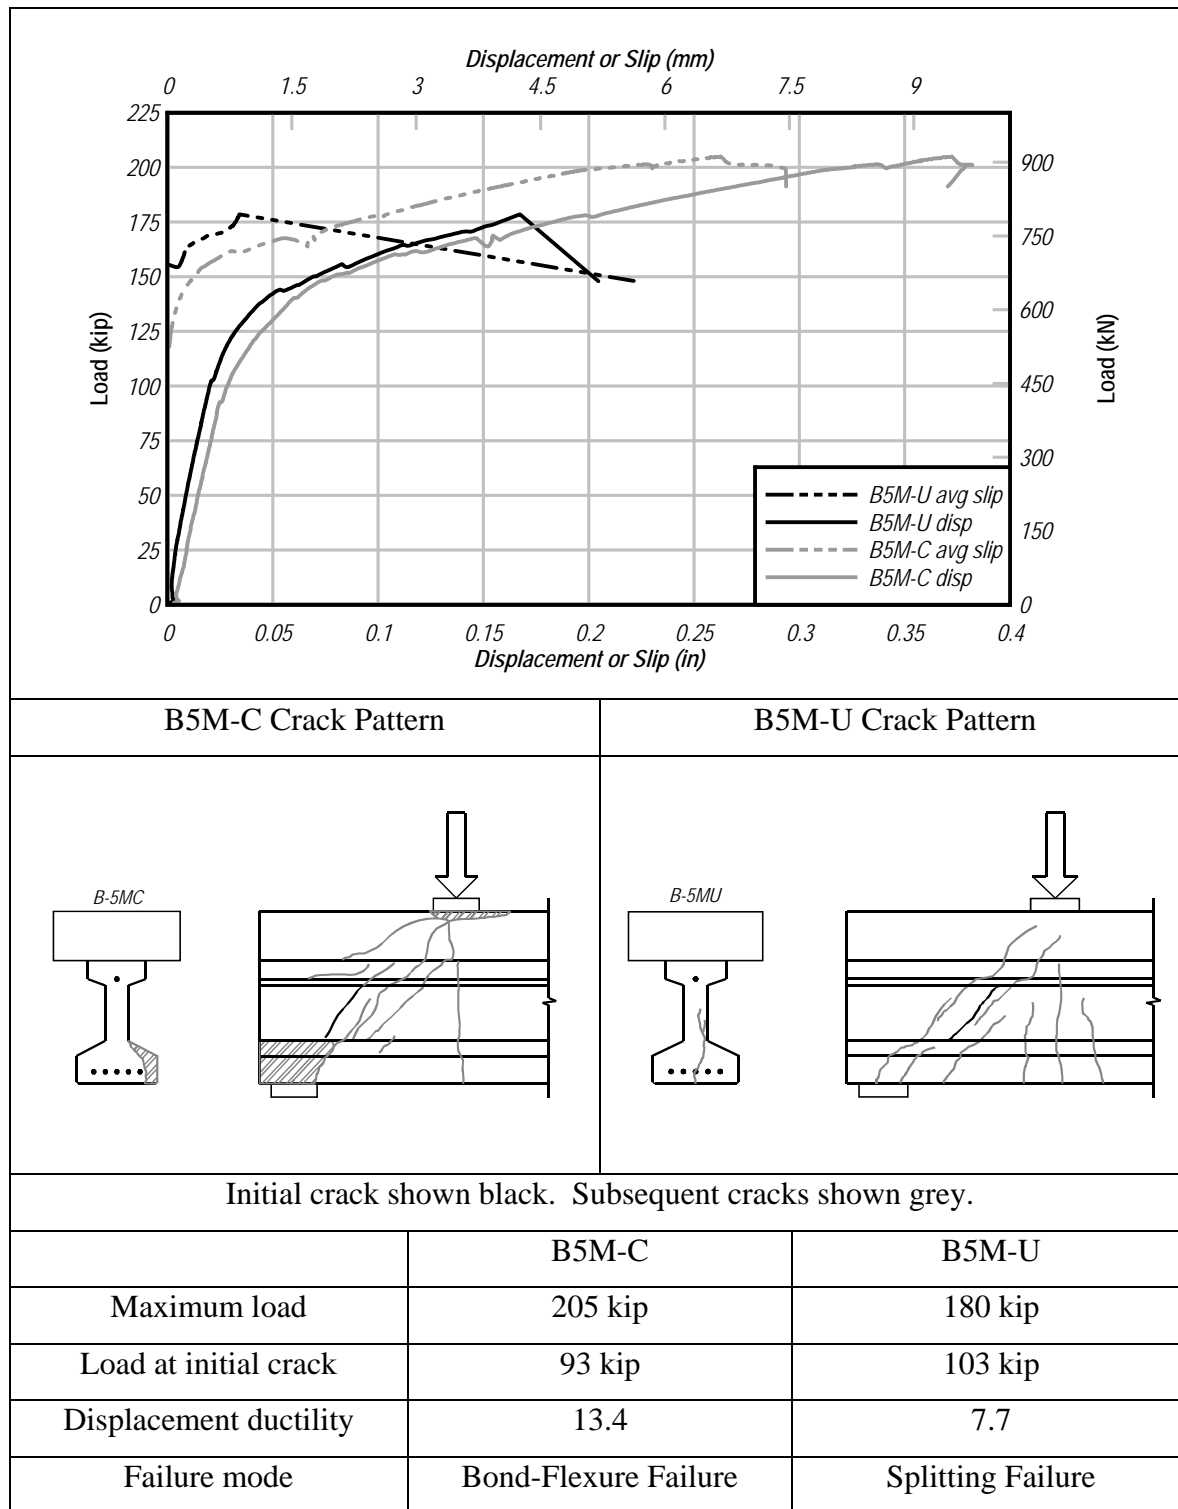
Figure 22–Summary of results for B5M-C and B5M-U

Figure 22 summarizes the test results of B5M-C and B5M-U. Each of these specimens had (5) 0.5-in. diameter strands and varied only due to the presence or lack of confinement reinforcement. Both specimens behaved linear elastically until the formation of cracks. The first cracks were inclined cracks occurring in the web between the near support and the load point. Strain data from S2 gages indicate that initial cracks formed at applied loads of 93 kip and 103 kip for B5M-C and B5M-U, respectively. As the load increased, additional cracks formed in each specimen, and the cracks propagated into the flanges and the deck. Stiffness of each specimen was similar throughout loading.

Splitting failure did not occur in B5M-C, allowing this specimen to support additional load and displacement beyond the point at which B5M-U failed. Absence of splitting in B5M-C is attributed to the confinement reinforcement which controlled formation of splitting cracks. By preventing splitting, the confinement reinforcement allowed larger loads to be developed in the top strand and vertical reinforcement, which added to the specimen capacity. B5M-C supported a maximum applied load of 205 kip. At this load, the compression zone on either side of the load point crushed. The rotation that led to compression zone crushing was augmented by strand slip. Failure of B5M-C (Figure 24) is designated as a bond-flexure failure.

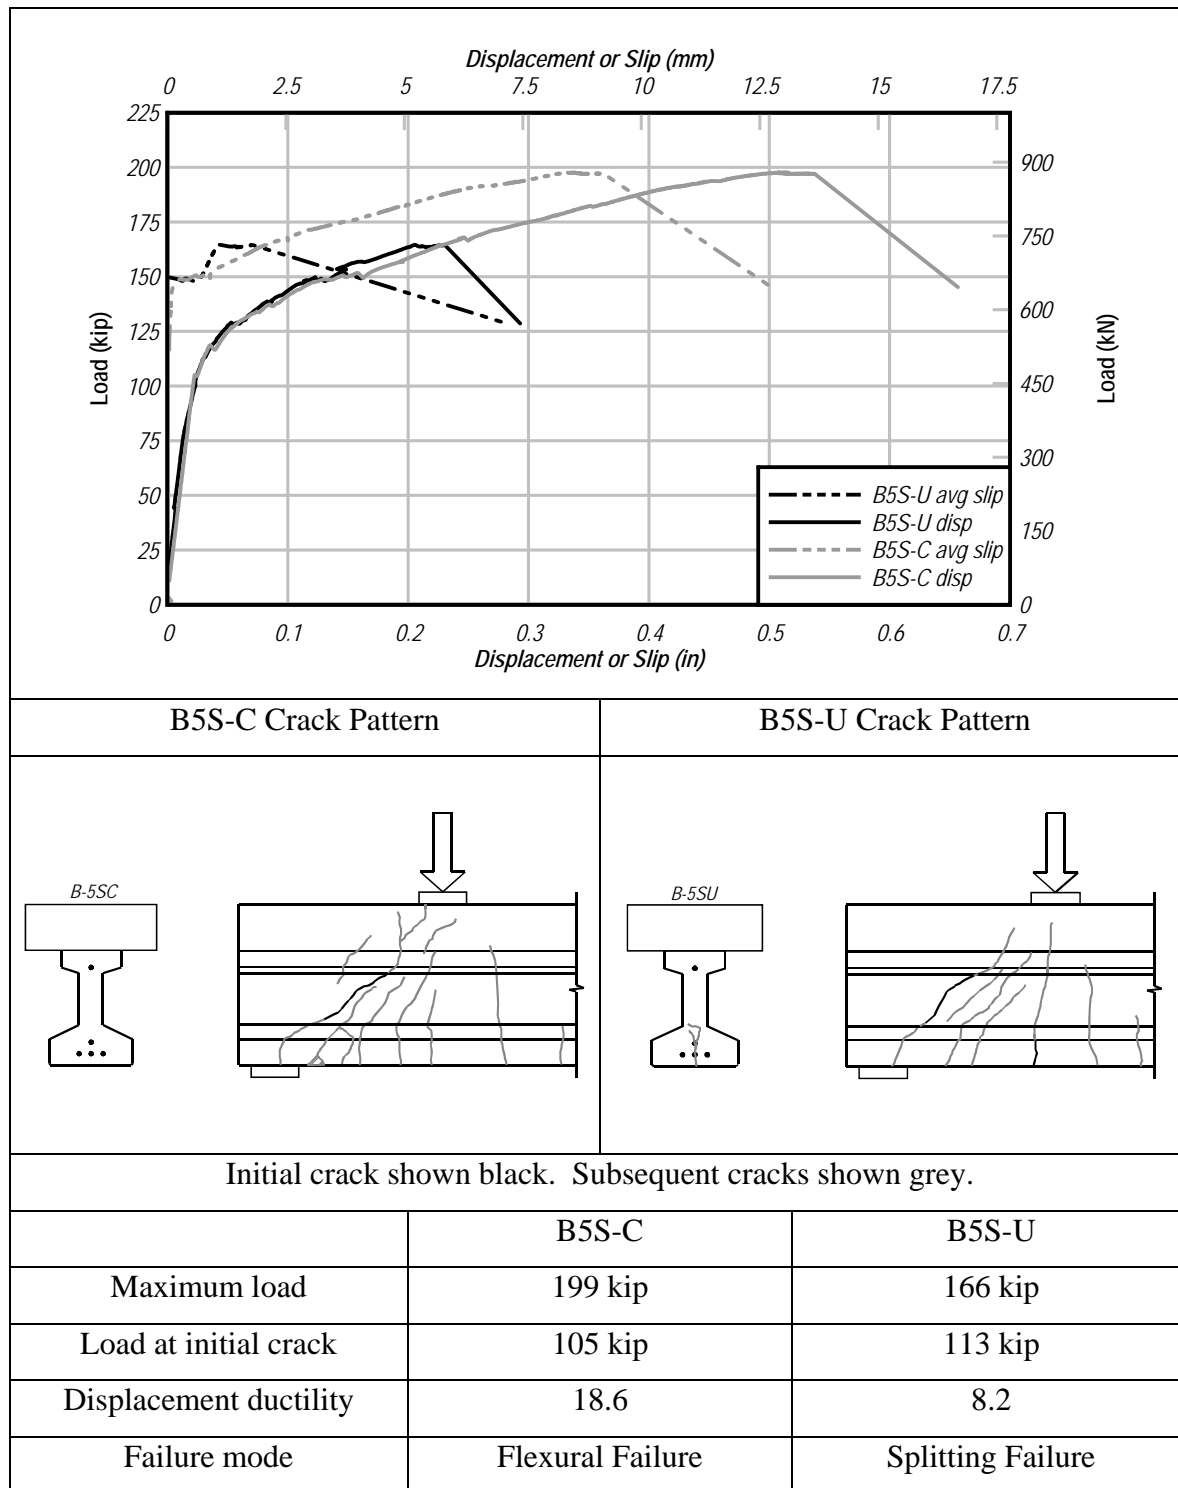
Figure 25– Summary of results for B5S-C and B5S-U

Splitting failure did not occur in B5S-C, allowing this specimen to support additional load and displacement beyond the point at which B5S-U failed. Absence of splitting in B5S-C is attributed to the confinement reinforcement which controlled formation of splitting cracks. By preventing splitting, the confinement reinforcement allowed larger loads to be developed in the top strand and vertical reinforcement, which added to the specimen capacity. Specimen B5S-C supported a maximum applied load of 199 kip. At this load, testing was terminated because the specimen had almost no stiffness. Continuation of the test would not have resulted in significantly higher load, but would have resulted in additional displacement, rotation, slip, and eventually crushing of the compression zone. Because B5S-C exceeded its nominal moment capacity, failure was categorized as a flexural failure. Figure 20 shows B5S-C after testing.

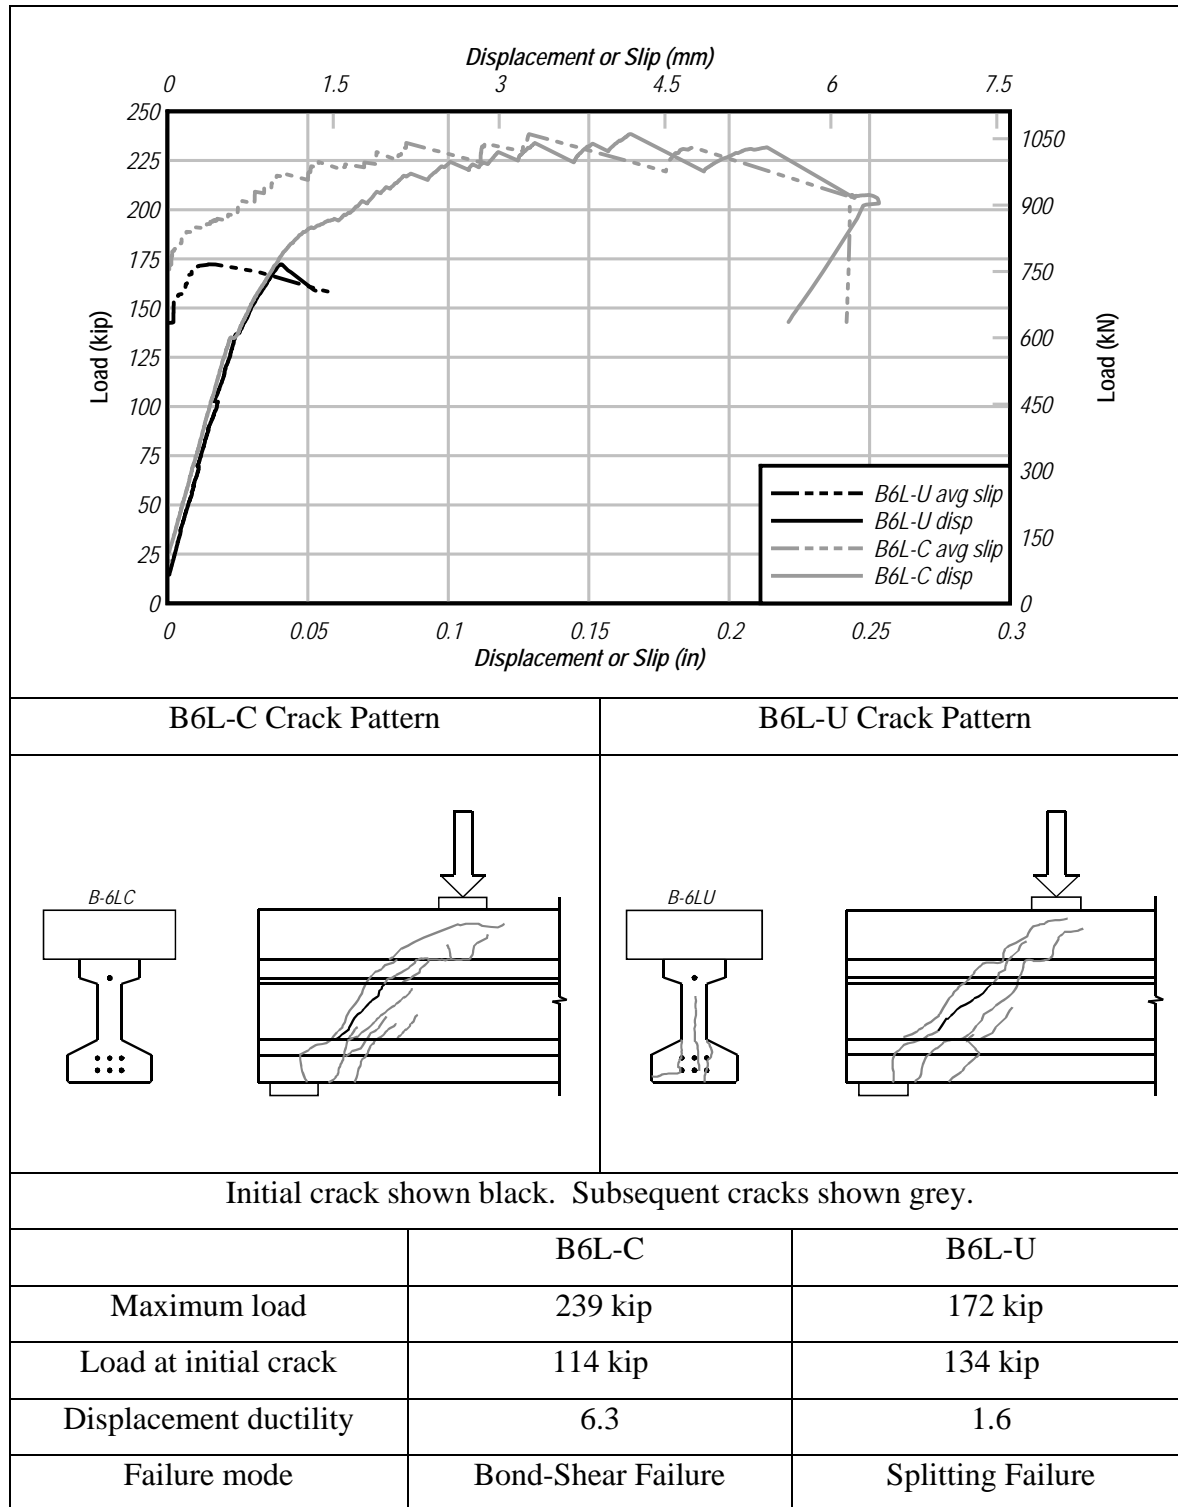
Figure 26– Summary of results for B6L-C and B6L-U

Failure of B6L-C (Figure 18) is designated as a bond-shear failure. The 239 kip load support by B6L-C is the largest load supported by any of the test specimens.

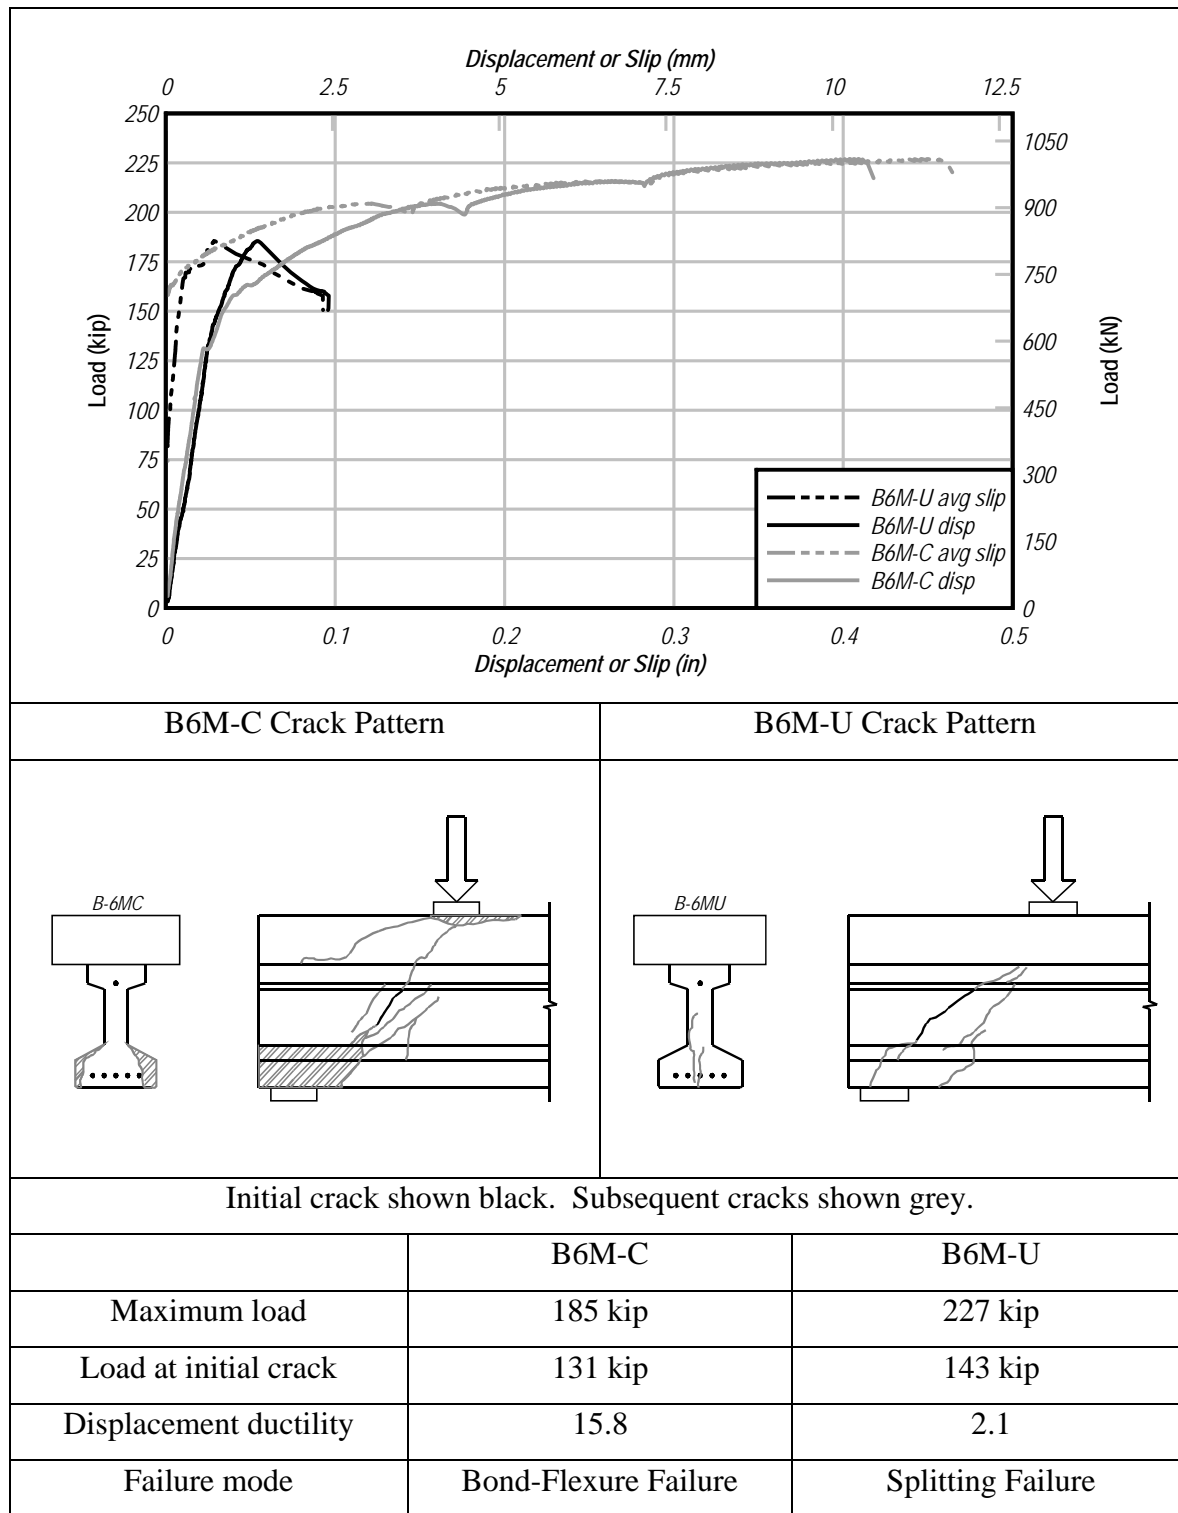
Figure 27– Summary of results for B6M-C and B6M-U

preventing splitting, the confinement reinforcement allowed larger loads to be developed in the top strand and vertical reinforcement, which added to the specimen capacity. Specimen B6M-C supported a maximum applied load of 227 kip. At this load, the compression zone on either side of the load point crushed. The rotation that led to compression zone crushing was augmented by the strands slipping. Failure of B6M-C (Figure 19) is designated as a bond-flexure failure.
