Final Report

March 2013

END REGION DETAILING OF PRETENSIONED CONCRETE BRIDGE GIRDERS

Sponsor:
Florida Department of Transportation (FDOT)
Sam Fallaha, P.E. – Project Manager

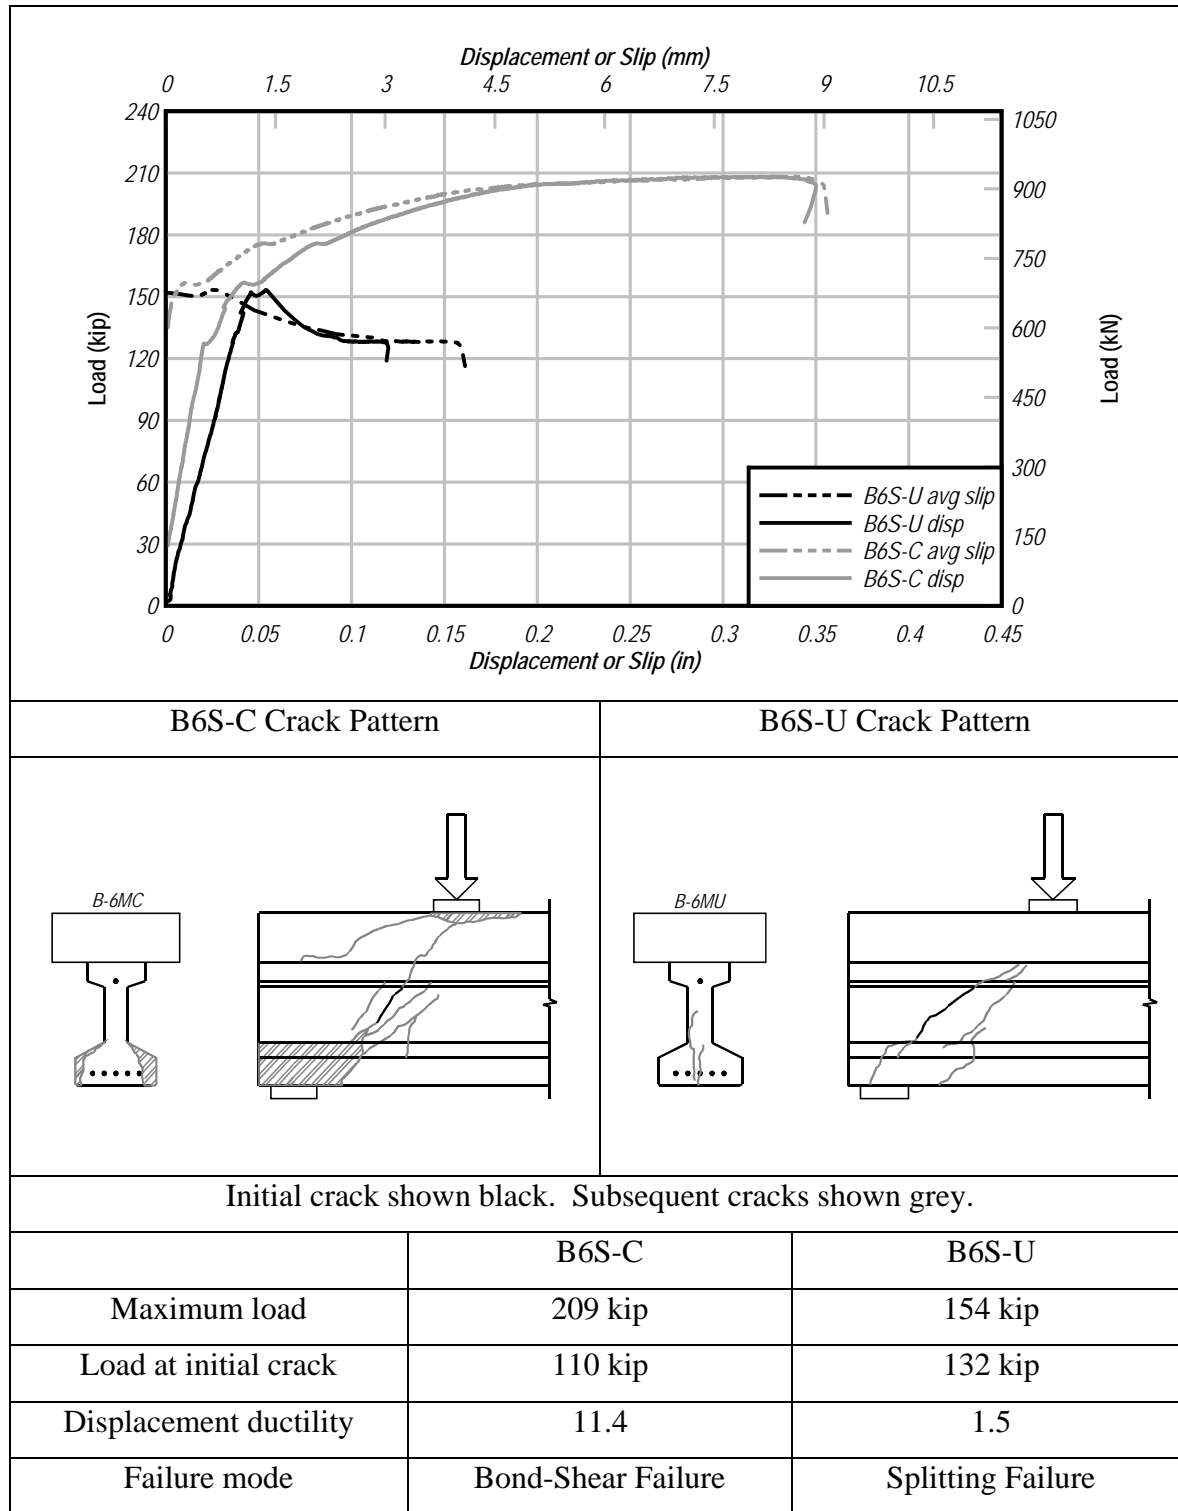
Figure 28– Summary of results for B6S-C and B6S-U

Splitting failure did not occur in B6S-C, allowing this specimen to support additional load and displacement beyond the point at which B6S-U failed. Absence of splitting in B6S-C is attributed to the confinement reinforcement which controlled formation of splitting cracks. By preventing splitting, the confinement reinforcement allowed larger loads to be developed in the top strand and vertical reinforcement, which added to the specimen capacity. Specimen B6S-C supported a maximum applied load of 209 kip. At this load, testing was terminated because the specimen had almost no stiffness. Continuation of the test would not have resulted in significantly higher load, but would have resulted in additional displacement, rotation, slip, and eventually crushing of the compression zone. Failure of B5S-C (Figure 29) is designated as a bond-shear failure.

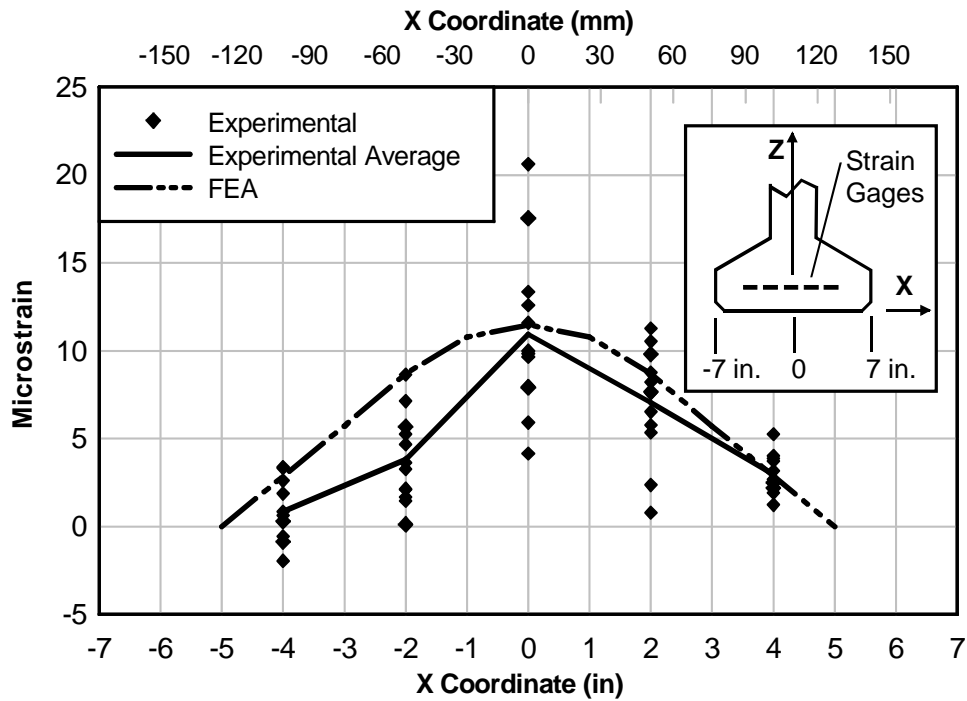
Figure 30–Transverse strain above near support (load =15 kip)

Strain gages were placed at the end of the specimens above the near support (Figure 15) to measure the transverse strain in the bottom flange. Figure 30 shows the strains reported by these gages at a load of 15 kip. This load was chosen because it was well within the linear-elastic range of all tests. Strain gages from each specimen reported that transverse strain was greatest below the web and decreased towards the edges of the flange. Figure 30 also shows the results of a finite element analysis which will be discussed in Appendix F.

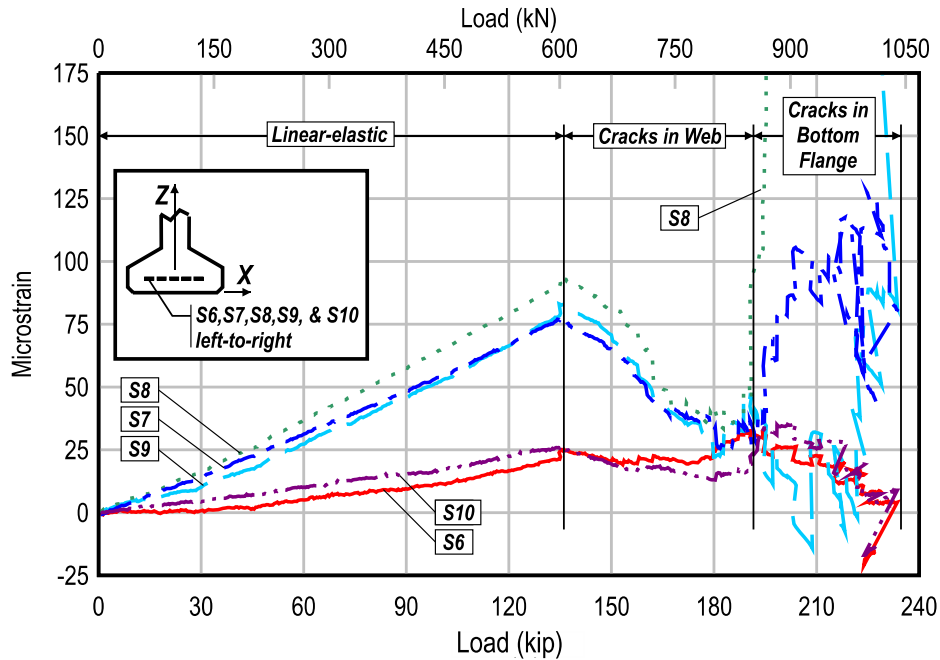
Figure 31–Effect of load on transverse strain in confined specimen (B6L-C).

Figure 31 presents the superimposed shear versus transverse strain data from gages on the end of B6L-C. The trends in the figure are representative of all tests with confinement reinforcement. At the beginning of the test the strain was initially proportional to the applied load, indicating linear-elastic behavior. The strain-load relationship became nonlinear after the formation cracking in the web, and changed rapidly after the cracks propagated into the bottom flange and the strands began slipping. Splitting cracks were not visually observed in the confined specimens; however strain data suggest that a vertical splitting crack likely formed at the end of the confined specimens. This can be observed in Figure 31, where gage S8 reported a sudden increase in strain tensile strain at a load of approximately 190 kip. The magnitude of tensile strain reported by S8 is indicative of crack formation. Because of the confinement reinforcement, these cracks were controlled and splitting failure was prevented.

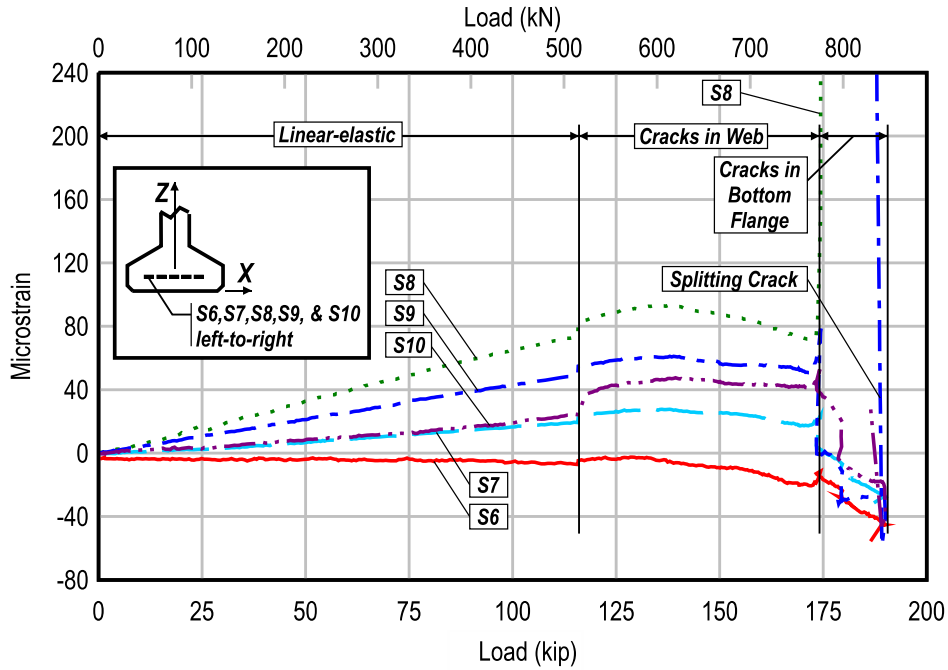
Figure 32–Effect of load on transverse strain in unconfined specimen (B5L-U)

nonlinearity. Because transverse tensile strains did not occur in the confined specimen, the confinement reinforcement was thought to have prevented the propagation of splitting cracks near gage S4. This conclusion is supported by a visual examination of the specimen, which did not detect any splitting cracks at the end of B5M-C.

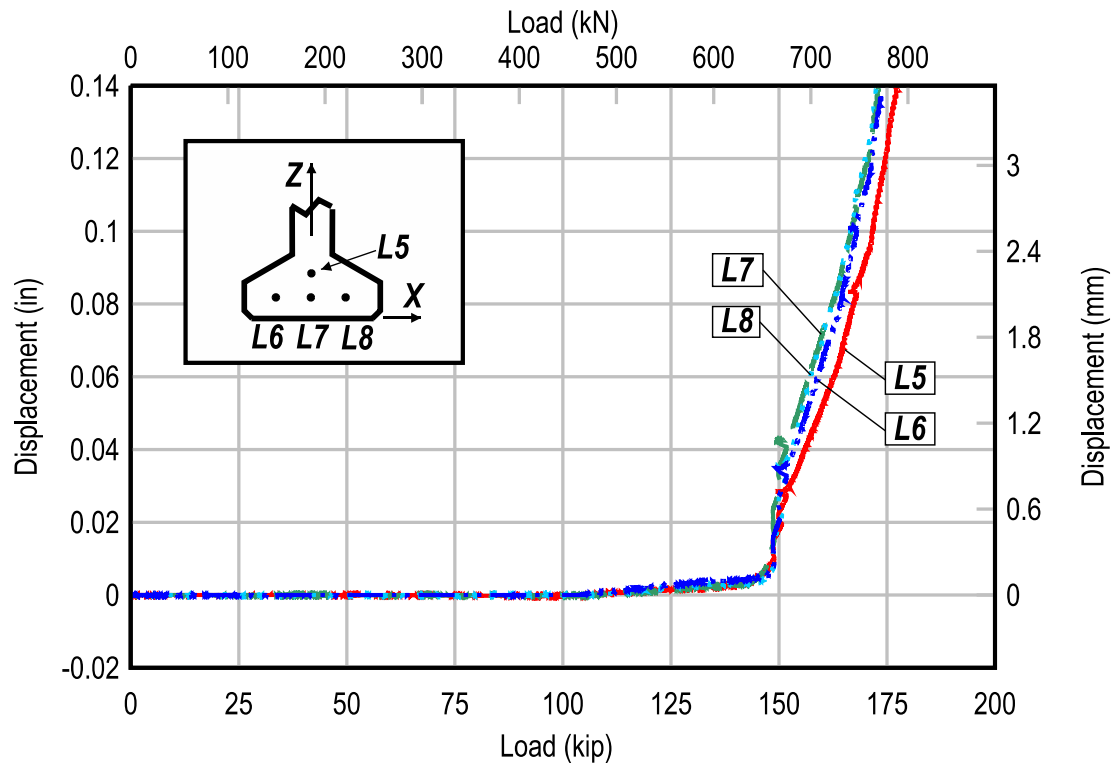
Figure 35–Prestressing strand slip in specimen B5S-C

Strand slip data have been presented as the average slip of the bonded strands. Average slip is a convenient way of evaluating overall slip behavior, but load-slip data from individual strands is also instructive. Figure 35 presents the load-slip data for each strand in specimen B5S-C, and demonstrates general trends observed in the slip data from confined tests. Strand slip in B5S-C began gradually after the formation of cracks at load of approximately 120 kip, then increased rapidly as cracks propagated into the bottom bulb at approximately 145 kip. Each strand slipped at approximately the same load and through the same distance.

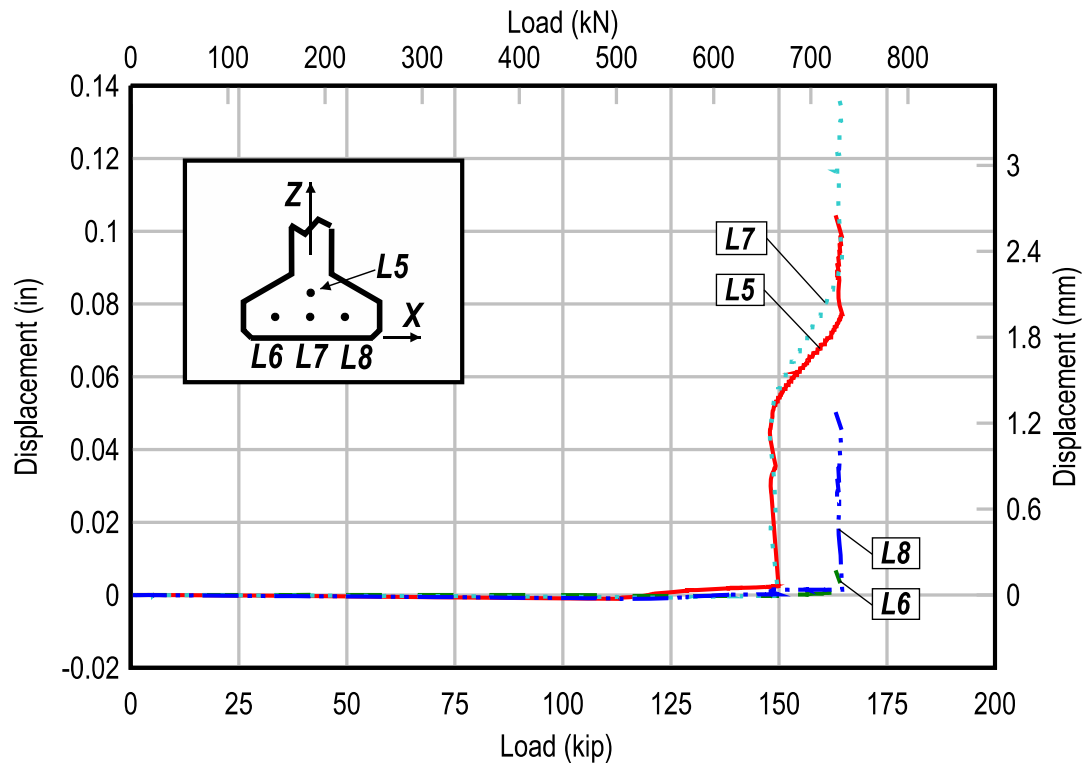
Figure 36–Prestressing strand slip in specimen B5S-U

Figure 36 shows the load-slip behavior for B5L-U, and demonstrates general trends observed in the slip data of the unconfined tests. Strand slip in the B5L-U occurred abruptly, and individual strands did not slip at the same load or through the same distance. The first strands to slip were those located at the centerline of the cross-section below the web. This can be seen in the figure, where strands 5 and 7 (located at the cross-section centerline) slipped first. Strands 6 and 8 were located away from the centerline and slipped later. An “unzipping” mechanism appears to have occurred in the unconfined specimens, where load was transferred to the outer strands after the inner strands began to slip. The outer strands also began to slip after the strand/concrete bond capacity was exceeded. All strands slipped when a splitting crack formed at the peak load of 166 kip.

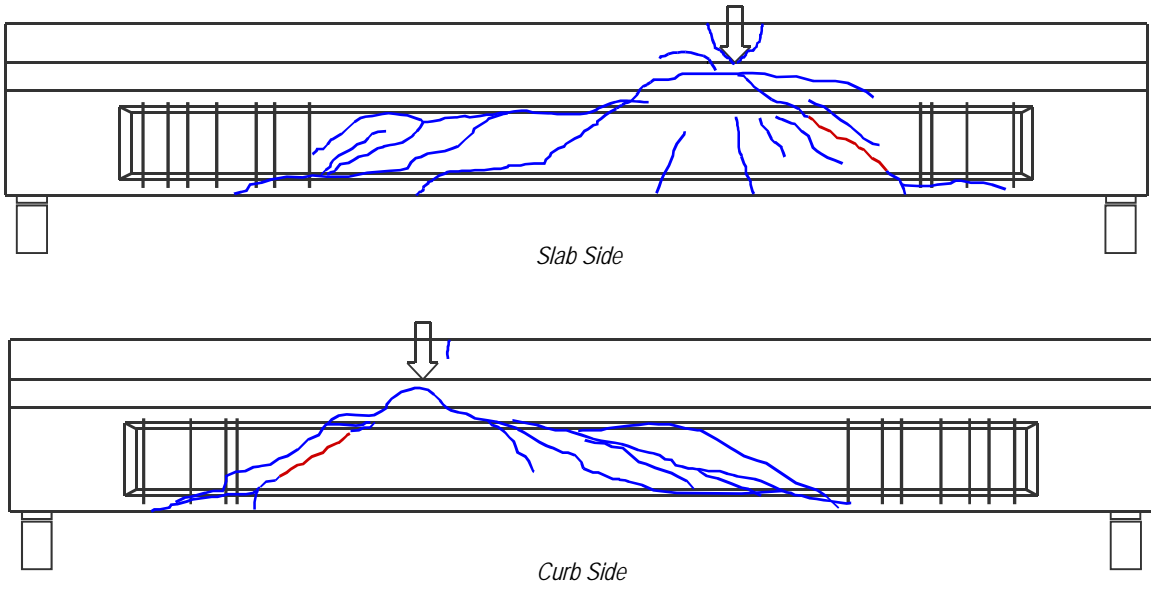
Figure 14–X7 cracks (initial crack in red)

Referring to Figure 12, the abrupt changes in the shear-displacement curve between 65kip and 70kip correspond to the formation of additional cracks. Cracks formed farther from the load point and at shallower angles as the load increased. Comparing the final crack pattern with the location the transverse reinforcement (Figure 14), it is noted that with only one exception, the cracks did not cross transverse reinforcement. Thus, after cracking the load could not have transferred through truss action, but rather was carried through arch action. Girder X7 supported a maximum superimposed shear of 84kip. At this load a punching shear failure occurred in the slab and curb. Figure 16 is a photo of the curb side of X7 showing the location of the punching failure. The red strap in the picture is from the crane which was lifting the girder as the photo was taken.

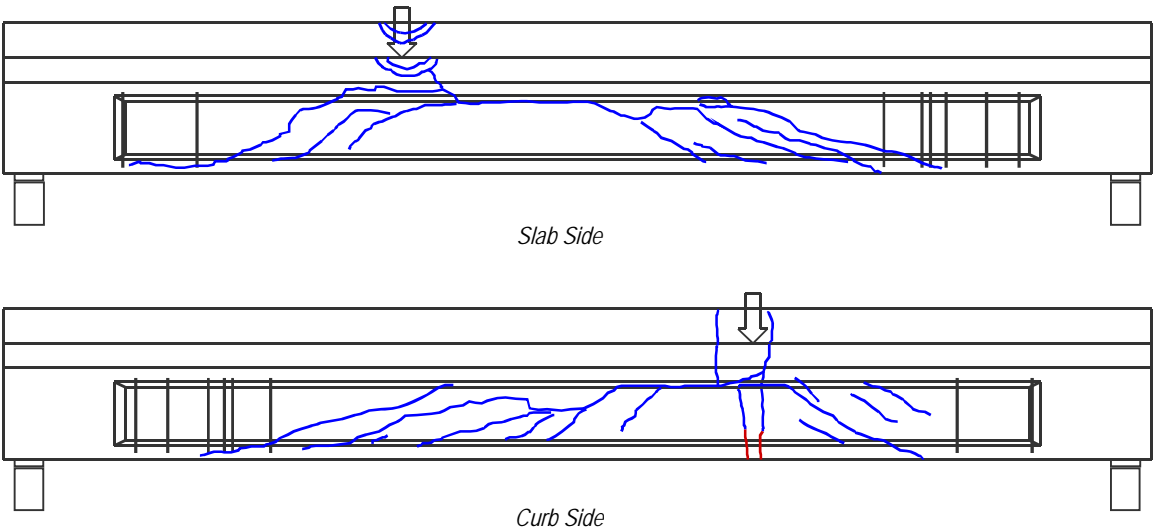
Figure 20-X4 cracks (initial cracks in red)

The abrupt changes in the shear-displacement plot at 62kip and 66kip correspond to the formation of incline cracks in the web. Cracks continued to form farther from the load point and at shallower angles as the load increased. At the final stages of the load test incline cracks had a maximum width of 1 in. As shown in Figure 20 vertical reinforcement was not engaged by the inclined cracks. The relatively large crack widths and absence of engaged vertical reinforcement suggest that the girder supported load by arch-action.

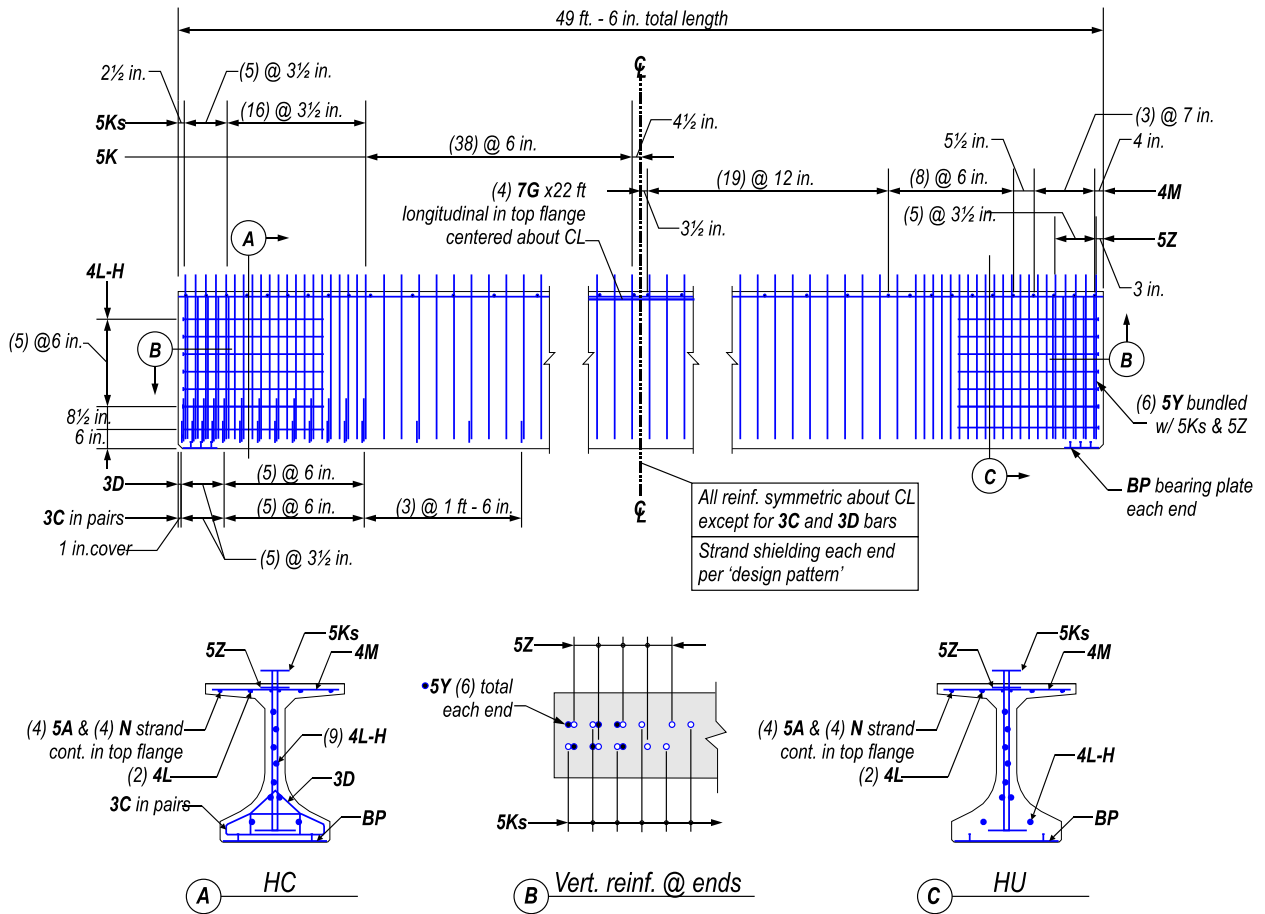
Figure 10—Reinforcement for girder H

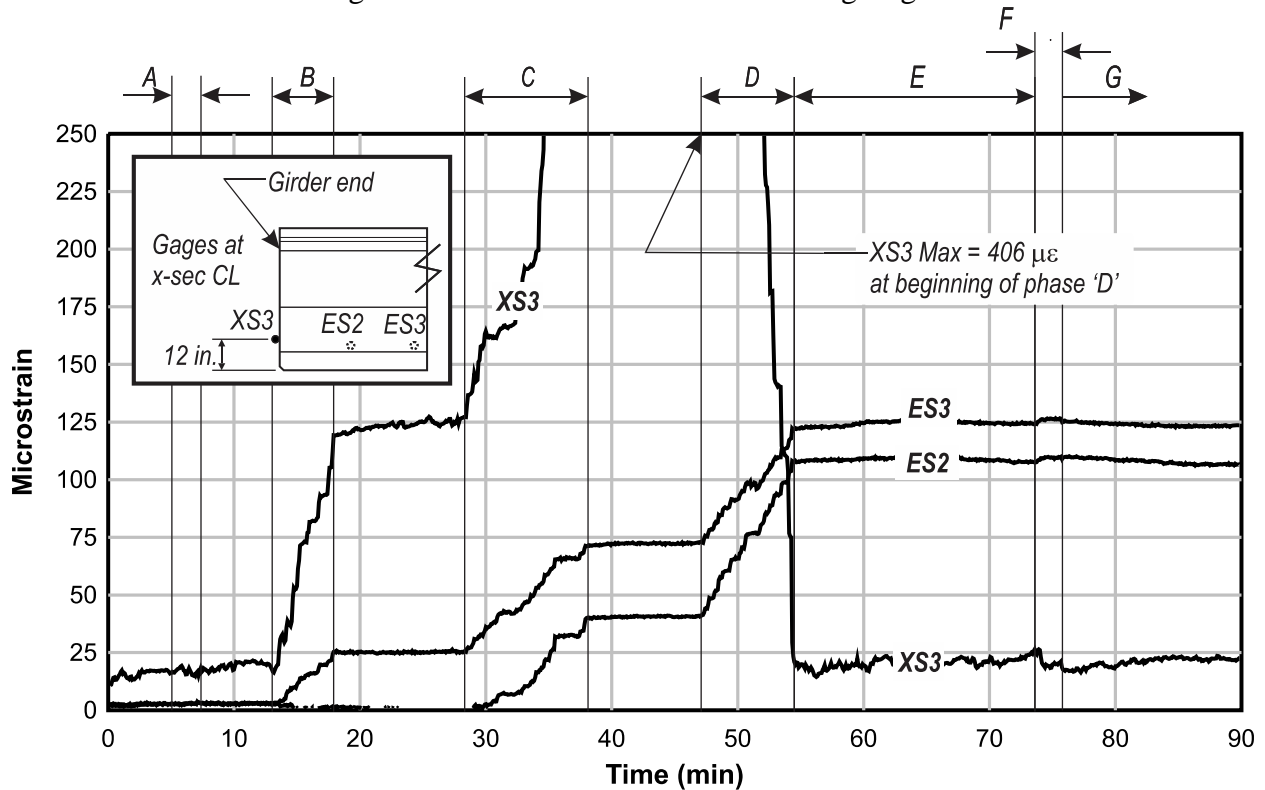
Figure 52–Transverse strain HC

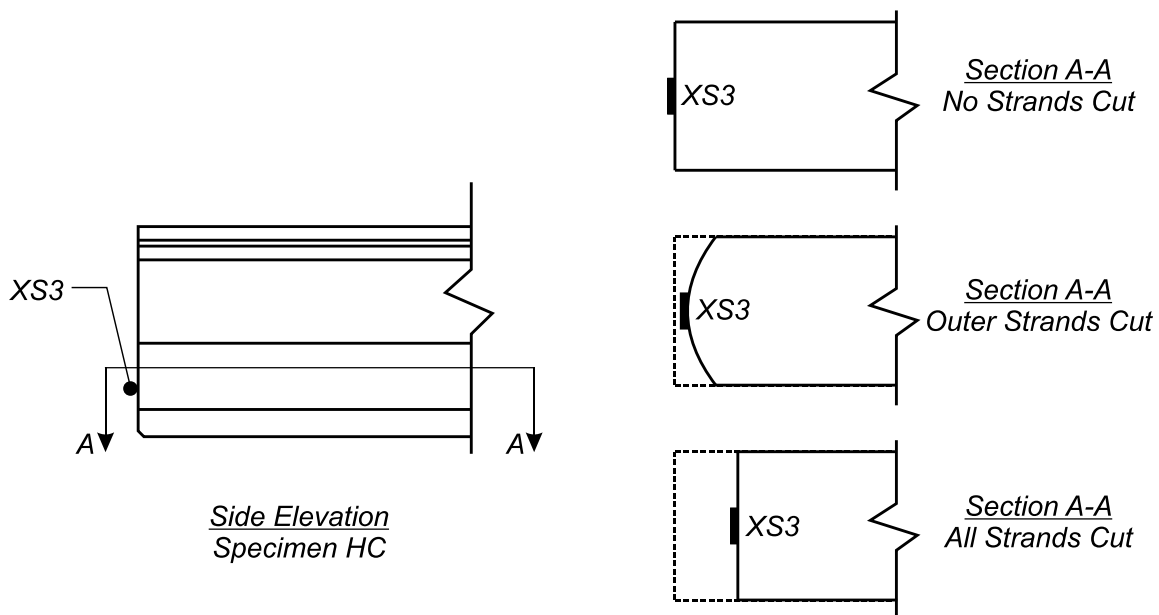
Figure 53–Flange displaced shapes for specimen HC

Transverse strain at gage XS3 decreased as inner strands were cut during stage D. The strain-time history from gage XS3 can be understood by considering the strand release pattern (Figure 51) and the resulting deformed shapes (Figure 53). As the outer strands were cut during stage B, the outside edges of the bottom flange deformed as shown in Figure 53. This deformed shape corresponded with the formation of tensile strains at the location of XS3. After the inner strands were cut, deformation of the bottom flange was more uniform and the tensile strain at XS3 was partially relieved. Once all of the strands were cut (stage E), the reported tensile strains at XS3 settled to approximately 25 microstrain.

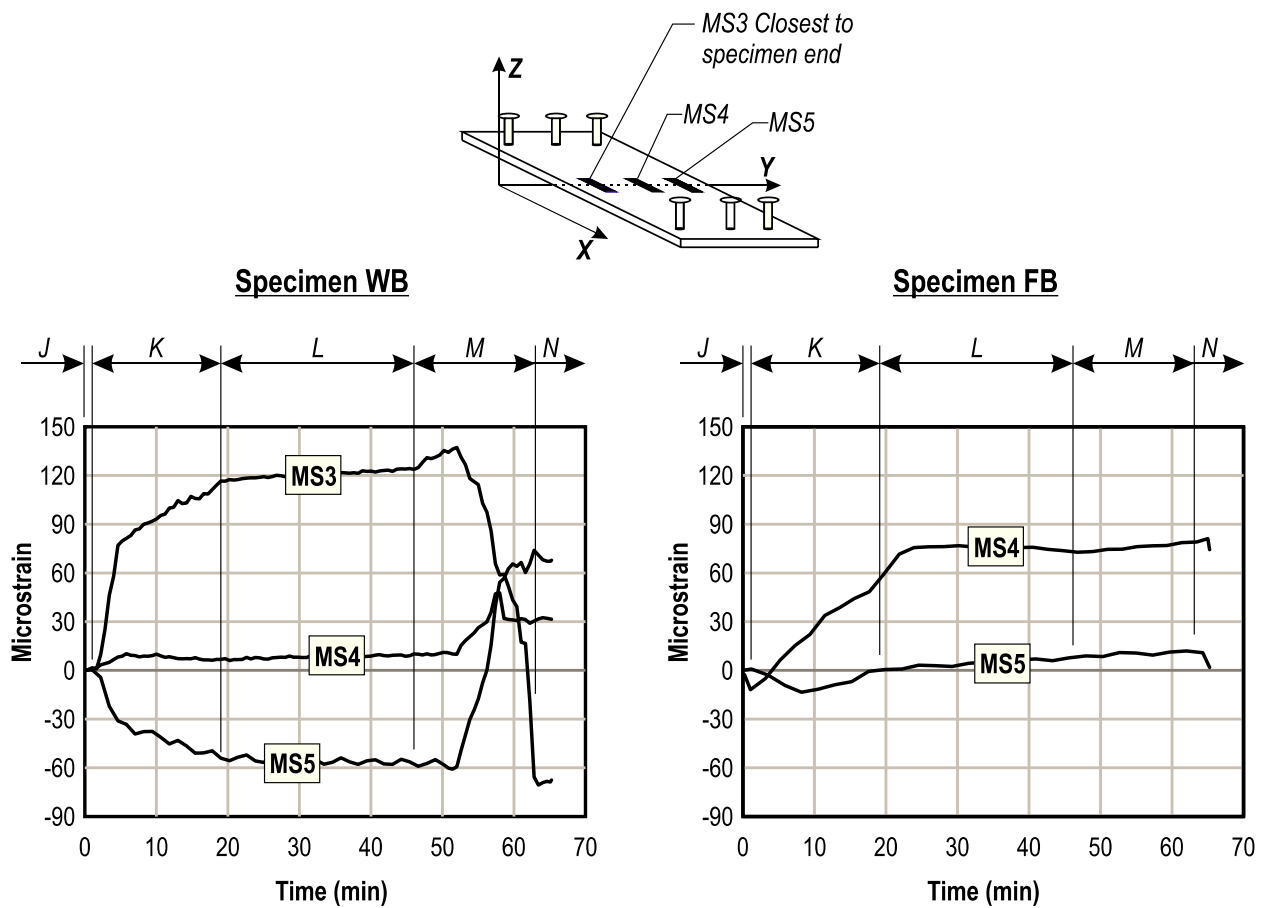
Figure 57–Bearing plate strain

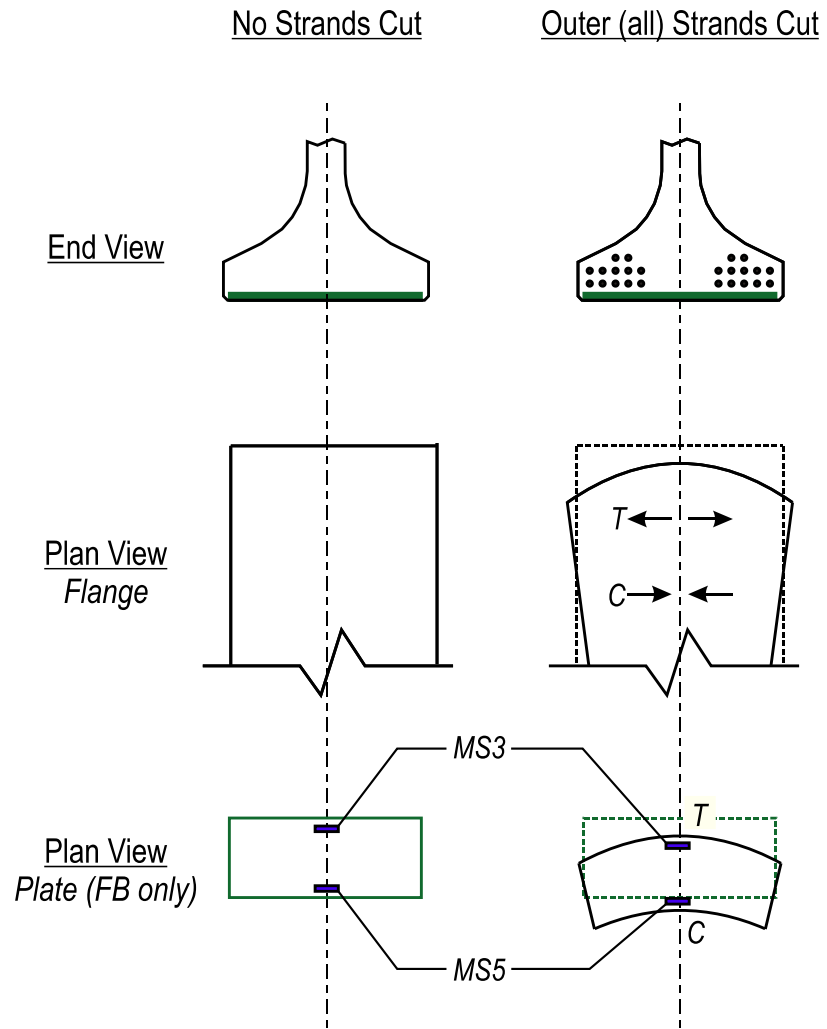
Figure 58–Flange displaced shapes specimens FN and FB

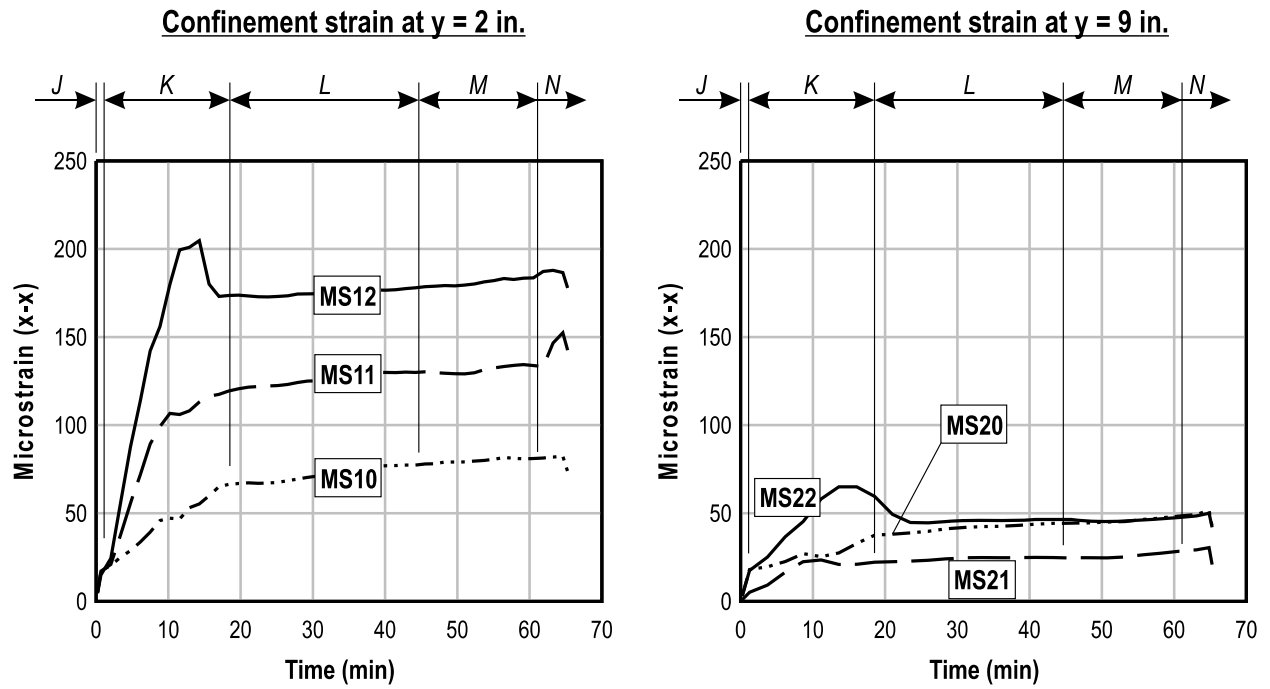
Figure 62–FB confinement reinforcement strain at 2 in. and 9 in. from end of girder

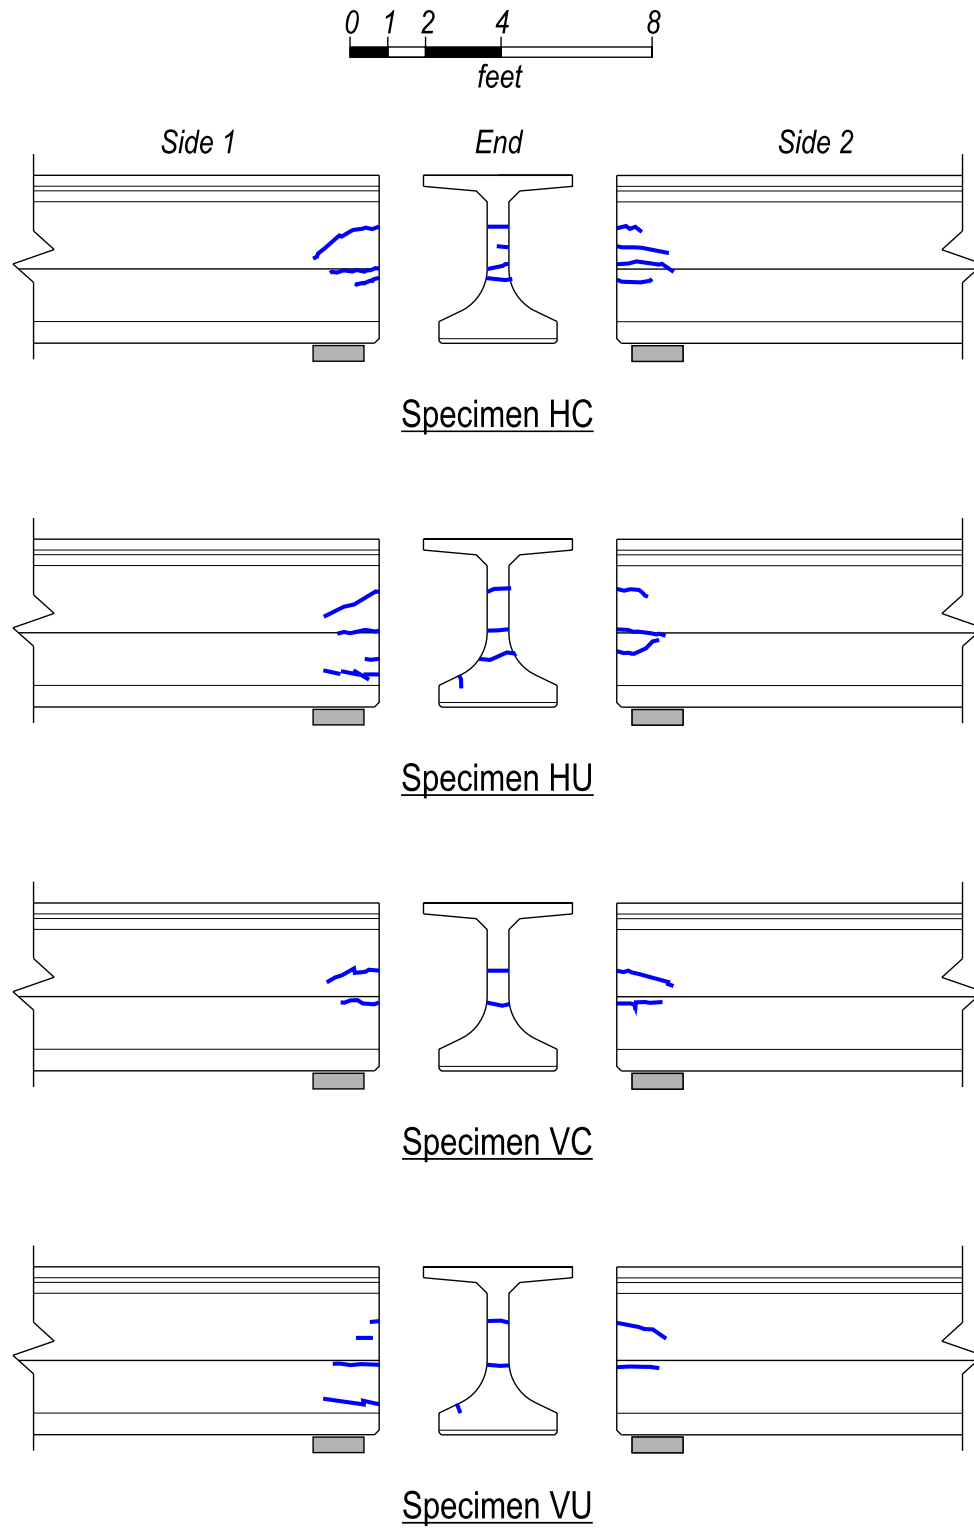
Figure 70–Girder H and V cracks prior to load tests

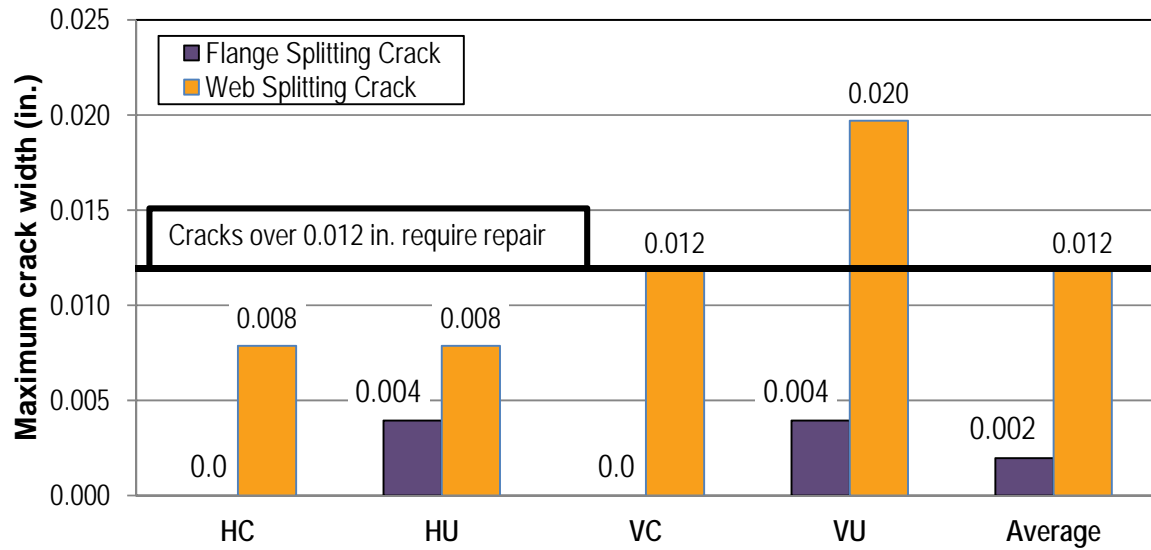
Figure 73–Maximum crack widths in girders H and V

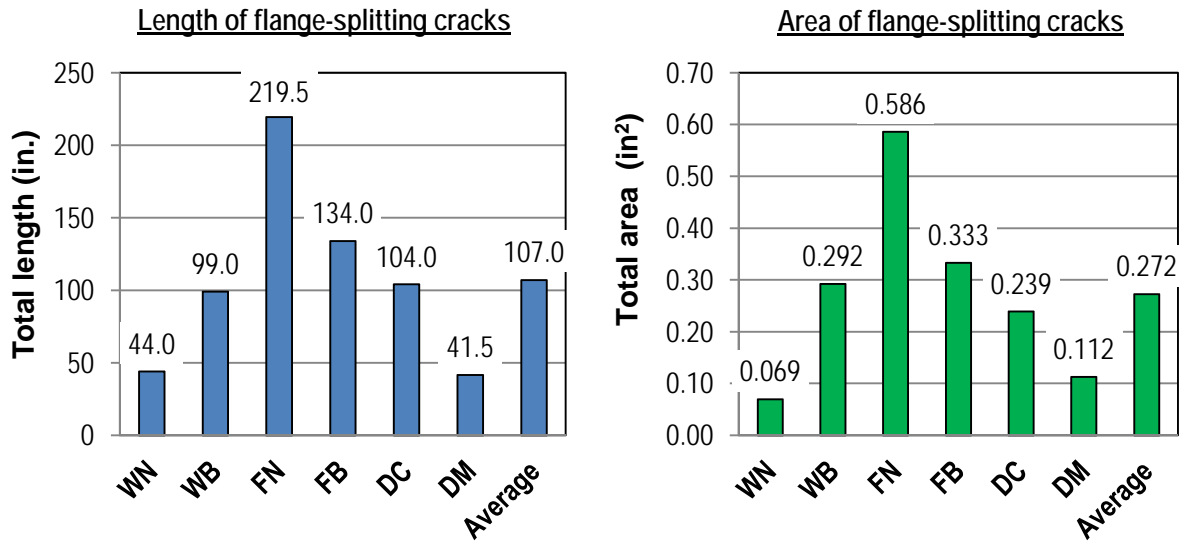
Figure 78–Flange splitting cracks in girders W, F, and D

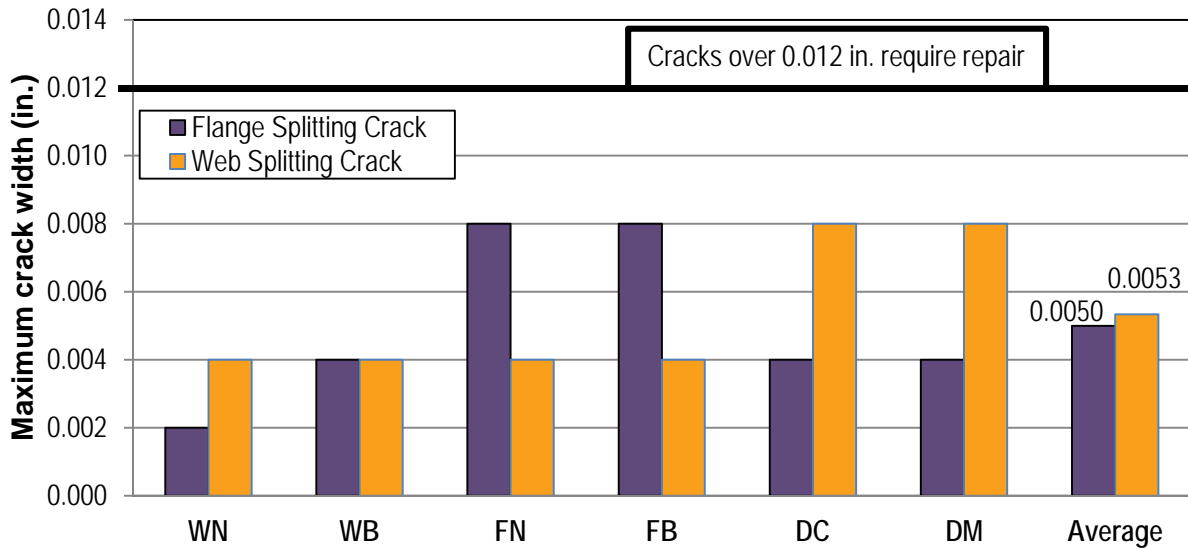
Figure 79–Maximum crack widths in girders W, F, and D

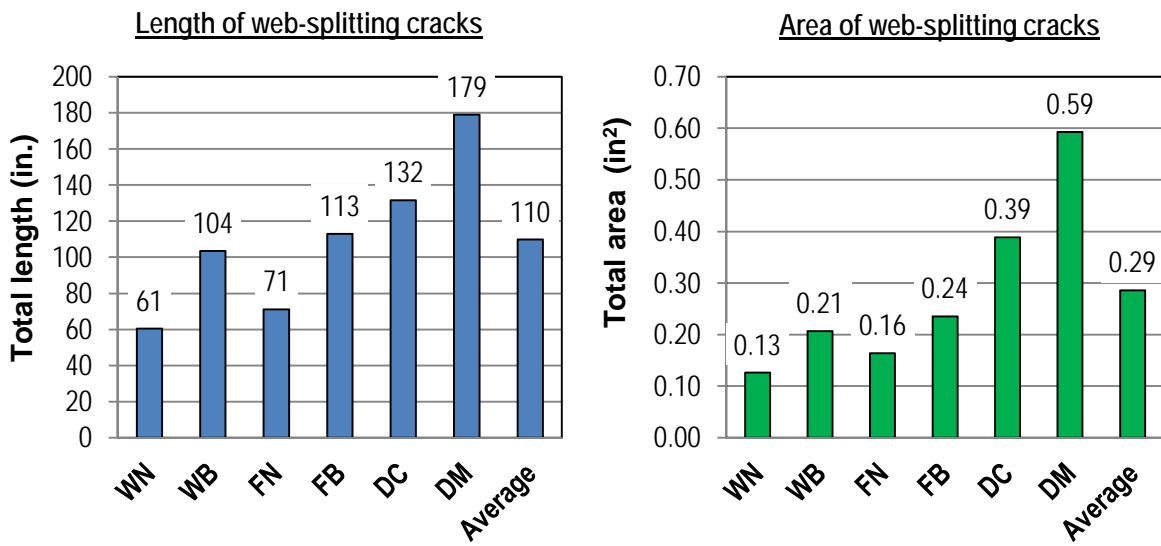
Figure 80–Web splitting cracks in girders W, F, and D

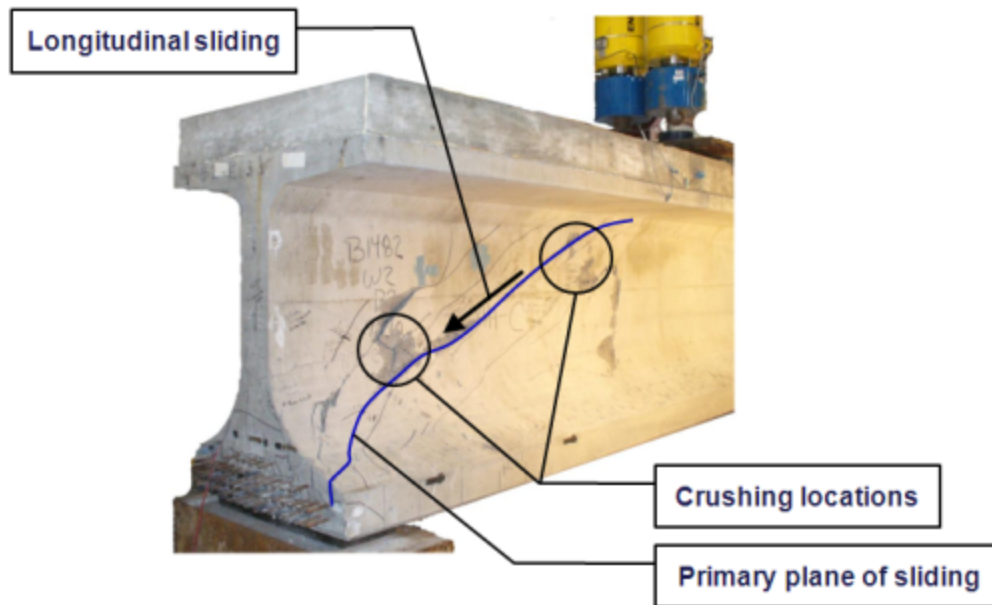
Figure 82–Web-shear failure

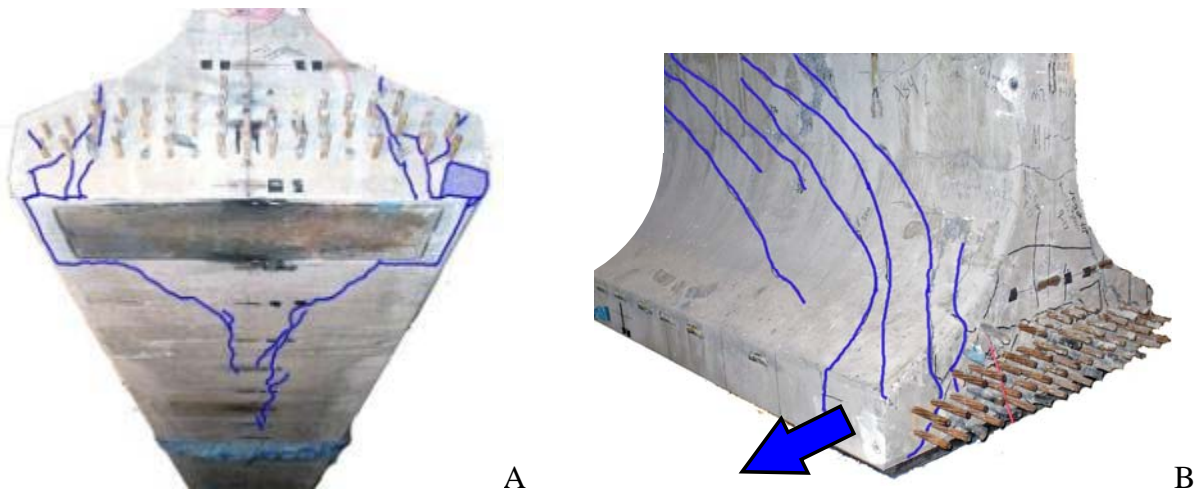
Figure 83–Lateral-splitting failure A) bottom view and B) side-end view

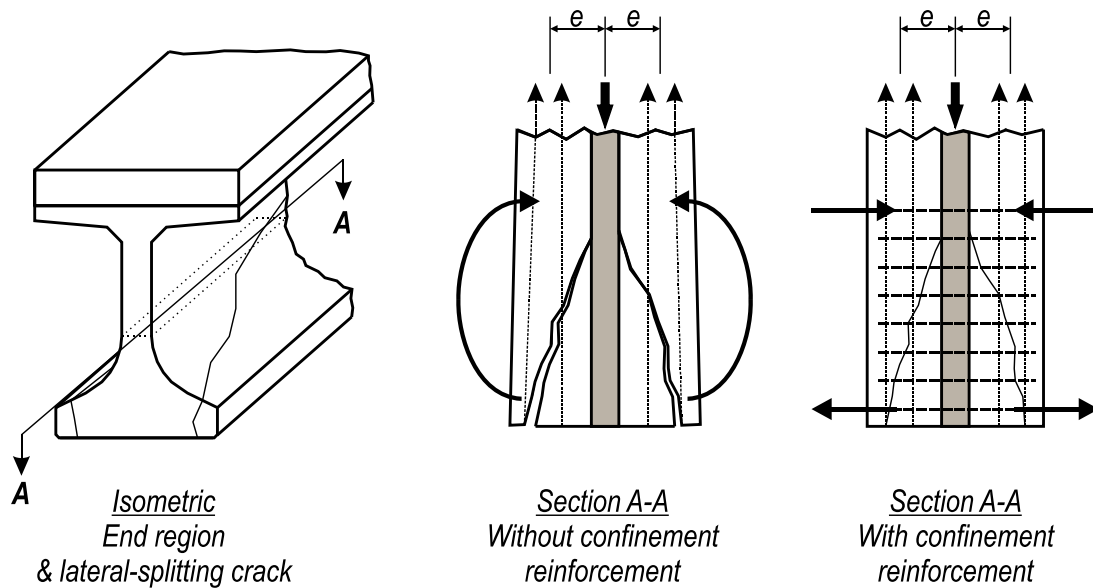
Figure 84–Lateral-splitting failure mechanics

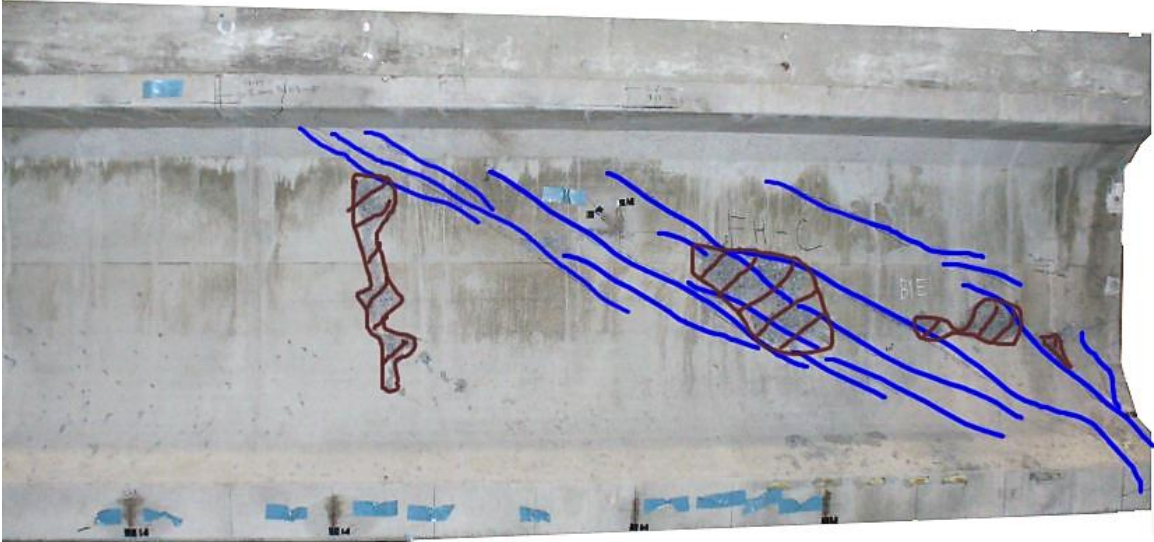
Figure 87–HC after load testing (cracks shown blue; spalling in brown)

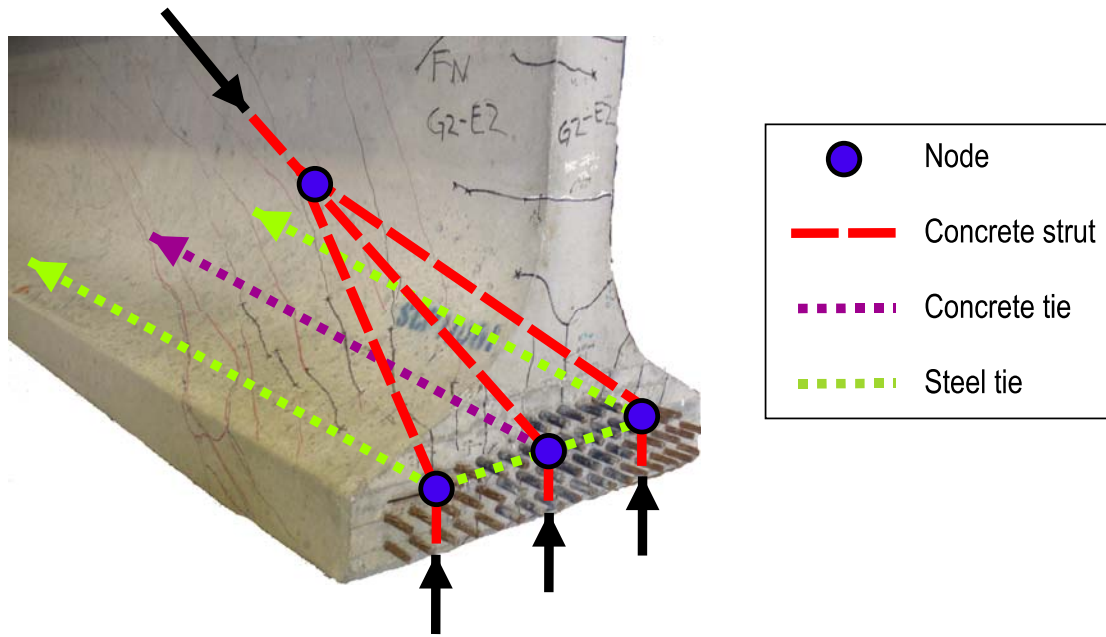
Figure 100–Strut and tie behavior specimen FN

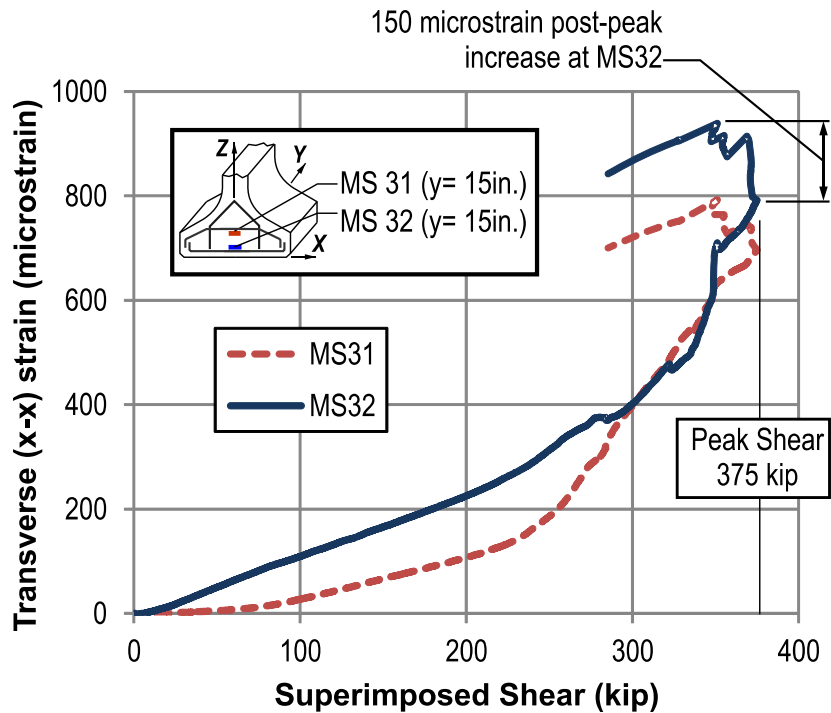
Figure 102–Confinement reinforcement strain specimen FN

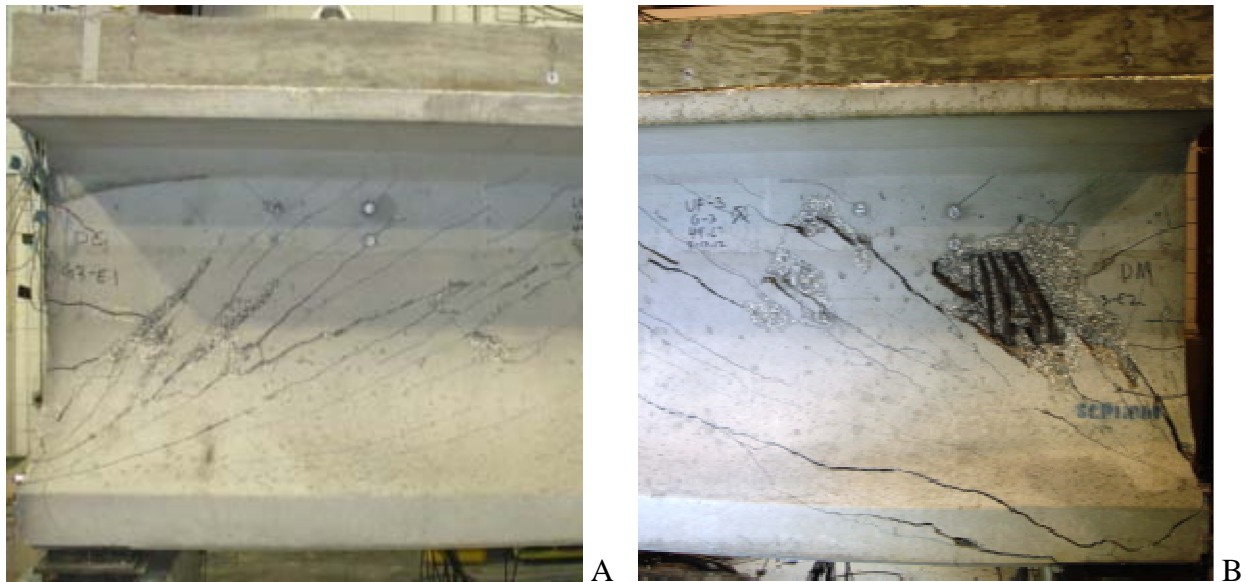
Figure 117–Girder D bottom flange cracking A) specimen DC with limited bottom flange cracking in front of bearing and B) specimen DM with severe bottom flange cracking in front of bearing
