Final Report

March 2013

END REGION DETAILING OF PRETENSIONED CONCRETE BRIDGE GIRDERS

Sponsor:
Florida Department of Transportation (FDOT)
Sam Fallaha, P.E. – Project Manager

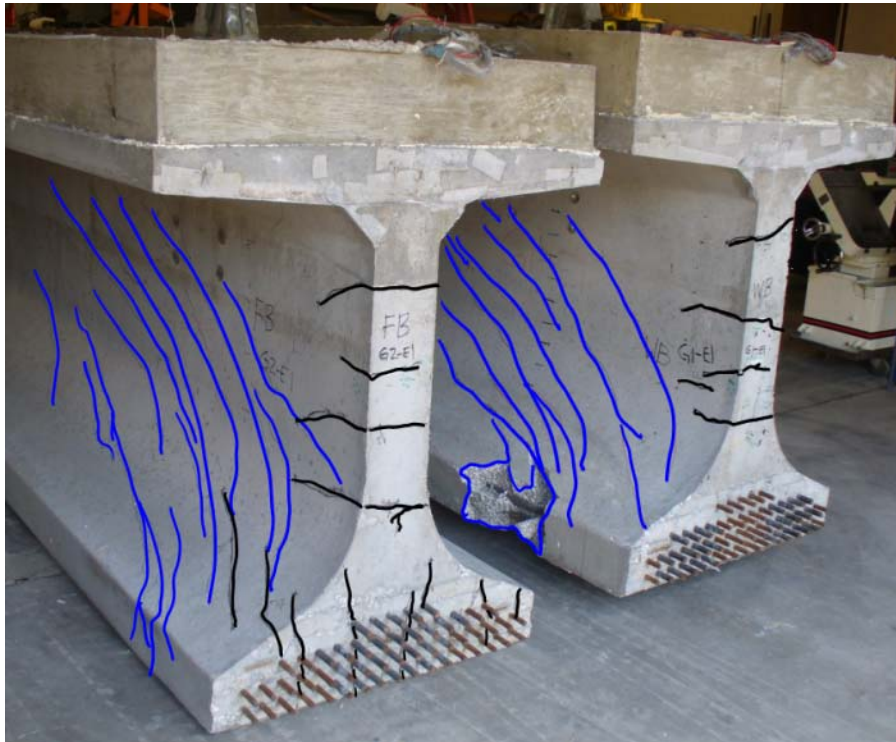
Figure 119–Comparison of FB (left) and WB (right)
(release cracks shown black; final cracks shown blue)

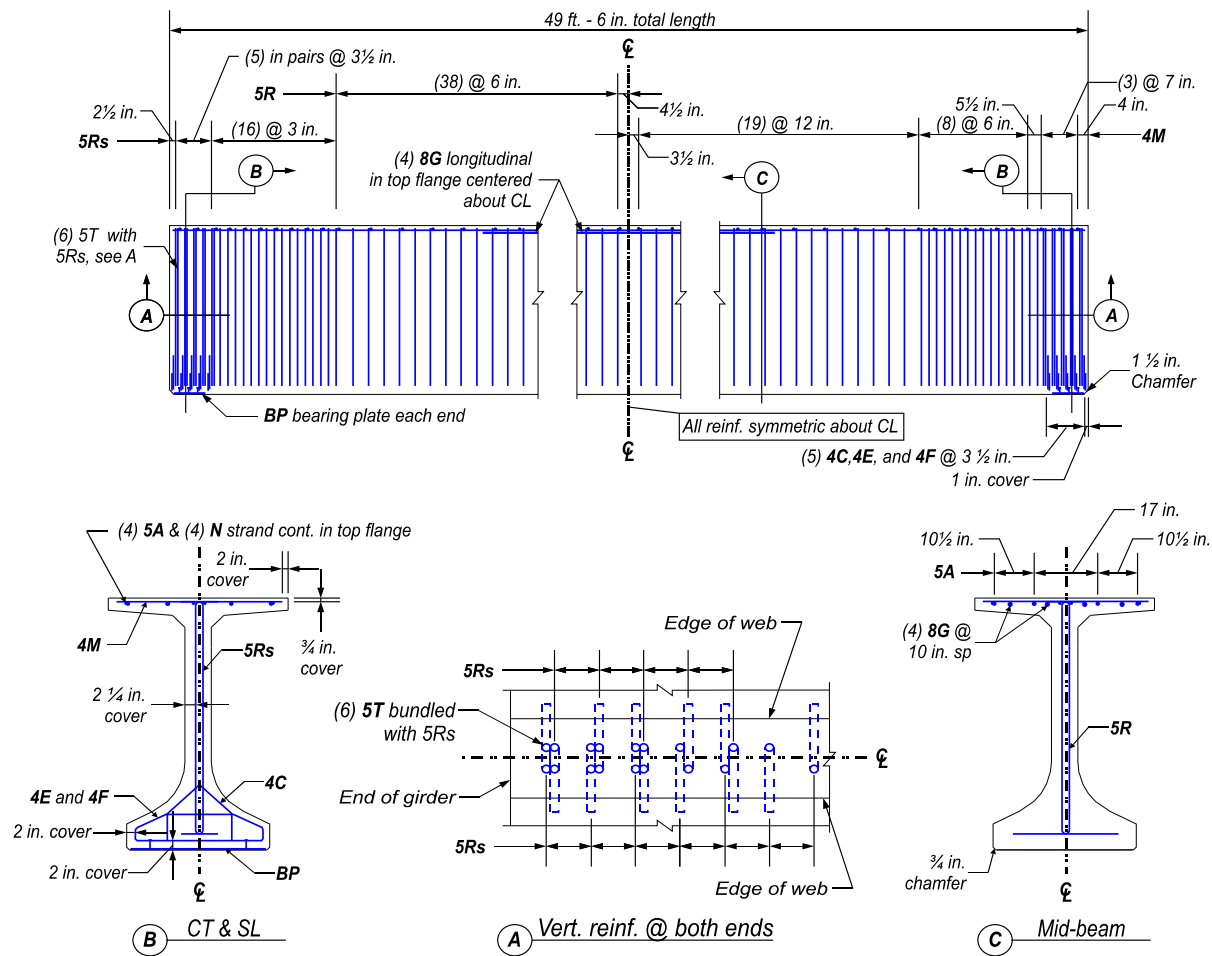
Figure 9–Reinforcement for specimens CT and SL

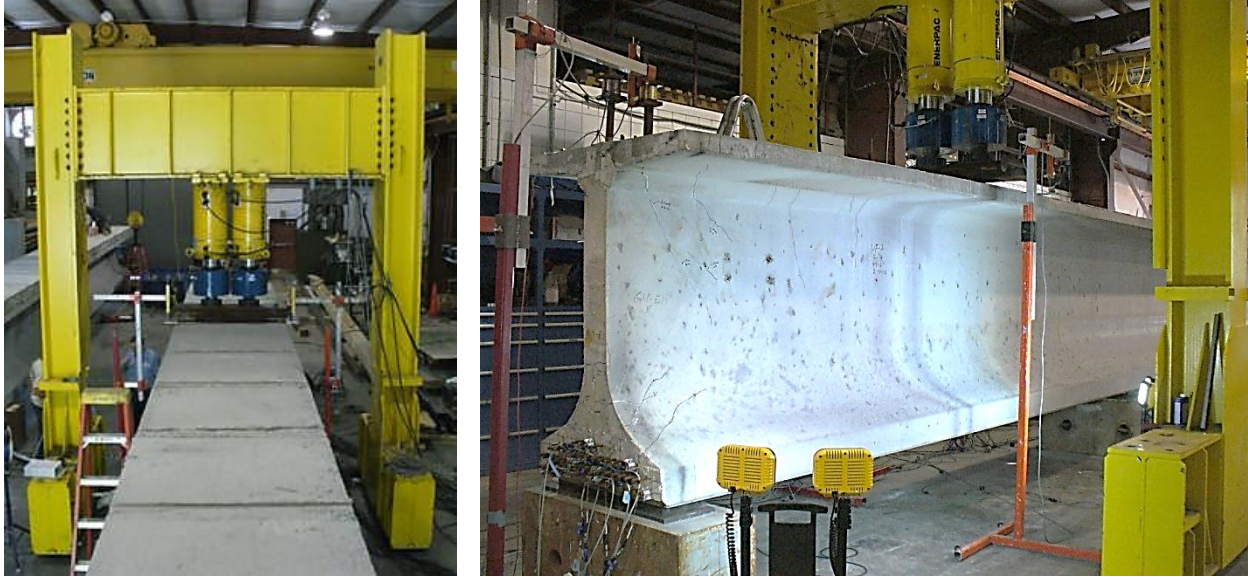
Figure 32–View of test specimen and load frame from above (left) and side view of specimen (right)

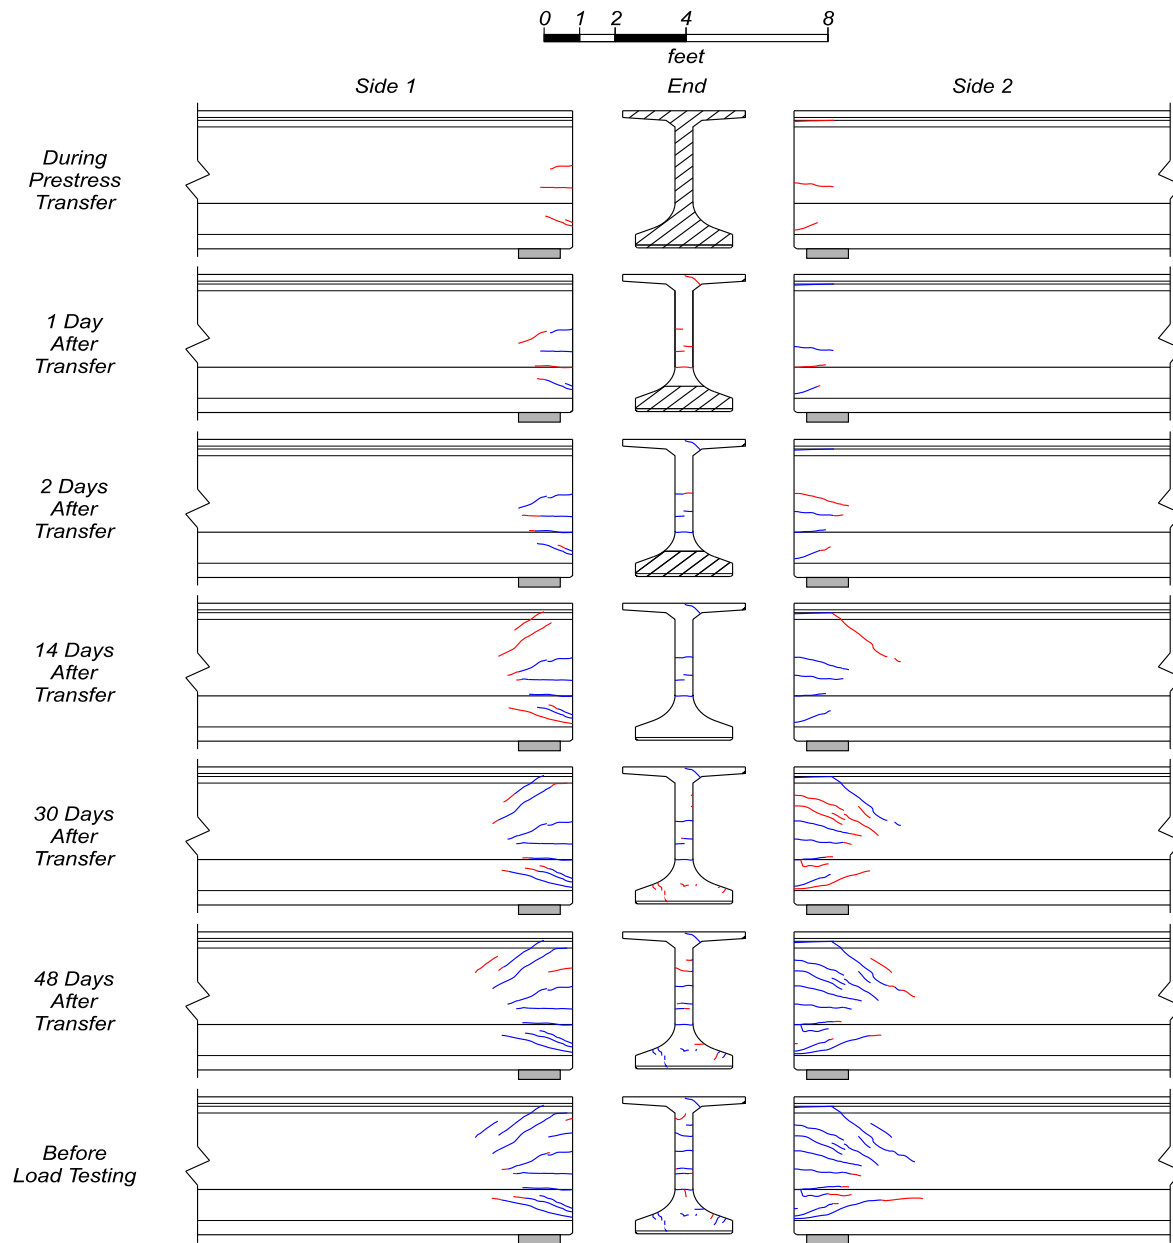
Figure 57–Crack growth in specimen CT (flexural cracks in top flange not shown)

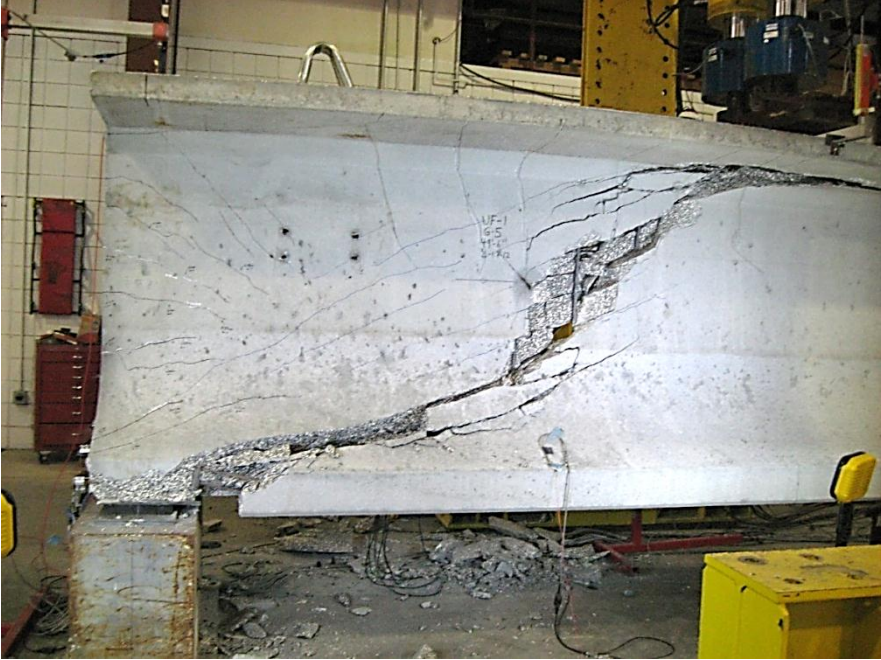
Figure 70–Specimen CT after load tests

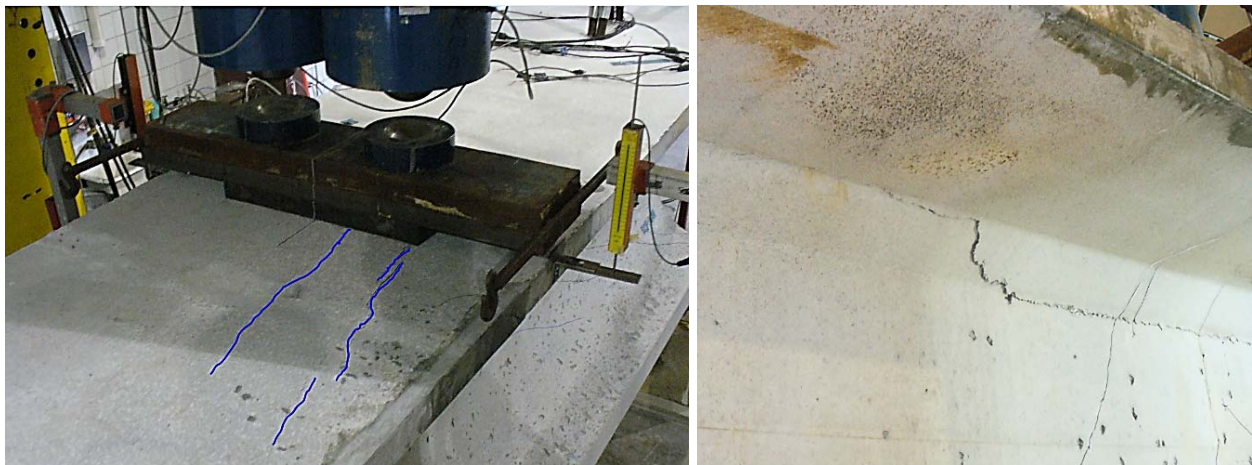
Figure 77–Punching failure from above (left) and below (right)

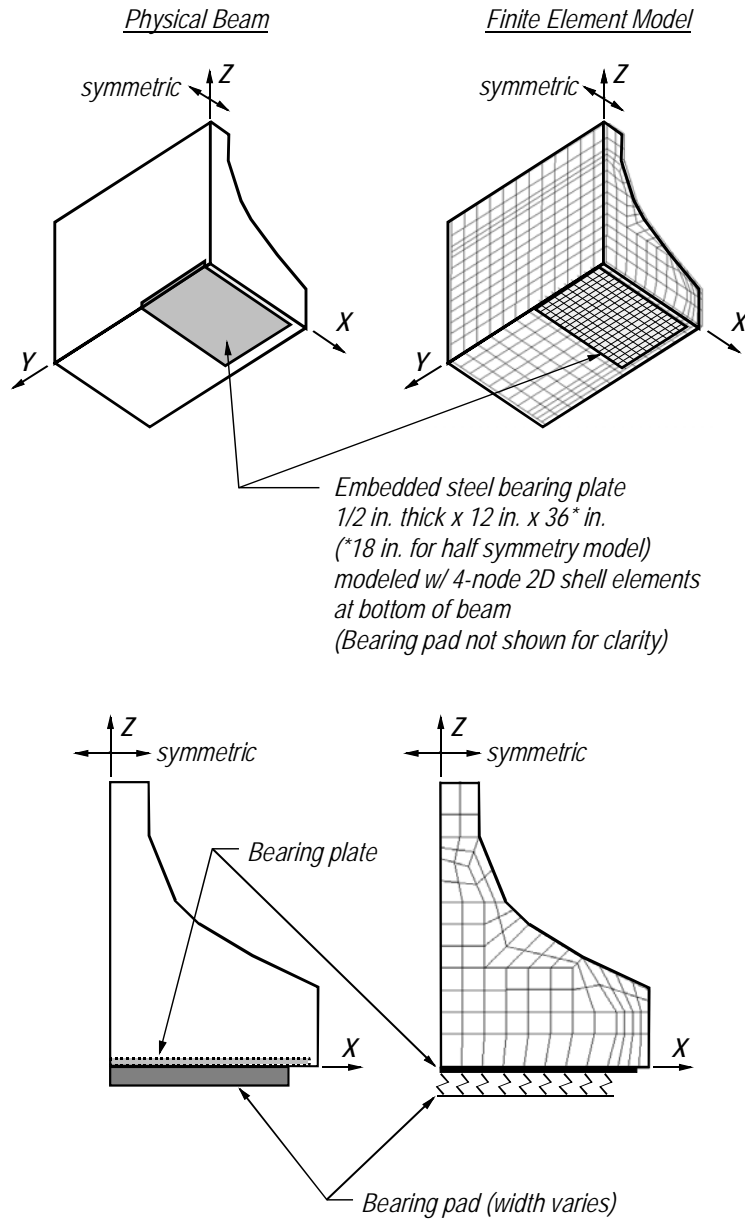
Figure 27–Steel bearing plate beam and model

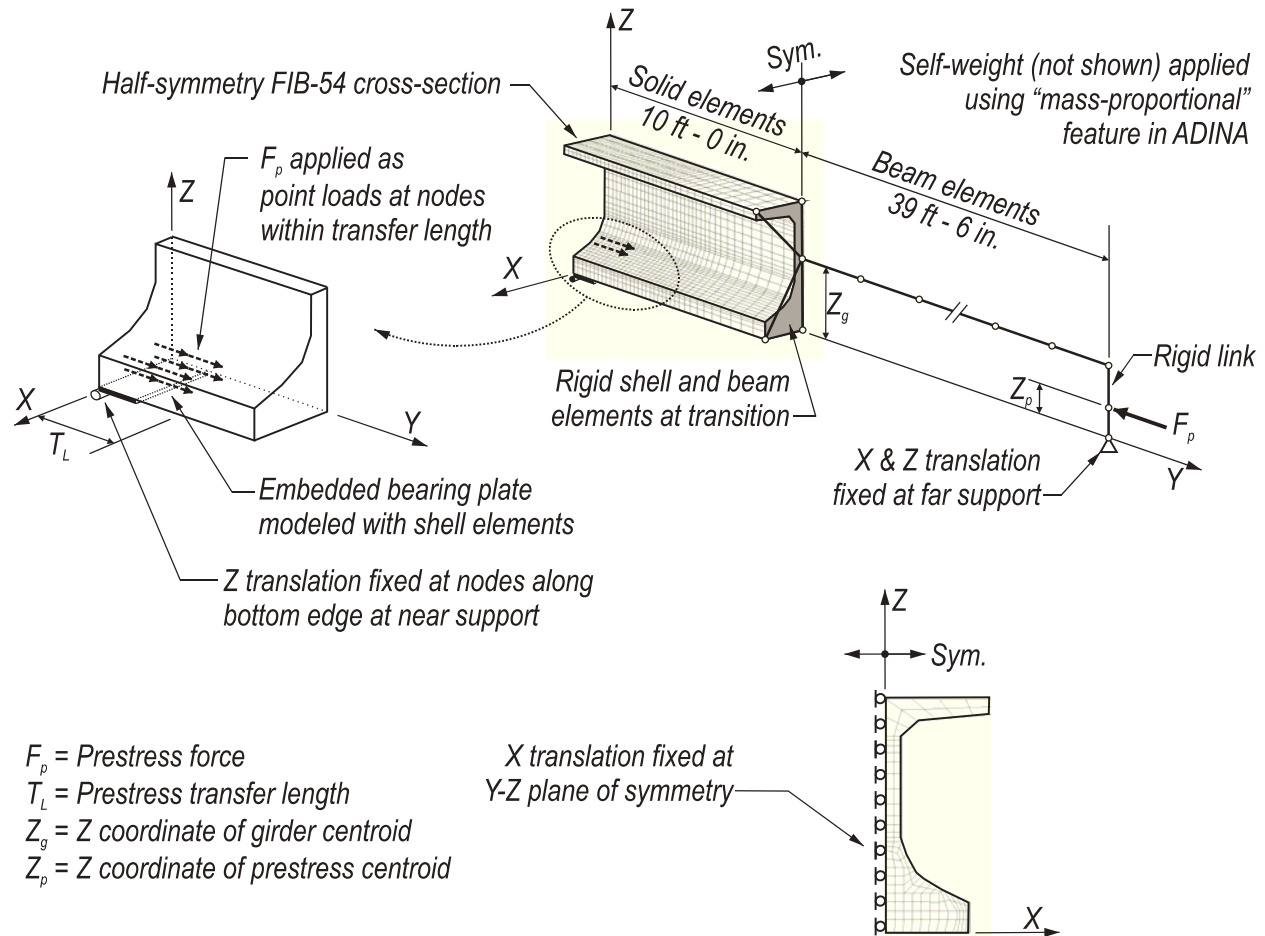
Figure 35-FE model details

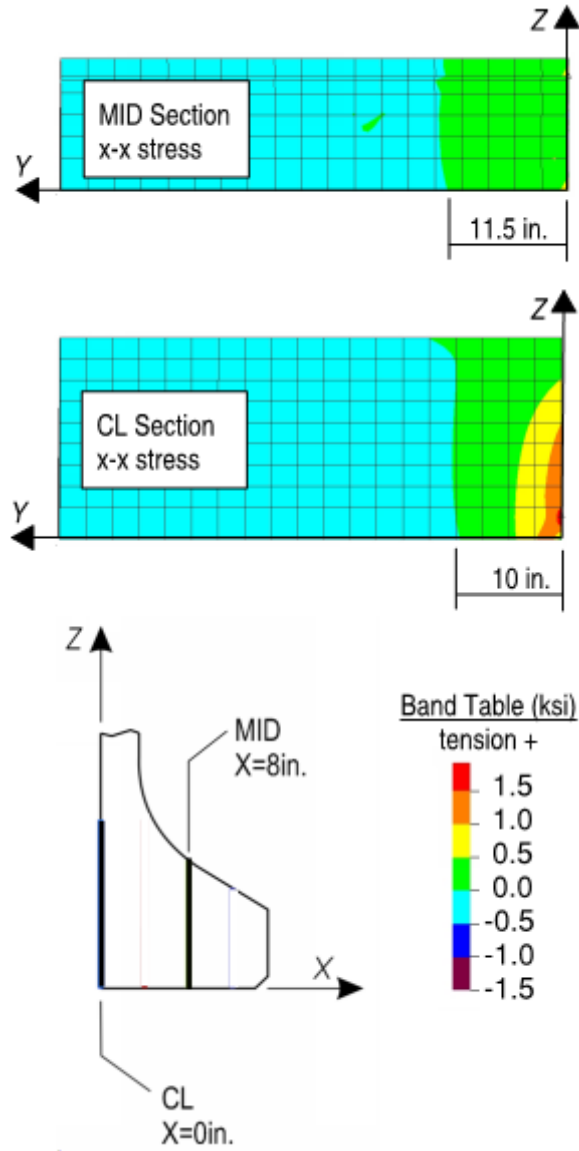
Figure 51–Transverse stress distribution with 17.5-in. transfer length (50% of strands cut)

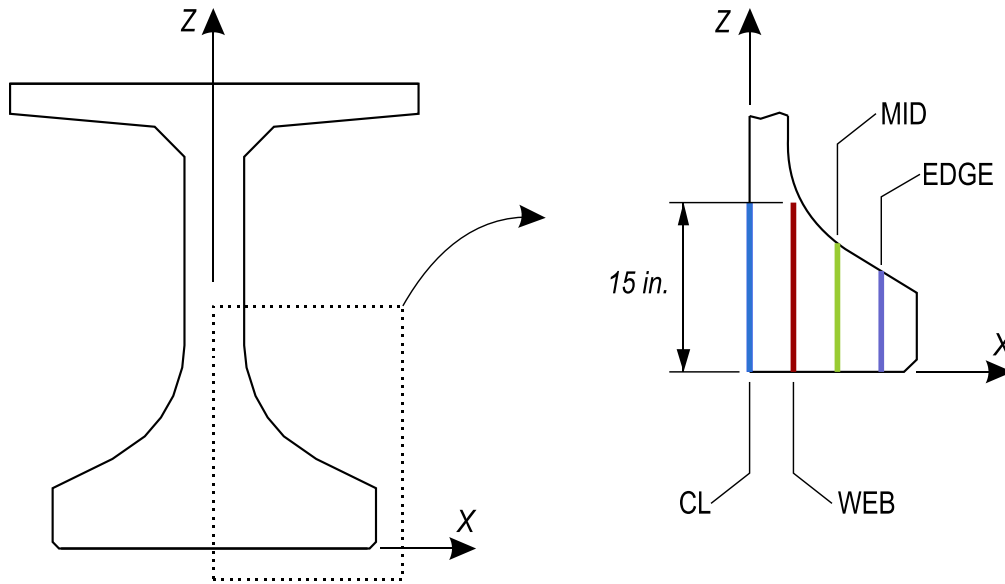
Figure 56—Lines for stress calculations

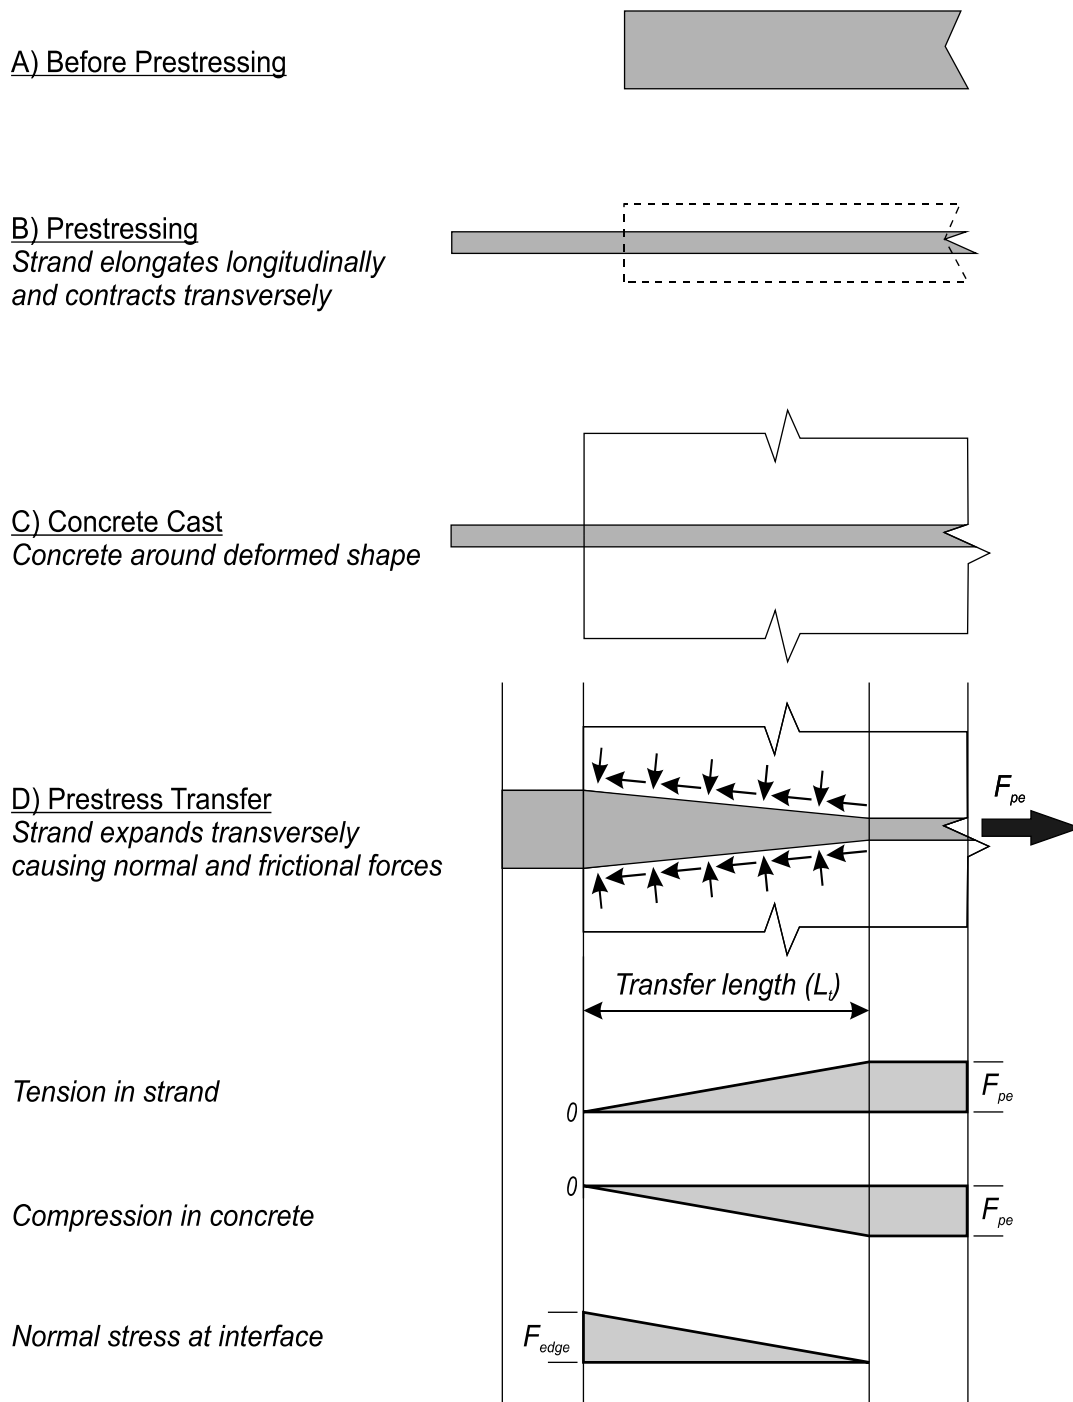
Figure 9–Hoyer effect A) strand before stressing, B) strand after prestressing, C) concrete cast around strand, and D) stresses and forces after transfer

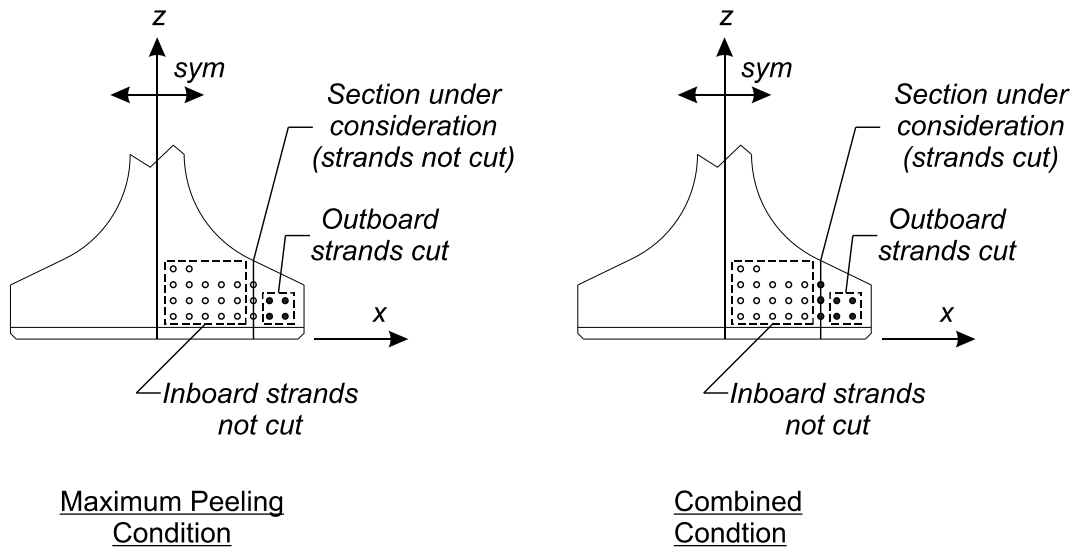
Figure 14–Strand cutting conditions

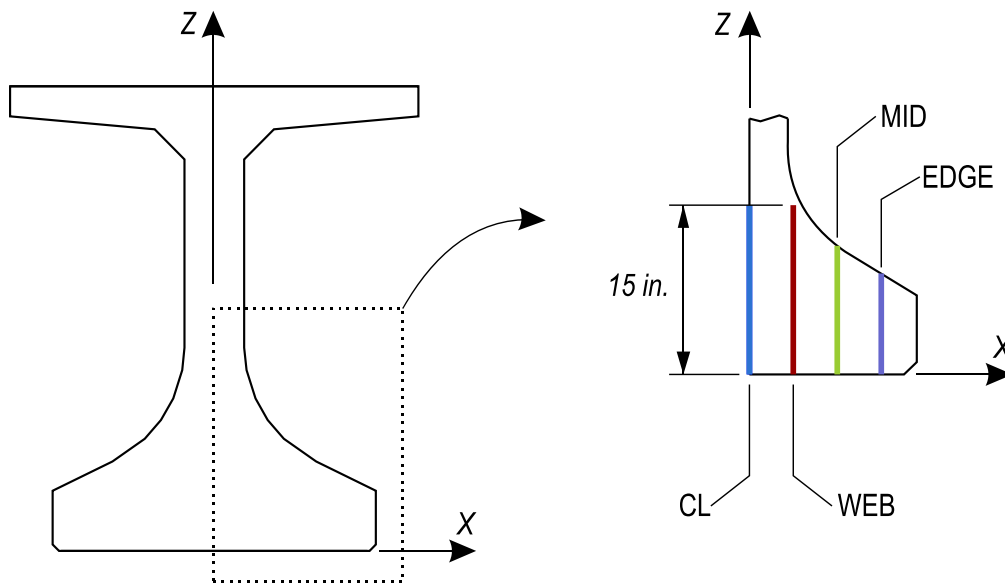
Figure 21–Analysis locations for determining F_{tos}

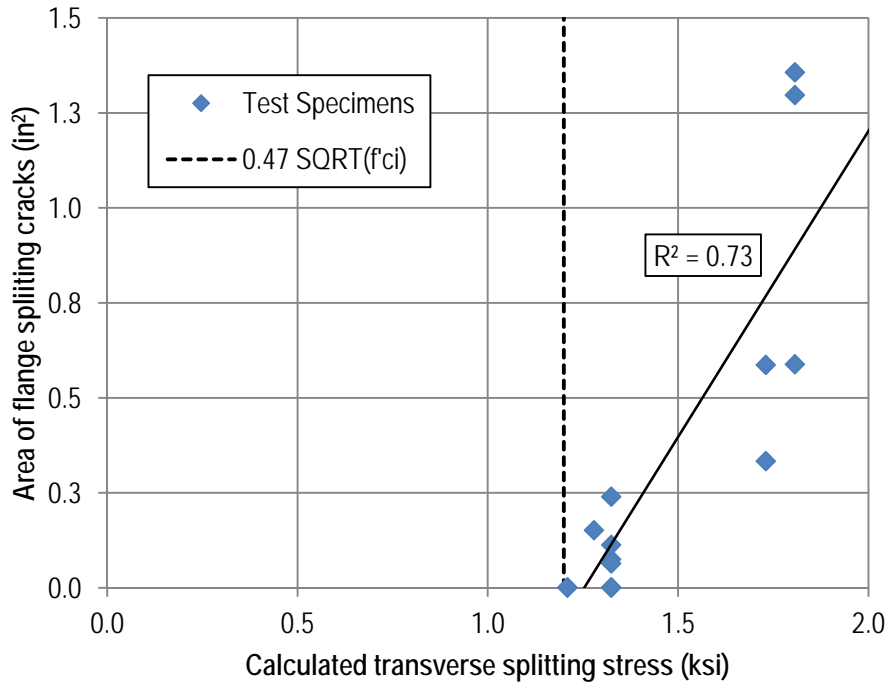
Figure 27–Calculated transverse splitting stress vs. experimental crack area

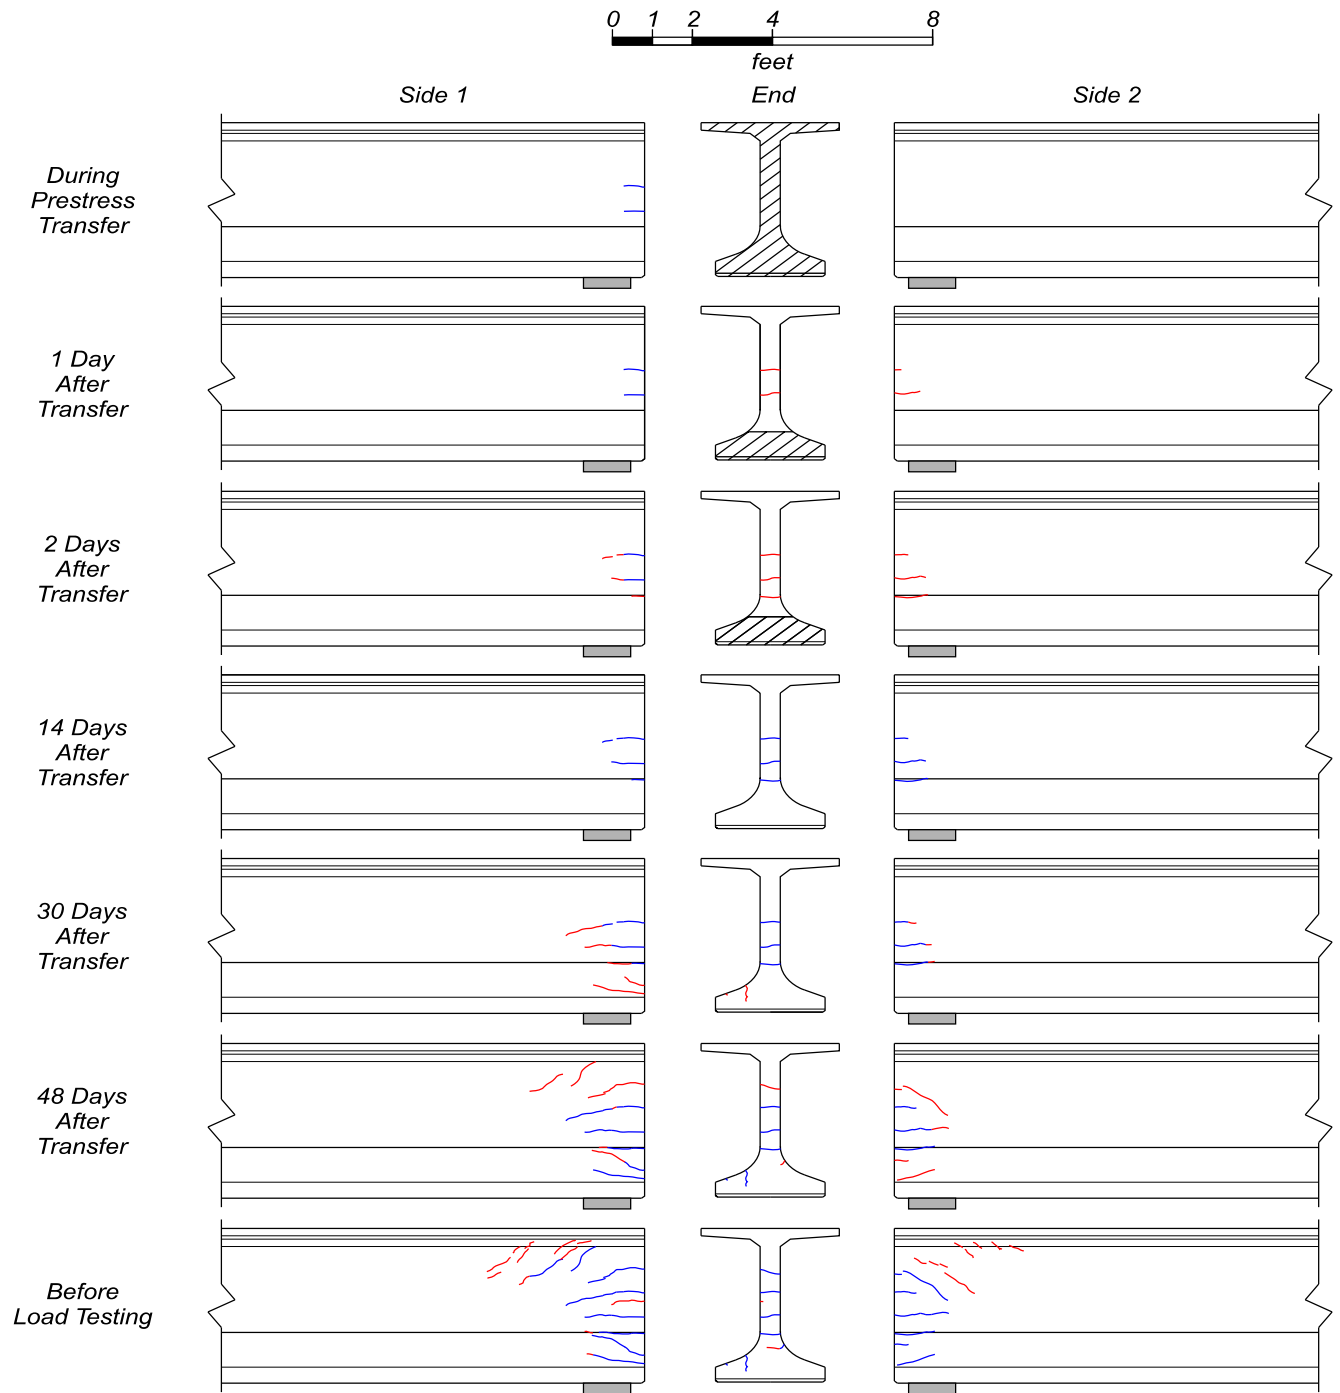
Figure 35—Crack growth in specimen SL (flexural cracks in top flange not shown)
