Florida Department of
TRANSPORTATION

Cracking of Reinforced and Prestressed Precast Concrete Deck Panels on Florida-I Beam Bridges: A Crack Disposition Study

M. H. Ansley Structures Research Center

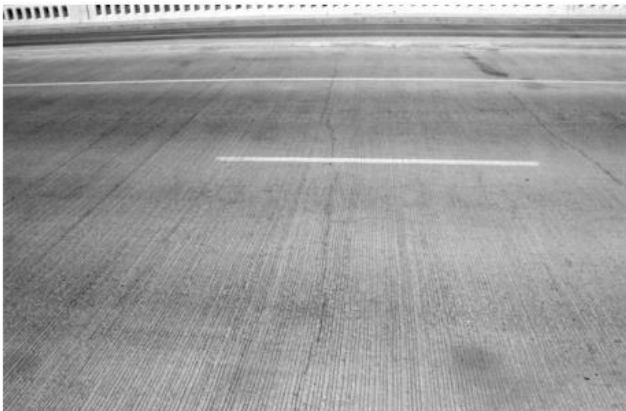
Figure 6: Transverse cracking (Frosch et al., 2003)

Vargas (2012) explains that transverse cracks develop in concrete bridge decks when the tensile strength of the concrete is less than the longitudinal tensile stresses in the deck and that these tensile stresses are produced by changes in temperature, concrete shrinkage, and from bending resulting from self-weight and traffic loads. He further explains that most transverse bridge deck cracks are caused by the combination of shrinkage and thermal stresses and that transverse cracks are known to develop rapidly with compressive strengths higher than 6000 psi. Krauss and Rogalla (1996) and Frosch et al. (2003) find these cracks are usually full-depth cracks, aligned above the transverse reinforcing (Figure 6), that the surface crack widths typically range from 0.002 in. (0.05 mm) to 0.025 in. (0.65 mm), and the cracks are spaced usually 3 to 10 ft (1 to 3 m) apart.

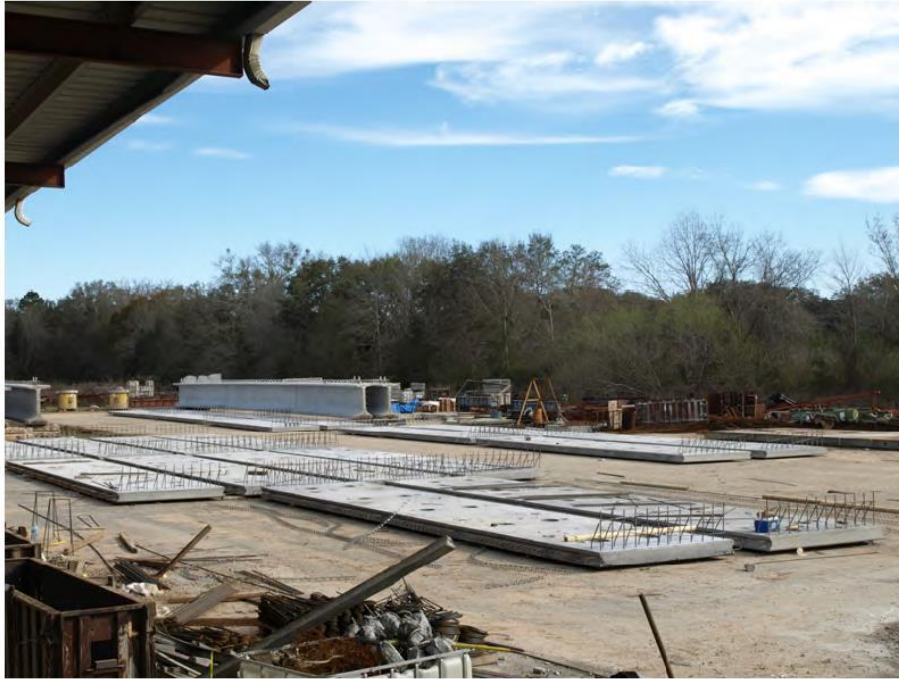
Figure 12: Non-prestressed precast concrete deck panels in casting yard (Roddenberry et al., 2019)

while westbound has precast prestressed concrete deck panels. This is also true for the bridges over Little River, the eastbound bridge panels are reinforced (non-prestressed) while the westbound bridge panels are prestressed – see Figures 1, 2, 12 and 13.

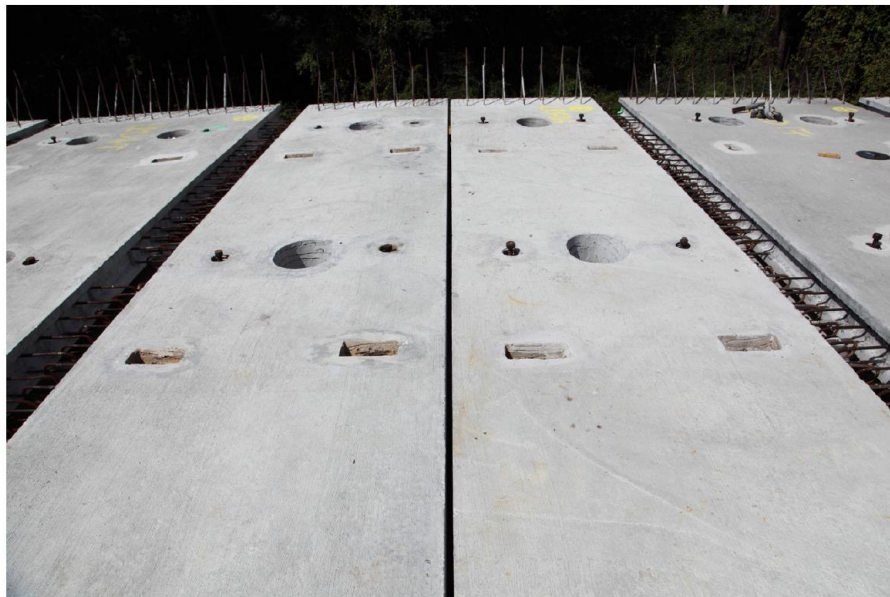
Figure 13: Precast prestressed concrete deck panels for LRWB (Roddenberry et al., 2019)

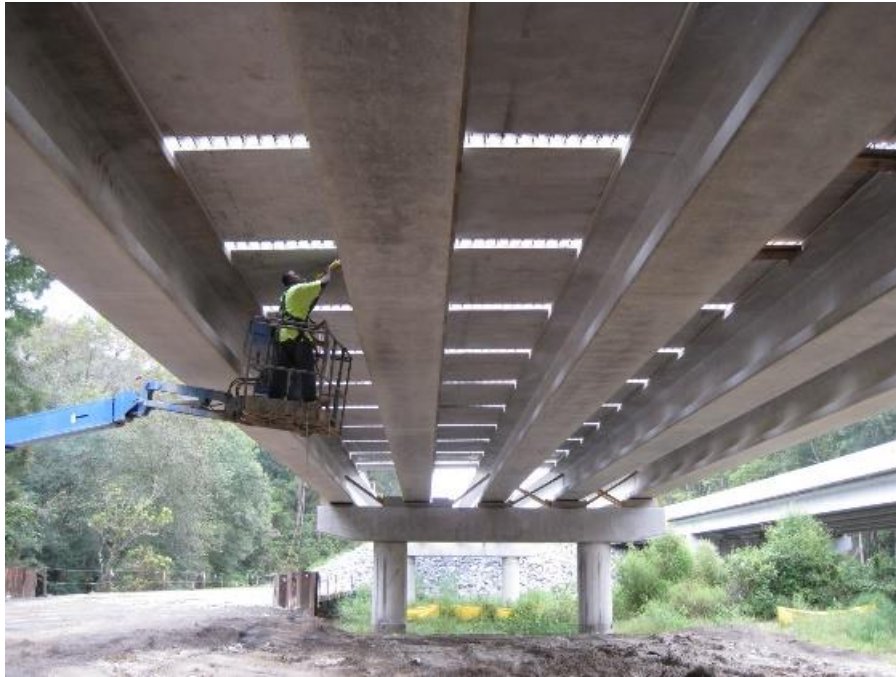
Figure 14: Precast Florida-I Beams and bridge decks

The panels were set on precast prestressed Florida – I beams (Figure 14). The gaps between the panels, called closure joints, were later filled with cast-in-place concrete.

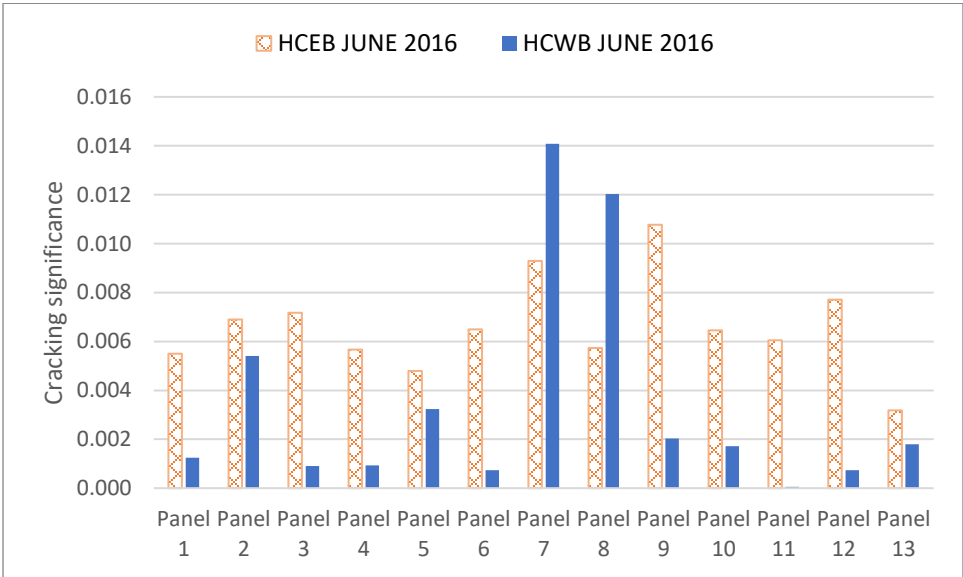
Cracking significance for HCEB (NON-PRESTRESSED) in June 2016, is shown in Table 1 and in Figure 16. Cracking significance ranged from 0.003 to 0.011. Panel 9 had the highest cracking significance, while Panel 13 had the least cracking significance. Out of the 197 cracks identified on HCEB, 193 would require no treatment while four would require further investigation. The four cracks in need of further investigation are on Panel 3 with an average crack width of 0.027 in.

Cracking significance for HCWB (PRESTRESSED) in June 2016 is shown in Table 1 as well as in Figure 16. Cracking significance ranged from 0.000 to 0.014. Panel 7 had the highest cracking significance. Several panels had very low cracking significance, and Panel 11 had approximately zero cracking significance. For HCWB, 157 cracks were identified, 141 of which would not require any treatment. Four of the cracks would require epoxy injection or methacrylate, and 12 would require investigation. All four cracks that would require epoxy injection are on Panel 7 and have an average crack width of 0.01 in. Five of the 12 cracks needing further investigation are on Panel 5, six are on Panel 7 and Panel 8 has one. They collectively have an average crack width of 0.052 in. Overall, the prestressed concrete panels experienced less cracking than the non-prestressed ones except for Panels 7 and 8 where there was more cracking in the prestressed than in the non-prestressed, as seen in Figure 16.

Figure 16: A plot of the cracking significance of HCEB (NON-PRESTRESSED) and HCWB (PRESTRESSED) in June 2016

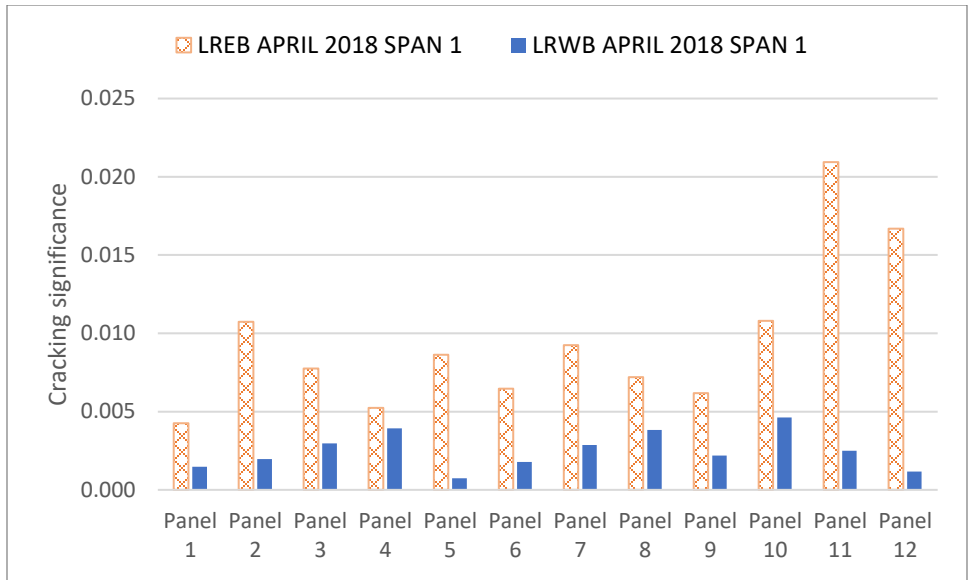
Figure 22: A plot of the cracking significance of LREB (NON-PRESTRESSED) span 1 in April 2018 and LRWB (PRESTRESSED) span 1 in April 2018

For LREB (NON-PRESTRESSED) span 1, as shown in Table 5 and Figure 22, Panel 11 has the highest cracking significance, 0.021, while Panel 1 has the least, 0.004. Panel 12 also has a relatively large cracking
