Evaluation of Techniques to Remove Defective Grout from Post-Tensioning Tendons

Final Report

February 2020

Florida Department of Transportation (FDOT)

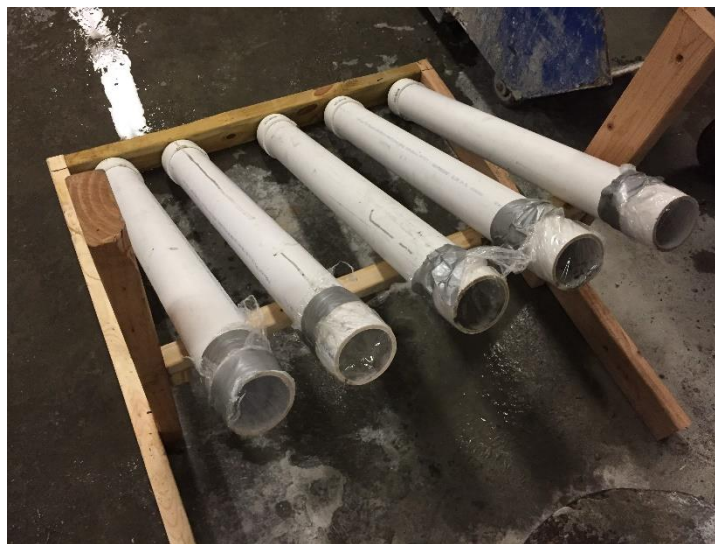
Figure 4-1. Mini-inclined testing

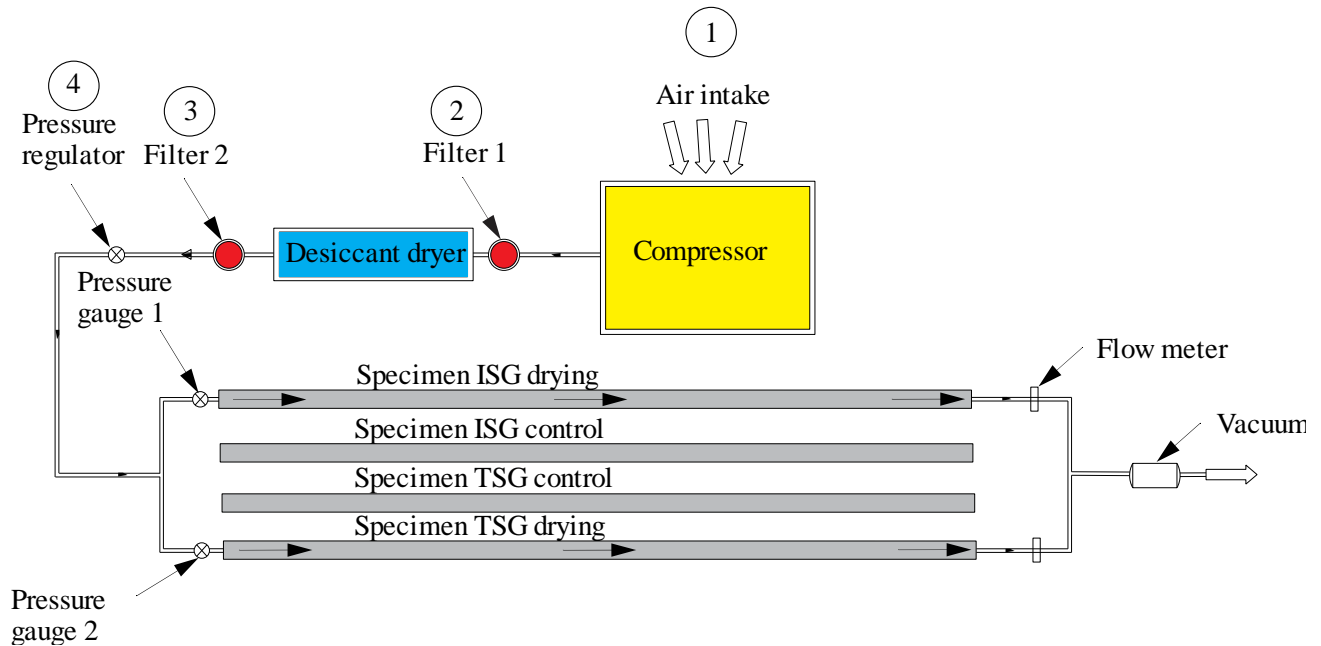
The drying system injected dried, pressurized air into the upslope end of the specimens; this air flowed through the specimen and was discharged at the opposite end (Figure 7-1). The drying system was designed to generate dry air with relative humidity (RH) less than 10% and was composed of a compressor, desiccant dryer, and filters. A pressure regulator was used to reduce the inlet air pressure to about 20 psi to prevent leaks through joints in specimens.

Figure 7-1. Layout of drying equipment

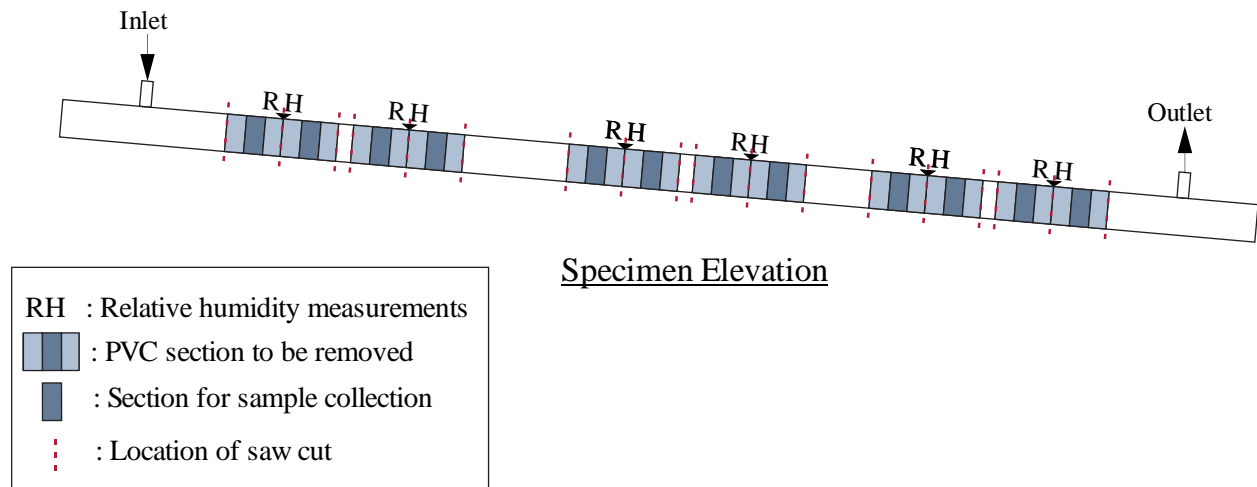
Figure 8-2 shows the sampling locations for grout in specimens ISG and TSG relative to the RH port where RH_g was measured. Grout samples were collected during dissection, and immediately weighed prior to placing them in the oven to determine their moisture content.

Figure 8-2. Dissection schematic

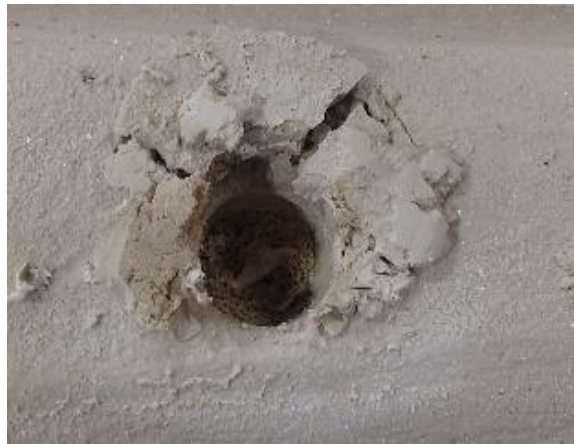
Figure 8-7. Soft grout as wet clayey sand

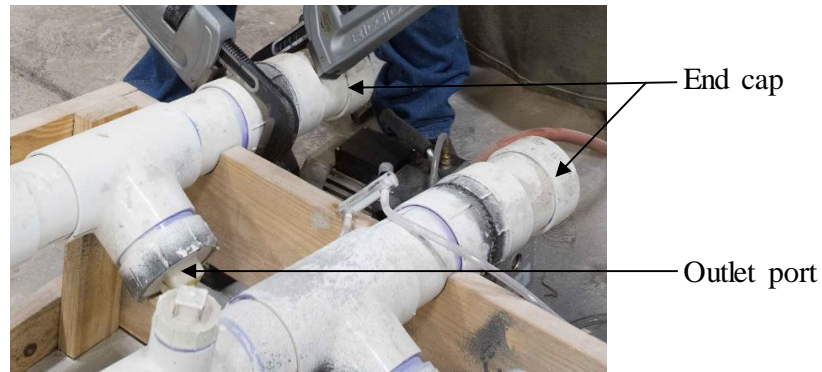
The 5 PC grout layer in the short length between the end caps and the air inlet or outlet ports (Figure 8-9) appeared to be dry similar to the remaining 5 PC layer in the specimen. From this observation, it can be concluded that the drying method was able to remove some moisture from the grout for a length of approximately 1 ft upstream from the air inlet and downstream from the air outlet even though air was not directed through it. Moisture content (MC) measurements of grout in these areas, however, indicated that the moisture had not been removed as effectively as the grout between the inlet and outlet points.

Figure 8-9. End caps and outlet port on specimens

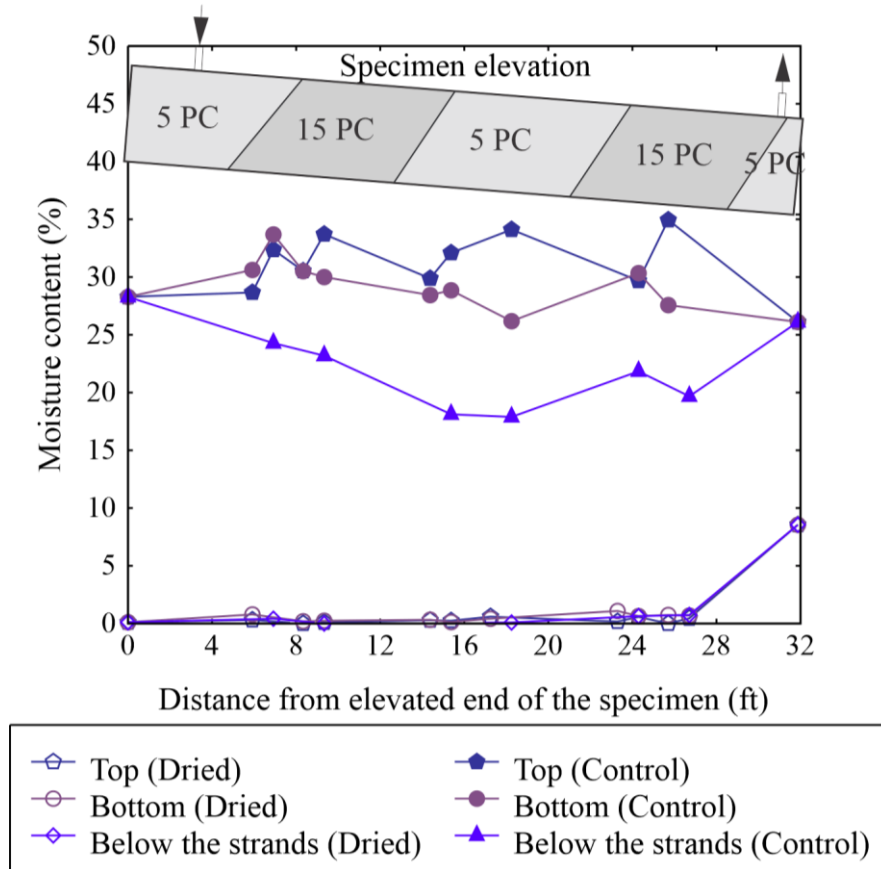
Figure 8-20. Comparison of moisture content for dried and control ISG

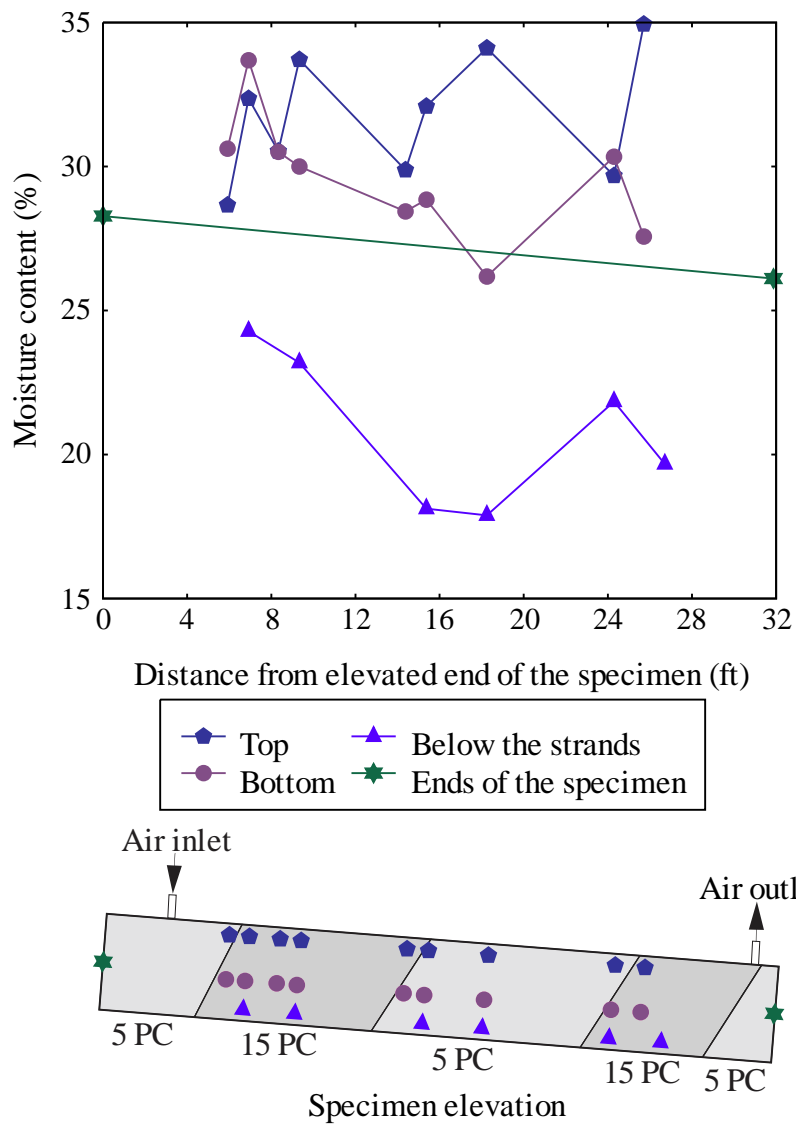
Figure 8-21. Variation of moisture content along the length of control specimen ISG

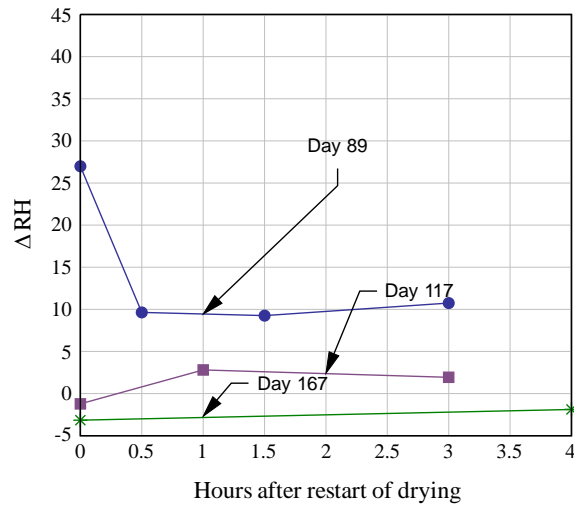
Figure 8-28. Dryness checks for dried specimen ISG

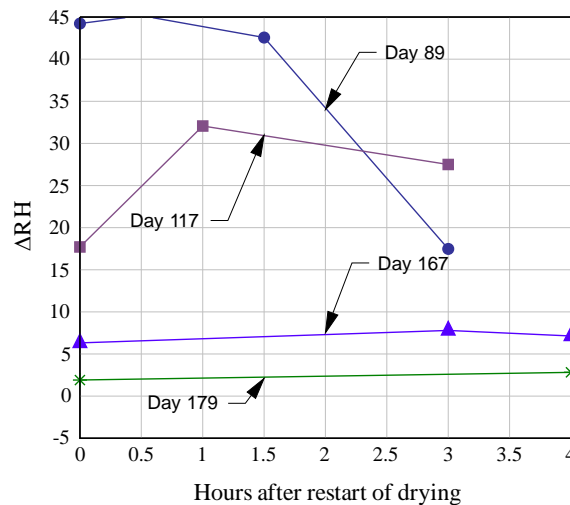
Figure 8-29. Dryness checks for dried specimen TSG

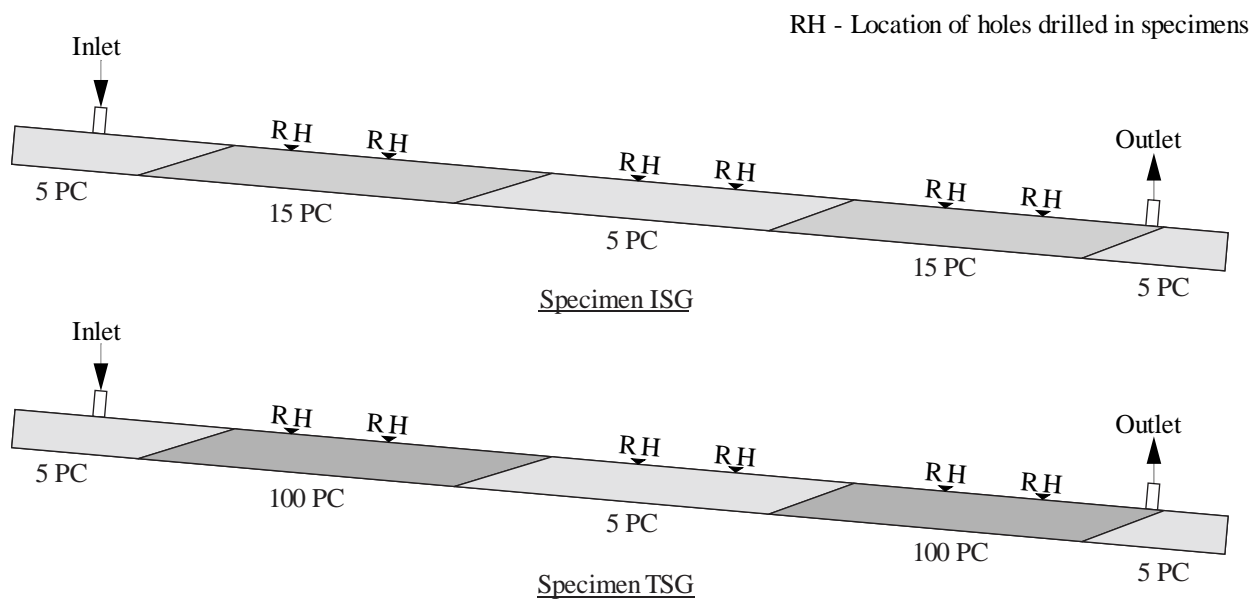
Figure 10-1. Mockup specimens

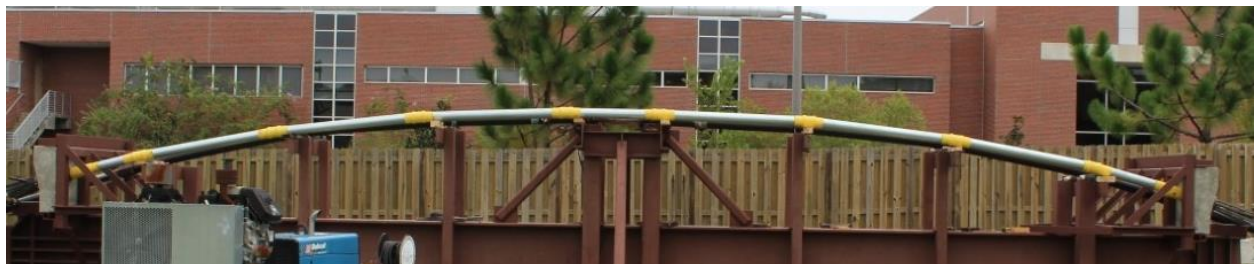
Figure A.2-2. Hydrodemolition specimen: schematic figure with location of 2x8
