# DIAGNOSTIC INVESTIGATION OF EXCESSIVE CAMBER IN PRESTRESSED SLAB UNITS

FLORIDA DEPARTMENT OF TRANSPORTATION  
M. H. ANSLEY STRUCTURES RESEARCH CENTER  
WRITTEN BY: ARIANA MORALES RAPALLO  
REVIEWED BY: CHRISTINA FREEMAN, P.E.

2020

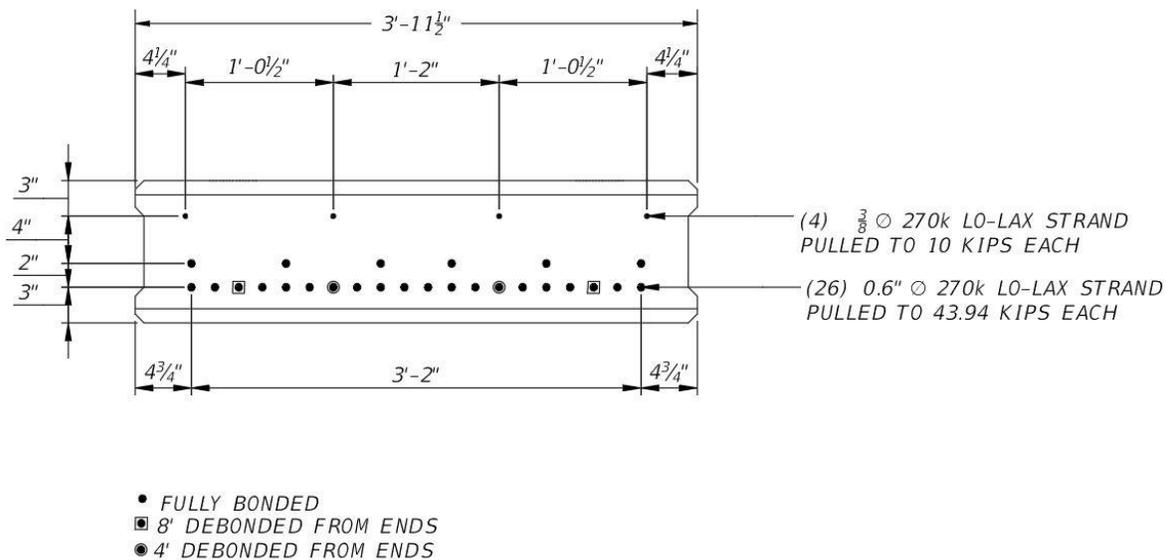
Figure 1 PSU Cross-Section

The slabs were designed to have three layers of prestressing strands. The bottom layer consisted of twenty-six (26), 0.6 in. diameter, 270 ksi lo-lax strands stressed to 43.94 kips. The distance from the bottom of the slab to the centroid of the bottom layer of strands was 3 in. Two (2) were debonded 8 ft from the ends and two (2) were debonded 4 ft from the ends. A second layer 5 in. from the bottom of the slab with six (6), 0.6 in. diameter, 270 ksi lo-lax strands were also stressed to 43.94 kips each. Finally, a top layer with four (4), 0.375 in. diameter, 270 ksi lo-lax strands were located 3 in. from the top of the slabs and stressed to 10 kips each. In Figure 1, the strand location and slab details are shown.

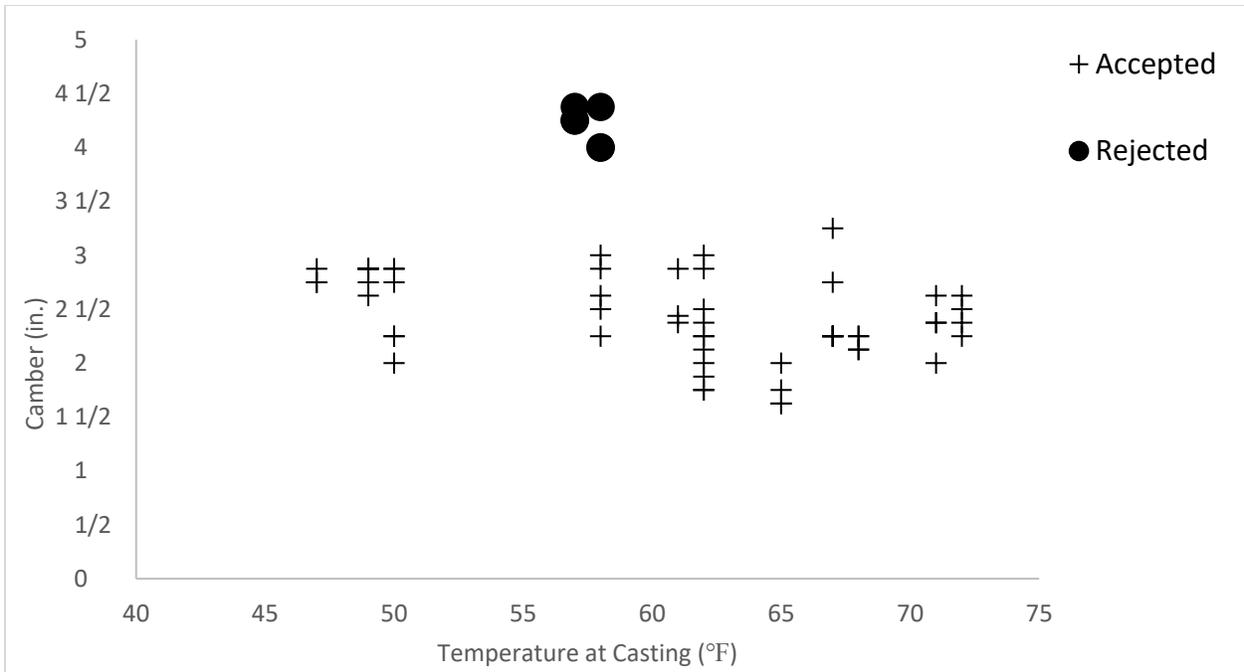
Figure 2 Camber vs Temperature at Casting

The rejected slabs were compared to the accepted slabs from the project to investigate any difference in the temperature at casting, the temperature at release, relative humidity and the strength of the concrete at release that might have caused the excess camber. This information was obtained from readings made by the precaster and public weather records and Figures 2-5 show the relationship between the accepted and rejected slabs for temperature, relative humidity, and concrete strength.

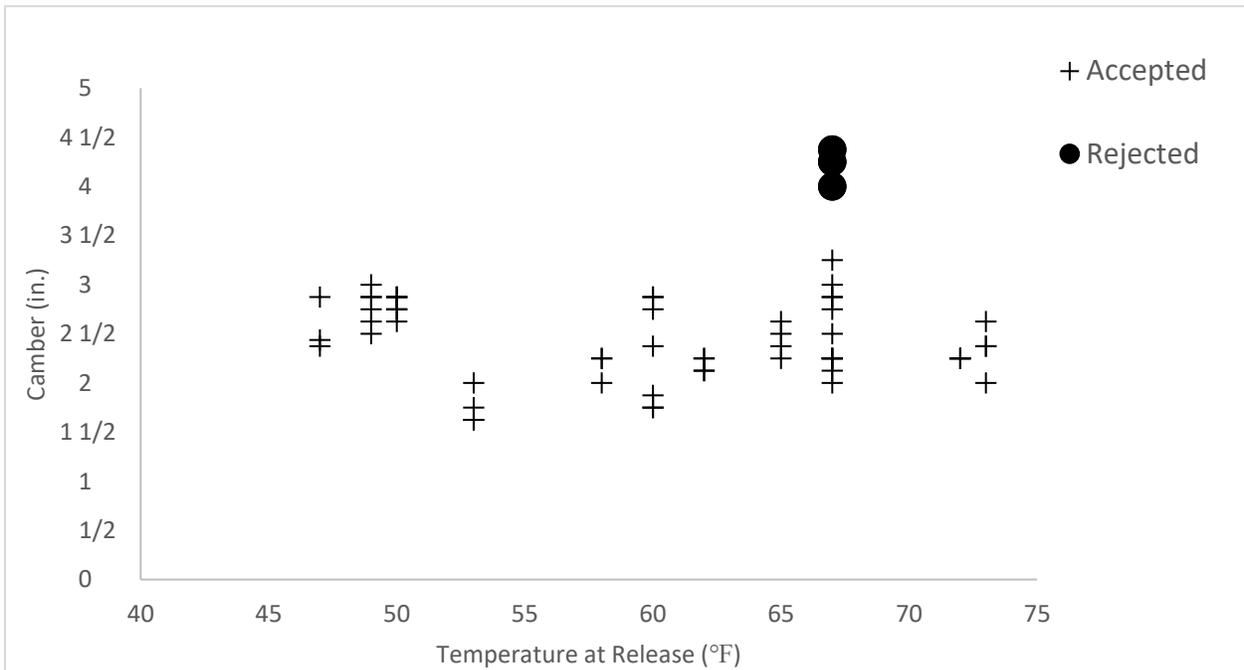
Figure 3 Camber vs Temperature at Release

However, the temperature at release in Figure 3 for the rejected slabs is located in the higher temperature range, between 60 and 75 degrees Fahrenheit, compared to the accepted slabs. It is important to mention that this temperature corresponds to the average temperature of the day, however, the exact temperature at casting time and release time are unknown. In Figure 4, the concrete strength at release of the rejected slabs corresponds to the lower range of the accepted slabs, yet, a high number of accepted slabs are in the low range of concrete strength between 5000 psi and 7000 psi at release. Since relative humidity can affect creep and shrinkage it was important to evaluate this variable at casting. As shown in Figure 5, the relative humidity present when the rejected slabs were cast is within the range of all slabs cast in the project.

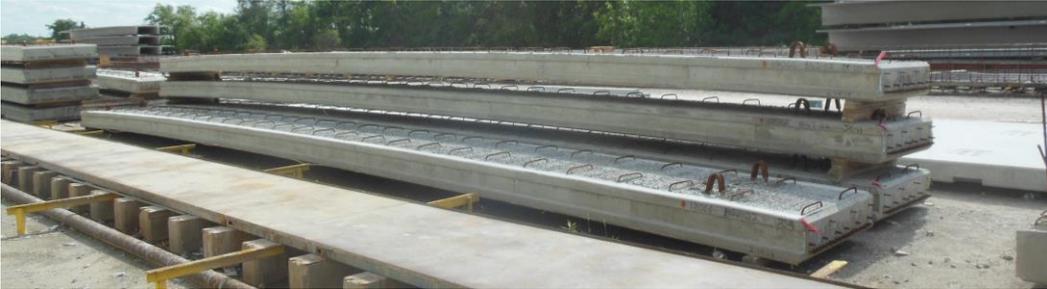
Figure 6 Slab Storage at the Precast Yard, Overall View

To evaluate the possibility of a thermal gradient affecting camber in the rejected slabs during the storage period, pictures from the precast yard were requested from the project’s CEI. The slabs were stored on top of each other as can be seen in Figure 6 and Figure 7. The four slabs shown in Figure 6 are all marked as slab type BS2-02. All four were 48 ft - 11 in. long and were rejected for high camber. As can be seen in Figure 6, the slabs were exposed to thermal effects unequally, with the lower slabs shaded. But, all four slabs had similar, unacceptably high camber.

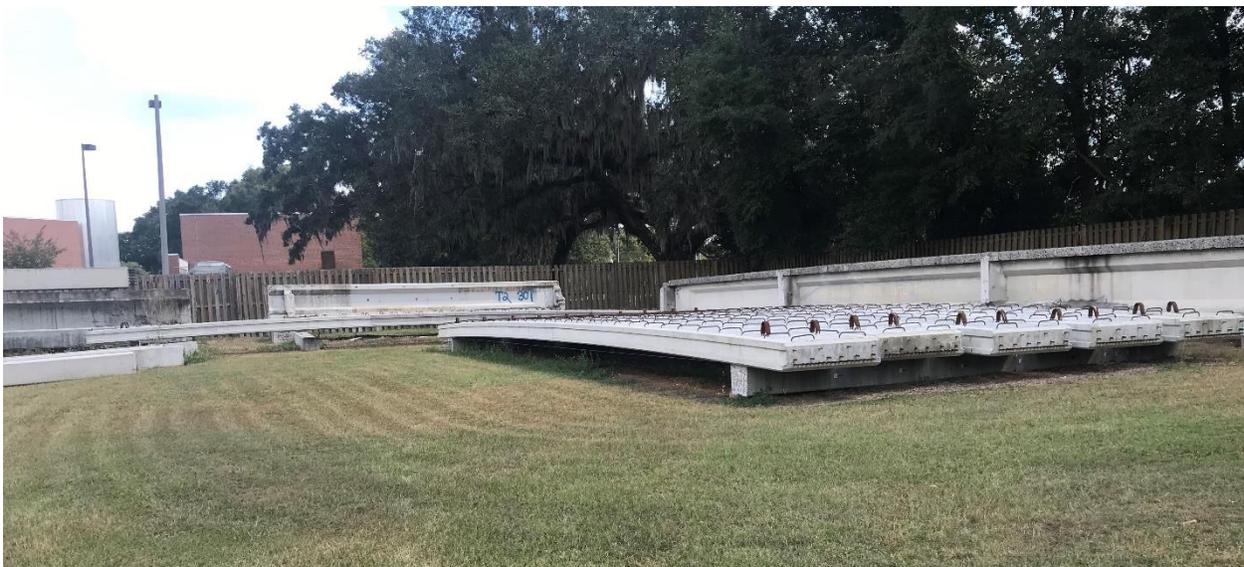
*Figure 8 PSU Slab Storage*

Over several months, while the Prestressed Slab Units (PSU) were stored at the FDOT SRC, weekly camber readings were taken using a ZipLevel Pro 2000 for the six rejected slabs. The ambient and concrete temperature were recorded as well to analyze the effect of temperature on the camber of the slabs. These readings were used to measure the effect of temperature in the slabs and the camber change in a non-destructive way. The slabs were stored on two concrete beams supports with a constant span length of 42 ft behind the FDOT Structure Research Center building. As shown in Figure 8, slabs JC-9, JC-10, JC-11, JC-12, and JC-14 were stored from east to west whereas slab JC-13 was oriented from north to south.

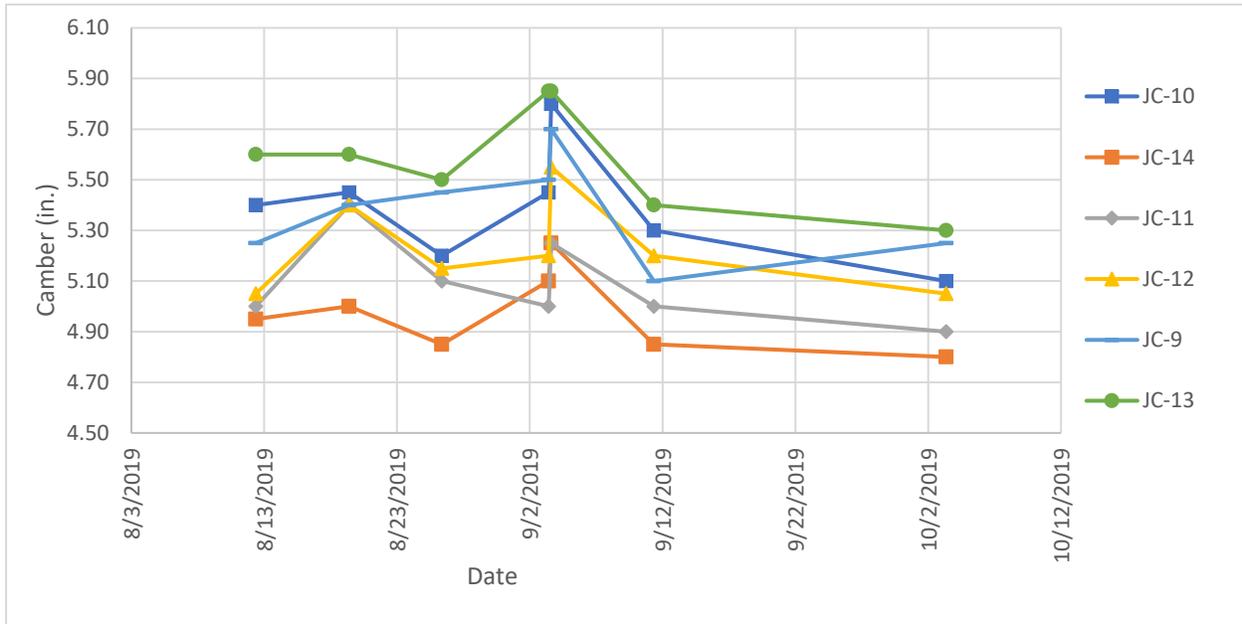
Figure 9 Camber Readings

As can be seen in Figure 9, all the slabs experienced similar camber changes throughout the measurement period. When the ambient and concrete temperatures were high the camber tended to be high. The readings during these two months showed a higher camber than what was measured at the precast plant when the slabs were rejected in May 2018, shown in Table 2. The primary reason for the difference is assumed to be the shorter span length during storage at FDOT SRC.

The camber readings seem to be consistent throughout the measurements, with a maximum change of 9% and the same behavior for all slabs. In the camber readings, time, ambient and concrete temperatures are shown for five different measurements throughout 2 months for the six slabs. Additionally, the camber was measured one last time when the slabs were placed on the supports just before being tested (JC-10, JC-11, JC-12, JC-14). It is important to note that these last readings were done inside the lab with a span length of 46 ft, which closely matches the storage conditions at the precast yard. The higher camber observed during storage at the FDOT SRC is likely due to the shorter support distance of 42 ft.

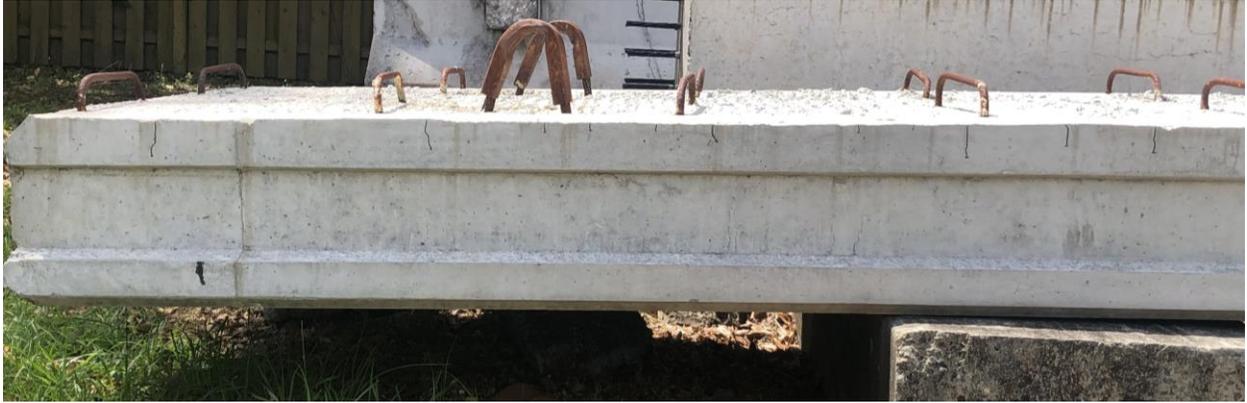
*Figure 10 Cracks Noted at the End of the Slab*

Cracks were visually identified and mapped for slab JC-13 at the FDOT Structures Lab facility to determine the extent and depth of cracks observed on the top of the Prestressed Slab Units (PSU), as can be seen in Figure 10 and Figure 11. The cracks were documented on May 5, 2020. The average depth of the cracks at the top tensile fiber was found to be 1.75 in. deep and the average width was 0.06 in. The cracks started to form approximately a foot away from the end and there was a high density of cracks from 3 ft to 9 ft away from the ends with an average distance in between cracks of 5 in. In the mid-span region, the cracks were approximately at 12 in. spacing.

Cracks evident in the top of one of the slabs indicate that the moment of inertia resisting upward movement (camber) of the slabs may be reduced compared to the uncracked section which is generally assumed for design. It was attempted to determine an effective cracked moment of inertia which would have produced the observed average 4.29 in of camber noted by the precaster. The PCI multiplier method was used, with the initial modulus of elasticity for concrete and gross and transformed properties. However, with a reduced moment of inertia, the deflection due to self-weight overcame the camber due to prestressing. A reduced moment of inertia due to cracking in the top fiber of the beam does not explain the unusually high camber.

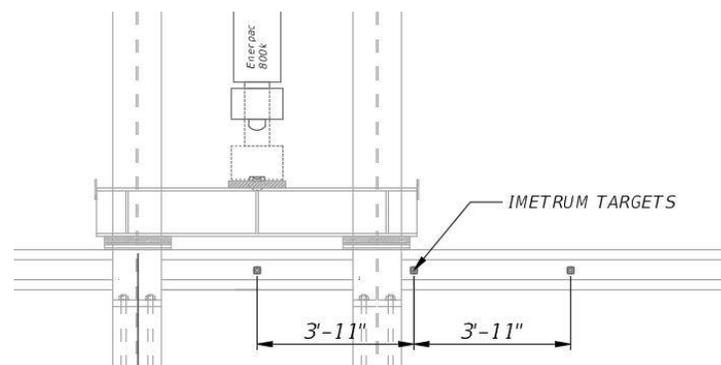
*Figure 12 Target Location*

- Two (2) high definition and fixed focal length cameras
- Two (2) 16mm lenses
- Three (3) targets equally spaced on the specimen as shown in Figure 12
- Target dimension of 3.5 in. x 3.5 in.

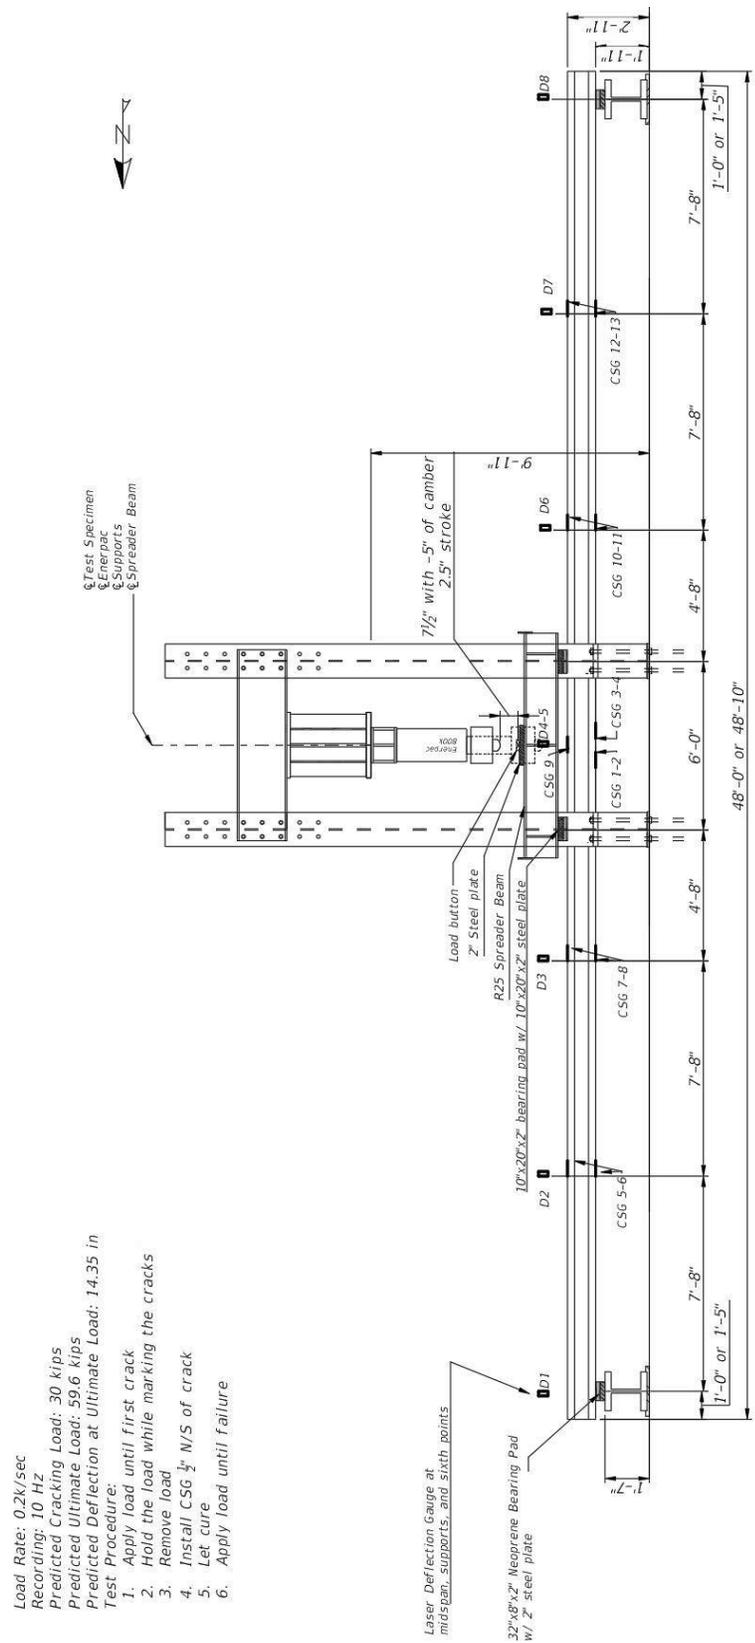
Figure 13 PSU Test Setup

For these tests, four slabs were tested in bending using a four-point loading until failure. The test setup and gage location can be seen in Figure 13. For these tests, foil strain gages were placed at even increments along the slab with deflection gages at the same locations as shown in Figure 13. The slabs were loaded with a rate of 0.2 kips/sec and the data was recorded at 10 Hz. The test procedure consisted of loading the concrete slab until the first crack was observed at approximately 30 kips, then holding the load to allow the cracks to be marked. The load was removed to install concrete strain gages (CSG) 0.5 in. north and south from the first crack. The slabs were untouched to let the gages cure properly for a few minutes. Finally, the load was applied one more time until the slab reached failure while strain, deflection, and load were recorded.

- Load Rate: 0.2k/sec  
 Recording: 10 Hz  
 Predicted Cracking Load: 30 kips  
 Predicted Ultimate Load: 59.6 kips  
 Predicted Deflection at Ultimate Load: 14.35 in
- Test Procedure:
1. Apply load until first crack
  2. Hold the load while marking the cracks
  3. Remove load
  4. Install CSG 1/4" N/S of crack
  5. Let cure
  6. Apply load until failure

Note: Locate gages CSG 1-4 1/2" North/South of first crack

Thirteen (13) 60 mm Kyowa strain gauges were installed on the specimen to measure the strain on the concrete. The concrete strain gauges CSG1 to CSG4 were installed after the first crack occurred in the concrete at approximately 30 kips at mid-span. These strain gauges were installed 0.5 in. from the crack with the purpose of measuring the crack opening after reloading the specimen. With this methodology, the decompression load was later determined. The strain was recorded at a rate of 10 Hz and was visually available in real-time. The instrumentation and setup plan can be seen in Figure 13, with the strain gauges denoted as CSG#.

Eight (8) MIT Microtrack 3 series LTS 300-200mm laser deflection gages were used along the specimen to determine the deflection at different points. These laser deflection gages were positioned every 7 ft - 8 in. along the beam and two (2) were located at midspan. Deflections were recording at a rate of 10 Hz and were visually available in real-time. The instrumentation layout for the test can be seen in Figure 13, with the deflection gages denoted as D#.

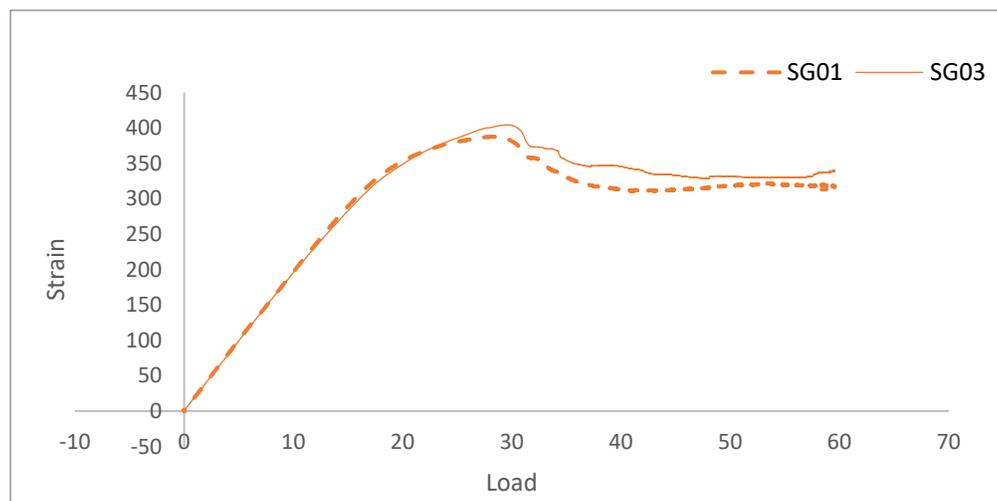
Figure 14 JC-10 Strain vs Load

The decompression load, defined as the load at which the stress at the extreme tensile fiber transitions from compression to zero, was obtained from the strain vs load graph. This load is represented as the point where the slope changes, as can be seen in Figure 14, in which the strain vs load of SG01 and SG03 for JC-10 are presented. For both gages, the first part of the graph has a linear behavior, however, it is challenging and imprecise to determine the point where the slope changes in this graph. This behavior occurred in all graphs for the four slabs tested.

The decompression load, effective prestress, and prestress loss, seen in Table 4, were calculated individually for each slab. The decompression load was obtained from the strain vs load graph, as shown in Figure 14, represented as the point where the slope of the graph changes. Once the decompression load was defined, the effective prestress was determined using the crack opening test calculation previously discussed, which considers the stress due to the dead load and the stress due to the applied load. Finally, the prestress loss was obtained comparing the effective stress with the stress to which the slabs were first pretensioned.

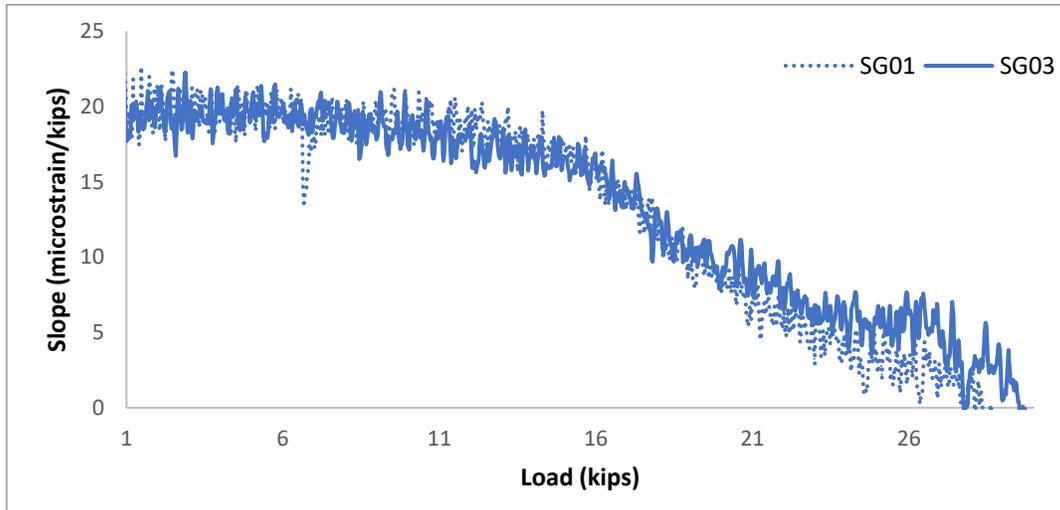
Figure 15 JC-10 Slope vs Load

To accurately determine the decompression load, the slope of both curves, taken at every 5 data points, was graphed versus the load, as shown in Figure 15. A change in the constant region of the slope vs load graph represents a change in slope in the strain vs load graph shown in Figure 14.

As can be seen in Figure 15, the first region of the graph has a relatively constant behavior at approximately 20 microstrain/kips, however, the line starts shifting downwards at approximately 16 kips. This change in behavior in the slope vs load graph represents a change of slope in the strain vs load graph, which means the decompression load can be taken as 16 kips for this test. The same methodology was used for the other slabs. In Table 4, the decompression load, effective prestress, and prestress loss of each slab tested can be seen. The effective prestress does not include the stress due to self-weight.

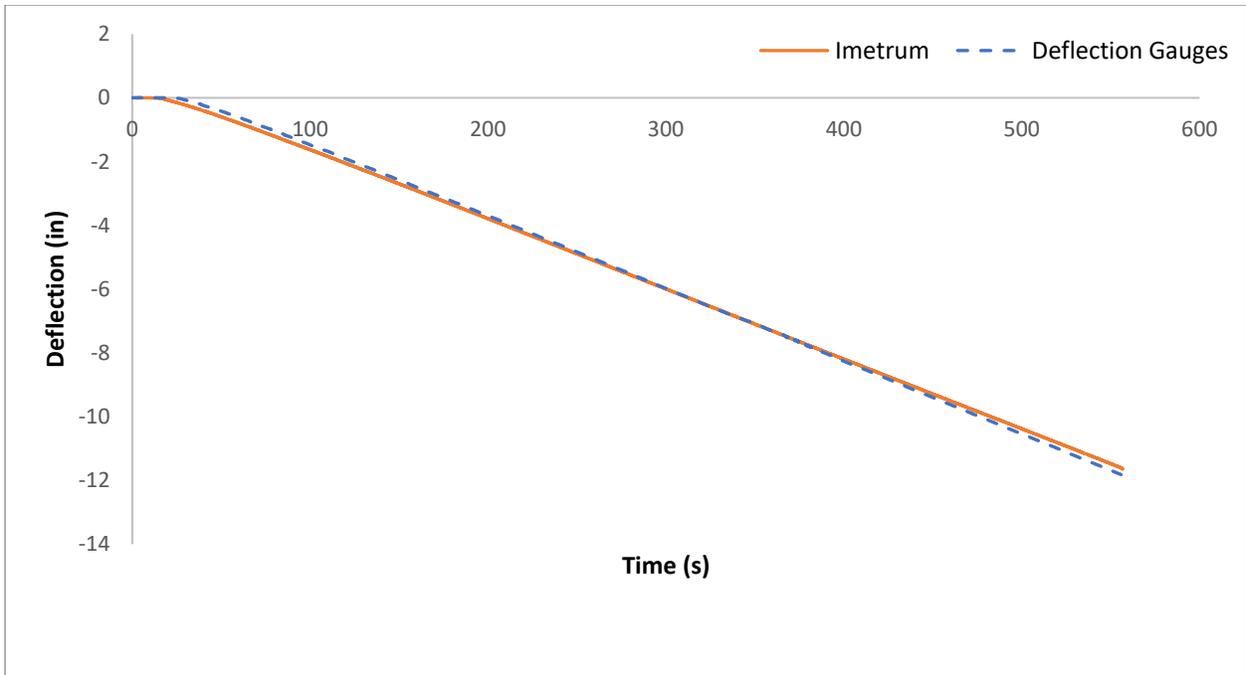
Figure 16 Deflection Gage and Imetrum System Readings at Midspan for JC-12

In Figure 16, the graph of the deflection obtained from the laser deflection gage and the Imetrum system at midspan for the JC-12 slab are shown. In solid line is the Imetrum system readings and in dashed line is the laser deflection gage readings. As can be observed in Figure 16, both readings are almost identical with a final deflection at midspan of -11.65 in. for the Imetrum system and -11.84 in. for the laser deflection gages. The percentage error of these two readings is 1.6% at maximum deflection.

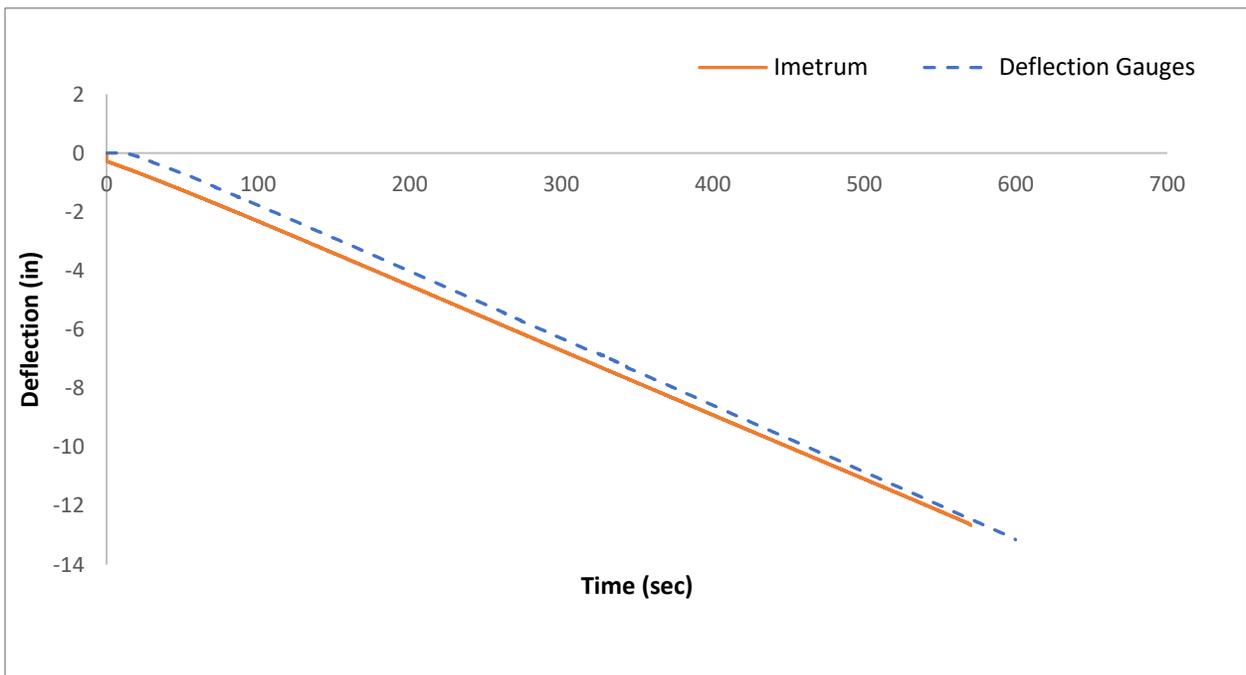
Figure 17 Deflection Gage and Imetrum System Readings at Midspan for JC-10

For the deflection evaluation at midspan of slab JC-10, Figure 17 shows the comparison of the laser deflection readings and the Imetrum system. As can be seen in Figure 17, both results were very consistent, however, the maximum deflection in the Imetrum system was less than what was recorded with the laser deflection gauge. The maximum deflection recorded using the Imetrum system was -12.67 in. and using laser deflection gauges, it was -13.19 in. Moreover, recorded data from the Imetrum system lasted 571 seconds and recorded data from the laser deflection gages was 600 seconds. The difference in time and deflection measurement was due to the beam deflecting below the field of view of the Imetrum system.

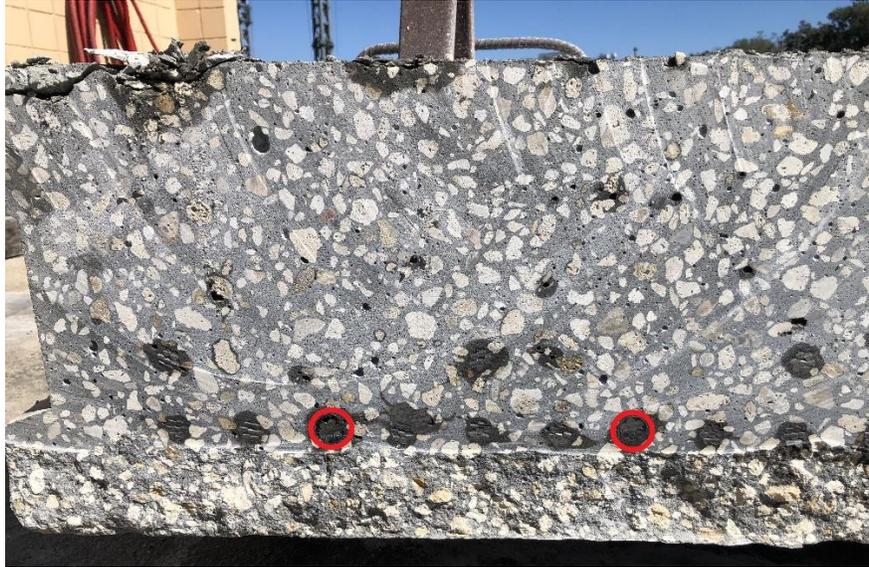
*Figure 18 Debonded Strands*

In Figure 18 , the debonded strands are circled in red. The strand closer to the edge is debonded 8 ft as stated in the shop drawings and the strand closer to the middle of the cross-section is debonded 4 ft as stated in the shop drawings. In Figure 19, the entire cross-section of the slab can be seen with the locations of the four debonded stands, both 4 ft and 8 ft from the ends, circled in red. Visual observations of the cut slabs indicate the slabs were debonded as planned.

An inaccurate debonded length of the strands was a hypothesis that could explain the excess camber of the slabs. To evaluate this hypothesis, slabs JC-11 and JC-12 were saw cut, after being tested in bending, at 3 ft -10 in. and 7 ft -10 in. from the end to visually confirm the presence of debonding sheathing, as can be seen in Figure 18 and Figure 19.

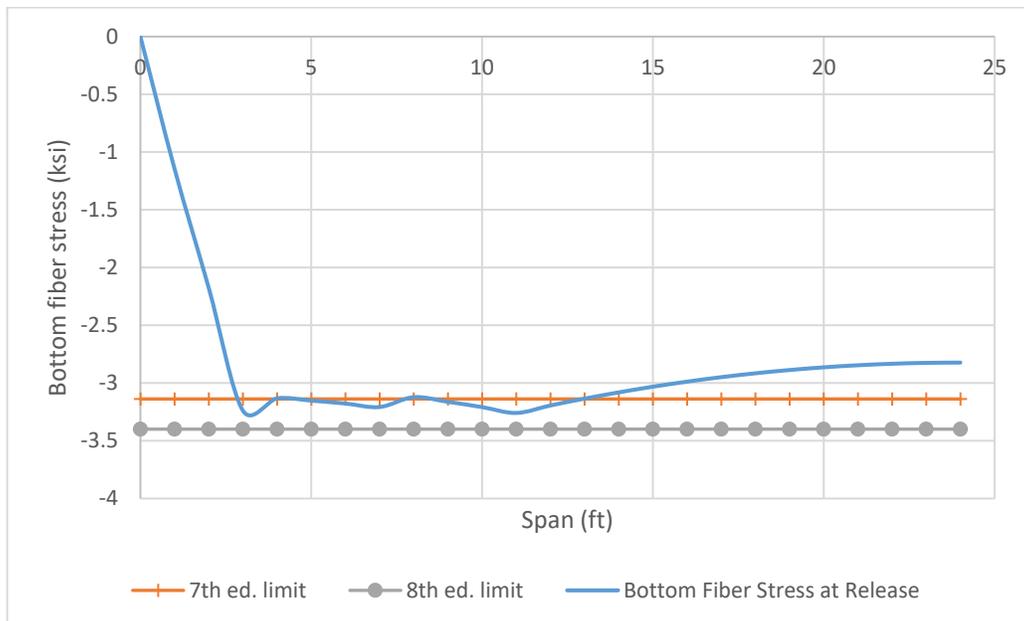
Figure 20 Bottom Fiber Compressive Stress at Release, 4 ft Wide Units

Compressive stresses at release were manually calculated using the tested properties of the concrete and were compared to the limits allowed by the AASHTO LRFD Bridge Design Specifications. As previously mentioned, the EOR designed the slabs based on AASHTO LRFD Bridge Design Specifications 7<sup>th</sup> edition (2016), which allows compressive stress at the bottom fiber of the slab to be up to  $0.6f'_c$ , whereas AASHTO LRFD Bridge Design Specifications 8<sup>th</sup> edition (2017), which is the current edition, allows  $0.65f'_c$ . When calculating the stress at release in the rejected slabs based on tested properties, it was noted that the stresses at the bottom fiber exceeded the stress limit for the applicable code at the time of design, AASHTO LRFD Bridge Design Specifications, 7<sup>th</sup> edition, by 2.9%. The bottom fiber stress at release can be seen in Figure 20. The  $0.6f'_c$  limit was exceeded but the  $0.65f'_c$  limit was not. Although the compressive stress was high compared to the AASHTO LRFD Bridge Design Specifications, it was less than the  $0.7f'_c$  limit recommended by Dolan and Krohn (2007) for avoiding excess camber.

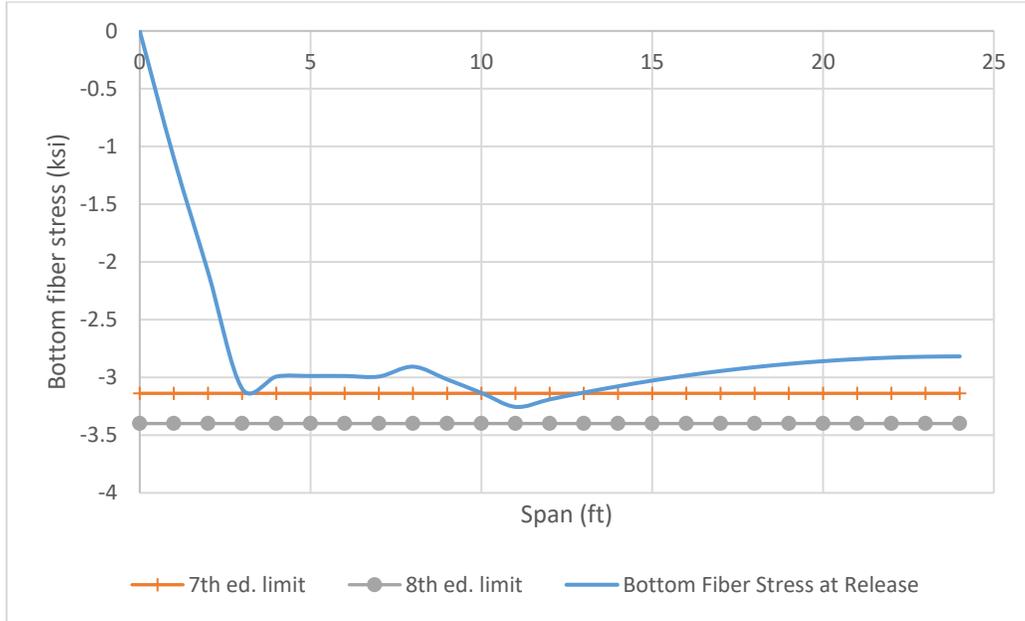
Figure 21 Bottom Fiber Compressive Stress at Release, 5 ft Wide Units

All of the 5 ft wide prestressed slab units, which were built for this bridge project at the same time as the 4 ft wide prestressed slab units studied herein, had an acceptable level of camber. All of those 5 foot wide units would have had bottom fiber stress exceeding the  $0.6f'_c$  limit as well, as shown in Figure 21, if concrete with the same unit weight and strength was used. The magnitude of exceedance is similar, however, the length of the beam for which the stress limit is exceeded is shorter.
