SHEAR FRICTION CAPACITY OF CORRUGATED PIPE CONNECTION IN PRECAST FOOTINGS

(Project No.: BDV29 977-39)

Final Report

July 2022

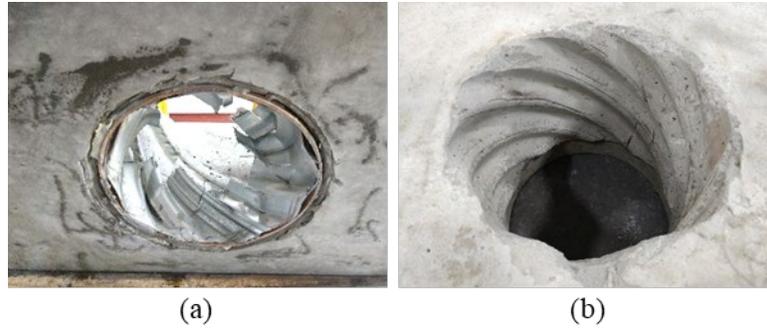
Figure 3.3: (a) Removal of corrugated pipe and (b) surface finish after removal of pipe and sandblasting

2. The pipe was removed after the concrete in the cap hardened (typically 1 to 3 days after casting of the cap), as shown in Figure 3.3. The surface preparation after removal of the pipe varied based on the desired interface condition.

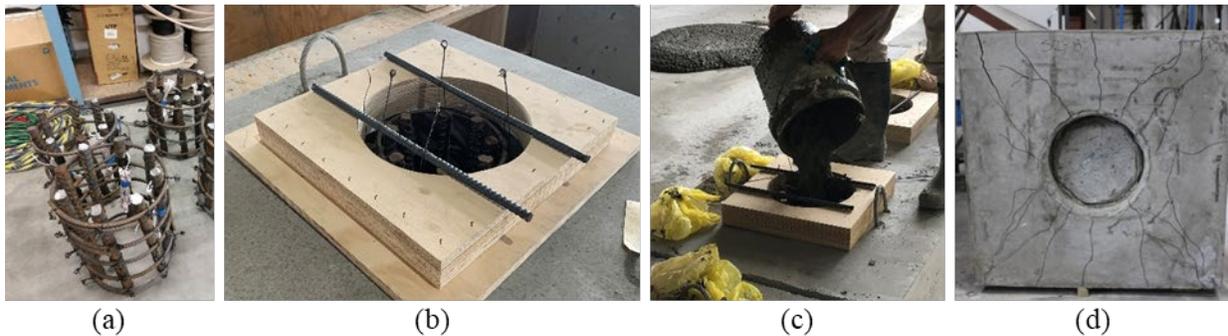
Figure 3.4: Plug construction: (a) typical plug reinforcement, (b) 3-inch cylindrical form on top of cap, (c) casting of plug concrete, and (d) 3-inch blockout on bottom of plug (after testing)

3. After the pipe was removed and the interface surface properly prepared, a 3-inch cylindrical form with the same diameter as the plug was placed on top of the cap and a 3-inch blockout was installed at the bottom of the plug, as shown in Figure 3.4. The plug was cast between 5 and 163 days after the cap (see §3.3.4).

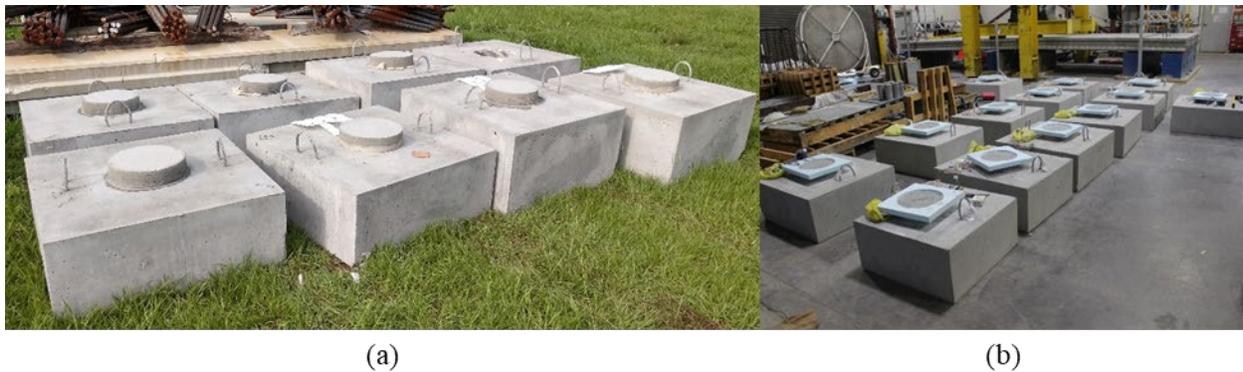
Figure 3.5: Finished specimens for (a) part of Series II and (b) Series III

4. After the concrete had hardened, the formwork and foam blockout were removed. The precast specimens were then shipped to FDOT's Structures Research Center and prepared for testing. The finished specimens were tested between 16 and 178 days after initial casting.

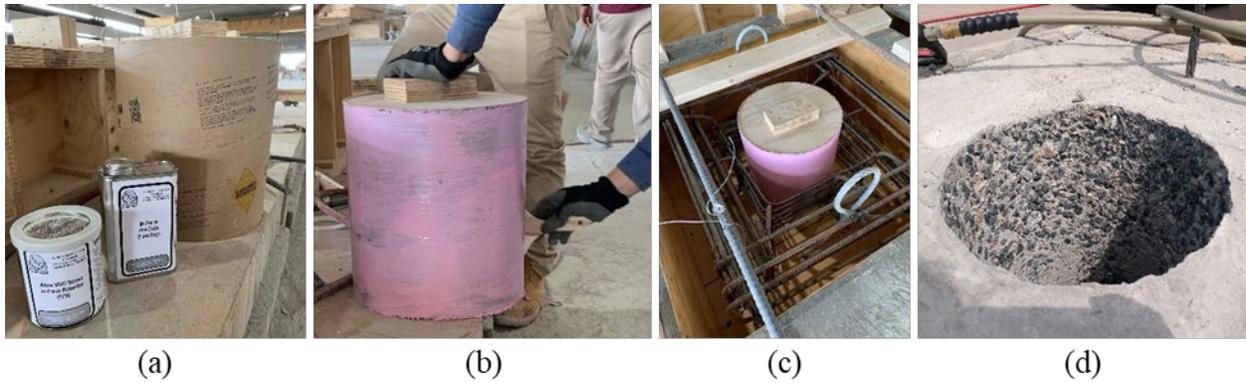
Figure 3.7: Procedure for achieving exposed aggregate finish: (a) application of polyurethane clear coat, (b) application of set retarding agent, (c) placement of void in cap, and (d) finish after pressure washing surface

3. The plug void was then placed in the cap, Figure 3.7 (c), and the cap concrete cast.
4. The plug form was removed within 24 hours of casting and a pressure washer was used to wash away the unhydrated paste on the surface of the plug. Care was taken to ensure the paste was washed away without fracturing the aggregate.

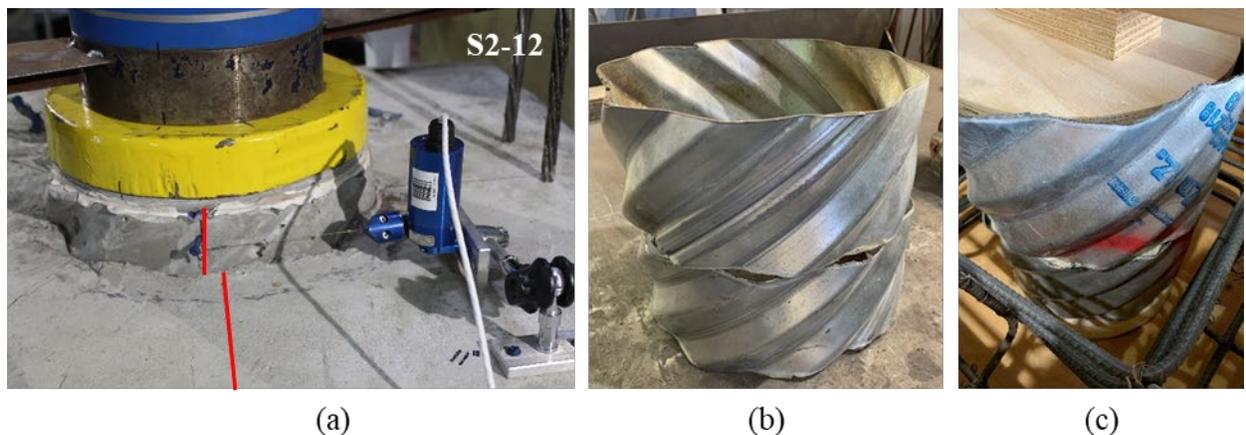
Figure 3.8: (a) Rotation observed in S2-12, (b) detail of the corrugated metal pipe when the pipe was left in place in later specimens, and (c) installed metal pipe with tape inside blocking voids

One adjustment was made in the construction of some of the Series II and all the Series III specimens when the corrugated pipe was left in place. Rotation of the plug was observed in the first two specimens in Series II with the corrugated metal duct left in place (S2-9 and S2-12), as shown in Figure 3.8 (a). For later specimens, the corrugated metal duct was cut at mid-height and rotated so that the corrugations did not align at the cut, as shown in Figure 3.8 (b). This was done to try and resist the rotation of the plug during testing. The two pieces were welded, and tape was used inside the pipe to avoid intrusion of the concrete when pouring the cap, as shown in Figure 3.8 (c).

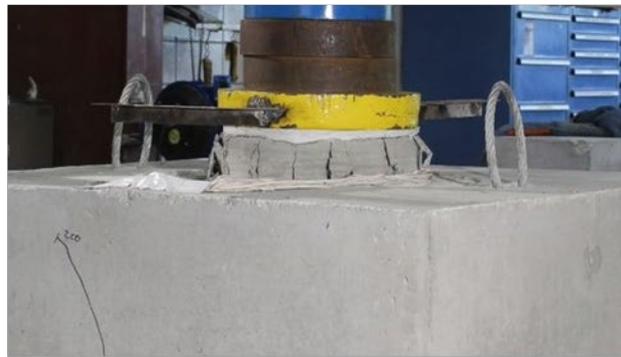
Figure 3.21: Failure details on (a) bottom, (b) cap, (c) top of plug and (d) plug detail during testing of the Specimen S3-13

Although there was no cold joint, the monolithic cast specimen (S3-13) also experienced a sliding failure along the interface between the plug and cap. The concrete strength was lower (4.7 ksi for cap and plug) than the specimens in Series I and II, so the normalized loads k are used for comparisons. Cracking began in the specimen at a normalized load k of 0.139 (125 kips), which was close to the average normalized cracking load k_{avg} of 0.133 for all the specimens tested. The observed crack pattern was like the typical crack pattern seen in the other specimens, as shown in Figure 3.21 (a) and (b). One difference was that concrete on the sides of the extended plug progressively spalled off during testing, as shown in Figure 3.21 (c) and (d).

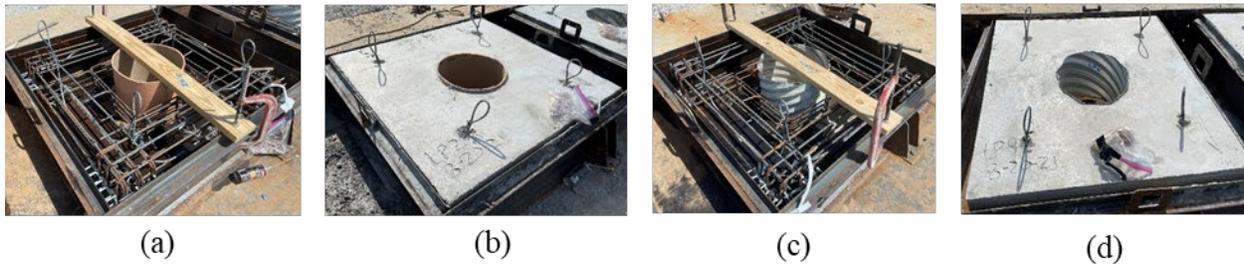
Figure 4.1: Construction and casting of cap: (a) placement of reinforcement and (b) casting of cap concrete for specimen with Sonotube and (c) placement of reinforcement and (d) casting of cap concrete for specimen with corrugated metal pipe.

1. A cube was cast with a cylindrical void in the center (referred to as the “cap”). The caps were 14 inches tall and 54 inches wide and deep with an 18-inch diameter cylindrical void. The cylindrical void was constructed using corrugated metal pipes and Sonotubes (smooth cylindrical tubes) to vary the corrugation spacing and depth, as shown in Figure 4.1.

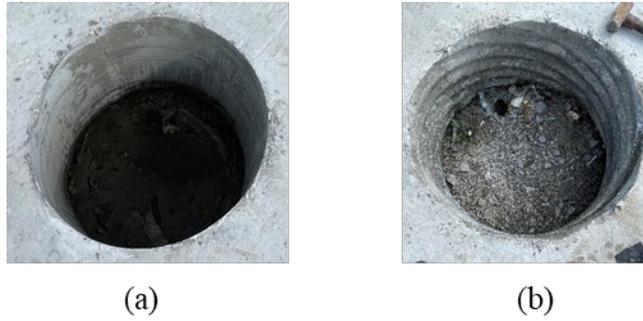
Figure 4.2: Surface finish after removal of pipe with (a) Sonotube and (b) corrugated pipe.

2. The pipe was removed after the concrete in the cap hardened (4 days after casting of the cap), as shown in Figure 4.2. The surface preparation after removal of the pipe varied based on the desired interface condition.

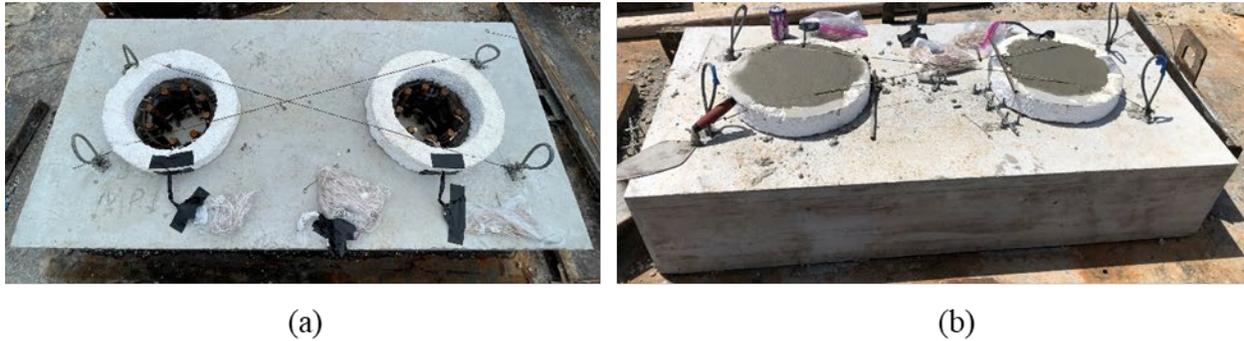
Figure 4.12: Casting of the plug: (a) 3-inch form and reinforcement was placed and (b) concrete was cast.

2. After the concrete had hardened, one of the plug forms was removed (4 days after casting of the cap) and the surface of the plugs were prepared as indicated in the test matrix. In the other cap, the pipes were left in place.
3. After the pipes were removed and the interface properly prepared, a 3-inch tall cylindrical form with the same diameter as the plug was placed on top of the cap and 5-inch blockout was installed at the bottom of each plug to create the correct dimensions for the plug. The plug reinforcement was then placed, and concrete cast as show in Figure 4.12.

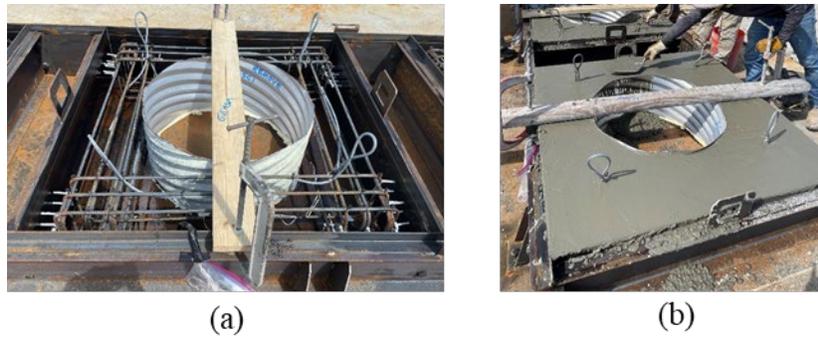
Figure 4.18: (a) Construction of the socket connection specimen and (b) casting of the cap.

1. An 18-inch pile with a 20-inch length was cast beforehand. The 20-inch length was cut from a longer standard 18-inch pile cast for a different job.
2. A reinforced concrete cube (referred as the "cap") was cast with a 30-inch cylindrical void in the center. The cylindrical void was constructed using corrugated metal pipe as shown in Figure 4.18.

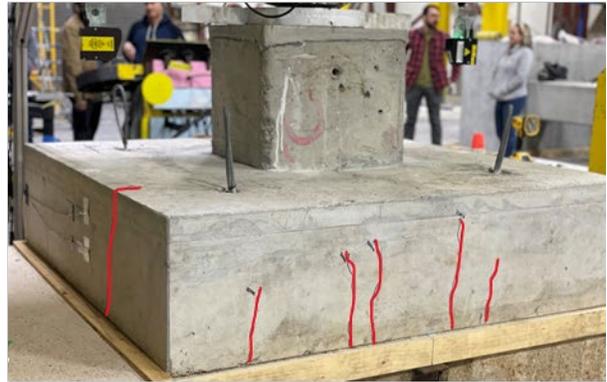
Figure 4.23: (a) Sample load versus deflection plot with stops and (b) crack pattern at 350 kips for Specimen SC-1

Both specimens were tested using the same loading procedure. The load was applied at a rate of 0.2 kips per second until a load of 175 and 350 kips was reached. For Specimen SC-1 only one stop at 350 kips was made, and for SC-2 both stops at 175 and 350 kips were made. In each stop, the respective load was held on the specimens while the specimens were inspected for cracks; cracks were marked, labeled, and documented, as shown in Figure 4.23. The load versus deflection plot for SC-1 with the stops made during testing are highlighted in Figure 4.23 (a). Load was then applied at the same load rate (0.2 kips per second) until failure of the specimen. Cracks were marked on all sides of the specimens after they were removed from the test frame.

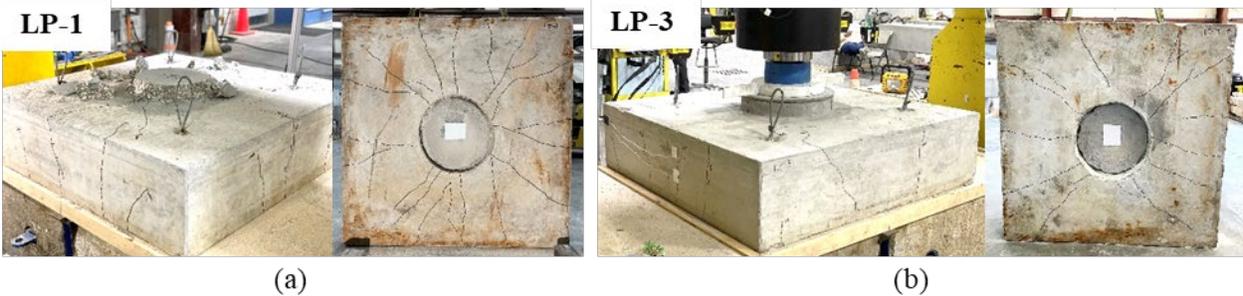
Figure 4.35: Crack patterns at failure for (a) LP-1 (smooth with 1/16-inch roughness) and (b) LP-3 (corrugated with 1/16-inch roughness)

Similar crack patterns were observed between LP-1 and LP-3, see Figure 4.35.

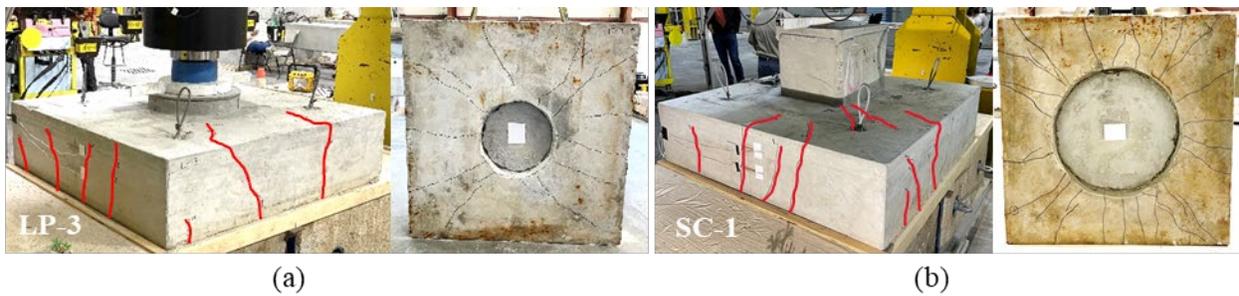
Figure 4.40: Crack patterns at failure for LP and SC specimens with corrugated interface (a) LP-3 and (b) SC-1

The crack patterns between the socket and pocket type connections were generally similar to one another, as shown in Figure 4.40 as an example.

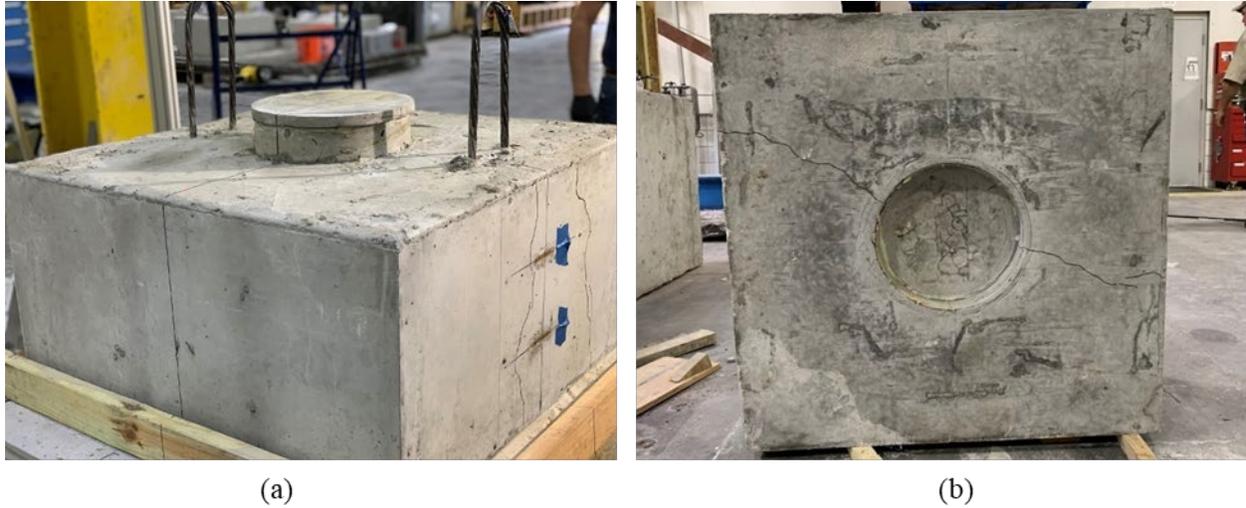
Figure A.24: Cracking on the (a) east side and (b) bottom of Specimen S2-1

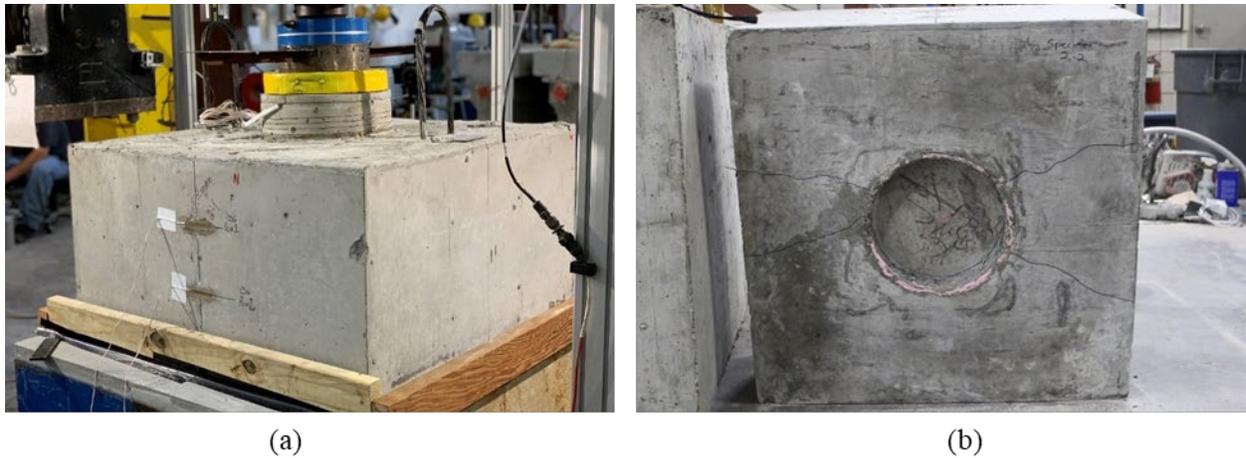
Figure A.31: Cracking on the (a) surface of the cap and (b) bottom of the specimen S2-2

Cracking was visually observed after the test was completed as shown in Figure A.31. The cracking was observed to extend from the bottom of the cap onto the top toward the plug in the east and west side as the Specimen S2-1.

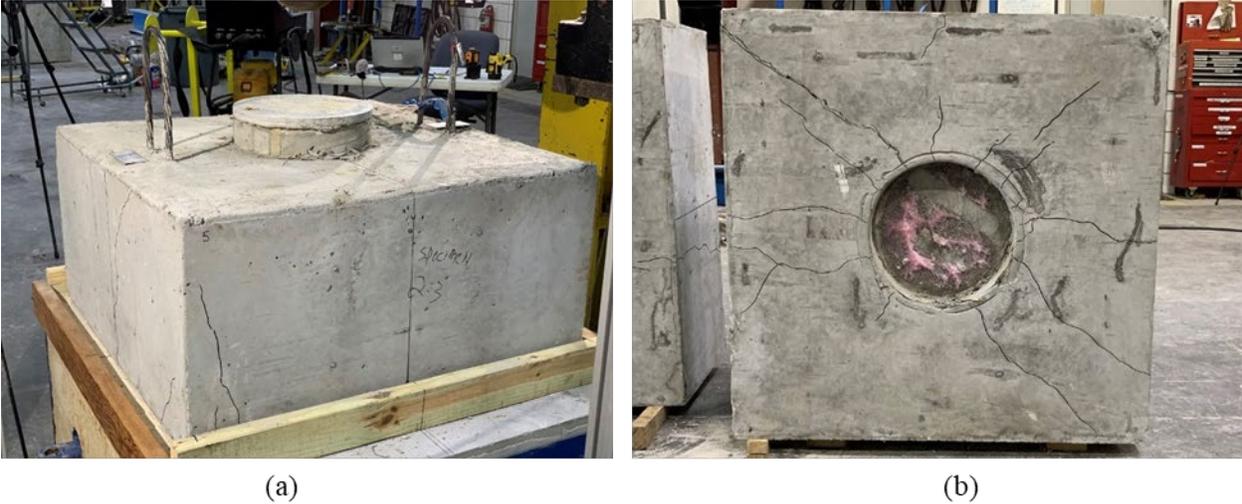
Figure A.38: Cracking on (a) cap and (b) bottom of the Specimen S2-3

Cracking was visually observed as shown in Figure A.38. The cracking was observed to extend from the bottom of the cap onto the top toward the plug in the east and west side. More splitting stresses were observed on the bottom cap when having a single rib on the interface.

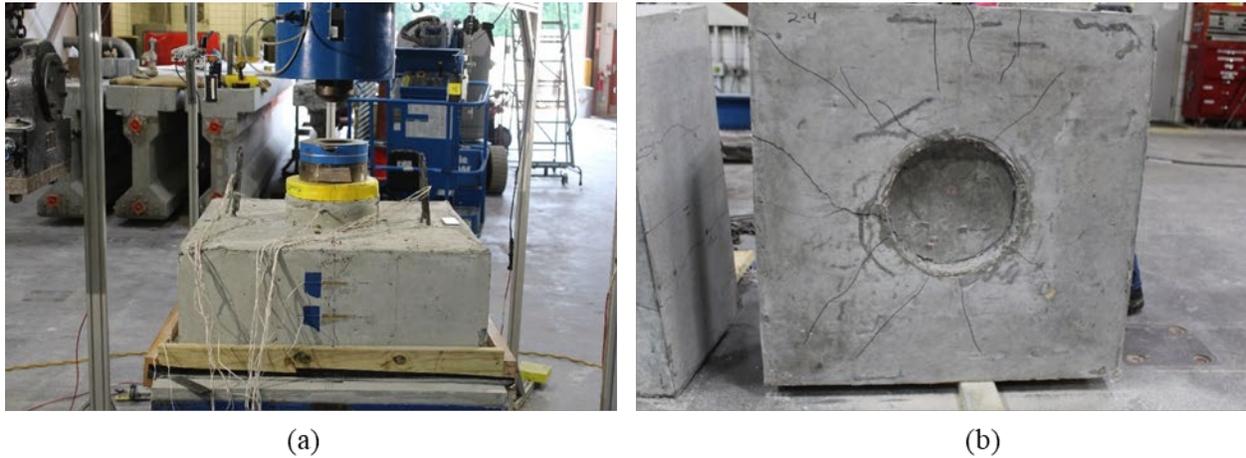
Figure A.45: Specimen S2-4 (a) elevation before testing and (b) bottom cracking after testing

Cracking was visually observed when the testing was finished as shown in Figure A.45. The cracks were observed to extend in the east and west side.

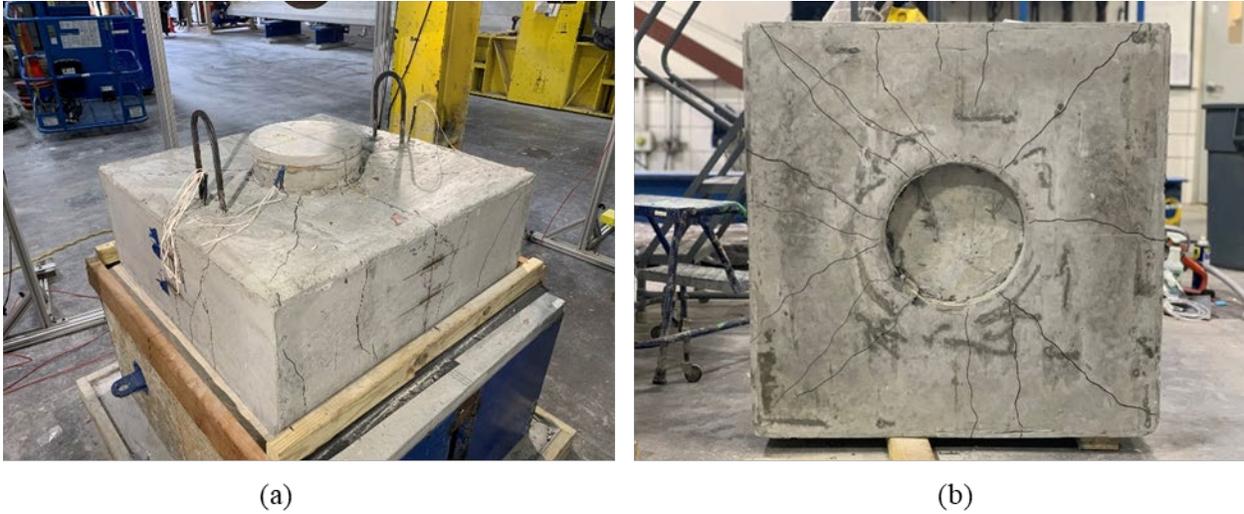
Figure A.52: Cracking on a (a) cap and (b) bottom of the Specimen S2-5

Cracking was visually observed as shown in Figure A.52. The cracks extended from the bottom of the cap to the top toward the plug in the north and south sides. More splitting stresses were observed on the bottom cap when having a single rib on the interface.

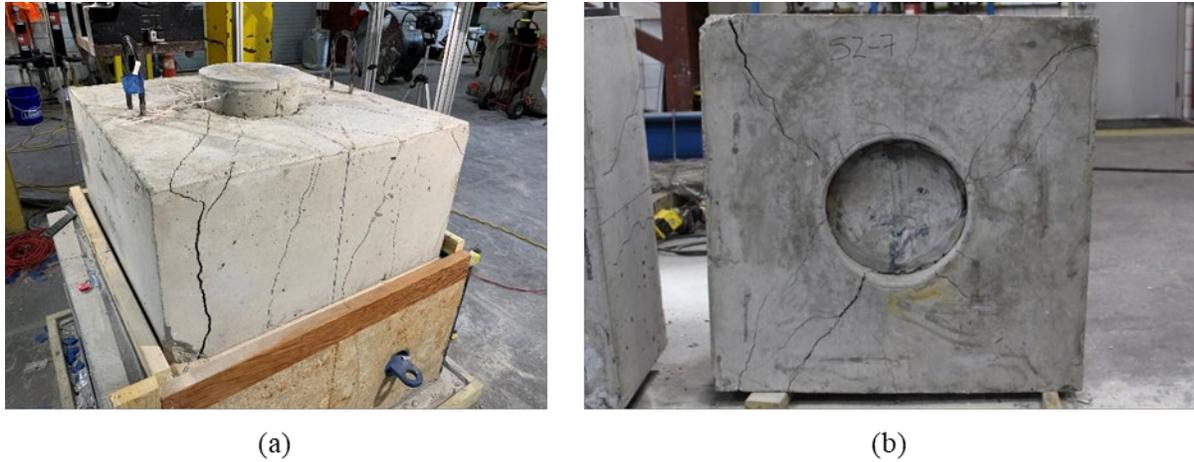
Figure A.66: Cracking on (a) cap and (b) bottom of Specimen S2-7

When the testing was finished, cracks were also observed as shown in Figure A.66. Cracks extended from the bottom, going up to the cap toward the plug as the reading of the gauges suggested. Bigger cracks were observed on the east-west side than the north-south side of the specimen.

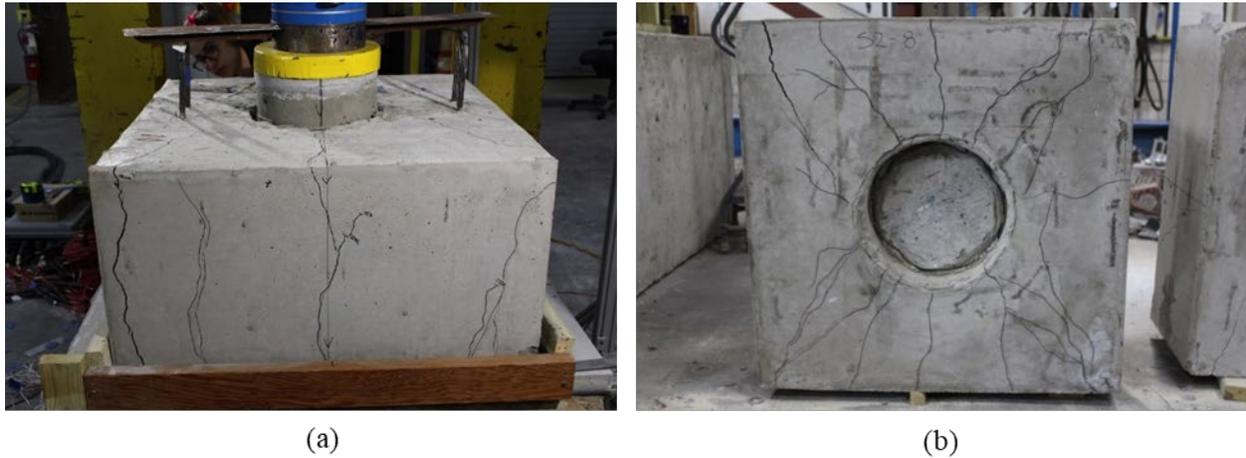
Figure A.73: Cracking on (a) cap and (b) bottom of Specimen S2-8

Cracking was visually observed as shown in Figure A.73. As shown in all the results, the plug started to move after formation of the cracks.

As expected, specimen S2-8 (1/2 corrugated) had less capacity than the specimen S2-7 (full corrugated). Also, similar stresses distributions and cracks propagation was seen during the testing. These results suggest the ribs in the corrugation are effective in transferring stresses between the interfaces.

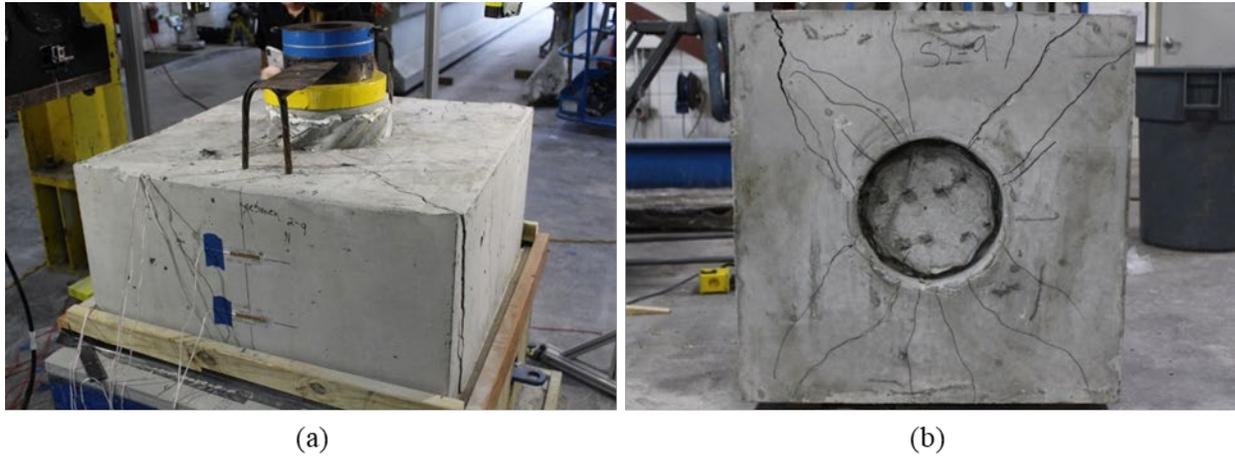
Figure A.80: Cracking on (a) cap and (b) bottom of Specimen S2-9

When the testing was finished, cracks were also observed as shown in Figure A.80. Cracks extended from the bottom, going up to the cap toward the plug as the reading of the gauges. Bigger cracks were observed on the east-west side than the north-south side of the specimen.

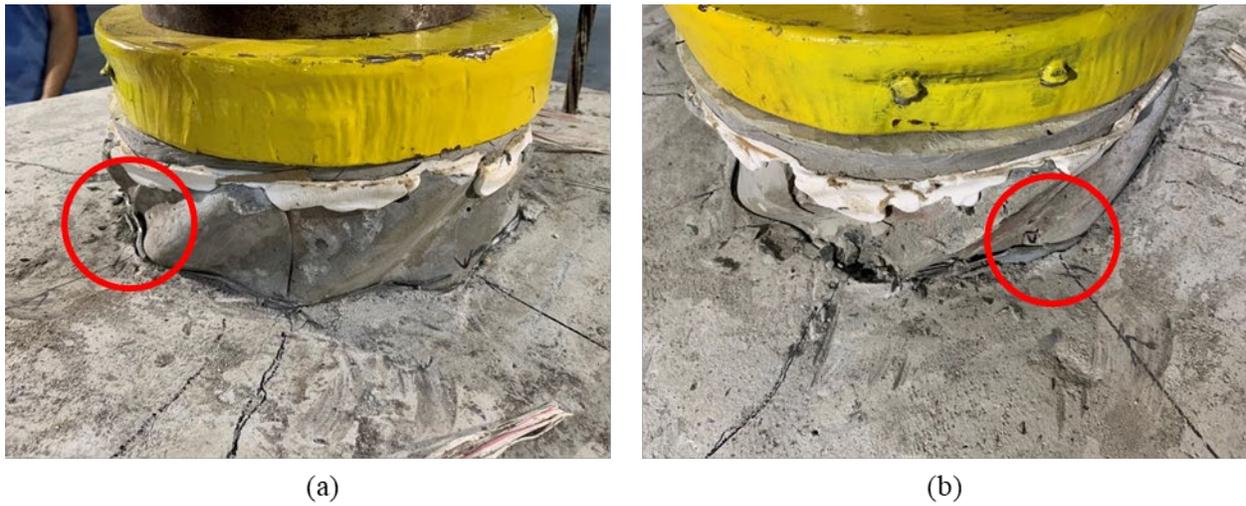
Figure A.82: Details of plug rotation in (a) separation of the interface is observed and in (b) reference lines do not match

In this specimen rotation was noticed in the interface. It seems that after the bonding was broken, the plug started to rotate following the corrugation path. This rotation can be observed in Figure

A.82. In Figure A.82 (b), we can see how the reference lines that were drawn in the plug and cap before the testing does not match after testing.

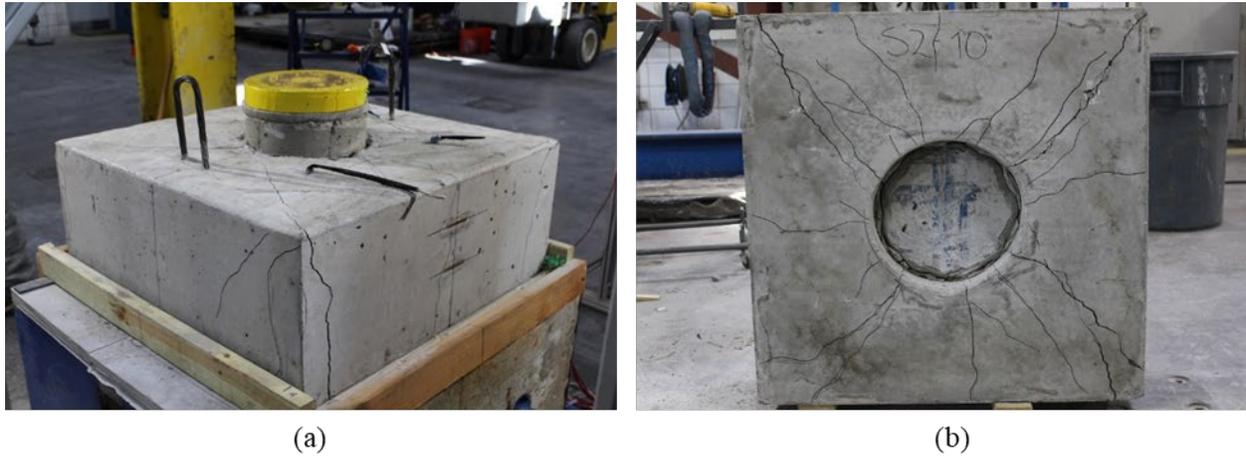
Figure A.88: Cracking on (a) cap and (b) bottom of Specimen S2-10

When the testing was finished, cracks were also observed as shown in Figure A.88. Even though cracking started on the north side of the specimen, bigger cracks were observed more on the east-west side than the north-south side of the specimen.

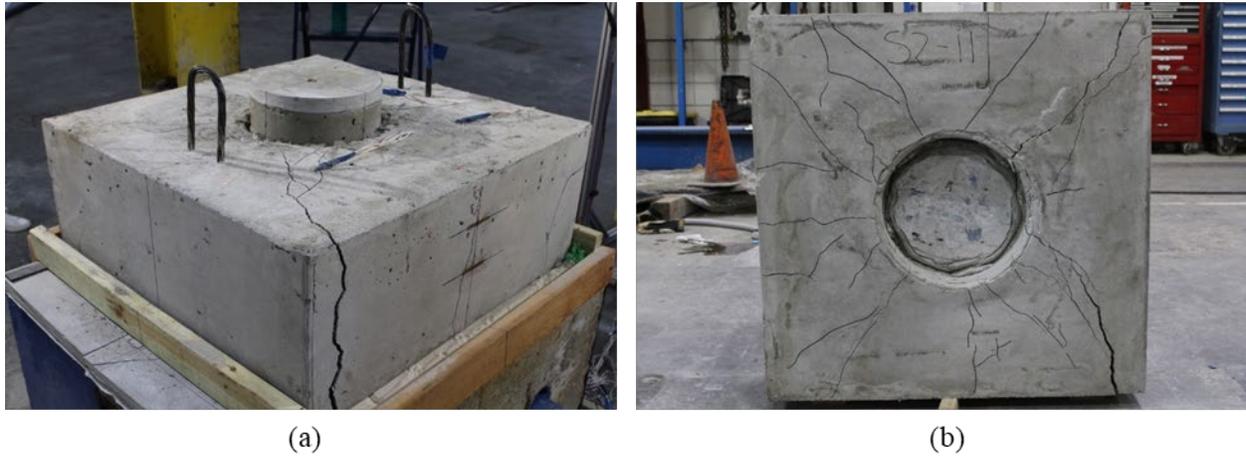
Figure A.95: Cracking on (a) cap and (b) bottom of Specimen S2-11

Cracking was visually observed as shown in Figure A.95. As shown in all the results, the plug started to move after propagation of the cracks, which would suggest that expansion of the plug happened before sliding.

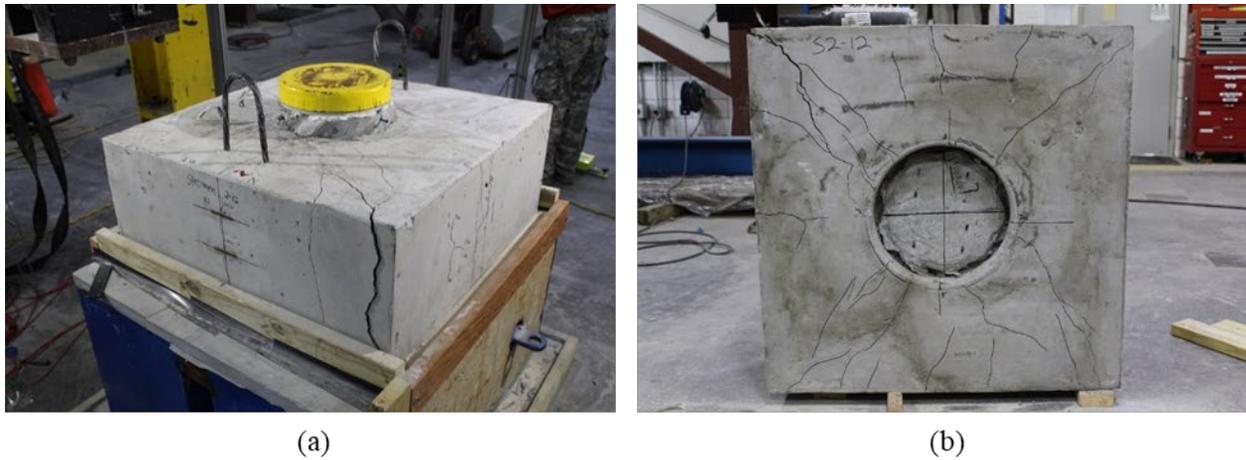
Figure A.102: Cracking on (a) cap and (b) bottom of Specimen S2-12

When the testing was finished, cracks were also observed as shown in Figure A.102. Cracks extended from the bottom, going up to the cap toward the plug as the reading of the gauges. Bigger cracks were observed on the north-south side than the east-west side of the specimen.

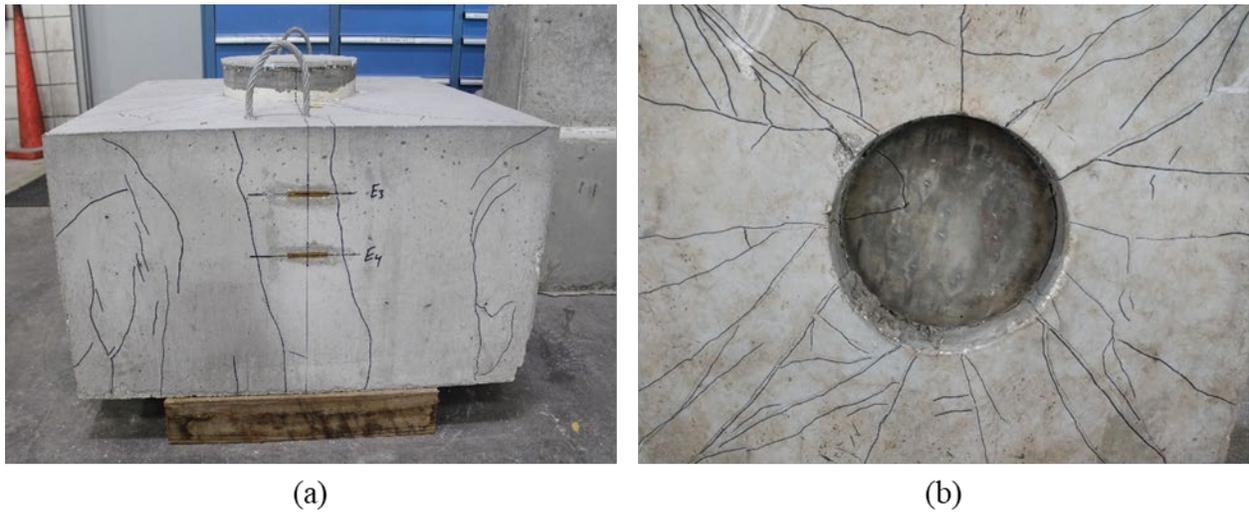
Figure A.110: Cracking on the (a) east side and (b) bottom of specimen S2-13

Cracking was observed in the concrete strain gauges and visually after the test was completed as shown in Figure A.109 and Figure A.110. Cracks were observed to extend from the bottom of the cap onto the top toward the plug in the north and south side around 360 kips.

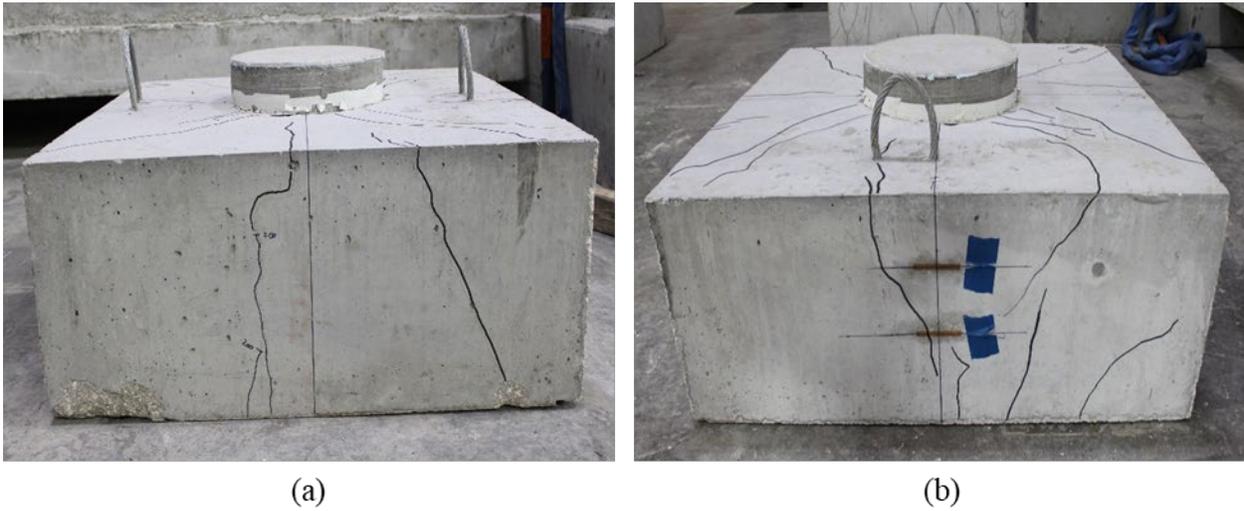
Figure A.114: Cracking on the (a) south side and (b) east side on specimen S2-14

Cracking was observed in the surface concrete at a load of around 130 kips in the north side of the specimen as shown in Figure A.113. In this specimen, cracking was later observed in the east side on a load of around 250 kips. Crack propagation was initiated from the bottom to the top of the cap. The crack pattern after testing is shown in Figure A.114.

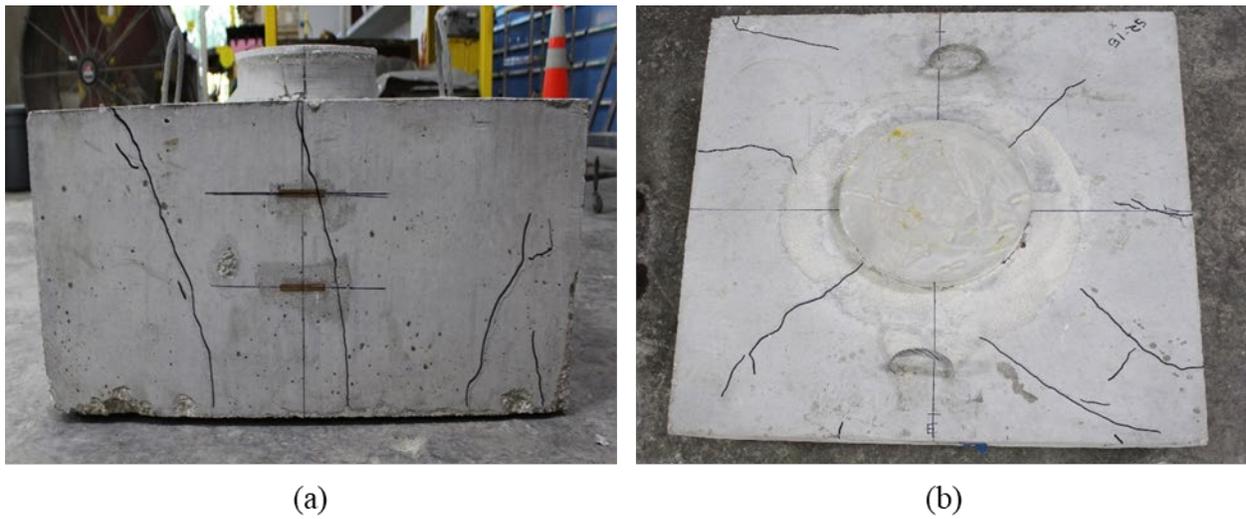
Figure A.118: Cracking on the (a) north side and (b) top of the cap

Cracking was also measured with the surface concrete gauges at a load of around 100 kips in the east side of the specimen as shown in Figure A.117. Cracks were also observed later in the north side in a load around 300 kips. Cracking was visually observed as shown in Figure A.118. The cracks extended from the bottom of the cap to the top toward the plug.

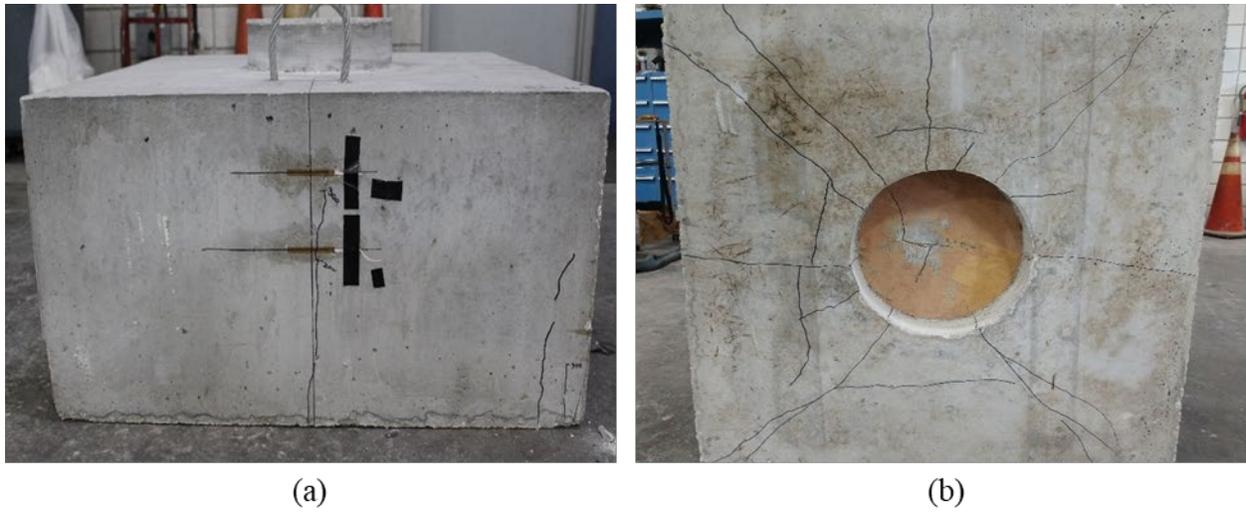
Figure A.122: Cracking on the (a) east side and (b) bottom of Specimen S2-16

Cracks were measured with the surface concrete gauges around 400 kips and 450 kips on the east and north side, respectively. However visual cracks were observed around 200 kips. The reading

of the concrete surface gauges is shown in Figure A.121. When the testing was finished, cracks were also observed as shown in Figure A.122.

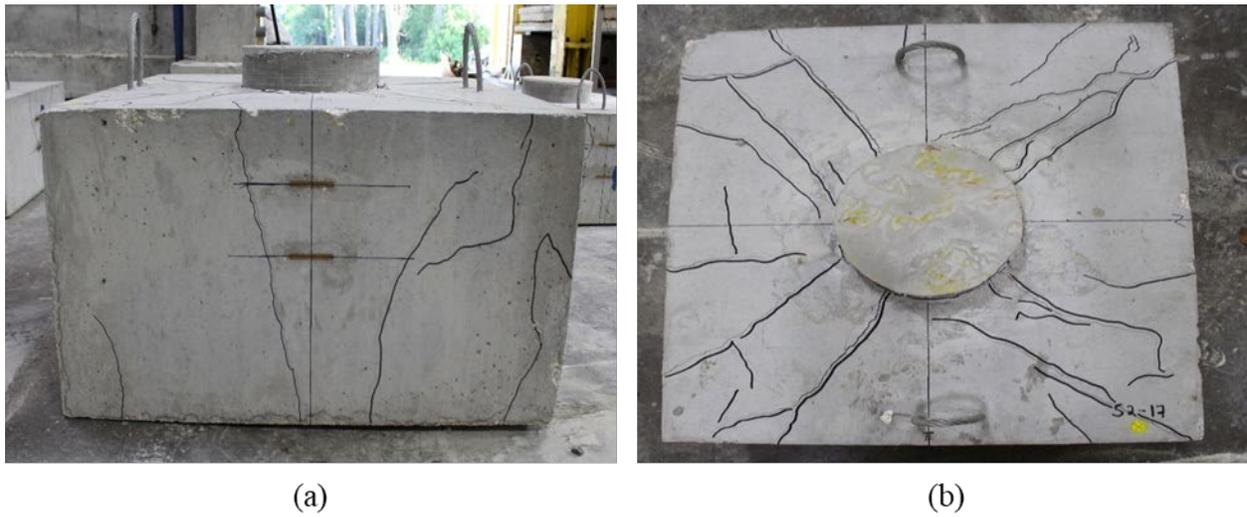
Figure A.126: Cracking on the (a) east side and (b) top of the Specimen S2-17

Cracks were measured in the surface concrete in both sides of the specimen around 160 kips as shown in Figure A.125. When the testing was finished, cracks were also observed as shown in Figure A.126. Cracks extended from the bottom, going up to the cap toward the plug.

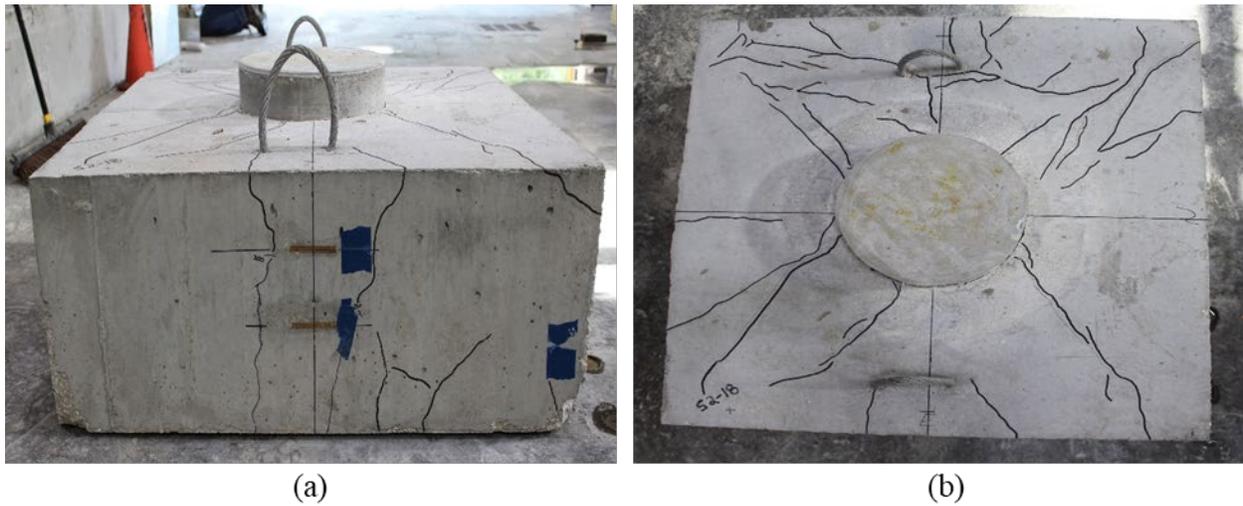
Figure A.130: Cracking on the (a) east side and (b) top of the specimen S2-18

A crack was measured around 180 kips on the east side of the specimen in the bottom part with the concrete surface gauges. This crack was also visually observed in a stop made at 200 kips of loading. Later, when the load was around 450 kips cracks were measured in the north side of the specimen. Crack propagation seemed to start at the bottom part of the specimen towards the top. The reading of the concrete surface gauges is shown in Figure A.129. When the testing was finished, cracks were also observed as shown in Figure A.130.

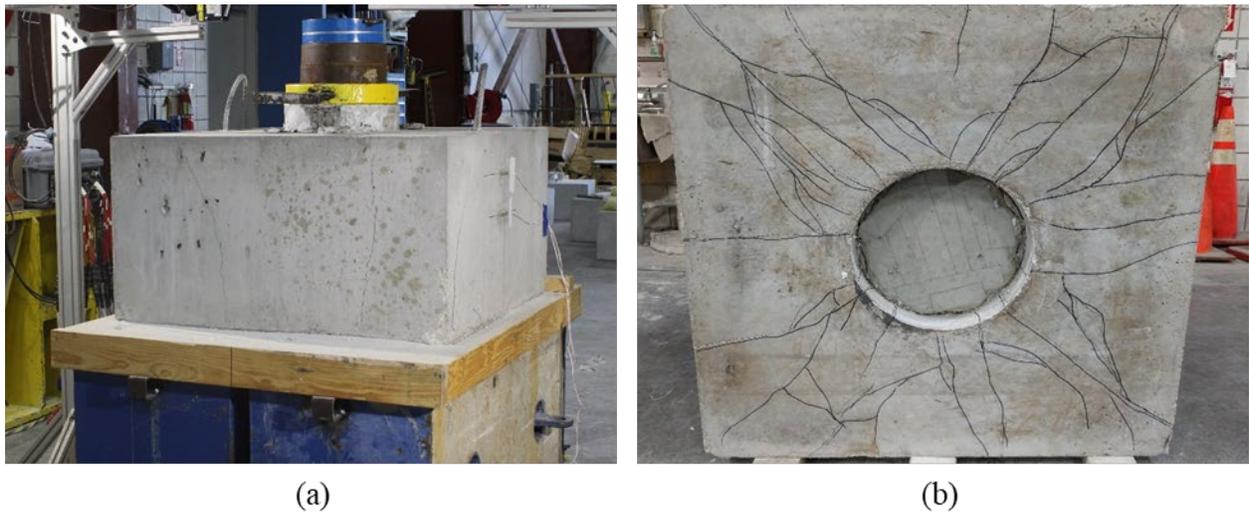
Figure A.138: Cracking on the (a) south side and (b) bottom of Specimen S2-20

Cracks started to develop on both sides of the specimen around 200 kips. The reading of the concrete surface gauges is shown in Figure A.137. When the testing was finished, cracks were also observed as shown in Figure A.138. Cracks extended from the bottom, going up to the cap toward the plug.

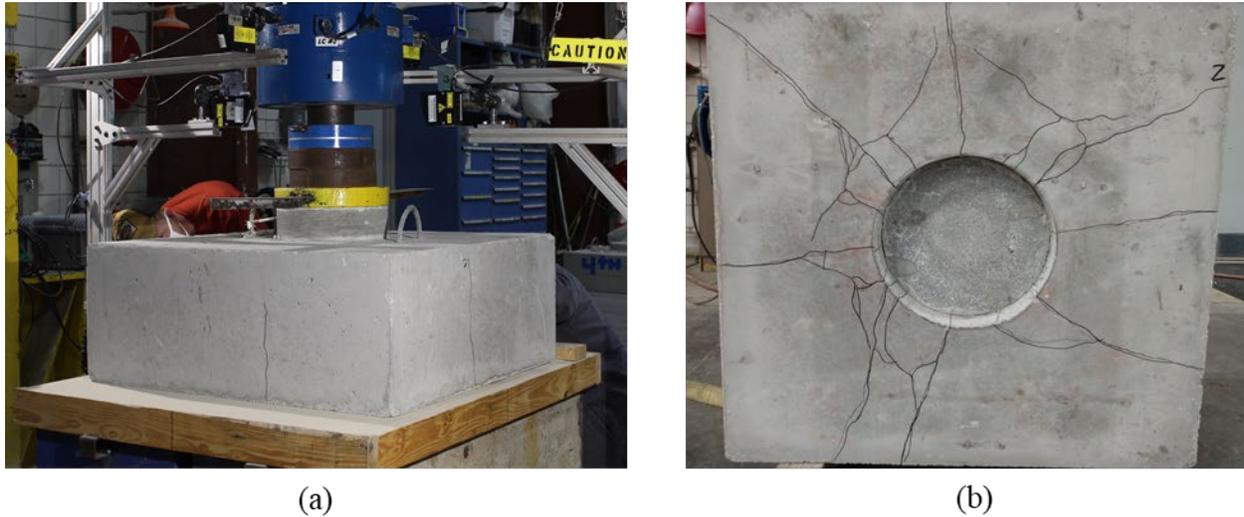
Figure A.144: Specimen S3-1 (a) elevation during testing and (b) bottom cracking after testing

Cracking was visually observed when the testing was finished, as shown in Figure A.144. A circular-shaped crack developed around the plug at failure in addition to the several radial cracks extending from the plug to the sides of the specimen.

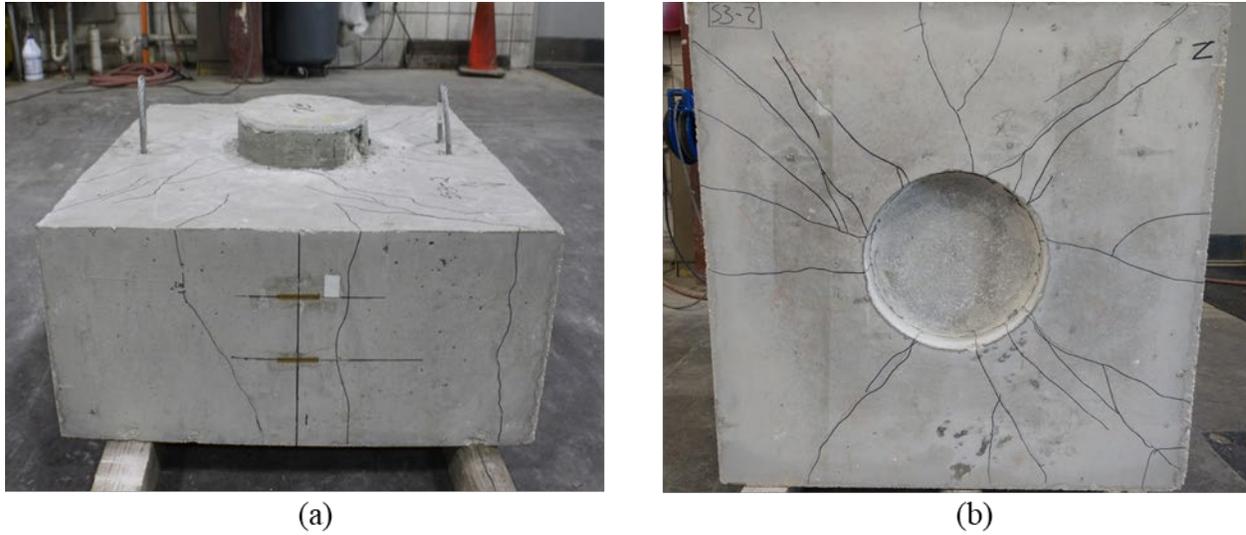
Figure A.150: Cracking after testing on (a) east side of cap and (b) bottom of Specimen S3-2

When the testing was finished, cracks were also observed as shown in Figure A.150. The cracks were observed to extend radially from the plug to all sides of the specimen.

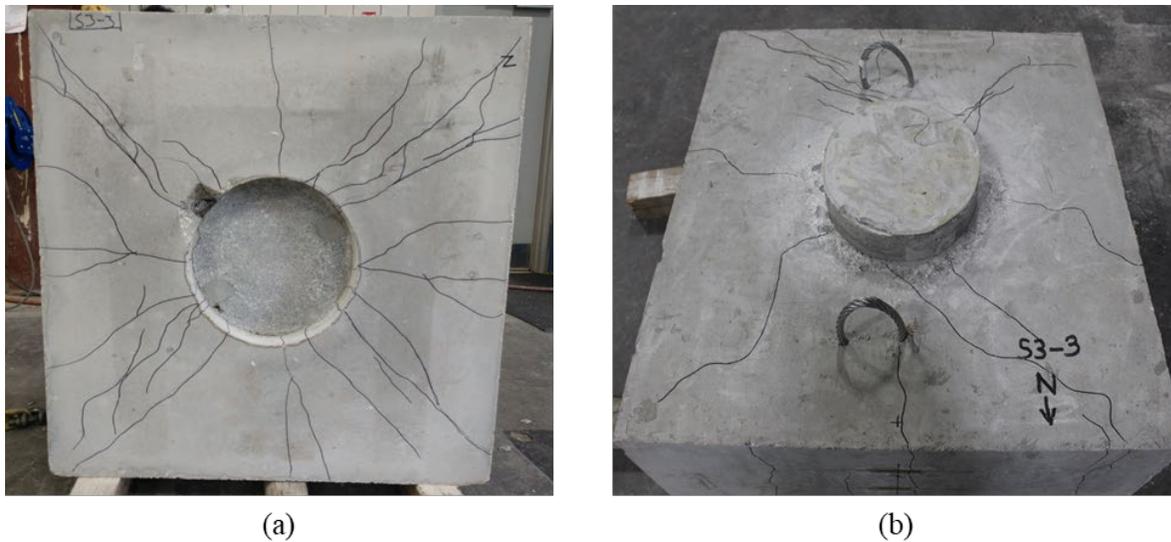
Figure A.156: Cracking after testing on (a) bottom of the cap and (b) top of the cap of Specimen S3-3

The crack pattern at failure for S3-3 is shown in Figure A.156. Larger cracks were observed on the north-south side than the east-west side of the specimen. Some of the largest cracks extended radially out of the plug to the corners of the specimen.

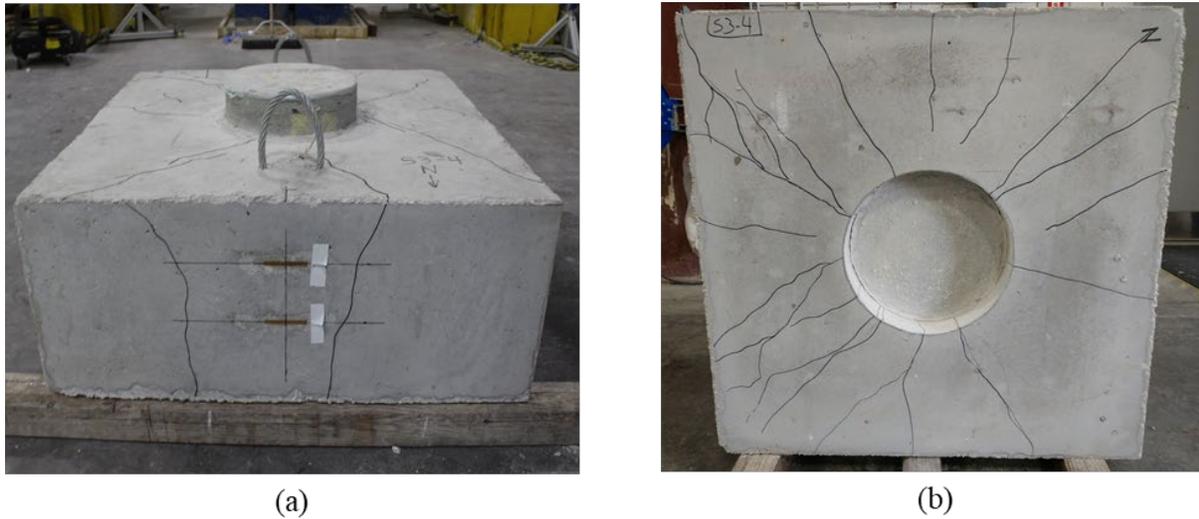
Figure A.163: Cracking on (a) cap and (b) bottom of Specimen S3-4

The crack pattern at failure for S3-4 is shown in Figure A.163. The cracks were observed to extend in all sides of the specimen in the top and bottom. A large radial crack extended from the side of the plug to the south-west corner of the specimen.
