SHEAR FRICTION CAPACITY OF CORRUGATED PIPE CONNECTION IN PRECAST FOOTINGS

(Project No.: BDV29 977-39)

Final Report

July 2022

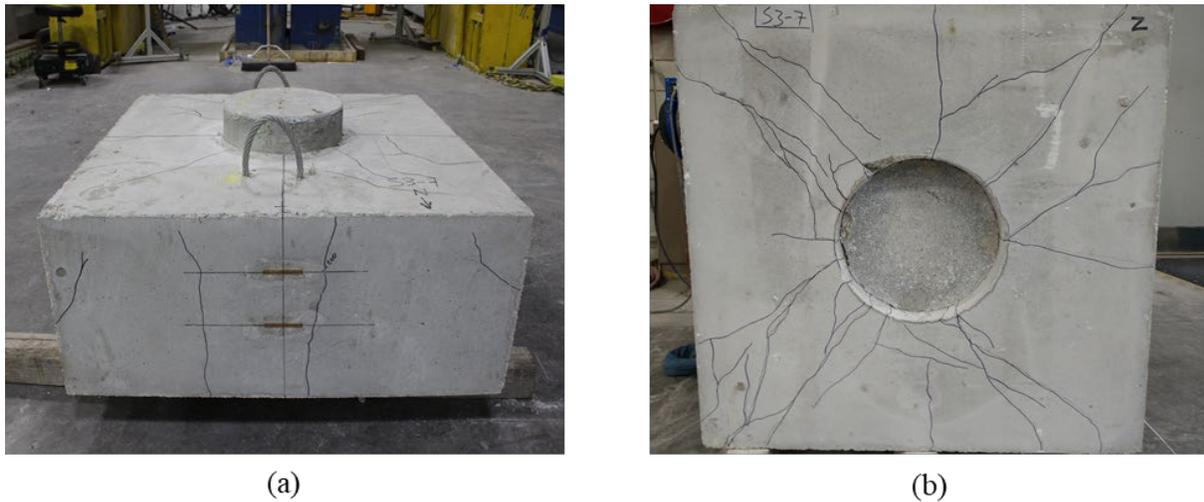
Figure A.183: Cracking on (a) cap and (b) bottom of Specimen S3-7

The crack pattern at failure for S3-7 is shown in Figure A.183. The cracks were observed to extend radially from the edge of the plug toward all sides of the specimen in the top and bottom.

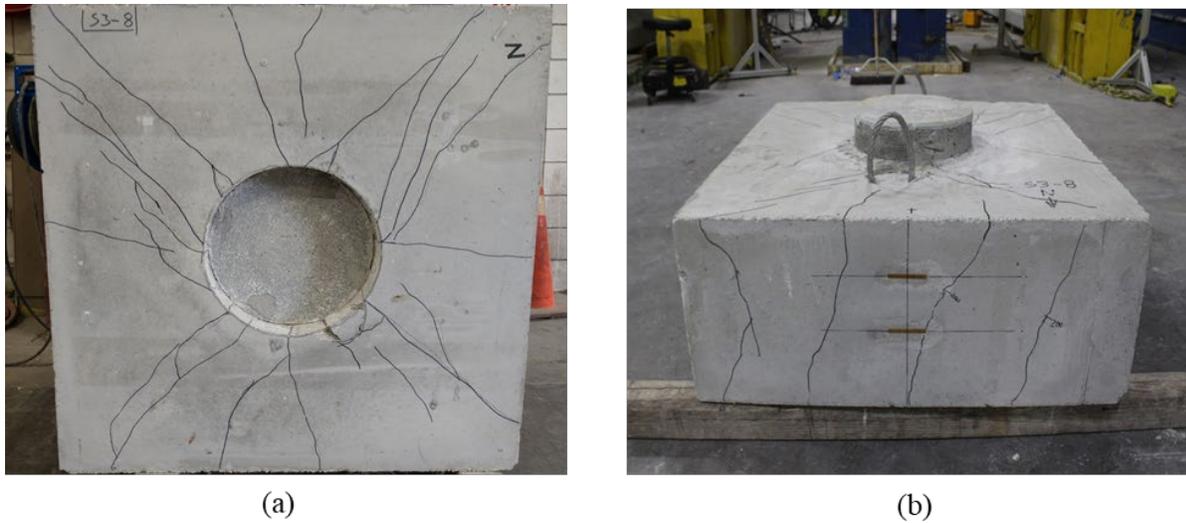
Figure A.190: Cracking on (a) bottom and (b) cap of Specimen S3-8

The crack pattern at failure for S3-8 is shown in Figure A.190. The cracks were observed to extend radially from the side of the plug toward all sides of the specimen in the top and bottom.

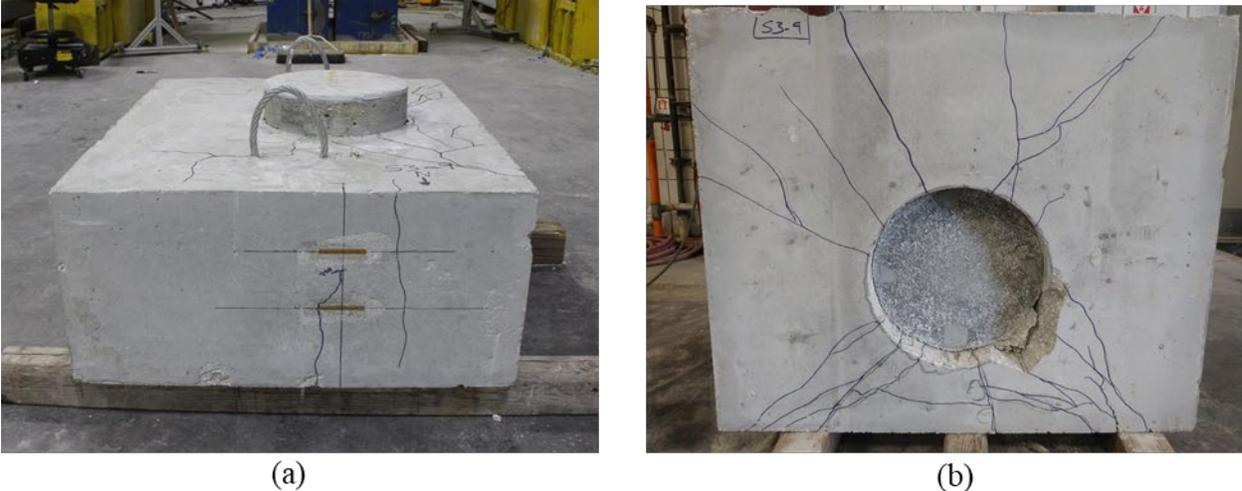
Figure A.197: Cracking on (a) cap and (b) bottom of Specimen S3-9

The crack pattern at failure for S3-9 is shown in Figure A.197. The cracks were observed to extend radially from the pocket with more cracking concentrated on the side with the shorter edge distance. Some cracking parallel to the edge was also observed on the side with the shorter edge distance, shown in Figure A.197 (b).

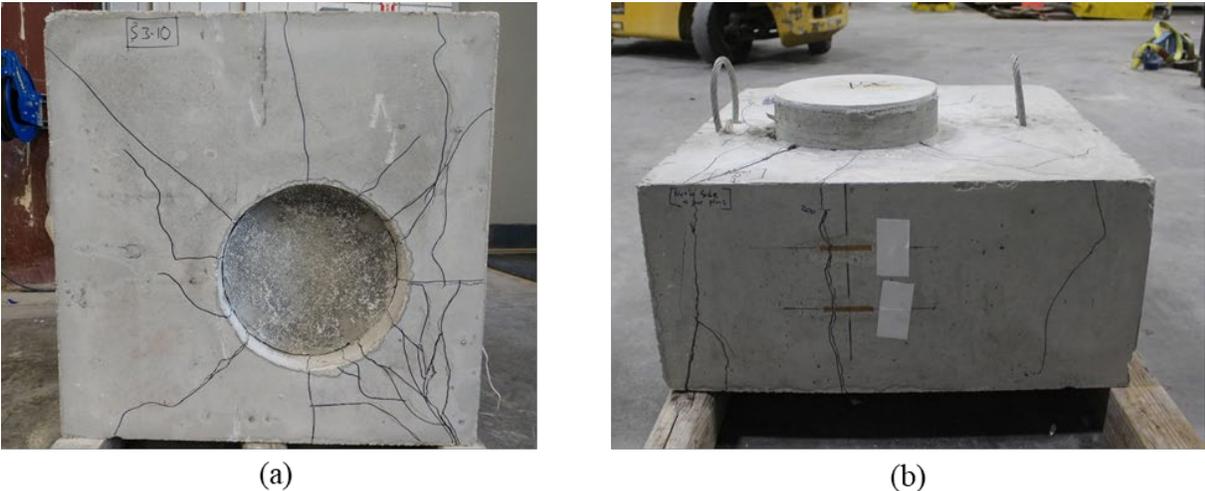
Figure A.204: Cracking after testing on (a) bottom and (b) cap of Specimen S3-10

The crack pattern at failure for S3-10 is shown in Figure A.204. The cracks were observed to extend radially from the plug toward all sides, but there was a concentration of cracking and larger cracks observed toward the corner between the two short edges.

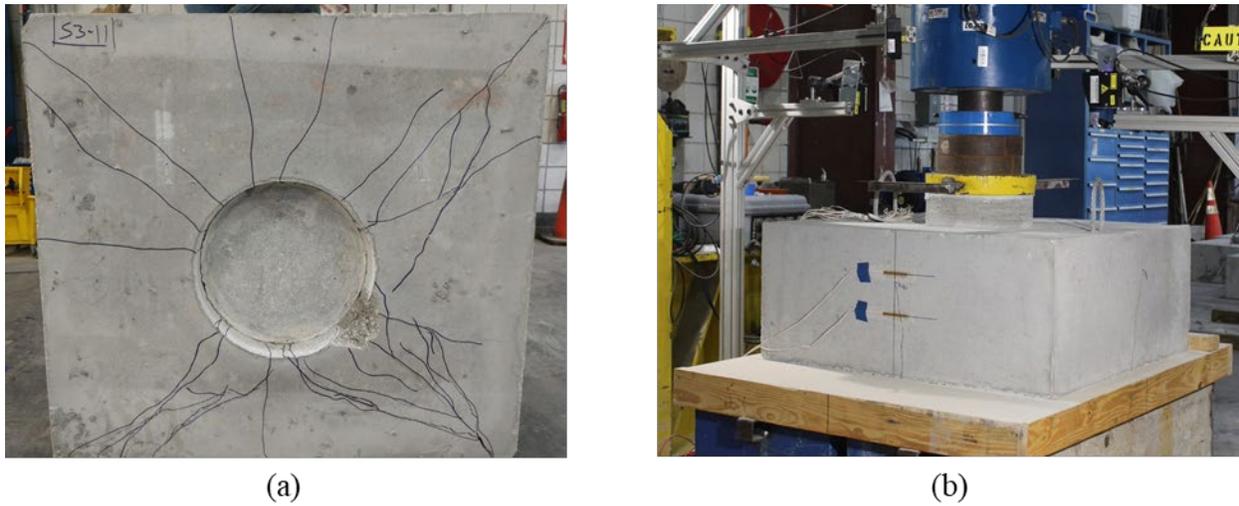
Figure A.211: Cracking on (a) bottom after testing and (b) cap during testing of Specimen S3-11

The crack pattern at failure for S3-11 is shown in Figure A.211. The cracks were observed to extend radially from the plug in all directions with most cracking going to the corners of the face with the reduced edge distance.

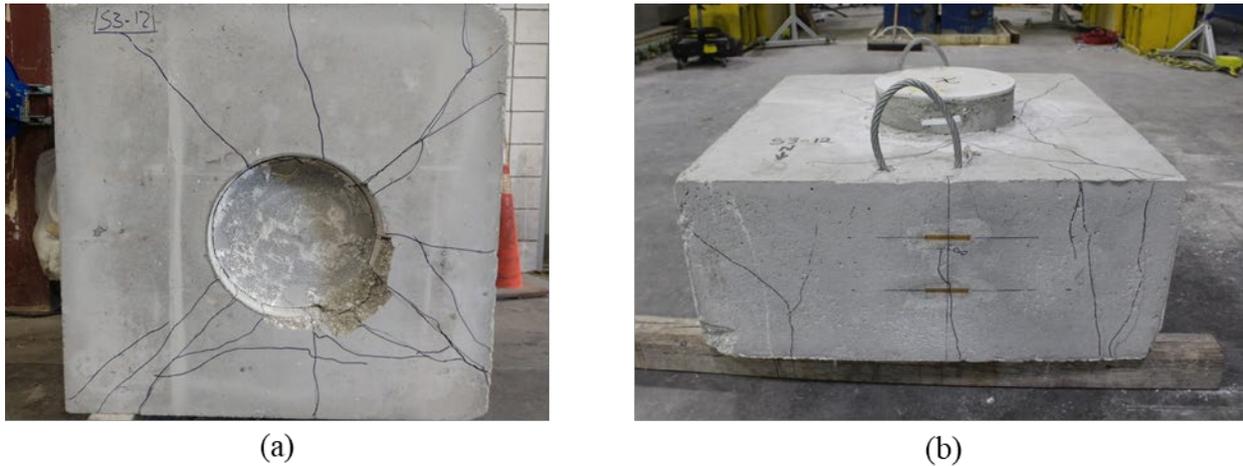
Figure A.218: Cracking after testing on (a) bottom and (b) cap of Specimen S3-12

The crack pattern at failure for S3-12 is shown in Figure A.218. The cracks were observed to extend radially from the plug toward all faces with more cracking extending toward the faces with shorter edge distances. Some cracking parallel to the exterior faces was also observed on the bottom of the specimen on the shorter edges.

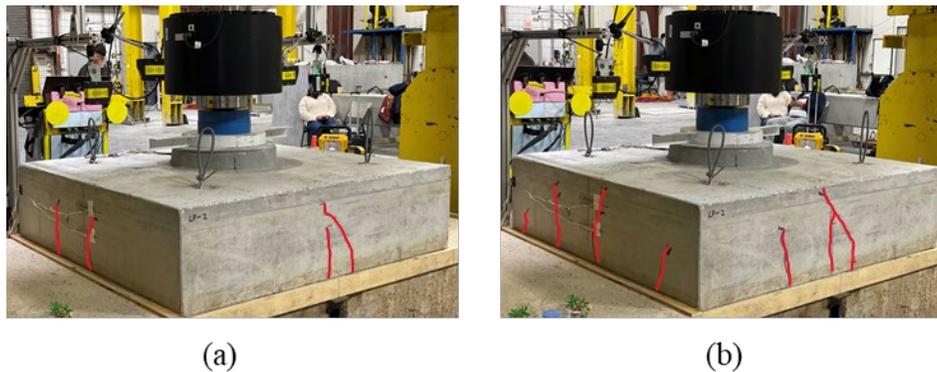
Figure B.10: Crack progression during testing at (a) 200 kips and (b) 300 kips

Cracking was visually observed during testing on all four faces of LP-2 at 200 kips, as shown in Figure B.10, which corresponds to the cracking loads determined from the RSGs in the longitudinal reinforcement.

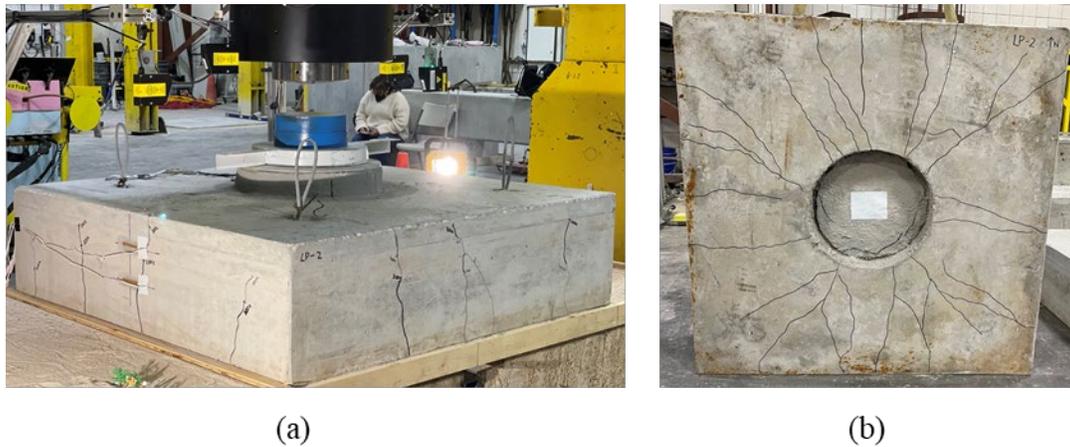
Figure B.14: Cracking after testing on (a) south-west side and (b) bottom of the Specimen LP-2

Photographs of LP-2 after testing are shown in Figure B.14. The cracking was observed to extend from the bottom of the cap onto the top toward the plug in all sides of the specimen as LP-2.

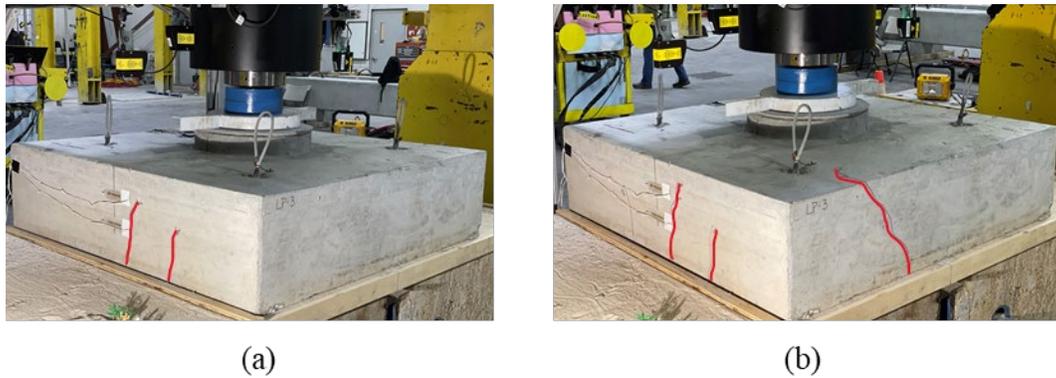
Figure B.17: Crack progression for LP-3 during testing at (a) 200 kips and (b) 300 kips

Cracking was first visually observed on LP-3 at the first stop at 200 kips on the east and west sides of the specimen, as shown in Figure B.17 (a). Cracking was first observed on the north and south sides of the specimen at the second stop of 300 kips, as shown in Figure B.17 (b).

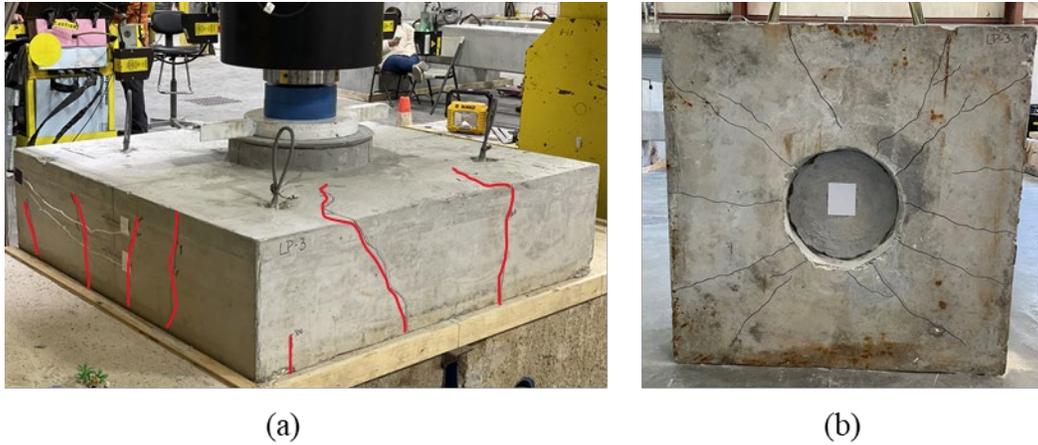
Figure B.21: Cracking after testing on (a) south-west view and (b) bottom of specimen LP-3

The crack pattern after the conclusion of testing on the sides and bottom of the specimen is shown in Figure B.21. Cracks extended radially from the bottom of the plug, Figure B.21 (b), and continued vertically up the sides of the specimen, Figure B.21 (a).

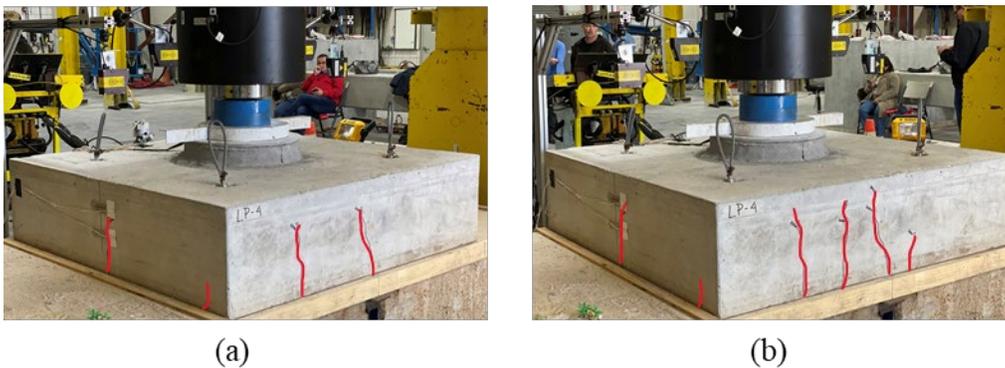
Figure B.24: Crack propagation during testing at (a) 200 kips and (b) 300 kips

As suggested by the longitudinal gauge readings, cracks were visually seen at the first stop at 200 kips in both directions as shown in Figure B.24 (a). Existing cracks continued to grow, and new cracks developed on all sides of the specimen as the load was increased, as shown in Figure B.24 (b).

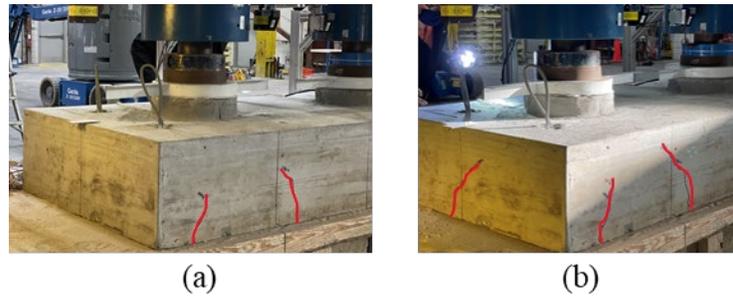
Figure B.37: Crack progression during testing at (a) 150 kips and (b) 250 kips

Cracking was first visually observed on MP-1 at the first stop at 150 kips on the north and south faces toward the west plug, shown in Figure B.37 (a). These cracks continued to grow, and

additional cracks began to develop on the west face and around the east side of the specimen at the next stop at 250 kips, shown in Figure B.37 (b). The visually observed cracking generally corresponded to cracking noticed by RSG and CSG readings.

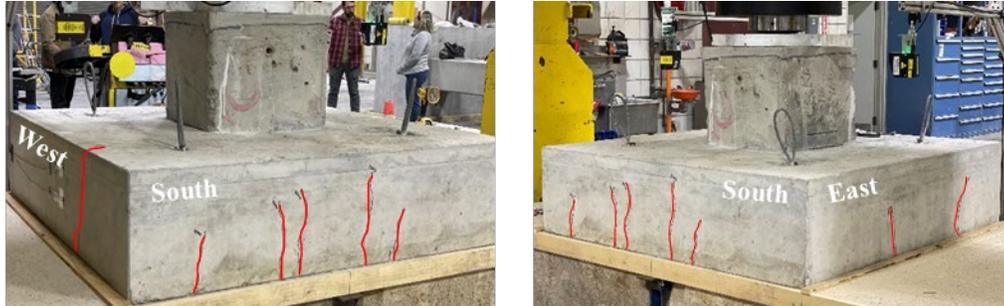
Figure B.45: Crack pattern at 350 kips for SC-1

Cracking was first visually observed on all faces of SC-1 at the first stop at 350 kips, as shown in Figure B.45. More cracking was observed on the north and south faces of the specimen, which corresponds to the additional engagement of the reinforcement toward the north face of the specimen.

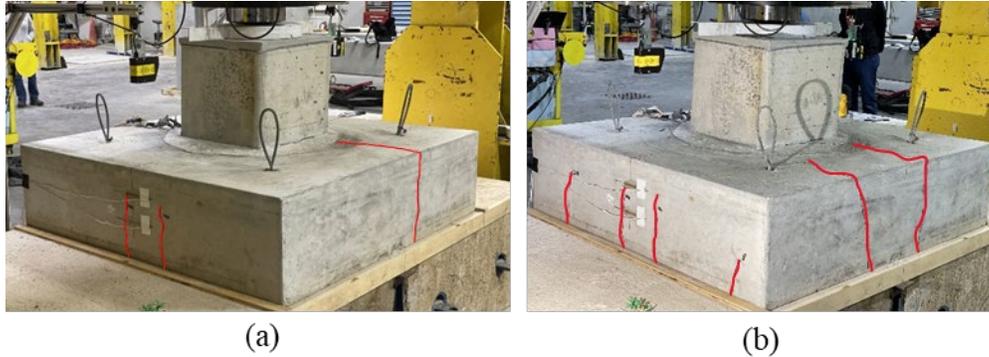
Figure B.54: Crack pattern at (a) 175 kips and (b) 350 kips for SC-2

Cracking was first visually observed on all faces of SC-2 at the first stop at 175 kips, as shown in Figure B.54 (a). A large crack formed from the bottom of the north face to the top face next to the plug. Existing cracks grew in size and length and additional cracks formed as the load was increased, see Figure B.54 (b).

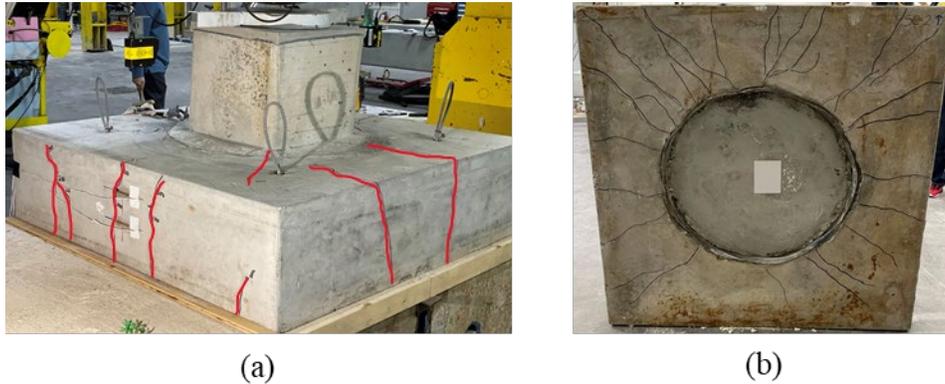
Figure B.58: Cracking on (a) cap and (b) bottom of Specimen SC-2

The crack pattern after failure for SC-2 is shown in Figure B.58. Cracks extended radially from the bottom of the plug and continued up the sides of the cap. Some of these cracks continued onto the top of the cap and into the plug toward the embedded pile.
