Final Report for Research Project

**LONG TERM BRIDGE MAINTENANCE MONITORING
DEMONSTRATION ON A MOVABLE BRIDGE**

A framework for structural health monitoring of movable bridges

Florida Department of Transportation

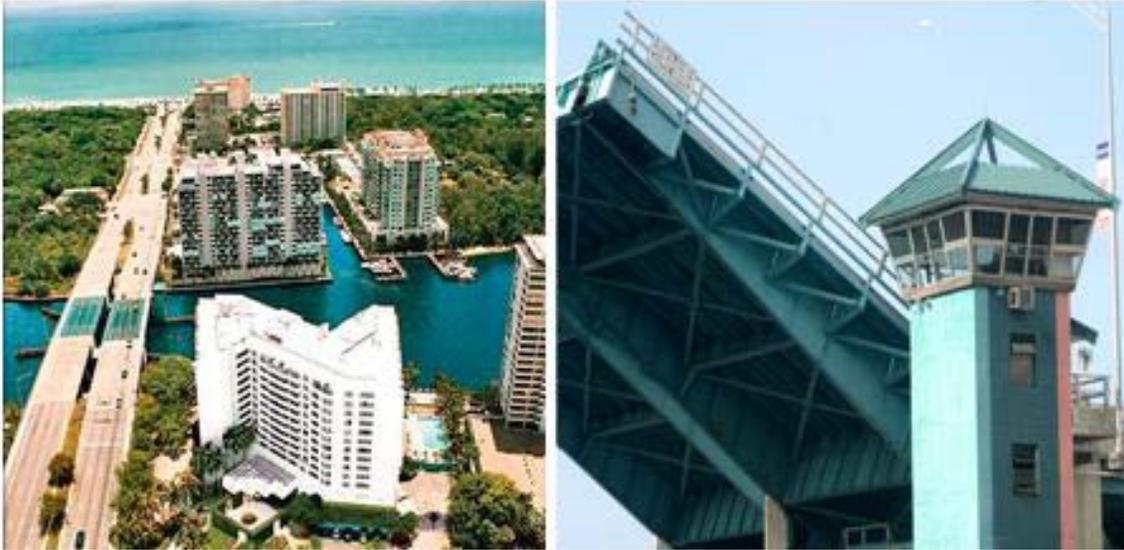
Figure 1: Sunrise Bridge in Ft. Lauderdale, Florida

As a result, the monitoring system is designed and implemented on a representative bridge in District 4 in Ft. Lauderdale, Florida. The selected representative movable span is the West-bound span of two parallel spans on Sunrise Boulevard in Ft. Lauderdale. This span was constructed in 1989. It has double bascule leaves with a total span length of 117 ft and a width of 53.5 ft, carrying three traffic lanes. Each leaf is 70-ft long and 40-ft wide. The bridge can be opened every 30 minutes when requested. Depending on the boat traffic, the bridge opens usually about 10 to 15 times a day. Details about the Sunrise Bridge will be given in later sections.

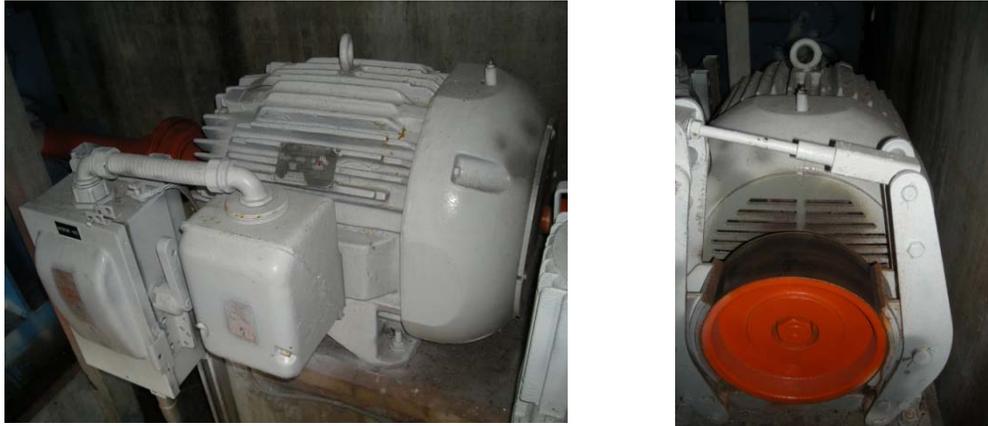
The electrical motors (Figure 3) generate the torque required for the opening and closing of the bridge. Some of the indicators of improper function are high amperage,

high temperature, vibration and high revolution speed. Therefore, it was decided that the monitoring system would include ammeters to measure the amperage levels for each one of the electric motor phases, accelerometers to measure the vibration on the motor during opening and closings, and infrared temperature sensors to check the temperature of the electrical motor.

Figure 3: Electrical Motor

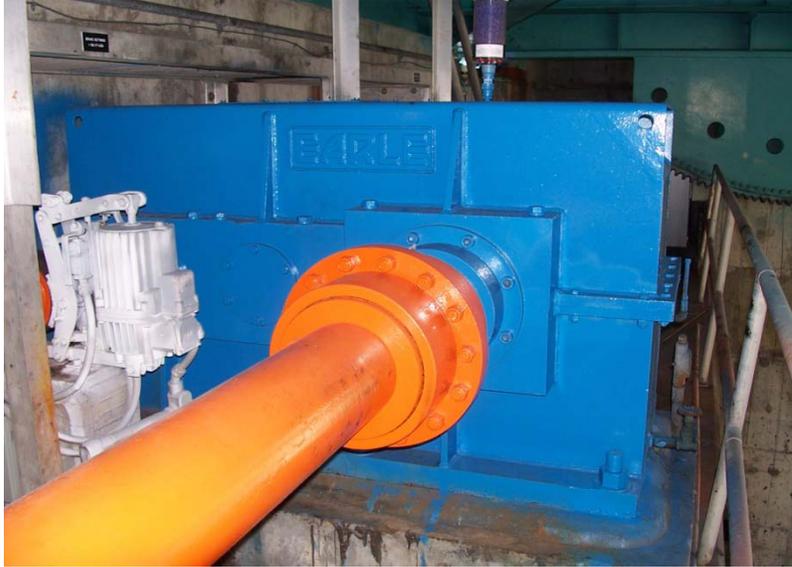
The gear boxes contain the assembly that transmits the torque generated by the motor to the shafts (Figure 4). When the gear boxes experience deterioration, or lack of lubrication, some change in the vibration and sound characteristics during operation should be noted. Abnormal vibration is an indicator of wear in the gears. Oil viscosity is also an important parameter for proper functioning of the gear box. Considering these issues, the monitoring system included accelerometers to measure the vibration on the gear box during openings and closings. Furthermore, microphones were also included within the gear box vicinity to determine the acoustic print corresponding to normal/abnormal lubrication.

Figure 4: Gear Box and Attached Drive Shaft

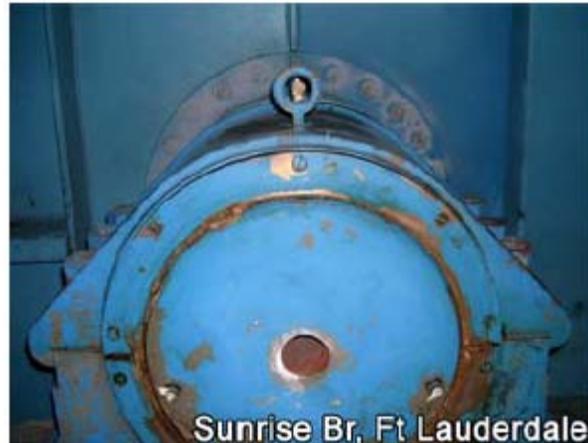
Figure 6: Trunnion

Trunnions (Figure 6) are the pivot points of the leaves. The alignment of the trunnion is critical to prevent premature wear of the trunnion bearings and to reduce out-of-plane web distortions that introduce fatigue damage. Misalignment in the trunnion axis can cause additional load on the trunnion-hub assembly and distress on the main girder plate, causing distortions, and eventually web buckling. Trunnion misalignment is also a major cause of wobble that can result in mismatch of the leaf tips, disturbing regular operation (Malvern et al. 1982; Besterfield et al. 2001; Koglin 2003; Patton 2006).

Based on the meetings with FDOT maintenance engineers, it was concluded that trunnion lubrication is a major factor for opening/closing operation friction previously discussed. For these reasons, the instrumentation plan contains strain rosette gages to calculate the shear values in the trunnion area, and microphones are included to catch any unexpected acoustic data. Tiltmeters were also included in the design of the instrumentation to measure the opening and closing angles, which are necessary measurements of the balance test.

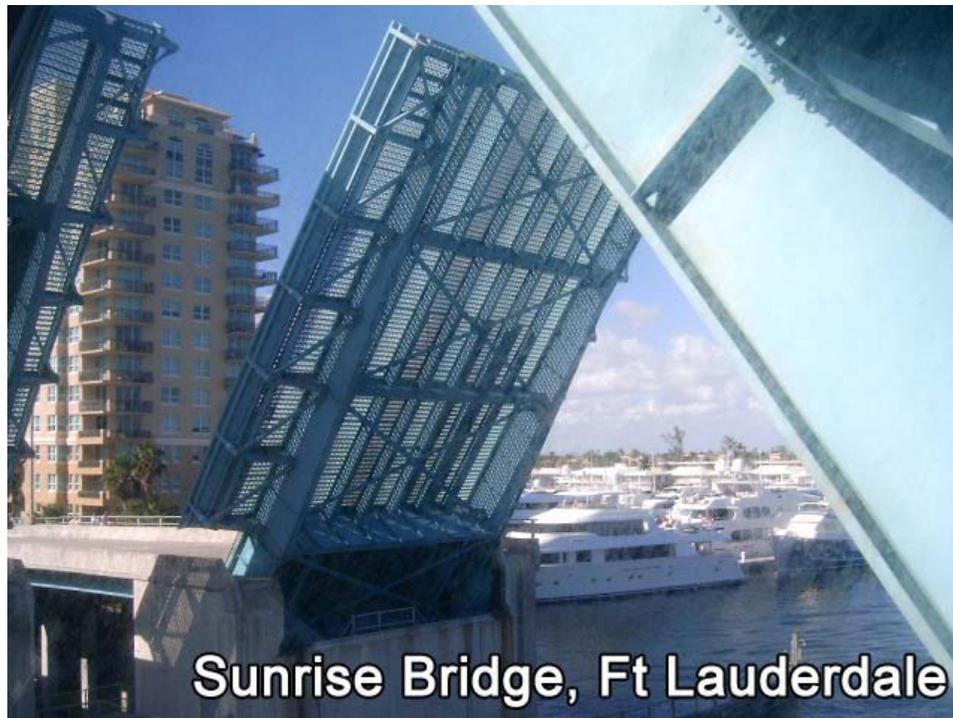
Main girders and floor beams form the main frame of the spans. They are made from both rolled and built-up sections with welded plates. Corrosion is a main concern on the bridge girders, floor beams, and stringers, especially on exposed surfaces. Corrosion leads to section loss and reduced capacity. Any misalignment, bending, or deformation can cause increased strain on the structure. Deformation or thermal effects can cause misalignment of the girders, leading to operation malfunction. The selected sensor layout provides the distribution of stresses on the girders and is expected to provide information regarding damage and deterioration for preventive maintenance purposes.

Figure 10: Main Girders in Open Position

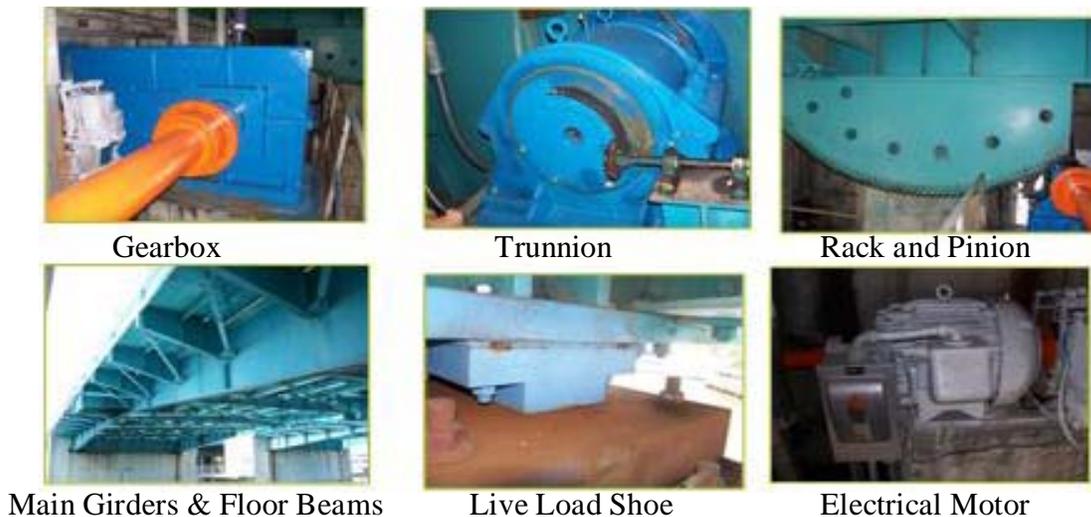
Figure 11: Some of the Monitored Bridge Components

After considering the issues related to movable bridges and several meetings with FDOT bridge engineers, maintenance engineers and consultants, the instrumentation plan was developed to monitor the most critical electrical, mechanical, and structural components. The final instrumentation plan consists of an array of 160 sensors, which add up to 200+ channels. The monitored structural components include main girders, floor beams, stringers, and live load shoes. As for the mechanical and electrical components, the electrical motor, gear box, shafts, open gear, rack and pinion and trunnions are monitored with various sensors. It should be mentioned that the instrumentation plan for system-wide applications is expected to be reduced significantly to an optimum level based on the findings of this current research. In addition, this study explores the performance of different sensors and their signals such as pressure or images for detecting anomalies and sudden changes in signal characteristics..

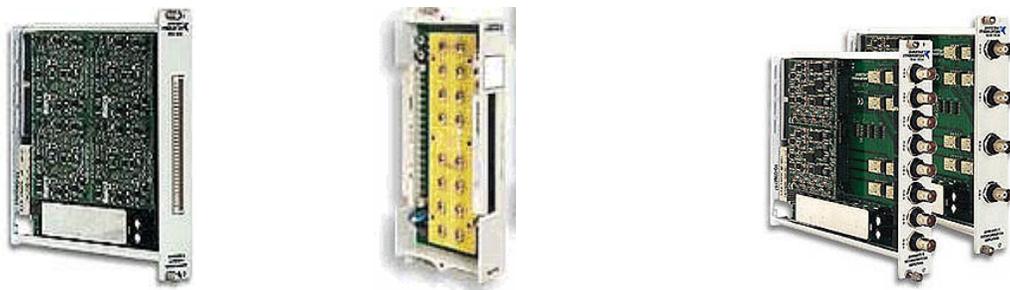
The SCXI-1520 module is an eight-channel module for interfacing with strain-gage bridges and other Wheatstone-bridge based sensors (Figure 19-left). Terminal block SCXI 1314 provides interface between the module and sensors (Figure 19-center). The National Instruments SCXI-1531, shown in Figure 19-right is a signal conditioning module for Integrated Electronic Piezoelectric (IEPE) compatible accelerometers and microphones. Each of the eight input channels includes a programmable AC instrumentation amplifier, 4-pole Bessel low pass filter, and excitation current source. The NI SCXI-1531 offers simultaneous sampling to preserve inter-channel phase relationships. This module also offers parallel-mode operation for faster scanning rates and BNC connectors to simplify signal connection.

Figure 19: SCXI - 1520 Module (left), 1314 Terminal Block (center), 1531 Module (right)

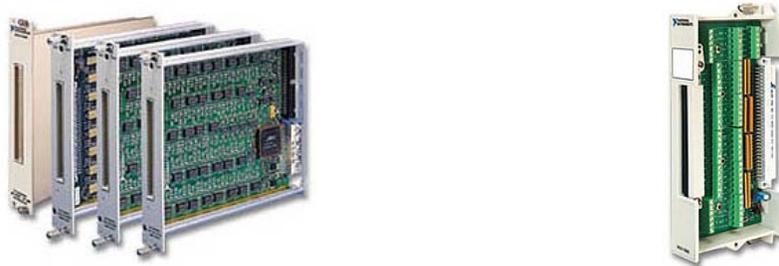
Figure 20: SCXI - 1102 Module (left), 1303 Terminal block (right)

The National Instruments SCXI-1102 (Figure 20-left) is designed for high-accuracy thermocouple measurements. The SCXI-1102 also can acquire millivolt, volt and 0 to 20 milliamp current input signals. Each of the 32 analog input channels includes an instrumentation amplifier and a 2 Hz low pass filter. The SCXI-1303 (Figure 20-right) is a terminal block for use with the SCXI-1102B modules and includes isothermal construction that minimizes errors caused by thermal gradients between terminals and the cold-junction sensor. The SCXI-1303 also includes circuitry for open-thermocouple detection as well as automatic ground referencing for floating (non-grounded) thermocouples.

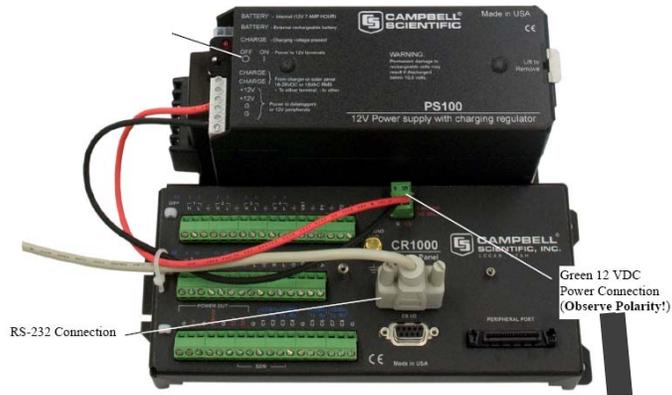
Figure 21: Power and Wiring Panel of CR1000 (<http://www.campbellsci.com/cr1000>)

CR1000 by Campbell Scientific is used to collect slow speed vibrating wire strain gage data. The components of the CR1000 are the power station, wiring panel, multiplexer and vibrating wire interface. The wiring panel provides terminals for connecting sensors, power and communications devices. In case of power loss, a lithium battery backs up the CR1000 clock, program, and memory. Figure 21 shows the CR1000 power station connected to the wiring panel. Through a RS-232 type of connection, the data acquisition system can be connected to the computer.

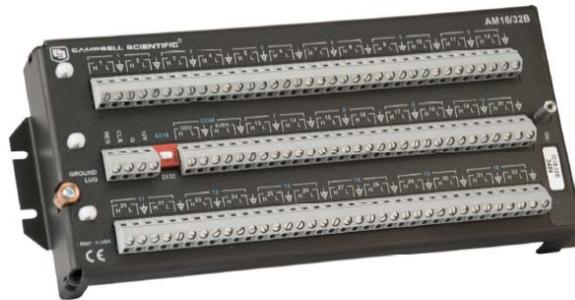
Figure 23: AM16/32B Multiplexer of CR1000

Multiplexers are the critical links between the gages and the data acquisition systems. The AM16/32B multiplexer has the capability to work more efficiently with the AVW200-series vibrating wire interfaces, and also allows the data acquisition to measure more sensors. In Figure 23, a 32 channel AM16/32B multiplexer is shown.

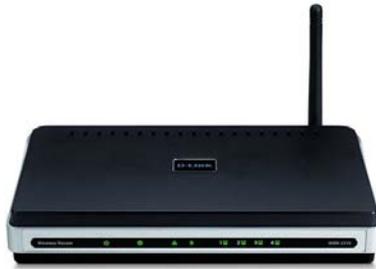
Figure 25: D-Link WBR-2310 Wireless Router

Communication and transmittal of data between the two separated data acquisition systems is accomplished through a D-Link WBR-2310 wireless router (Figure 25), which is a combined 4-port switch plus range booster type G router. For security, this network is password protected.

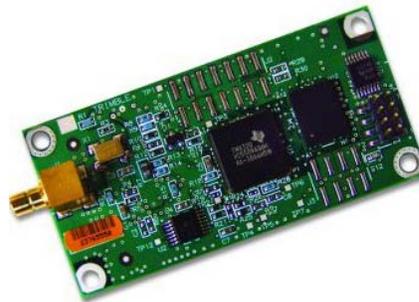
Figure 26: Trimble Resolution T GPS Timing Receiver

Because of the high-speed data, further refining in the synchronization was needed. The desired synchronization was achieved by using a Trimble Resolution T Global Positioning System (GPS) timing receiver at each side (Figure 26). The receiver is a full 12-channel, parallel tracking, embeddable GPS receiver designed to provide precise GPS or UTC (Coordinated Universal Time) time, which is needed for synchronization. These GPS timing receivers, not only provides location information, but also supply a global time reference, accurate up to a few micro seconds. Every second, each GPS outputs a pulse whose leading edge is synchronized. These signals were captured simultaneously with other sensor data and embedded within the data files. By matching pulses on both computers, desired synchronization was achieved.

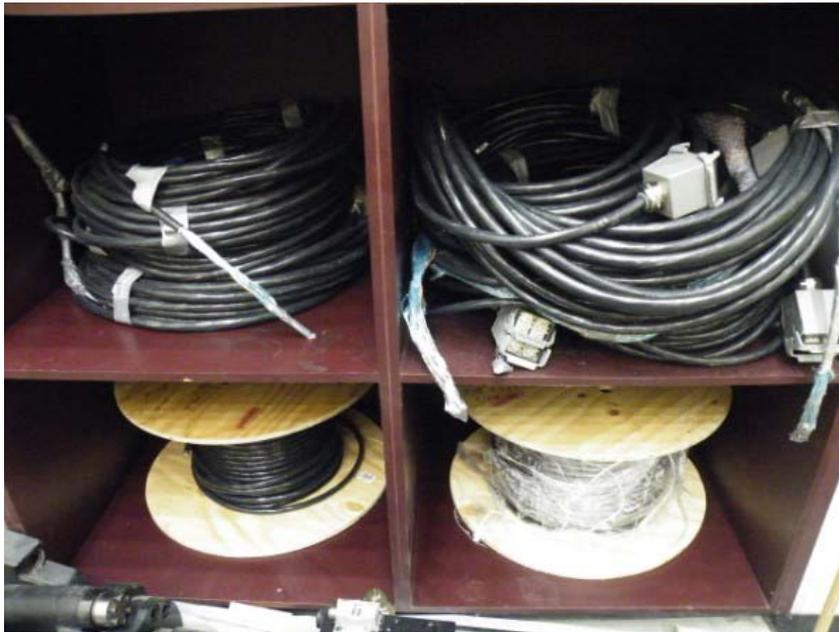
Figure 27: Belden Cable 1079a and 1080a

The quantity of sensor channels needed at each sensor group, or node, determined the selection of the number of twisted pairs needed for our project. 16-Pair (Belden Product 1079a) and 24-Pair (Belden Product 1079a) cables were selected since they offered the optimal configuration for the current application. Please see Appendix 10.3 for more information about the cable properties.

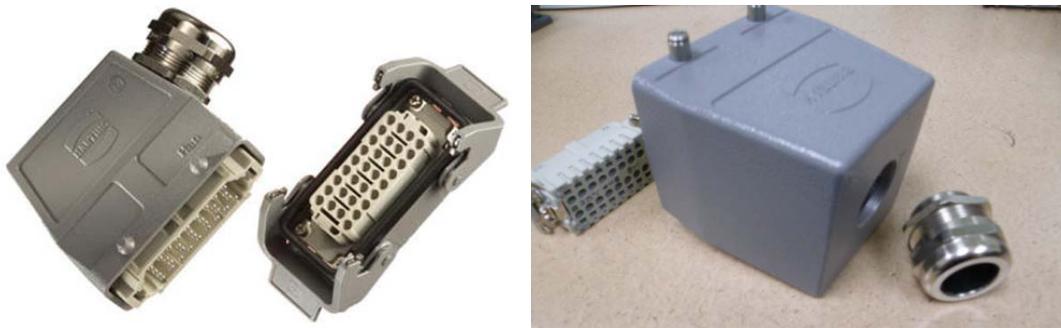
Figure 29: Harting Han Industrial Connector

Upon analysis of the design options, the Harting brand Han industrial connector product was selected. This product provided the best time critical and quality controlled solution to the sensor/main cable connection.

The Harting Han industrial connectors have both male and female parts, with each of these actually composed of four (4) distinct components: the outer weather-proof housing, the internal electrical connector, the opening reducer, and the cable gland. The two different main cable sizes (24-pair & 16-pair) resulted in an increase in the variation of required connector components. A summary of the components contained in each complete connection (both halves) and associated product names are provided in Appendix 10.6.

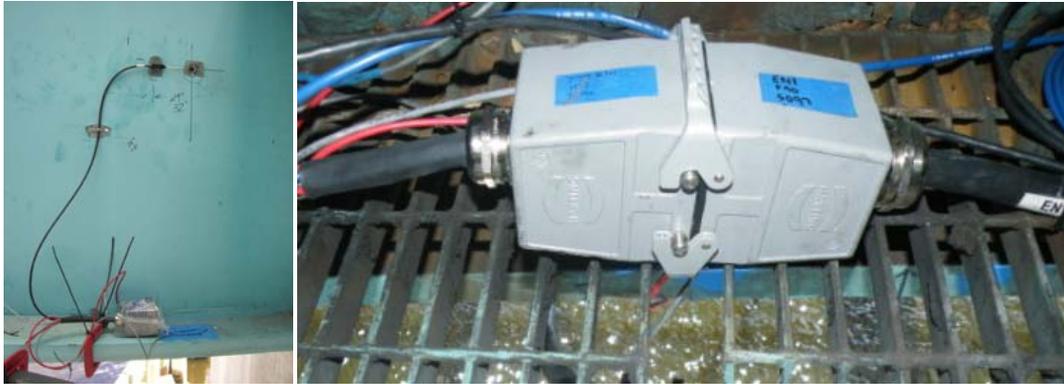
Figure 30: Sensor Group Installation (Left) and Cable Connected Installation (Right)

The use of connectors enabled a critical option during the installation procedure; the opportunity to install the sensor group and main cable at separate times. Upon completion of both individual installations, each half of the connector was quickly connected together and locked with a watertight seal by two snap connectors.

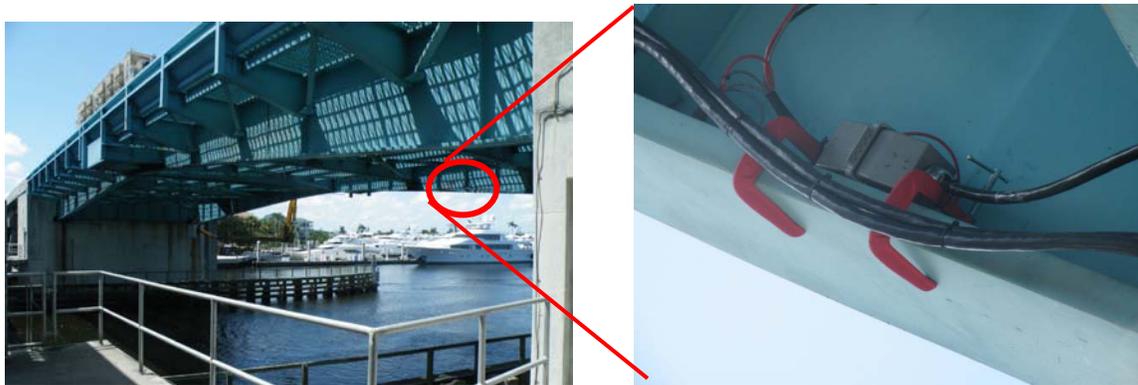
Figure 31: Installed Connector Secure on the Bottom Flange of the Main Girder

The relatively small profile of each connector enabled it to rest on the bottom flanges of the girders and be held in place with two C-clamps. As seen in Figure 31, this installation method on the bottom flange of the main girder proved to be both efficient during installation and secure during bridge openings.

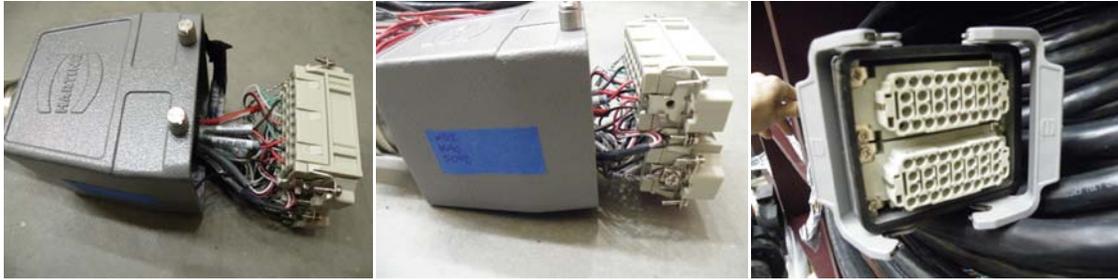
Figure 32: Different Views of the Connector

Due to the variety of components ordered, the first step prior to field installation was the assembly of each connector with proper components. The connectors are of two different types, cage clamp and crimp terminal. The crimp terminal type required that each incoming and outgoing wire have a crimp contact installed with the use of a specialized crimping tool. The wire bundle for each cable was then fed through the cable gland, reducer, and outer housing. The crimp terminals were then installed into the crimp terminal type connectors with another specialized tool. The cage clamp connectors had the appropriate wires installed into each slot with a flat head screwdriver. Finally, the

connectors were fitted back into the outer housings and secured (Figure 32). To ensure quick field installation each sensor group, with attached connector half, was packaged in a box and labeled.

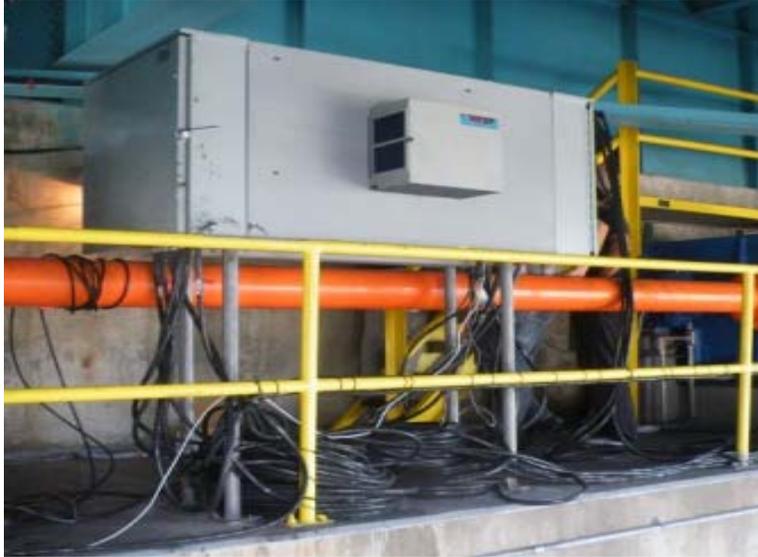
Figure 34: East Leaf Cabinet

The DAQ systems for each leaf are housed in environmentally controlled cabinets. Each cabinet consists of 3 major components of cabinet enclosure to house the data acquisitions and computer, four legs to hold the cabinet and two side junction boxes to sort the individual pairs of the main cables. Based on a market search, the researchers

decided to custom design a cabinet for their specific purposes and prepare the inside panels themselves in a cost-effective manner. Cabinet fabrication was commissioned by ProMark Engineered Systems Inc. Dimensions of the water resistive steel cabinet, without the junction boxes, is 30" x 30" x 48". Since the computer and the data acquisition would increase the inside temperature, an air conditioner system was installed on the back side of the cabinet.

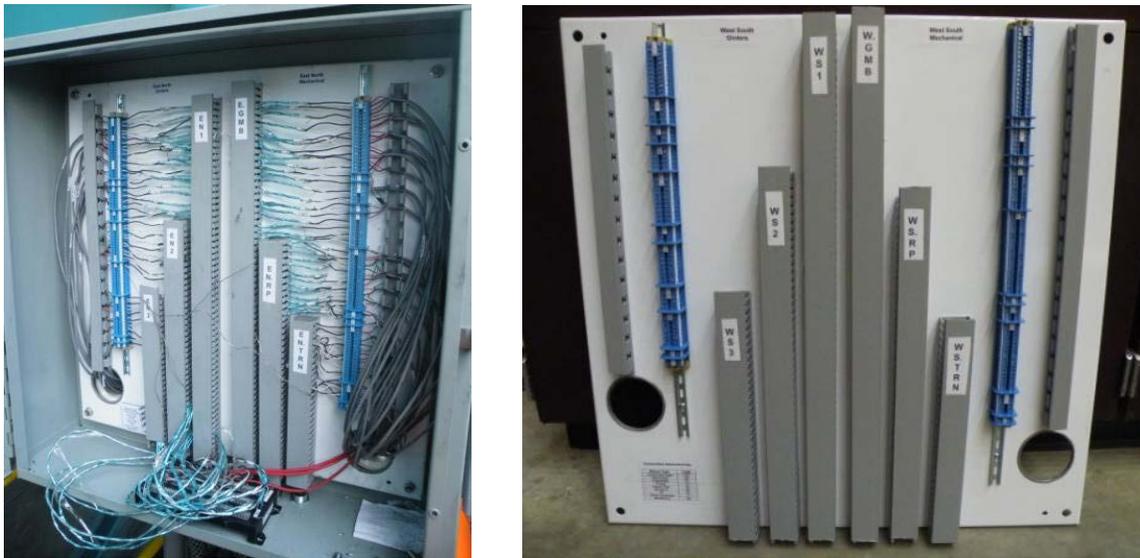
Figure 35: Interior View of Side Junction Box (Left) and Lab Prepared Junction Box Panel (Right)

The main cables enter the side junction boxes from the bottom and were held in place by strain reliefs (see Appendix 10.7 for details). The individual pairs from the main cables were sorted in the slotted cable sorters and terminate at the appropriate terminal block along DIN rails. The individual lab pre-installed NI cables left the adjacent side of the terminal block and were sorted by another slotted cable sorter. These wires then traveled through one of the holes connecting the side junction box to the cabinet. The cable then entered the proper NI terminal block and was connected to the appropriate channel (Figure 35-left).

The interior components of the side junction boxes were installed on the provided removable back panels. Figure 35-right shows a completed back panel ready for installation into the appropriate junction box. Configuration of the DIN rail mounted terminal blocks was designed for a stagger, or tiered, layout of the main cables which can be seen in (Figure 36).

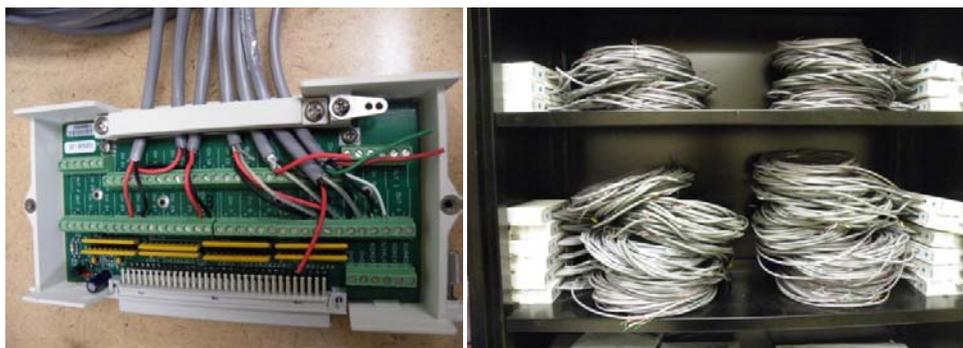
Figure 37: Lab Prepared NI Terminal Block and Completed NI Terminal Blocks Ready for Field Installation

Each sensor channel must be connected to the appropriate NI terminal block channel. The SCXI 1531, SCXI 1303 and SCXI 1314 all house channels in a screw-down metal enclosure. Therefore, the connections of the NI terminal block cables to the appropriate NI terminal block channel were done in the lab. Figure 37 shows a terminal block with its cover off and NI terminal blocks and their cables ready for field installation.

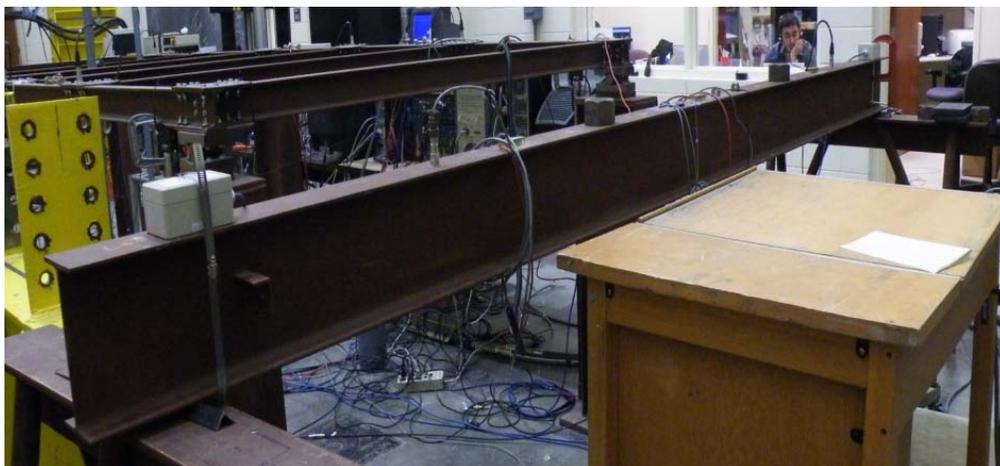
Figure 39: Beam and Sensor Locations

The test setup design was as follows (Figure 38): Two symmetrical sensor layouts of tilt meters were installed at the support locations whereas the strain gages (3) and accelerometers (3) were installed at middle of the beam on the top flange. Using this kind of configurations on the same beam allowed for comparison of different hardware setups (see Testing below). Loading and unloading of the beam with approximately 300lb took place during each test, and both averaged data and raw data were saved. The beam can be seen in Figure 38 and Figure 39.

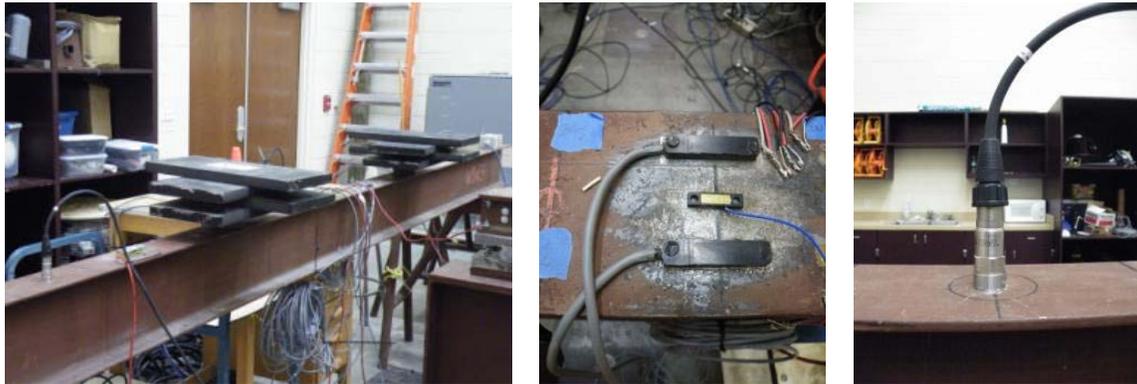
Figure 40: Loading Plates (Left), Installed Strain Gages (Center) and Accelerometer (Right)

- Strain and Acceleration Test: A simple test was conducted on a laboratory beam. The test procedure involved loading the beam with 300 lb at the one third locations with plates (Figure 40 a) and collecting strain data. Due to the loading, the vibration on the beam was also collected. The strain gage and accelerometer plots can be seen in Figure 40.

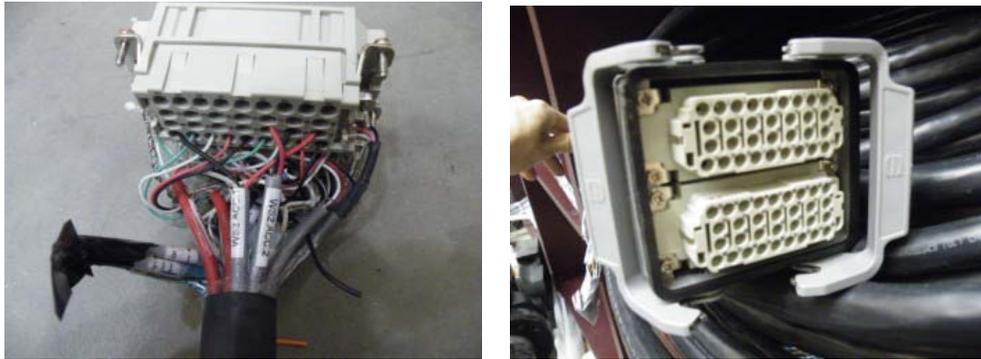
- Connector Test: To identify the noise source at the field, a 150 ft multiconductor cable segment was tested in the structures laboratory, with and without the connector (shown in Figure 44) installed. Acceleration and strain data was collected using the beam test setup. Figure 45 shows the acceleration plot and Figure 46 shows the strain plot, each with the connector installed. From comparison of the two testing configurations, it was observed that the connectors have a minimal noise impact, and quality of the signal is not affected by the use of the connector.

Figure 44: Different Views of the Connector

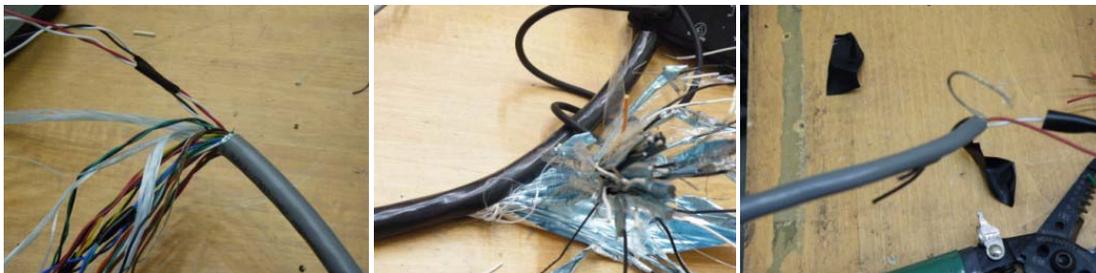
Figure 47: Grey Cable (Left), Black Cable (Center), Sensor Wire (Right)

In addition, the researchers conducted several tests to minimize the noise in the signals. Two filters (100 Hz and 60 Hz) and grounding the cable were employed to reduce the noise level. Totally, 13 tests were conducted on the laboratory beam, which had three strain gages and three accelerometers in the middle span (Figure 38). There were two main setups due to the cables. In the first cable setup, a 30 ft black cable, 150 ft black cable, and a 30 ft sensor wire were compared. In the second cable setup, a 30 ft black cable, a 20 ft grey cable, and sensor wire were compared (Figure 47). In each test, the variables were as follows: power cord nearby, grounding, excitation value, and cable bundled or straight.

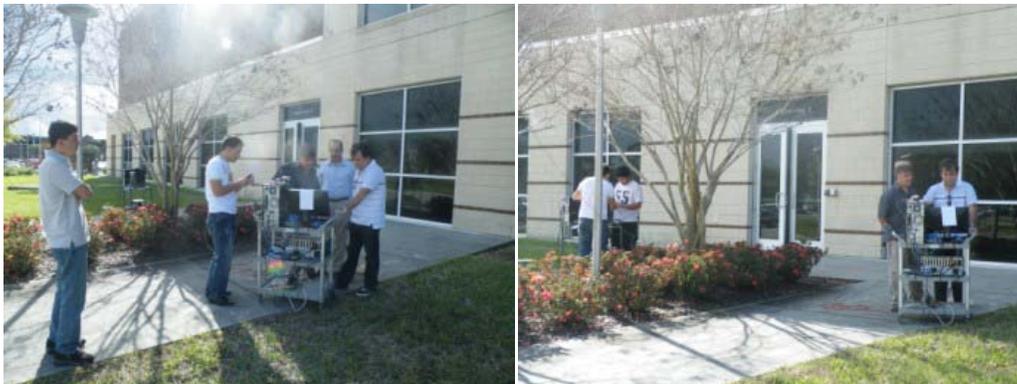
Figure 49: Outdoor Testing of Wireless Connection and GPS Synchronization

Before the field trip for the data acquisition system installation, the two computers and National Instrument systems were setup to test communications and simulate the two separate DAQ systems of the bridge. With this test, the wireless connection and synchronization of the systems were evaluated (Figure 49).

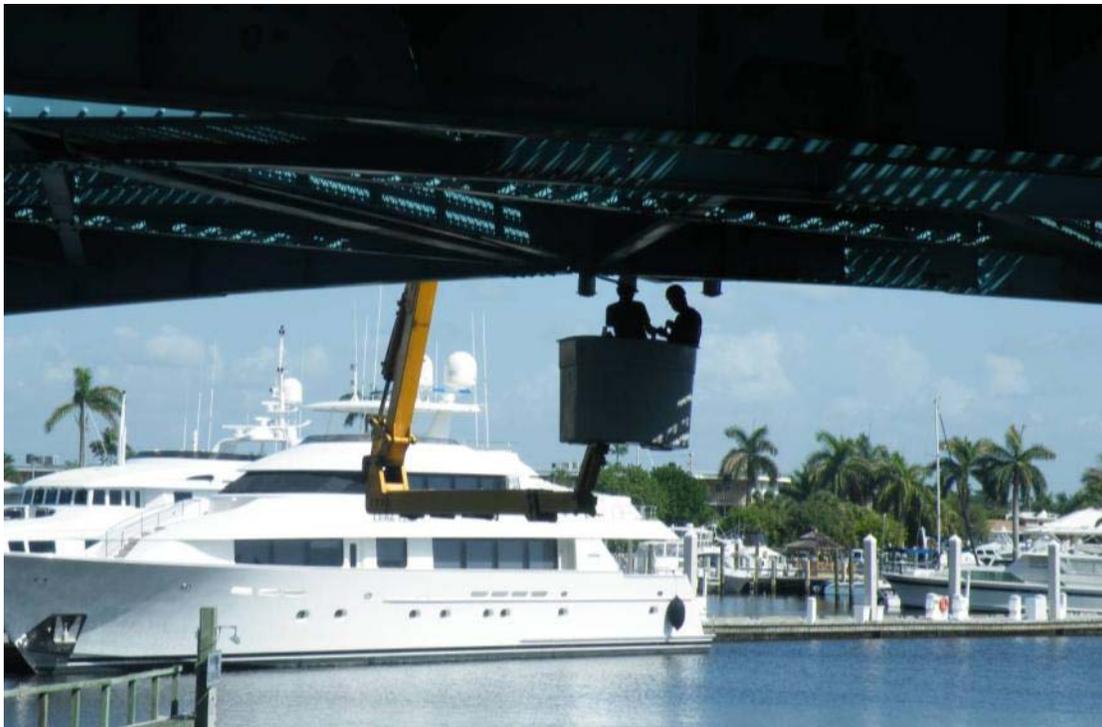
Figure 50: Sensor Installation Under the Bridge

The sensors on the structural elements were installed with the help of a snooper truck to reach the underneath locations (Figure 50). Figure 51 shows an example picture, showing the installed sensors, such as vibrating wire strain gage, dynamic strain gage, strain rosette and accelerometer, at the live load shoe area. Furthermore, Figure 51 also shows a top view of some of the sensors and a specially designed connector on the bottom flange. Finally, Figure 52 shows the instrumentation with an accelerometer and a rosette gage at the gear box of the mechanical parts. The installation procedure for strain gages and rosette gages was as follows (Figure 53): (1) Grind a small surface area with a grinder, (2) Weld the gages by using Micro-dot welder, (3) Paint the sensors against rust. In Figure 54, a close view of the vibrating wire and dynamic sensors can be seen before and after painting. On the other hand, the installation procedure for accelerometer and tiltmeter was as follows: (1) Grind the surface, (2) Epoxy the gage, (3) Paint the sensor against rust. The tiltmeter installation in the span lock room is shown in Figure 55. Lastly, ampmeters, infrared temperature sensors and microphones were directly installed with epoxy or c-clamps.

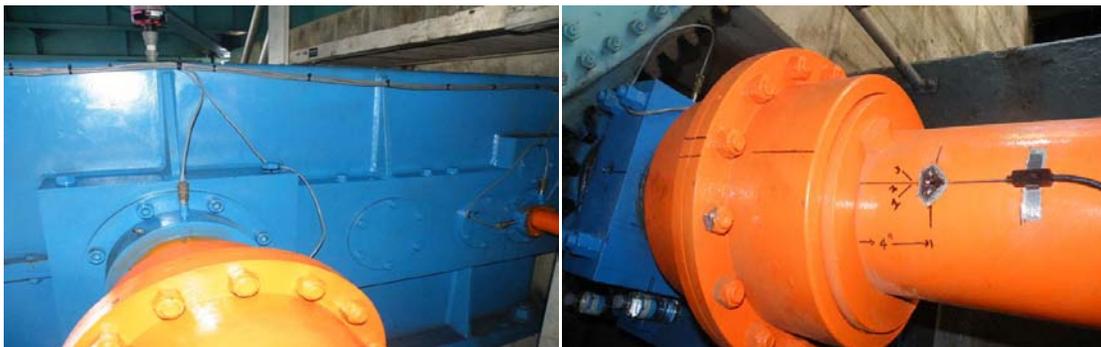
Figure 52: Accelerometers at the Gear Box and Strain Rosettes at the Drive Shaft

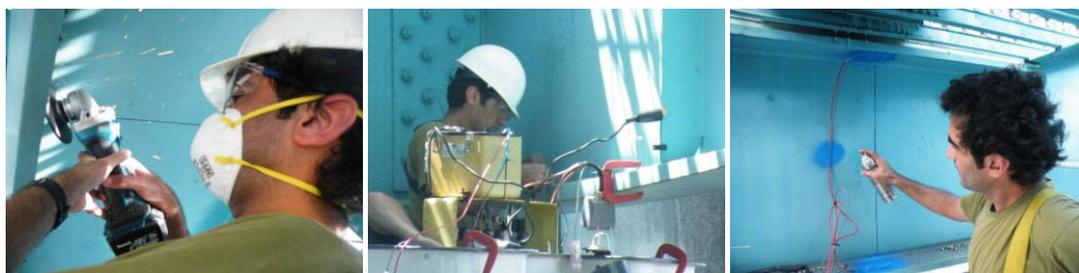
Figure 53: Strain Gage Installation Steps Under the Bridge: Grinding, Welding and Painting

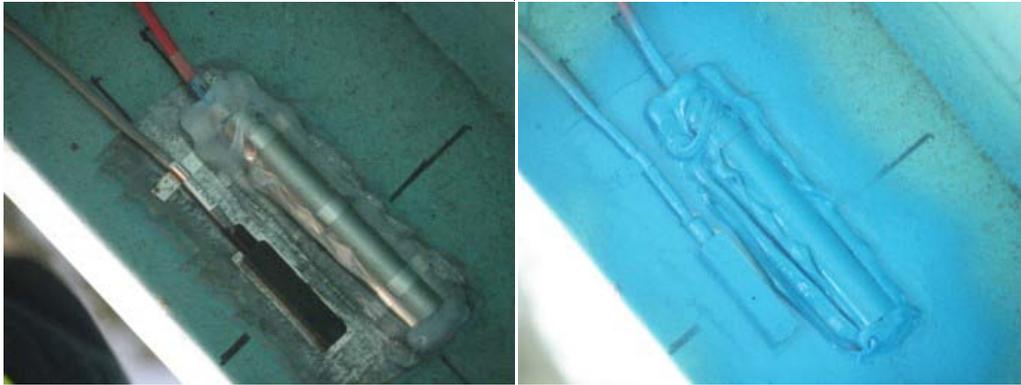
Figure 54: Close View of the Vibrating Wire and Dynamic Strain Gages Before and After Painting

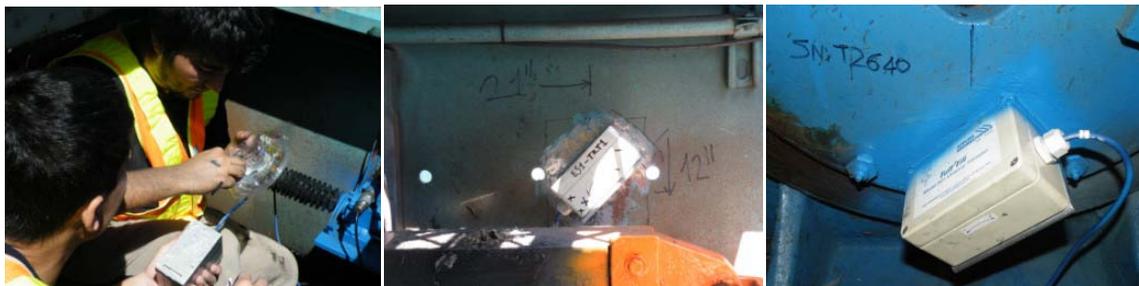
Figure 55: Tiltmeter Installation at the Span Lock Room

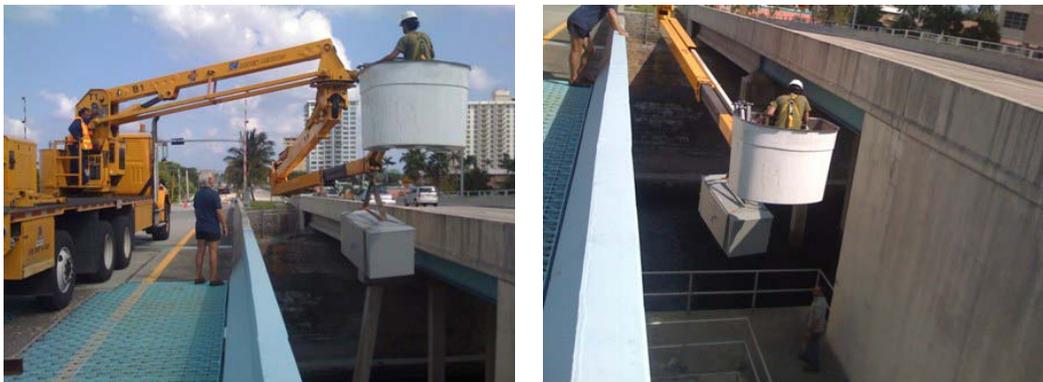
Figure 56: Moving the Cabinets with Snooper Truck

The cabinets were lowered down to mechanical rooms with the help of a snooper truck (Figure 56). In the mechanical room, first their legs were installed to the ground with high strength bolts, and then the cabinets were put on top of them and connected to the legs. Finally the air conditioner was attached to the back of the cabinet (Figure 56).

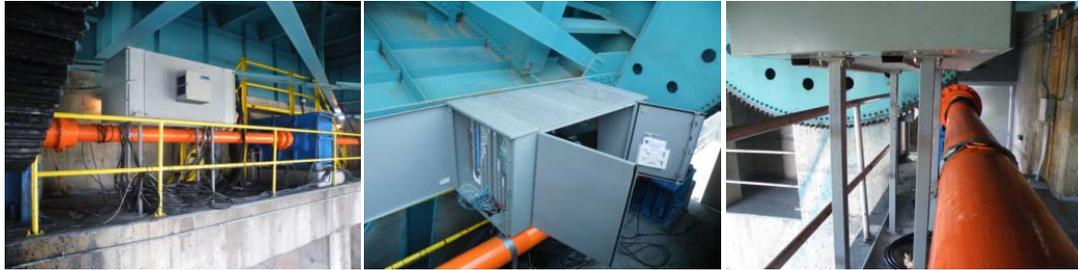
Figure 57: Cabinet Location and Different Views

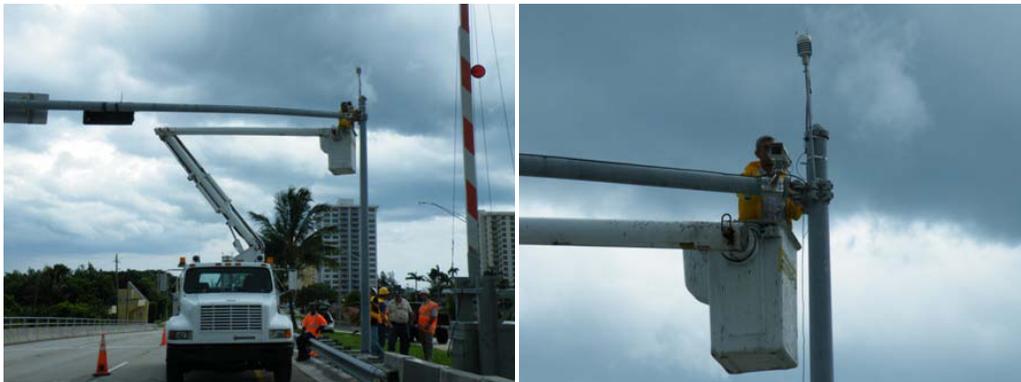
Figure 58: Installation of the Weather Station and Traffic Camera

The weather station and the traffic camera were installed on top of the traffic light pole on the east north bound of the movable bridge. A lift truck was used for installation (Figure 58). During the installation, the camera view angle and the weather station direction were also set (Figure 59). After these operations, the cables of these systems were run through pipes which were attached to the median side of the bridge.

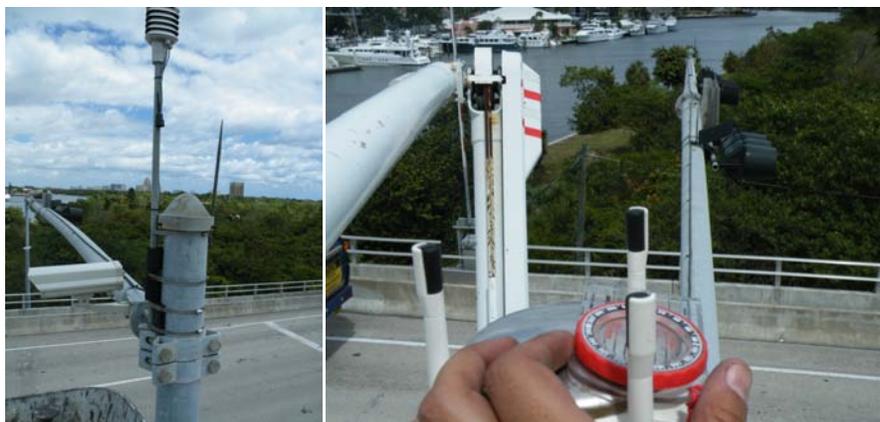
Figure 59: Setting of the Weather Station Direction with a Compass

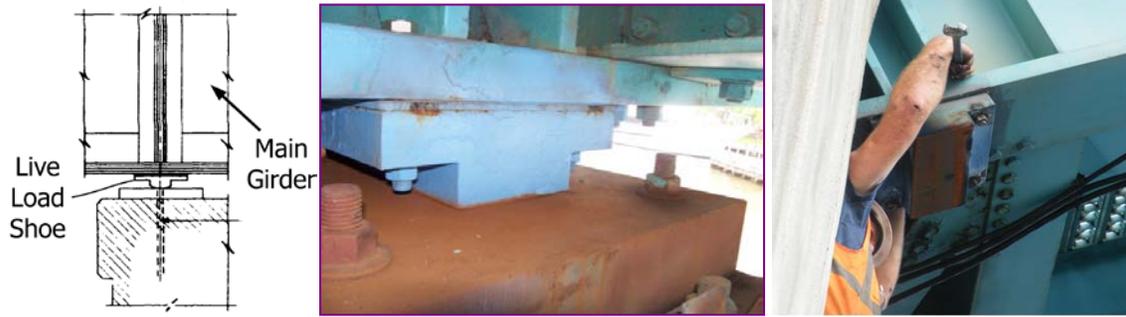
Figure 126: Live Load Shoe (LLS) and the Shim Removal Operation by FDOT Contractors (sketch adapted from Christa McAuliffe Bridge construction plans)

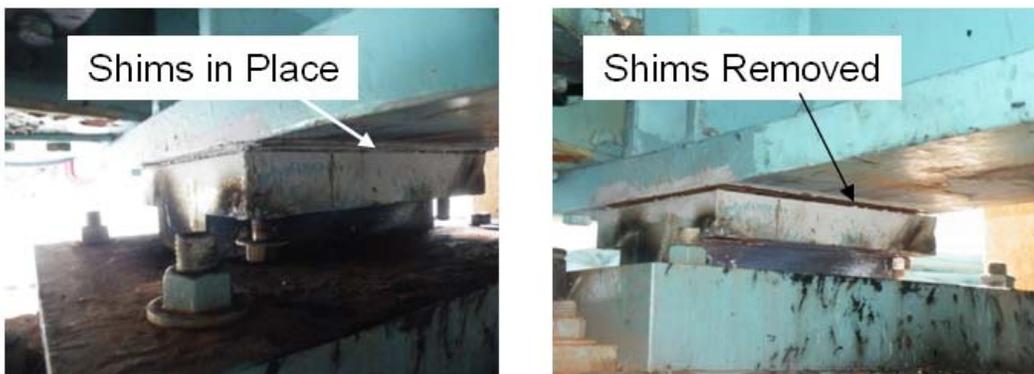
Figure 127: LLS with Shims and Without Shims

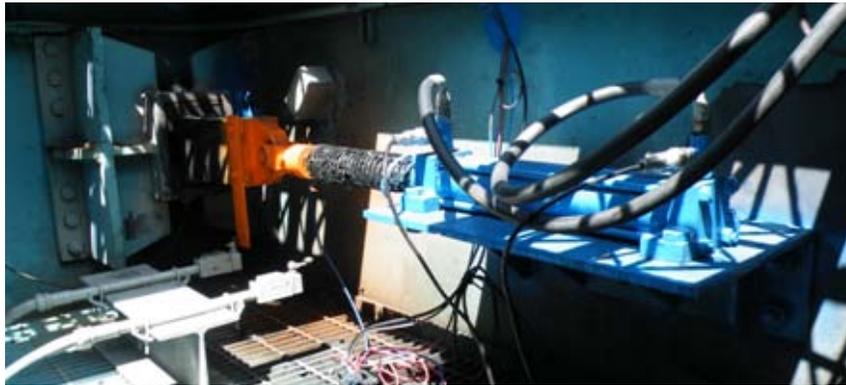
Figure 128: Typical Span Lock (SL)

In double leaf bascule bridges, Span Locks (SL) are used to connect the tip ends of two cantilever bascule leaves; therefore, both leaves are forced to deflect equally (Figure 128). Consequently, this situation prevents a discontinuity in the deck during the operational traffic. In most of the span locks, there are two main components: the receiver and the rectangular lock bar. These elements are located in different leaves. During operation, the lock bar slides across bronze shoes, mounted in the rectangular guide and receiver housings.

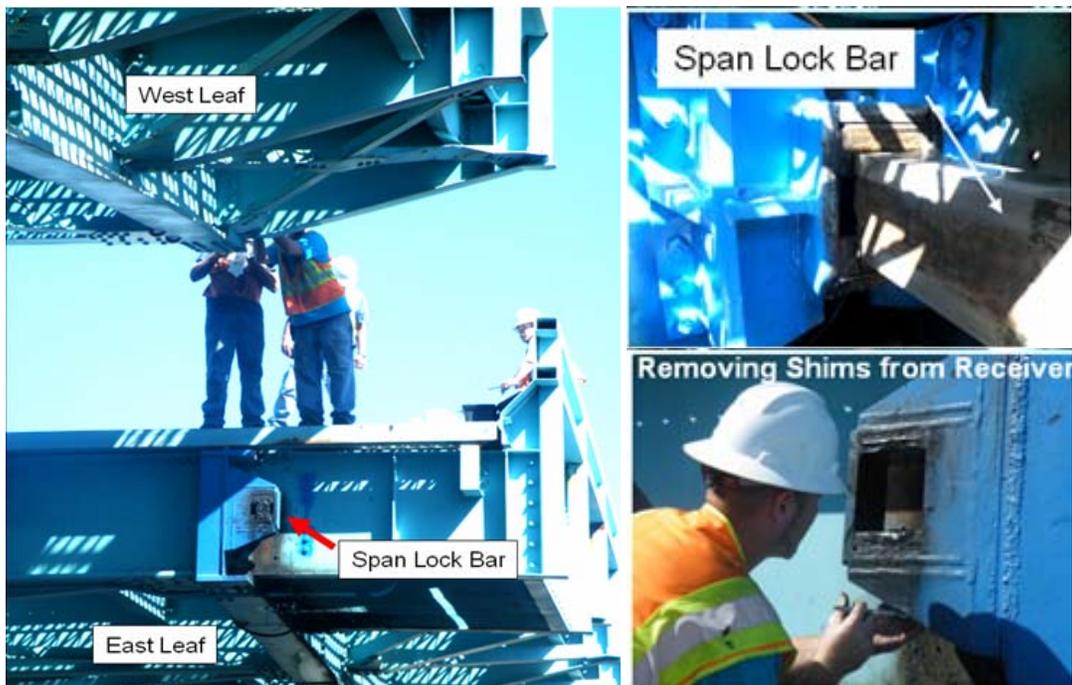
Figure 130: FDOT Contractors Removing Some of the Shims from the SL

The main concern for the span locks is that the coupling has to be loose enough to allow a proper opening operation, but at the same time, the gap between the bar and the receiver has to be small enough to ensure the adequate connection with minimal bouncing while vehicles cross from one leaf to the other. This is achieved by placing metallic sheets (or shims) to adjust the spacing. The housings are usually mounted to the side of the bascule girders, or in the webs of the floor beams. Lock bars are typically driven or retracted directly, using a linear actuator that can be electric, hydraulic or mechanical (Figure 129). Span locks are some of the members that fail the most due to deterioration or incorrect operation. For the SL shims removal case, some of the shims were removed to create a gap of approximately 1/8" up to 3/16" on the West South SL (Figure 130).

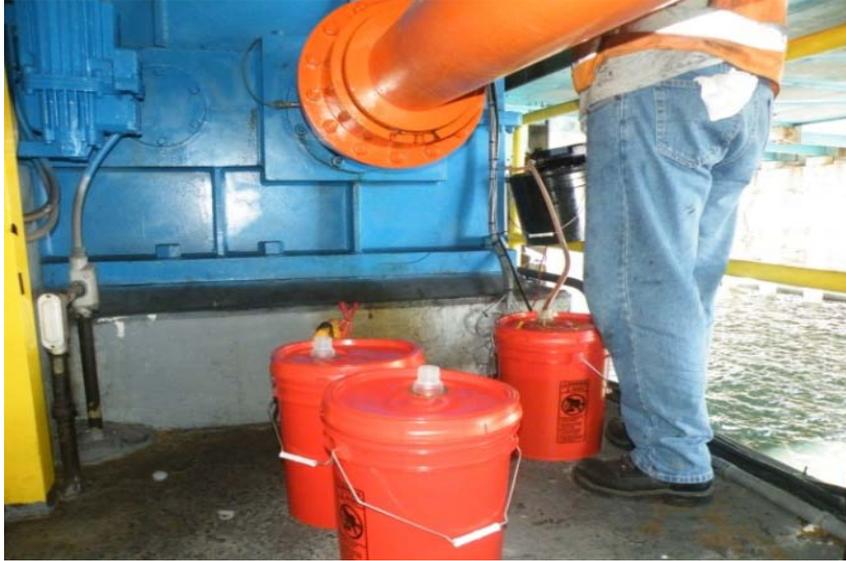
Figure 131: Removal of the Oil from the Gearbox

was partially removed to provide data corresponding to such an undesirable condition. Figure 131 shows the removal of the oil from the gear box. Only 25% of the oil was removed, and the effect of the oil reduction was monitored by six accelerometers attached to the gear box during a few openings.

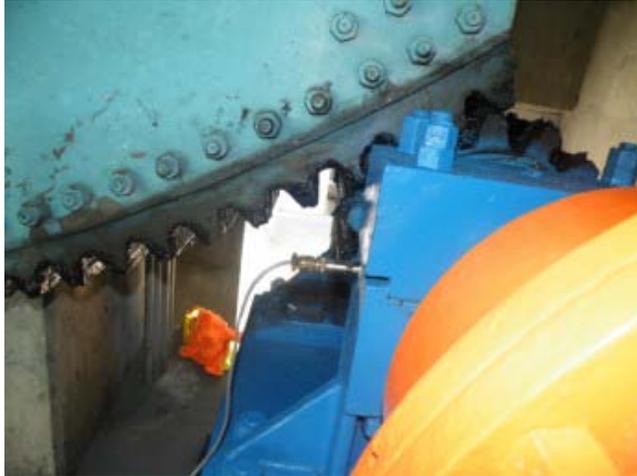
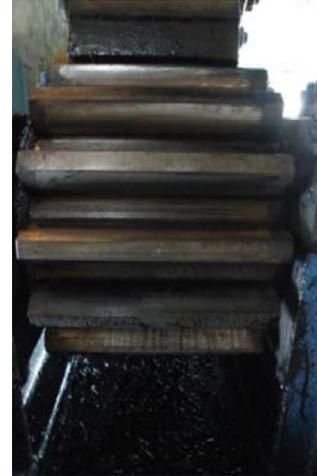
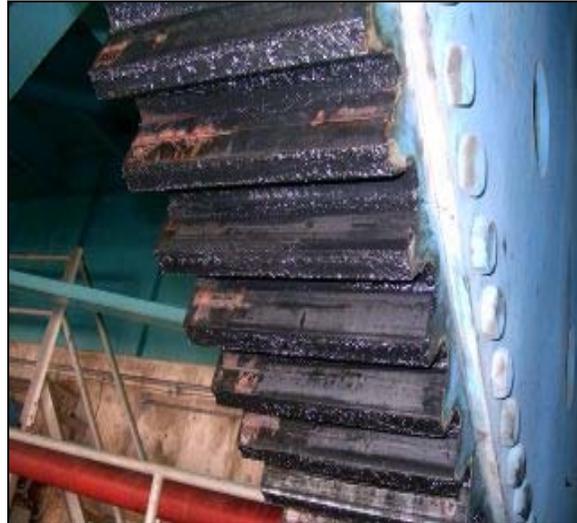
a) Open Gear

b) Gear on Rack and Pinion

c) Open Gear without Grease

Figure 132: Removal of Open Gear Grease

The open gear is situated where the superstructure and the mechanical parts meet (Figure 132a). The shaft delivers the force to Rack and Pinnion (RP), while the RP gear delivers the force to the open gear shown in the Figure 132a. For smooth operation, the open gear and RP gear should be properly lubricated. In order to observe the effect of lack of lubrication at these gears, grease was removed, and the response was monitored by the horizontal accelerometer on Rack and Pinnion. Figure 132c and d show the open gear with and without the grease.
