Final Report for Research Project

**LONG TERM BRIDGE MAINTENANCE MONITORING
DEMONSTRATION ON A MOVABLE BRIDGE**

A framework for structural health monitoring of movable bridges

Florida Department of Transportation

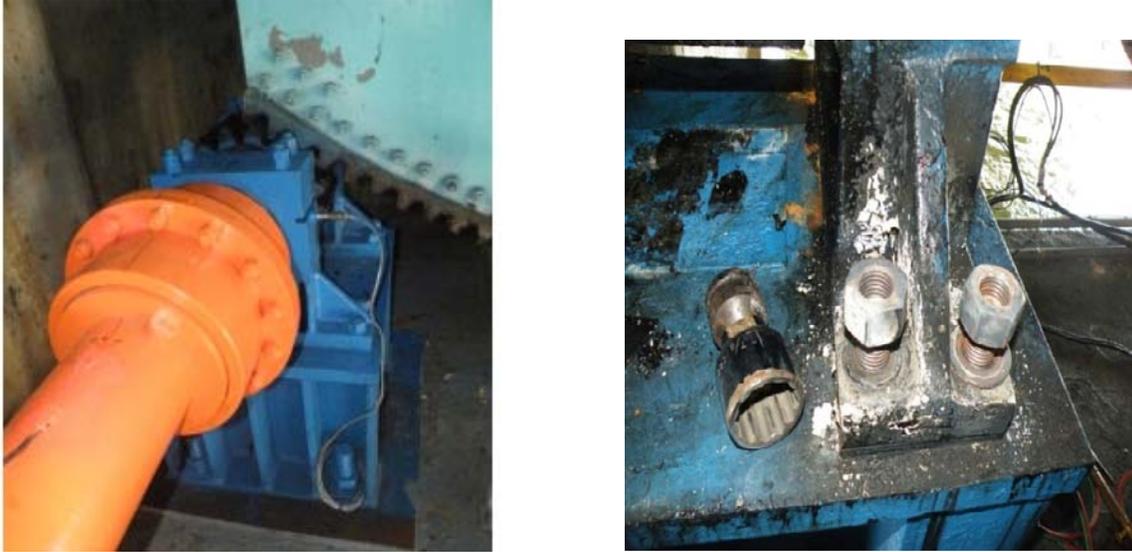
Figure 133: Rack and Pinnion Bolt Removal

The Rack and Pinnion is located between the shaft and the open gear; therefore, it can be considered a transmission zone for opening and closing operation forces. Therefore, it should be free from defects to ensure safe operation of the bridge. Here, the removal of bolts was the simulated damage scenario, and the effect of the absence of these bolts was monitored by one horizontal accelerometer. Figure 133 shows the Rack and Pinnion with the removal of the bolts.

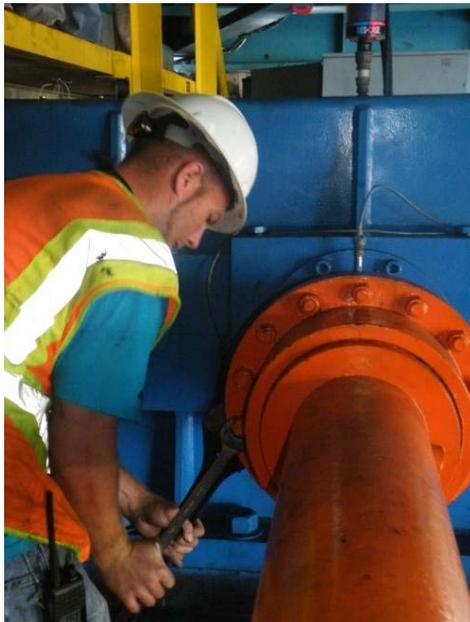
Figure 134: Removal of the bolts

Another important mechanical component is the shaft between the gearbox and RP, which is used for transmitting torque and rotation. Since the shafts are subjected to torsion and shear stress, they should be strong enough to bear these forces. In this study, the effect of loosening the bolts at the location where the shaft is connected to the Gearbox was monitored. Figure 134 shows the removal of the bolts from the shaft.

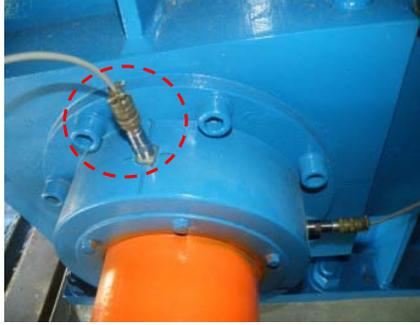
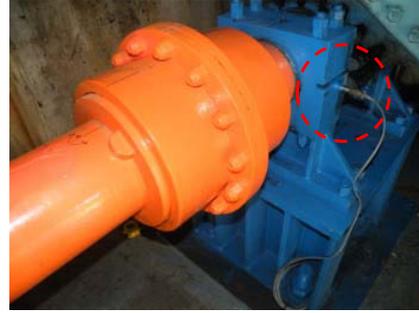
a) Gearbox

b) Rack and Pinnion

In this section, the removal of the gearbox oil and open gear grease are investigated by using the data from accelerometers installed on these components. The critical characteristics and distinct behavior change in dynamic response can be tracked over time by means of structural monitoring. Two recurrent types of damage were identified for bridge components namely, leakage from the gear box and inadequate lubrication of the open gear. The detection and diagnosis of damage in these parts are of great practical significance and importance in the sense that an early detection of these faults may help to avoid performance degradation and major damage to the machinery. The gearbox (Figure 147-a) was instrumented with six accelerometers at different locations in both the horizontal and vertical directions. The Rack and Pinions (Figure 147-b) was instrumented with one horizontal sensor to monitor the open gear. A large number of data sets from the healthy condition of these parts were collected (Figure 147-c and Figure 147-d). In order to see the effect of leakage from gear box, 25% of oil from the gearbox was removed. In addition, to simulate inadequate lubrication of open gear, large portion of the grease on the open gear was removed. Under these damage conditions, the gearbox and the rack and pinion were monitored during the opening and closing of the leaves of the bridge. Using healthy (baseline, undamaged) and unhealthy (altered, damaged) data sets, an artificial neural network-based framework was developed for detecting the mechanical alterations at the gearbox and the rack and pinion.

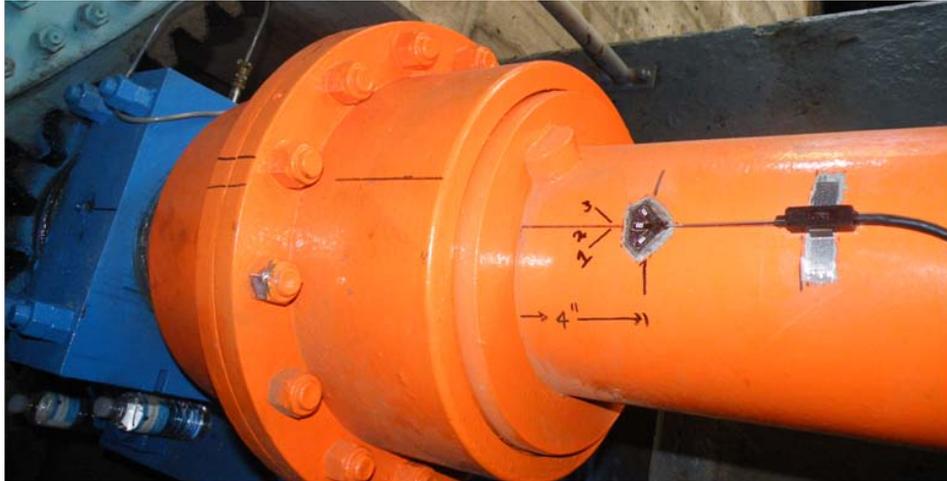
Figure 152: Strain Rosette on the Drive Shaft

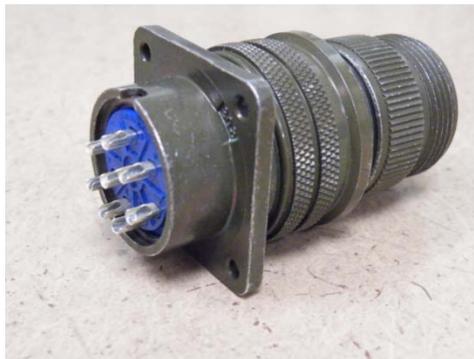
Figure 164: Military Style Connector (Not Selected for Use)

- **Pre-Connect sensors to cable in Lab**
 - *Pros:* Provides best quality control, secure hardwired connection, lower cost
 - *Cons:* Extremely difficult installation procedure due to securing of main cable prior to sensor installation, very difficult to repair
- **Fixed Junction Box Enclosures**
 - *Pros:* Scaled down version of side junction boxes, easy to repair
 - *Cons:* Higher cost, requires robust attachment to girders to prevent detachment during openings, time consuming at time of installation
- **Military Style Connectors ()**
 - *Pros:* Low cost alternative connector, quick field installation
 - *Cons:* Poor design requires soldering each individual wire in lab, extremely time consuming, poor quality control
