## Florida Department of Transportation Research

# Diagnostic Investigation of Excessive Camber in Prestressed Slab Units

October 2020

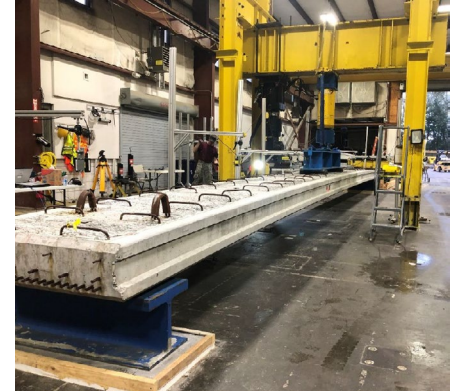
Figure 1. Slab with higher camber than expected.

The prestress losses found in four of the six slabs, tested two years after construction, averaged 27%. The as-built concrete strength was found to exceed the design value while the weight of the concrete was lower than expected. A lower weight corresponds to a lower initial modulus of elasticity and therefore a member with less stiffness. The compressive stress at release was found to exceed the limit of 0.6f<sub>c</sub> by approximately 2.9%. Cracks observed in the top of the slab beam had an average depth of 1.75 in., with a higher concentration at 4 ft. to 10 ft. from the ends. The actual ultimate capacity was higher than design capacity by an average of 12.5% and 1% higher than predicted capacity using as-built concrete properties.
