Testing of a Vision-Based Pedestrian Collision Warning System on Transit Vehicles

FDOT Project No.: BDV29 TWO 943-07

Final Report

Lehman Center of Transportation Research Florida International University

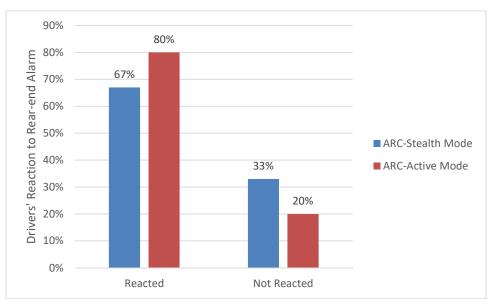
Figure E-1: Drivers' Reaction to Overall Rear-End Collision Threats

The hypotheses associated with this performance measure is that when the installed devices are active, the number of the bus drivers' reactions to potential threats will increase. Under the stealth mode, the bus drivers are not aware of the alarms, but the researchers are able to obtain the alarm times via the telematics data. The results presented in this section is only for ARC since there is no active mode for the BRC. The driver's reactions were observed from the video clips. The results indicate that there is a minor difference in the reaction between the active and stealth modes with regard to the HW and FCW. However, there was a significant improvement in the reaction to Urban FCW threats with the active mode. When considering all rear-end crash warnings, there was an improvement of 13%, from 67% reaction to 80% reaction, as shown in Figure E- 1. Hypothesis testing indicates that this difference in proportion is significant at the 95% significance level.

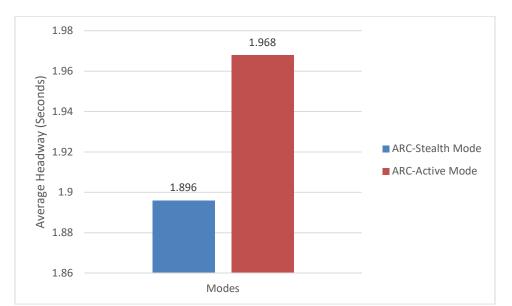
Figure E- 2: Average Headway Comparison between Stealth and Active Modes

The hypotheses associated with these performance measure is that when the installed devices are active, the drivers tend to drive in a safer manner as a result of being informed on safer driving behaviors and to avoid getting the alarms. Figure E- 2 shows that the drivers tend to leave longer headways on average with the active mode (1.968 seconds vs. 1.896 seconds, which is 3.8% improvement). Please, note that the system records the headway data only around the time that the warnings are issued. Figure E- 3 shows that the drivers tend to perform the hard brake less frequently with the assistance of the Mobileye system (166 miles per hard brake vs. 105 miles per hard brake, which is 37% improvement).

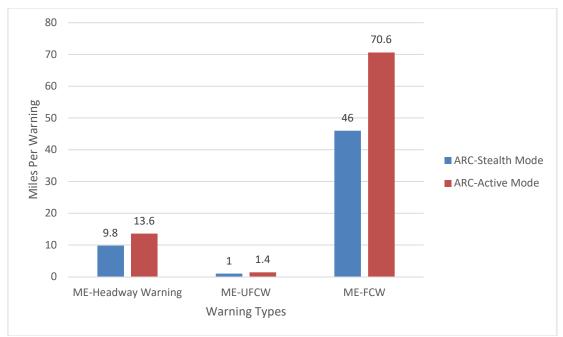
Figure E- 4: Frequency of Rear-End Warning in Miles per Warning

The hypotheses associated with this performance measure is also that the drivers will tend to drive in a safer manner as a result of being informed on safer driving behaviors and to avoid the alarms. Figure E- 4 and Figure E- 5 show a significant reduction in the warning with the active mode of all three types of threats. For example, when measured in mile per warning the reduction ranges from 28% (13.6 miles per warning vs. 9.8 miles per warning) to 34% improvement (70.6 miles per warning vs. 46.0 miles per warning), depending on the warning type. The lower number of warning with the active mode indicates more conservative driving.

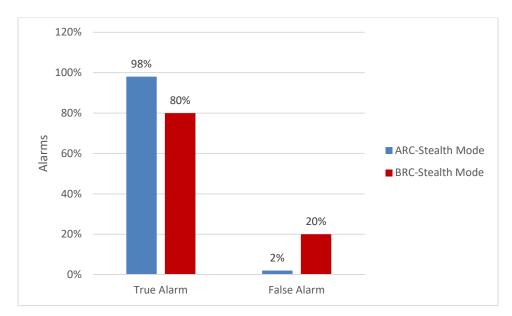
Figure E- 6: Accuracy of Headway Warning

To estimate the accuracy of the rear-end alarms, 60 videos were downloaded and observed for each of the three alarm types (HW, UFCW, and FCW) for the before changing the route and after changing the route condition. If there was no observed vehicle in front of the bus or the front

vehicle was too far from the bus at the alarm time, then the alarm was regarded as a false alarm. Figure E- 6 to Figure E- 8 show the percentage of and false alarms for headway warnings, Urban FCW, and FCW, respectively. After route changing, it can be seen that the percentage of the true alarm is 98%, 98%, and 92% for the three warnings, respectively; indicating a very high accuracy. Before route changing, the corresponding true alarms were 80%, 62%, and 82%; respectively.

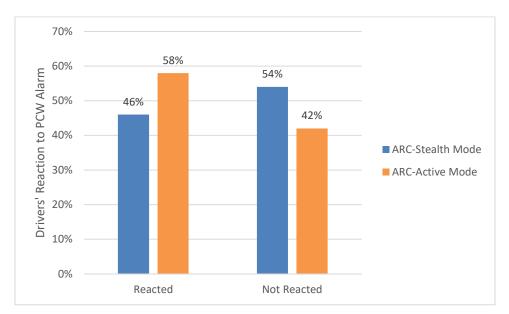
Figure E- 9: Overall Bus Drivers' Reaction

For the warnings based on the middle front, left front, and left rear cameras; the driver reaction improved from 77% to 98%, 27% to 100%, and 32% to 95%; respectively. For the warning based on the right rear cameras, the reaction was better in the stealth mode compared to the active mode (85% vs. 68%). Overall, Figure E- 9 shows a 26% improvement in the reaction with the active mode (from 46% to 58%). Hypothesis testing indicates that this difference in proportion is significant at the 95% significance level.

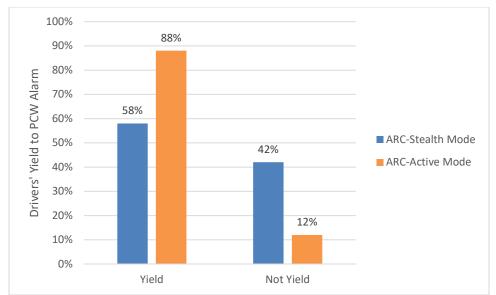
Figure E- 10: Overall Drivers' Yielding to Pedestrians

To further check the bus drivers' reaction to the PCWs, their yielding to the pedestrians who were crossing or intended to cross the streets was also observed from the video clips. For the warnings based on the middle front, left front, right front camera; the driver yielding behavior improved from 29% to 70%, 41% to 94%, and 83% to 87%. For the warning based on the rear-right camera; the yield was 100% in both cases. Overall, Figure E- 10 shows an improvement in the yielding

with the active mode (from 58% to 88%). Hypothesis testing indicates that this difference in proportion is significant at the 95% significance level.

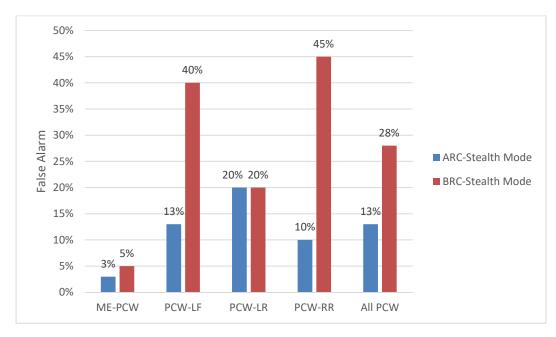
Figure E-11: Percentage of False PCW

To estimate the accuracy of the pedestrian/bicyclist alarms, 60 videos were also downloaded and observed for each warning category (by camera location). If there is no observed pedestrian in the field of view at the warning time, the alarm is regarded as a false alarm. Figure E- 11 shows the percentages of false alarms for each direction of the warning and for the overall observations. It can be seen that, before changing the route, the warning based on the right-rear and left-front

directions have high false alarm rate (45% and 40%, respectively). After changing the route, the false alarms for these two cameras are only 10% and 13%, respectively.

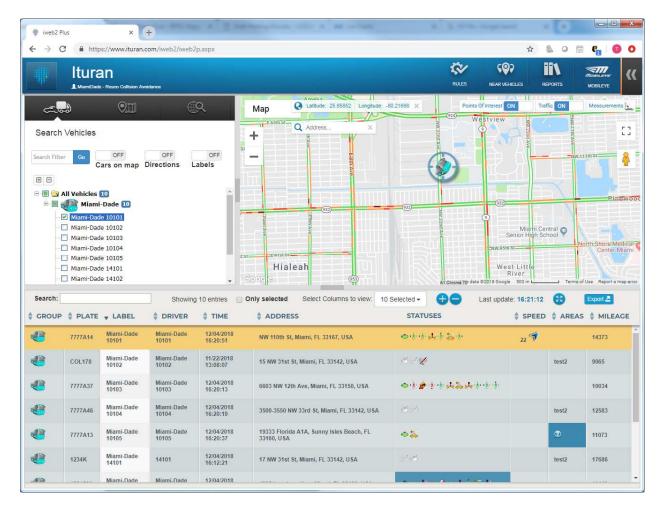
Figure 9-1: Vendor Project Website to Download Telematics Data

The vendor installed the telematics equipment to relay the alarms data. The data can be downloaded from the project website set by the vendor. Figure 9-1 shows the screenshot of the website.

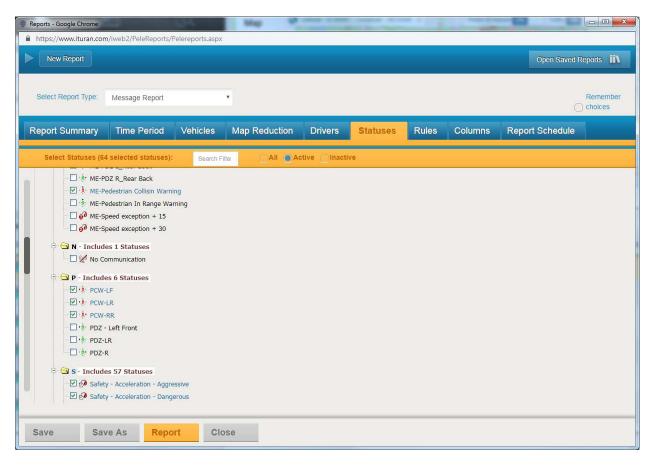
Figure 9-3: Ituran Website Interface to Generate Alarm Data Report

From the project website, one can also generate detailed alarm data reports by specifying the time period, vehicles, statuses including the types of alarm generated by the system, and other attributes such as the speed, and heading of the bus, etc. These detailed alarm data were collected and verified with the video recording to estimate the accuracy of the Mobileye system. Figure 9-3 shows the interface to generate the reports.

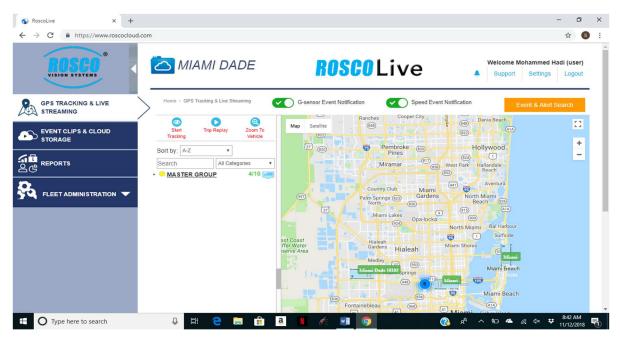
Figure 9-6: Screenshot of ROSCO Live Website

The vender installed the video recording equipment on the buses to record the video using digital video recording (DVR). The cameras were installed at four locations of each bus. One is facing inside to the driver. Another one is facing forward to the front of the bus. The other two are at the left rear and right rear of the bus, respectively. The recorded video was available to be requested and downloaded from the ROSCO Live website provided by the vender. Figure 9-6 shows a screenshot of the website.

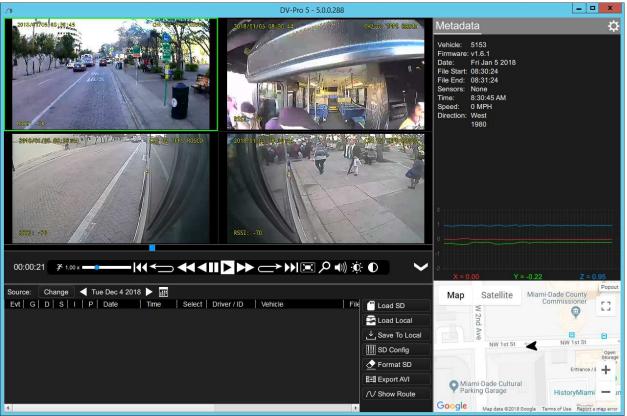
Figure 9-8: NVR Video Played by DV-Pro

The downloaded video files are in NVR format and can be opened by the software DV-Pro provided by the vendor. As shown in Figure 9-8, the software can play the videos from the four

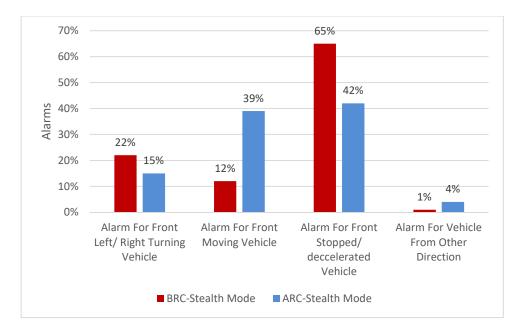
Figure 10-1: Statistical Distributions of the Alarm Types

Figure 10-1. It can be seen that for BRC, a higher percentage of the alarms is due to front vehicle stopping or decelerating compared to ARC (65% vs. 42%). The alarms for approaching a front moving vehicle is higher for ARC (39% vs. 12%). This possibly reflects the more dense urban nature of the streets that constitute BRC (the Miami Beach area). The alarms due to turning left and right in front of the leading vehicle in front of the bus are comparable (15% vs. 22%).

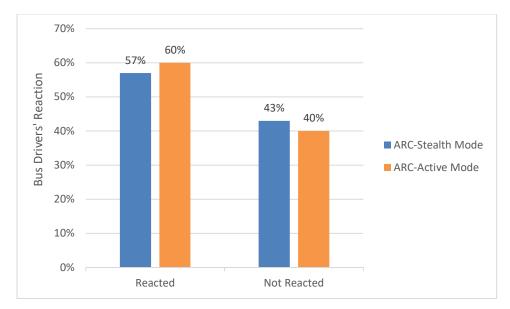
Figure 10-2: Bus Drivers' Reaction to Headway Threats

The hypotheses associated with this performance measure is that when the installed devices are active, the number of the bus drivers' reactions to potential threats will increase. Under the stealth mode, the bus drivers are not aware of the alarms, but the researchers are able to obtain the alarm times via the telematics data. The results presented in this section is only for ARC since there is no active mode for BRC. The driver's reaction were observed from the video clips. Figure 10-2 to Figure 10-4 show the results for the HW, UFCW, and FCW, respectively. These figures indicate there is a minor difference in the reaction between the active and stealth modes with regard to the Headway and FCW threats (2%-3% higher reaction with the active mode). However, there is a significant improvement in the reaction to UFCW threats with the active mode (by 21% from 82% to 100%, as shown in Figure 10-3). When considering all alarms, there was an improvement of 13%, from 67% reaction to 80% reaction, as shown in Figure 10-5. Hypothesis testing indicates that this difference in proportion is significant at the 95% significance level.

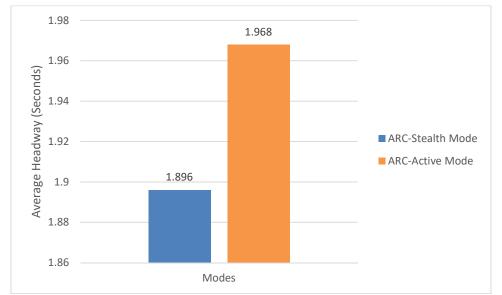
Figure 10-6: Average Headway Comparison between Stealth and Active Modes

The hypotheses associated with this performance measure is that when the installed devices are active, the drivers tend to drive in a safer manner as a result of being informed on safer driving behavior and to avoid the alarms. The results presented in this section is only for ARC since there is no active mode for BRC. The data were obtained from the vendor's web site. Figure 10-6 shows that the drivers tend to leave longer headways on average with the active mode (1.968 seconds vs. 1.896 seconds, which is 3.8% improvement). Figure 10-7 shows that the drivers tend

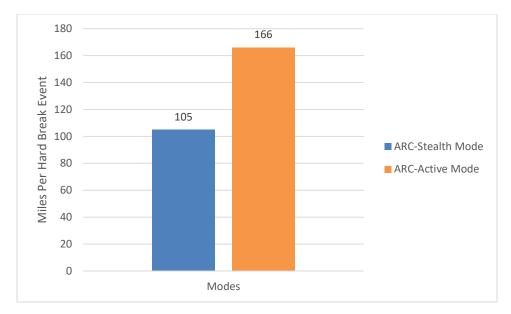
Figure 10-7: Frequency of Hard Brakes in Miles per Hard Brake Event

to perform the hard brake less frequently with the assistance of the Mobileye system (166 miles per hard brake vs 105 per hard brake, which is 37% improvement). Figure 10-8 and Figure 10-9 show a significant reduction in the warnings with the active mode of all three types of threats. For example, when measured in mile per warning the reduction ranges from 28% (13.6 miles per warning vs. 9.8 miles per warning) to 34% improvement (70.6 miles per warning vs. 46.0 miles per warning), depending on the warning type. The lower number of warning with the active mode indicates more conservative driving.

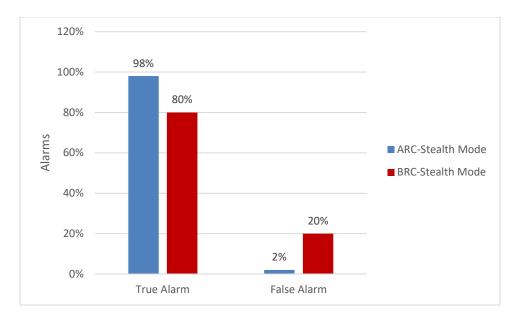
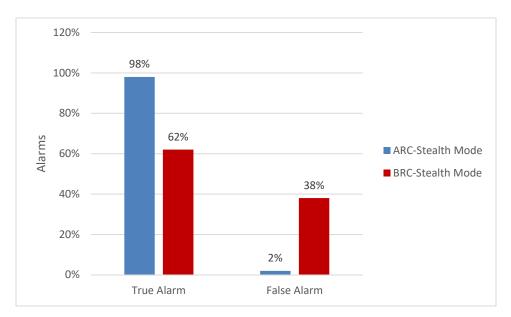
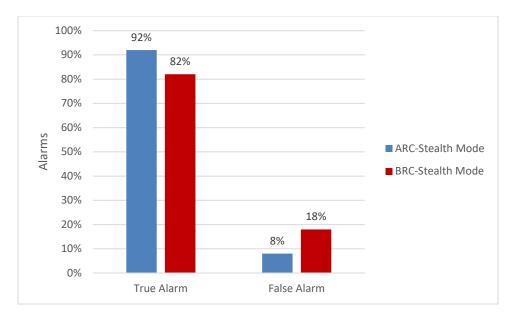
To estimate the accuracy of the rear-end alarms, 60 videos were downloaded and observed for each of the three alarm types (HW, UFCW, and FCW) for the before changing the route and after changing the route condition. If there was no observed vehicle in front of the bus or the front vehicle was too far from the bus at the alarm time, then the alarm was regarded as a false alarm. Figure 10-10 to Figure 10-12 show the percentage of and false alarms for headway warnings, UFCW, and FCW, respectively. After route changing, it can be seen that the percentage of the true alarm is 98%, 98%, and 92% for the three warnings, respectively; indicating a very high accuracy. Before route changing, the corresponding true alarms were 80%, 62%, and 82%; respectively.

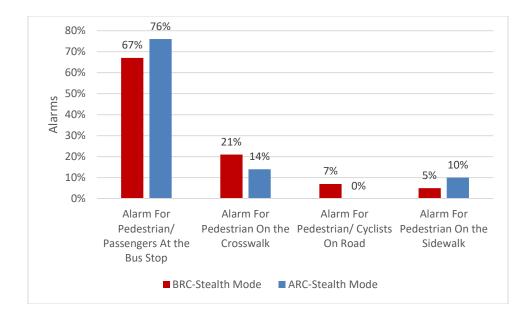
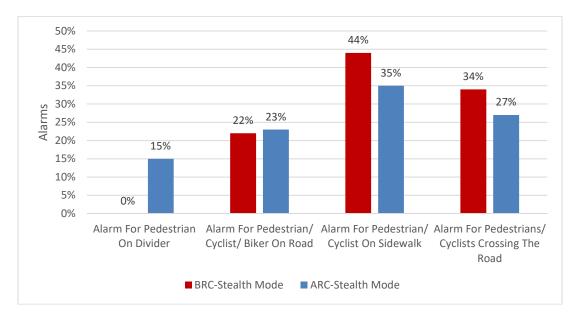
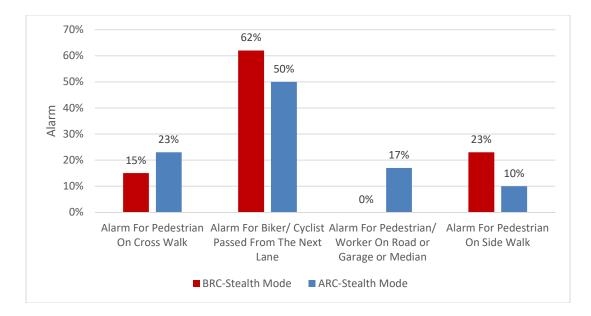
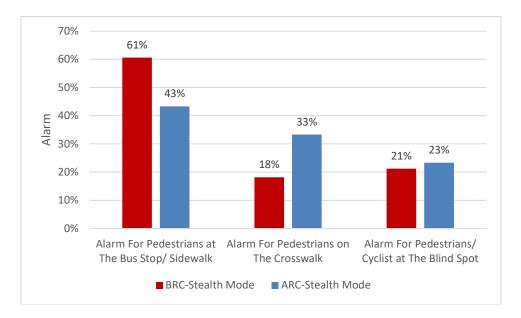
To get the distribution of the reasons for the pedestrian collision warnings, 60 videos were observed for each detection direction. The results are shown in Figure 10-13 to Figure 100-16. The figures show that the pedestrians walking on the sidewalks, waiting on the bus stops, crossing the roads, and running to catch the bus are the main causes of the warnings.

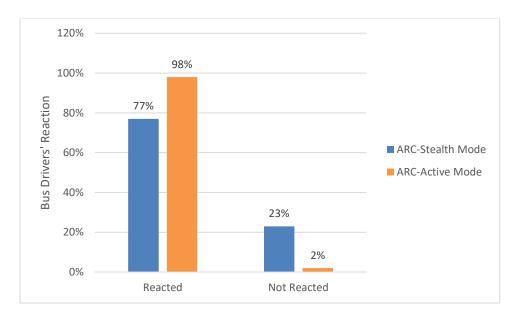
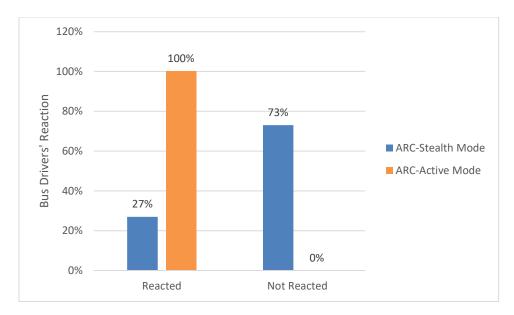
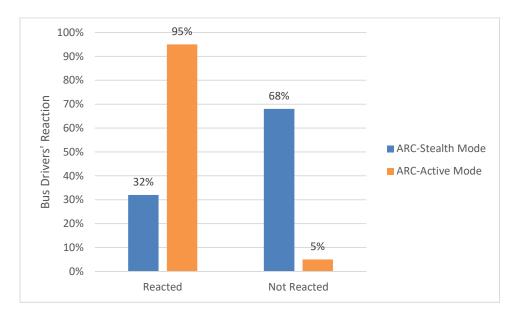
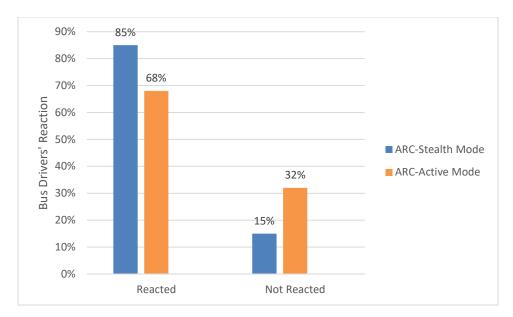
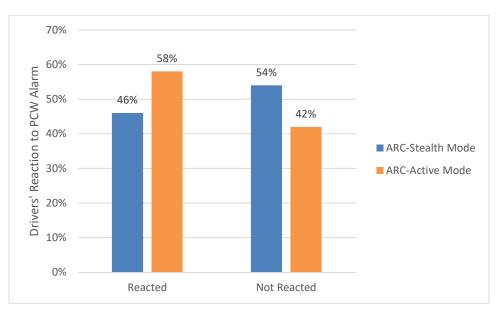
possible that the driver had no response. For the warnings based on the middle front, left front, and right front cameras; the driver reaction improved from 77% to 98%, 27% to 100%, 32% to 95%; respectively. For the warning based on the rear-right cameras, the reaction was better in the stealth mode compared to the active mode (85% vs. 68%). Overall, Figure 10-21 shows an improvement in the reaction with the active mode (from 46% to 58%). Hypothesis testing indicates that this difference in proportion is significant at the 95% significance level.

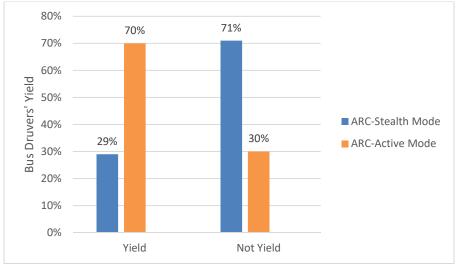
Figure 10-22: Bus Drivers' Yielding to Pedestrians for ME-PCW

To further check the bus drivers' reaction to the PCWs, their yielding to the pedestrians who were crossing or intended to cross the streets was observed from the video clips. The results are shown in Figure 10-22 to Figure 10-25. For the warnings based on the middle front, left front, right front, the driver yielding behavior improved from 29% to 70%, 41% to 94%, and 83% to 87%. For the rear-right, the yield was 100% in both cases. Overall, Figure 10-26 shows an improvement in the

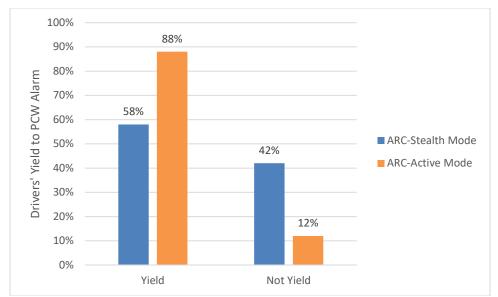
Figure 10-26: Overall Drivers' Yielding to Pedestrians

yielding with the active mode by 51.7% (from 58% to 88%). Hypothesis testing indicates that this difference in proportion is significant at the 95% significance level.

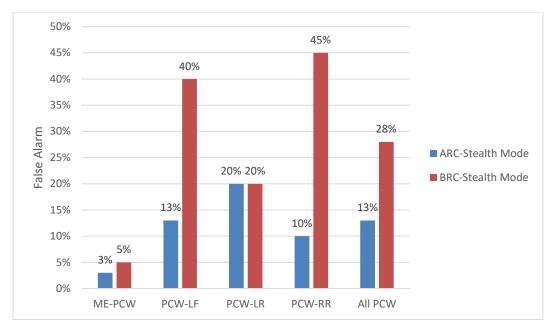
Figure 10-27: Percentage of False PCW

To estimate the accuracy of the pedestrian/bicyclist alarms, 60 videos were also downloaded and observed for each warning category (by camera location). If there is no observed pedestrian in the field of view at the warning time, the alarm is regarded as a false alarm. Figure 10-27shows the percentages of false alarms for each direction of the warning and for the overall observations. It can be seen that, before changing the route, the warning based on the right-rear and left-front directions have high false alarm rate (45% and 40%, respectively). After changing the route, the false alarms for these two cameras are only 10% and 13%, respectively.
