EVALUATION OF SELF CONSOLIDATING CONCRETE AND CLASS IV CONCRETE FLOW IN DRILLED SHAFTS

BDV25-977-25

FINAL REPORT

January 2020

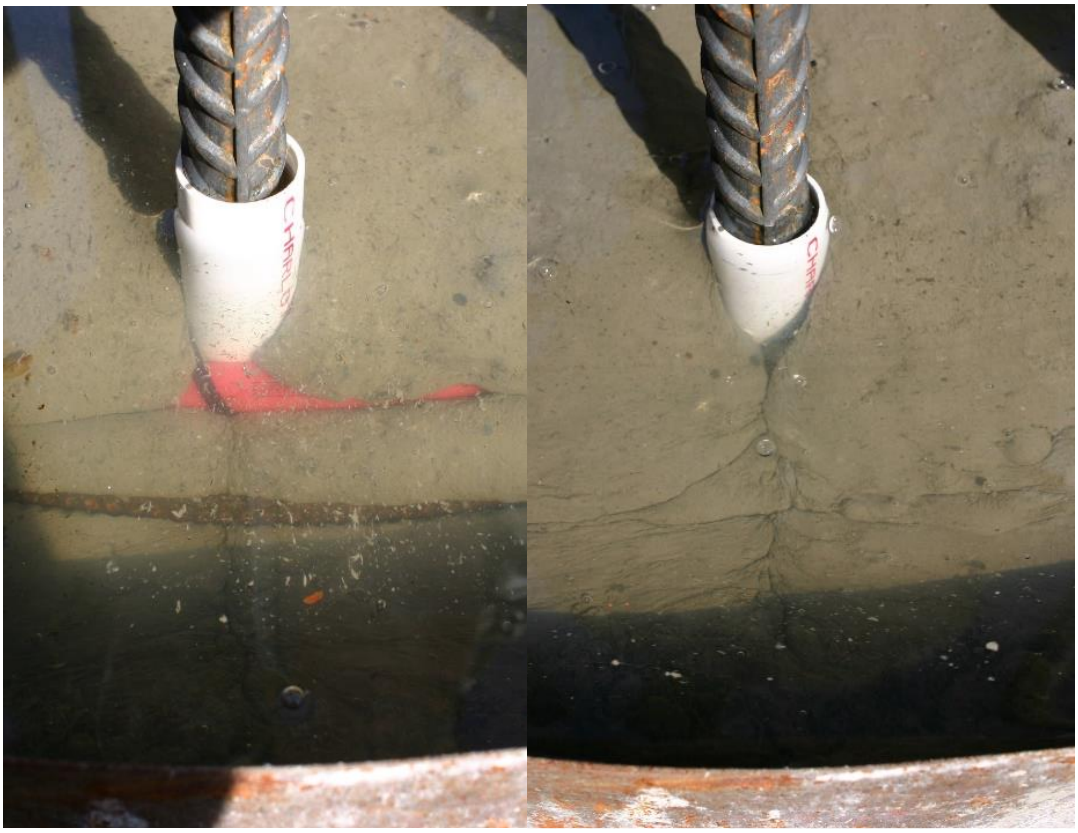
quilted grid pattern. The depth of the creases can extend to the reinforcing steel and this presents significant durability issues as the openings facilitate the corrosion process by providing transport pathways for the ingress of detrimental materials existing in the surrounding soil. Figure 8.3 shows a conceptual view of the radial concrete flow and the vertical creases that form. This hypothesis would explain the poor corrosion performance noted in visually perfect specimens. Figure 8.4 shows the same phenomenon that forms horizontal creases simultaneously.

Figure 8.2 The concrete flowing radially and forming quilting.

Figure 12.1 Comparison of idealized flow with observed (Mullins, 2005)

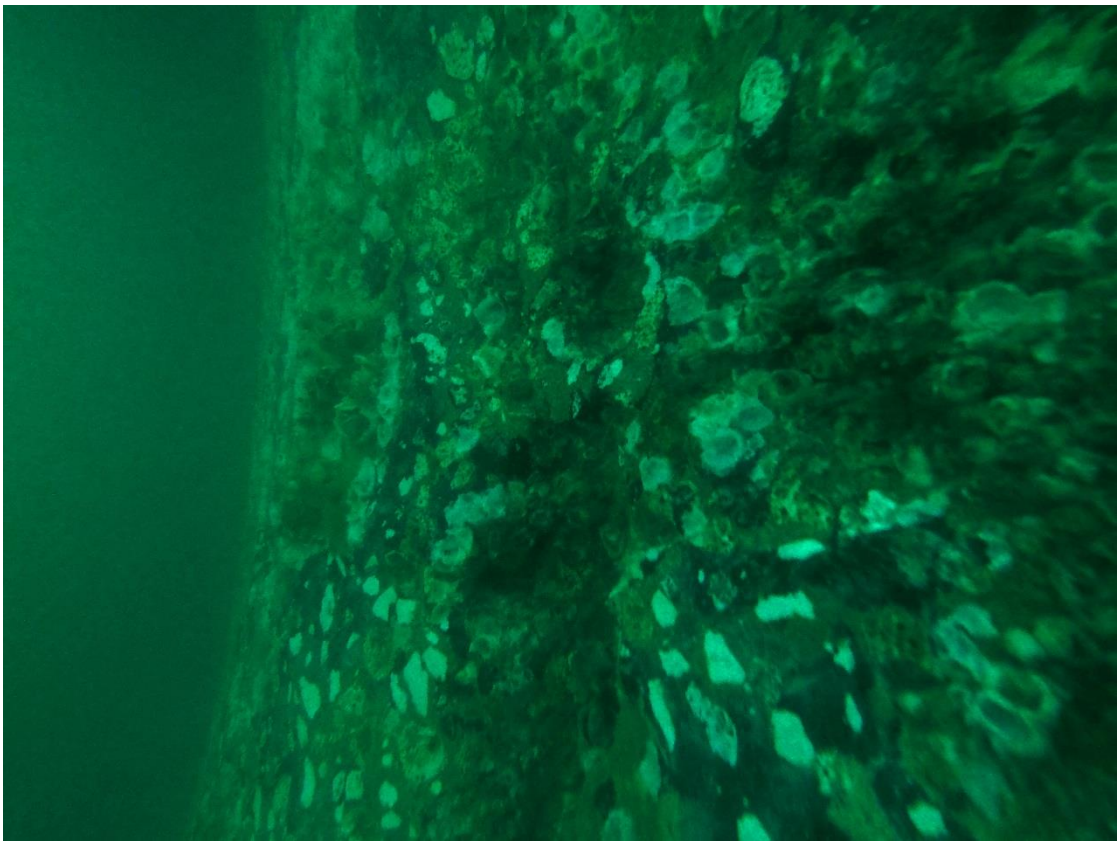
Figure 10.23 Large void found on the south side of 71-4.

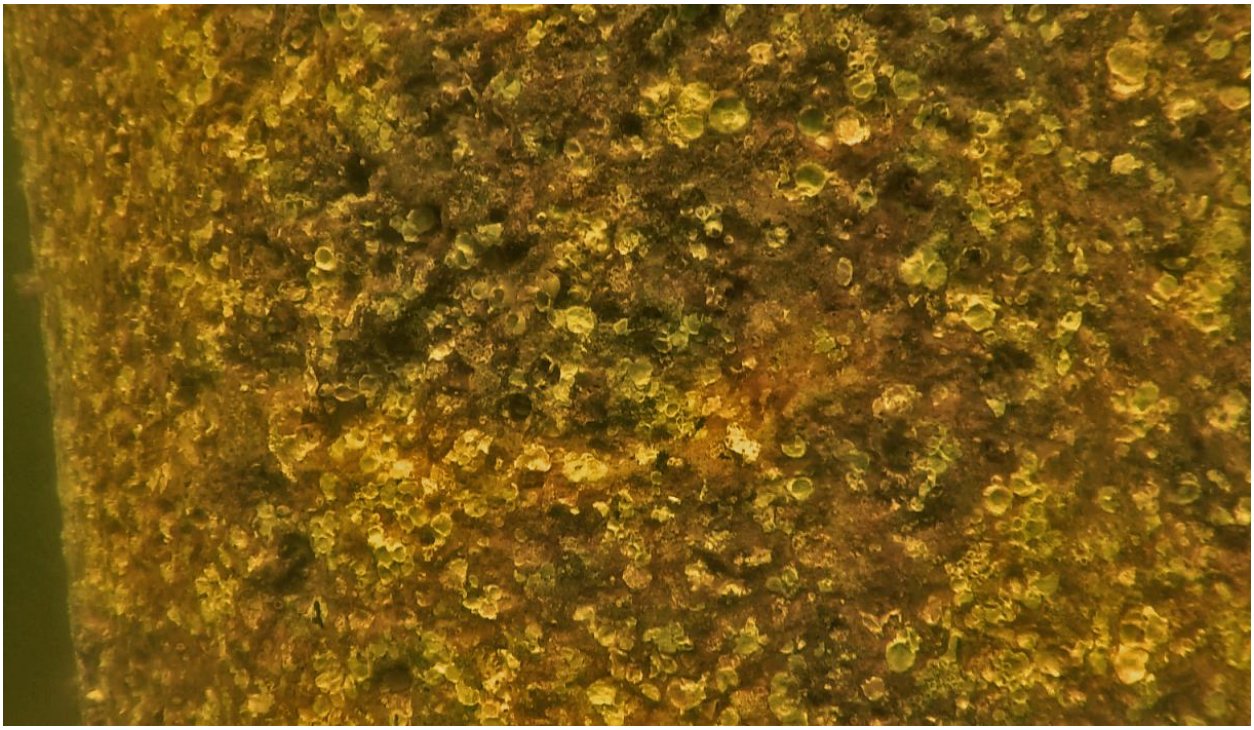
Pier 84 was noted to have voids on all four shafts and contains 6-ft diameter Type 1 reinforced shafts (Figure 10.19(c)). Shaft 84-4 was chosen for cleaning and inspection as it was listed as having two voids. Figure 10.24 shows 84-4 with a thick layer of barnacles prior to cleaning. This

Figure 10.24 Shaft 84-4 prior to cleaning.

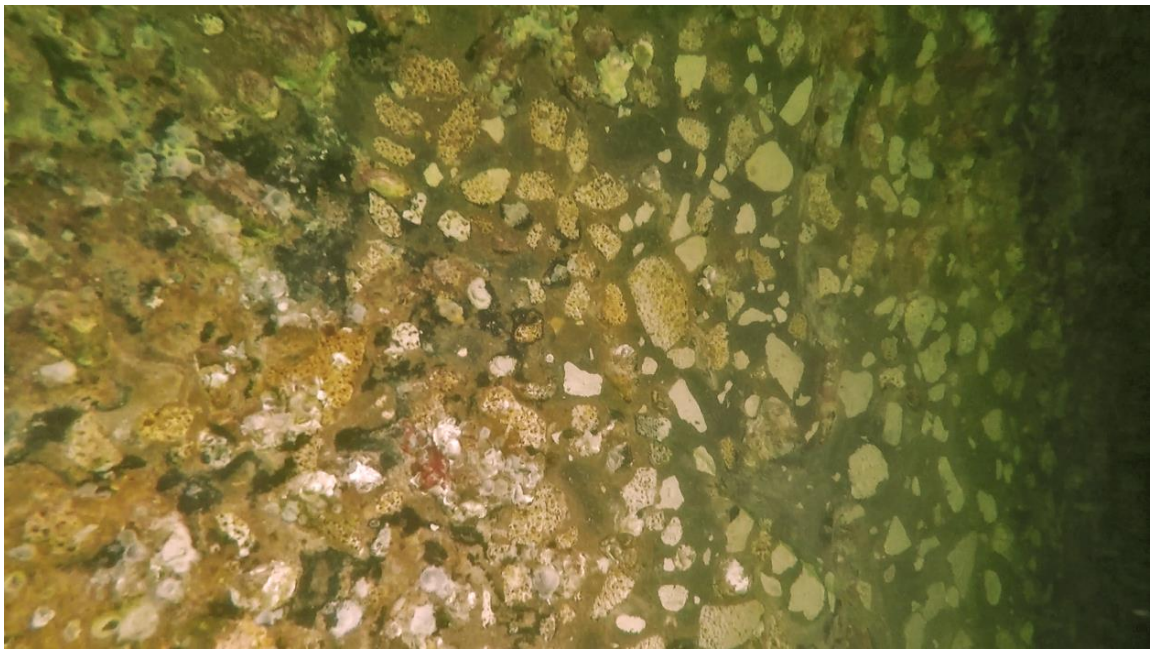
layer is better viewed in Figure 10.25 where the cleaned concrete transitions into the barnacle layer. Figures 10.26 and 10.27 show the cleaned portions of the shaft from east and southeast sides. It can be seen in these figures that the concrete is not completely smooth. The circled red areas on Figure 10.26 represent areas of the cleaned concrete that are filled with barnacles. Therefore the 6-ft Type 1 shafts seem to experience at least small voids in the concrete. This is suspected to have been caused by the double reinforcement cage. Figure 10.28 shows the layers found when cleaning the concrete. Consistently throughout the examination of the Gandy shafts, encrustations were found consisting of barnacles and miscellaneous plant life/organisms. Upon initial cleaning, barnacles were knocked/scraped off and the remnants of the barnacle attachment were then removed. Below this layer, a thin black layer was encountered which was difficult to remove. In cases of smooth surfaces with no significant voiding, pristine concrete could clearly be seen. Rougher surfaces with voids retained the plant life, barnacles and black layer. Except for isolated instances, there was no attempt to dig into voids and determine the full depth.

Figure 10.27 Cleaned portion of 84-4, east side of shaft.

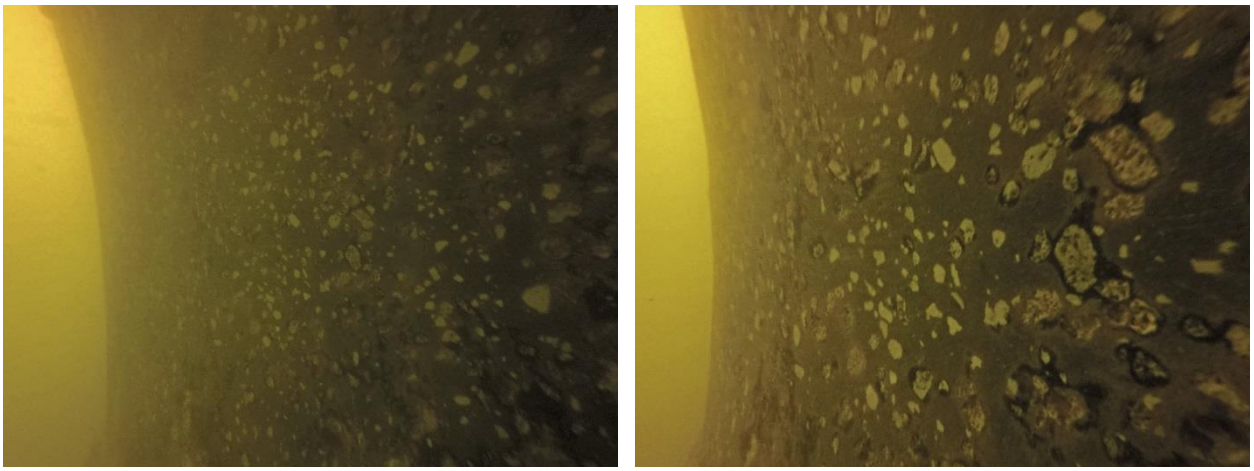
Unfortunately there is no image of 85-2 before cleaning; however, it looked similar to others covered in barnacles (Figure 10.24). While the cleaned section of the shaft overall shows a smooth surface (Figure 10.29), there are small crevices. As seen in Figures 10.30 and 10.31, barnacles and sea-life fill in these voids. As noted above, the small voids/crevices are believed to have been caused by the double reinforcement cage; note this was not observed on the 4-ft diameter, single reinforcement cage shafts inspected at Pier 95.

Figure 10.29 Shaft 85-2 after cleaning.

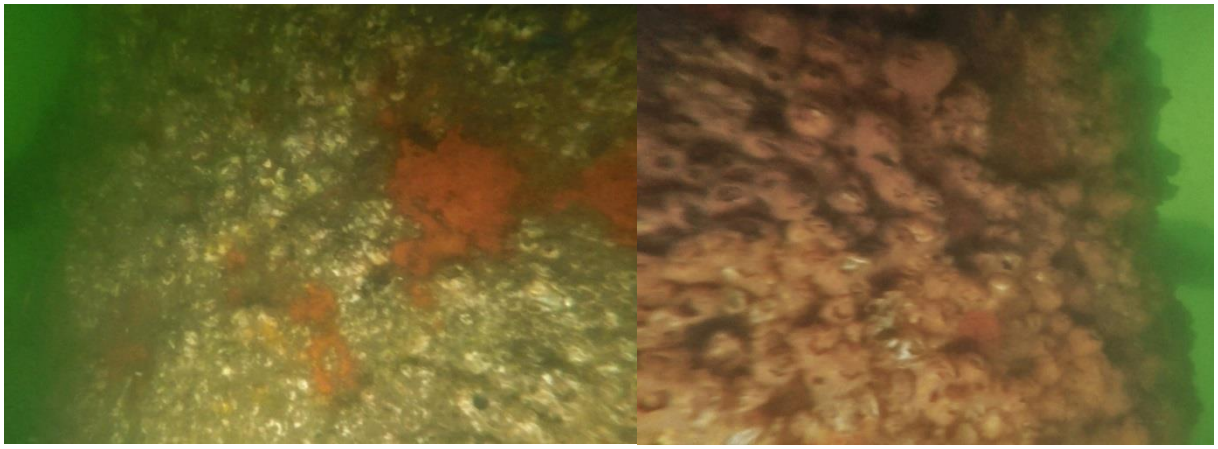
Pier 94 was not mentioned in the diver report, and therefore it was thought to be a good candidate to have a casing. Upon initial inspection, it can be difficult to tell if the shaft has a casing or not because of the thick layer of barnacles attached to the shaft concrete or its casing. Therefore, shaft 4 from Pier 94 (94-4) was chosen for cleaning to demonstrate what steel casing looks like versus the concrete. Figure 10.32 shows 94-4 prior to cleaning and Figure 10.33 shows 94-4 during cleaning. In Figure 10.34 the steel from the casing is visible. As seen from Figure 10.34, there is a black layer underneath the encrustation and on top of the steel casing.

Figure 10.32 Shaft 94-4 pre-cleaning.

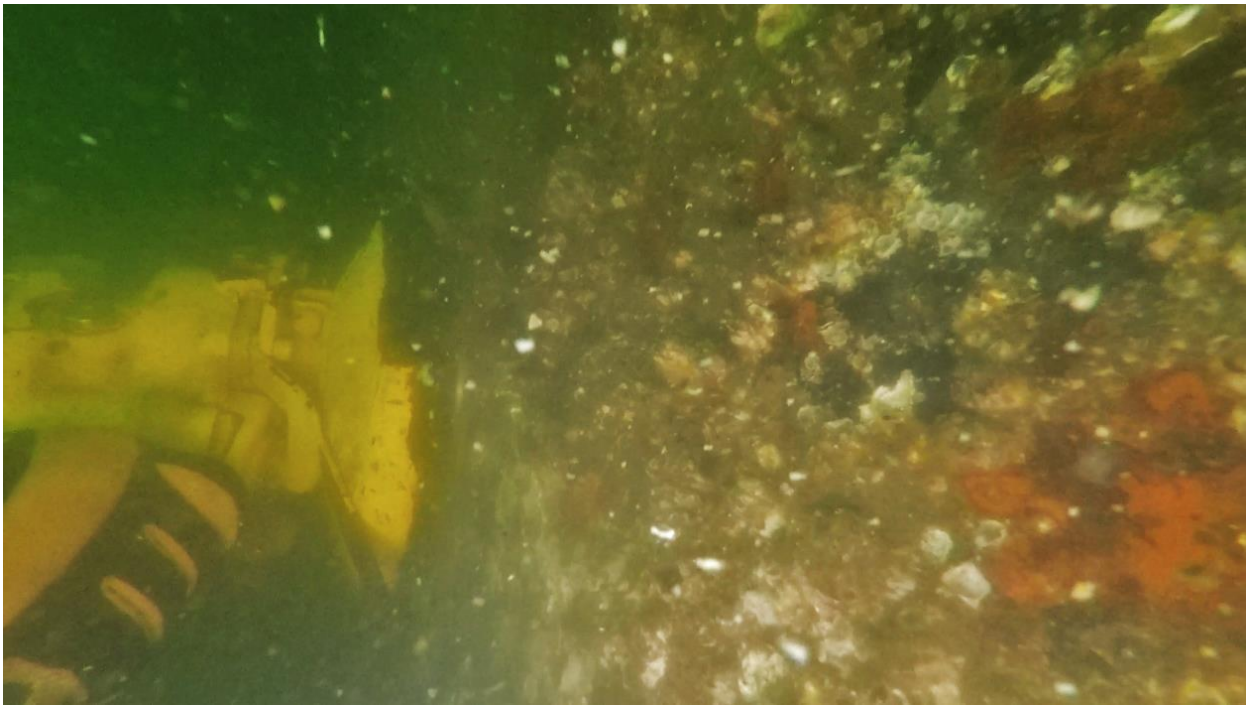
Figure 10.33 Shaft 94-4 during cleaning with the grinder.

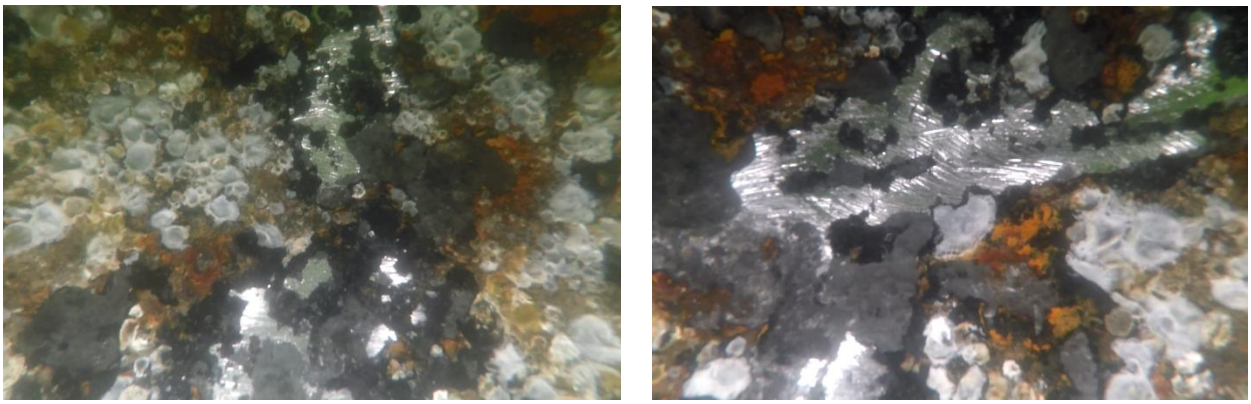
Figure 10.34 Shaft 94-4 after cleaning showing steel casing.

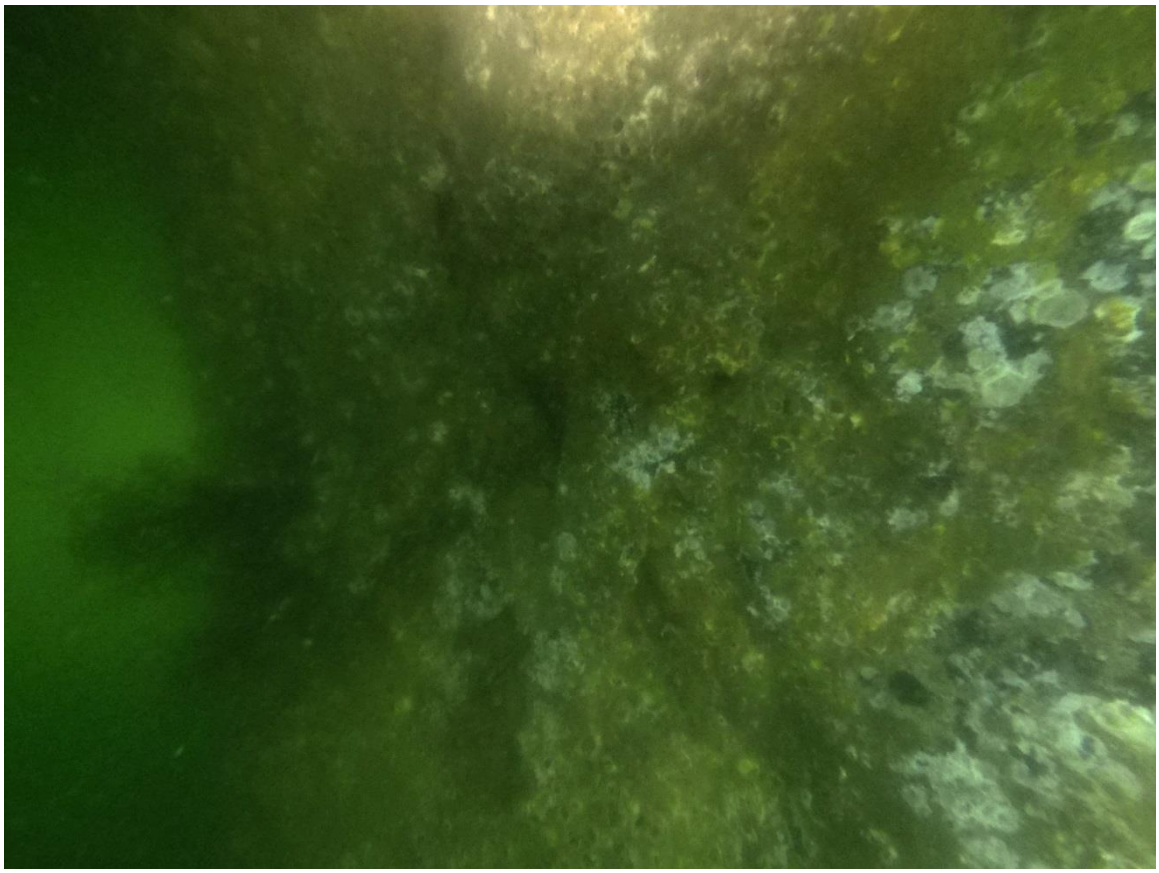
All shafts at Pier 95 are 4 ft in diameter and have a Type 1 reinforcement cage (Figure 10.19b). Two shafts, 95-1 and 95-3 on the north side, were chosen for cleaning and inspection on Pier 95 as the casing had previously been removed. Noted in the diver report, 95-1 had a void 12 in. below the footing/seal that is 32 in. H x 12 in. W x 2 in. D. Shaft 95-3 had no known/noted deficiencies.

Shaft 95-1 did have a void as noted, and it was noticeable even prior to cleaning (Figure 10.35). This void was substantial; Figure 10.36 shows the void before cleaning, which involved scraping barnacles, grinding and/or wire-brushing. A screwdriver was used for reference of void depth, which was about 2-3 in. (Figure 10.37). However, on the south (interior) side of the same shaft,

Figure 10.35 95-1 prior to cleaning.

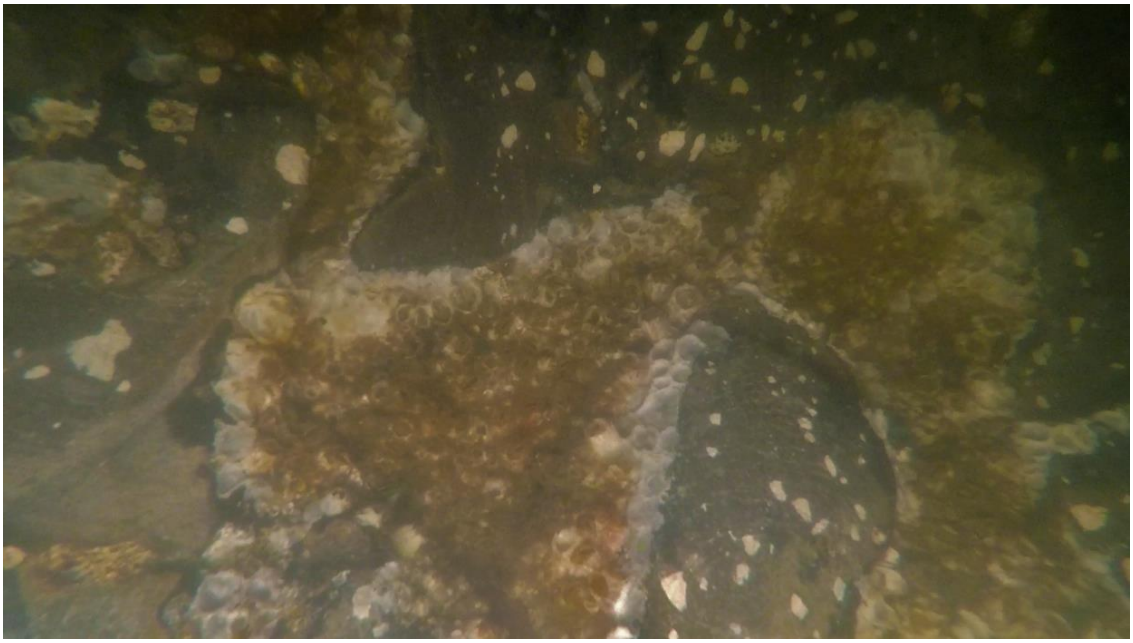
Figure 10.36 Void on 95-1, this was taken after grinding the shaft and before scraping out the barnacles residing in the voids.

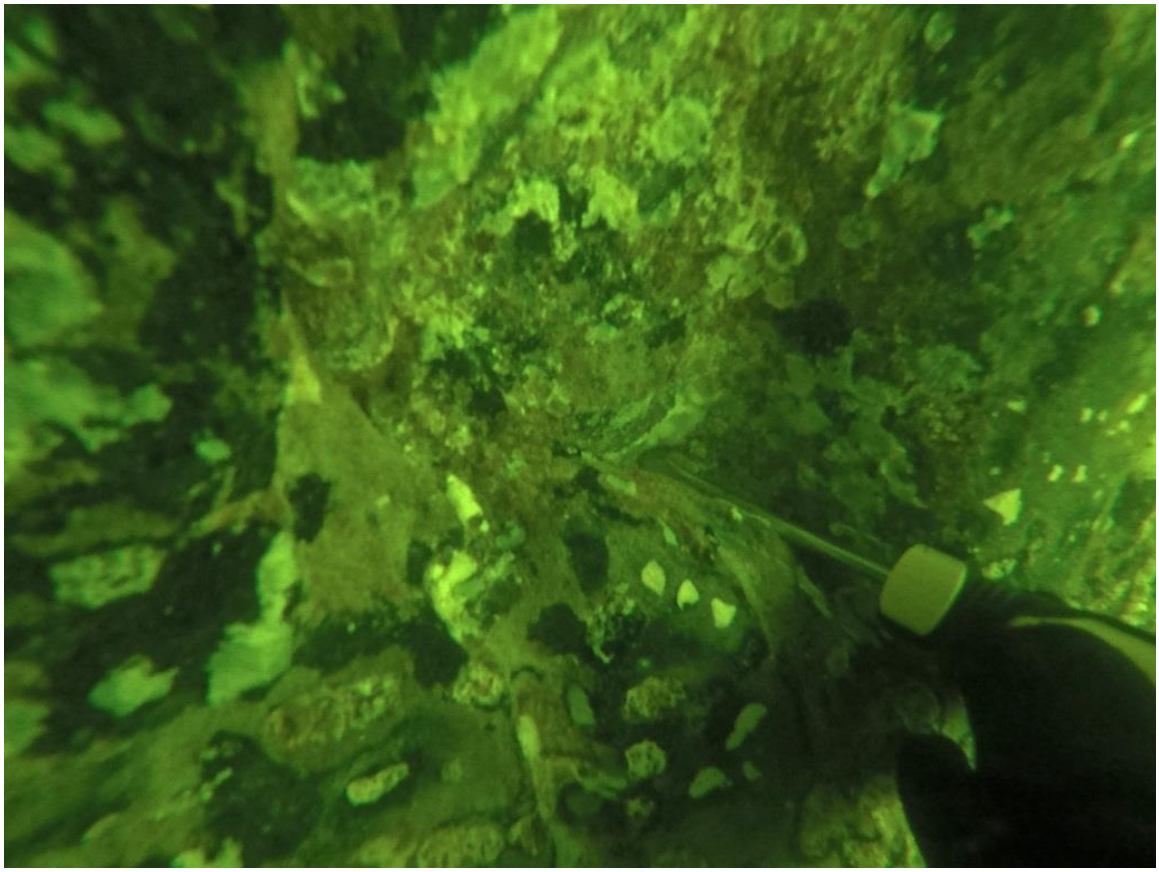
Figure 10.37 Two-to-three inch void in Shaft 95-1 post-barnacle scraping.

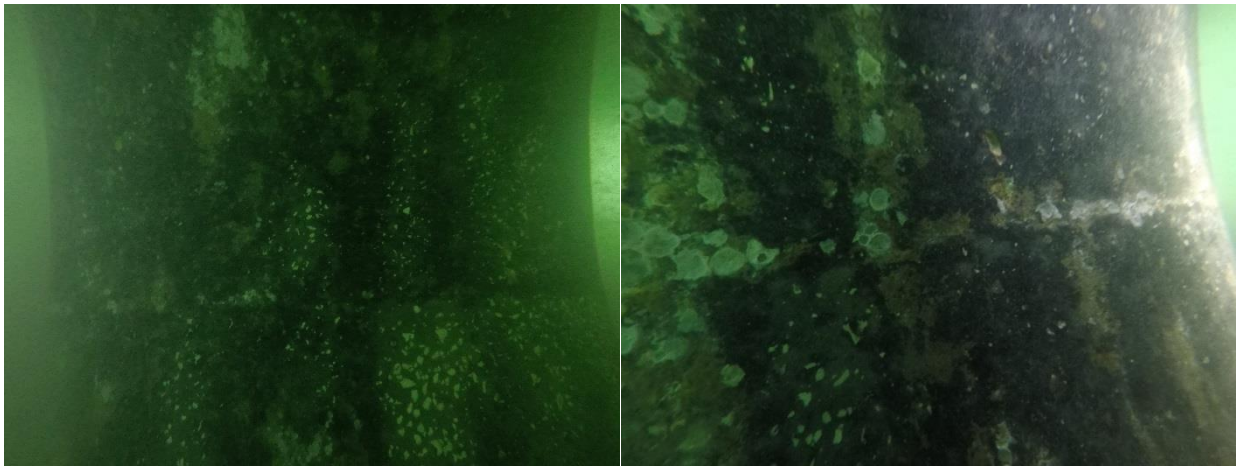
the concrete was smooth (Figure 10.39). Figure 10.39 does demonstrate a crease, however this was noted to be from casing removal as it was a singular occurrence. The north and south sides of the shaft can be seen in Figure 10.38 and 10.39 respectively. It should be noted that while the sides of shafts appear to be concave this is from camera lens distortion.

Figure 10.39 (a) South (interior) side of 95-1 post-cleaning, (b) zoomed in view of (a).

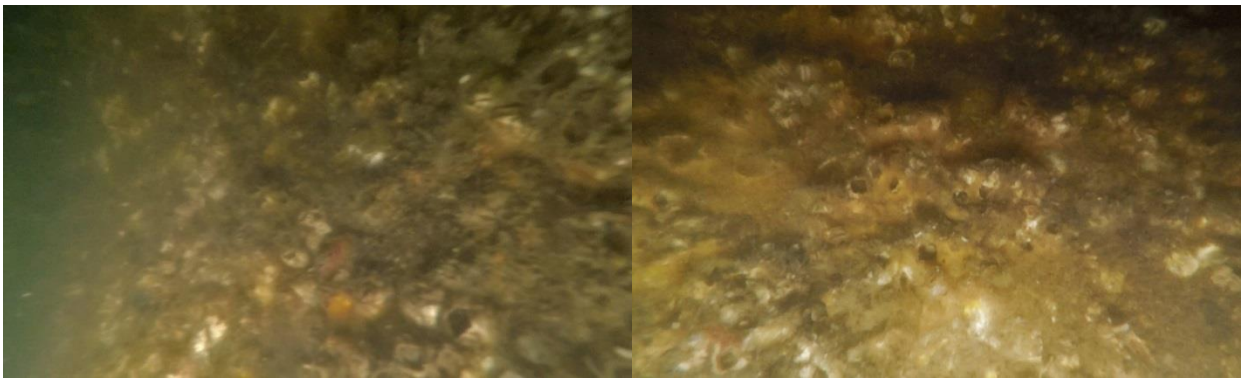
Shaft 95-3 was cleaned for comparison as a shaft with no observed problems. Figure 10.40 shows 95-3 prior to cleaning. Due to the lack of water clarity on the day of inspection it was difficult to take a picture of the entire shaft, so sections are presented instead of an overall image. Figure 10.41 demonstrates a cleaned portion of the shaft. This shaft did not have any noticeable voids like 95-1. As seen from the cleaned portions the concrete surface was smooth.

Figure 10.40 Shaft 95-3 pre-cleaning.

Figure 10.41 Shaft 95-3 sections post-cleaning.

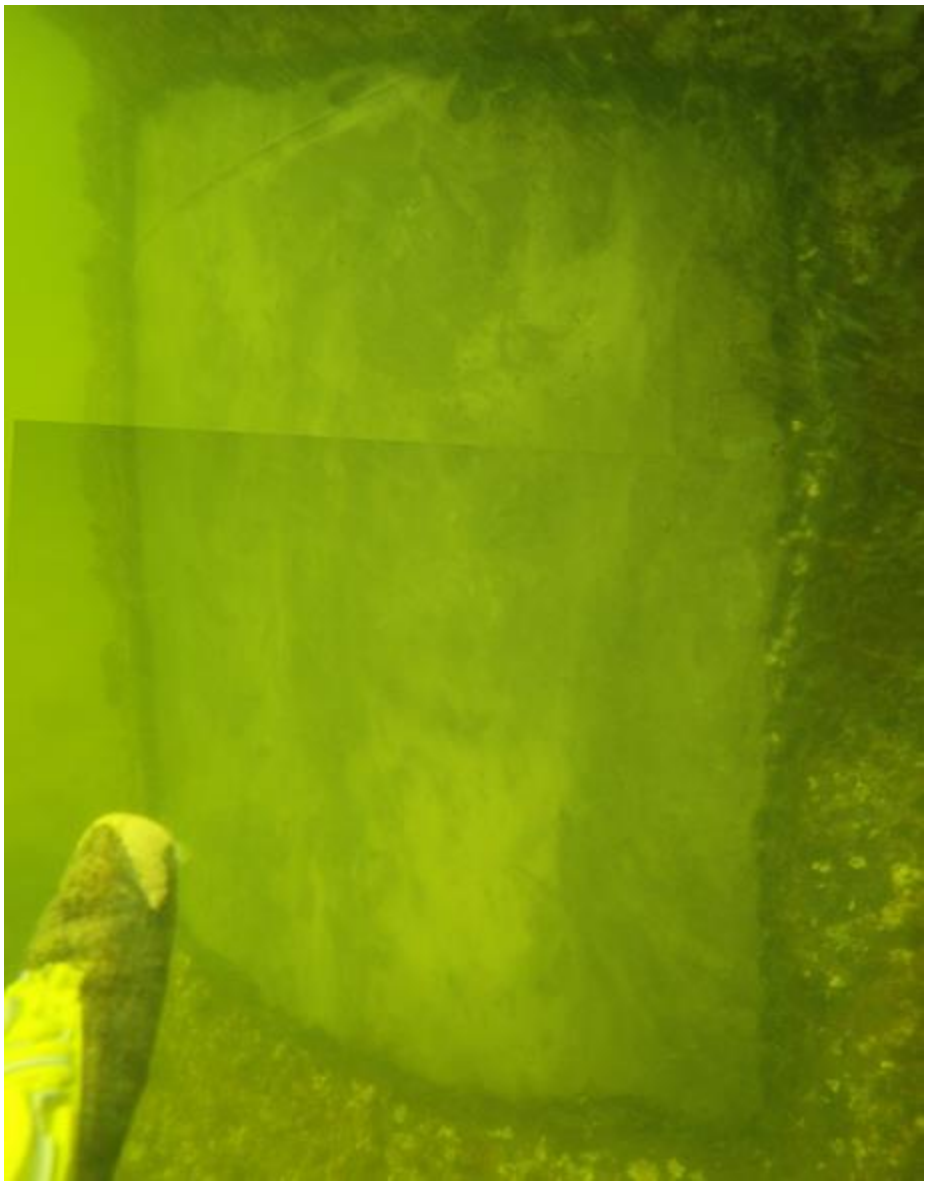
Figure 10.44 Pier 60 SE shaft (60-4).

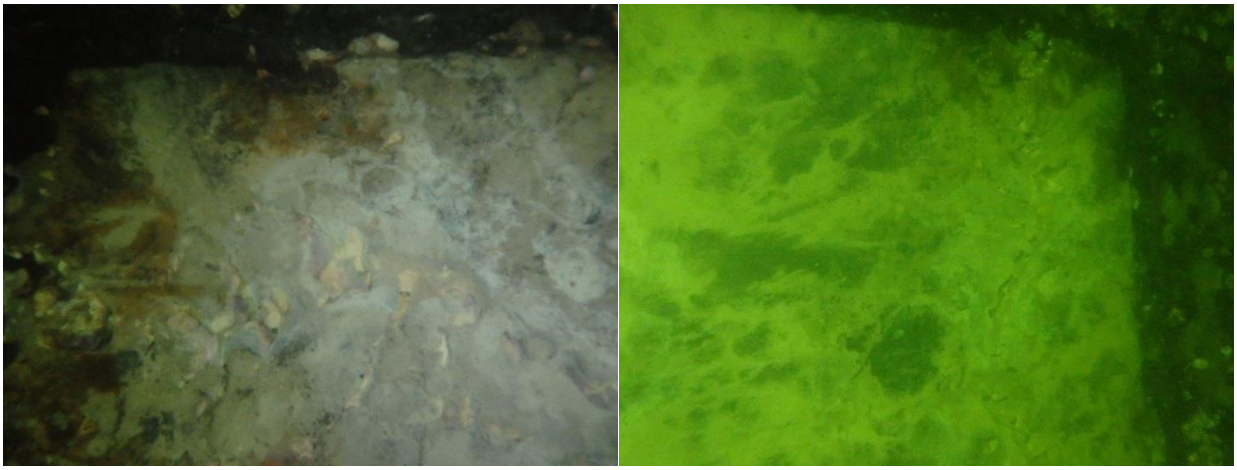
For comparison to the shafts inspected on Pier 71, Pier 70 was selected for casing removal as it also has 7-ft diameter Type 1 shafts (Figure 10.19(d)), however, there was no evidence of previous casing removal. Thus, two casing windows were cut and removed on shafts 70-1 and 70-3. This revealed the fresh concrete surface, in comparison to one covered by sea life. A map similar to that shown for Pier 60 can be viewed in Figure 10.45. Note while shaft 70-1 (Figure 10.46) displayed smooth concrete, shaft 70-3 showed a rough surface with light creasing and visible aggregate (Figure 10.47).

Figure 10.47 Shaft 70-3.

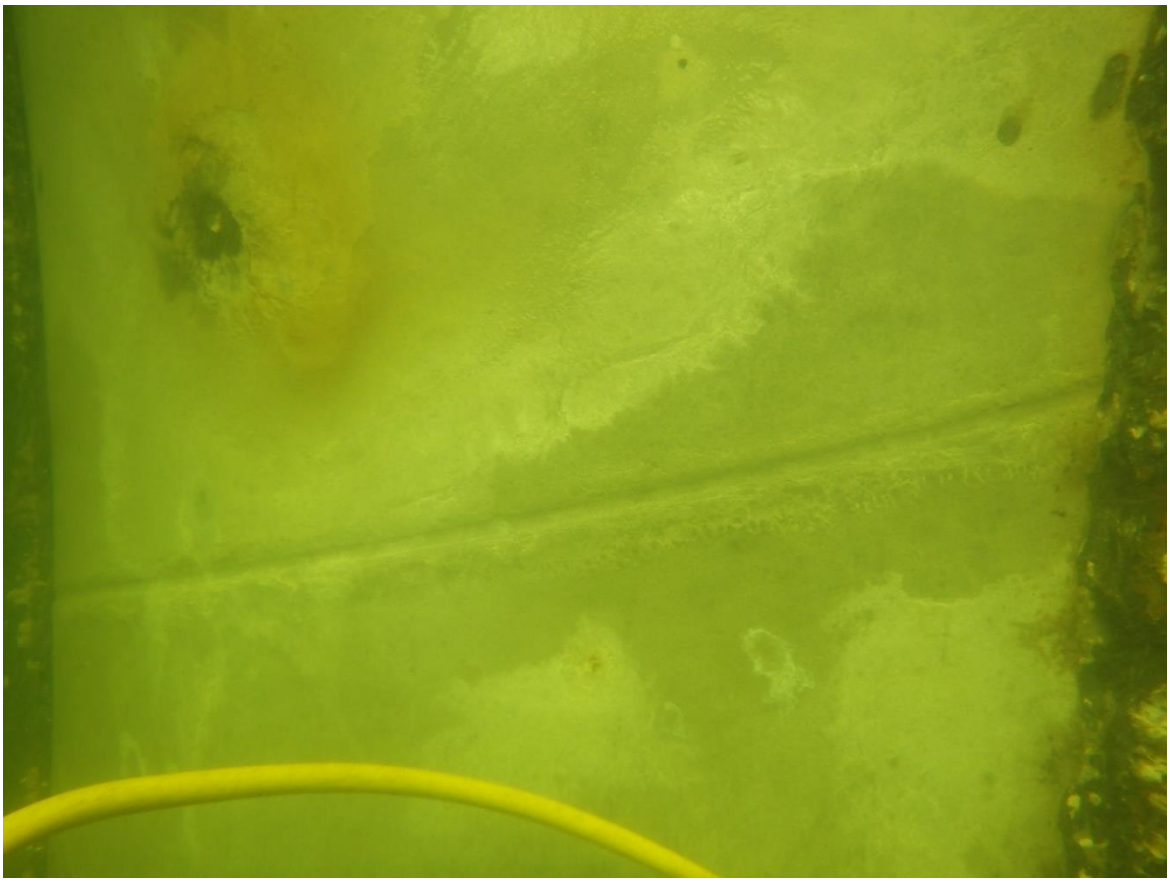
Pier 91 was chosen to have two windows of steel casing removed to inspect the fresh concrete surface as there were no notes of previous casing removal. Pier 91 has shafts 4 ft in diameter with a Type 1 reinforcement cage (Figure 10.19b). This can be compared with the cleanings and observations noted at Piers 94 and 95. Figure 10.48 displays the shaft formation as well as which shafts had casing removed and their surface condition upon removal. The legend is displayed at the base of Figure 10.48. The blue shading indicates both shafts exhibited ideal, smooth concrete surfaces. Figure 10.49 is an indicator of this as it shows a photograph of Shaft 91-2.

Figure 10.49 Shaft 91-2 (SW) immediately after casing window removal.

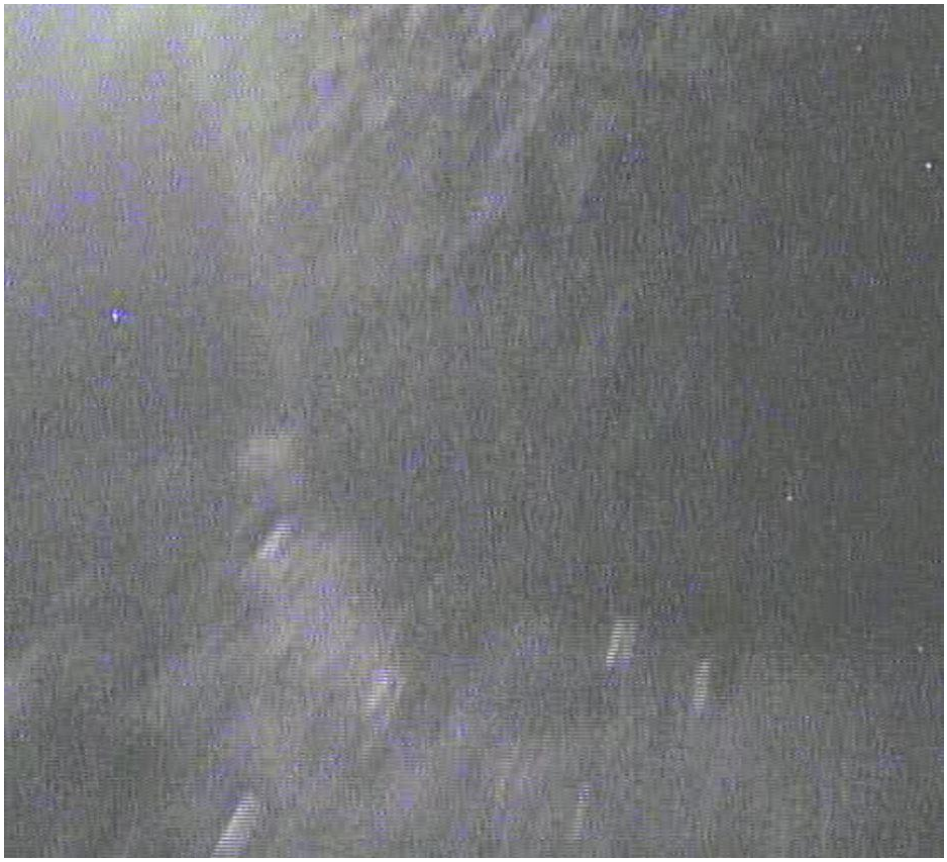
Figure 10.55 One of the columns at the mudline, no exposed shaft available for inspection.

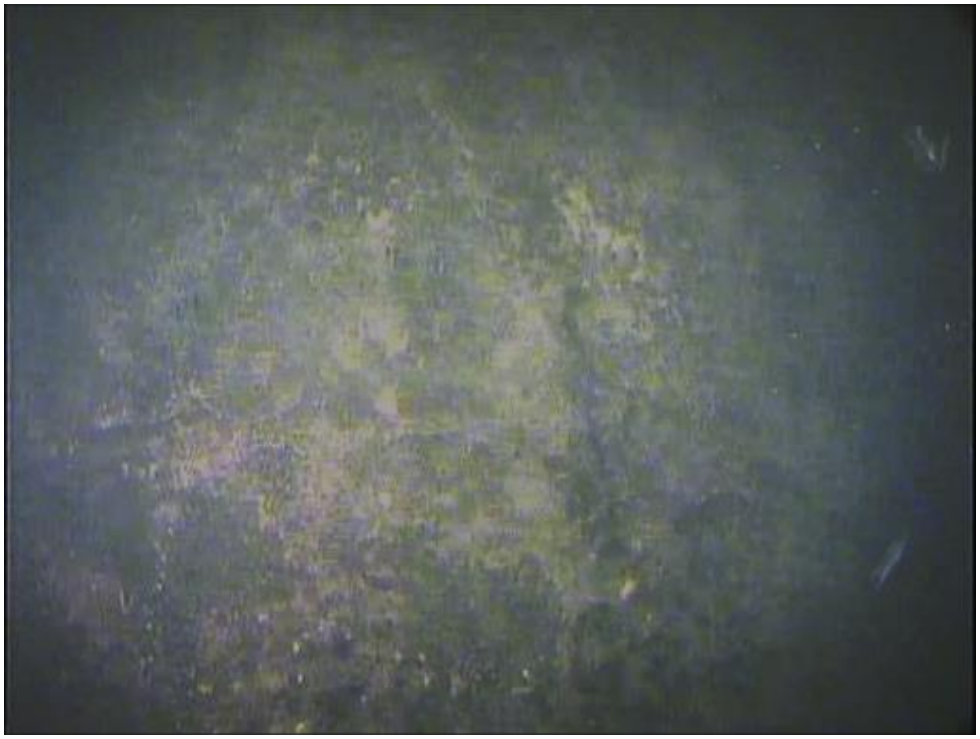
Figure 10.62 Shaft 58-1 prior to cleaning

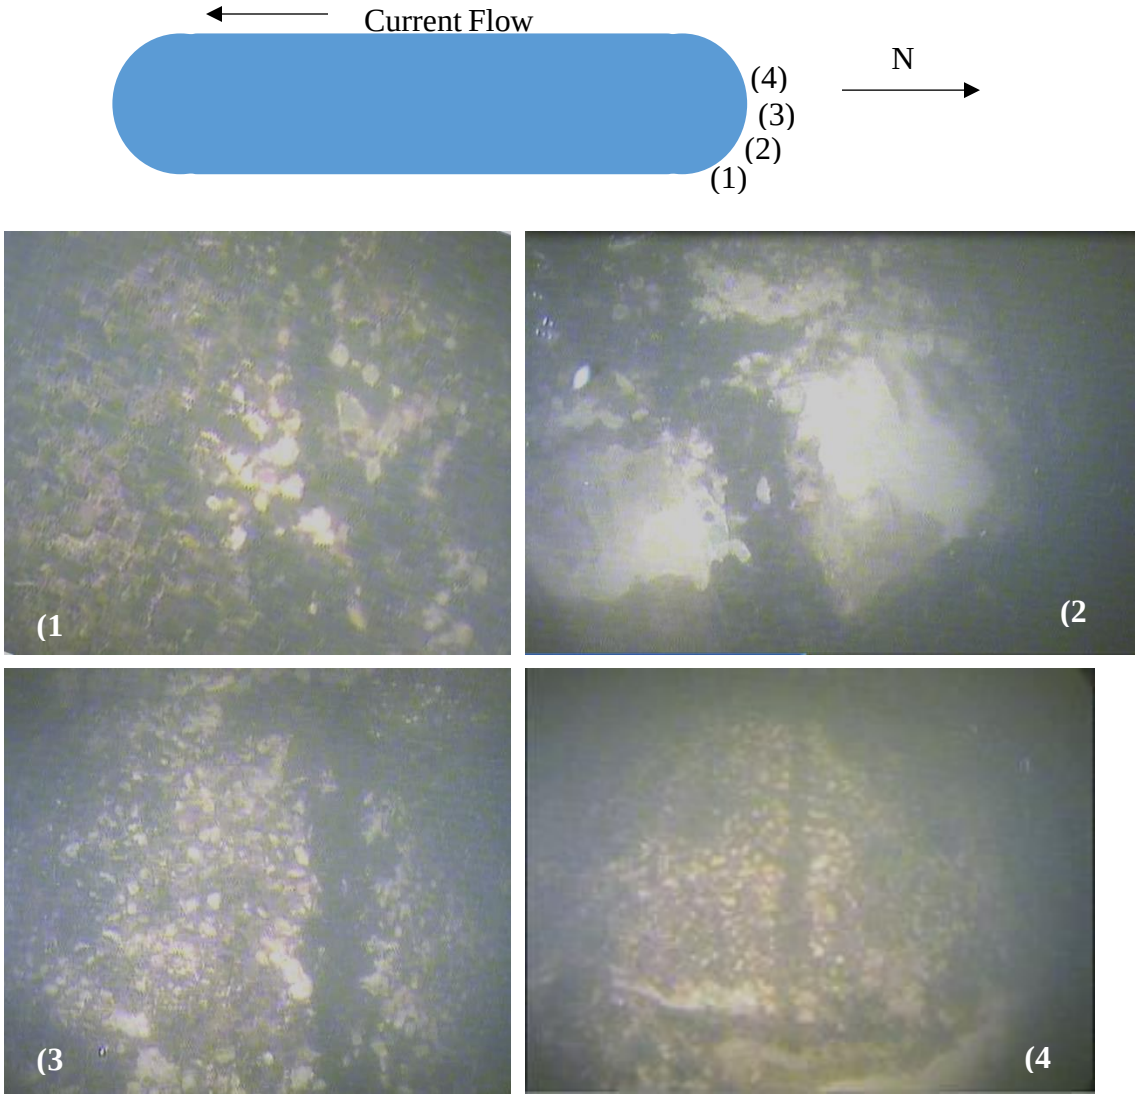
Figure 10.63, vertical or horizontal creases were found; image (2) shows both vertical and horizontal creases (camera slightly tilted) along with a white patching compound in the center of the squares that was not concrete.

Figure 10.63 Images demonstrating quilting on Shaft 58-1. Images 1-4 correlate to positions 1-4 noted at the top of the figure.

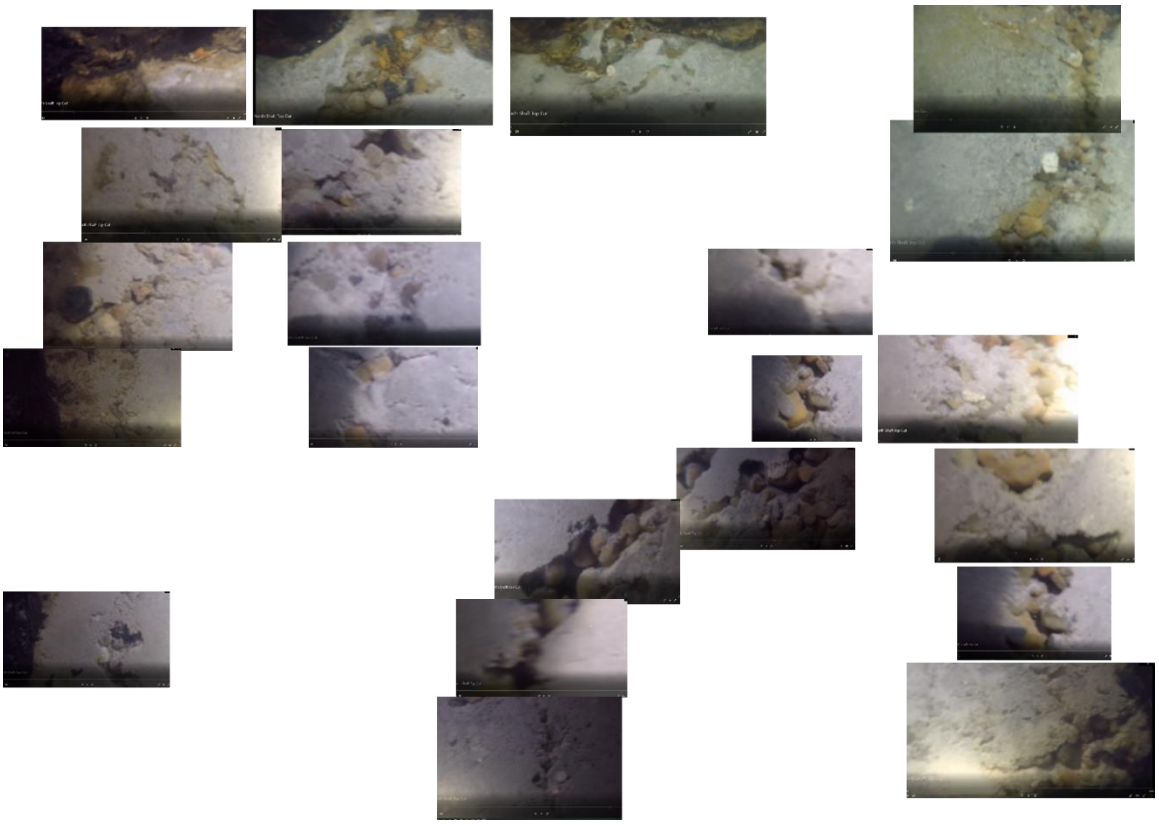
Figure 10.69 Shaft 58-1 stitched together images showing defects in upper portion of the shaft.

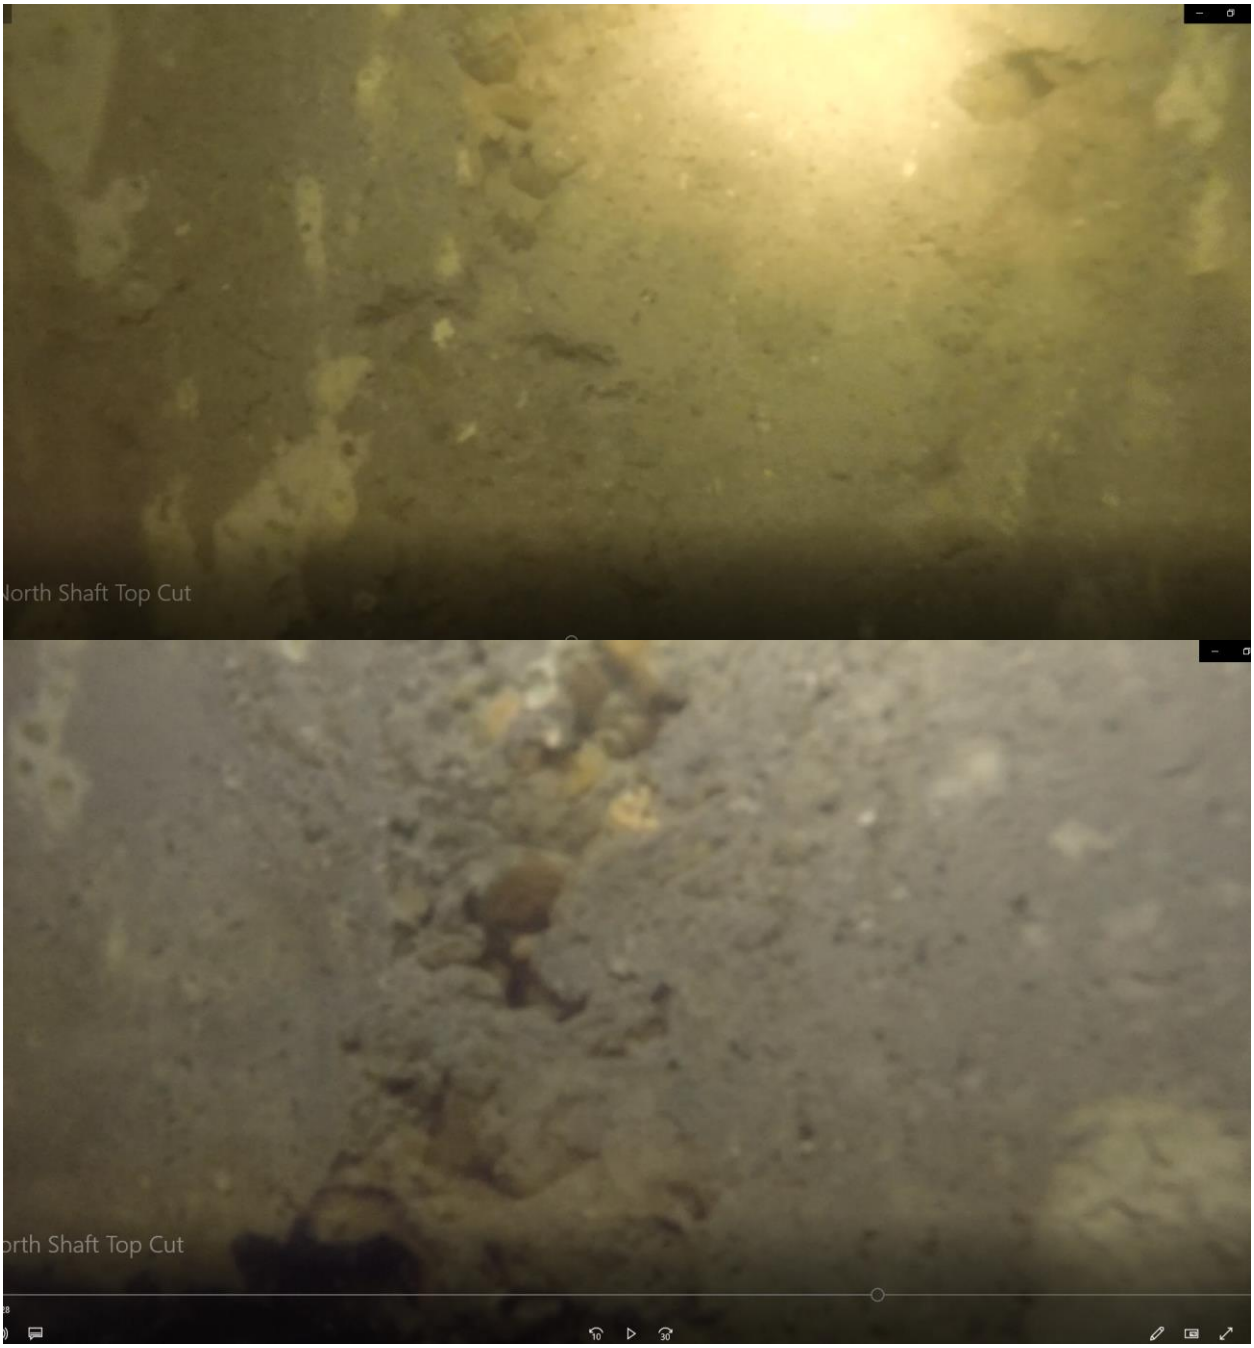
Figure 10.73 Shaft 59-1 with the casing removed from the upper portion of the shaft.

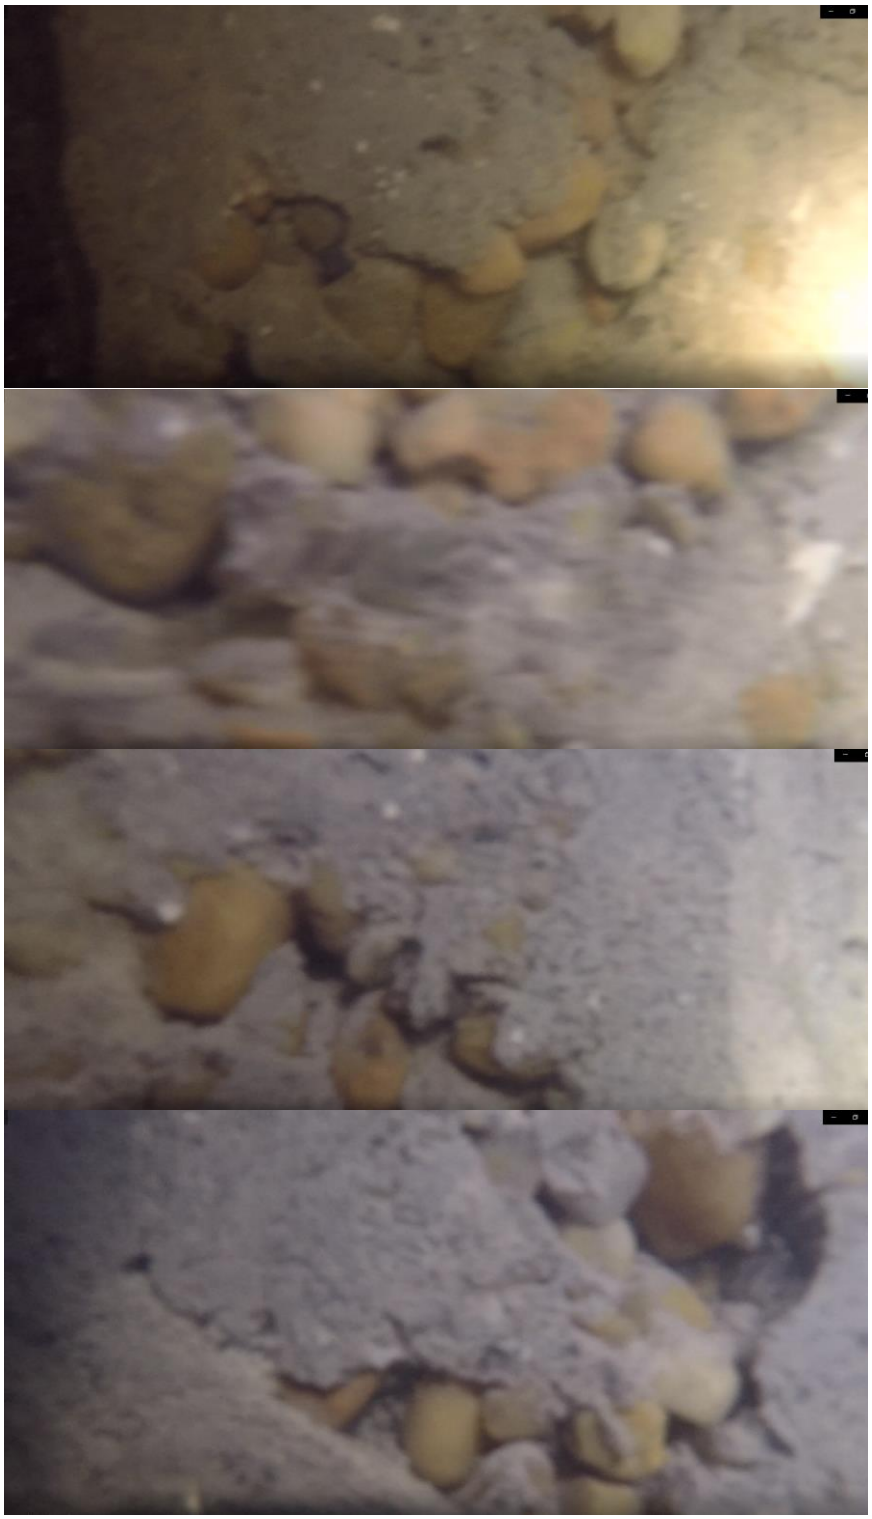
Figure 10.75 Shaft 59-2 with the casing removed from the upper portion of the shaft.

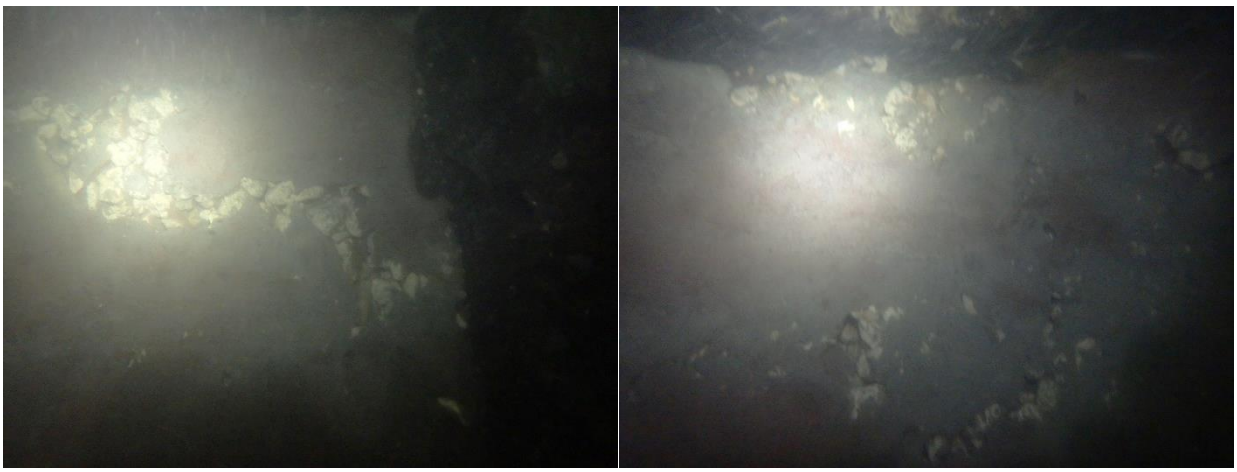
Pier 18 also had a window of casing removed per shaft. Only the SE shaft displayed poor concrete quality, while the other three shafts were noted to have clean concrete surfaces. A summary of this and the corresponding visual inspection notes is seen in Figure 10.87. Figure 10.88 displays photographs taken of the SE shaft.

Figure 10.88 Pier 18 SE shaft concrete quality.
