EVALUATION OF SELF CONSOLIDATING CONCRETE AND CLASS IV CONCRETE FLOW IN DRILLED SHAFTS

BDV25-977-25

FINAL REPORT

January 2020

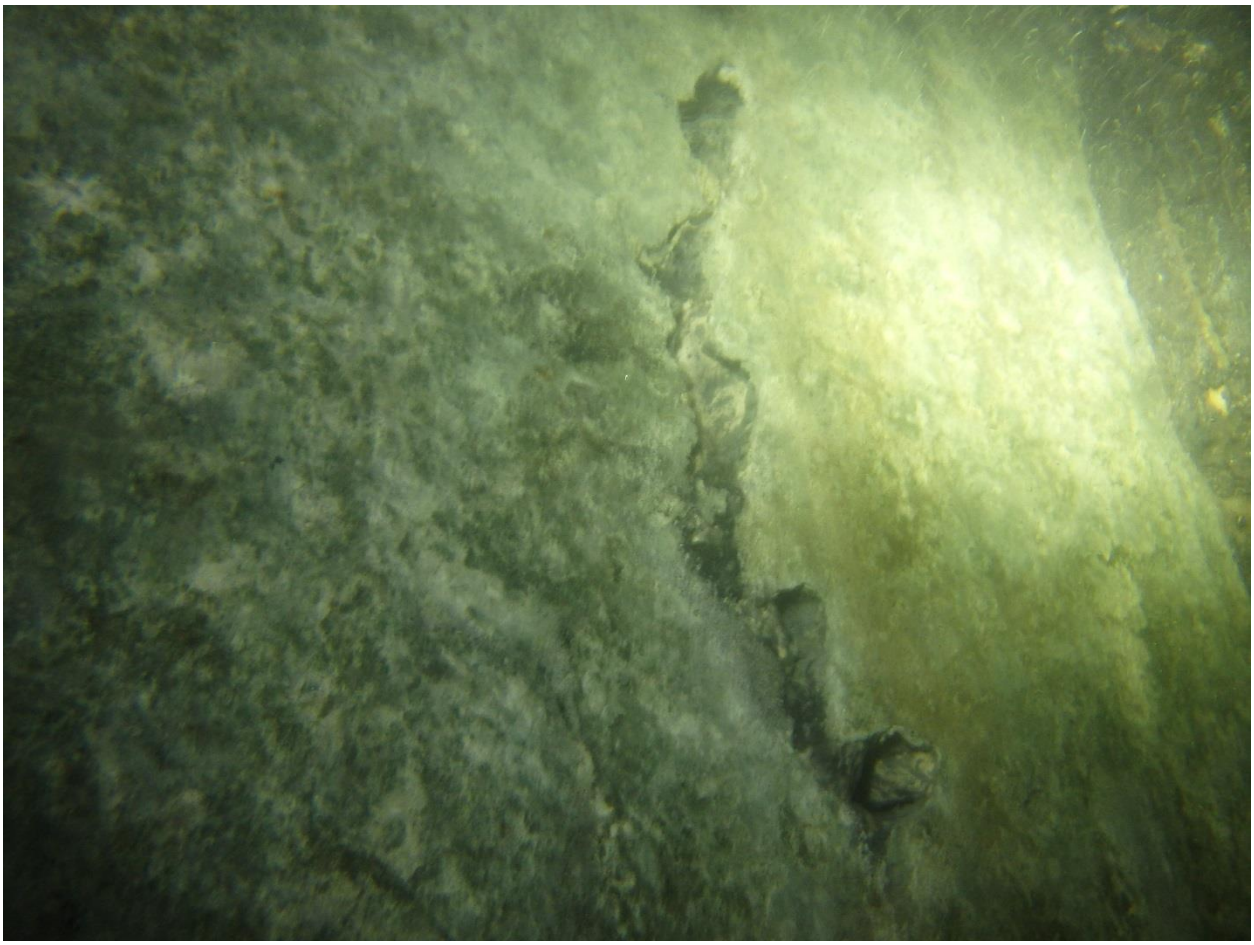
On Pier 19, only the NW, NE, and SE shafts had a window of casing removed. While the NW shaft showed smooth concrete, the NE and SE shafts showed poor concrete surface quality. A summary of this and the corresponding visual inspection notes is seen in Figure 10.89. Figures 10.90 and 10.91 display photographs taken of the NE and SE shafts, respectively.

Figure 10.91 Pier 19 SE shaft concrete quality.

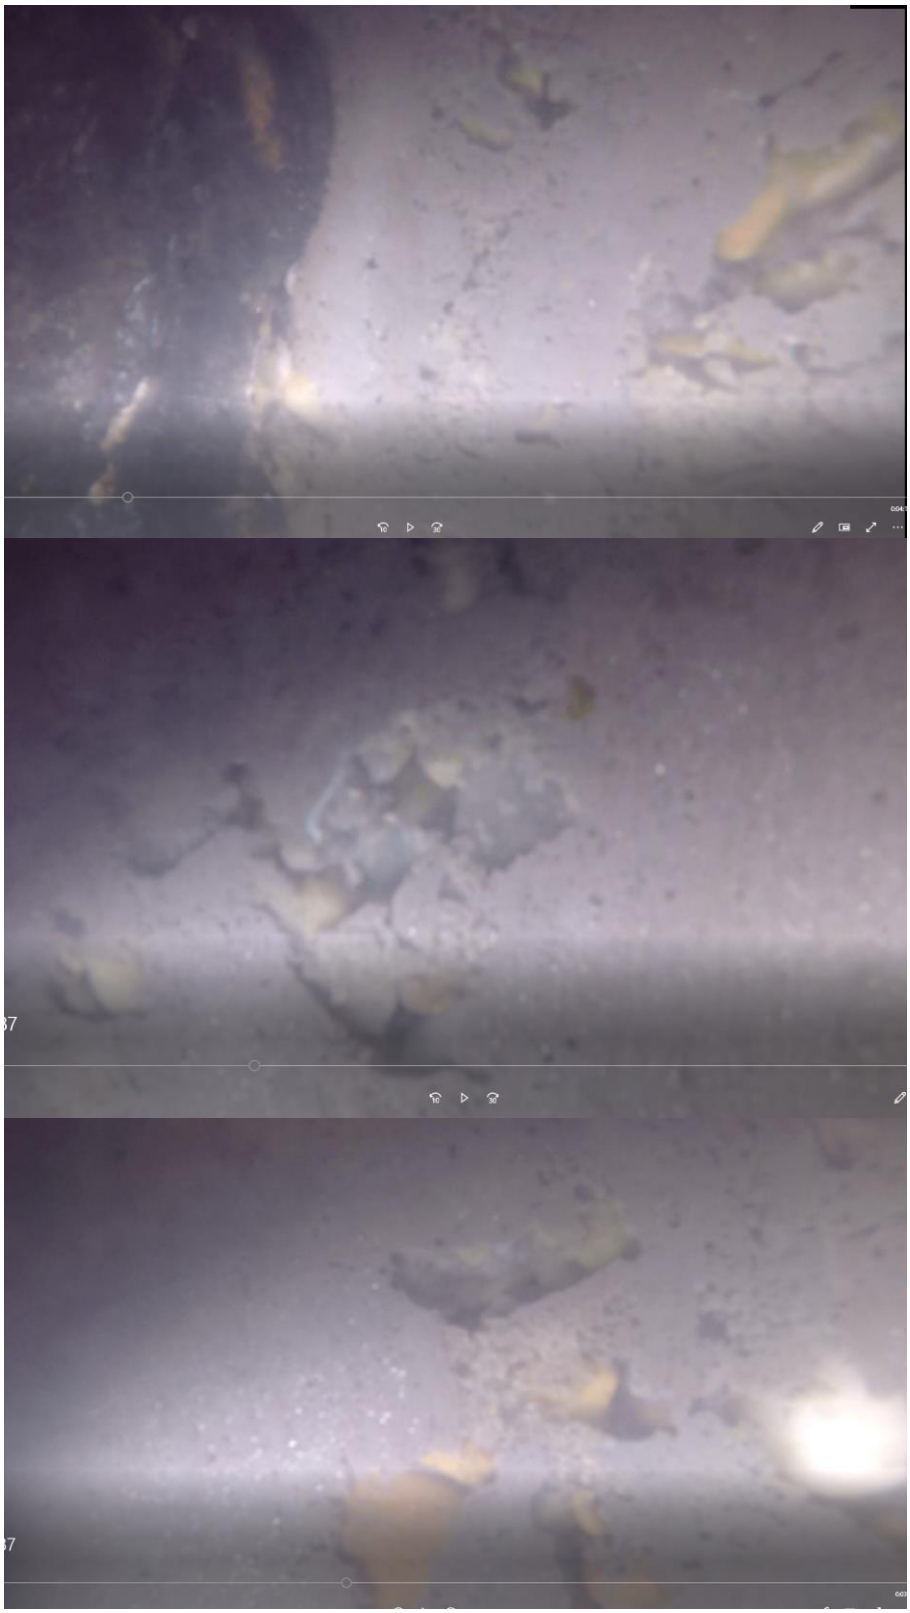
Table 10.19 displays the locations of casing removal along with the initial concrete quality observed. Only one shaft (13-2) displayed clean concrete; however, on the opposing side, mattressing was seen, suggesting the possibility of poor construction. On the creased side of 13-2, the crease was noted to start above water and continue the entire length of the shaft. Figures 10.98 to 10.103 display images from the casing removal inspections of Piers 13, 14, and 15, for shafts 13-1, 13-2, 14-1, 14-2, 15-1, and 15-2, top and bottom, respectively.

Figure 10.99 Shaft 13-2 lower casing removed.

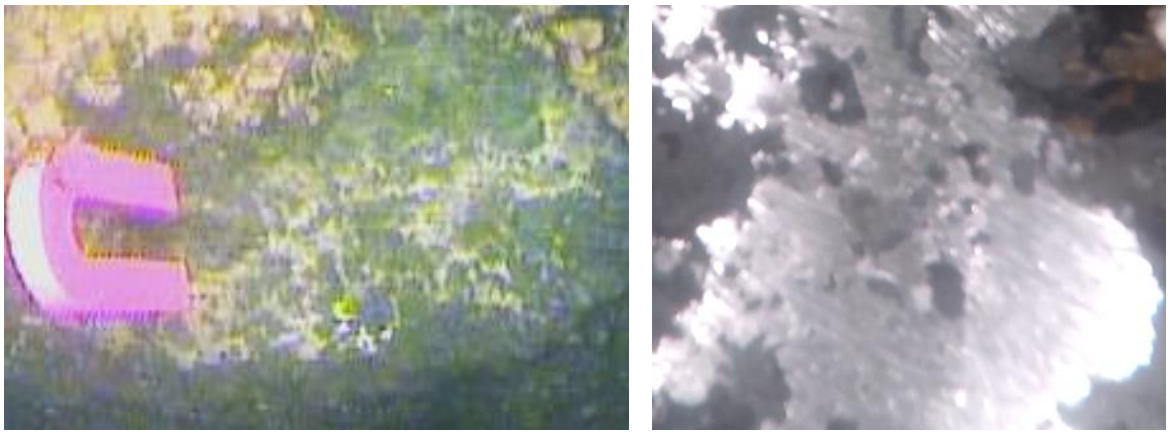
A surprising discovery from diving both fresh and salt water bridges was that pitting in the steel casing was much worse in fresh water (Figure 10.104) when compared to salt water. The bridges compared, Gandy and Blountstown, were almost the same age, built in 1996 and 1998, respectively. Figure 10.104 shows pronounced pitting corrosion at Blountstown and very little visible pitting in the Gandy casings. When preparing the surface of the Gandy shafts, a thin, black, presumably organic layer was found that was difficult to remove (Figure 10.104 and 10.105). This layer was hypothesized to be a layer of anaerobic decay from the barnacles and sea-growth, which would be an oxygen barrier and may slow or prevent corrosion. Discussions with the USF Department of Integrative Biology confirmed similar observations of a black layer under oyster and barnacle growth. Some consideration will be given to promoting encrusted surfaces that would be beneficial to both concrete and steel surfaces under these conditions. While the Bridge of Lions casing was heavily encrusted, no data or observations were collected which could have provided insight into the effect of east coast marine conditions on corrosion.

Figure 10.104. Pitting corrosion in freshwater (left); very little pitting in marine environment (right).

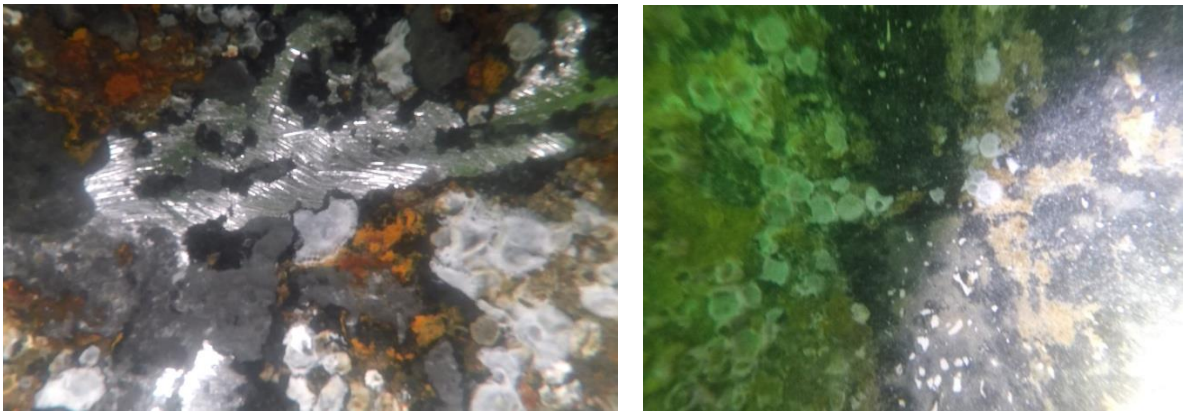
Figure 10.105 Black organic layer beneath barnacle growth: on steel casing (left), on concrete (right).

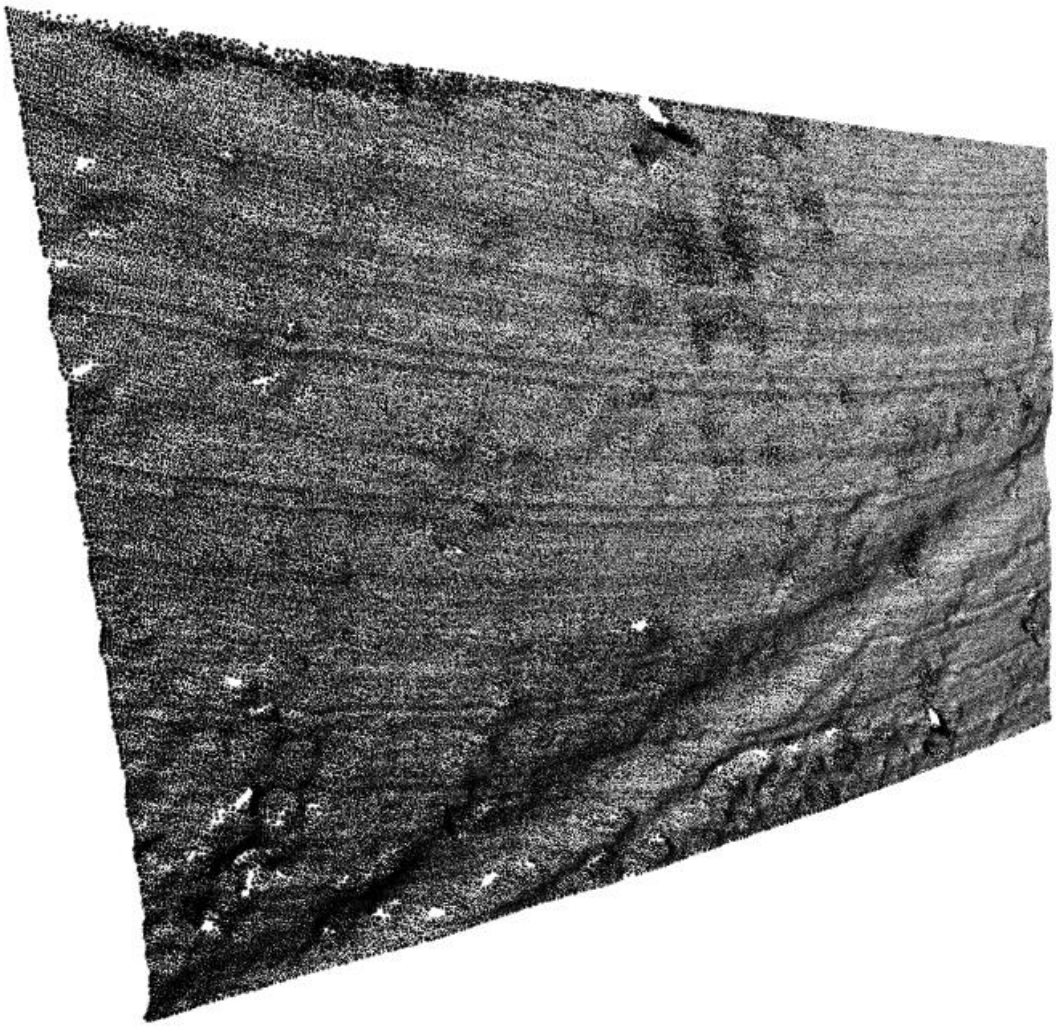
Figure 11.11 Raw Imported Point Cloud Data

The imported point cloud resembles the shaft surface being scanned, as seen in Figure 11.11. The crease that strikes across the surface is a welding crease from the previously removed steel casing.

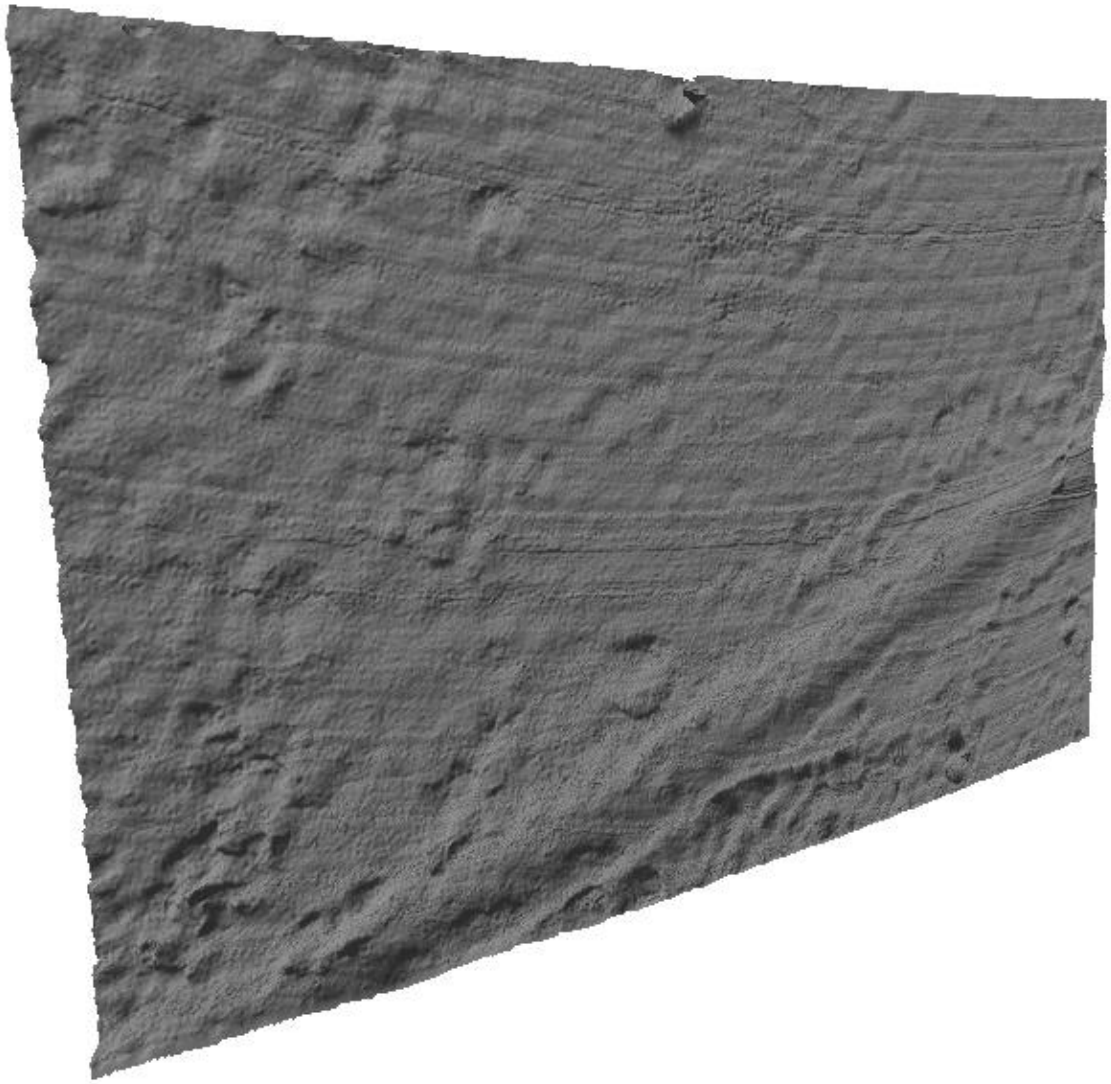
Figure 11.15 Completed Surface Model

Figure 11.15 shows the completed surface model generated in MeshLab. The shaft surface was relatively smooth with a large welding crease seen diagonally across the surface. This method of validating scanning settings and checking scan quality has proven quick and effective in the field.

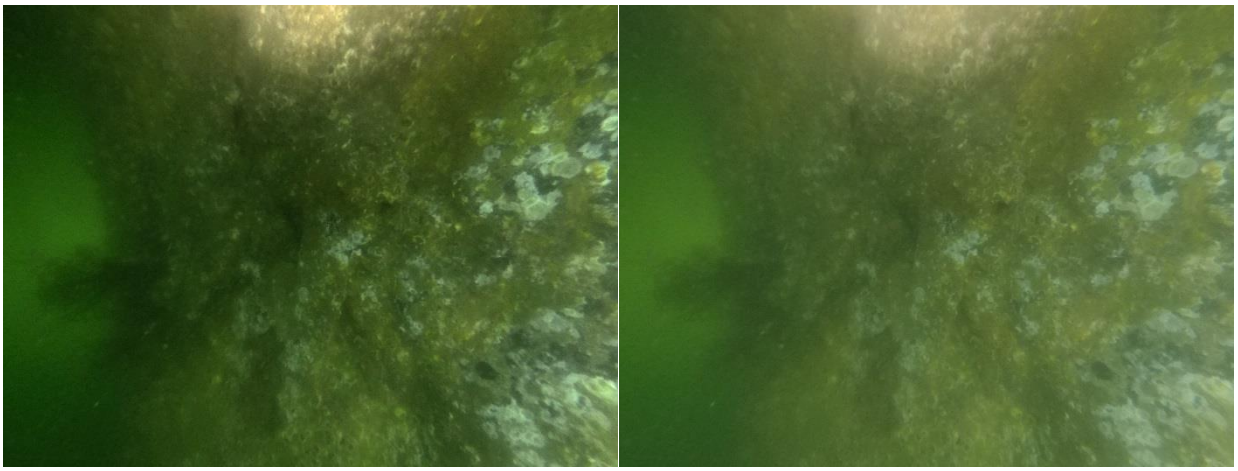
Figure M.1. Figure 10.20, photoshopped (left) and original (right)

Figure 10.20 Shaft 71-4 post-cleaning.

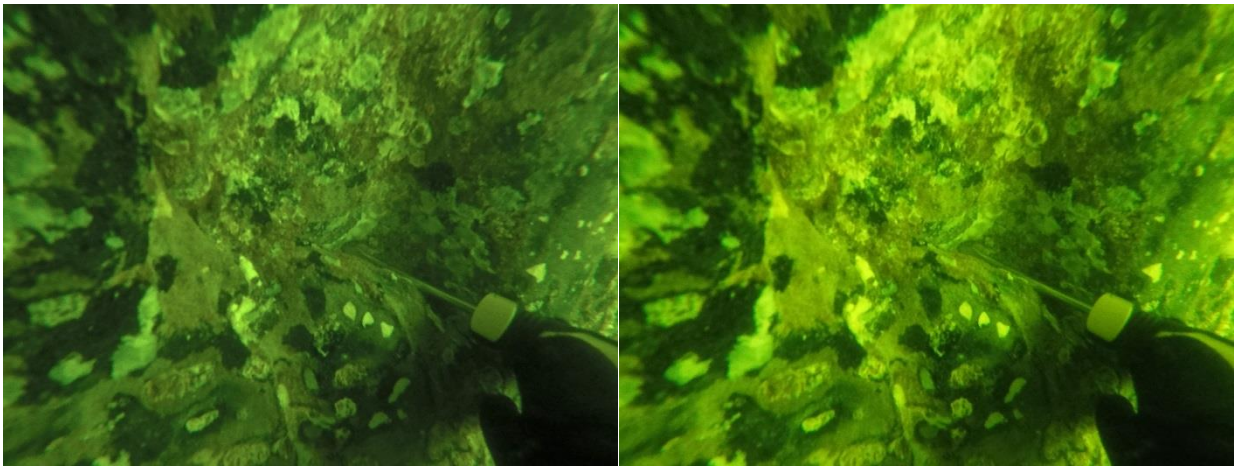
Figure M.2. Figure 10.22, photoshopped (left) and original (right)

Figure 10.22 Cleaned concrete on 71-4, close-up pictures.

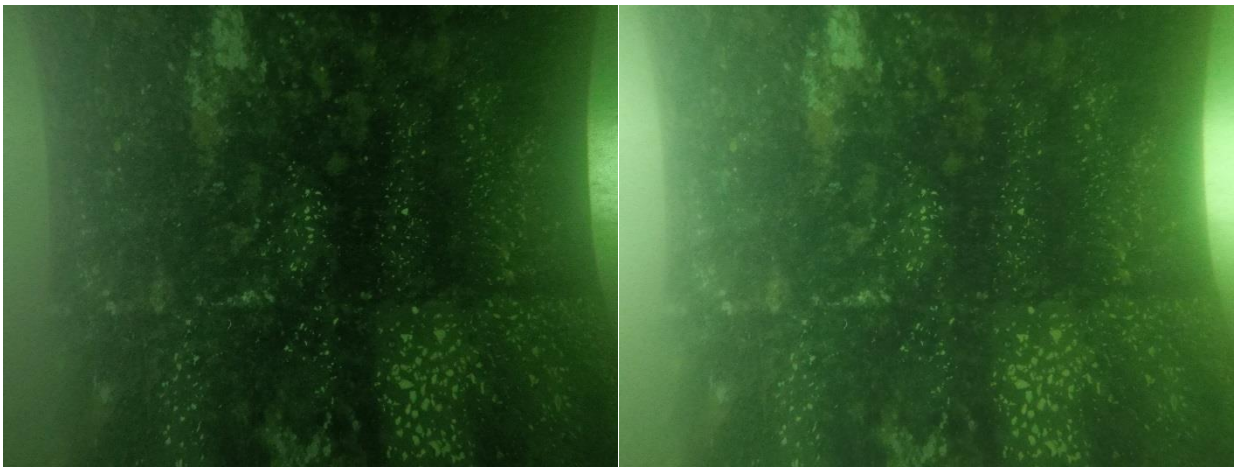
Figure M.5. Figure 10.24(a), photoshopped (left) and original (right)

Pier 84 was noted to have voids on all four shafts and contains 6-ft diameter Type 1 reinforced shafts (Figure 10.19(c)). Shaft 84-4 was chosen for cleaning and inspection as it was listed as having two voids. Figure 10.24 shows 84-4 with a thick layer of barnacles prior to cleaning. This

Figure 10.24 Shaft 84-4 prior to cleaning.

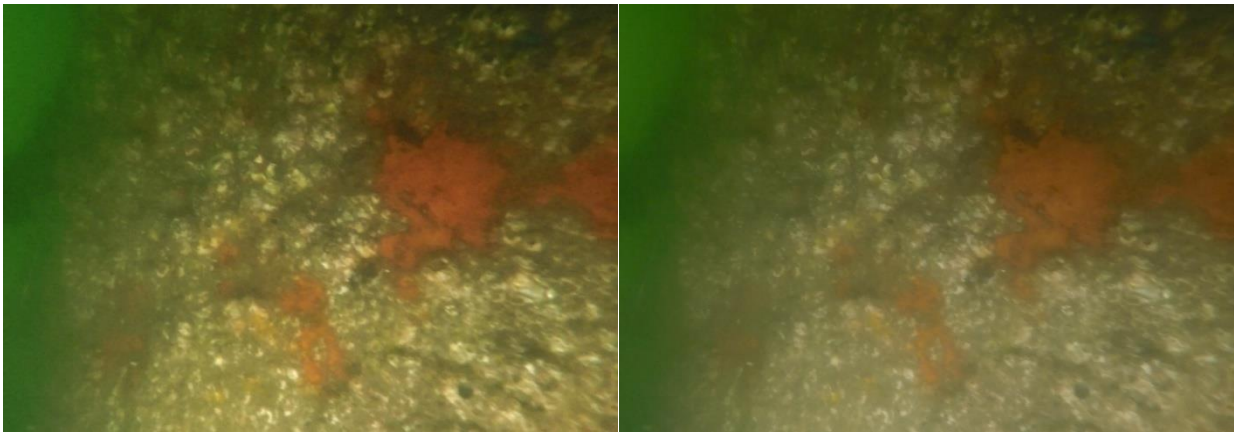
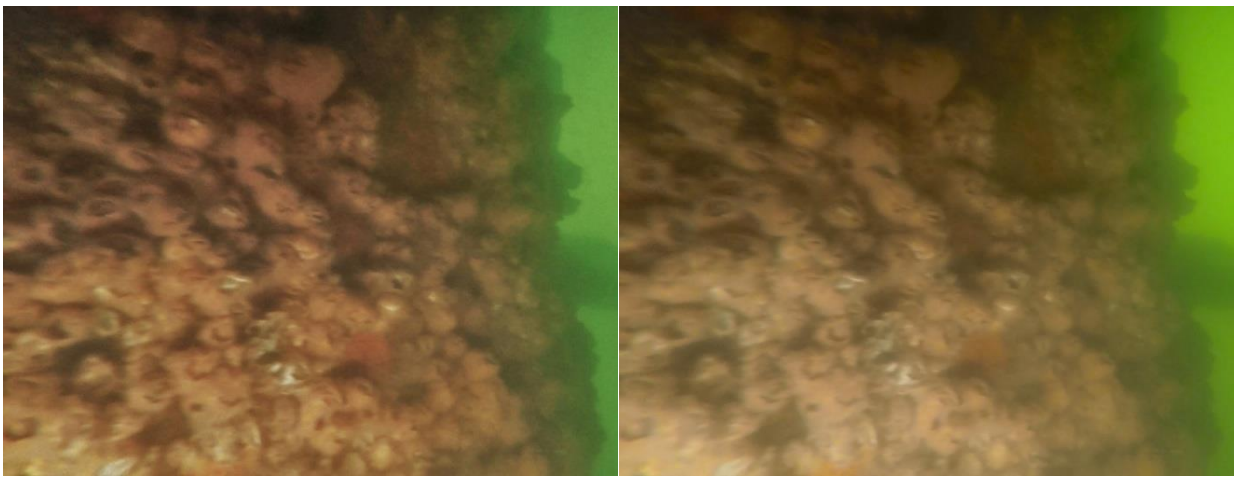
Figure M.6. Figure 10.27 (left image), photoshopped (left) and original (right)

layer is better viewed in Figure 10.25 where the cleaned concrete transitions into the barnacle layer. Figures 10.26 and 10.27 show the cleaned portions of the shaft from east and southeast sides. It can be seen in these figures that the concrete is not completely smooth. The circled red areas on Figure 10.26 represent areas of the cleaned concrete that are filled with barnacles. Therefore the 6-ft Type 1 shafts seem to experience at least small voids in the concrete. This is suspected to have been caused by the double reinforcement cage. Figure 10.28 shows the layers found when cleaning the concrete. Consistently throughout the examination of the Gandy shafts, encrustations were found consisting of barnacles and miscellaneous plant life/organisms. Upon initial cleaning, barnacles were knocked/scraped off and the remnants of the barnacle attachment were then removed. Below this layer, a thin black layer was encountered which was difficult to remove. In cases of smooth surfaces with no significant voiding, pristine concrete could clearly be seen. Rougher surfaces with voids retained the plant life, barnacles and black layer. Except for isolated instances, there was no attempt to dig into voids and determine the full depth.

Figure 10.27 Cleaned portion of 84-4, east side of shaft.

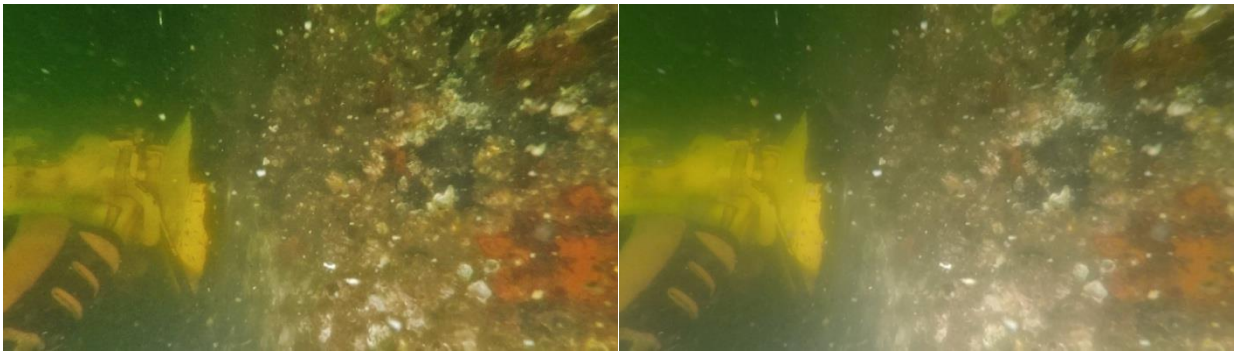
Figure M.8. Figure 10.28, photoshopped (left), original (right)

Figure 10.28 Layers from barnacles to black unknown layer to concrete.

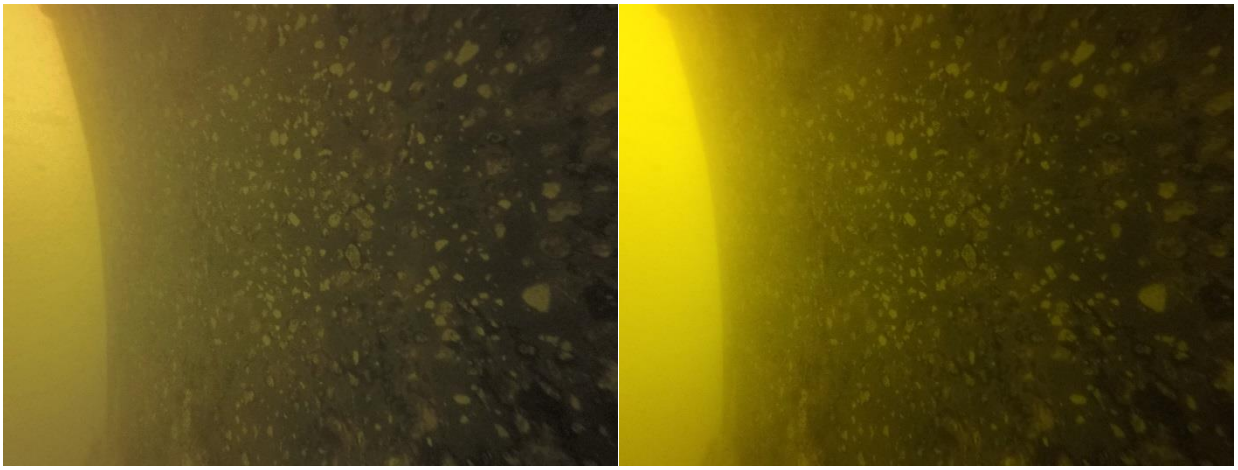
Figure M.9. Figure 10.30 (left image), photoshopped (left) and original (right)

Unfortunately there is no image of 85-2 before cleaning; however, it looked similar to others covered in barnacles (Figure 10.24). While the cleaned section of the shaft overall shows a smooth surface (Figure 10.29), there are small crevices. As seen in Figures 10.30 and 10.31, barnacles and sea-life fill in these voids. As noted above, the small voids/crevices are believed to have been caused by the double reinforcement cage; note this was not observed on the 4-ft diameter, single reinforcement cage shafts inspected at Pier 95.

Figure 10.30 Crevices in 85-2 filled with barnacles.

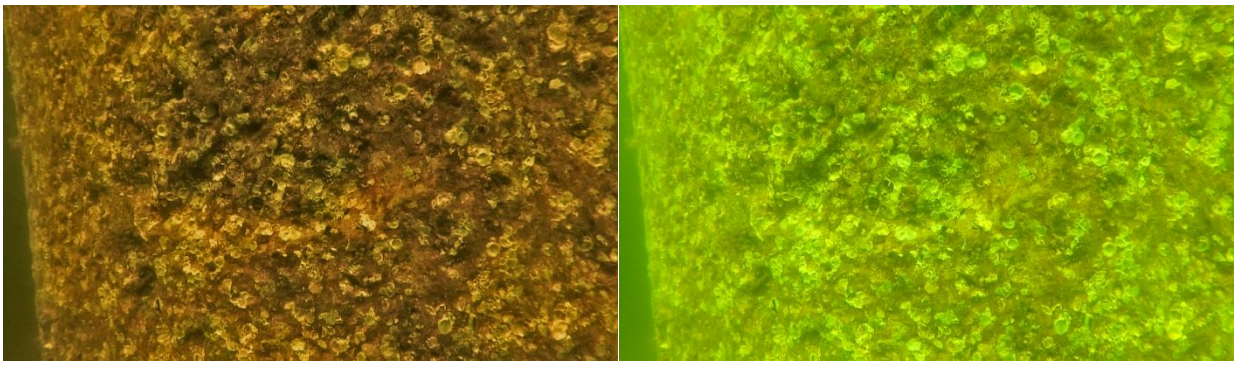
Figure M.15. Figure 10.33, photoshopped (left) and original (right)

Figure 10.33 Shaft 94-4 during cleaning with the grinder.

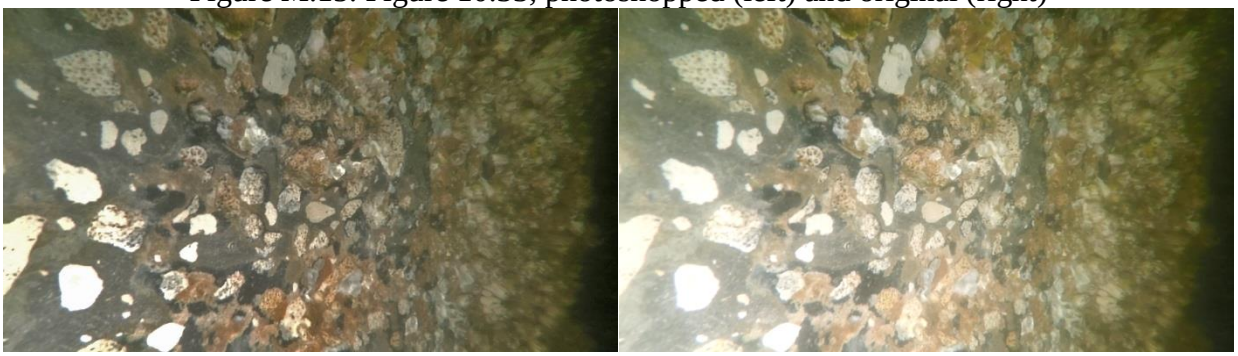
Figure M.16. Figure 10.34, photoshopped (left) and original (right)

Pier 94 was not mentioned in the diver report, and therefore it was thought to be a good candidate to have a casing. Upon initial inspection, it can be difficult to tell if the shaft has a casing or not because of the thick layer of barnacles attached to the shaft concrete or its casing. Therefore, shaft 4 from Pier 94 (94-4) was chosen for cleaning to demonstrate what steel casing looks like versus the concrete. Figure 10.32 shows 94-4 prior to cleaning and Figure 10.33 shows 94-4 during cleaning. In Figure 10.34 the steel from the casing is visible. As seen from Figure 10.34, there is a black layer underneath the encrustation and on top of the steel casing.

Figure 10.34 Shaft 94-4 after cleaning showing steel casing.

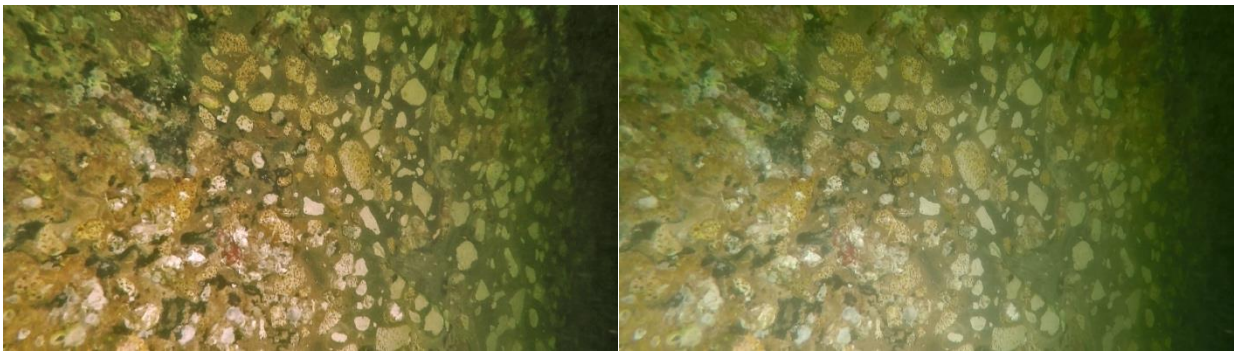
Figure M.18. Figure 10.36, photoshopped (left) and original (right)

Shaft 95-1 did have a void as noted, and it was noticeable even prior to cleaning (Figure 10.35). This void was substantial; Figure 10.36 shows the void before cleaning, which involved scraping barnacles, grinding and/or wire-brushing. A screwdriver was used for reference of void depth, which was about 2-3 in. (Figure 10.37). However, on the south (interior) side of the same shaft,

Figure 10.36 Void on 95-1, this was taken after grinding the shaft and before scraping out the barnacles residing in the voids.

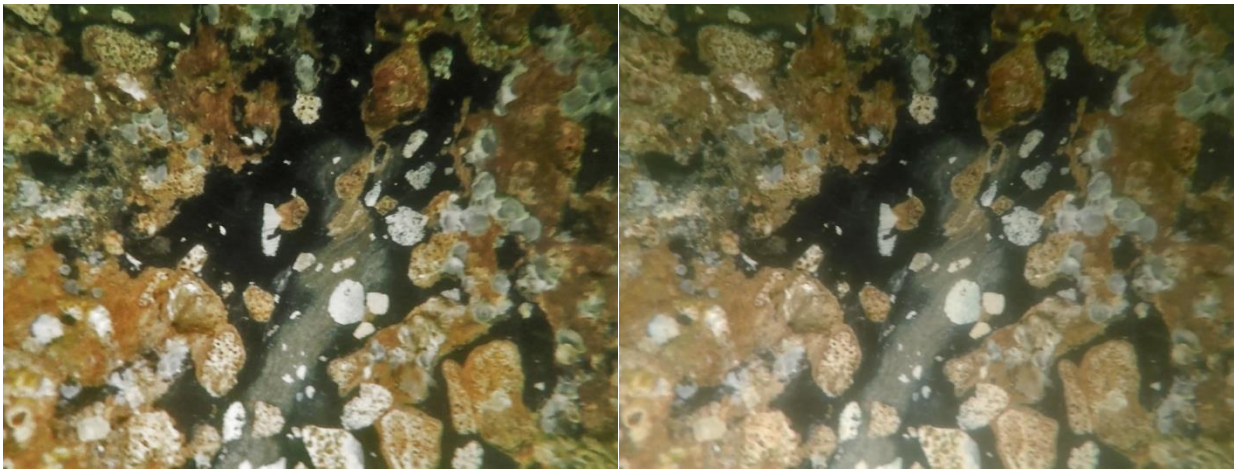
Figure M.19. Figure 10.37, photoshopped (left) and original (right)

Figure 10.37 Two-to-three inch void in Shaft 95-1 post-barnacle scraping.

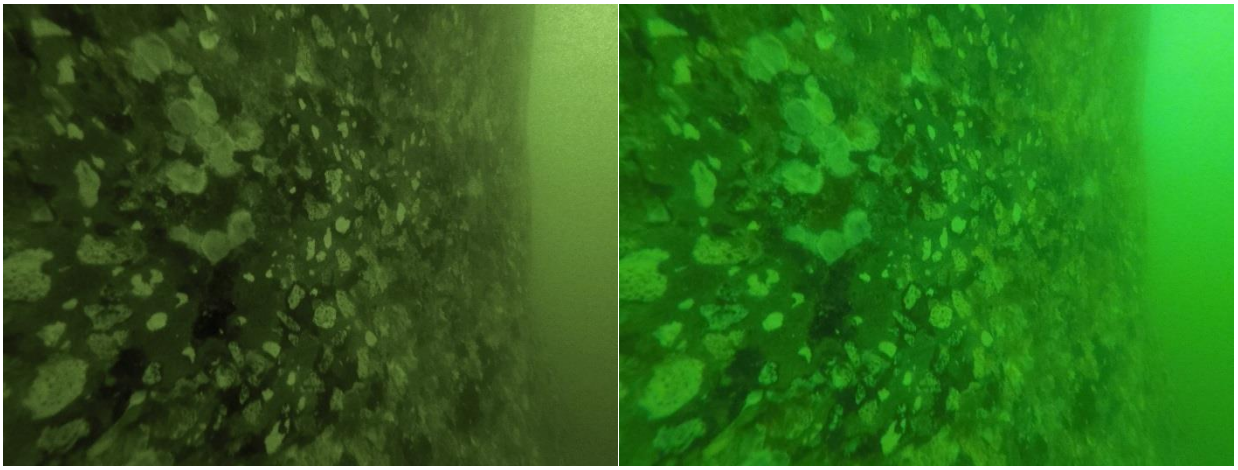
Figure M.20. Figure 10.38 (left image), photoshopped (left) and original (right)

the concrete was smooth (Figure 10.39). Figure 10.39 does demonstrate a crease, however this was noted to be from casing removal as it was a singular occurrence. The north and south sides of the shaft can be seen in Figure 10.38 and 10.39 respectively. It should be noted that while the sides of shafts appear to be concave this is from camera lens distortion.

Figure 10.38 (a) View of the north side of 95-1 post-cleaning, (b) zoomed in view of (a).
