Florida ATMA Pilot Demonstration and Evaluation

Final Report

Prepared by:
University of Florida

March 2021

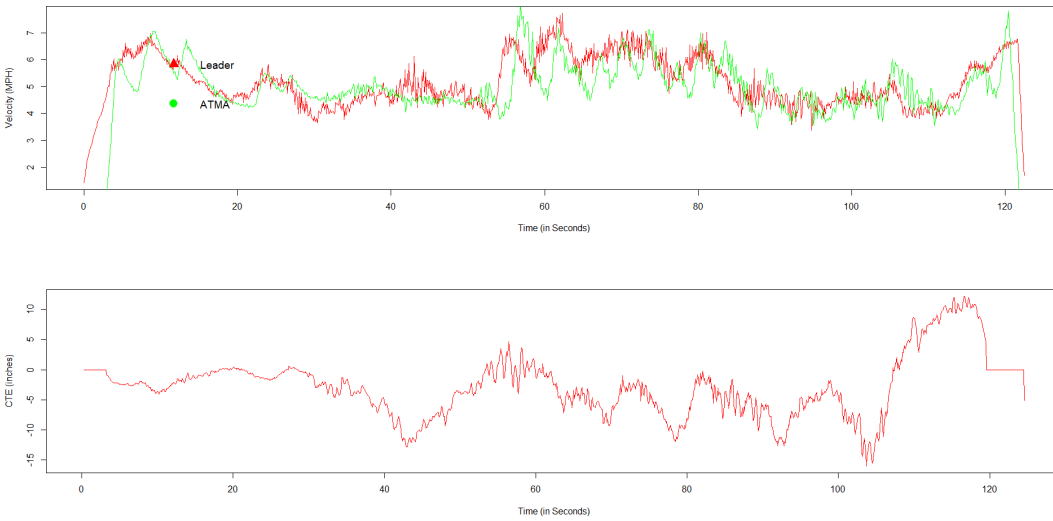
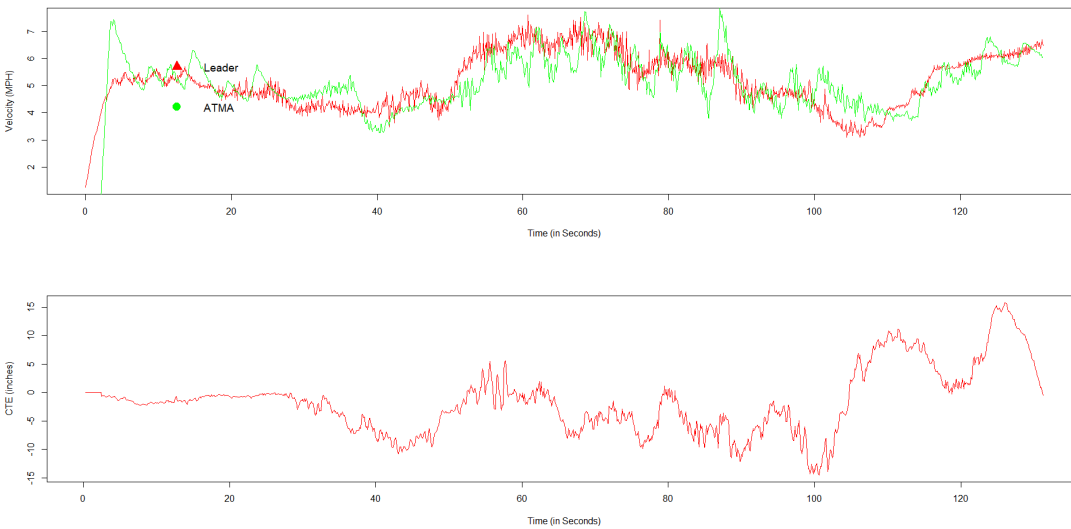
The velocity graphs and CTE distributions are shown below. The ATMA followed the leader closely in maintaining the speed profile. Table 6-32 shows the CTE distribution, which indicates that the ATMA followed the leader's path with a deviation between -15.98 inches to 15.83 inches which is greater than the 6-inch threshold.

Figure 6-76. Test Case 12, Run 1 at 5 mph: follower truck velocity (top); cross track error (CTE) (bottom)

Figure 6-77. Test Case 12, Run 2 at 5 mph: follower truck velocity (top); cross track error (CTE) (bottom)

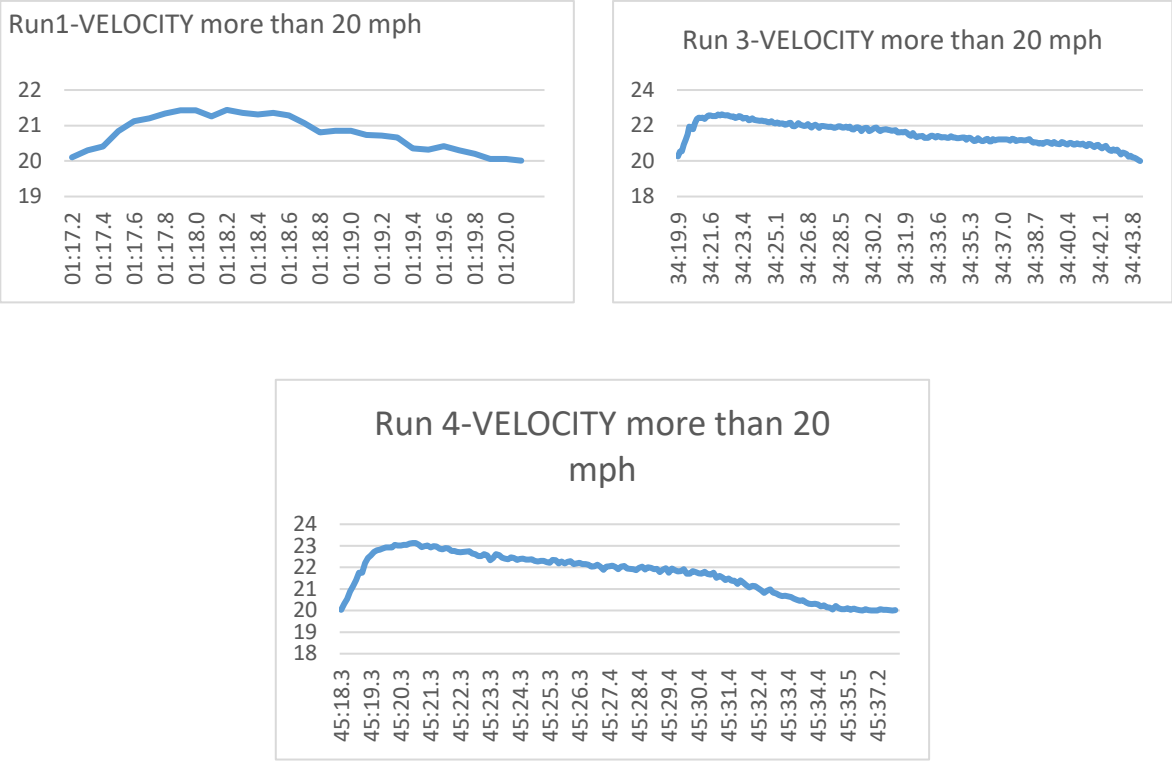
Figure 6-98. Velocity distribution showing Runs 1, 3, and 4 exceeding 20 mph in order to catch up to the leader vehicle. (Note: Run 2 did not exceed 20 mph.)

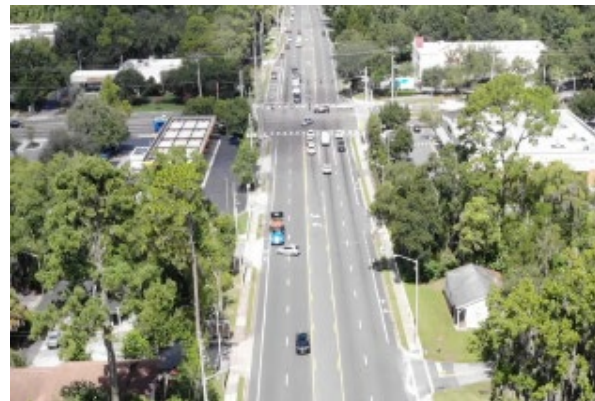
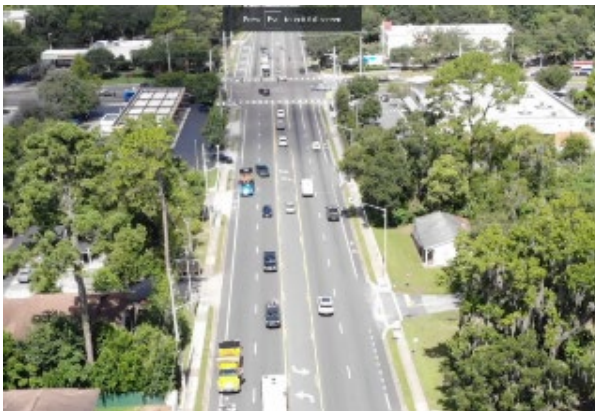
Figure 6-116. ATMA stop near driveways causes issue for ATMA as well as for public access

Figure 6-117. ATMA stop too close to intersection caused traffic backup for left-turning traffic at intersection

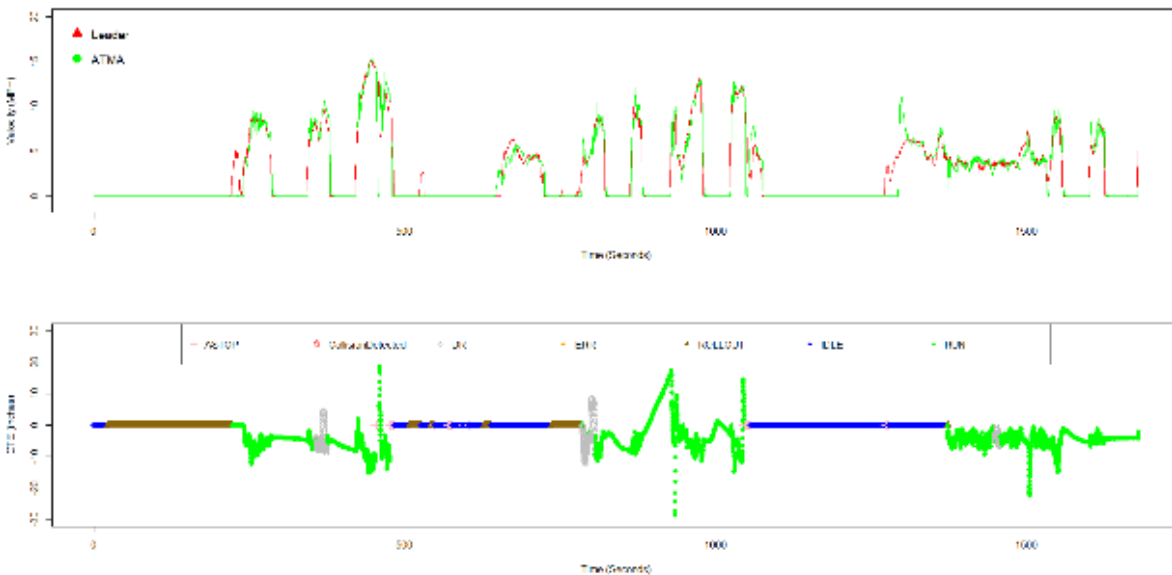
Figure 6-133. Velocity and cross track error of SR-26 field test (EB)

the steering lock.
- The system misreported a hard brake event as a collision, and the safety operator (Kratos staff) was required to change to Idle mode. Kratos staff mentioned that this can be eliminated by system upgrades or enhancements.
- At intersections, driver training is critical to understand the implications of ATMA operation, e.g., the FWD test was being performed downstream of the intersection, and the work platoon blocked the left-turning traffic. This may cause a traffic bottleneck at the intersection (Figure 6-133) and, in some cases, safety concerns.

The duration and percentage of various ATMA states are shown in Table 6-64. For 4.5% of the duration, the ATMA was in dead reckoning mode. The CTE statistics were as follows: minimum value of −28.70 in, maximum of 20.31 in, mean of −1.76 in with a standard deviation of 3.55 in.
