<u>**Final Report**</u>

Contract No. BDV29-977-13

Develop Epoxy Grout Pourback Guidance and Test Methods to Eliminate Thermal/Shrinkage Cracking at Post-Tensioning Anchorages

Phase II

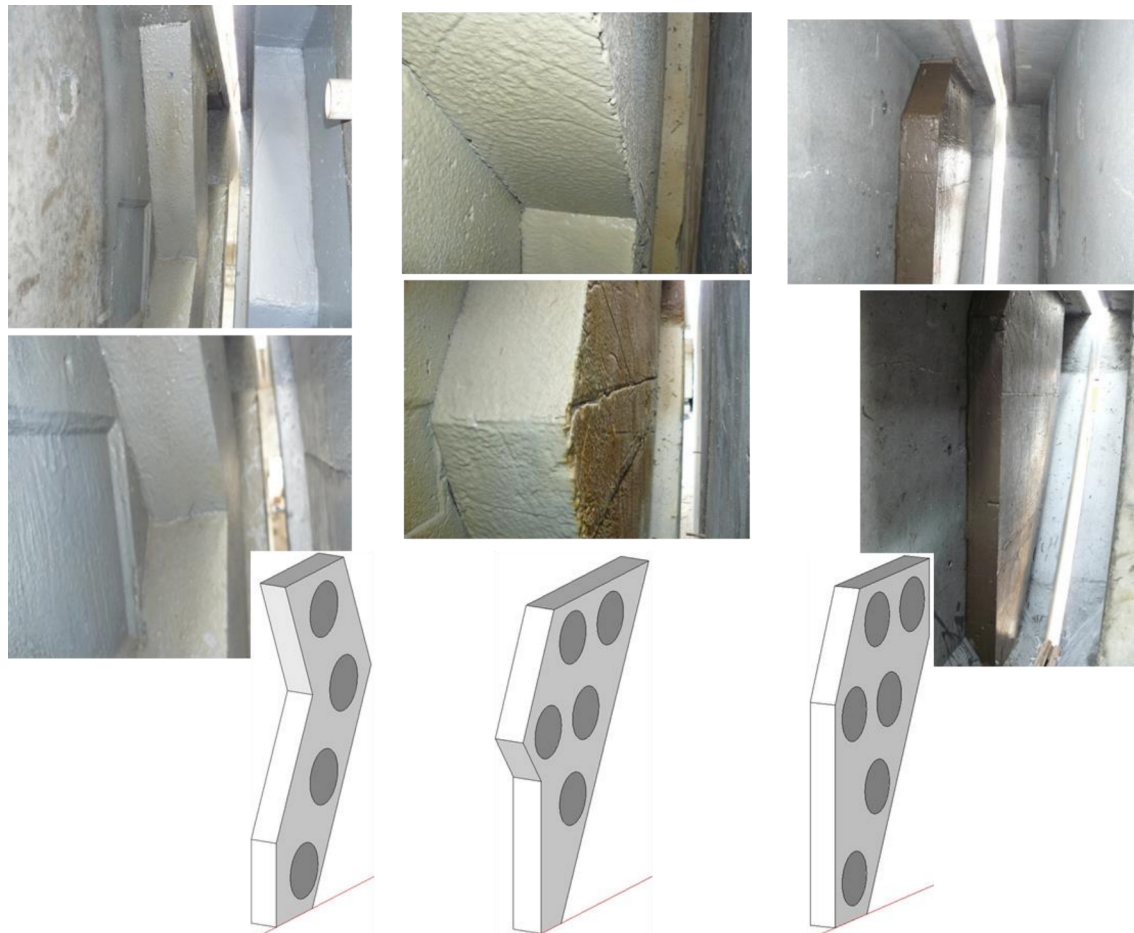
Figure 3-2: Pourbacks geometry on the LeRoy Selmon Crosstown Expressway

Three different large pourbacks' geometry were used on the LeRoy Selmon Crosstown Expressway as shown in Figure 3-2. These pourbacks were 4 to 6 in thick and were irregular shapes depending on the pattern of the anchorages on the dead-end segment. One common feature between the shapes was the volume-to-surface ratio with an average value of 0.31 as illustrated in Figure 3-3.

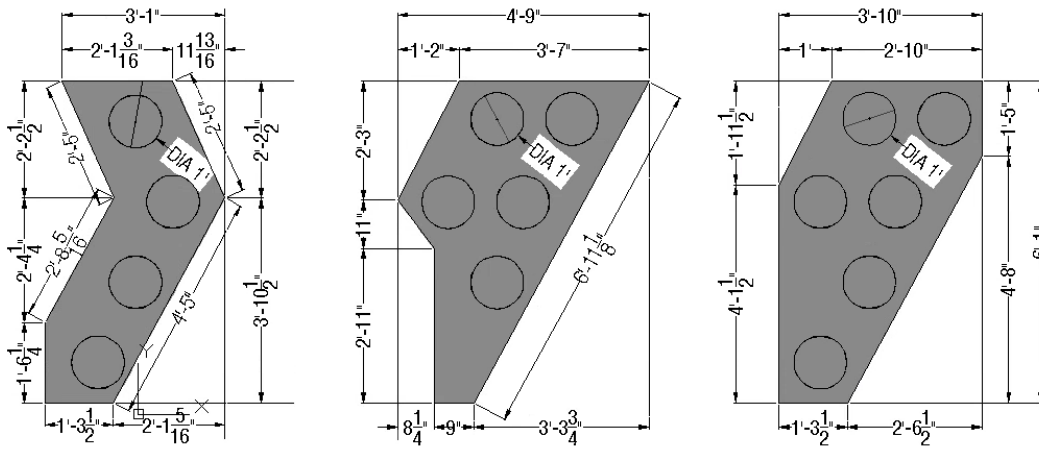
Figure 3-3: Volume-to-surface ratio and dimension of pourbacks

Overall, only pattern 3 (P3 in Figure 3-3) experienced cracking and spalling. The cracking seemed to be initiated from the sharp corner but some cracks were also found at other locations as shown in Figure 3-4. Figure 3-5 illustrates a summary of the field observation and proposed solutions for preventing epoxy pourbacks cracking.

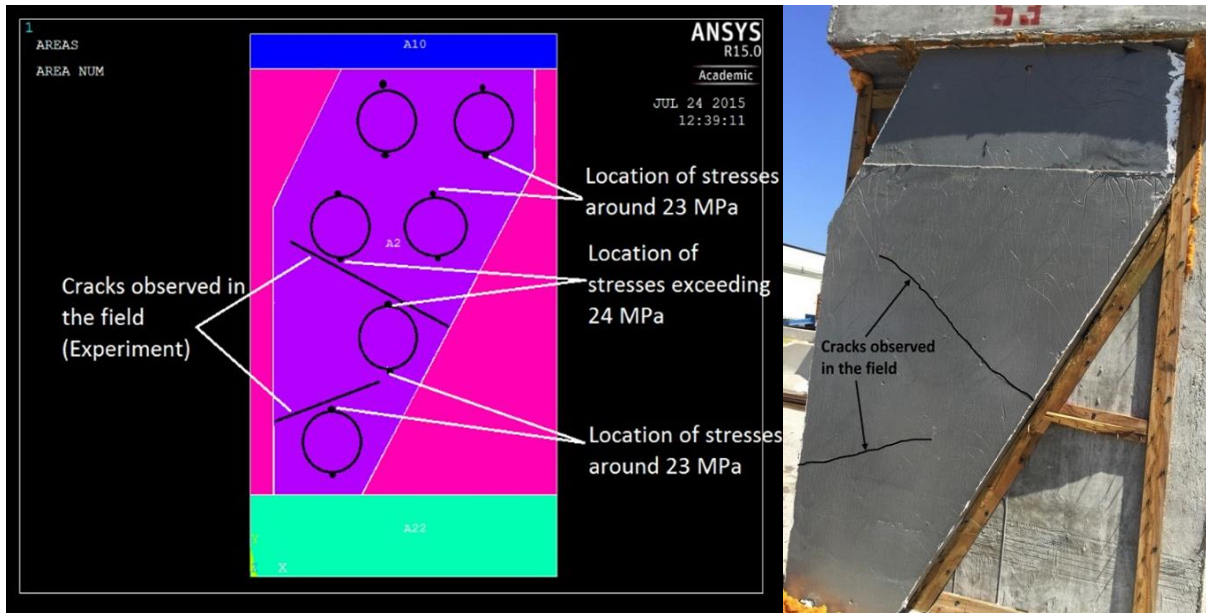
Figure 5-9: Comparison of crack locations between FEM and experimental observations for S3 specimen

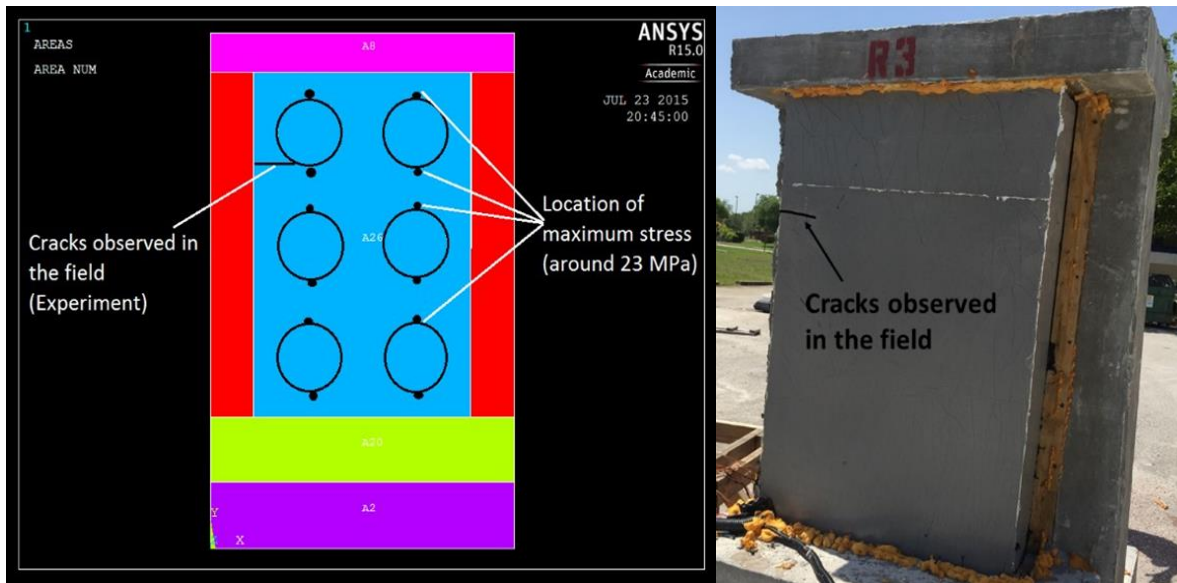
Figure 5-10: Comparison of crack locations between FEM and experimental observations for R3 specimen

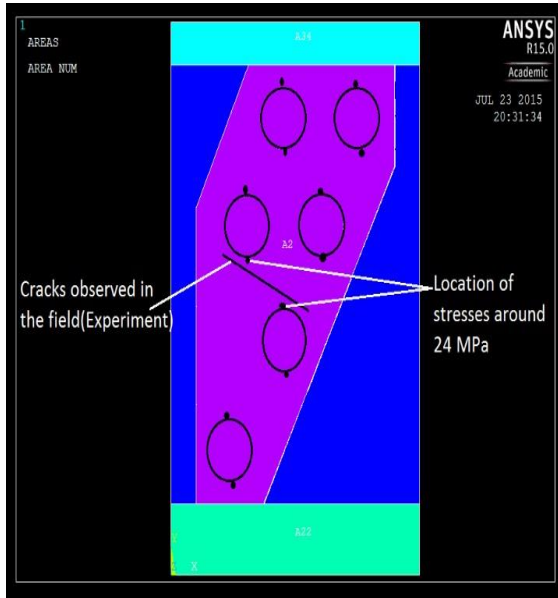
Figure 5-11: Comparison of crack locations between FEM and experimental observations for S2.5 specimen
