US 27/SR 25 Pavement Evaluation

State Materials Office

FL/DOT/SMO/11-542

May, 2011

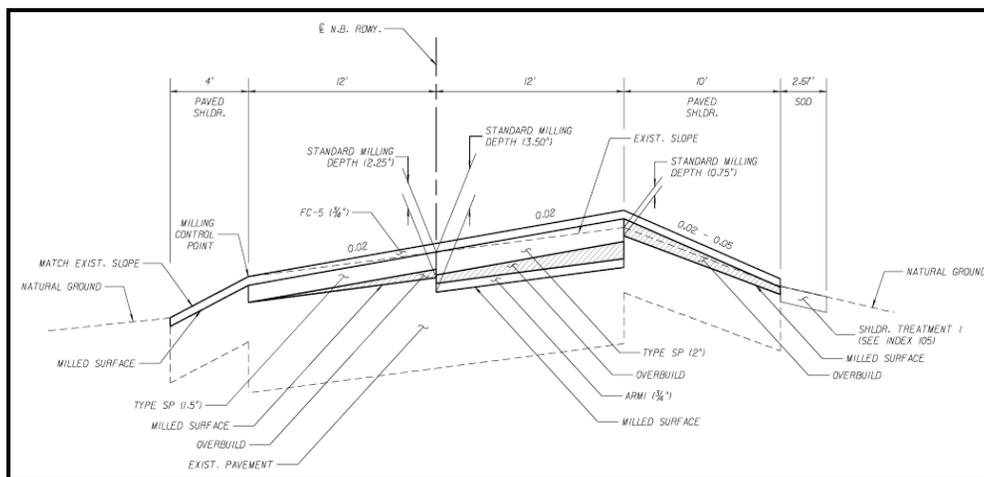
Figure 3 US 27/SR 25 northbound lanes proposed cross-section

Resurfacing of this one mile section is programmed for December, 2012. The scope calls for variable milling of both lanes and shoulders, with overbuild and cross-slope correction. The resurfacing includes 0.75 in of FC5 with 1.5 in of type SP in R1; 0.75 in of FC5, 2 in of type SP, and 0.75 in of Asphalt Rubber Membrane Interface (ARMI) in R2 (Figure 3).
