I-295/SR9A Joints Evaluation

State Materials Office

FL/DOT/SMO 18-590

04/30/2018

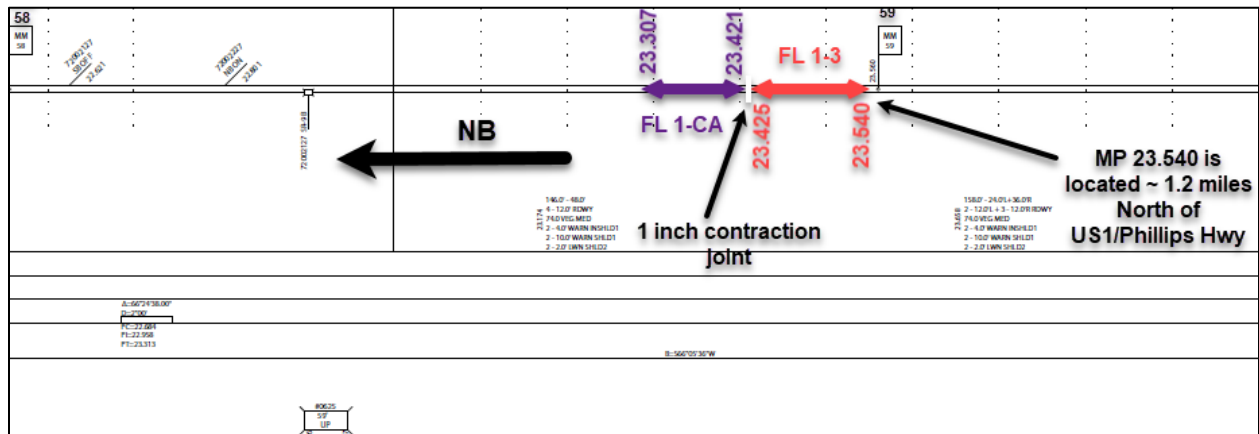
Figure 2 FL 1-3 and FL 1-CA test sections

Therefore, the evaluation area included the remaining two adjacent 608-ft sections in the northbound truck lane, namely, FL 1-3, and FL 1-CA (control). A 1-inch contraction joint separates the two sections identified by a 6-inch white paint mark across the travel lane.
