Repair of Construction-Related Deterioration in Precast Deck-Panel Bridges

Atiq H. Alvi, Ivan Gualtero, Rajan Sen, and Gray Mullins

Transportation Research Record: Journal of the Transportation Research Board, No. 2292, Transportation Research Board of the National Academies, Washington, D.C., 2012, pp. 104–112.
DOI: 10.3141/2292-13

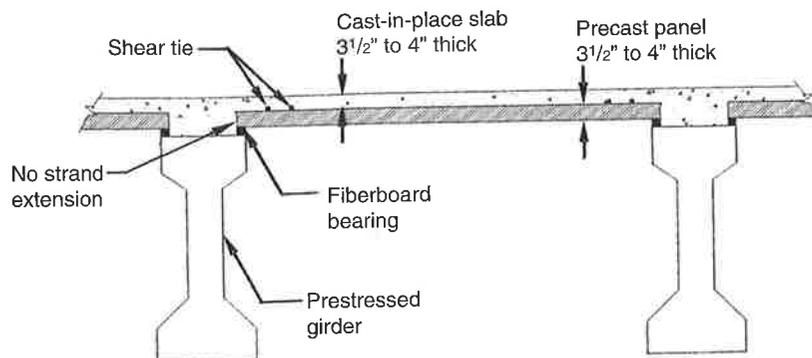
FIGURE 1 Cross section of precast, prestressed panel deck.

composite action necessitates steel from the precast panel to extend into the CIP slab (7). Bearing length and height below the panel also must be sufficient so that vertical shear can be transferred to the prestressed girder. In the drawing shown in Figure 1, these conditions are not met; the panel is supported only by the fiberboard material at its end. Moreover, the steel strands from the panel terminated at the end of the panel and did not extend into the CIP concrete.
