*Florida Department of Transportation
Central Structures Office*

**TEST AND ASSESSMENT OF NDT METHODS
FOR POST-TENSIONING SYSTEMS IN SEGMENTAL
BALANCED CANTILEVER CONCRETE BRIDGES**

DMJM HARRIS

February 15, 2003

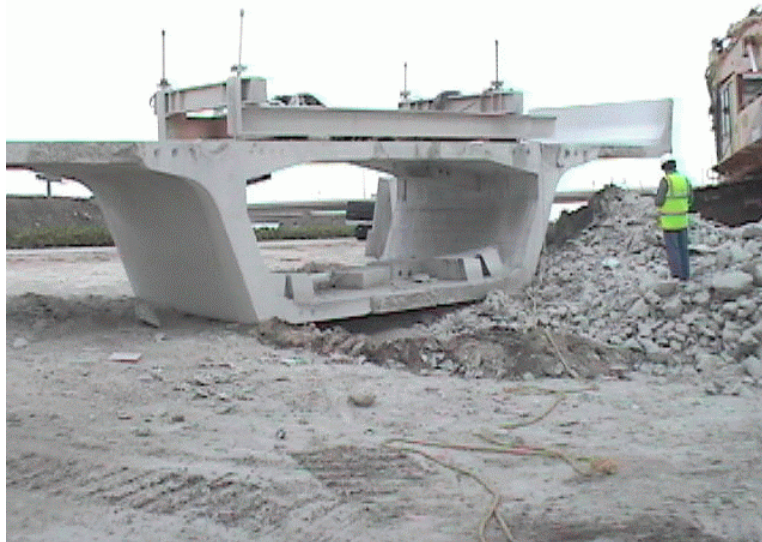
In addition to core drilling, a total of nine segments from Spans 5 and 6 were inspected after their disassembly (See Chapter 7 and Appendix D). Most of the bridge was demolished using a concrete crushing machine that demolished the concrete segments in their original place. Only sections of the bridge on Spans 5 and 6 were disassembled by cutting across the bridge cross section at the segment joints using a wire cutting machine. Some of these segments were visually inspected prior to demolition. A disassembled bridge segment is shown in Figure 4.7. Figure 4.8 shows a tendon duct with a small void, which was typically found in most of the ducts. Documentation of these inspections, including pictures of each of the inspected tendon ducts, is included in Appendix D. A total of 216 points were visually inspected in the following segments: Segments 63, 64, and 65 of Span 5, and Segments 68, 69, 70, 71, 75 and 76 of Span 6. As previously noted, voids smaller than $1/2$ " deep were reported as small voids. The statistics of this inspection shows that approximately 70% of the locations were classified as small voids, 10% as voids and 20% as fully grouted ducts. It should be noted that the strands in the ducts with small voids were mostly encased within the grout.

Figure 4.7 - Bridge segment after removal.

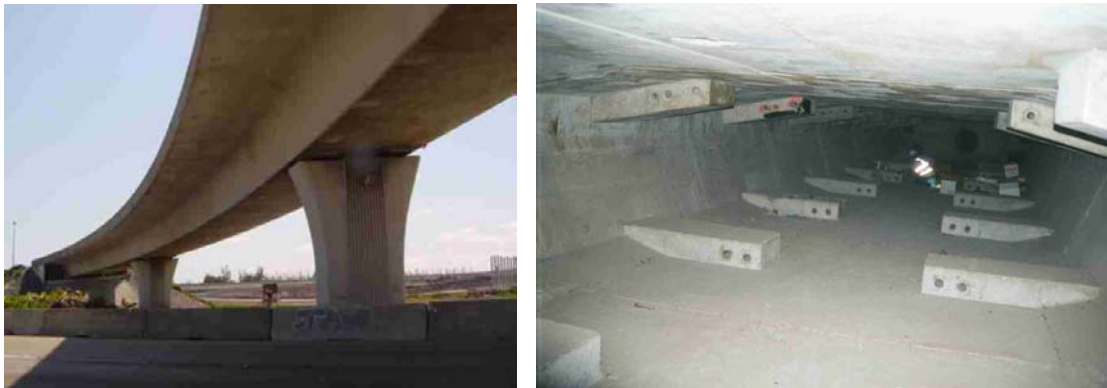
placed on the low side of the cross-section to remove rainwater runoff from the bridge deck. These scuppers adequately drained the bridge and no ponding was evident on the deck during heavy rains. The riding surface was in good condition and provided a pleasantly smooth ride. The exterior faces of the bridge including the box girder and the piers had a coated finish that provided an aesthetically pleasing structure. A visual inspection of the exterior of the bridge was performed from below the bridge (Figure 7.13) and an inspection of the inside was performed from the inside of the girder (Figure 7.14). There were no evident signs of concrete deficiencies or distress present.

Figure 7.13 and 7.14 – Exterior and interior view of structure

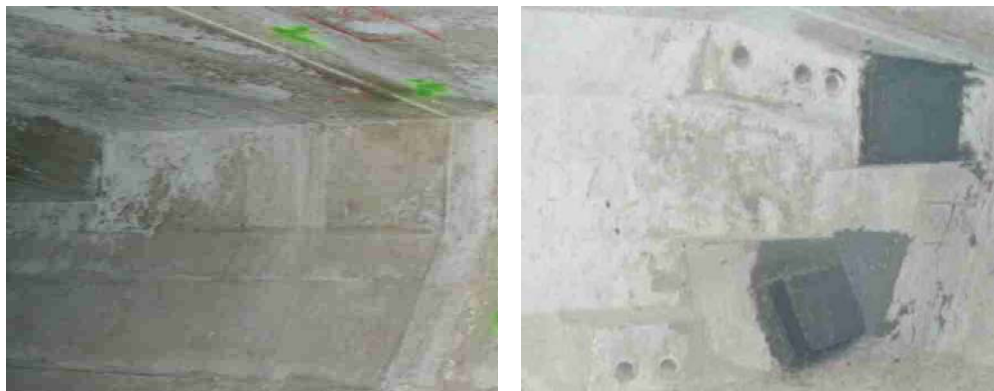
The bridge was constructed with the balanced cantilever method of erection, which requires wet joints (epoxy at the segment joints). These joints had epoxy present and did not present any signs of water leakage (Figure 7.15). Water leakage at the joints can allow water to seep into the post-tensioning ducts creating corrosion. Since the bridge was constructed by balanced cantilever method of erection with internal post-tensioning, the only pour backs remaining exposed were for the bottom slab and web continuity tendons. These could be seen from the inside of the box girder and were in very good condition (Figure 7.16). Pot bearings at Pier 6 were checked with the snoopers and were found in very good condition and showed no signs of distress (Figure 7.17 & Figure 7.18). The modular expansion devices did not show any sign of distress.

Figure 7.15 and Figure 7.16 – Segment joint and post-tensioning pourbacks

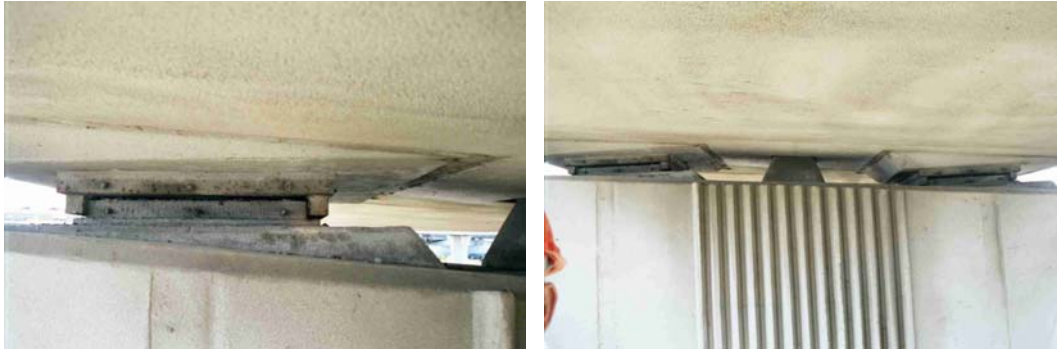
Figure 7.17 and Figure 7.18 – Pot bearings at Pier 6

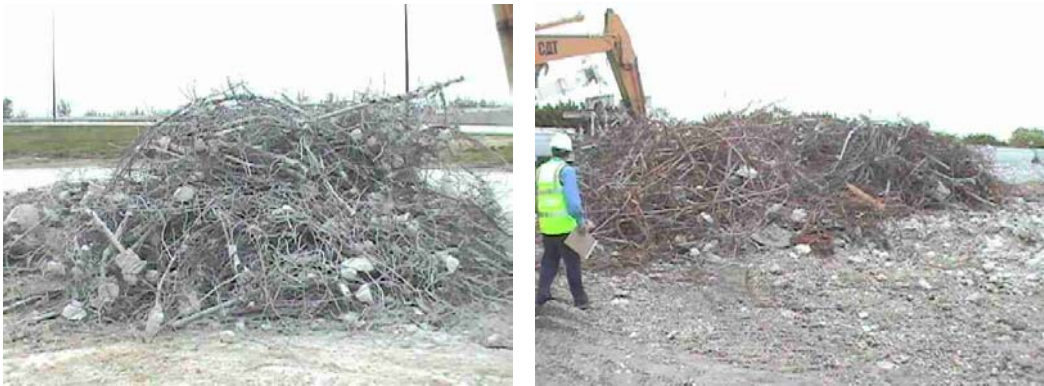
As described in Section 7.2 of this report, two methods were used to demolish the bridge. Most of the bridge was demolished using a concrete crushing machine. This was the most effective method of deconstruction for the contractor. However, the nature of this demolition method did not allow inspectors to perform a forensic investigation of the segments post-tensioning system for voids in the tendon ducts. For the portions of the bridge that were dismantled by crushing, the steel remains were separated from the concrete, which permitted an evaluation of the post-tensioning remains (Figures 7.21 and 7.22). This was achieved by climbing through the steel remains and performing a hands-on inspection of fully intact anchor systems (Figures 7.23, 7.24, 7.25), post-tensioning strands (Figures 7.26), the ducts and grout within the ducts (Figures 7.27). This inspection of the remains allowed a detailed evaluation of the structures post-tensioning system. In some cases there was a fully intact tendon with the anchoring system, strands and portions of the duct still intact with the grout (Figures 7.28). An overall condition of the post-tensioning remains (including anchoring system, strands, grout and duct) were found to be very good, with no deficiencies noted except minor surface rust that developed after days of being exposed to environment (Figures 7.29 and 7.30).

Figure 7.21 and 7.22 – Steel remains of crushed segments

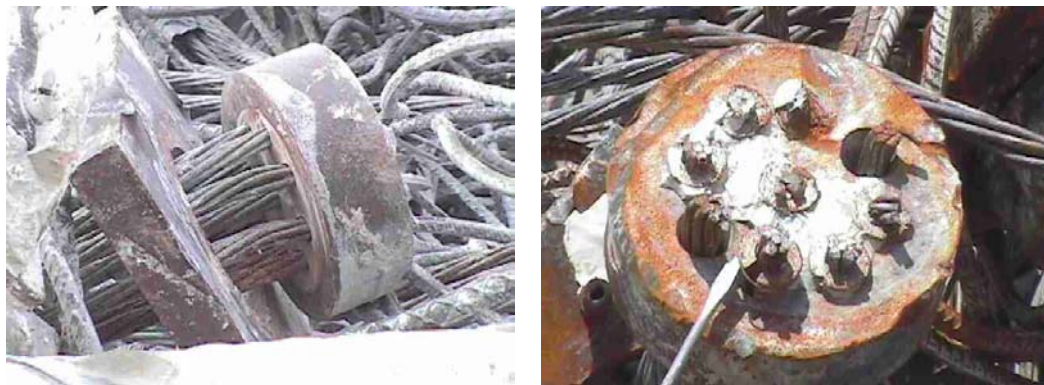
Figure 7.23 and 7.24 – Intact anchor systems in remains

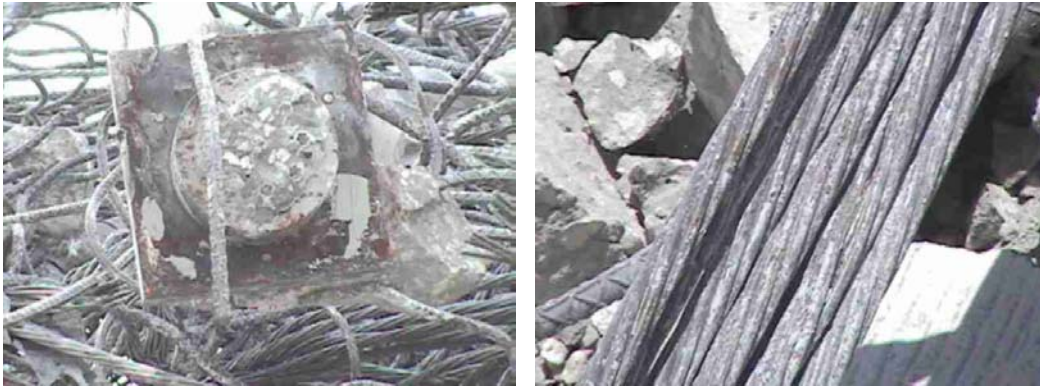
Figure 7.25 and 7.26 – Post-tensioning anchor and strands

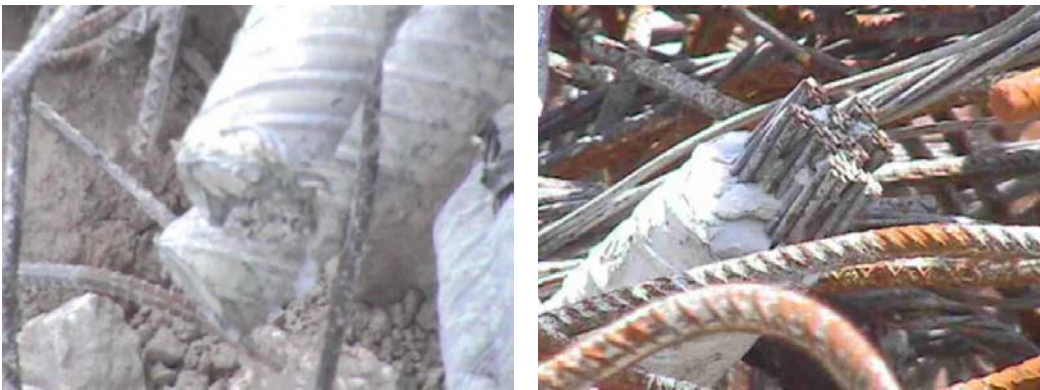
Figure 7.27 and 7.28 – Fully grouted duct with strands

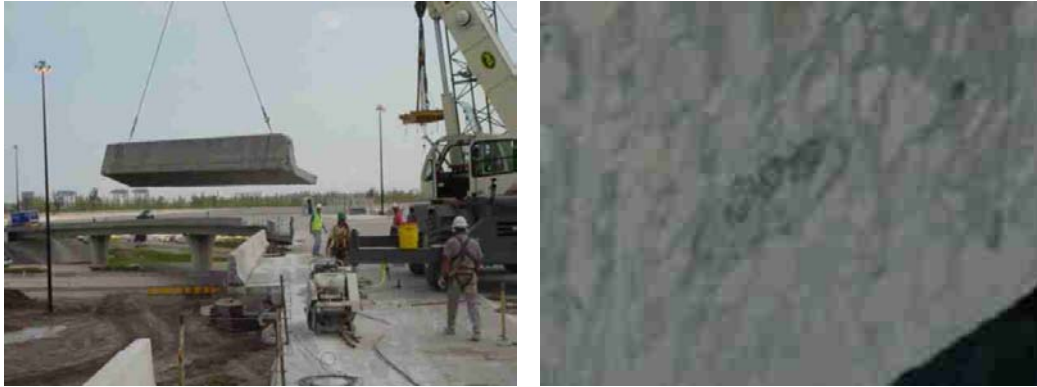
Figure 7.31 and 7.32 – Removal of portion of cantilever and transverse post-tensioning

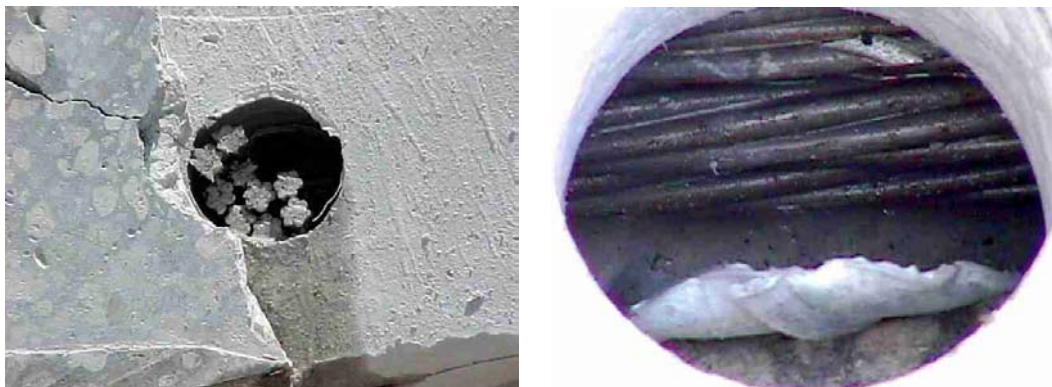
A statistical analysis was performed of the voids found on the top (cantilever) tendons during the forensic investigation. This was based on describing a void as ½" deep or larger, a small void as less than ½" deep (bleed water void) and grouted as no void. The recorded statistics are, approximately, 70% small voids, 9% voids and 21% fully grouted. It should be noted that the strands in the ducts with small voids were mostly encased within the grout and overall the strands were in good conditions. These findings (9% relevant flaws) are consistent with the endoscope findings (8.3% of relevant flaws). One testing area, which was not included in this forensic evaluation, was the segments adjacent to Pier 5. These segments were crushed before the forensic investigation could be performed. These areas showed significant voids in the top tendons (Figures 7.34 and 7.35), although the core drilling shows that the tendons had no signs of corrosion (Figure 7.36).

Figure 7.35 and 7.36 – UngROUTED tendon

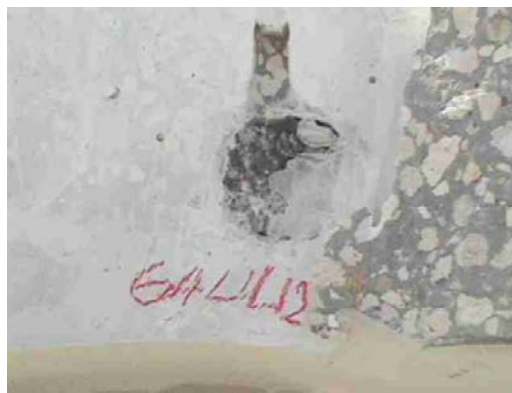
Figure 7.39 - Endoscopy inspection location not penetrating duct

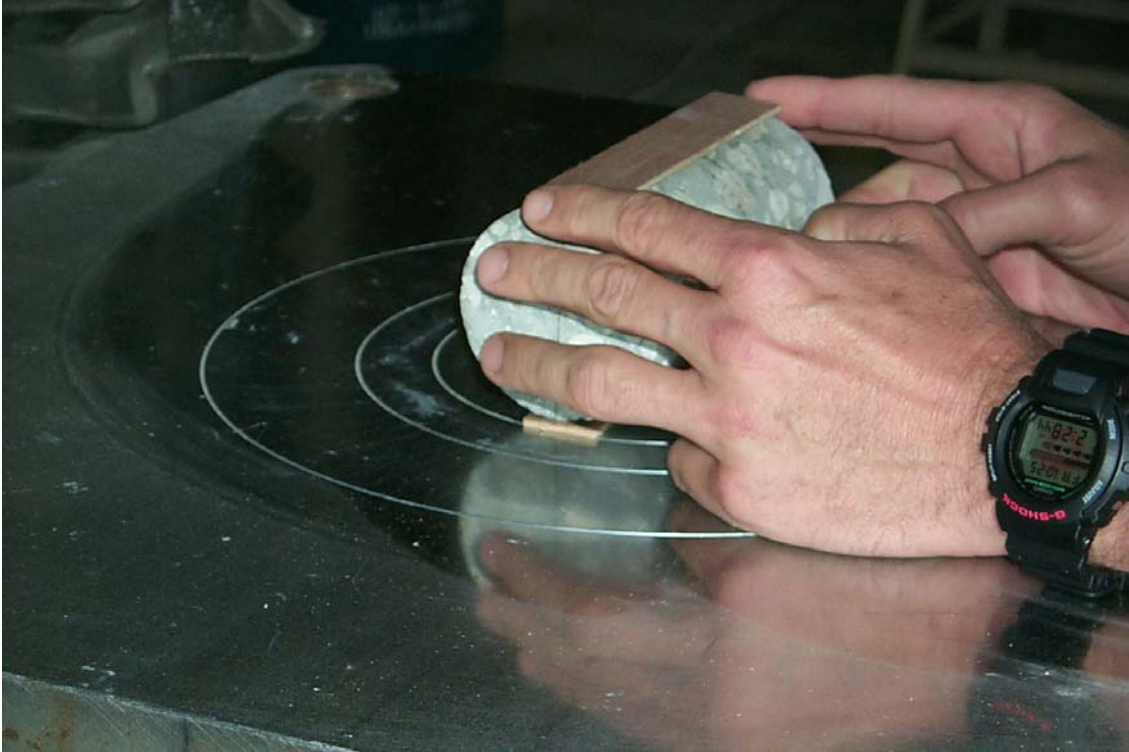
Picture 16 – Split Tensile Test on Core #6

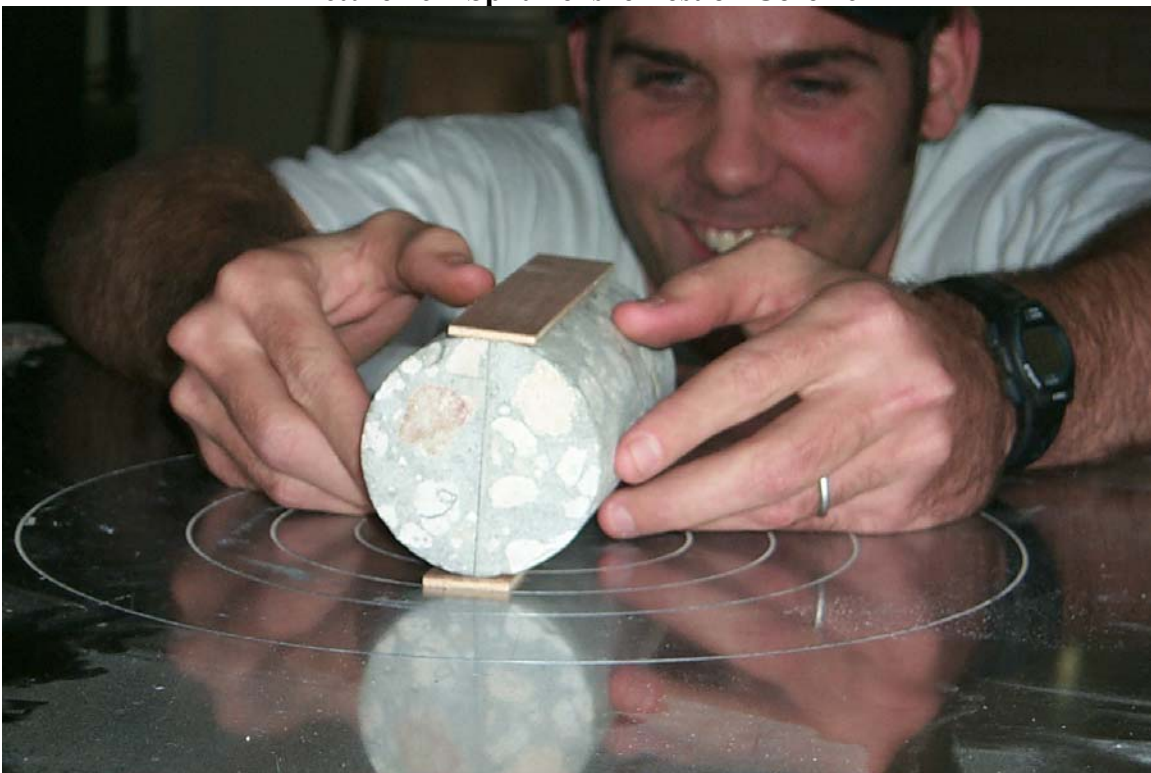
Picture 17 – Split Tensile Test on Core 6. Joint Vertical

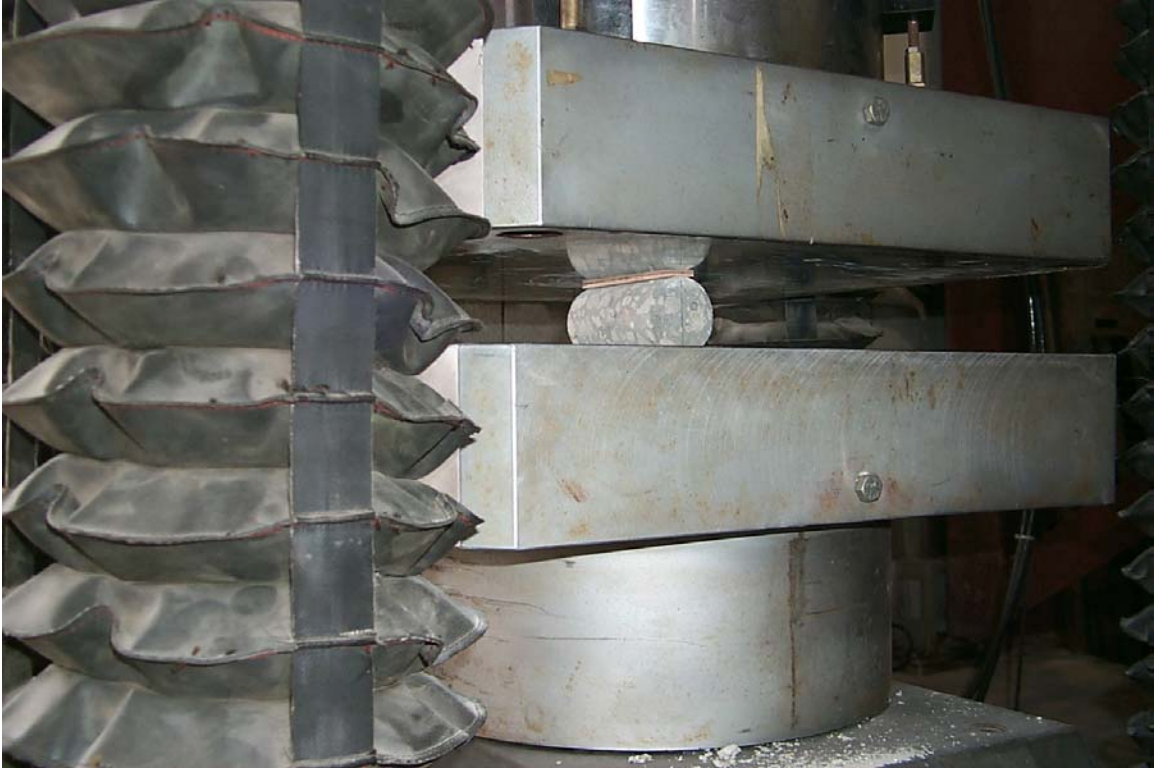
Picture 18 – Split Tensile Test on Core 6

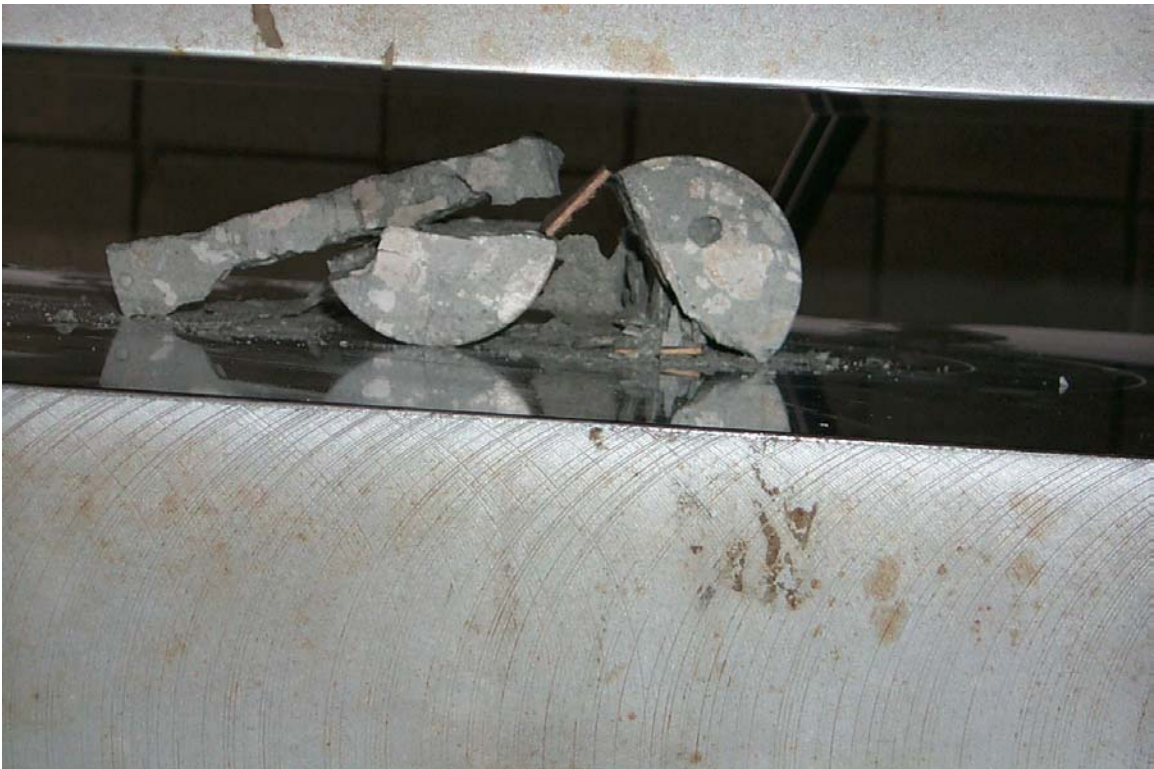
Picture 19 – Split Tensile Test on Core 6

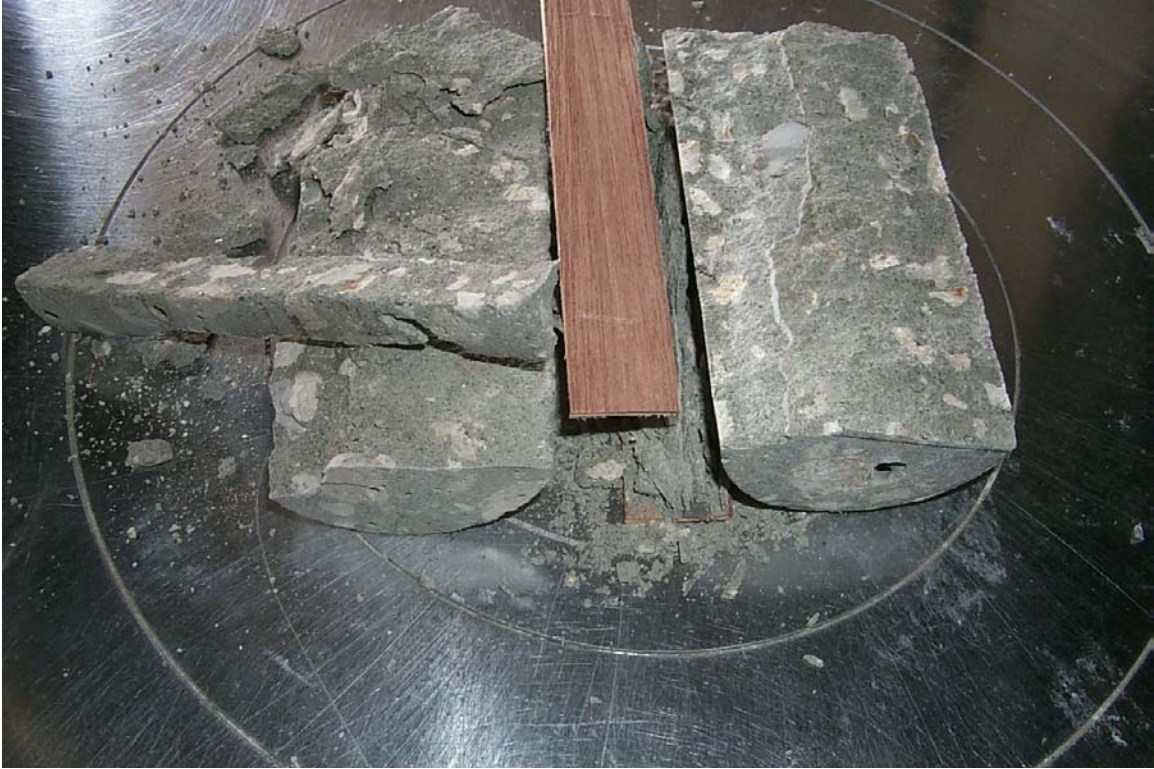
Picture 20 –Split Tensile Test on Core 6

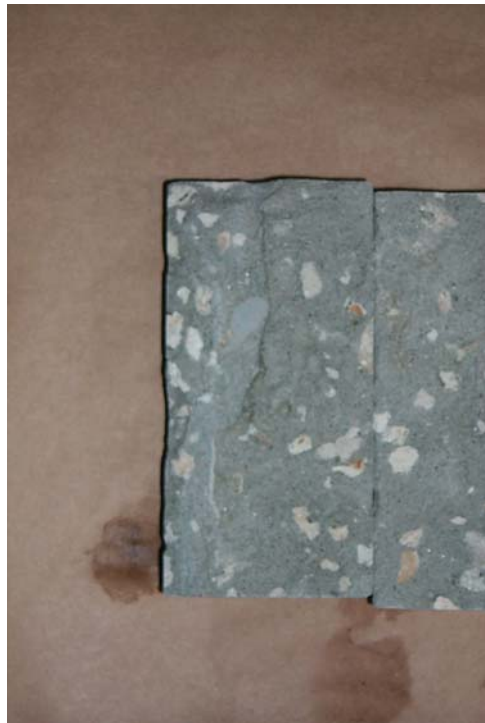
Picture 21 – Split Tensile Test on Core 6

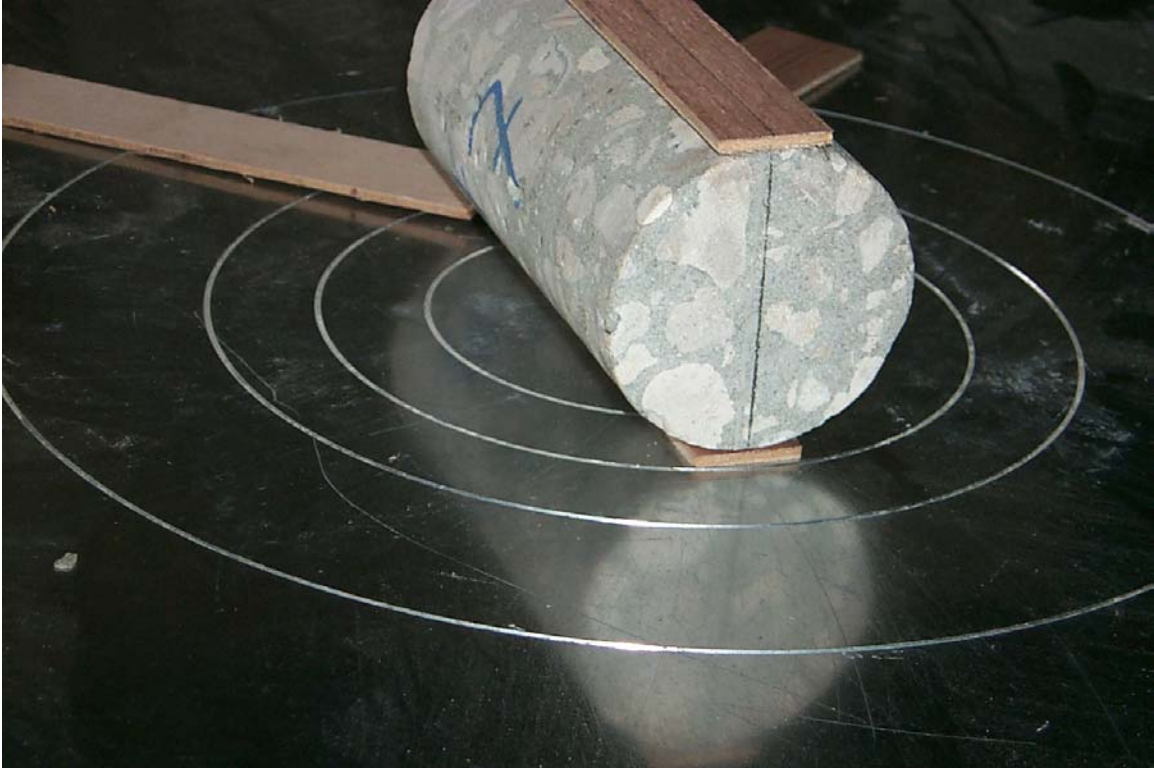
Picture 22 – Split Tensile Test on Core #7. Joint Vertical

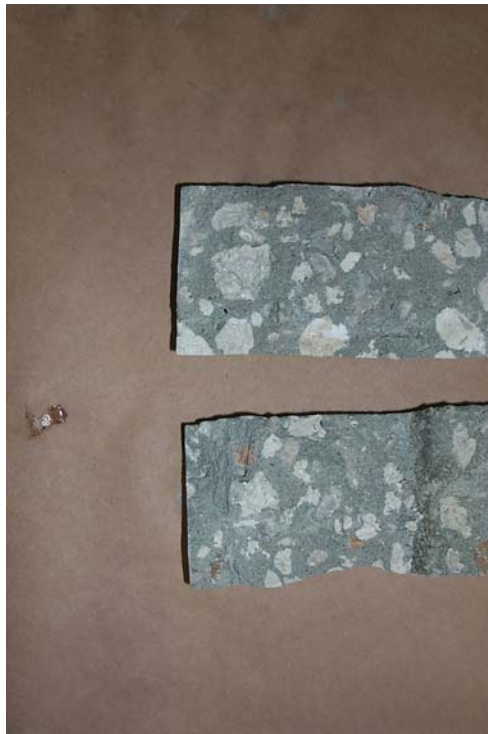
Picture 23 – Split tensile Test on Core #7

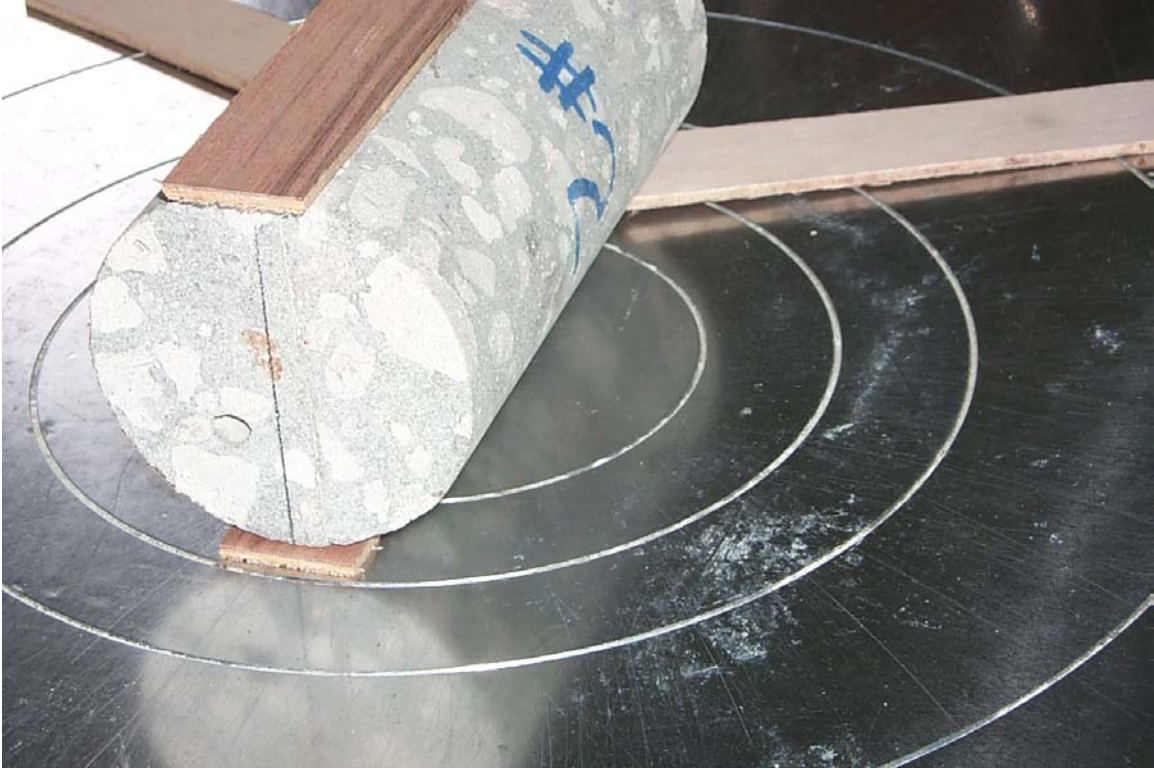
Picture 24 – Split Tensile Test on Core #2. Joint Vertical

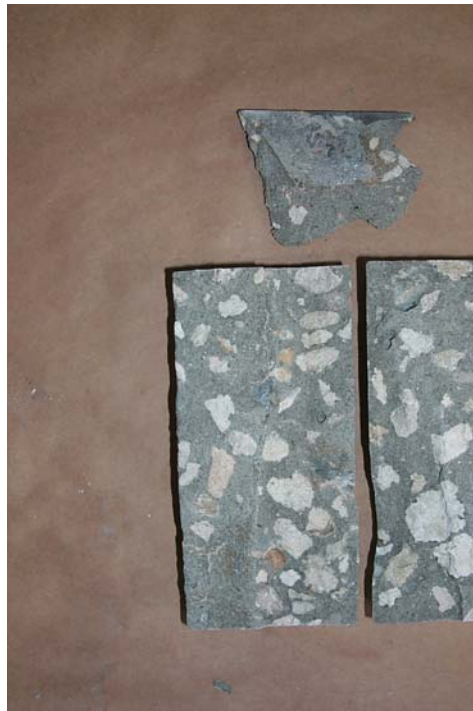
Picture 25 – Split Tensile Test on Core #2.

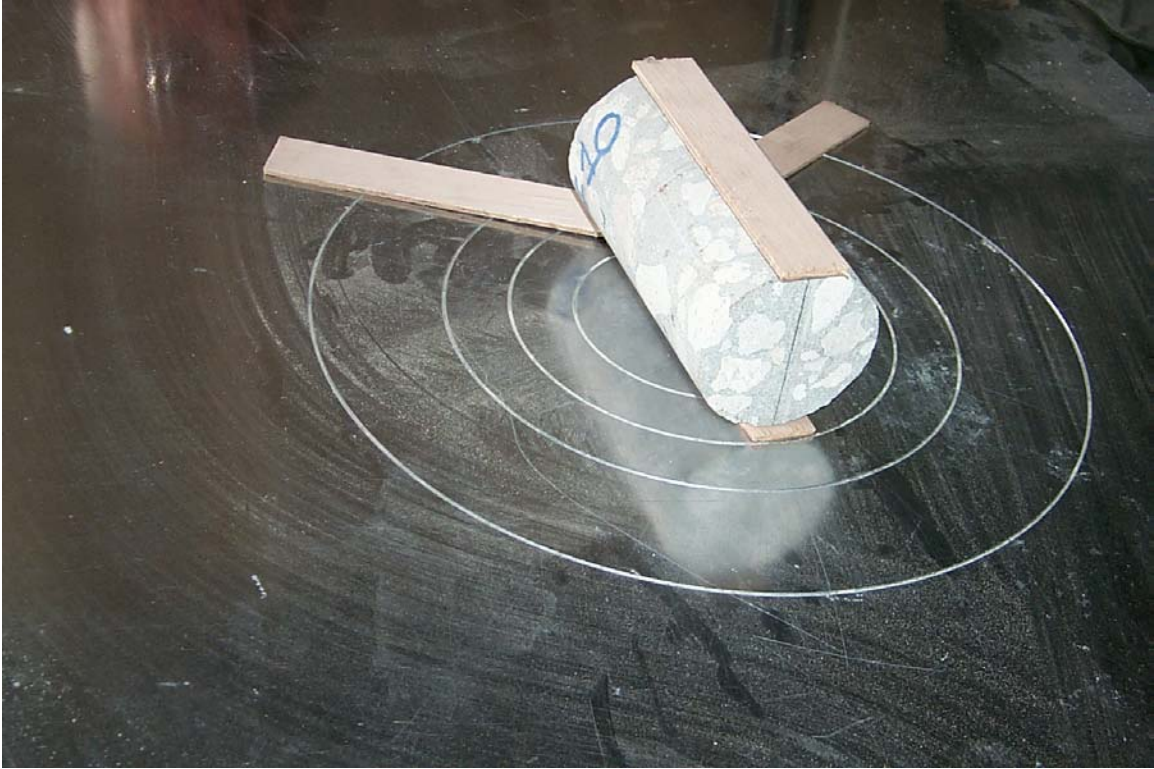
Picture 26 – Split Tensile Test on Core #10. Joint Vertical

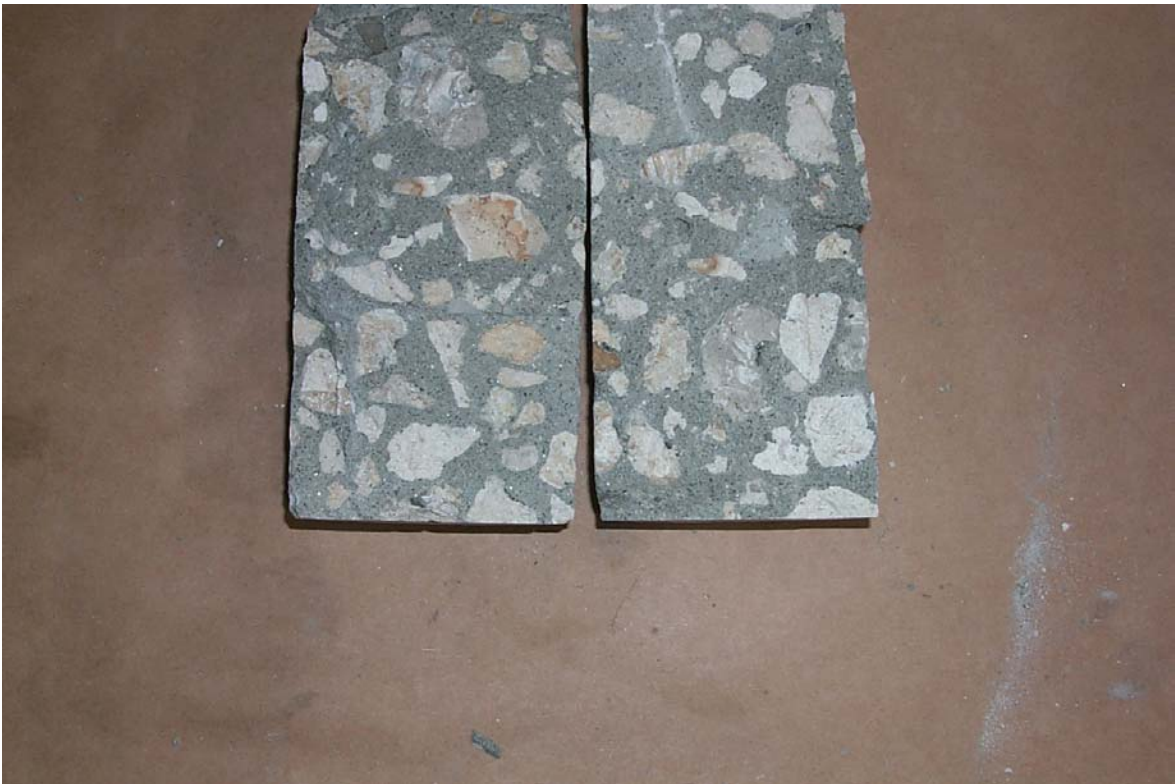
Picture 27 – Split Tensile Test on Core #10

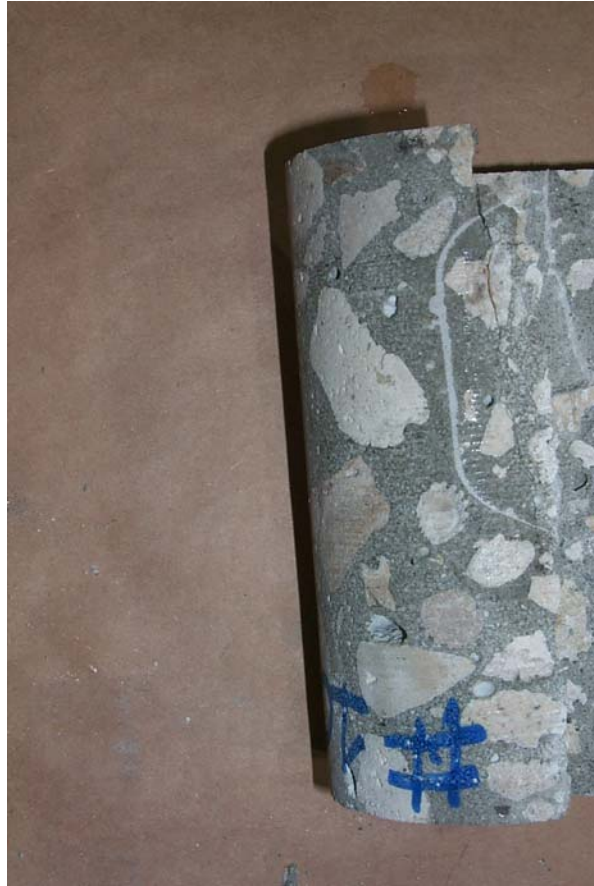
Picture 28 – Split Tensile Test on Core #10
