ALUMINUM LIGHTWEIGHT ORTHOTROPIC DECK EVALUATION PROJECT

FLORIDA DEPARTMENT OF TRANSPORTATION
M. H. ANSLEY STRUCTURES RESEARCH CENTER
WRITTEN BY: CHRISTINA FREEMAN, P.E.
REVIEWED BY: WILLIAM POTTER, P.E.
2017

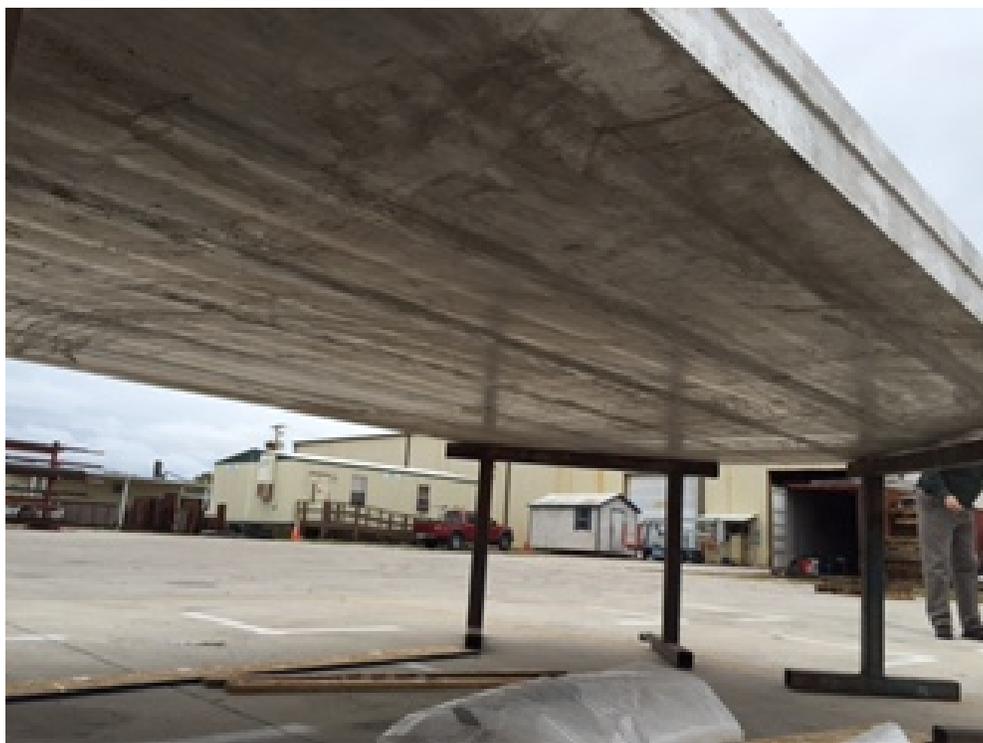
Figure 8: Fabrication Support Conditions

Additional evidence of galvanic corrosion documented during the preliminary photographic inventory consisted of a diagonal affected area approximately 2 inches wide and eighteen inches long, located between stringers 2 and 3 on the generation I panel. Galvanic corrosion is evident by rust colored staining and minor pitting, shown in Figure 7. Figure 8 shows the aluminum panel was supported by bare steel during storage. The location of the supports coincides with the documented galvanic corrosion, therefore the corrosion is likely due to contact with dissimilar metals during fabrication. For future use, Specifications should be incorporated to ensure proper handling during fabrication and installation. The manufacturer and contractor should have proper quality controls in place to verify the aluminum does not come in contact with dissimilar metals during the fabrication process. If proper controls are not in place, service life of the product could be reduced.

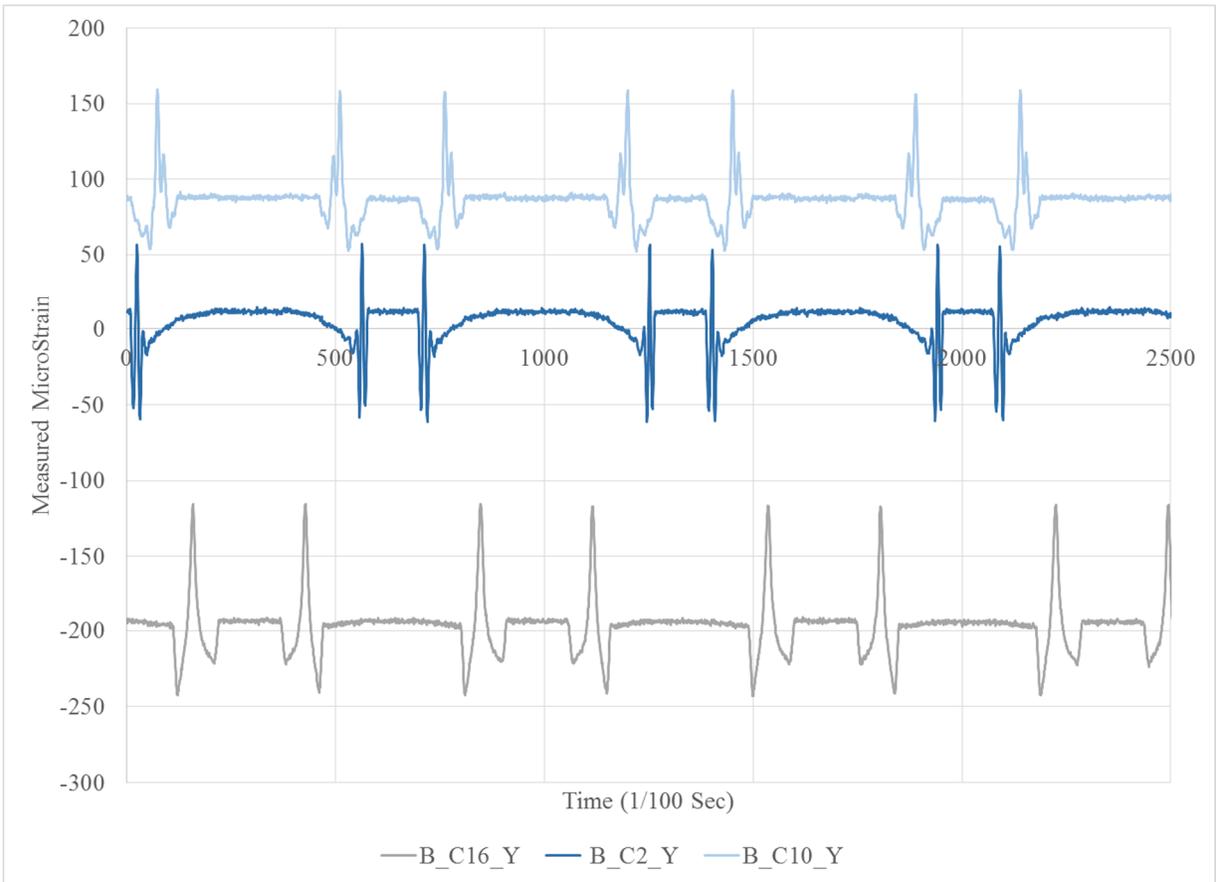
Figure 49: Recorded MicroStrain on 5/26/2016 at 1 AM for Gages B_C16_Y and B_C2_Y

Due to the moving nature of the Heavy Vehicle Simulator load, stress reversal occurs for strain in the travel direction of the tire load. The maximum level of strain reversal was observed at gage B_C16_Y, in the generation I panel. The measured strain showing the stress reversal behavior is shown in Figure 49. Gage B_C16_Y had the highest recorded strain range for gages in the travel direction of the tire. Measurement at gage B_C2_Y is also included in Figure 49 as that gage had the highest recorded strain range for the generation II panel. Gage B_C10_Y is included as that gage is at a similar position in the generation II panel as gage B_C16_Y for the generation I panel.

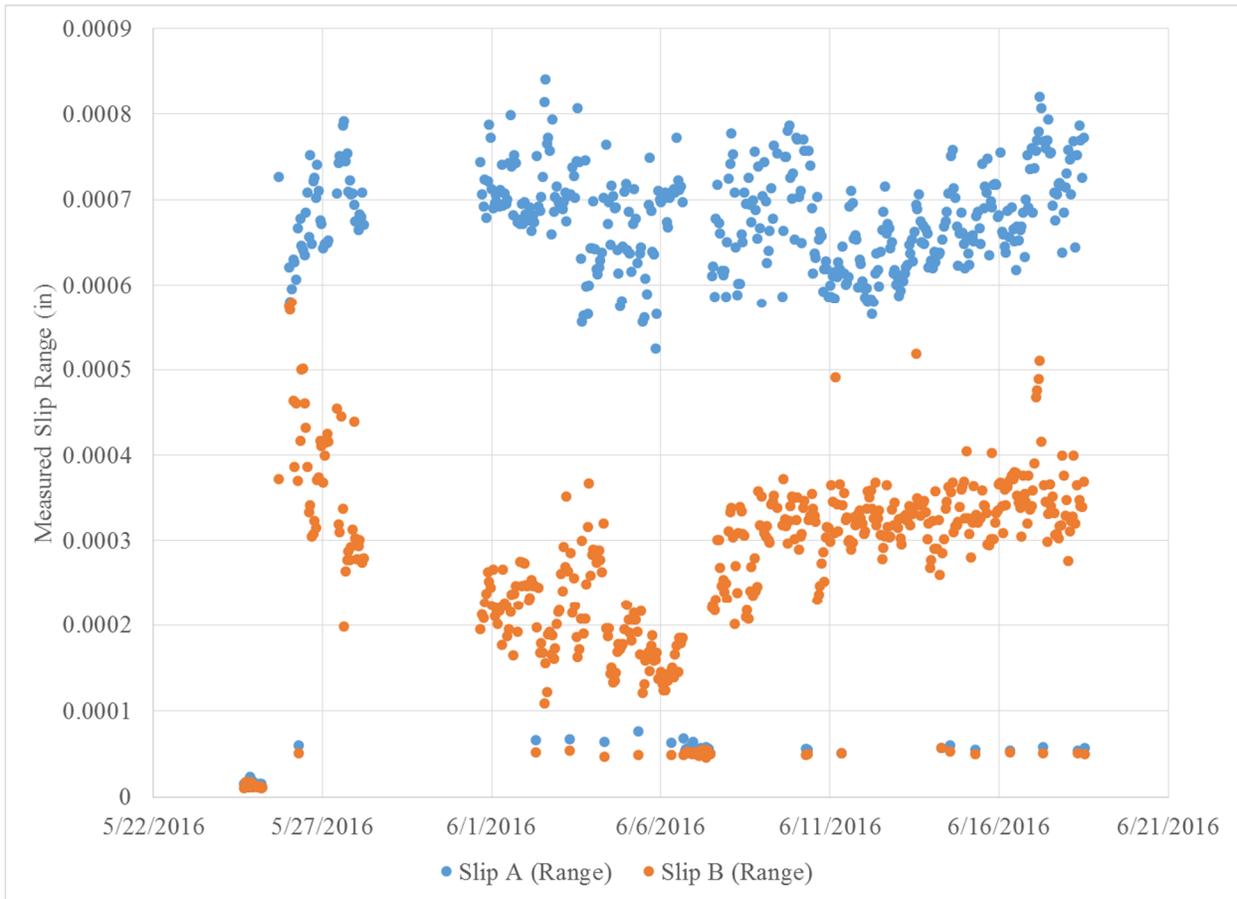
Figure 53: Slip Range Measurement vs. Time for Entire HVS Test

For most of the Figures presented in this report, the data was post-processed so that the data recorded while the heavy vehicle simulator was stopped is not included in the Figures. However, Figure 53 includes all data recorded. At the beginning of the test, while the heavy vehicle simulator was being set up and was not running, slip range was measured as a value close to zero. At the mid-point of the test, the HVS was stopped to complete the heated phase of the test and to set up for the saturated wearing surface phase of the test. Again, the slip range was measured as a value close to zero. During the test, when the heavy vehicle simulator was stopped for maintenance, the slip range shows intermittent values close to zero. Slip between the steel stringer and aluminum deck was only recorded while the heavy vehicle simulator was running and the deck was loaded. The recorded slip range is close to zero when there is no vehicular load on the test specimen. Figure 54 shows evidence that slip is recorded only when the HVS tire is in contact with the deck. The spikes shown in Figure 54 occur when the wheel leaves the test specimen at each end.

Evident from Figure 53 is that slip readings for gage A, on the generation I panel are consistently higher than readings for gage B on the generation II panel. The average reading for gage A is approximately double the average reading for gage B. The gap between the panel and stringer is larger for the generation I panel than the generation II panel and may be the cause of higher slip readings.

The recorded slip is clearly a function of structural loadings since readings start and stop according to when the heavy vehicle simulator was running. The cause is unknown. The recorded measurement is potentially due to axial compression, bending in the test specimen, or a combination thereof. Slip readings are much lower than would be expected due to thermal loads, by a factor of 100. The panel may not be performing as designed since slip due to thermal loads was not observed during testing. Inherent conservatism in the design of the faying surface and slip-critical bolted connection is a likely reason that the panel does not slip due to thermal effects. The behavior does not appear to be detrimental to performance of the system and the lack of significant slip between the panel and stringer may be preferred so that the inorganic zinc coating does not wear off of the steel beam and result in corrosion between the dissimilar metals.

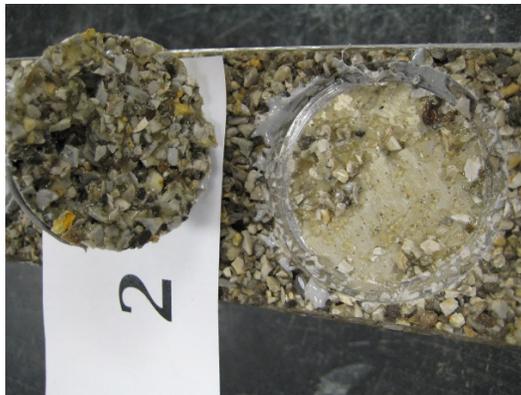
Figure 55: Bond Test 1C, Location 2

The results of the laboratory tests are presented in Table 5. Odd numbered locations were tested under laboratory temperature after allowing the epoxy adhesive to cure for about 1.5 hours, while even numbered locations were tested after an additional 2 hours of placement in a heated chamber. The bond strength at Location 9a exceeded the capacity of the tester at lab temperature. Location 9 was retested at elevated temperature since the dolly was still affixed and the results are presented as location 9b. The temperature of each location was measured with an IR thermometer immediately after each test. Figure 55 and Figure

56 show the two extreme failure modes of the bond test. Photos of all bond test locations are included in Appendix F: Bond Test Location Plan and Photo Inventory.

Location	Bond Strength (psi)	Failure Mode	Temperature (°F)
1	396	~75% epoxy/dolly, ~25% intra-epoxy	75.5
2	288	~85% overlay/Al, ~15% intra-overlay	114.5
3	232	~75% epoxy/dolly, ~25% intra-epoxy	75.5
4	294	~30% overlay/Al, ~50% overlay fail, ~20% epoxy/dolly	115.5
5	220	~100% epoxy/dolly w/neg. epoxy failure	75.5
6	256	~20% epoxy/dolly, ~80% intra-overlay	114.5
7	542	~90% intra-epoxy w/Agg pull out, ~10% epoxy/dolly	75.0
8	405	~30% epoxy/overlay w/agg pullout, ~70% intra-epoxy	110.5
9a	548	Reached the maximum capacity of tester without breaking	75.5
9b	324	~20% overlay/Al, ~80% intra-overlay	110.5
10	373	~30% intra-epoxy, ~70% intra-overlay	108.5

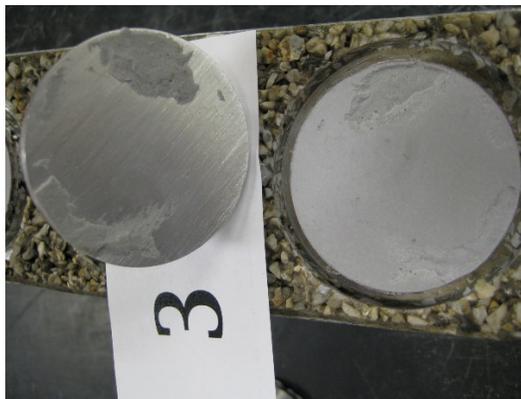
Figure 56: Bond Test 1C, Location 3

Considering only the results of bond tests 1B and 1C, since the results of test 1A were inconclusive, there were two test locations with a bond strength less than the required 250 psi. Those tests were locations 3 and 5 for test 1C. For both of those tests, the failure mode was within the epoxy used to bond the steel dolly to the overlay or at the bond surface between that epoxy and the steel dolly. Per ASTM C1583, section 11.4, results should be discarded if that failure mode occurs. Therefore, the bond test indicates the wearing surface applied to the lightweight aluminum full size test specimen and smaller sample has an acceptable bond strength of greater than 250 psi.

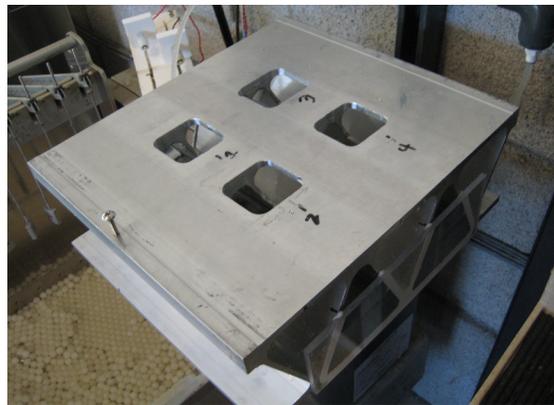
Figure 57: Aluminum Extrusion Sample

The accelerated corrosion testing plan consists of measuring the current flowing through wires between steel fasteners and a sample of the aluminum extrusion. Refer to Figure 57 and Figure 58. The ends of the extrusion are partially capped and Hollo-Bolt fasteners are suspended in the saltwater filling the chambers without directly contacting the aluminum. The Hollo-Bolts are meant to be used to replace the original fasteners as needed to maintain the structure. No testing was conducted with the original fasteners. Prior to testing, the Hollo-Bolts were disassembled, and the manufacturer's grease was removed mechanically and by solvent. They were re-assembled, and suspended in the saltwater in the extrusion cavities without directly contacting the aluminum. The fasteners were not plastically deformed as they would be if they were torqued to manufacturer's specification. When used as intended, the threaded wedge causes the tangs on the fastener's outer sleeve to bend outward creating some plastic deformation in the aluminum deck as well. The galvanic corrosion circuit was completed via wiring through shunt resistors, measuring current flowing through the wires between the fasteners and the extrusion.

The corrosion test specimens show a dark discoloration of the aluminum surface. The testing indicates the aluminum is slightly anodic with respect to the fasteners (positive current) as an examination of the galvanic series in seawater would concur. That is, the aluminum is presently providing a small measure of cathodic protection to the galvanized fasteners. The oxidation on the fasteners shows there is still some consumption of the zinc. As the zinc is consumed, the corrosion current will likely increase since iron and aluminum are farther apart on the galvanic series. The net current measured to date is shown in Figure 59. It is unlikely the corrosion will be as severe in actual service given the exposure will probably be limited to light salt spray or mist rather than full, long-term immersion.

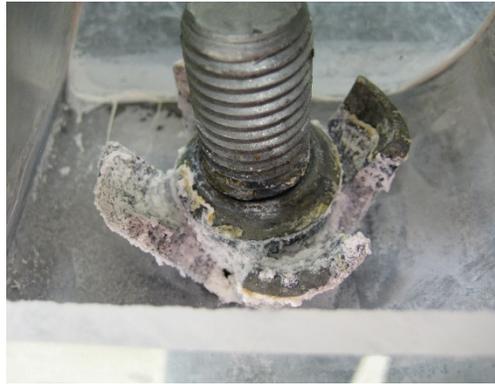
Figure 60: Fastener Used for Corrosion Testing

Further testing qualitatively evaluated corrosion of plastically deformed fasteners. Two Hollo-Bolt fasteners were used to attach steel plate coupons to a section of a Generation I deck specimen, as shown in Figure 60. The bolts were torqued to manufacturer's specification. The intent of the test was to qualitatively gauge how severe the corrosion might get as well as look into possible crevice and stress related corrosion effects.

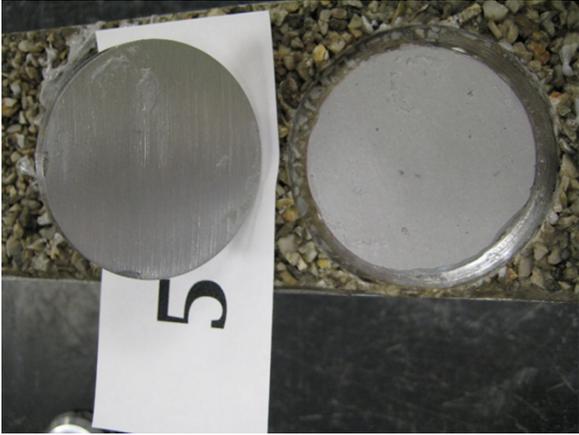
Location 4a- Incorrect Dolly

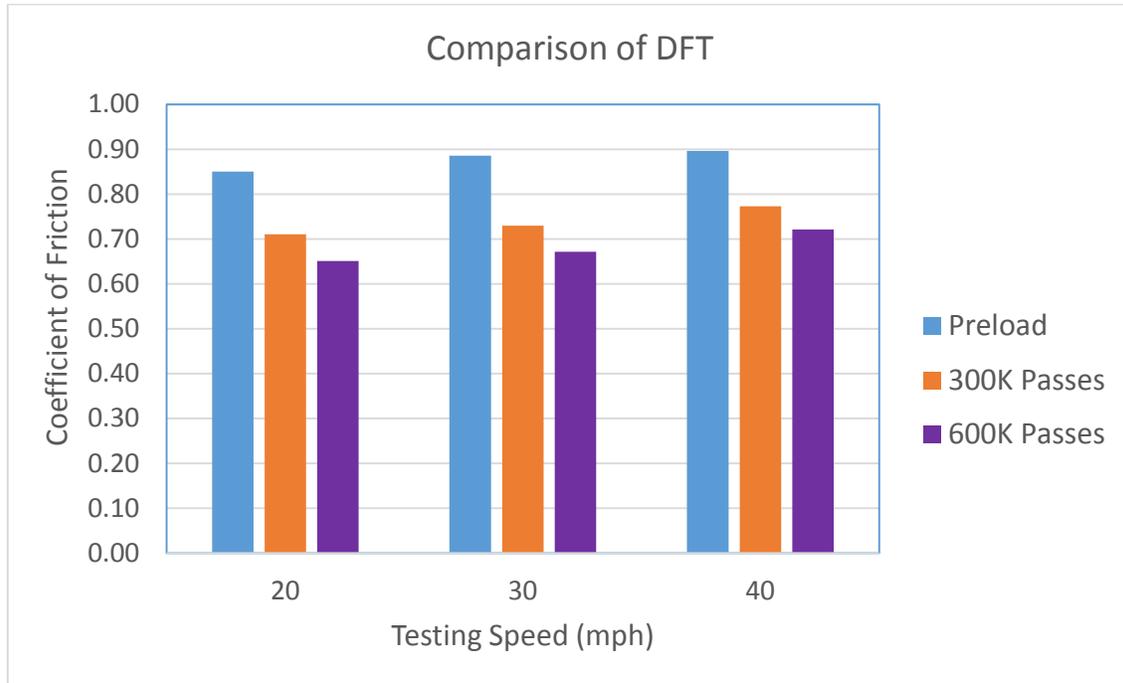
Figure 3. Comparison of average DFT measurements between Preload and 300K HVS Passes

The equivalent FN40Rs for three loading phases exceed the requirement of 55 according to the developmental specification 403-Epoxy Overlay for Sealing and High Surface Treatment on Concrete Bridge Decks. Figure 3 shows the comparison between preload phase and the 1st 300K HVS passes. As shown, the coefficient of friction dropped about 20% on averaged after 600K HVS passes.

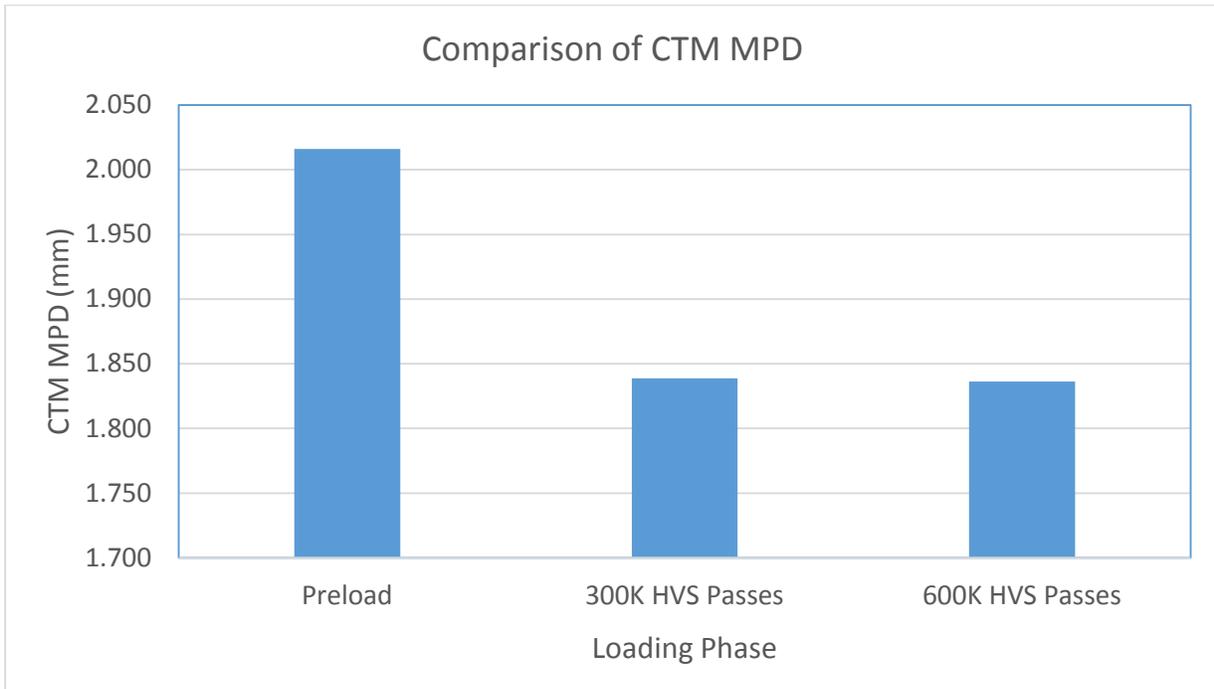
Figure 4. Comparison of average CTM measurements among three loading phases

The results of CTM measurements for three loading phases are presented in table 2. Detailed measurements are provided in Appendix I. As shown, the average MPD values are 2.016 mm for preload phase, 1.839 mm after 300K HVS passes and 1.836 mm after 600K HVS passes. For comparison purposes, the average MPD for the aluminum bridge deck section is higher when compared to a typical MPD for newer in-service longitudinal diamond grinding (LGD) concrete pavement (typically 0.6 mm) and longitudinal grind and transverse grooved bridge deck (typically 1.3 mm). Figure 4 shows the comparison among three loading phases. As shown, the MPD has dropped about 9% on average after 300K HVS passes. However, the MPD doesn't change much after 600K HVS passes as compared to the MPD after 300K HVS passes. Figure 5 shows the comparison of the surface texture between preload phase and after 600K HVS passes. As shown the texture seems to show minor aggregate wear and loss after 600K HVS passes. As a side note, due to the high friction surface texture of the deck surface, noticeable tire wear was observed as shown in Figure 6.

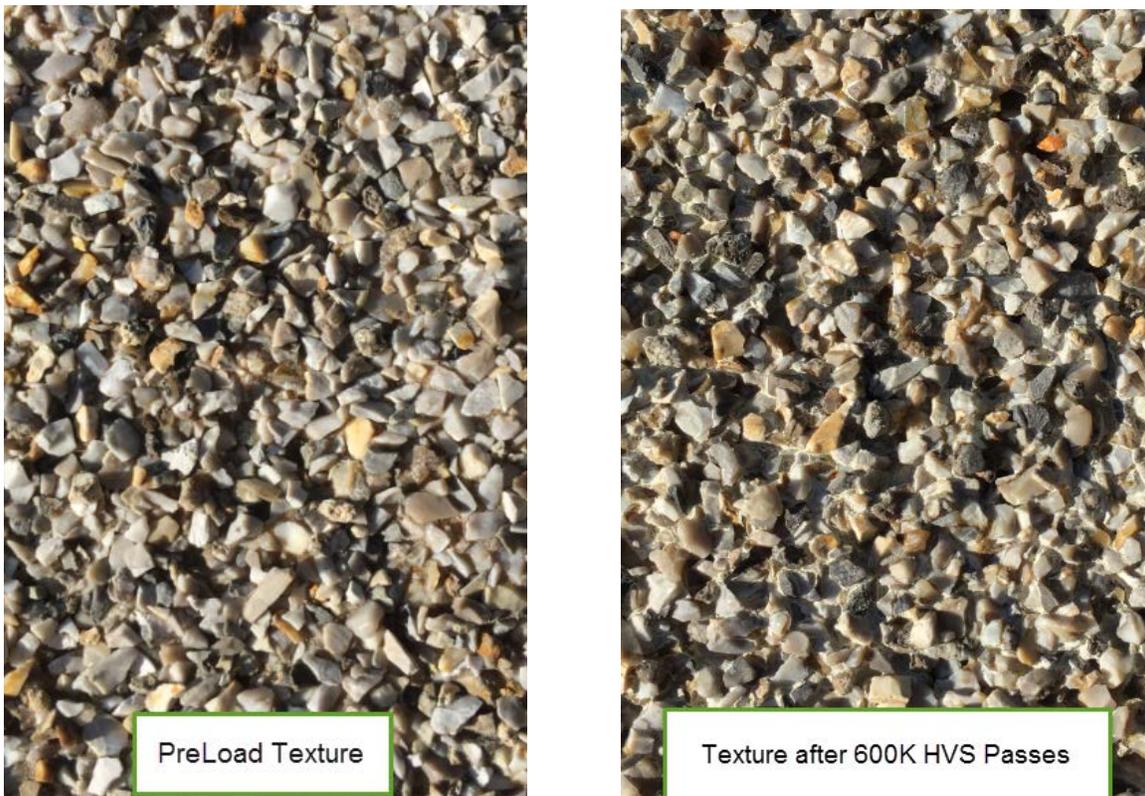
Figure 5. Comparison of texture before load and after 600K HVS passes.

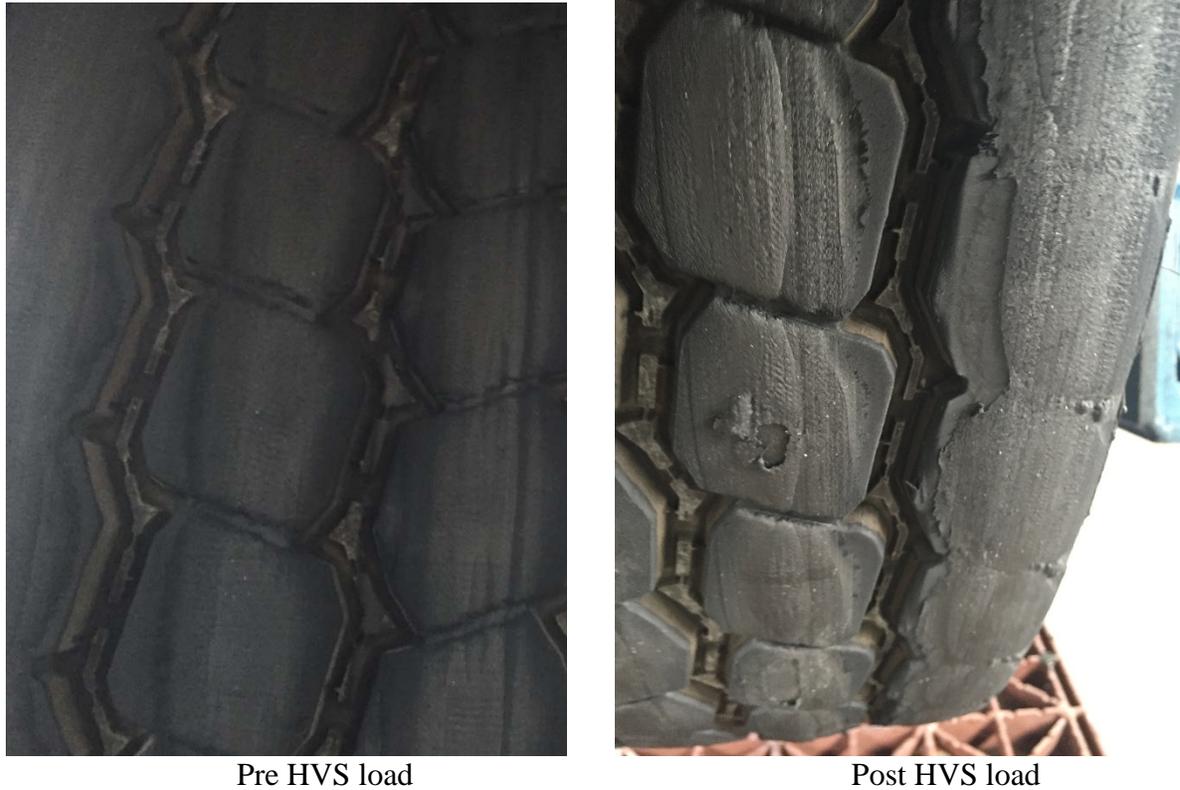
Figure 6. Comparison of tire wear before load and after HVS load.

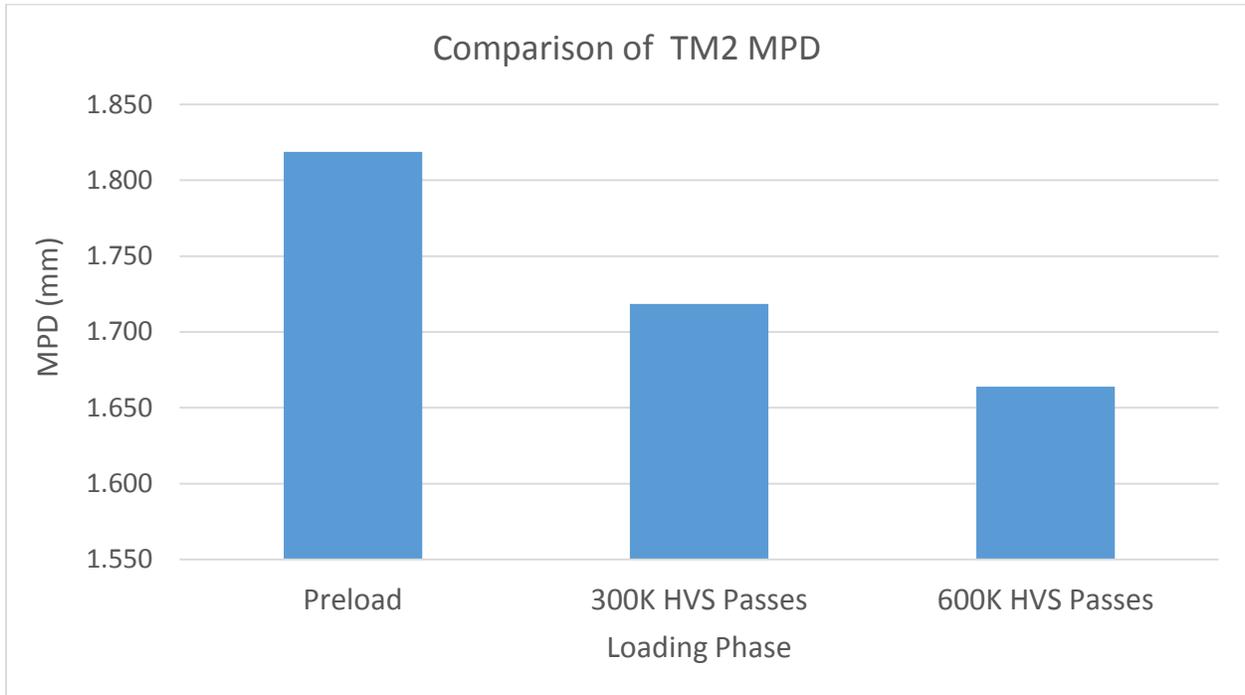
Figure 8. Comparison of average TM2 measurements among three loading phases

The results of TM2 measurements for three loading phases are presented in table 3. A detail dataset is provided in Appendix II. As shown, the average MPD values are 1.819 mm for preload phase, 1.719 mm after 300K HVS passes and 1.664 mm after 600K HVS passes. Figure 8 shows the comparison among three loading phases. As shown, the MPD is dropped about 9% on averaged after 600K HVS passes, which is similar to CTM test.
