Final Report

June 2006

UF Project No. 00051711
Contract No. BD545, RPWO #27

ST. GEORGE ISLAND BRIDGE PILE TESTING

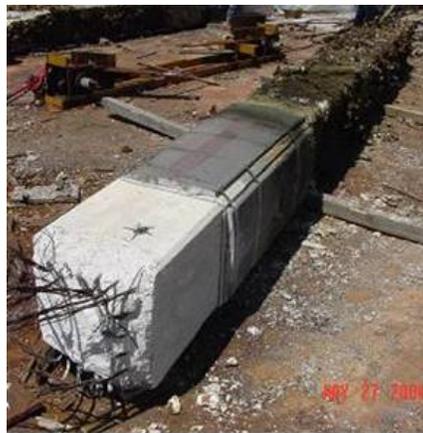
There was concern that the results of the structural testing would be adversely effected by the damage caused during pile removal. The cutting process, however, affected a relatively isolated area near the pile ends. Cracking and spalling of the concrete usually extended into the pile no more than 20-in. (Figure 5e).

Figure 5 – (a) Prestressed pile bents after cap removal; (b) Pile “beaver” used to cut the piles at the mud line; (c) Pile being lifted from the water after being cut; (d) Pile Recovery; (e) pile immediately after recovery. Note damage at end of pile from cutting.

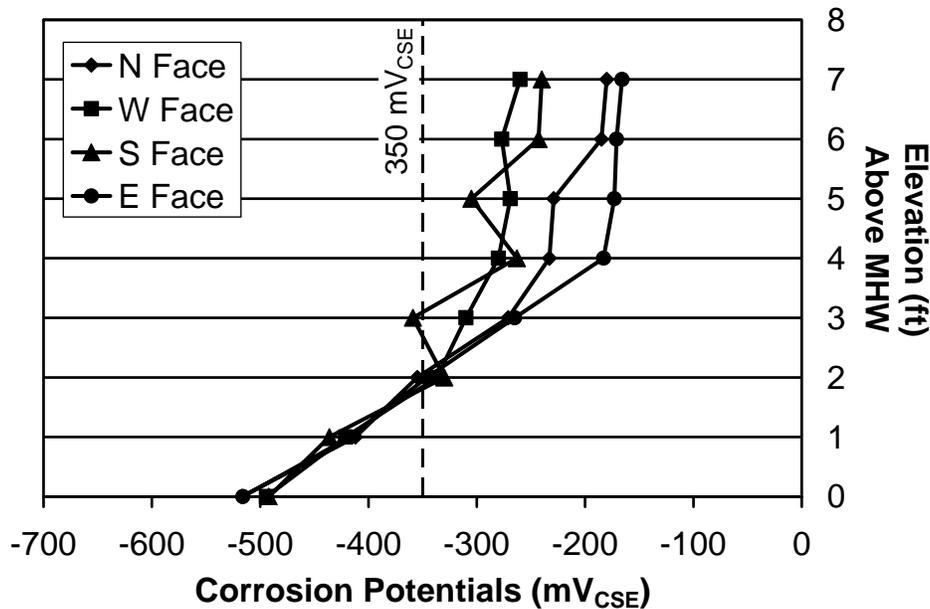
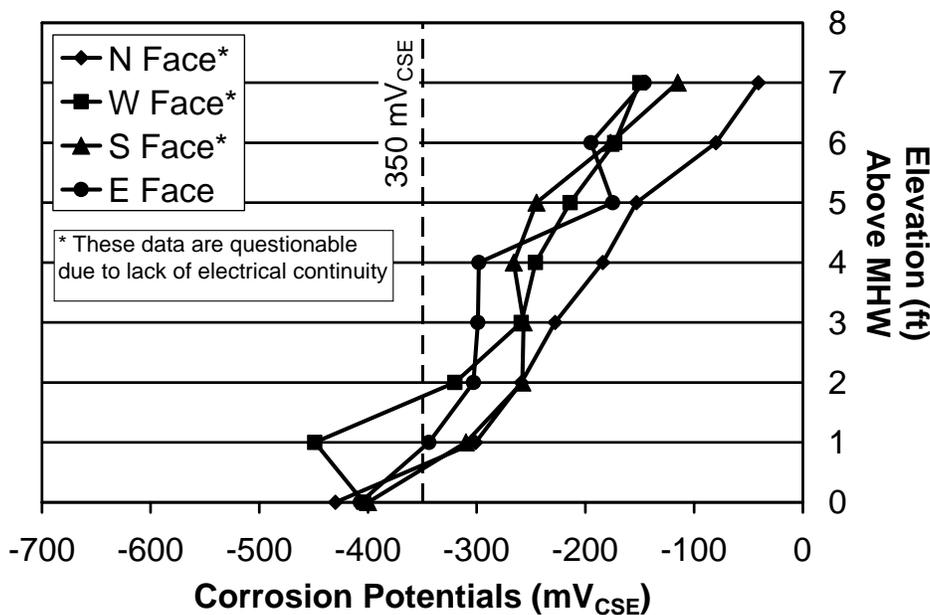
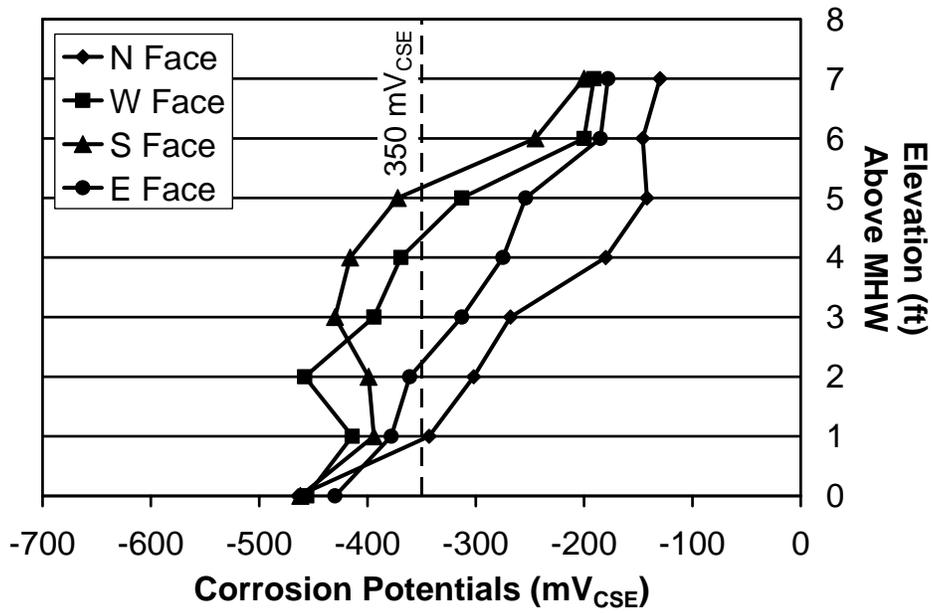
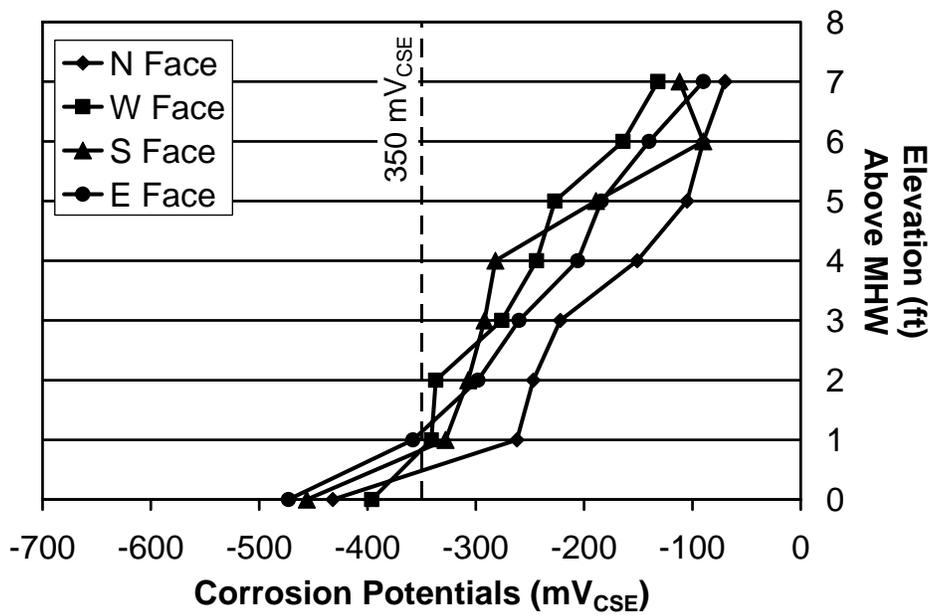
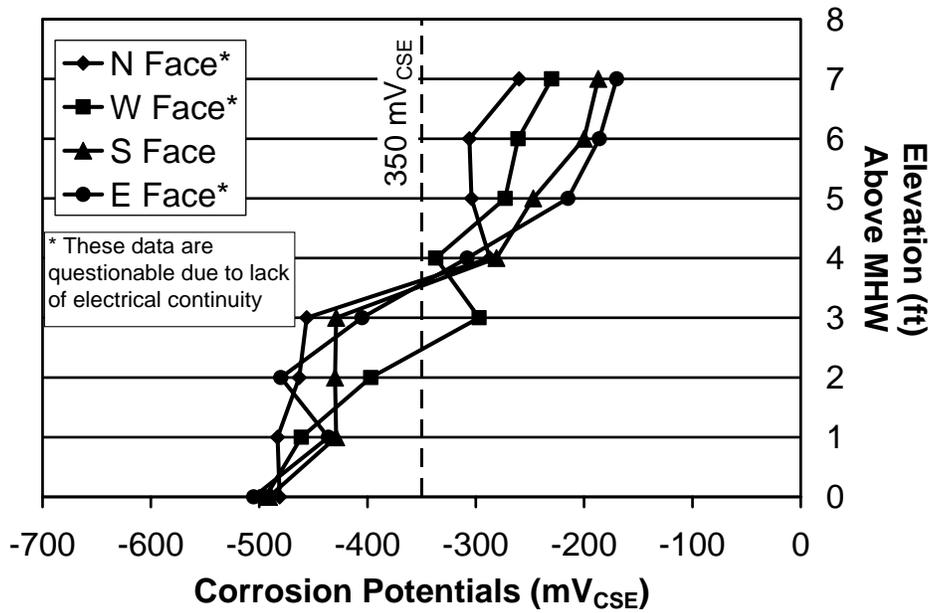
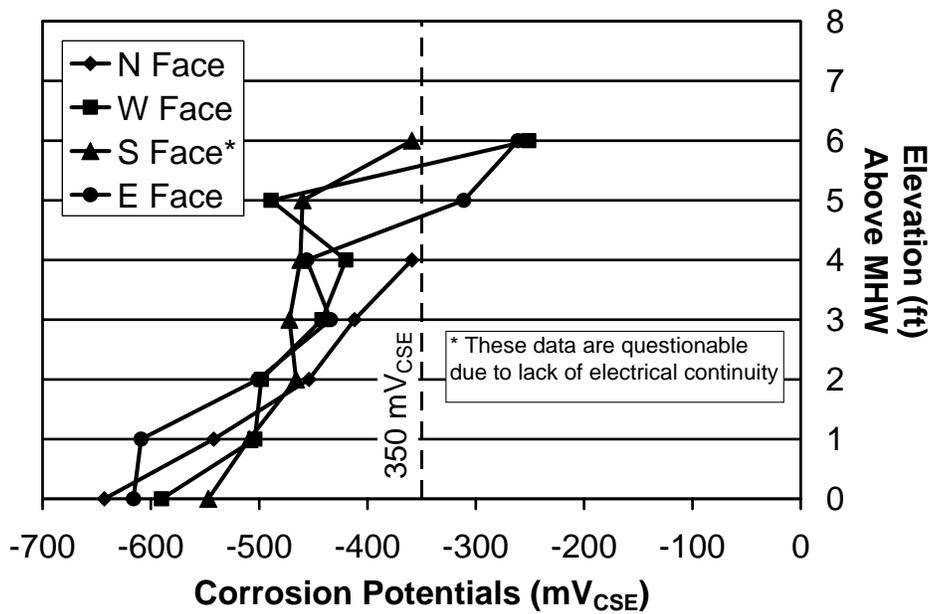
The $-350\text{mV}_{\text{CSE}}$ demarcation on the plots provides an elevation below which corrosion activity was likely. Piles 39-2 and 40-3J have potentials more negative than $-350\text{mV}_{\text{CSE}}$ over most of the seven feet above MHW. Piles 40-4, 29-2, and 44-2 have potentials less negative than $-350\text{mV}_{\text{CSE}}$ over the height where measurements were taken, while pile 32-3J is split nearly evenly. These results will be related to the flexural capacities later in this report.

Figure 6 – Corrosion potentials of selected piles. Measurements taken in the field.

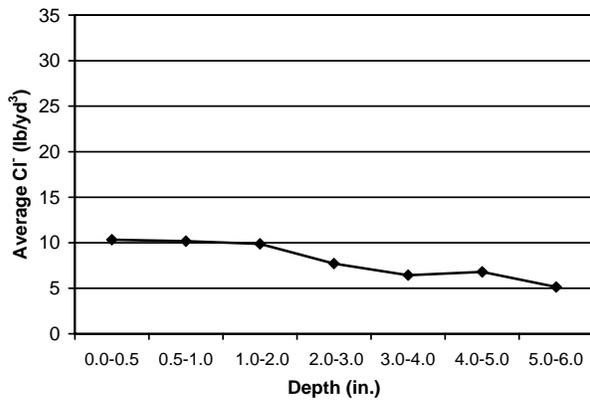
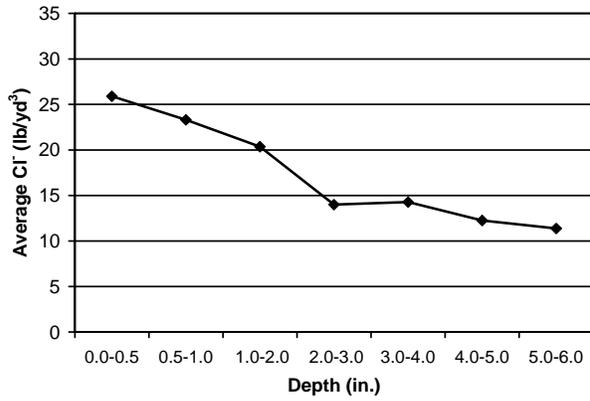
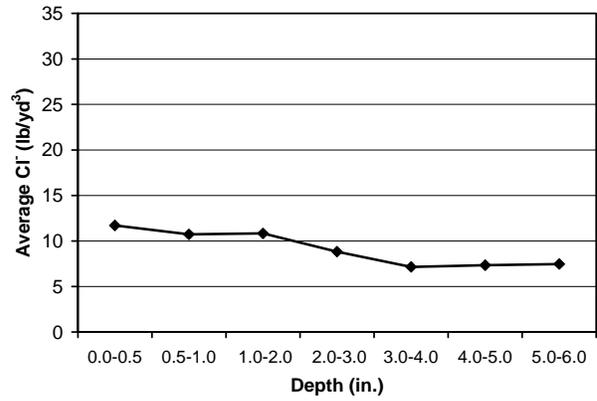
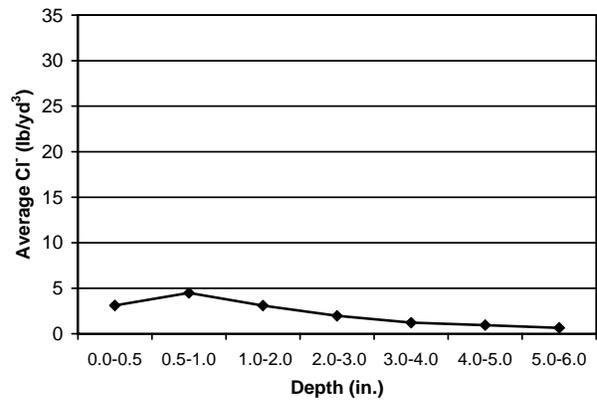
Figure 8 – Chloride content, Pile 32-3J

The chloride profiles show that the greatest contamination occurs in the submerged portion of the pile where the concrete is continuously exposed to the salt water. The location of next greatest contamination is that of the tidal zone where the concrete is repeatedly submerged by the tidal fluctuation, followed by the splash zone and then the dry zone. Corrosion generally occurs in the splash zones due to the combination of chloride contamination and oxygen availability to support the corrosion reactions.

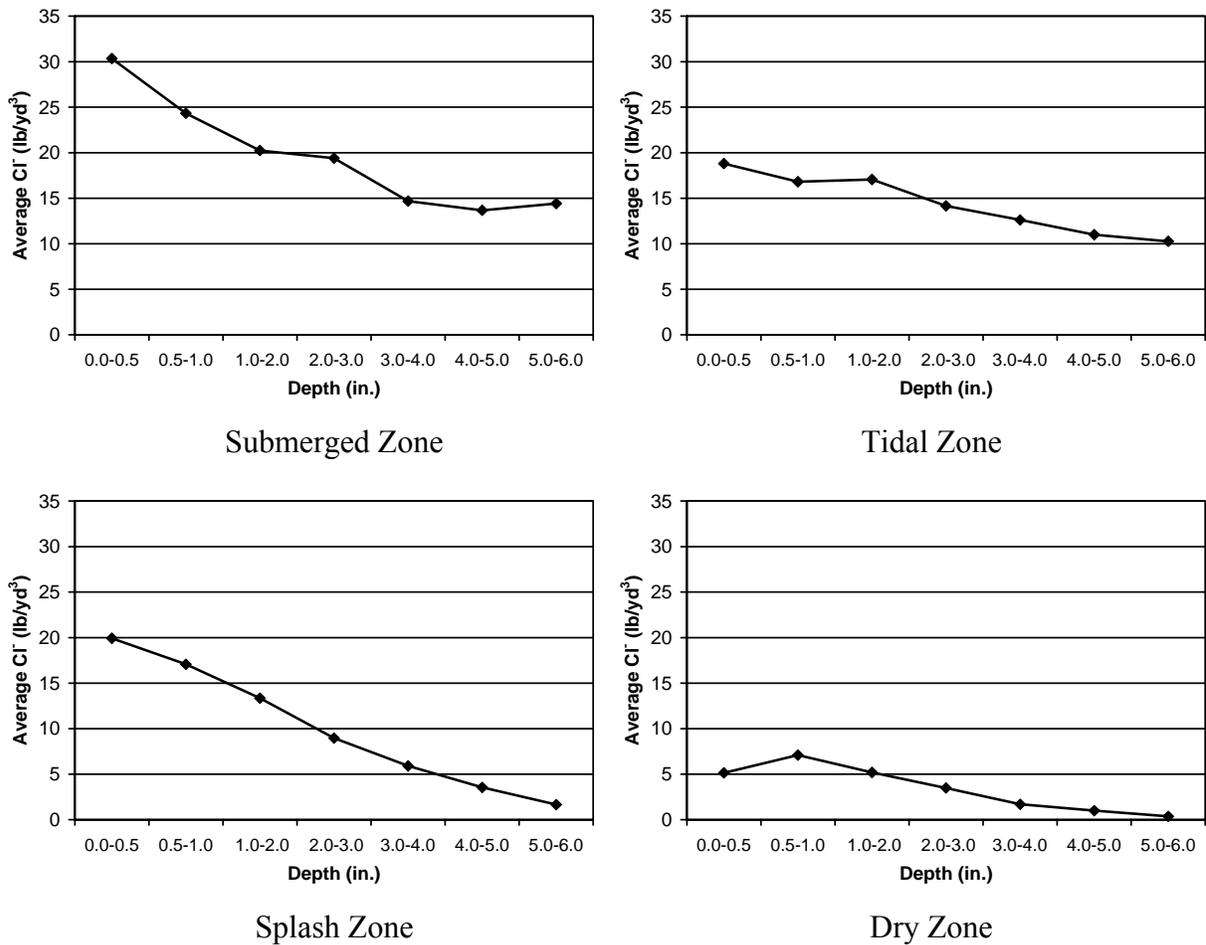
Figure 9 – Chloride content, Pile 44-2

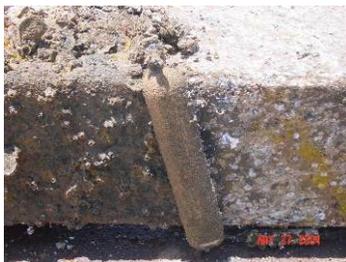
The first pile sampled was 21-4, which was cut and pulled from the bay on May 27, 2004. The pile was placed on the demolition barge to allow samples of the prestressing strand to be taken for hydrogen testing. Although potentials were not taken following extraction of 21-4, inspection of the bulk anode indicated that the anode was still electrically connected to the strand and likely providing protection. The second pile was 44-2, which was sampled at the FDOT Structures Research Center after it had been tested in flexure. This pile did not have a cathodic protection system installed. Accordingly sampling of this pile was intended to provide background data on the dissolved hydrogen.

Figure 10 – Bulk zinc anode on pile 21-4

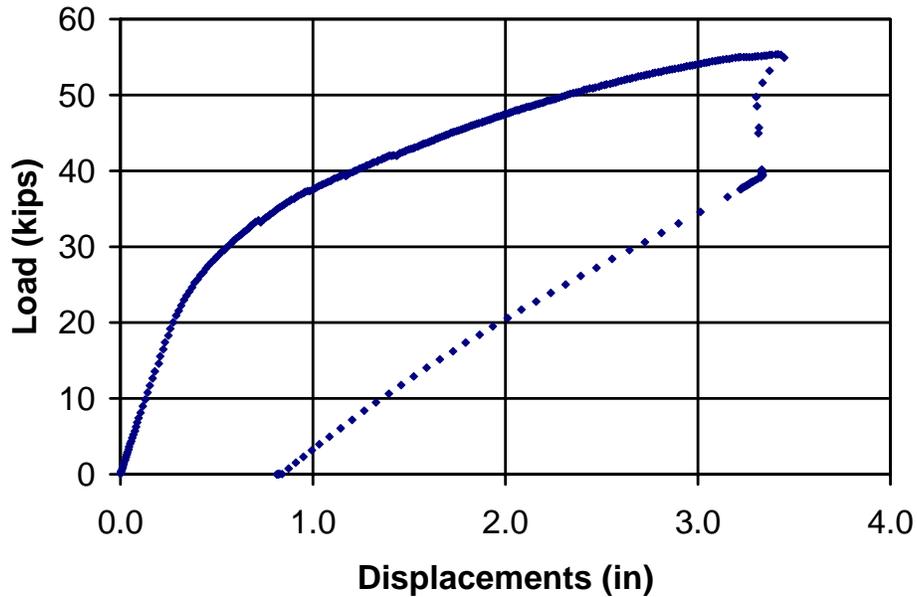
flexural capacity comparable to that measured in the shear test. No strands ruptured during this test as indicated by the smooth and continuous load deflection response.

Figure 23 – Pile 40-4 load displacement response

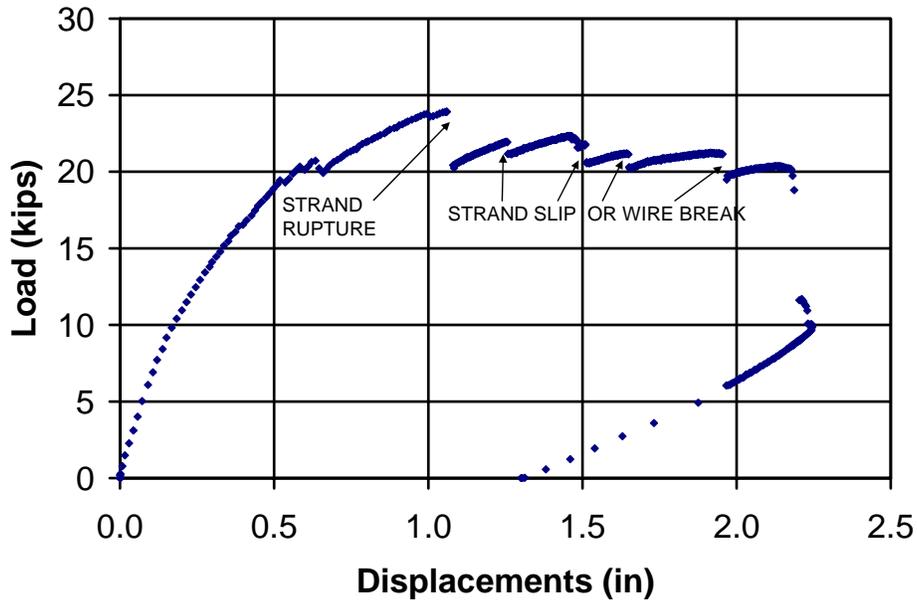
In many of the tests, the pile capacity was controlled by strand rupture or slip or both. Figure 24 shows the load-displacement behavior for pile 32-3J. Denoted on the plot are the locations where drops in load corresponded to audible sounds video-recorded during testing. These sounds are attributed to either strand rupture or slip since they are associated with a sharp reduction of load. Video recordings of each test were reviewed to determine the number of breaks or slips noted in each test. These are presented along with the failure mode in Table 13.

Figure 24 – Pile 32-3J load-displacement response

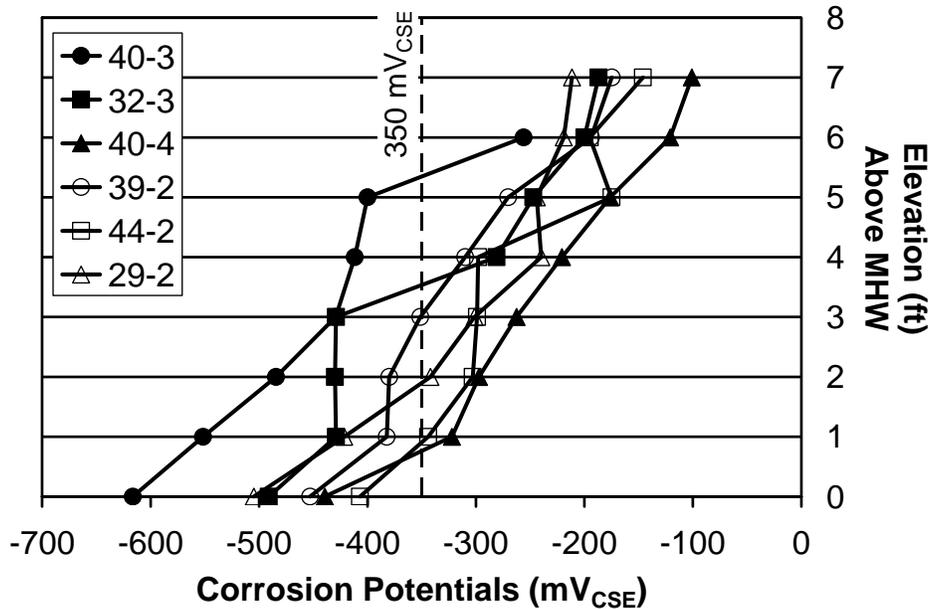
elevation including only those data in which electrical continuity of the ground connection was confirmed. The plot clearly indicates that some of the piles have very negative potentials over most of their height. Pile 40-3J, for example, has readings more negative than -350 mV up to nearly 6 ft. above MHW. This pile retained only 31% of its calculated capacity. Conversely, pile 44-2 has only one reading more negative than -350mV near the MHW line and retained more than 100% of its calculated capacity. As the length of pile in the splash zone that has very negative readings increases it appears that the flexural capacity decreases.

Figure 25 – Compilation of the average corrosion potential of the tested piles.

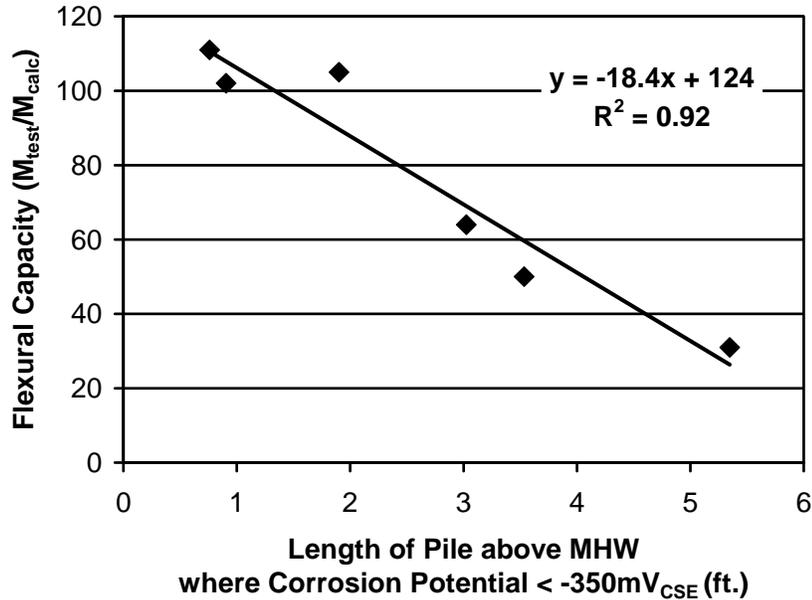
Figure 26 – Relationship between flexural capacity and corrosion potential

Figure 26 illustrates this trend. The normalized moment capacities are shown on the vertical axis and the horizontal axis shows the length of pile above the mean high water over which the measured corrosion potentials are less than -350 mV_{CSE}. There appears to be a linear relationship between the measured corrosion potential and flexural capacity that is quite strong ($R^2 = 0.92$). Visual inspection of the strand after the flexural test indicated that corrosion was most severe at the base of the splash zone (just above the MHW) and would taper in intensity as the distance from the MHW was increased. Field observations also confirm that the corrosion tends to migrate upward on the pile through the splash zone, which supports the behavior illustrated by the plot. The plot can be summarized as follows. When the average corrosion potential was less than -350 mV_{CSE} over an approximate height of:

- 1 ft. above the MHW, then 100% of the pile capacity remained.
- 3 ft. above the MHW, then approximately 68% of the pile capacity remained.
- 5 ft. above the MHW, then approximately 32% of the pile capacity remained.

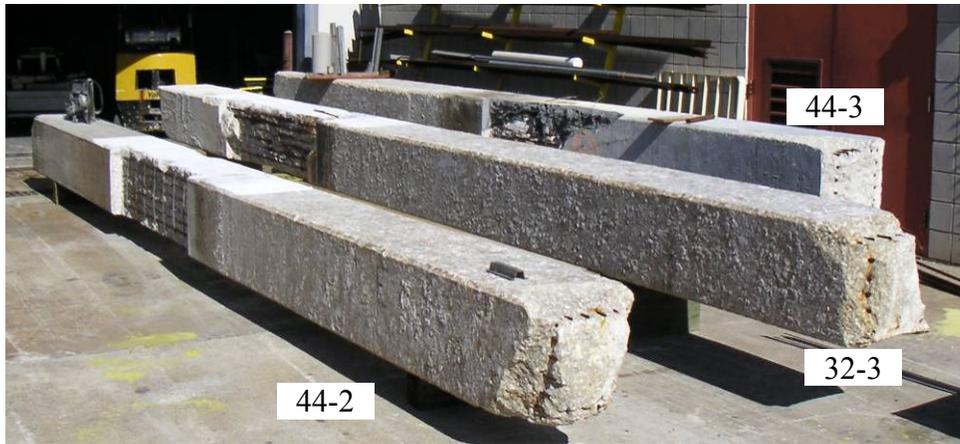
Figure 27 – Piles being excavated to examine corroded strand.

Following flexural testing, piles 44-3CP (cathodically protected), 32-3J (concrete jacket), and 44-2 were excavated to inspect the strands in the splash zone. Figure 27 shows the piles after excavation. Concrete was removed from the face that carried the extreme flexural tension during flexural testing, which was oriented to coincide with the splash zone. Strands were examined for corrosion and wire breaks. Generally, moderate to severe corrosion was noted on the prestressing strands. In some cases the prestressing strands were completely consumed by corrosion as can be seen in the top two strands in Figure 28. Figure 29 shows a range of corrosion. The top two strands are severely corroded while the bottom four strands have corrosion ranging from light to severe as the strands enter the splash zone. The portion of the pile above the splash zone when it was in service is to the left of the figure.

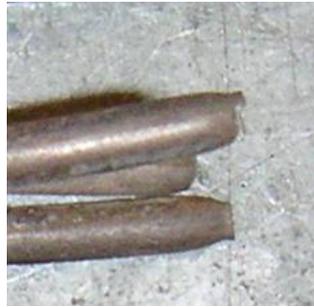
Figure 33 shows the behavior of a severely corroded strand when loaded to rupture. The wires generally ruptured at varying locations along the length of the strand. In contrast, Figure 34 shows the rupture pattern of an uncorroded strand taken from the piles in which the individual wire ruptures occur in very close proximity to each other. Furthermore, each wire exhibits the ductile necking and cup/cone fracture surface.

Figure 34 – Failure mode of uncorroded prestressing strand sample taken from pile 44-2. Ductile necking of the cross section and cup/cone fracture surface are shown.

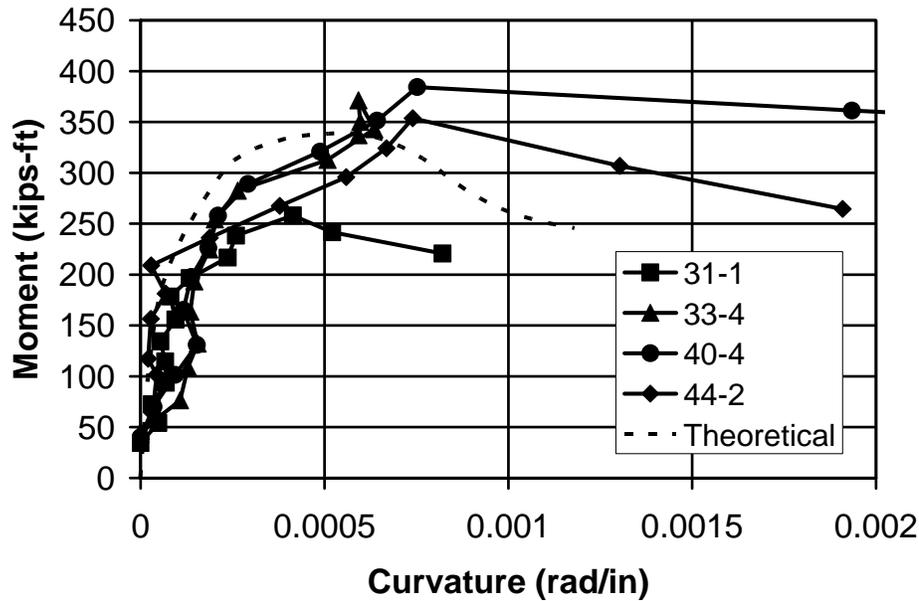
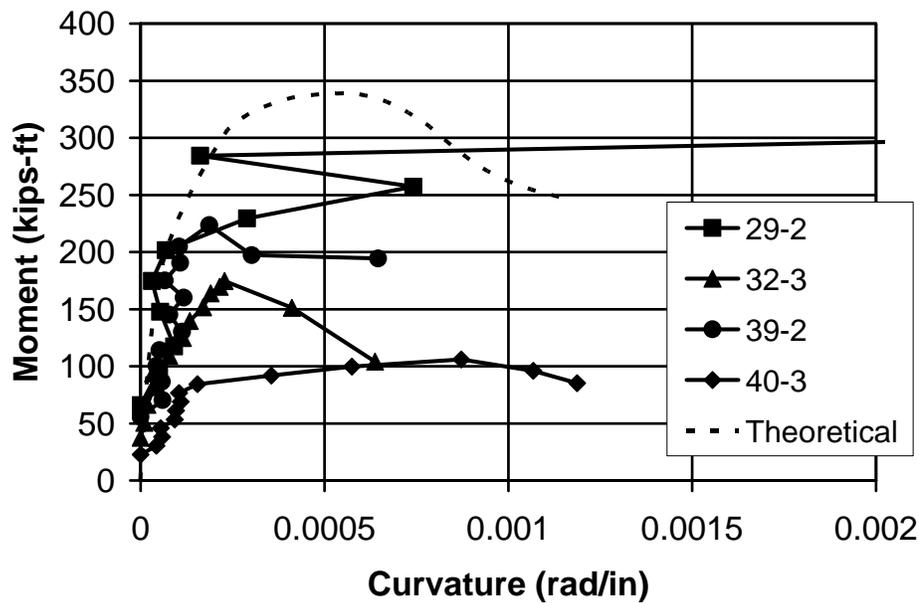
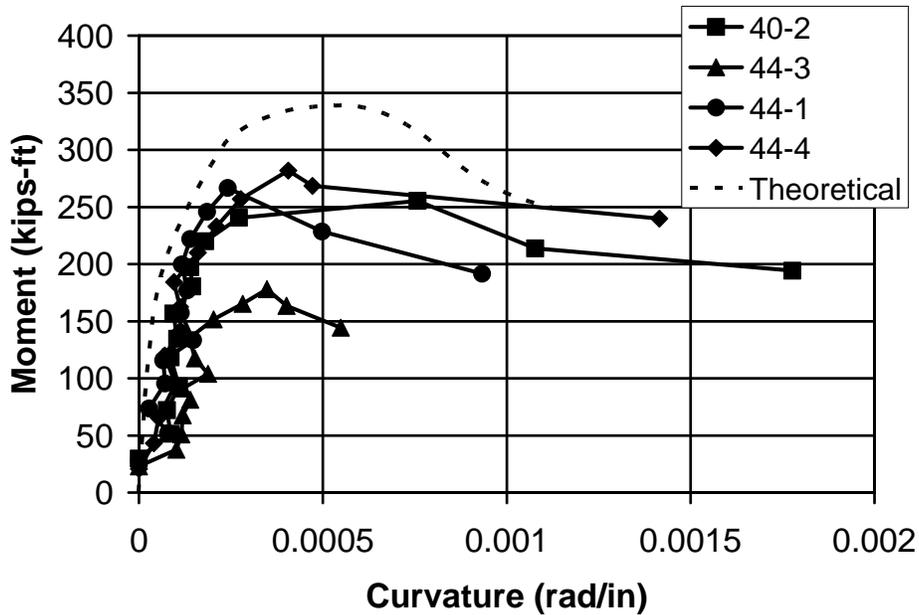
Figure 35 – Actual vs. theoretical moment-curvatures

curvatures at or adjacent to that location were used in all other points for a particular pile. Figure 35 shows the results of the moment-curvature analysis. Although this method compounds error and results in somewhat distorted curvature profiles, the results are still insightful. Individual plots are included in Appendix D.

Each plot in Figure 35 also shows a theoretical moment curvature, which was calculated using strain compatibility along with the material properties obtained from tests on concrete cores and prestressing strand coupons pulled from the piles following the structural tests. Table 15 shows the properties used to calculate the moment curvature relationship. The average compressive strength of the two cores taken from pile 31-1 was used along with an average effective depth of 17.19 in. Average mechanical properties of the strands were also used to derive the moment curvature.

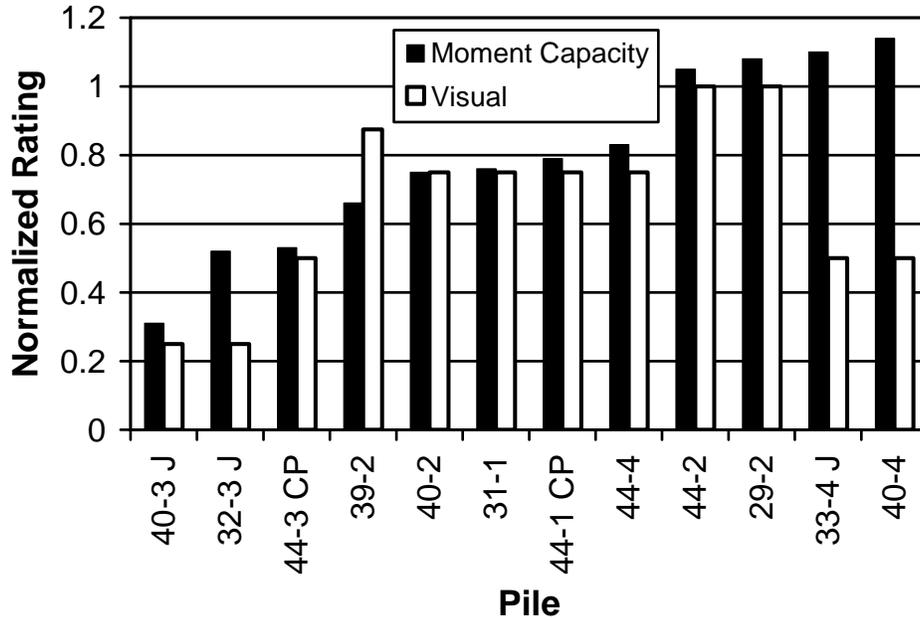
Figure 36 shows the data plotted in order of increasing moment capacity to give a visual impression of the distribution of capacity loss that these piles experienced. Several of the piles retained their full capacity while the most damaged pile lost nearly 70% of its capacity.

Figure 36 – Comparison of visual rating with experimental moment capacities

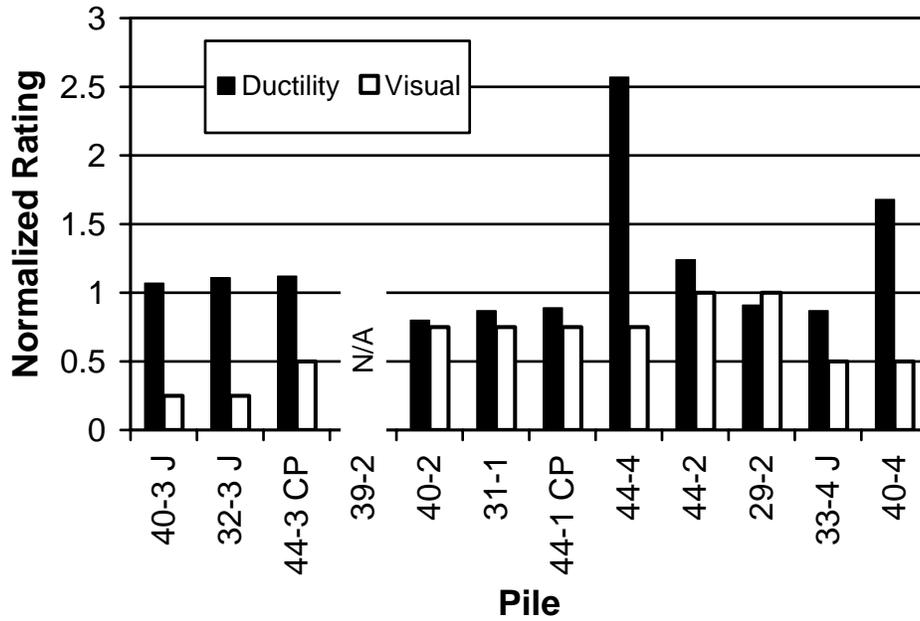
Figure 37 shows a comparison of the visual ratings and the ductility factors calculated from the experimental data. Ductility appears to be relatively constant with the exception of 44-4 and 40-4. Consequently, no clear relationship between visual ratings used in this research and the ductility factors was found.

Figure 37 – Comparison of visual rating with experimental ductility

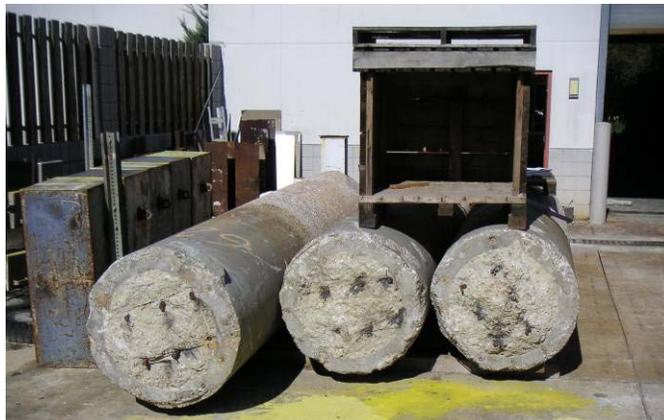
Precast post-tensioned cylinder piles from the Escambia Bay bridge carrying route I-10 were tested to determine flexural capacity. The piles were taken from the piers that were damaged by Hurricane Ivan in 2004. The bridge was constructed in 1964. Figure 38 shows the piles as recovered from the bay. The photo shows the top end of the pile, which has been filled with concrete to connect to the cap beam. The connection was made by six mild steel reinforcing bars. Figure 39 shows the opposite end of the piles. The cylinder piles were approximately 36-in. diameter with a 5-in. thick wall. Twelve post-tensioning tendons were evenly spaced around the perimeter at the mid-thickness of the cylinder wall. Each tendon had 10 0.192-in. diameter parallel prestressing wires surrounded by prestressing grout (Figure 40). The number of wires in the tendons was increased to twelve in the region near the connection to the cap beam. It appears that the tendon passages were cast into the cylinder piles without the use of a conduit.

Figure 38 – Three piles prior to testing, view of filled end of pile.

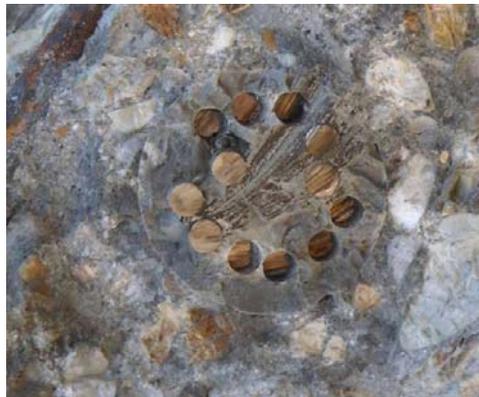
Figure 40 – Prestressing tendon from cylinder pile. Note grout surrounding wire with no evidence of conduit.

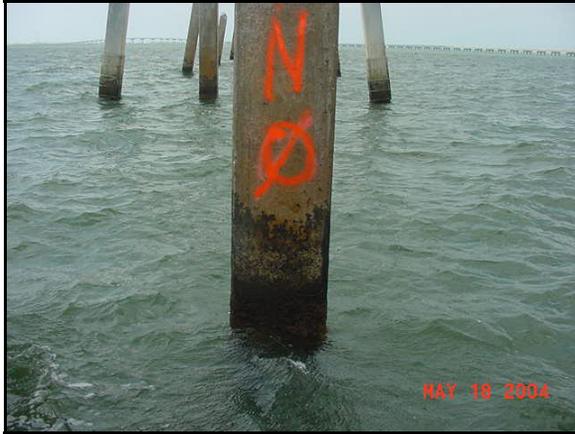
1

NORTH FACE PILE 29-2

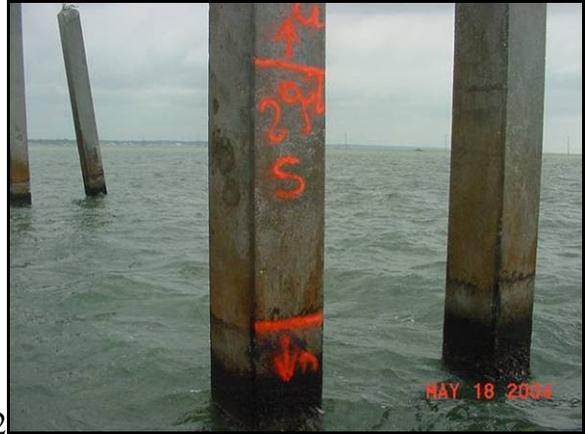
2

SOUTH FACE PILE 29-2

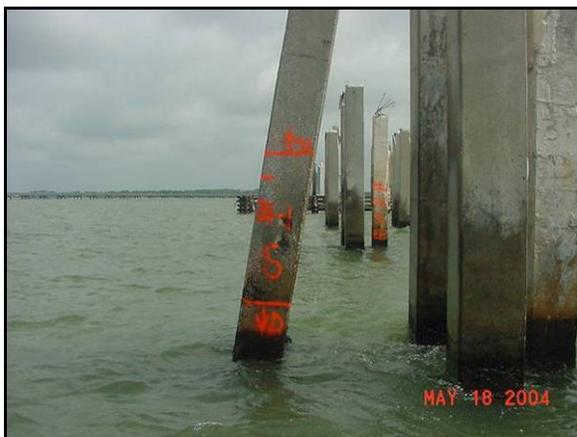
5

SOUTH FACE PILE 31-1

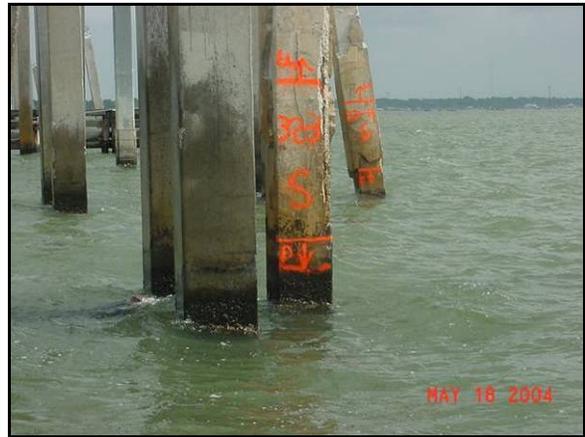
10

SOUTH FACE PILE 32-3J

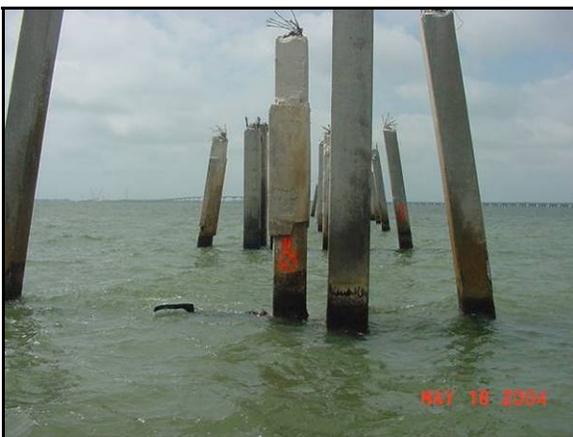
11

NORTH FACE PILE 32-3J

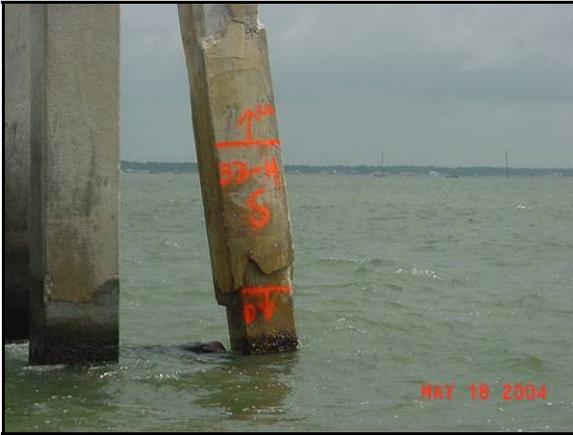
15

SOUTH FACE PILE 33-4J

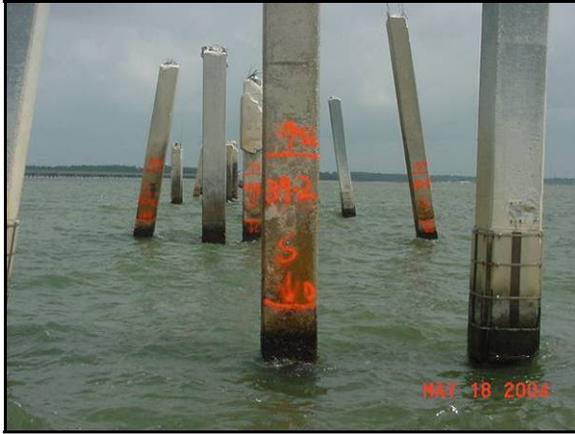
19

SOUTH FACE PILE 39-2

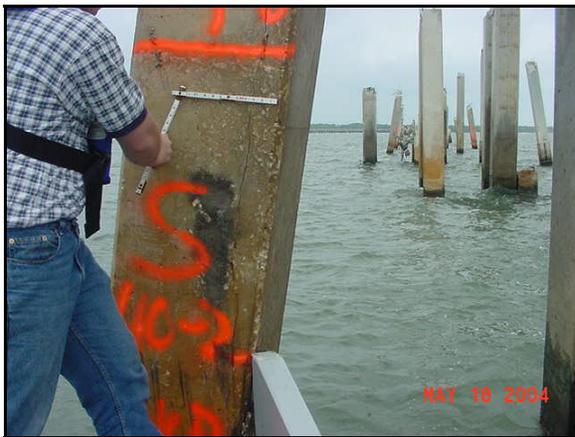
22

NORTH FACE BENT 40

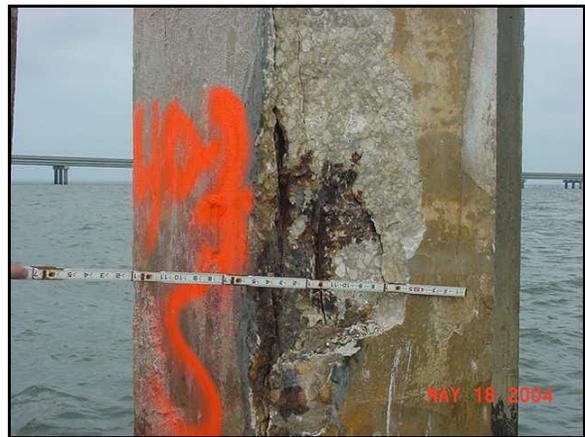
23

SOUTH FACE PILE 40-2

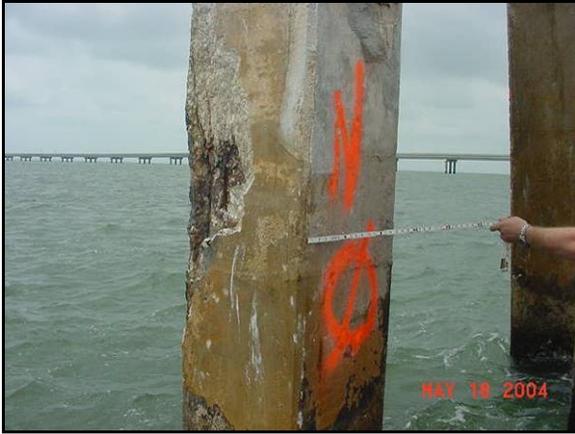
24

SOUTHEAST CORNER PILE 40-3J

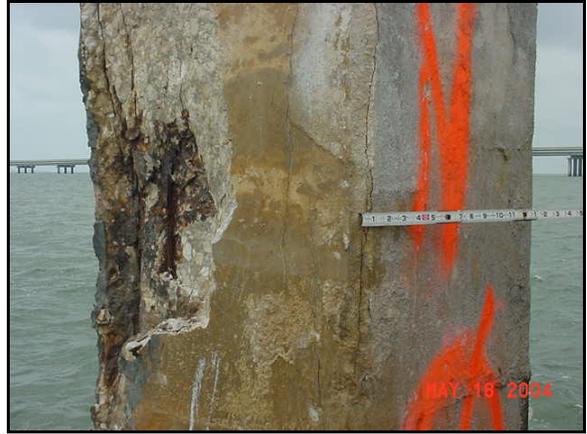
25

NORTHEAST CORNER PILE 40-3J

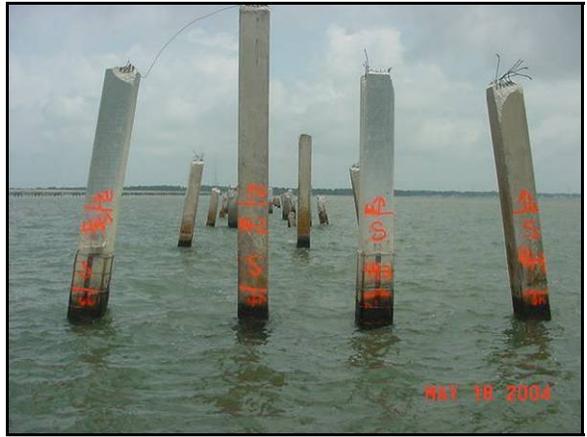
27

SOUTH FACE BENT 44

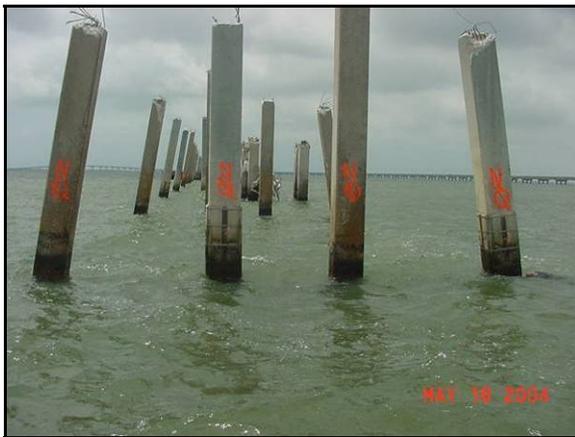
28

SOUTH FACE BENT 44

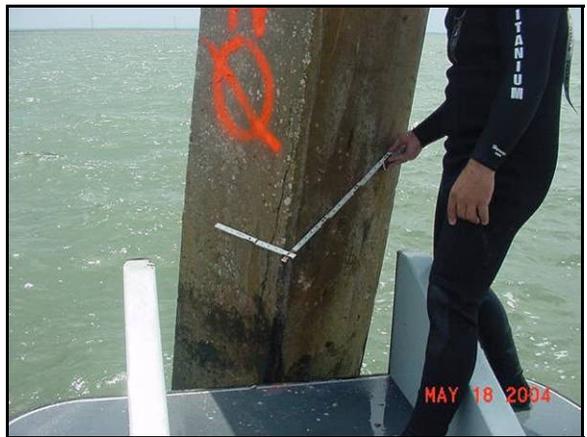
29

NORTH FACE BENT 44

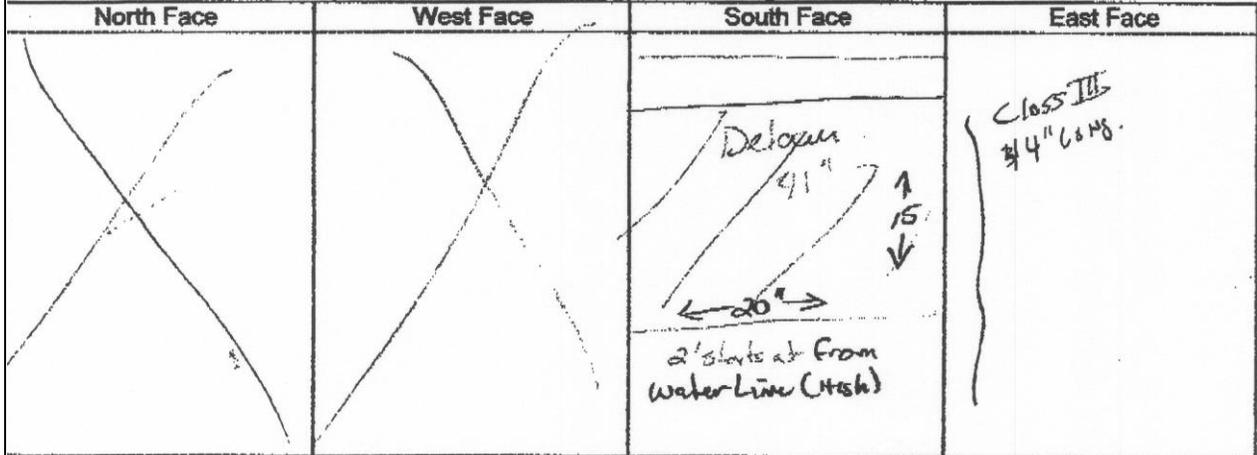
Piling 39-2

NDT Concrete Cover Measurements: 2.5", 2.95", 2.9", 2.65", 3.1", 3.3"
 Original Cover on Exposed Steel: 2.5"

Elevation, ft *	Corrosion Potentials, mV CSE				Concrete Resistivity, Kohm-cm
	N Face Strand 18	W Face Strand 12	S Face Strand 8	E Face Strand 6	E Face
0	-464	-456	-462	-430	43.1
1	-343	-414	-394	-378	26.1
2	-302	-458	-399	-361	29.4
3	-268	-394	-430	-313	30.6
4	-180	-369	-416	-275	63.1
5	-142	-313	-372	-254	44.3
6	-146	-200	-245	-185	63.7
7	-130	-191	-200	-178	68.1
8					
9					
10

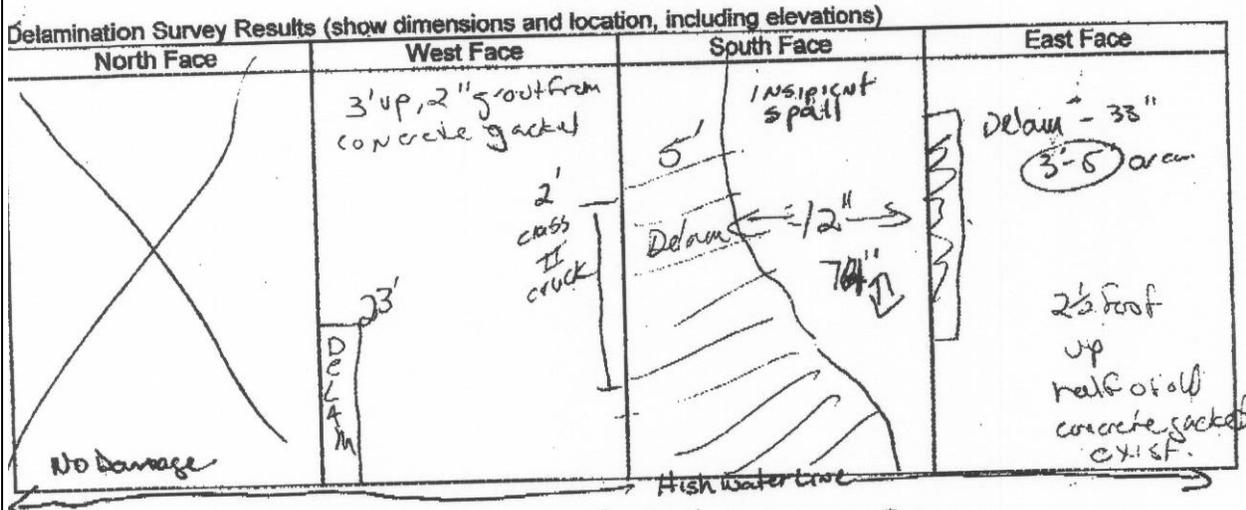
Piling 32-3J

NDT Concrete Cover Measurements: 2.7", 2.9", 2.95", 2.8", 2.5", 3.0"
 Original Cover on Exposed Steel: 3.0", 3.0", 2.75"

Elevation, ft *	Corrosion Potentials, mV CSE				Concrete Resistivity, Kohm-cm
	N Face Strand 17 ¹	W Face Strand 12 ¹	S Face Strand 9	E Face Strand 5 ¹	W Face
0	-481	-494	-491	-505	9.0
1	-483	-461	-429	-436	6.8
2	-463	-397	-430	-480	10.8
3	-456	-297	-429	-405	17.2
4	-287	-337	-281	-308	23.7
5	-304	-273	-247	-215	25.1
6	-306	-261	-200	-186	32.5
7	-260	-230	-187	-170	35.3
8					
9					
10

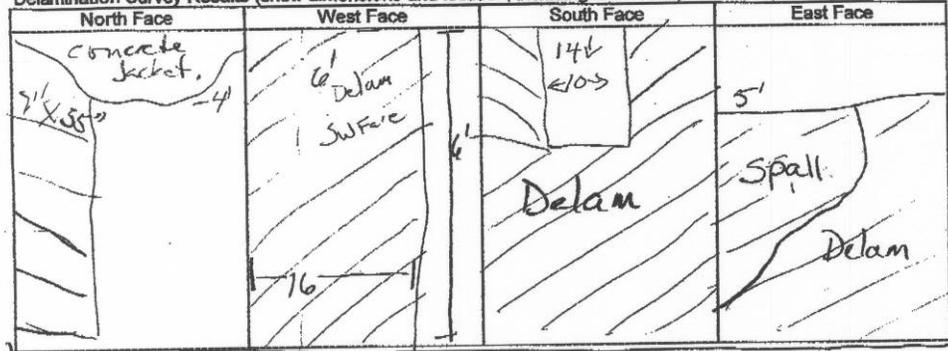
NDT Concrete Cover Measurements: 2.45", 2.5", 2.25", 2.6", 2.7", 2.65"
 Original Cover on Exposed Steel: 2-7/8", (2-3/4", 3.00") Exposed bars

Elevation, ft *	Corrosion Potentials, mV CSE				Concrete Resistivity, Kohm-cm
	N Face Strand 18	W Face Strand 12	S Face Strand 6 ¹	E Face Strand 1	W Face
0	-643	-590	-547	-616	925
1	-542	-504	-509	-609	9.2
2	-454	-498	-466	-501	8.2
3	-412	-442	-472	-434	16.6
4	-359	-420	-462	-456	16.3
5		-489	-460	-311	14.9
6		-251	-359	-261	29
7					
8					
9					
10

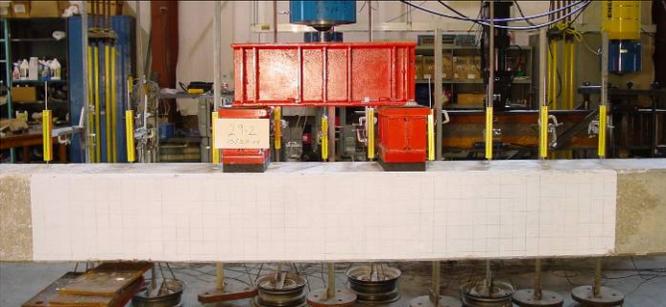
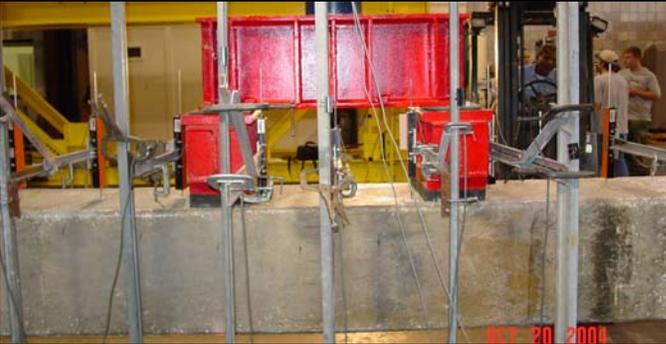
29-2

Pre-Test Condition	
Minimal to no damage was visible on this pile.	
Pre-Test Photos

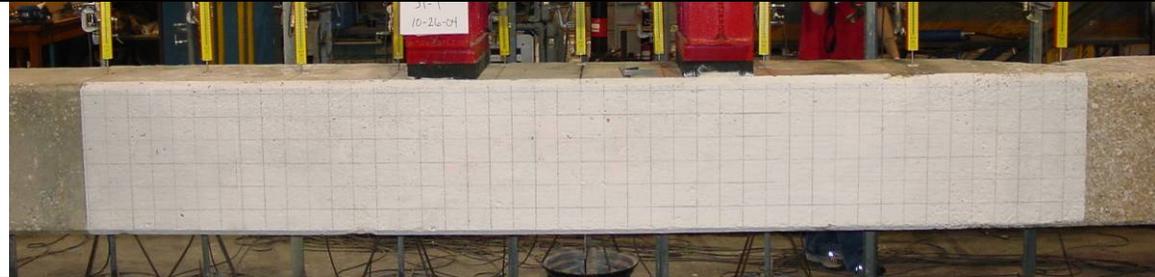
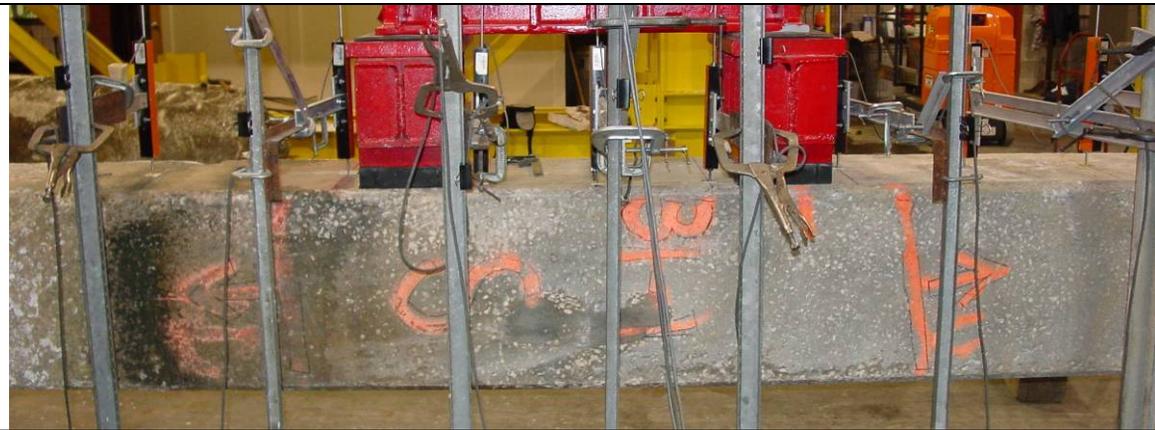
31-1

Minimal damage was visible on the pile.

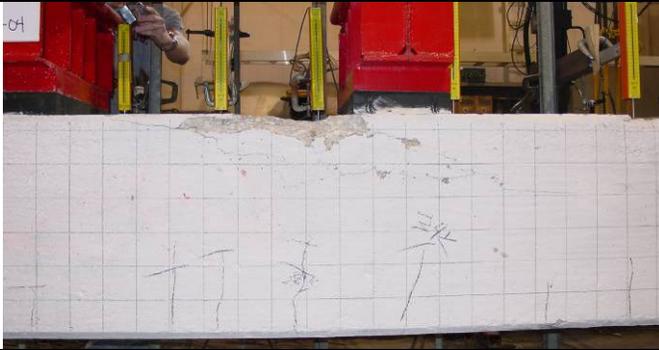
First crack appeared at 28 kips. The compression zone concrete was only slightly crushed. The pile showed compression zone crushing to a limited extent. The flexural cracks mostly closed after unloading.

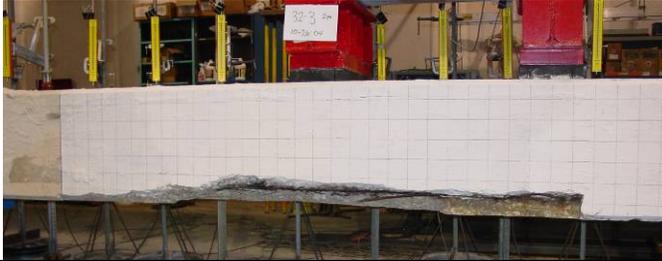
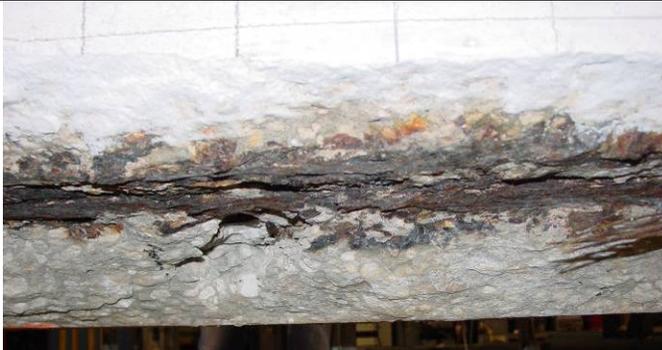
32-3J

Severe spalling, corrosion and strand damage were visible. Under the northern load application point, the bottom west corner had spalled off to expose the steel strands which were completely rusted through and had debonded from the concrete.

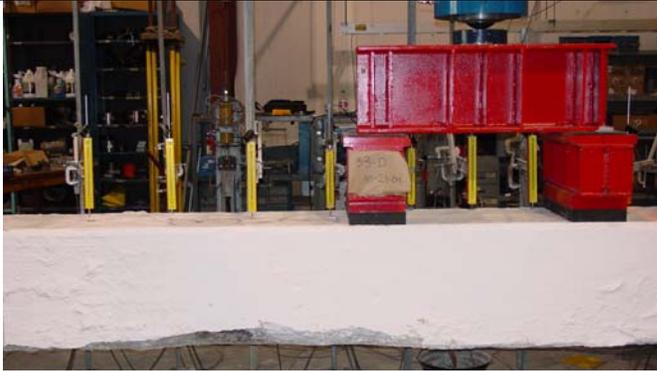
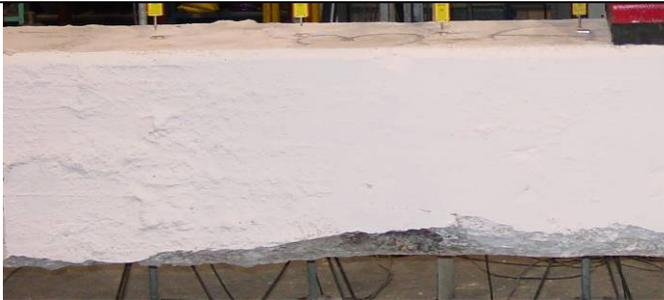
33-4J

Concrete had spalled off from the bottom west corner of the cross section under the north loading point. Strands were exposed and rust was visible.

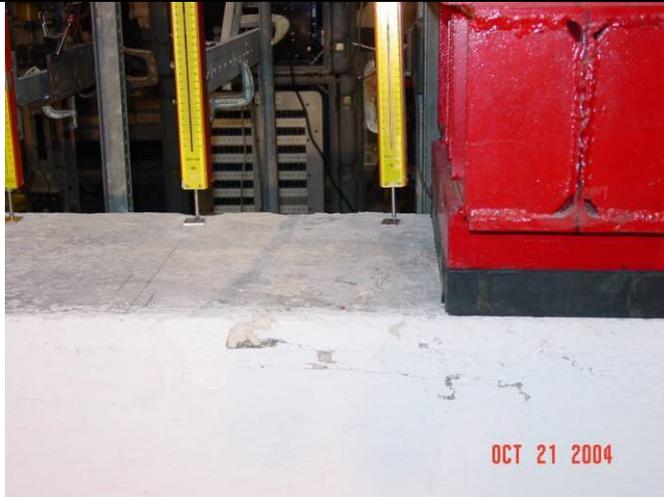
There were flexural cracks visible on the pile. The concrete in the compression zone was only slightly crushed at the completion of the test.
