Final Report

June 2006

UF Project No. 00051711
Contract No. BD545, RPWO #27

ST. GEORGE ISLAND BRIDGE PILE TESTING

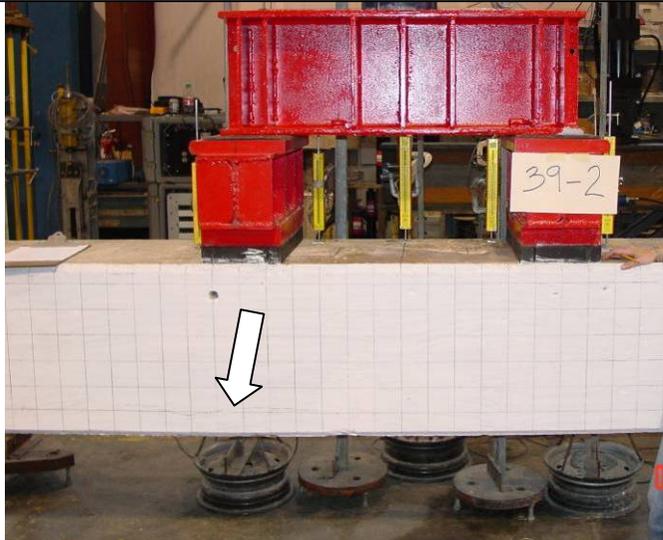
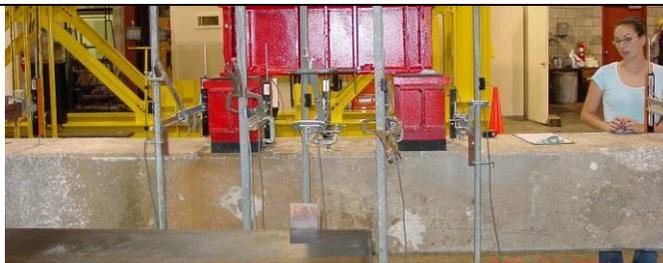
39-2

Minimal damage was visible on the majority of the pile. However, one crack was visible at the bottom of the west face of the pile, under the northern load point. The crack was approximately 30" long, running parallel with the bottom layer of steel at approximately 3" from the bottom edge.

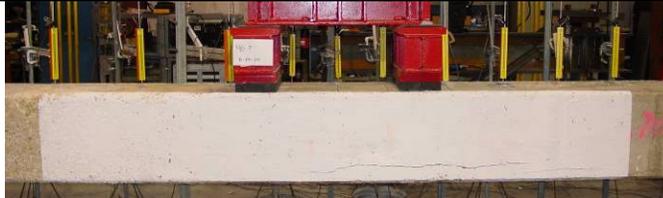
40-2

Cracks up to eight feet long were visible at the bottom side of the pile on both east and west faces. The crack was approximately 3" to 4" above the bottom edge of the pile. Rust staining was visible through the crack on the east face of the pile.

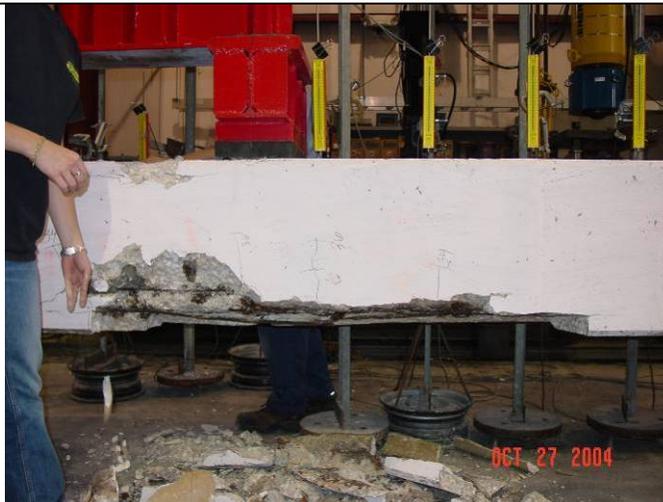
Cracking first appeared on this pile at 15 kips. Many flexural cracks were emanating off of the horizontal crack. Eventually all of the concrete below the horizontal crack fell off. This revealed that all of the strands were severely corroded and all the strands were broken. Crushing of the compression zone occurred between the load points. A dip in the load-deflection plot between 1" and 1.5" deflection may relate to the concrete falling off.

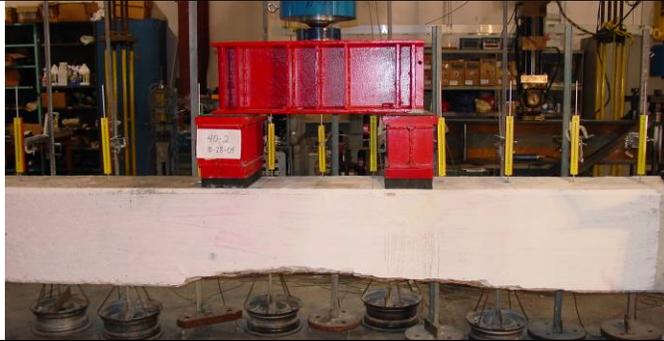
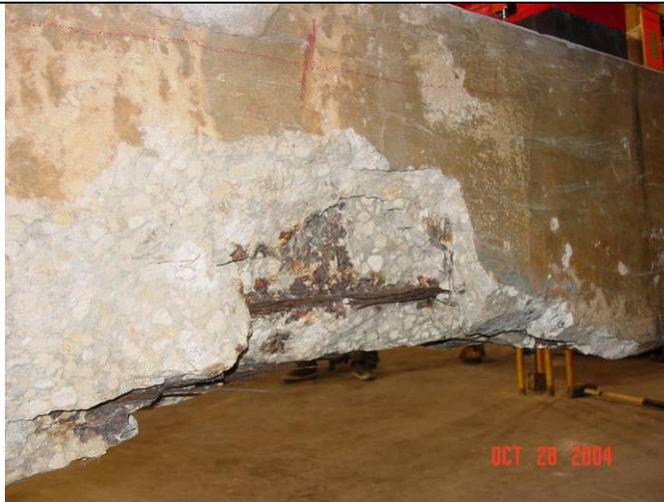
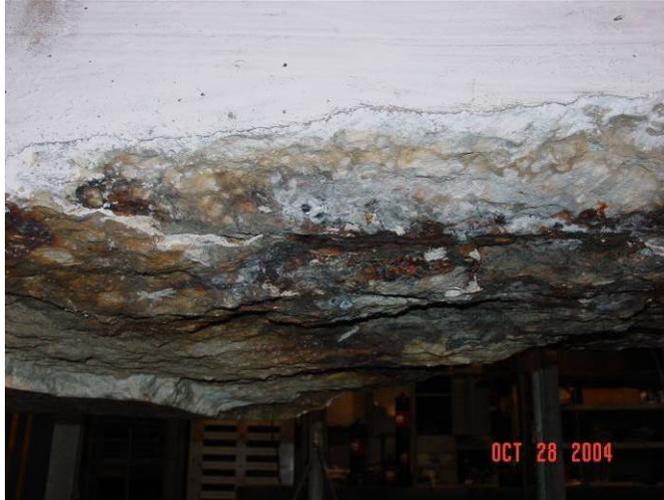
40-3J

Severe damage and spalling was evident on this pile. The bottom face of the cross section was missing prior to testing. Each strand on the bottom face of the pile was completely rusted through, had debonded and some were no longer intact. On the east face of the pile, a gap of approximately 12 in. wide and 12 in. high exposed another strand, which was also rusted and had debonded. Spalling and rust staining were extensive.

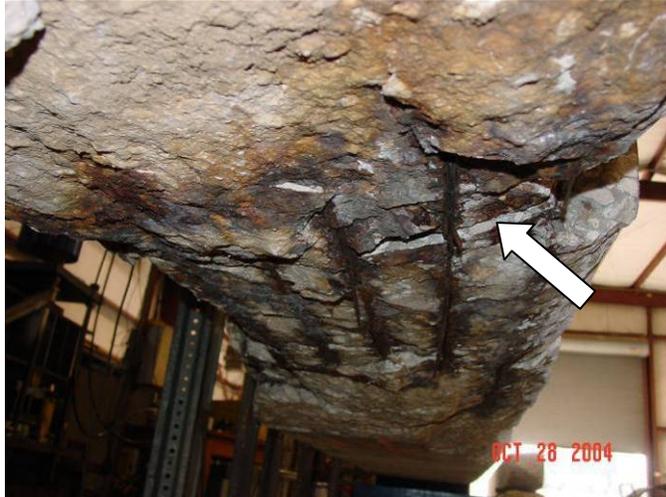
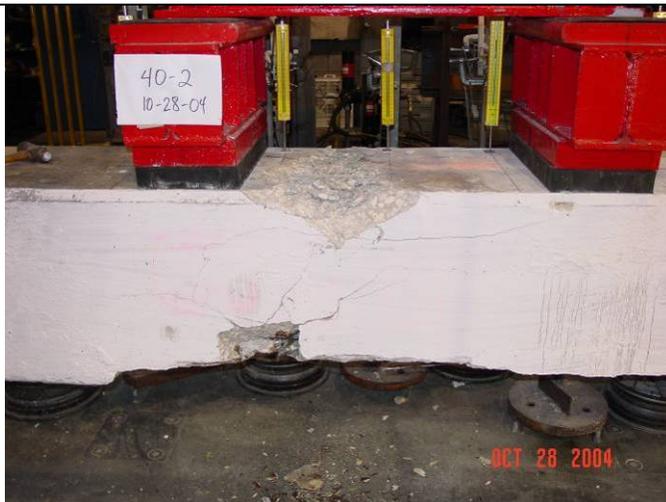
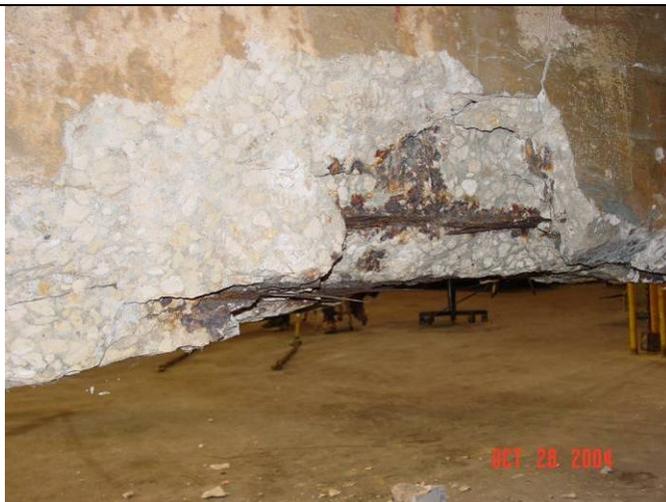
First crack appeared at 12 kips. Flexural cracks appeared mostly under the North load point. The concrete of the top face began to crush. Large pieces of concrete spalled off on the east side of the pile exposing more corroded strands.

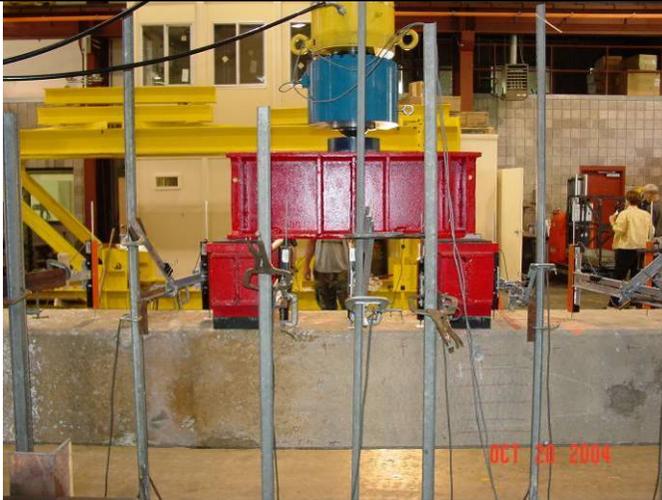
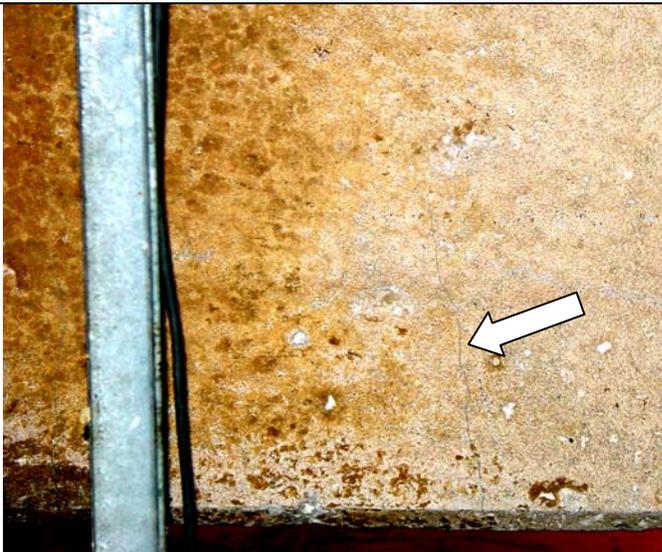
40-4

Some damage was evident on this pile. One vertical crack was visible on the west face of the pile in the middle of the splash zone. Some concrete spalling and subsequent patching was also evident.

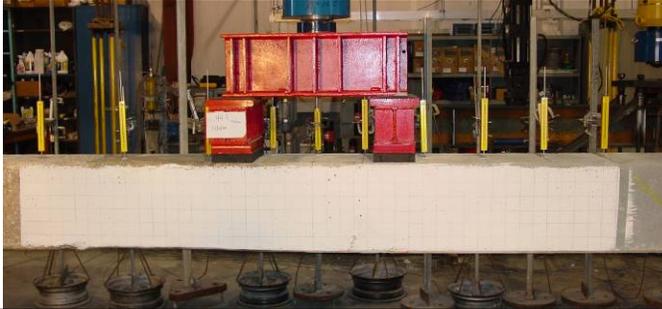
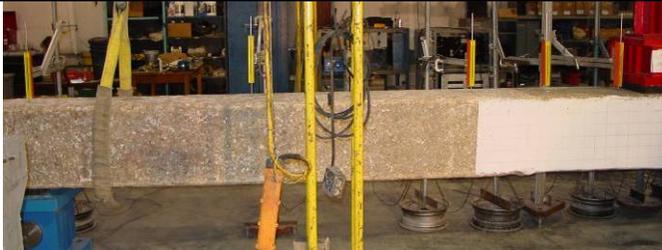
44-1CP

There were some small holes visible on the exterior of the pile, and minimal damage aside from one area on the bottom west corner approximately 2 ft. north of the north load point where a piece of concrete had chipped off.

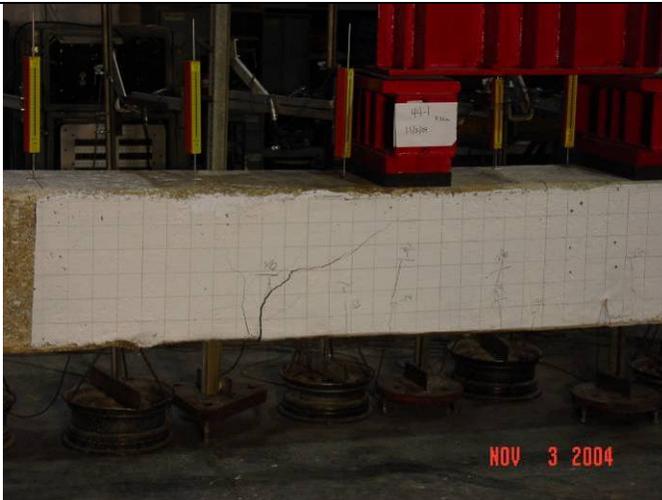
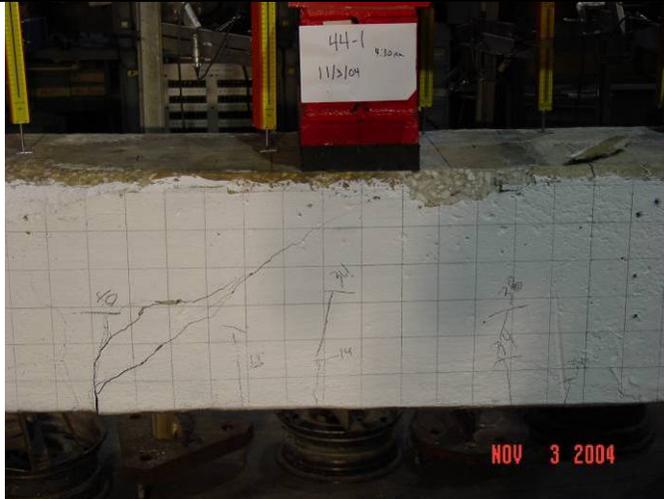
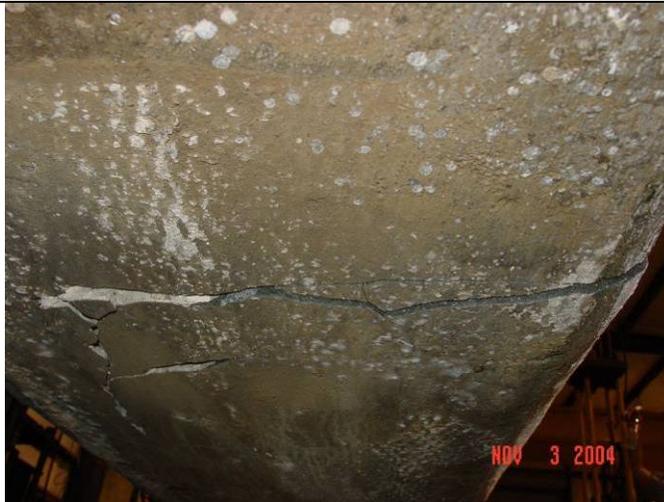
First crack appeared at 14 kips. The pile had multiple flexural cracks. One large flexural crack extended up from just under the north load point. The concrete on the top face was not crushed.

Underside of pile (bottom face of cross section)

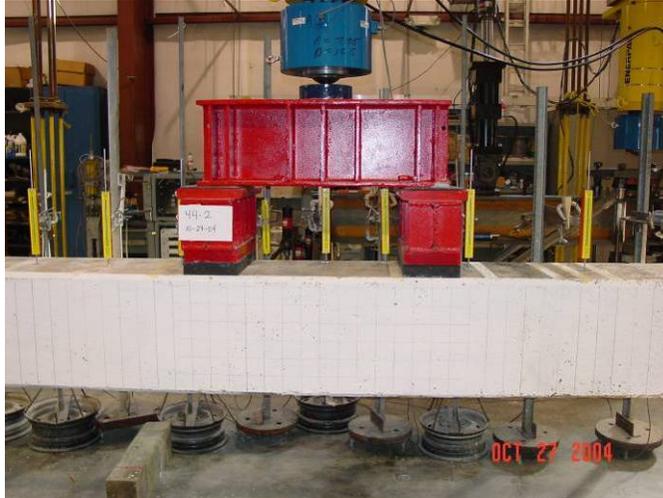
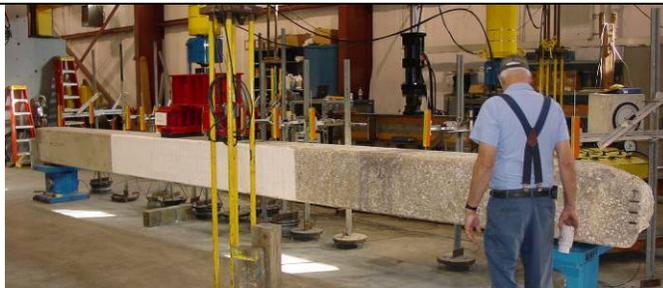
44-2

Minimal damage was visible in the splash zone of the pile.

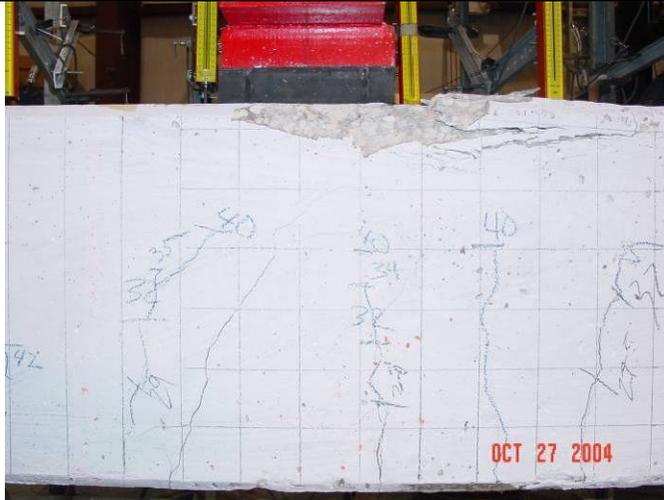
The first crack appeared at 24 kips. This pile had multiple flexural cracks within the splash zone. The concrete under the north support crushed. After testing, the cover was taken off the bottom face (tension zone) strands. There were a few broken wires but none of them were corroded very badly.

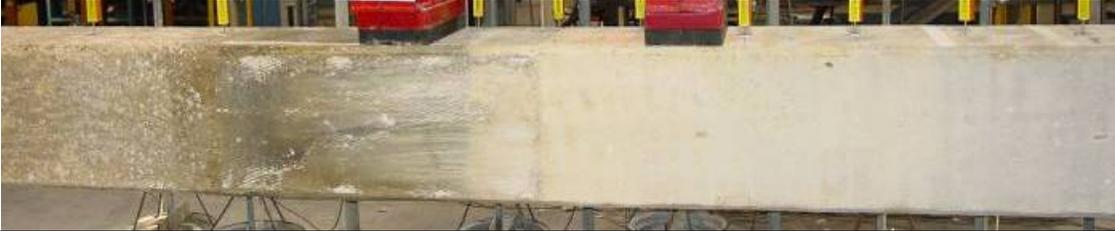
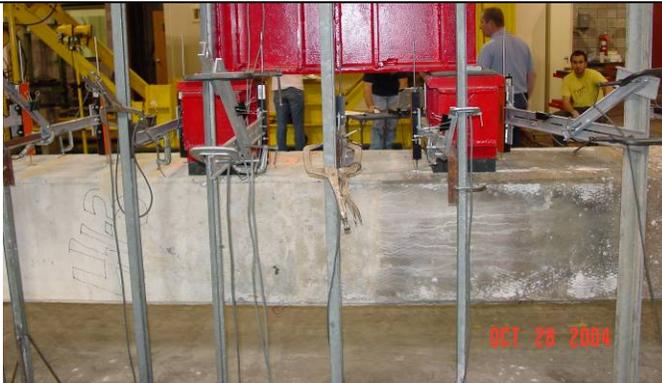
44-3CP

Minimal to no damage was visible on this pile.

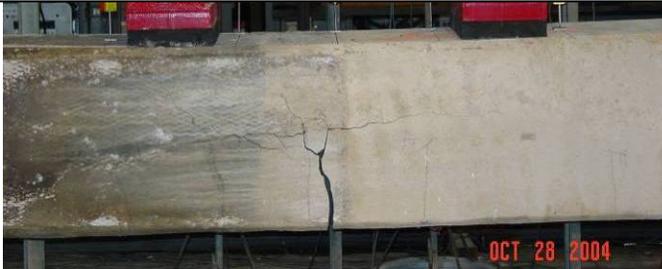
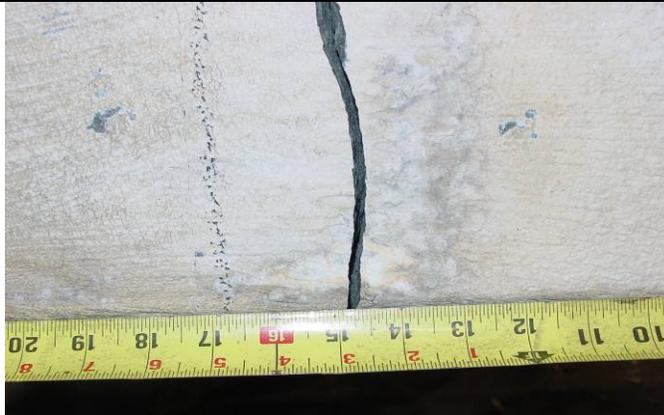
First crack appeared at 10 kips. A very large flexural crack opened up about midway between the north and south load points. This was the only crack visible and was approximately 1/4 in wide after the load was removed. The crack extended through the bottom face of the pile to the east face. Removal of the tension face concrete revealed that this pile had been patched. The strands in this pile were also severely corroded. Many of the strands were completely corroded.
