**FINAL REPORT**

**ON SITE EVALUATION OF  
BRIDGE DECK EXPANSION JOINTS**

**FLORIDA DEPARTMENT OF TRANSPORTATION  
STRUCTURES RESEARCH CENTER  
2007 EAST PAUL DIRAC DRIVE  
TALLAHASSEE, FLORIDA 32310**

**FEBRUARY 1996**

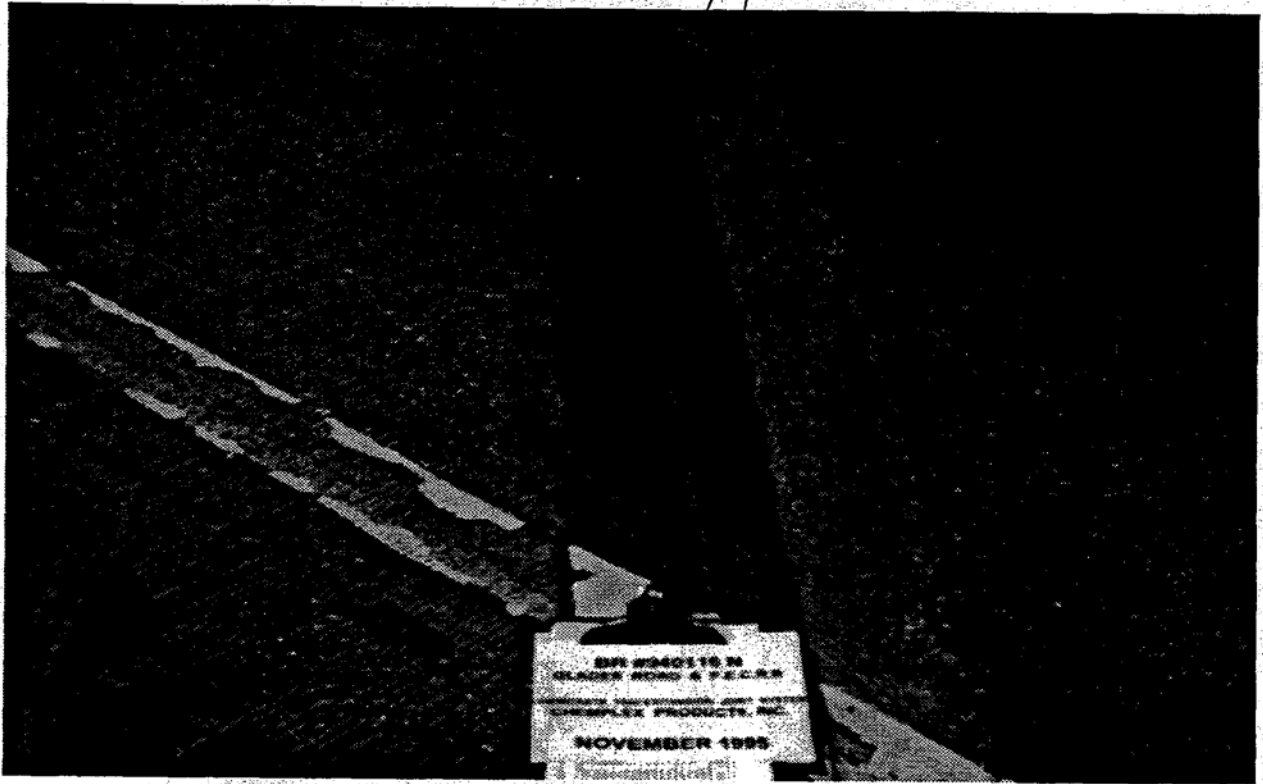
The joint system was spalling on both headers in all three traffic lanes. In the shoulders the nosing looked good. In the right traffic lane, there was a spall in the right wheel path. In the center lane there was a 12" spall in the left wheel path. The spall extended throughout the depth of the nosing. In the left lane there were three spalls; a 6" spall and a 7" spall near the right wheel path and a 12" spall near the left wheel path. See Figures 11 through 13.

Problem Areas

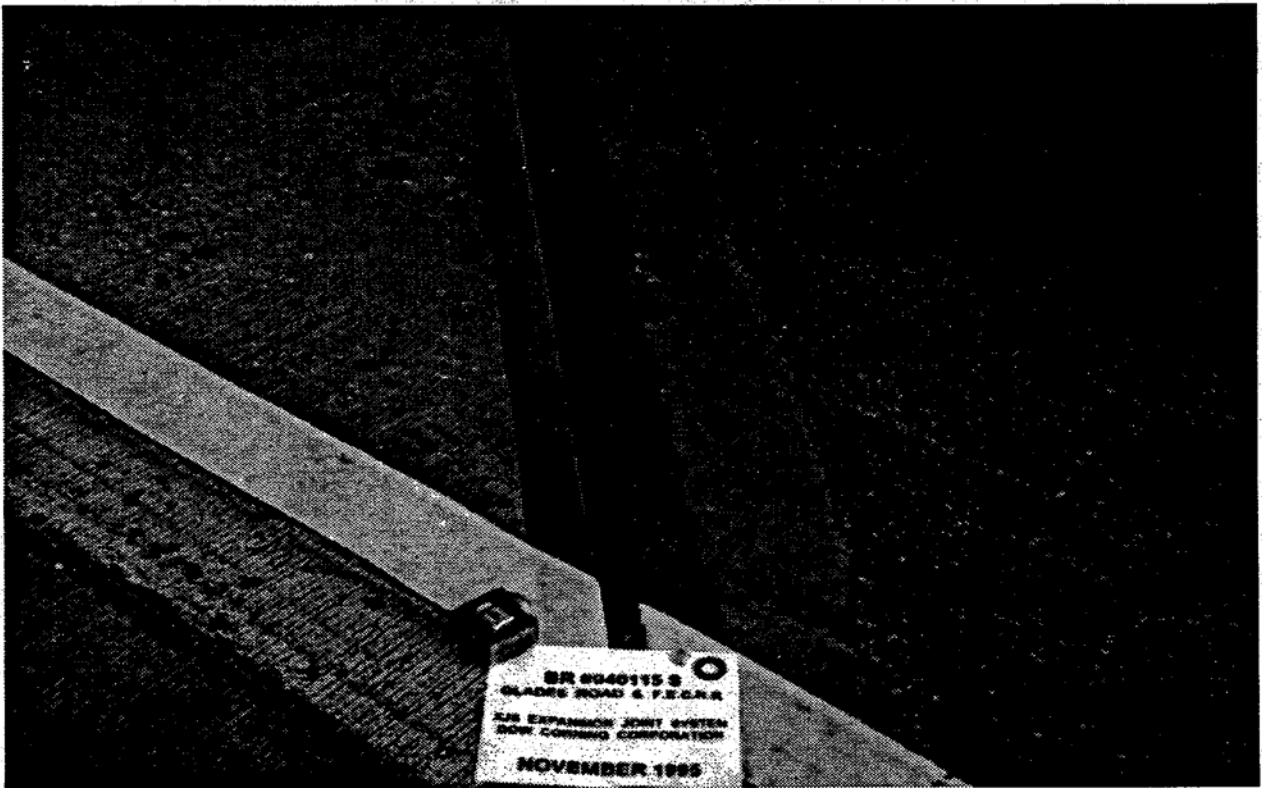
Figure 18

There was minor breakage and wear at the top surface on the inside edge ( See Figure 18). In other locations there were no major signs of wear. Overall, the nosing looked good and was doing well. There was slight debris on the deck in the shoulders. However, the joint sealant was near the deck surface in the shoulders.

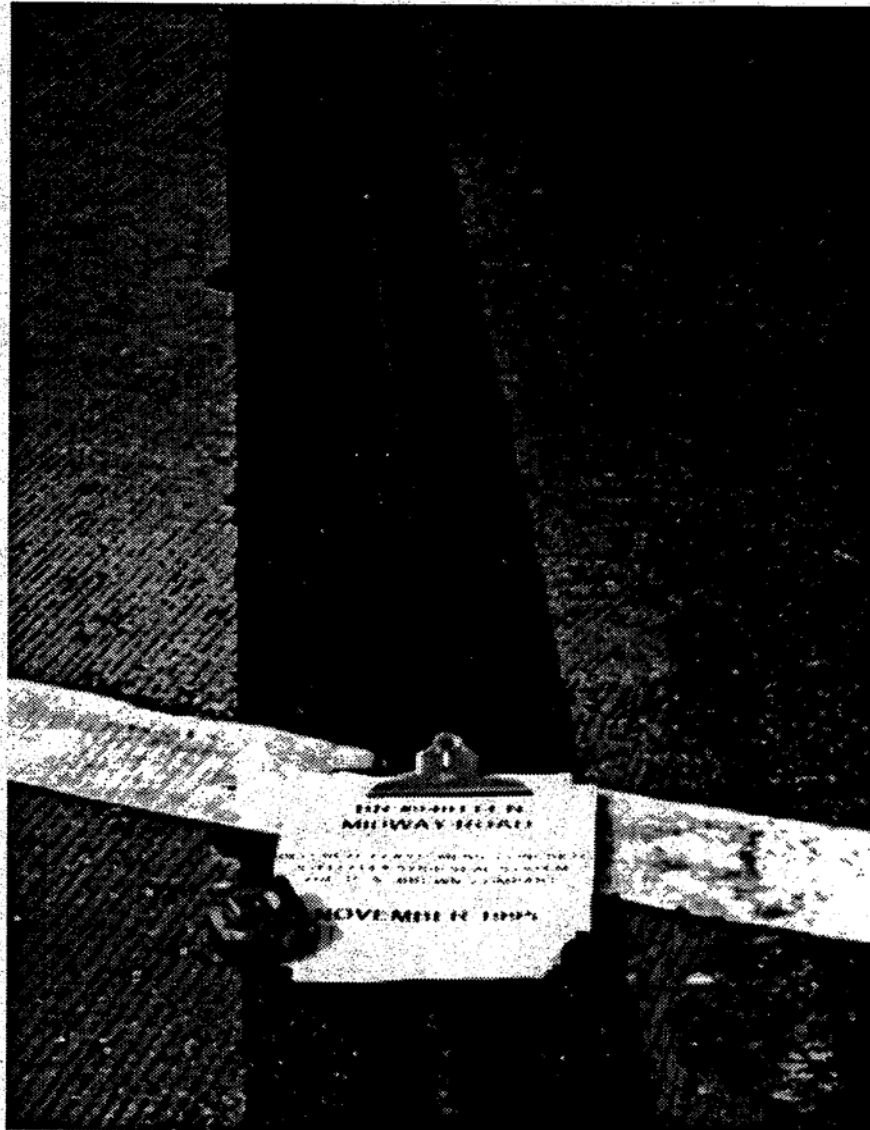
The joint nosing looked very good. However, debris was accumulating in the joint along most of its length. The joint opening was approximately two inches (2") . See Figure 21- 22.

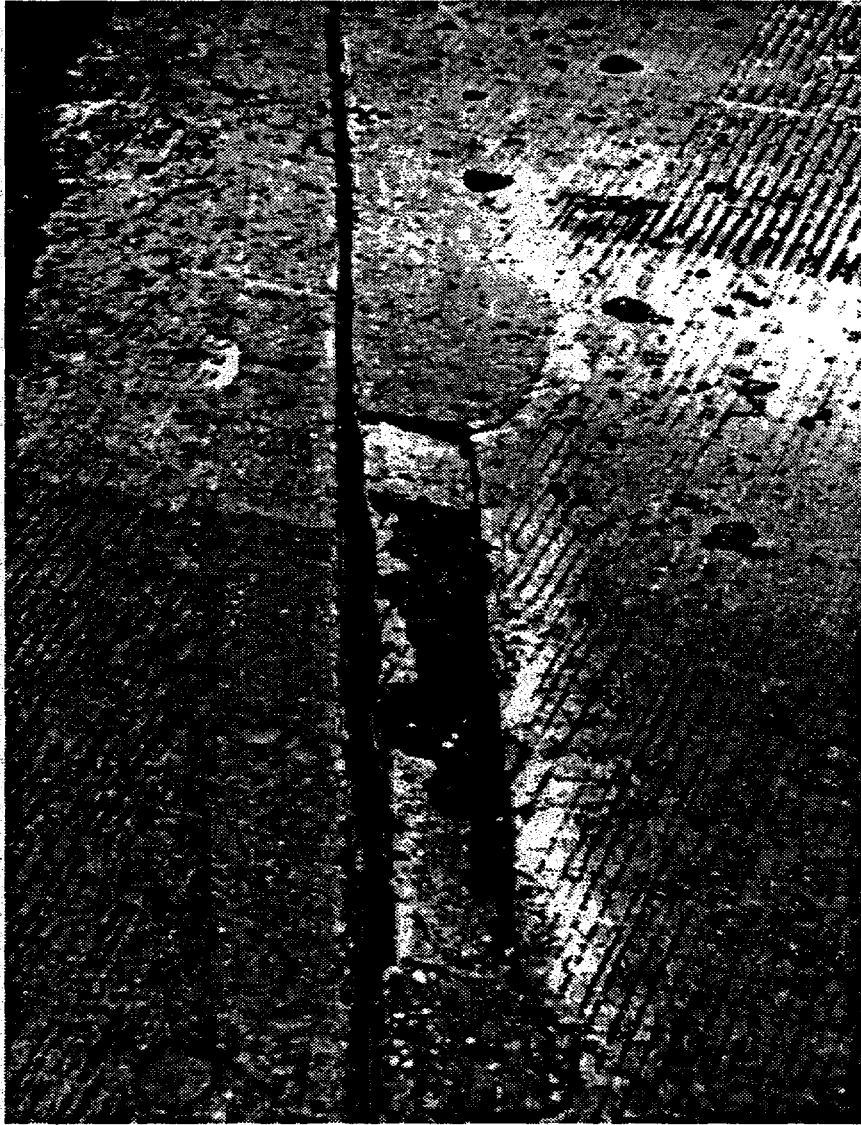
**FIGURE 36**

This joint had two major spalls. The first one is 28 inches long in the, right traffic lane on the north header and the second one is 24 inches long in the center lane on the south header. There was also a crack indicating a slight separation of the north header from the bridge deck in the right traffic lane. See Figures 36 and 37. Although, the nosing failed, the joint structural seal performed very well.

Problem Area

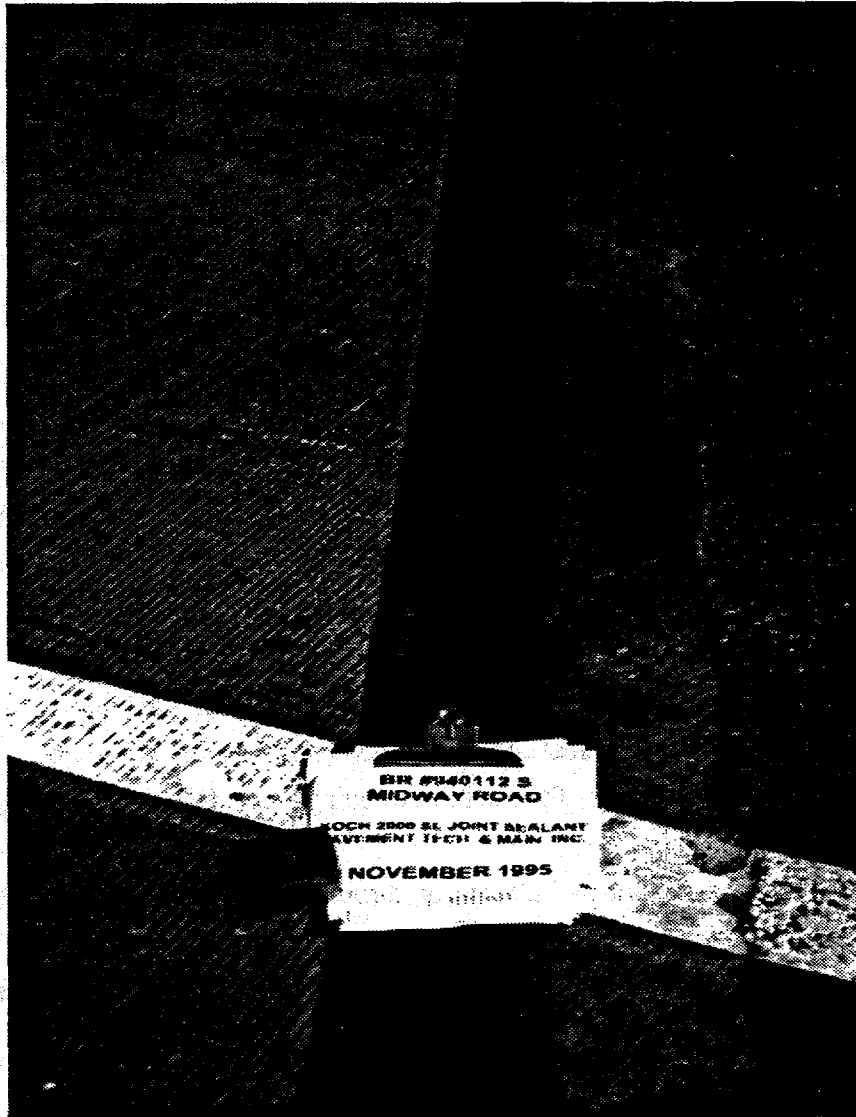
**Figure 47**

There were several puncture holes through the seal. At least six such holes were photographed. Due to poor performance, the sealant has failed. The joint leaks as documented in November 1994. See Figure 47.

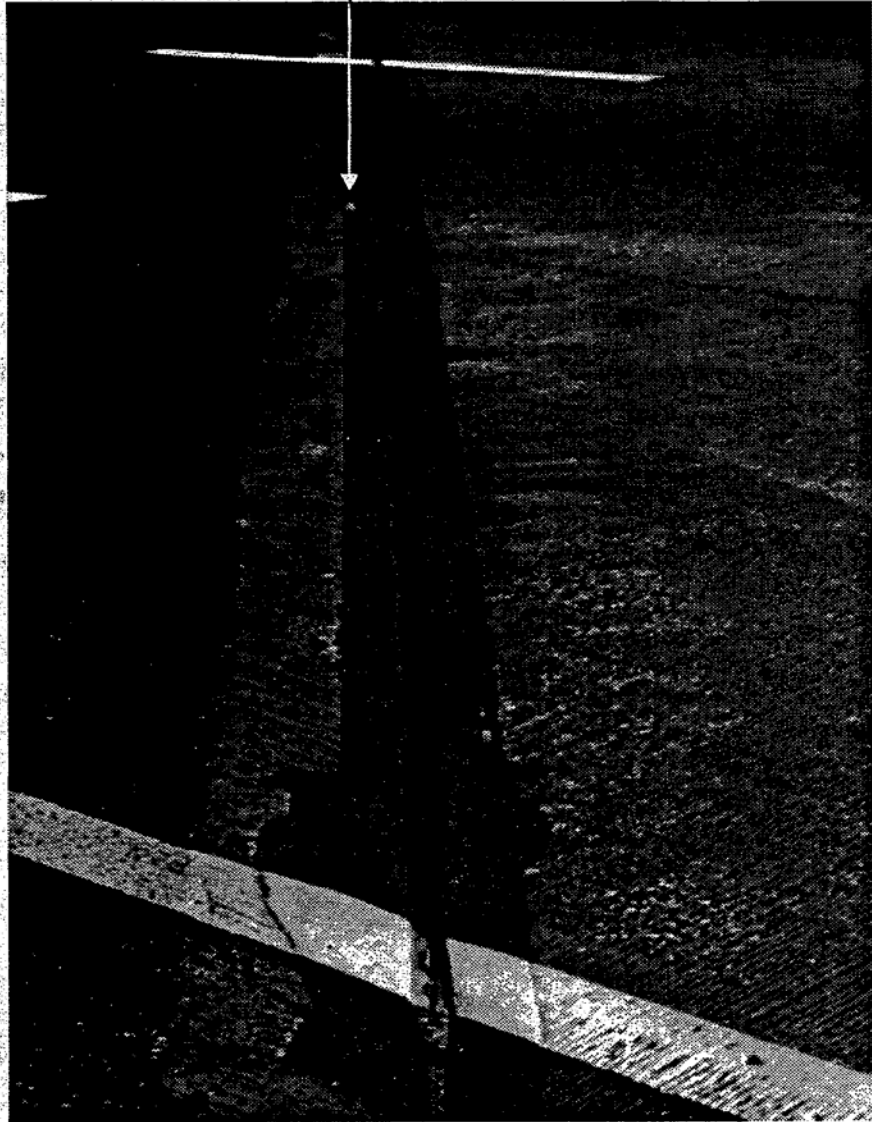
In the sections replaced in March 1994, the condition appears to be the same as in August 1994. At 2-3 foot intervals, there were transverse cracks. In the left lane that consists of nosing material placed in the original installation (August 1993) of RES TRF IV, there was a broken and displaced section of nosing. Also, there were some transverse cracks in the left lane. See Figure 53 - 54.

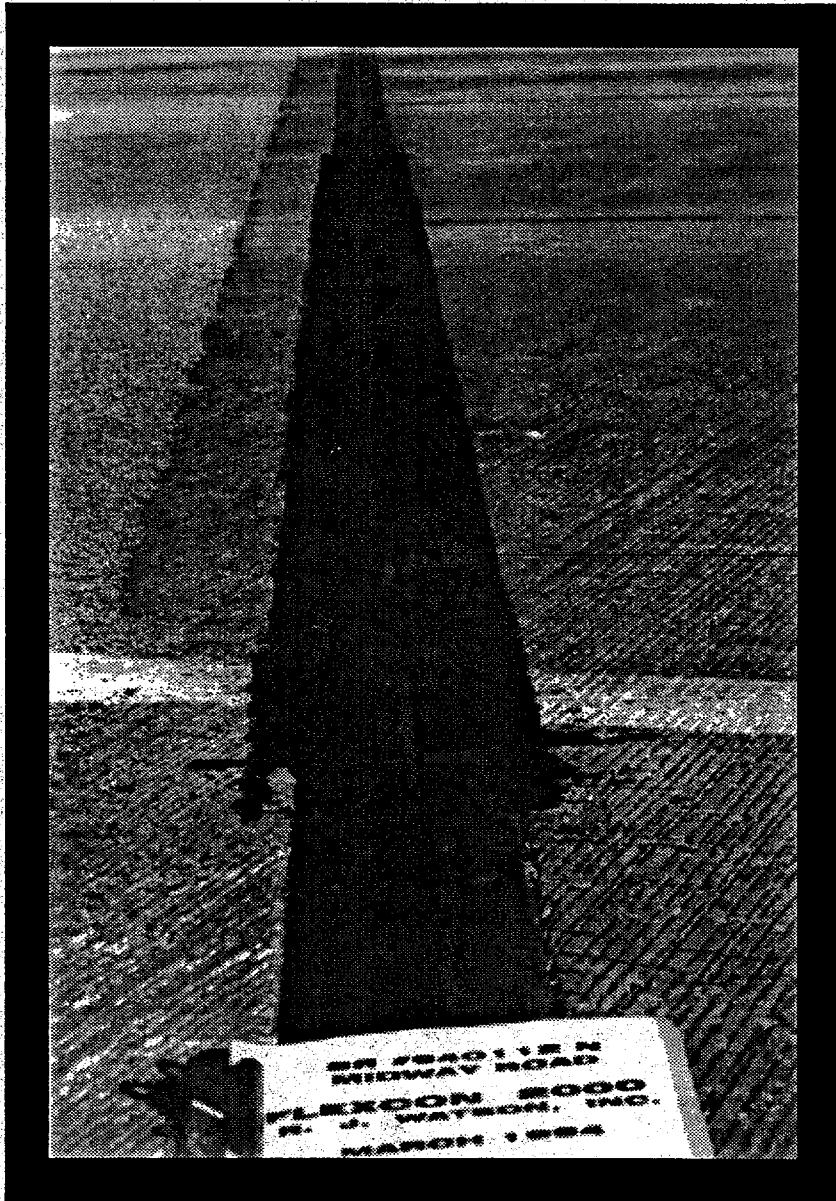
This joint system failed as was noted in August 1994. The joint system was replaced on December 7, 1994 with another company's joint system.

Problem Area

R. J. Watson: Flexcon 2000 Joint Sealing System (Problem Area)

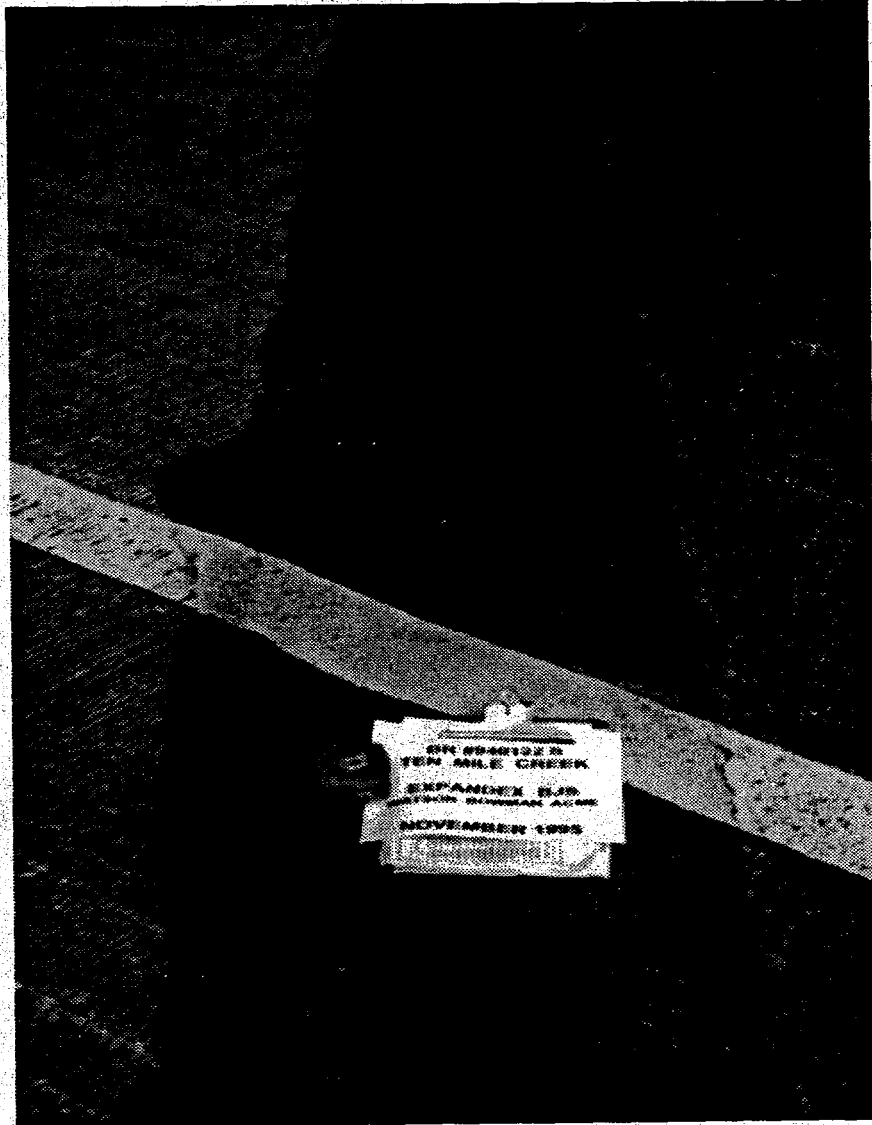
Figure 62

The Expandex Buried Joint System was performing well. The appearance of the material was practically the same as its original appearance. The material was still soft and flexible. The Expandex Buried *Joint* System is, shown in Figure 62.

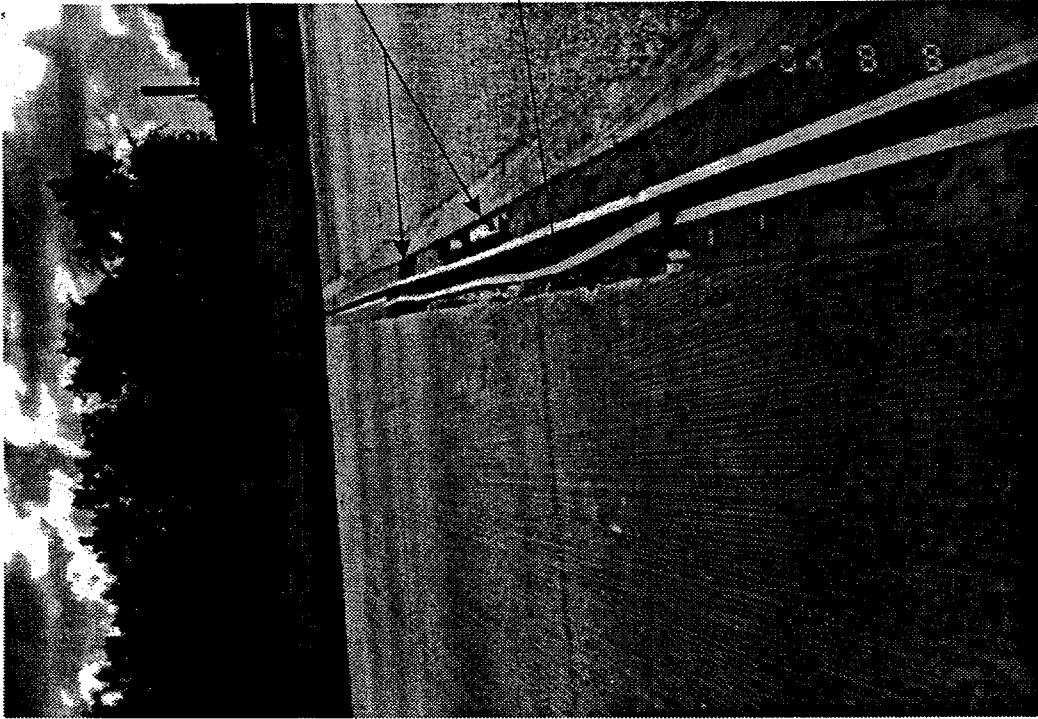
By early August 1994, the joint system failed completely. It broke loose from the roadway on both sides and could be lifted from the opening. The nosing material was breaking down in the center and right traffic lanes and was being strewn onto the roadway. The armor. angle was warped and bouncing up and down in the path of traffic posing a safety hazard to a motorist. A section of the armor angle eventually ended up on the roadway. In early August, the Fort Pierce Maintenance Office removed the joint system from the center and right traffic lanes (approximately 24 feet) and replaced it with asphalt. See Figure 65.

The joint failed in August. Two traffic lanes were removed and replaced with asphalt. Since August there was little change in the appearance of the patched joint. See Figure 65

The failed joint's appearance was the same as it was in August 1994. The Fort Pierce maintance office is planning the replacement of this joint in the future.

Asphalt

Separation

Void Sections

Warped  
Armor  
Angle

Watson, Bowman, and Acme: Wabocrete ACM Strip Sealant  
Expansion Joint (Failed Joint)

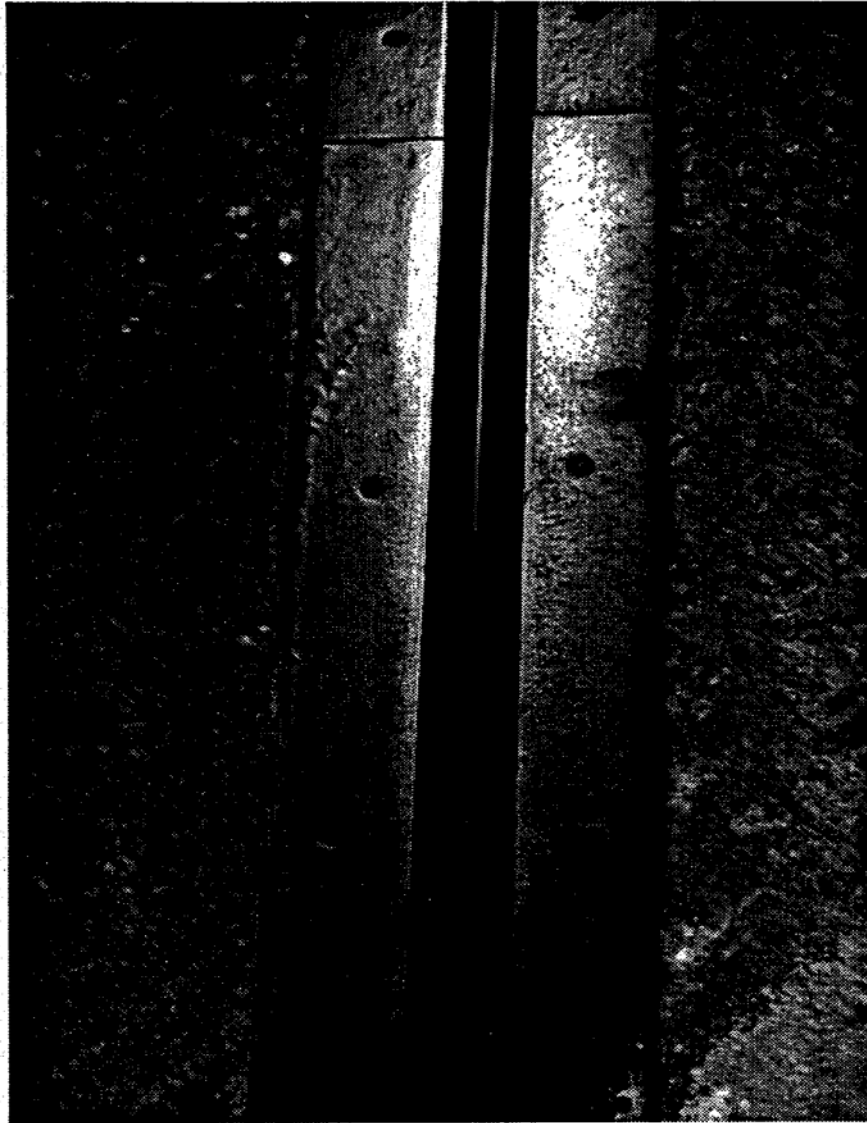
The seal looked very good. However, there was some debris accumulating in the joint. In addition, the seal did not, seal vertically along, the barrier wall. See Figure 67 - 69.

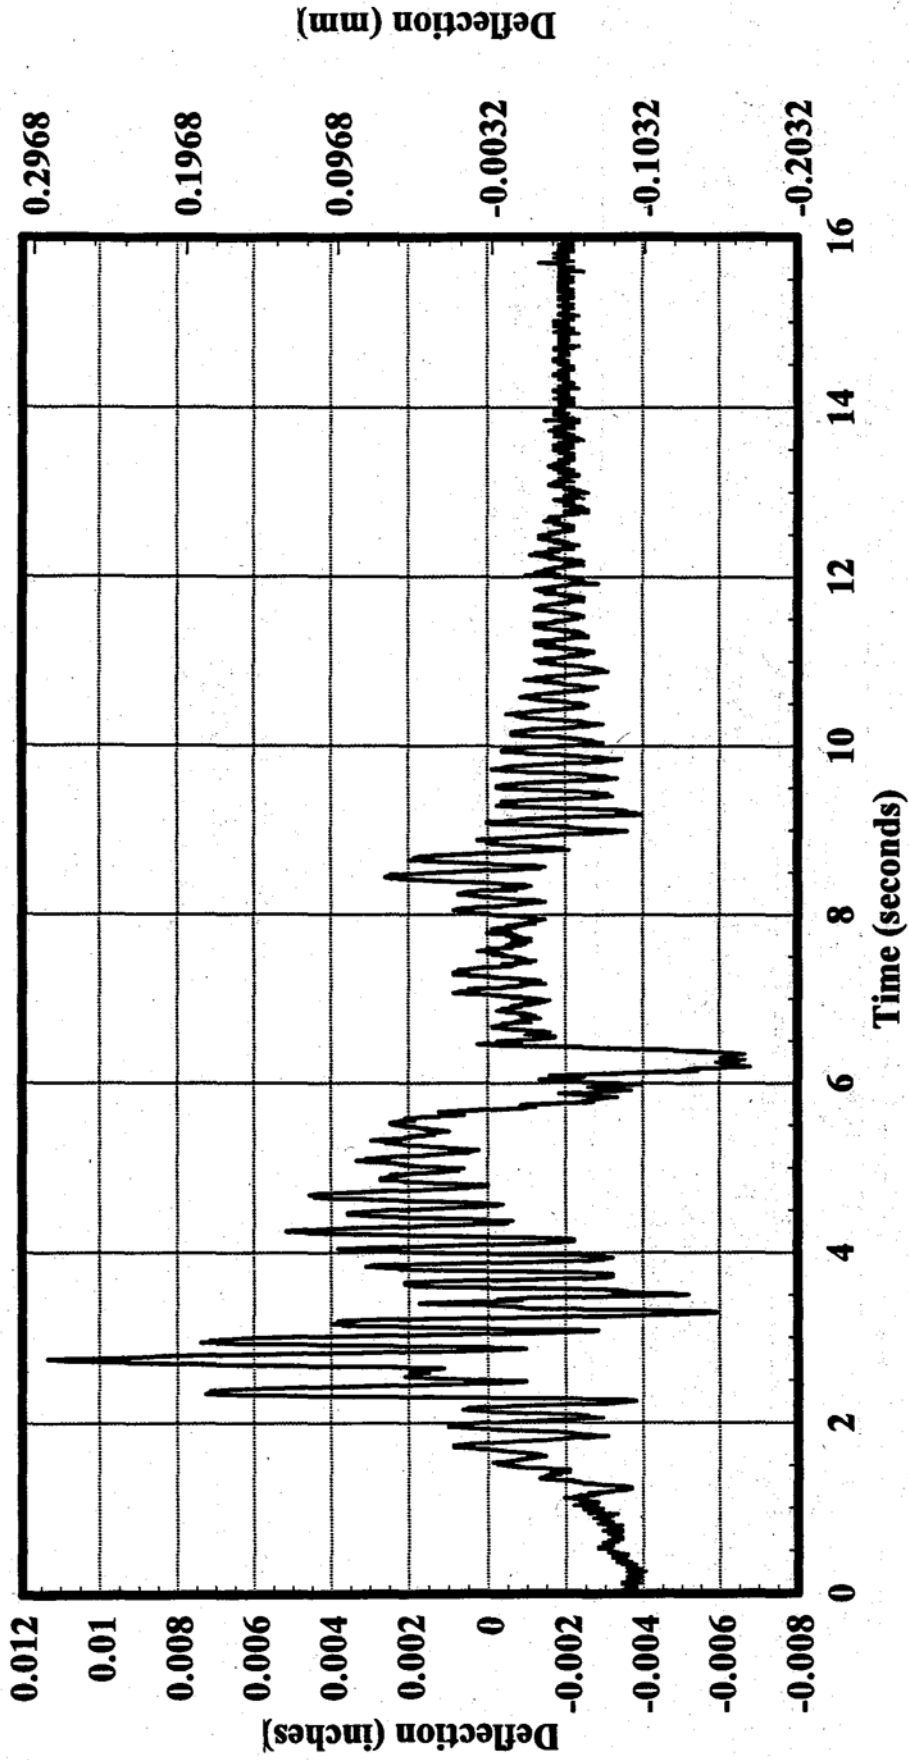
**Fig. 75**

Figure 75 shows that the maximum joint opening under loading from FDOT test vehicle was 0.012 inches. For the joint on I-95 North: Bound, North End bridge over Midway Road.

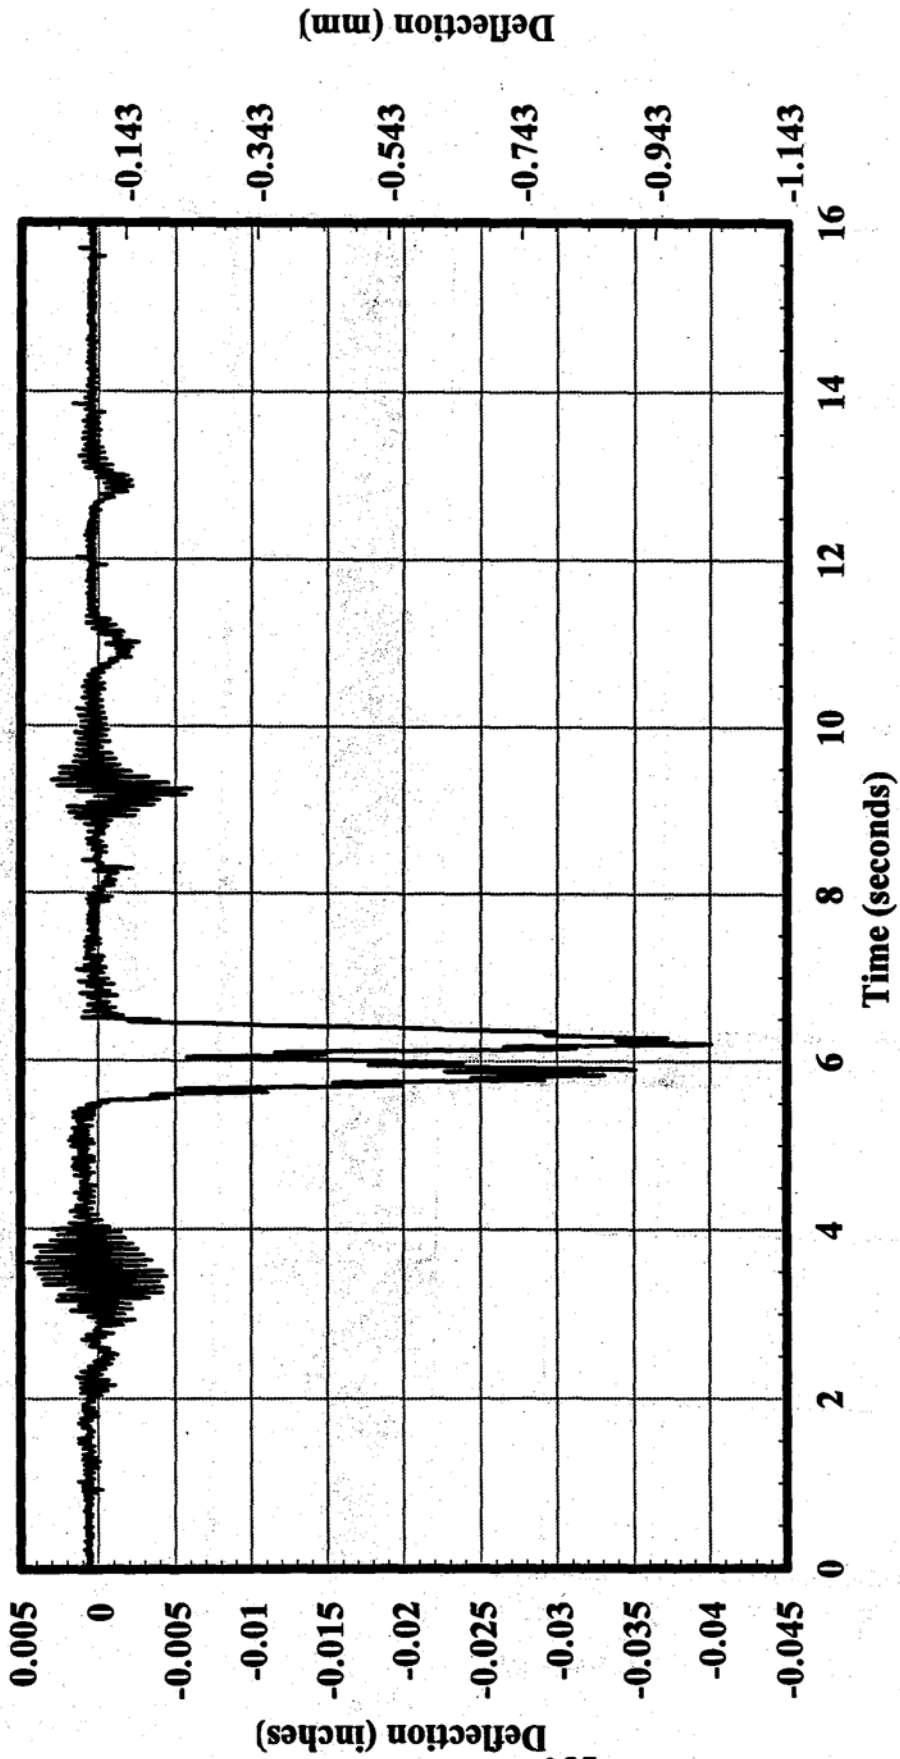
**Fig. 76**

Figure 76 shows the maximum vertical deflection of 0.04 inches. At center line of I-95 North Bound, North End bridge over Midway Road:

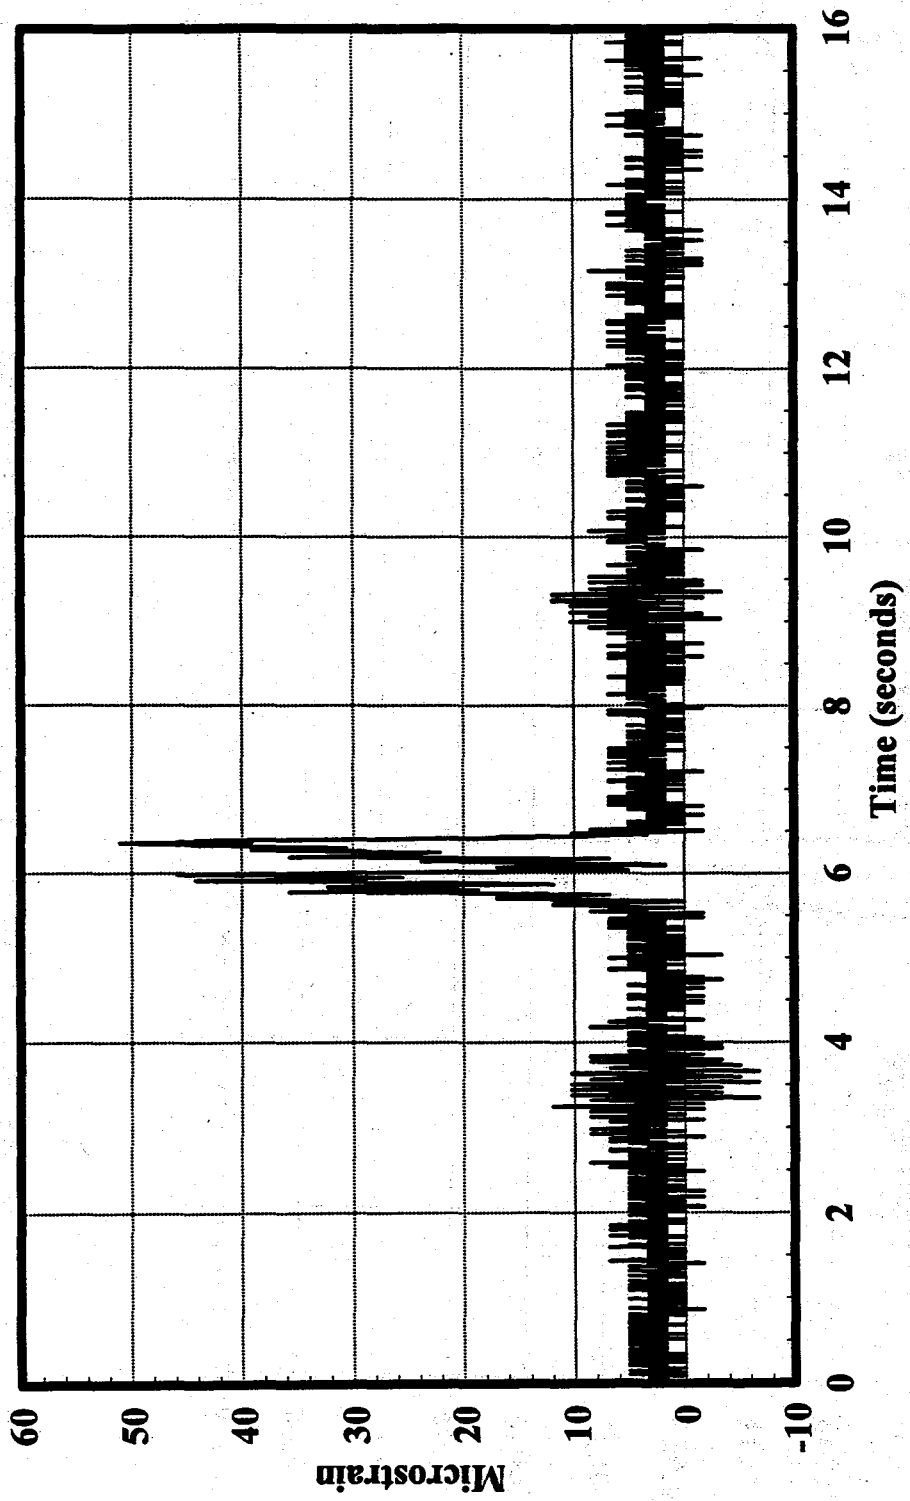
**Fig. 77**

Figure 77 shows that a maximum strains of 47 micro strains at a quarter span of I-95 North Bound, North: End bridge over Midway Road.

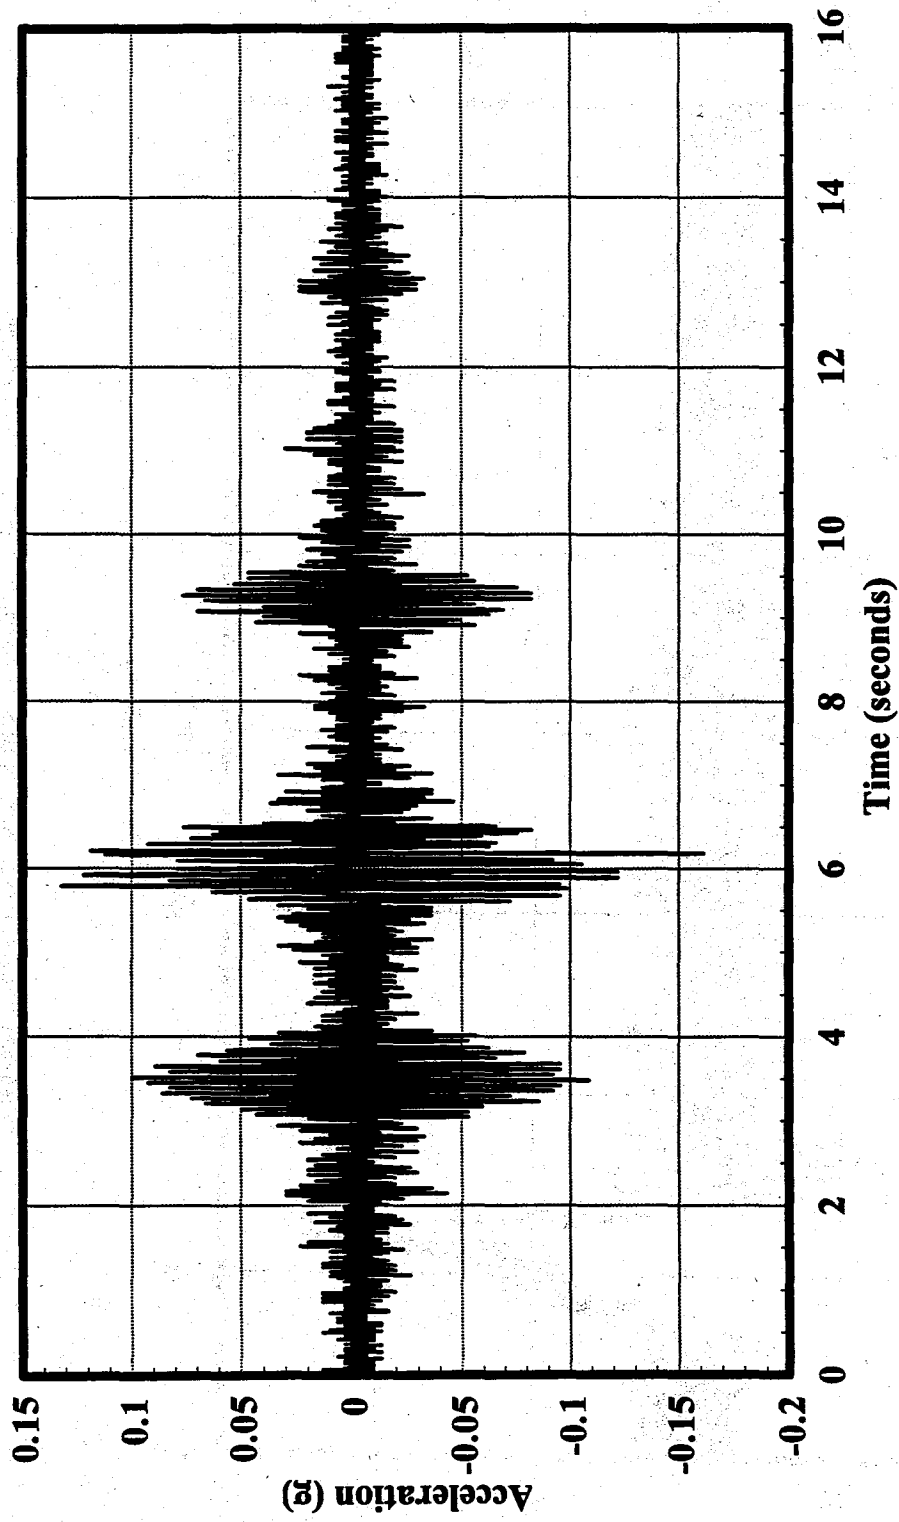
**Fig. 78**

Figure 78 shows that a maximum horizontal acceleration of 0.14 g of I-95 North Bound, North End bridge over Midway Road.
