**FLORIDA DEPARTMENT OF TRANSPORTATION
BRIDGE MANAGEMENT SYSTEM
Inspection/CIDR/Bridge Profile Report with PDF attachment(s)
Inspection**

Structure ID: 890151

BY: Transystems Corporation Consultants	STRUCTURE NAME: New Roosevelt
OWNER: 1 State Highway Agency	YEAR BUILT: 1997
MAINTAINED BY: 1 State Highway Agency	SECTION NO.: 89 015 000
STRUCTURE TYPE: 6 P/S Conc Continuous - 21 Segmental Box Girder	MP: 0.118
LOCATION: 1mi S of SR-707 on SR-5	ROUTE: 00001
SERV. TYPE ON: 5 Highway-pedestrian	FACILITY CARRIED: SB US-1/SR-5
SERV. TYPE UNDER: 8 Hwy-waterway-RR	FEATURE INTERSECTED: St. Lucie River/SR-707

TYPE OF INSPECTION: Regular NBI

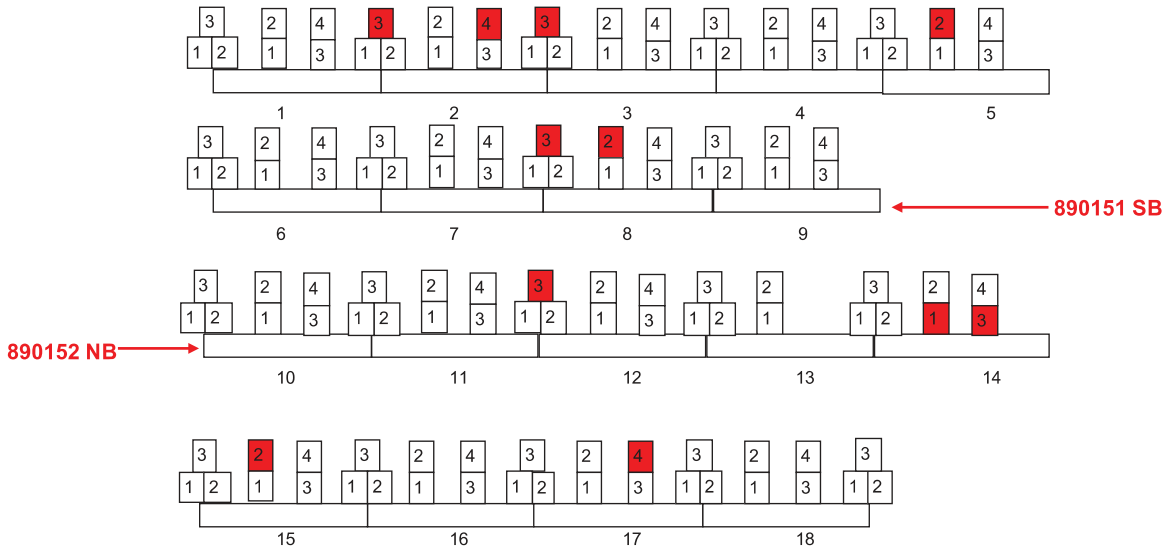
North Fender

Note: The fender system is shared with Bridge No. 890152 NB. Only sections 1 thru 9 of the north and south fender systems were inspected and quantified for this structure. Refer to fender sketches for layout and deficiency locations.
