Maintenance Guide for Stormwater Assets

May 2023

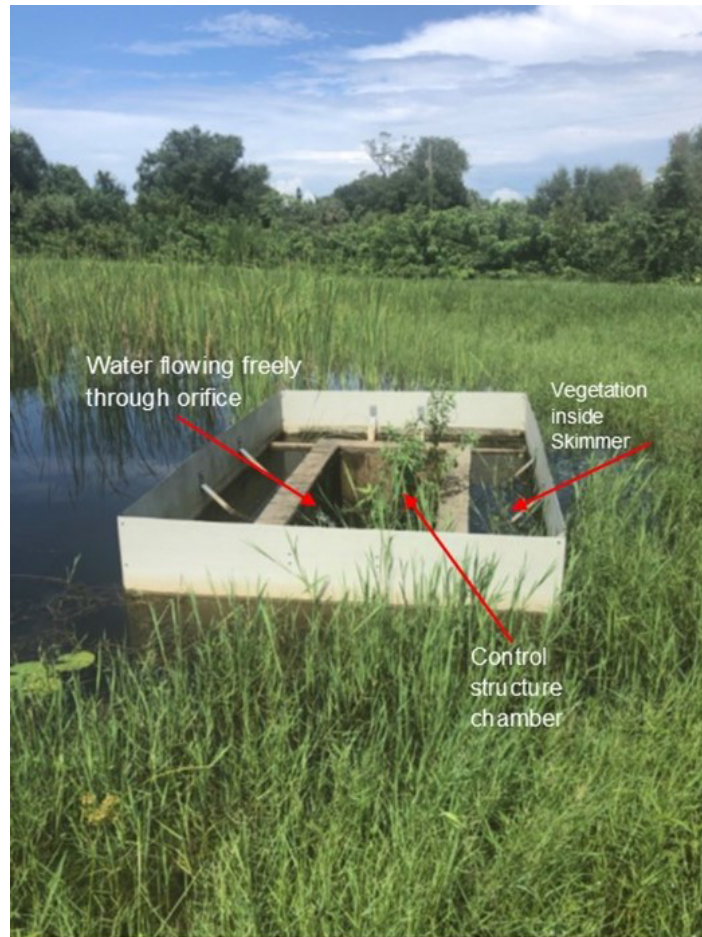
A-3

- Control Structure - Fair
 - Chamber– Fair – Vegetation present in chamber, but coverage is less than 25 percent
 - Orifice – Good – Observed flowing freely change to flowing orifice
 - Skimmer – Good – No damage or deterioration, some vegetation, but less than 25 percent of opening is obstructed
 - Grate – NA – As-built shows grate is not required for this structure
- Hydraulic Recovery – Good
 - Water is discharging freely from orifice indicating steady drawdown during recovery
- Vegetation – Fair
 - Excessive vegetation on side slopes

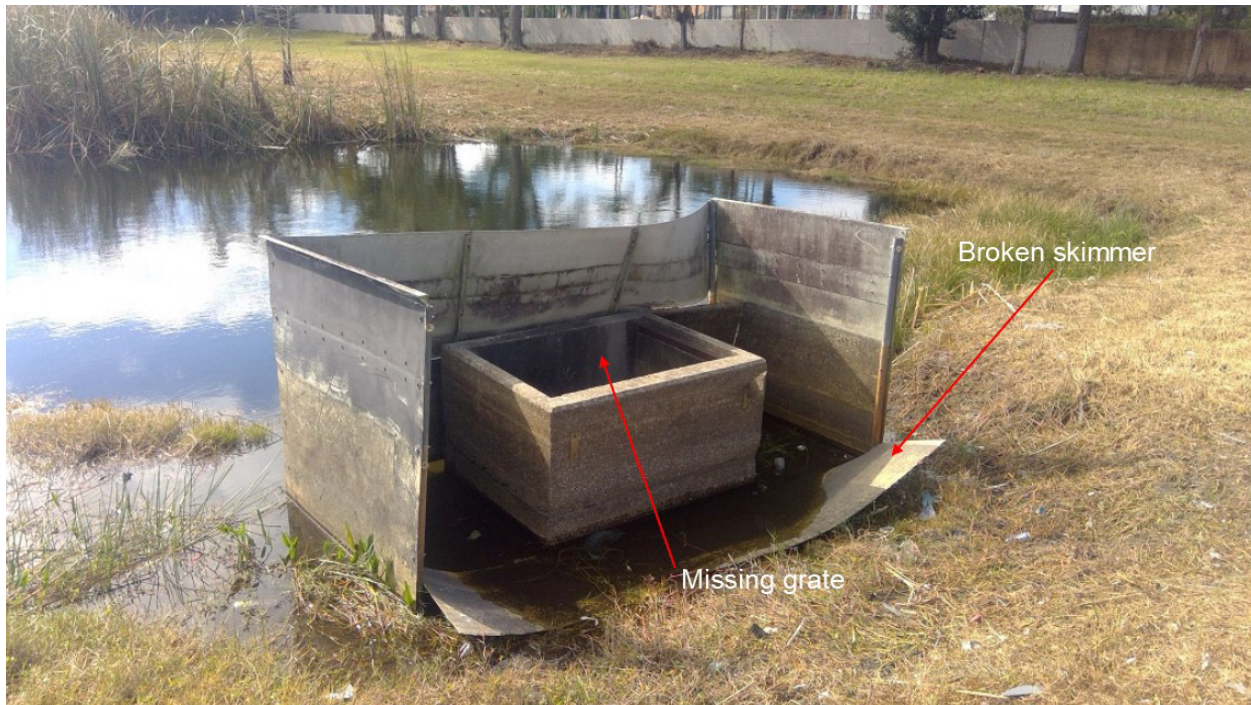
A-4

- Overall Control Structure – Poor
 - Chamber – Poor – Grate is missing
 - Skimmer – Poor – Skimmer is broken and detached

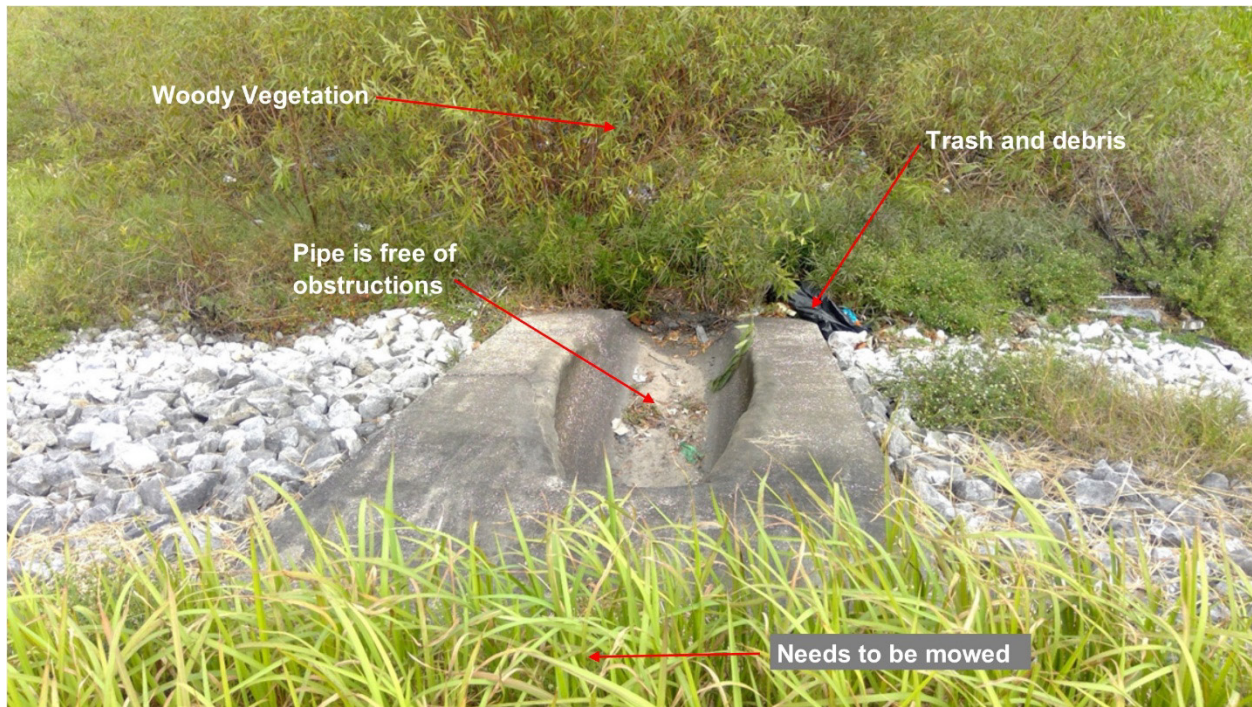
A-6

- Inflow and Outflow Pipes – Good
 - No significant cracks or undermining observed
 - Sedimentation observed, but less than 25 percent of pipe is obstructed
 - Pipe appears to be functioning as designed
- Vegetation Condition – Poor
 - Woody vegetation growing in pond bottom

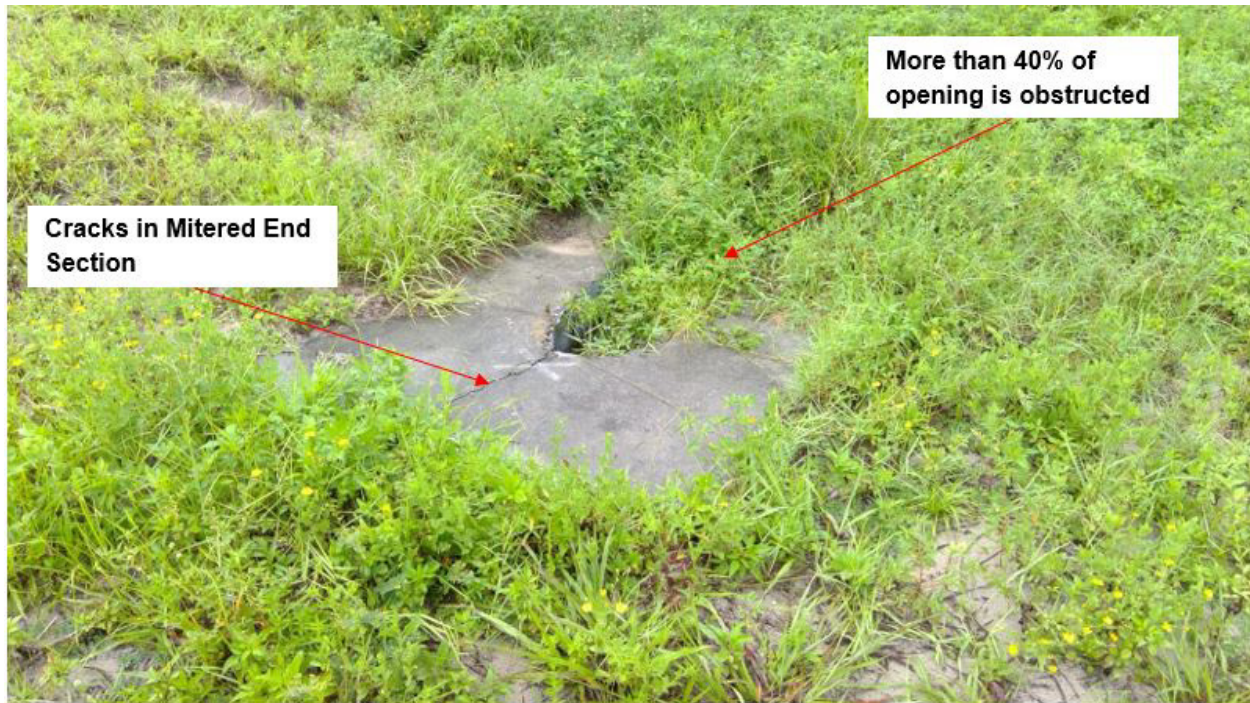
A-8

- Inflow and Outflow Pipes – Poor
 - More than 40 percent of pipe opening is obstructed
 - Crack in mitered end section
- Sedimentation – Poor
 - Sediment accumulation within inflow pipe is evident
- Vegetation Condition – Fair
 - Excess vegetation within inflow pipe
 - Vegetation in pond bottom needs to be mowed

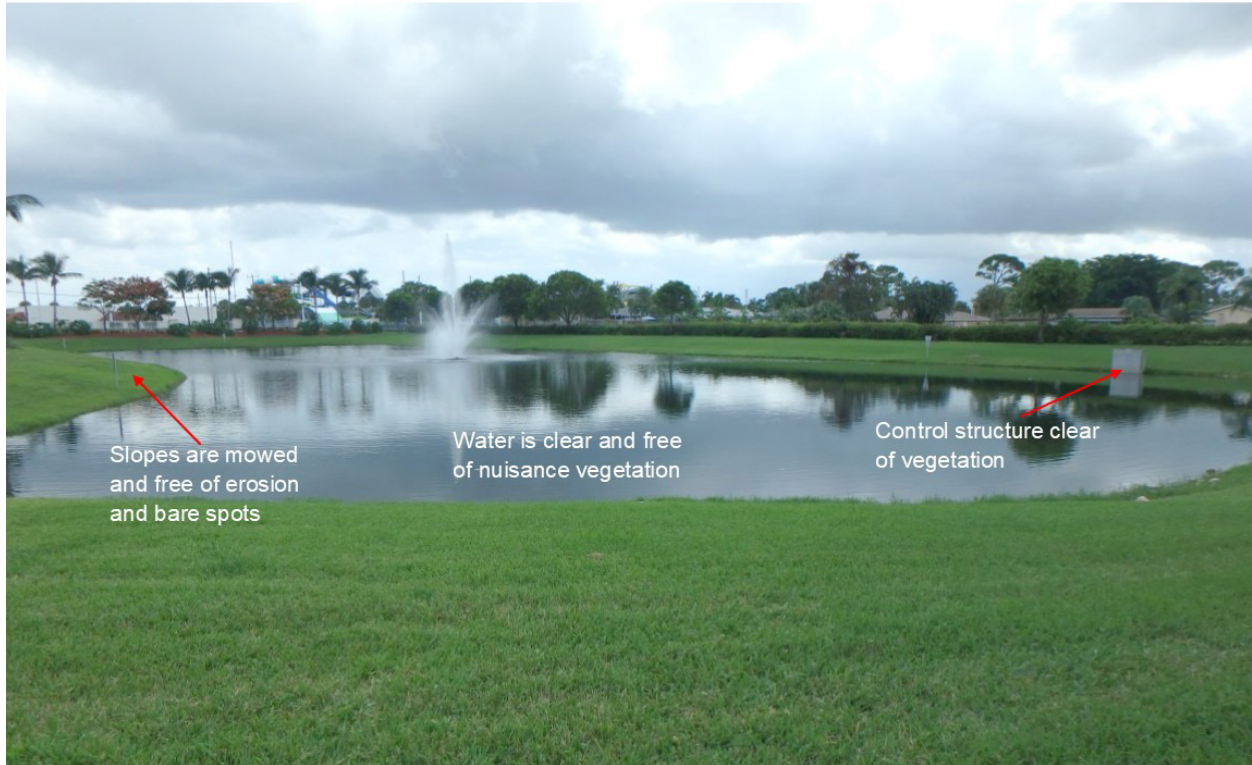
A-9

- Aesthetic Condition – Good
 - Slopes are mowed
 - No trash visible
 - Vegetative cover is intact, i.e., no bare spots
- Erosion Condition – Good
 - Slope vegetation is fully intact
 - No rills or gullies observed
- Water Condition – Good
 - Water is clear and free of any surface sheen
 - No water vegetation
- Vegetation Condition – Good
 - Vegetative cover is well maintained and in good condition
 - Side slopes are mowed
 - No nuisance or invasive vegetation is present
 - Control structure is visible and clear of vegetative growth

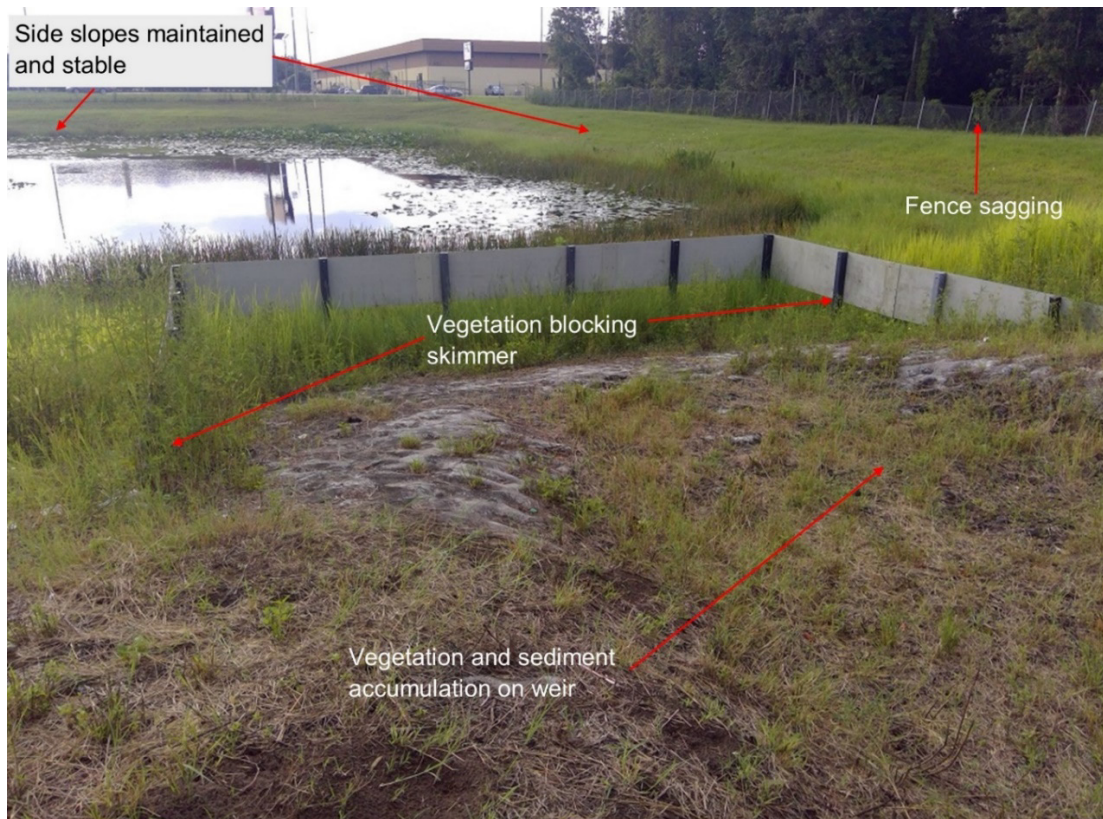
A-11

- Overall Appearance – Fair
 - Fence is sagging but the sag is not more than one-third of original height
 - Side slopes are maintained
- Sedimentation – Fair
 - Excess sediment on weir allowing vegetation to grow
- Vegetation Condition – Poor
 - Vegetation blocking skimmer affects system performance
- Control Structure – Poor
 - Skimmer – Poor
 - Skimmer opening more than 50% blocked by vegetation
 - Weir – Fair
 - Sediment allowing vegetative growth on weir, but still functioning as designed
- Erosion Condition – Good
 - Side slopes stable, no erosion evident

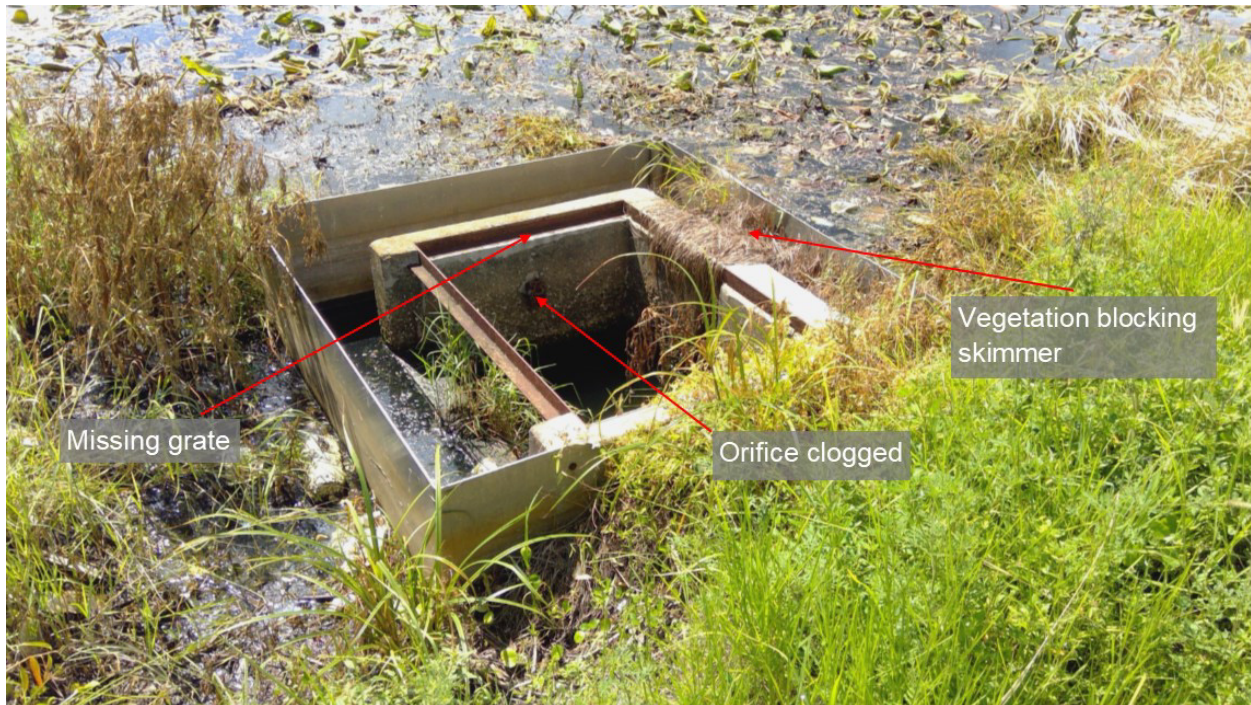
A-14

- Control Structure – Poor
 - Orifice – Poor – Orifice is clogged with debris
 - Skimmer – Fair – Vegetation blocking more than 25 percent but less than 50 percent of opening and is intruding into structure chamber
 - Chamber – Poor – Grate is missing
- Hydraulic Recovery – Likely poor due to blocked orifice

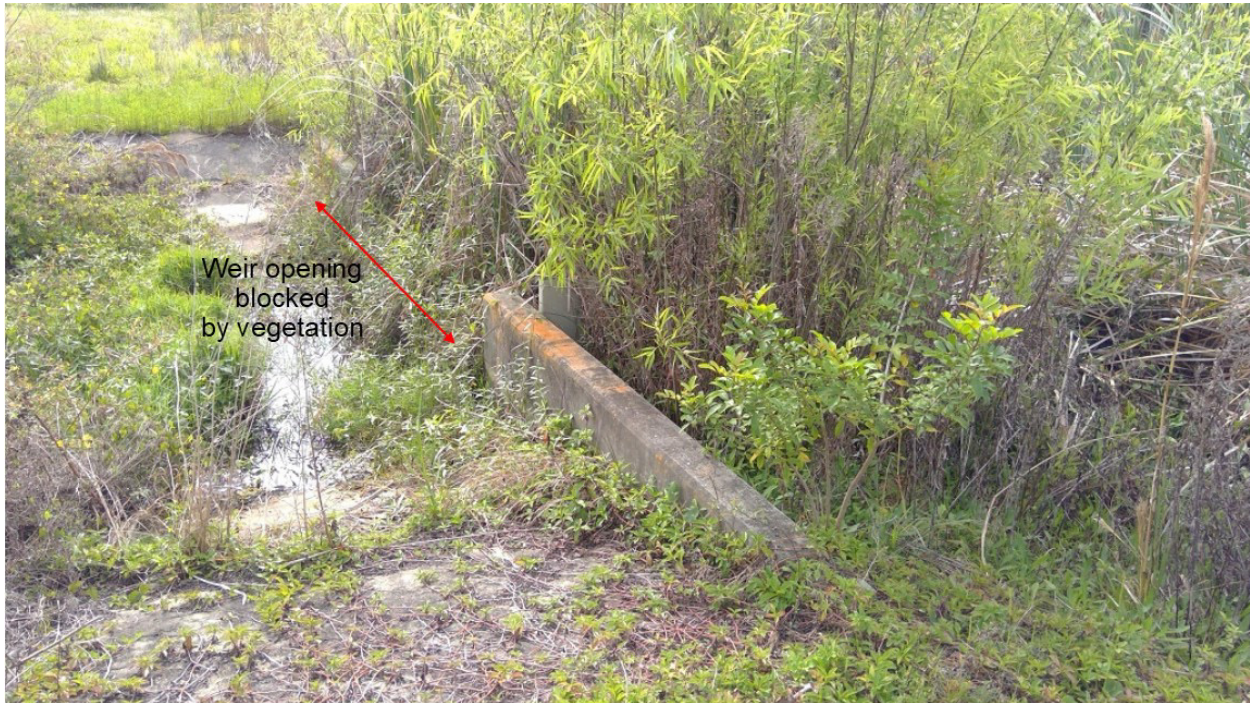
A-15

- Overall Appearance – Poor
 - Excessive vegetation
- Vegetation Condition – Poor
 - Woody vegetation present around control structure
- Control Structure – Poor
 - Weir opening is blocked by vegetation

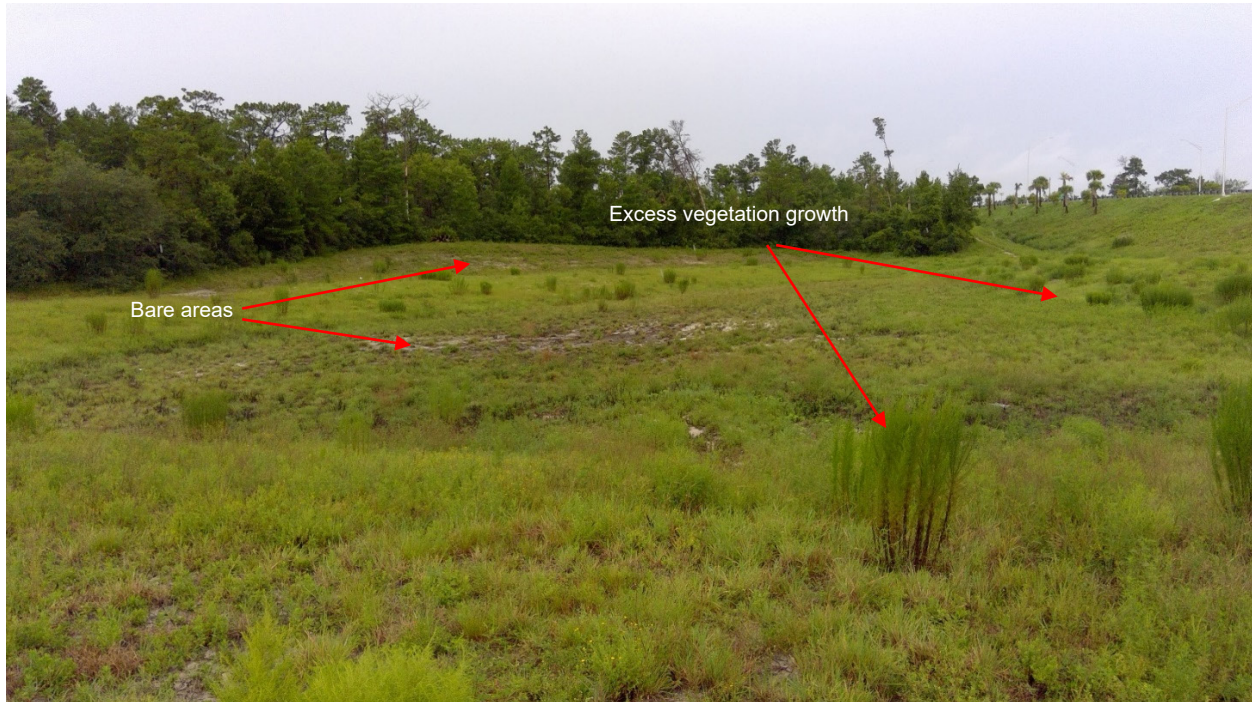
A-18

- Aesthetic Condition – Fair
 - Bare areas on side slopes and within pond
 - No debris or trash present
- Erosion Condition – Fair
 - Areas of bare soil observed within the pond and along the side slopes
- Hydraulic Recovery – Good
 - System dry, indicating the system is properly recovering
- Sedimentation – Good
 - No evidence of sedimentation problems observed.
- Vegetation Condition – Fair
 - Excessive vegetation growth observed within the pond bottom and along the side slopes

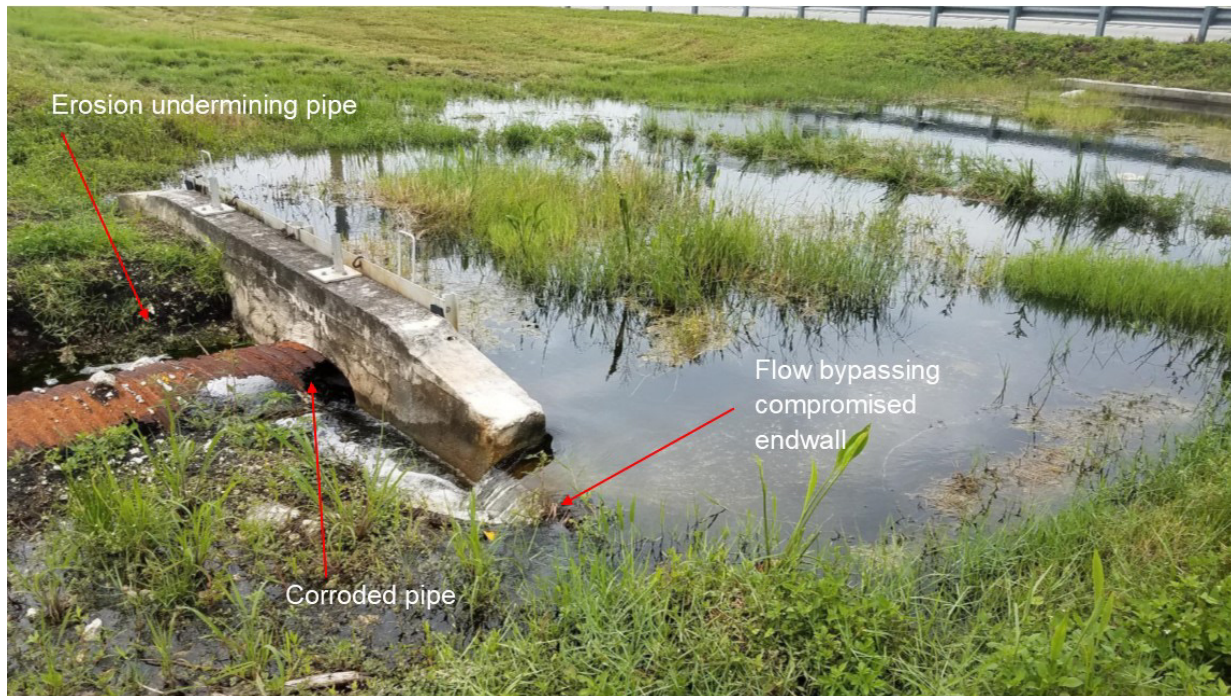
A-19

- Aesthetic Condition – Poor
 - Pipes corroded
 - Erosion at outfall pipe and adjacent to endwall
 - Excessive vegetation in and around pond
- Erosion Condition – Poor
 - Flow is bypassing endwall due to erosion
 - Erosion undermining pipe
- Sedimentation Condition - Fair
 - Emergent vegetation in pond
- Pipes – Poor
 - Pipes corroded
- Vegetation Condition – Fair
 - Emergent vegetation in pond
 - Excessive vegetation around pond

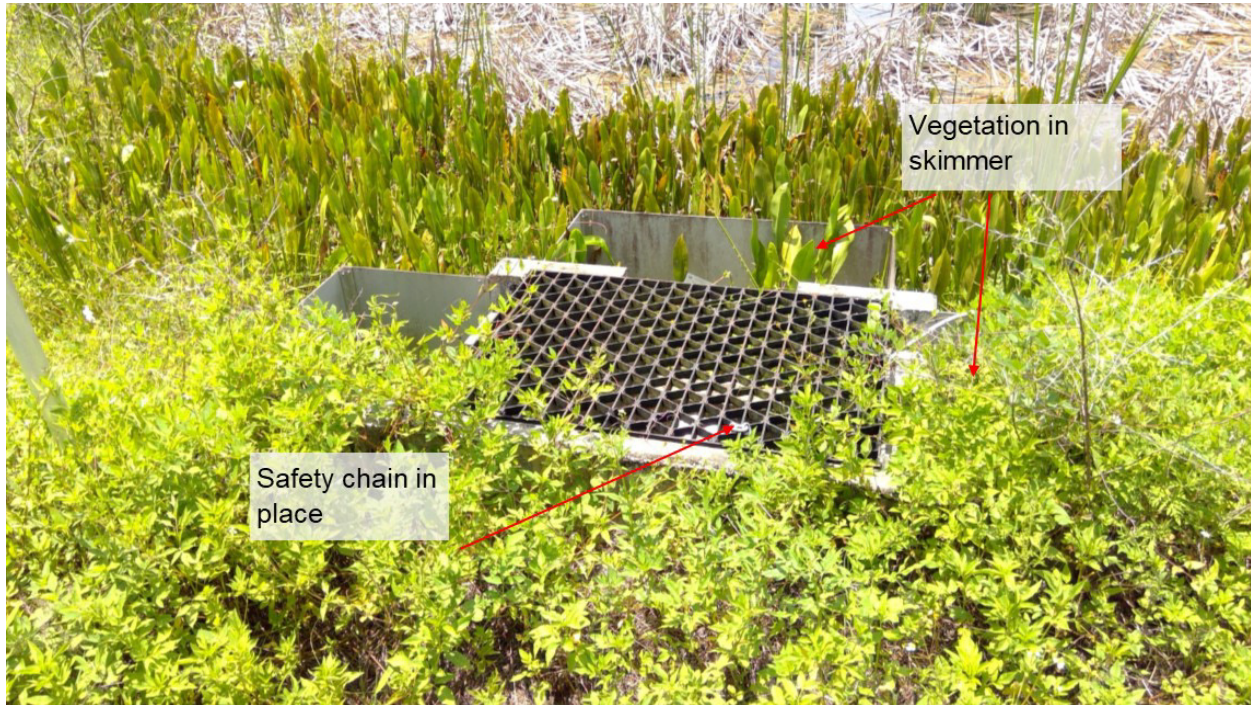
A-22

- Control Structure - Fair
 - Skimmer – Fair – More than 25 percent of opening is obstructed by vegetation
 - Grate – Good – Free of damage, safety chain in place
- Vegetation – Fair
 - Excessive vegetation around structure

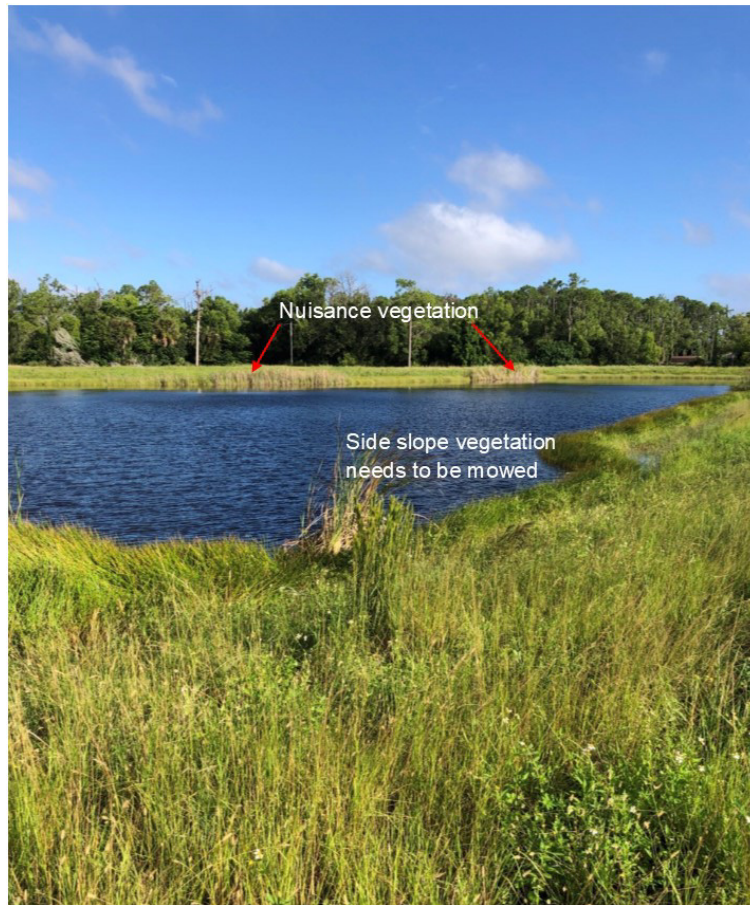
A-23

- Aesthetic Condition – Fair
 - Excess vegetation on side slopes
- Erosion Condition – Good
 - Slope vegetation is fully intact
 - No rills or gullies observed
- Water Condition – Good
 - Water is clear and free of any surface sheen
 - No water vegetation
- Vegetation Condition – Fair
 - Excess vegetation on side slopes
 - Nuisance vegetation present in pond

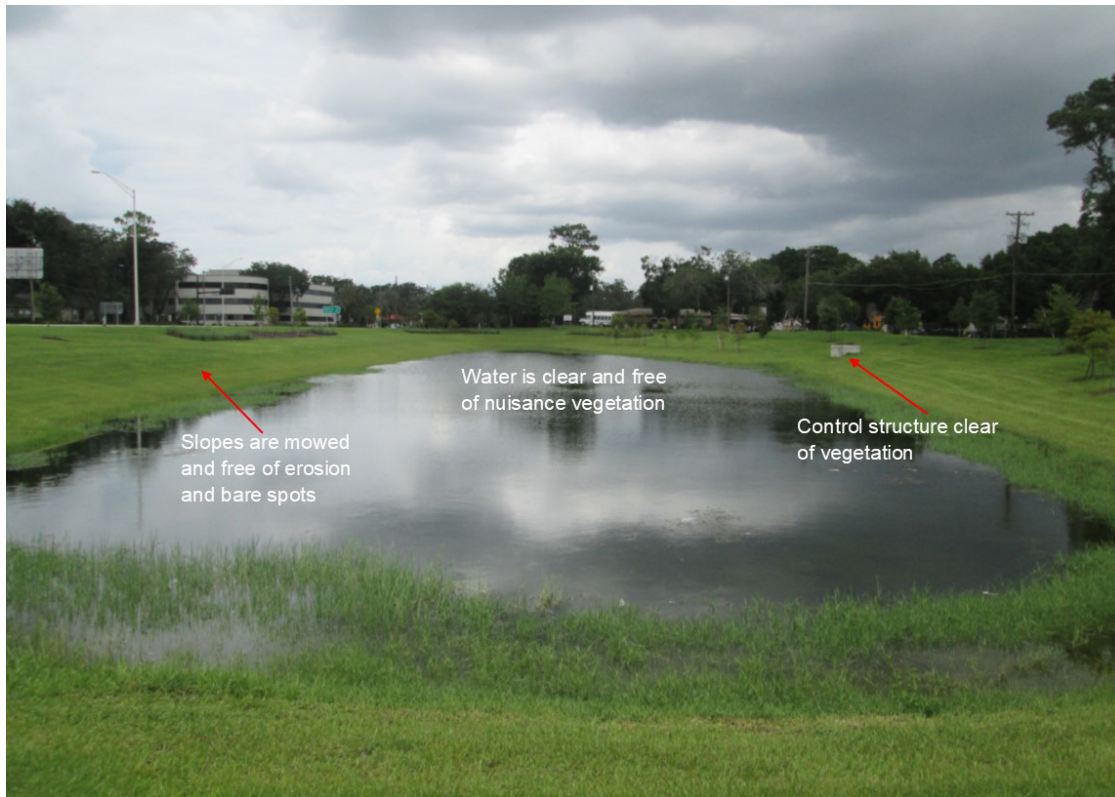
A-24

- Aesthetic Condition – Good
 - Slopes are mowed
 - No trash visible
 - Vegetative cover is intact, i.e., no bare spots
- Erosion Condition – Good
 - Slope vegetation is fully intact
 - No rills or gullies observed
- Water Condition – Good
 - Water is clear and free of any surface sheen
 - No water vegetation
- Vegetation Condition – Good
 - Vegetative cover is well maintained and in good condition
 - Side slopes are mowed
 - No nuisance or invasive vegetation is present
 - Control structure is visible and clear of vegetative growth

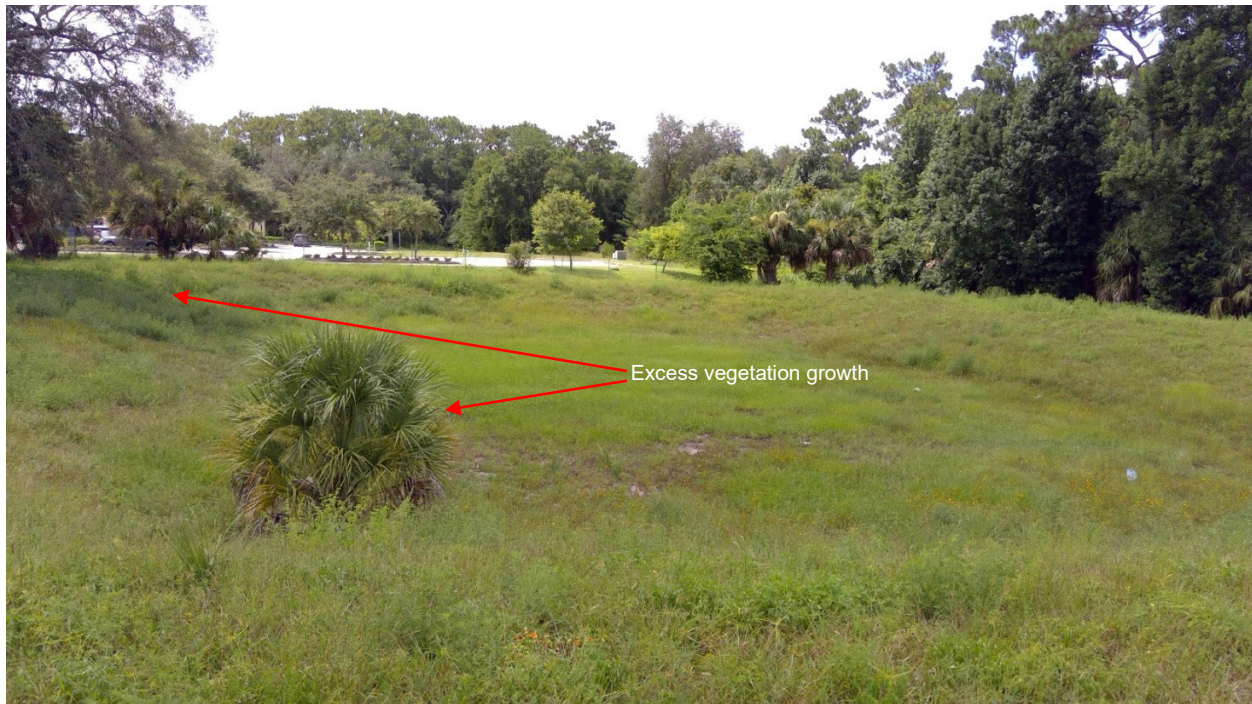
A-25

- Aesthetic Condition – Fair
 - No debris or trash present
- Erosion Condition – Good
 - No slope erosion or rills observed
- Hydraulic Recovery – Good
 - System dry, indicating the system is properly recovering
- Sedimentation – Good
 - No evidence of sedimentation problems observed
- Vegetation Condition – Fair
 - Excessive vegetation growth observed within the pond bottom and along the side slopes

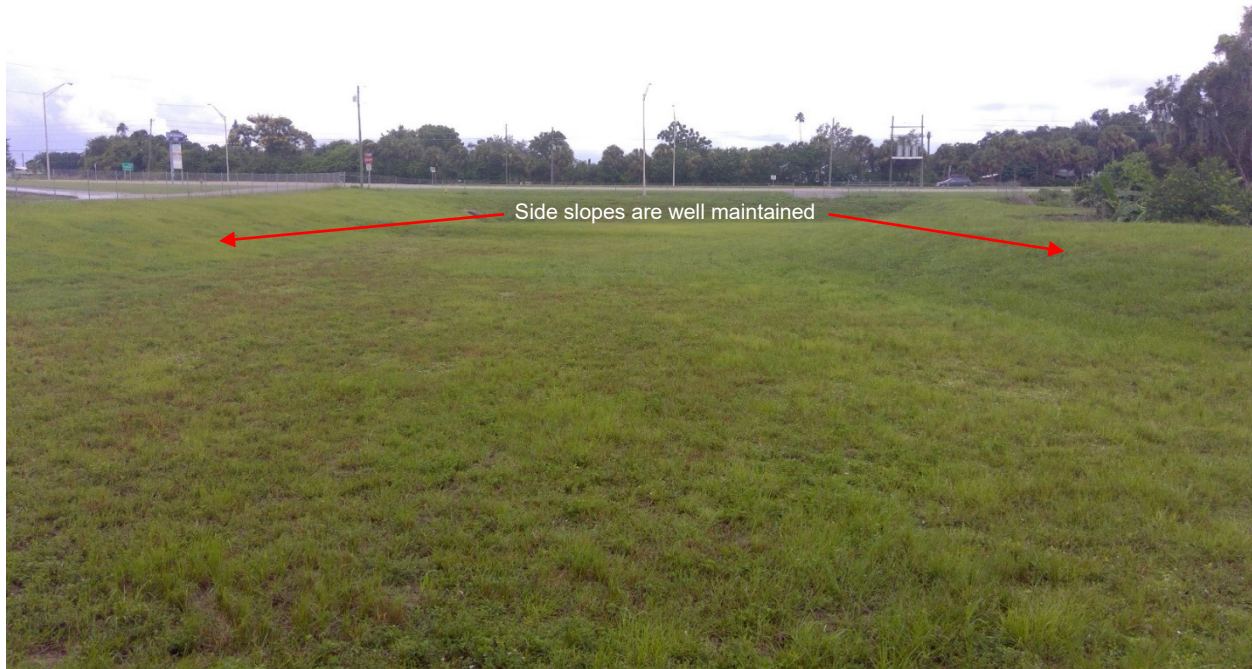
A-26

- Aesthetic Condition – Good
 - No debris or trash present
 - Side slopes are well maintained
- Erosion Condition – Good
 - No slope erosion or rills observed
- Hydraulic Recovery – Good
 - System dry, indicating the system recovering its treatment volume
- Sedimentation – Good
 - No evidence of sedimentation problems observed
- Vegetation Condition – Good
 - Vegetation cover intact, with no bare areas
 - Pond is mowed regularly

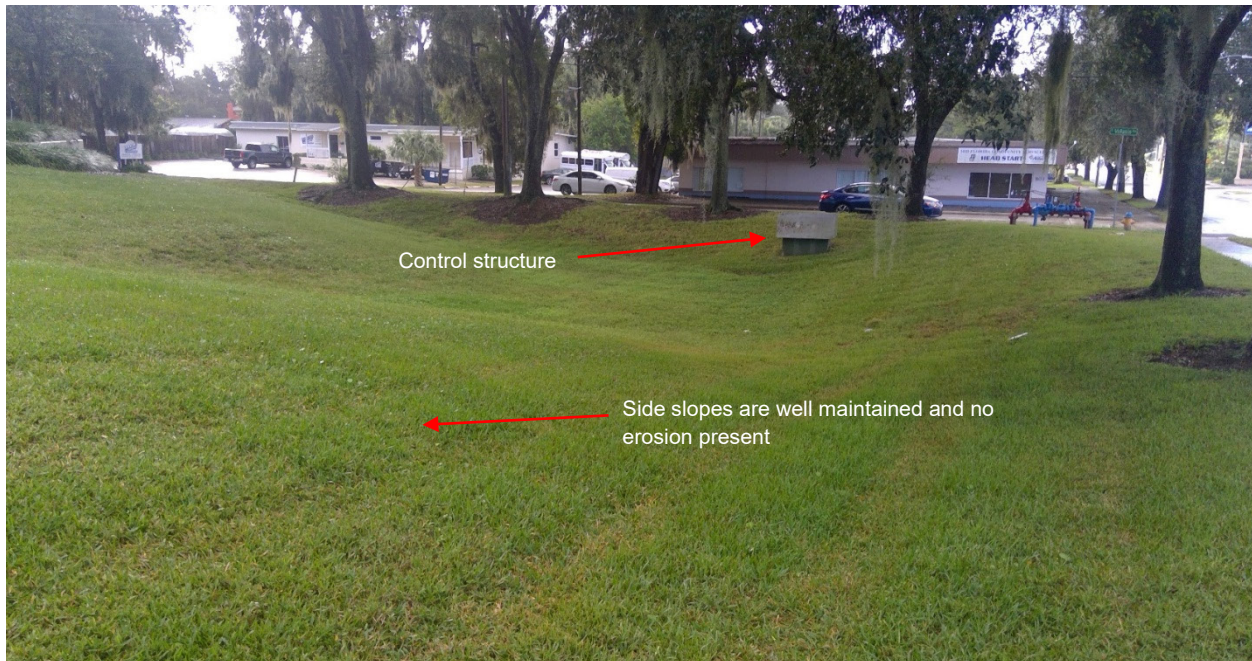
A-27

- Control Structures – Good
 - No visible damage
 - Free of vegetation growth
- Aesthetic Condition – Good
 - No debris or trash present
 - Side slopes are well maintained
- Erosion Condition – Good
 - No slope erosion or rills observed
- Hydraulic Recovery – Good
 - System dry, indicating the system is recovering its treatment volume
- Sedimentation – Good
 - No evidence of sedimentation problems observed
- Vegetation Condition – Good
 - Vegetation cover intact, with no bare areas
 - Pond is mowed regularly

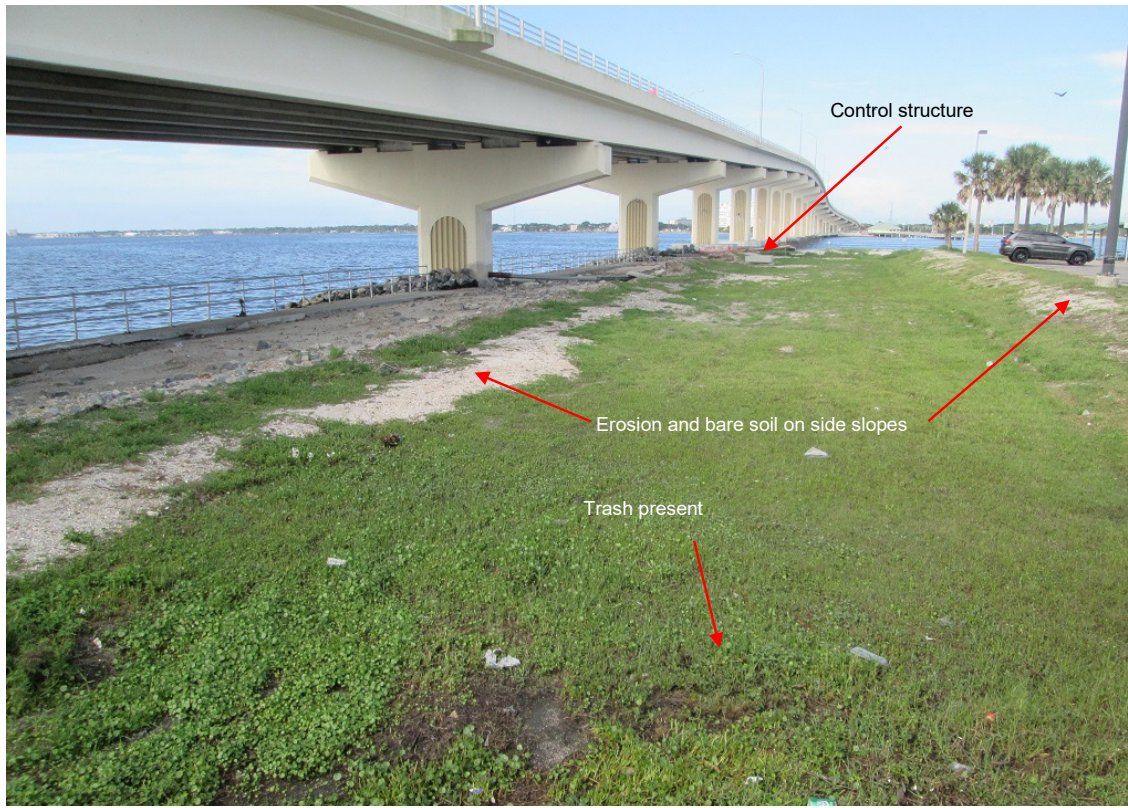
A-28

- Control Structure – Good
 - No visible damage
 - Free of vegetation growth
- Aesthetic Condition – Poor
 - Debris and trash present
 - Side slopes have areas of bare soil
- Erosion Condition – Fair
 - Erosion present on side slopes
- Hydraulic Recovery – Good
 - System dry, indicating the system is recovering its treatment volume
- Sedimentation – Good
 - No evidence of sedimentation problems observed
- Vegetation Condition – Poor
 - Vegetation on the side slopes has become destabilized

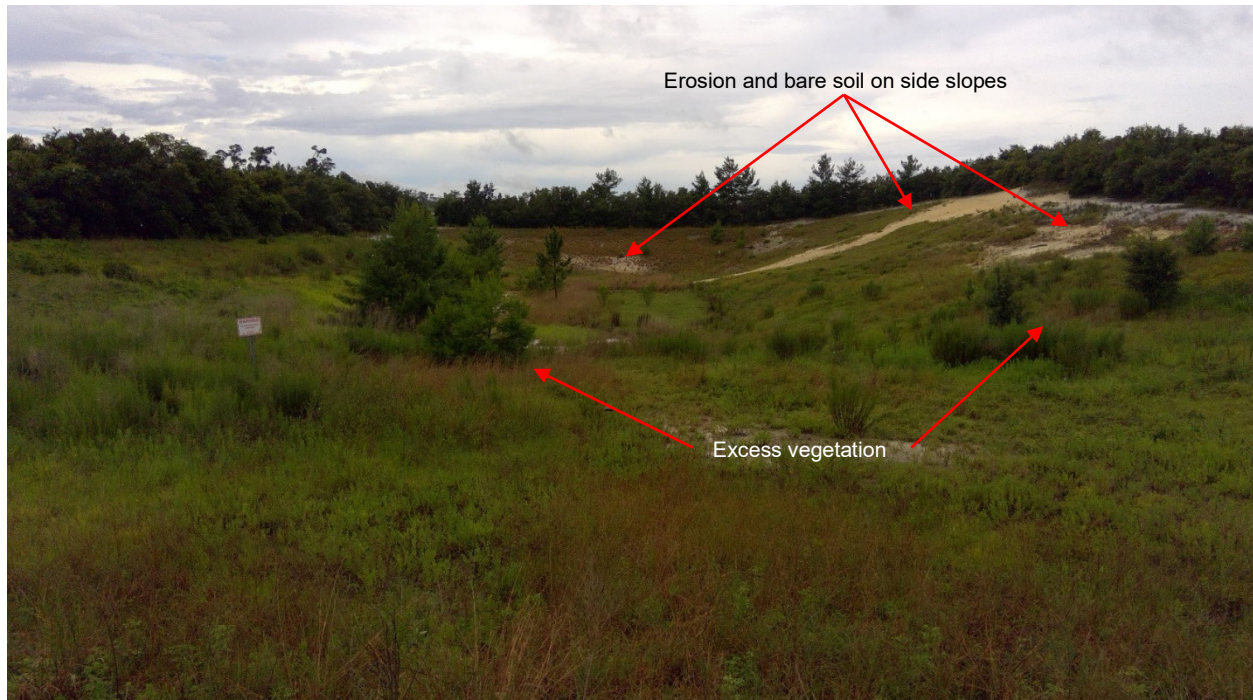
A-29

- Aesthetic Condition – Poor
 - Side slopes have areas of bare soil
- Erosion Condition – Poor
 - Erosion present that may compromise slope stability
- Hydraulic Recovery – Good
 - System dry, indicating the system is recovering its treatment volume.
- Sedimentation – Fair
 - Sedimentation to pond bottom present as a result of erosion on slopes.
- Vegetation Condition – Poor
 - Vegetation on the side slopes has become destabilized
 - Pond does not appear to be mowed regularly
 - Woody vegetation present within pond bottom and side slopes

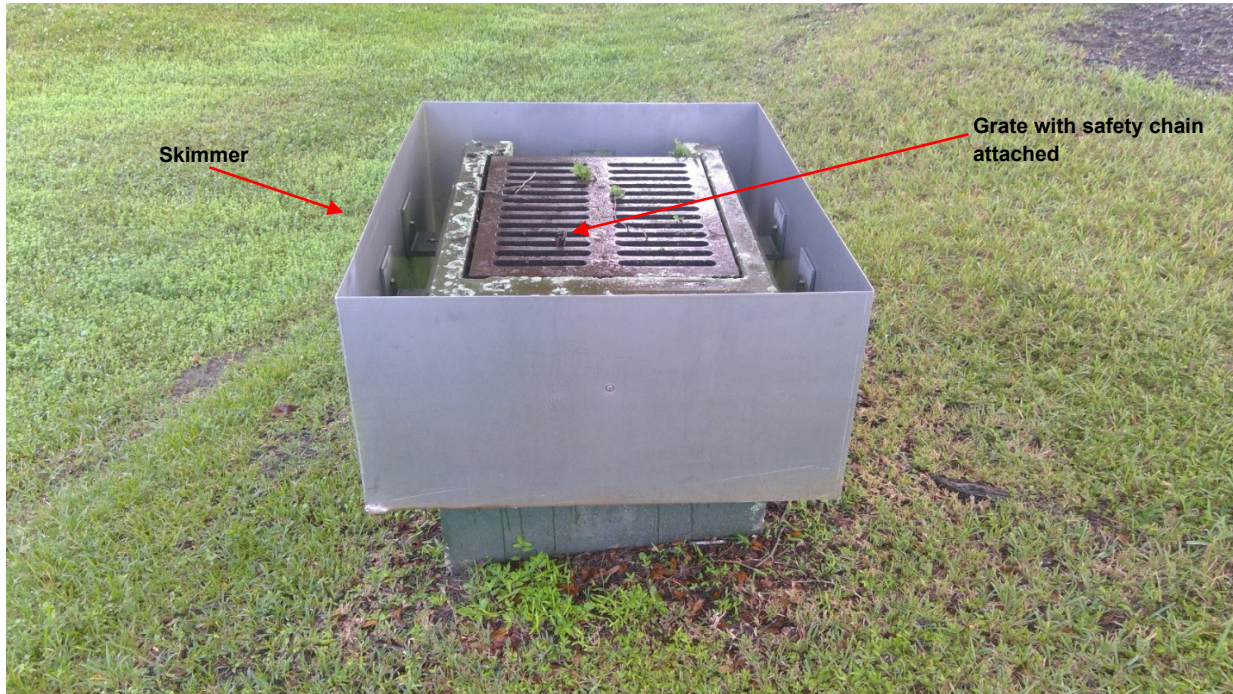
A-31

- Control Structure – Good
 - No visible damage
 - No sediment or vegetation accumulation in or around structure
- Aesthetic Condition – Good
 - No debris or trash present
 - Side slopes well maintained
- Erosion Condition – Good
 - No slope erosion or rills observed
- Hydraulic Recovery – Good
 - System dry, indicating the system is recovering its treatment volume
- Sedimentation – Good
 - No evidence of sediment accumulation
- Vegetation Condition – Good
 - Vegetation cover is intact with no bare areas
 - Pond is mowed regularly

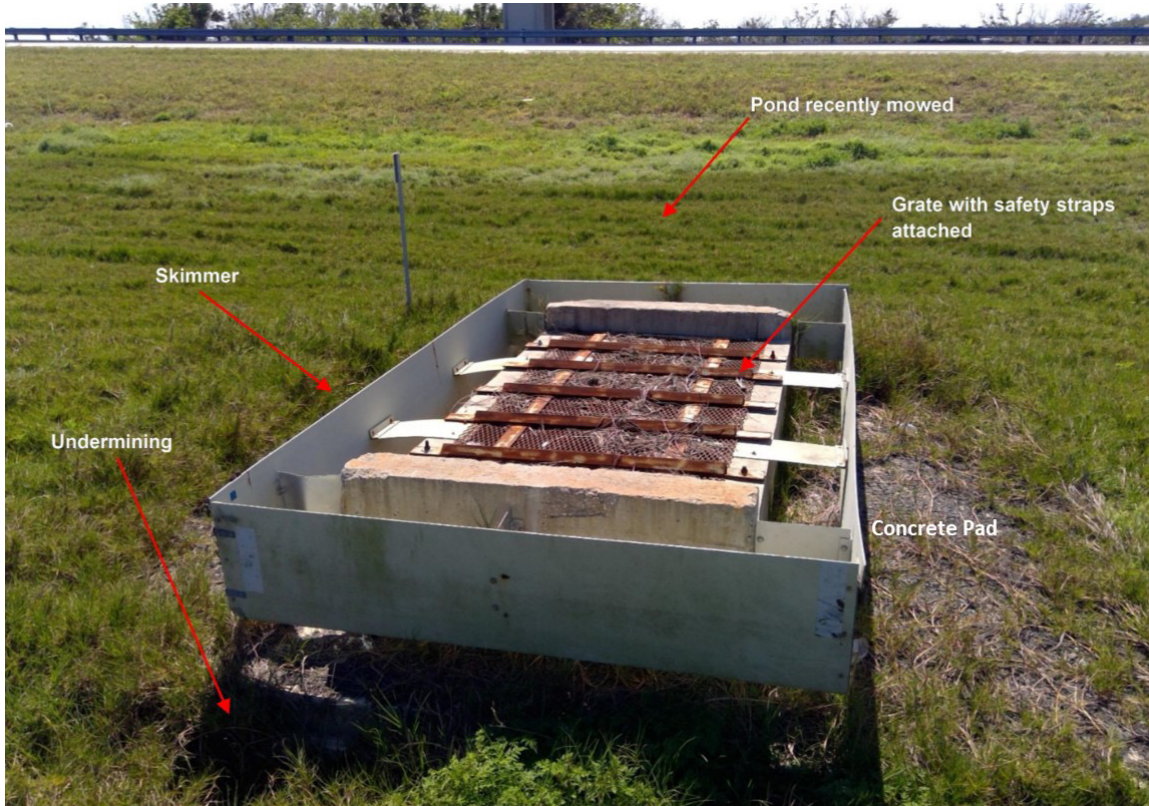
A-32

- Control Structure – Good
 - No sediment or vegetation accumulation in or around structure
 - Skimmer and grate are present and intact
- Aesthetic Condition – Good
 - No debris or trash present
 - Side slopes well maintained
- Erosion Condition – Fair
 - Minor undermining present around concrete slab but not sufficient to cause structural damage
- Hydraulic Recovery – Good
 - System dry, indicating the system recovering its treatment volume
- Sedimentation – Good
 - No evidence of sediment accumulation
- Vegetation Condition – Good
 - Vegetation cover intact with no bare areas
 - Pond is mowed regularly

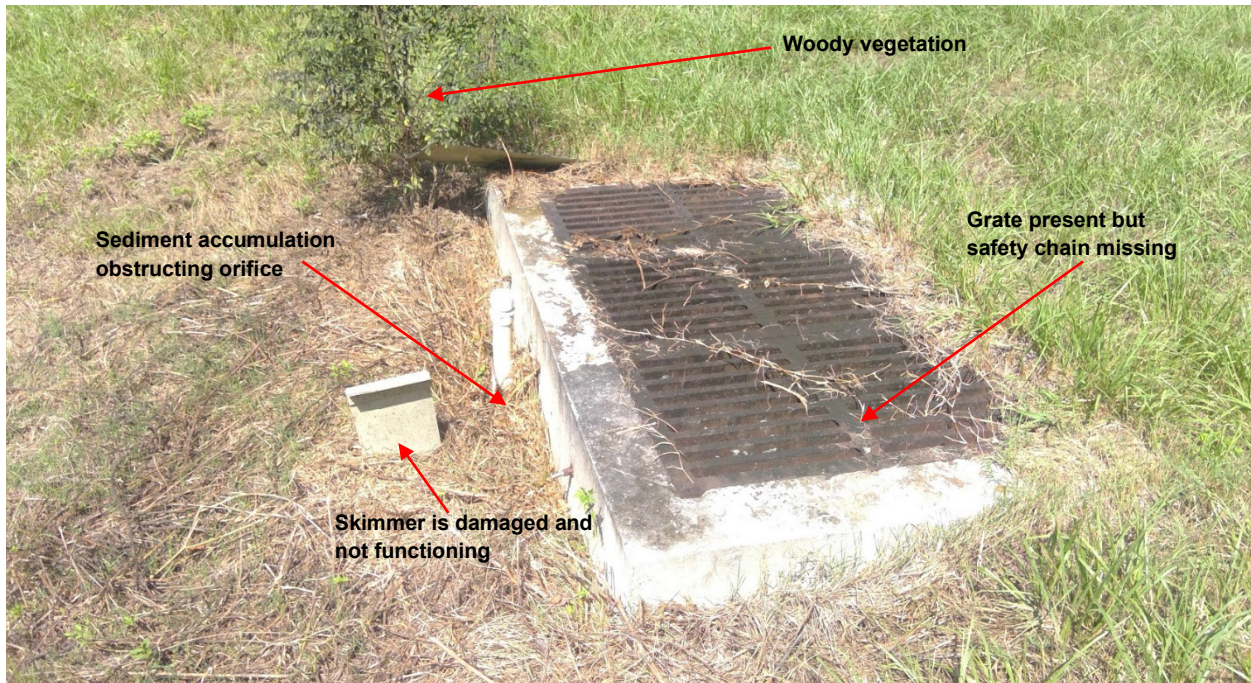
A-33

- Control Structure – Poor
 - Skimmer damaged and not functioning
 - Grate present but safety chain is missing
 - Orifice is blocked
- Aesthetic Condition – Good
 - No debris or trash present
 - Side slopes are well maintained
- Erosion Condition – Good
 - No slope erosion or rills observed
- Hydraulic Recovery – Good
 - System dry, indicating the system is recovering its treatment volume.
- Sedimentation – Poor
 - Sediment accumulation appears to be blocking the orifice.
- Vegetation Condition – Poor
 - Woody vegetation growth present

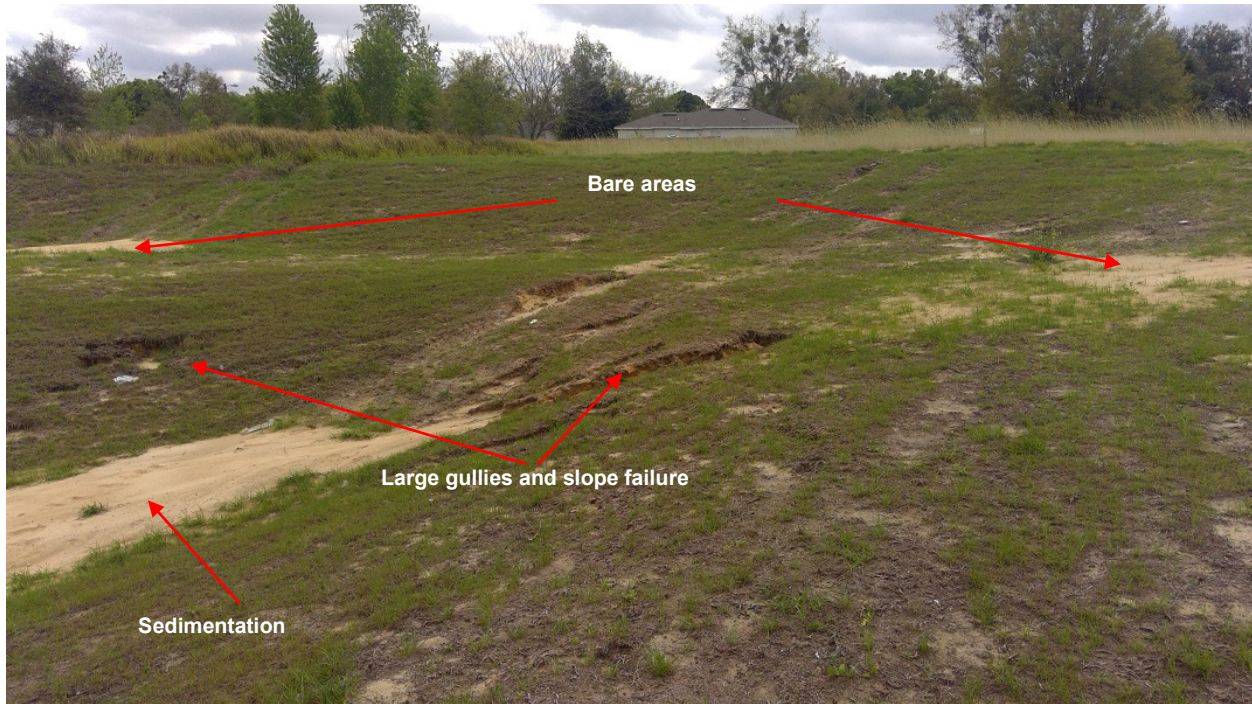
A-35

- Aesthetic Condition – Poor
 - Side slopes not well maintained
- Erosion Condition – Poor
 - Substantial erosion present
 - Large gullies present along slope
 - Slope stability compromised
- Hydraulic Recovery – Good
 - System dry, indicating the system is recovering its treatment volume
- Sedimentation – Fair
 - Sedimentation to pond bottom from slope erosion
- Vegetation Condition – Poor
 - Vegetative cover poor, with bare areas present

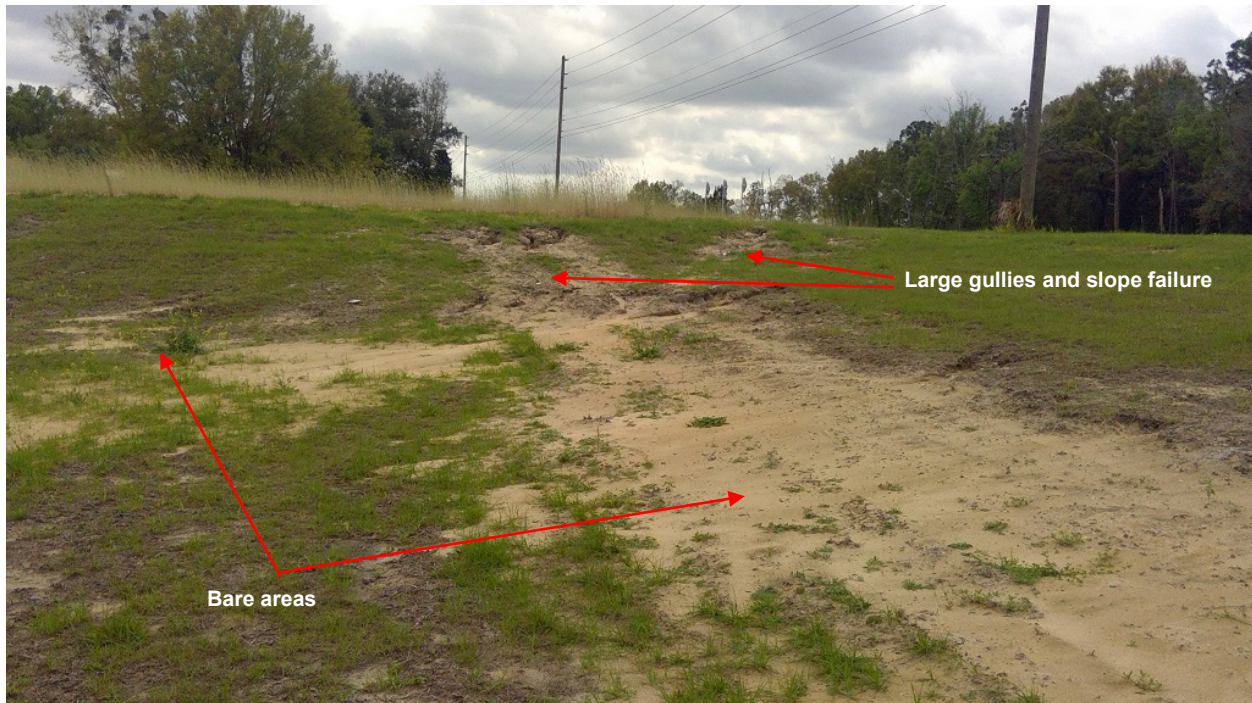
A-36

- Aesthetic Condition – Poor
 - Side slopes not well maintained
- Erosion Condition – Poor
 - Substantial erosion present
 - Gullies present along slope
 - Slope stability has been compromised
- Hydraulic Recovery – Good
 - System dry, indicating the system is recovering its treatment volume
- Vegetation Condition – Poor
 - Vegetative cover is poor with significant bare areas present
