Maintenance Guide for Stormwater Assets

May 2023

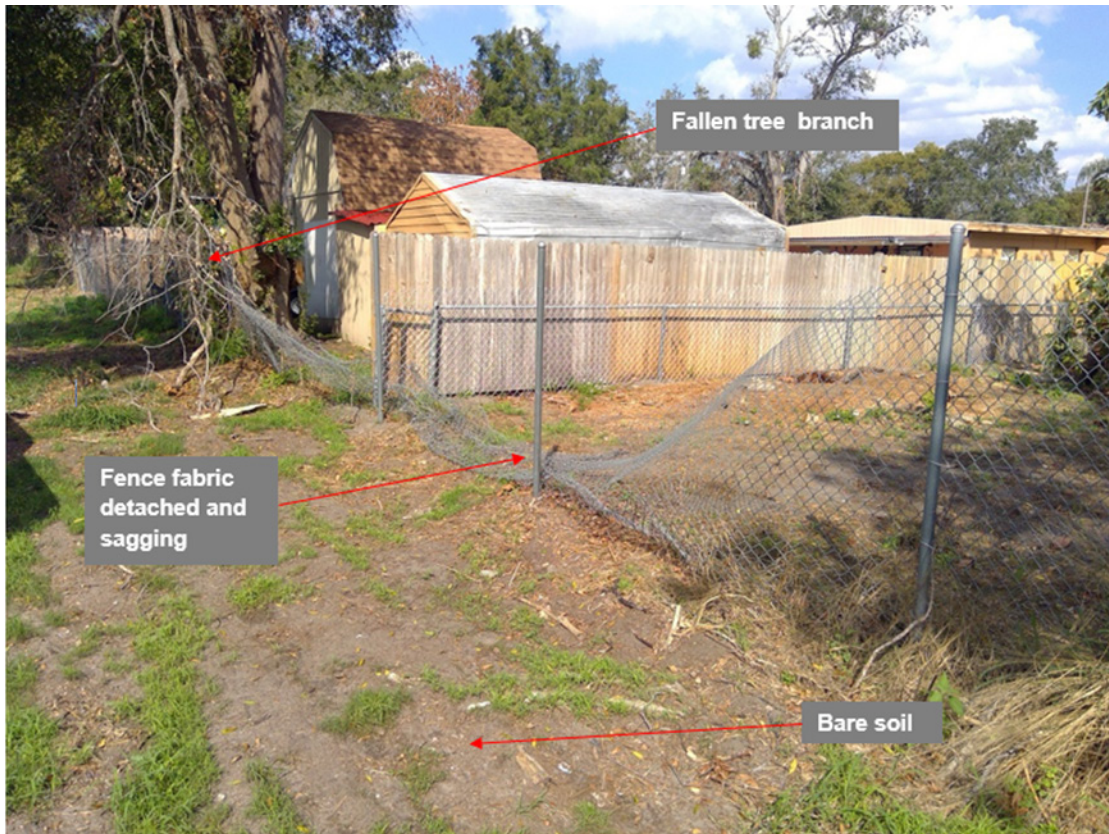
A-38

- Fence Condition – Poor
 - Fence fabric has become detached and is sagging greater than 1/3 its original height
- Vegetation Condition – Poor
 - Bare soil present on berm
 - Fallen tree branch on fence

- Reattach or repair fence fabric
- Re-establish turf/grass
- Remove fallen tree branch from fence

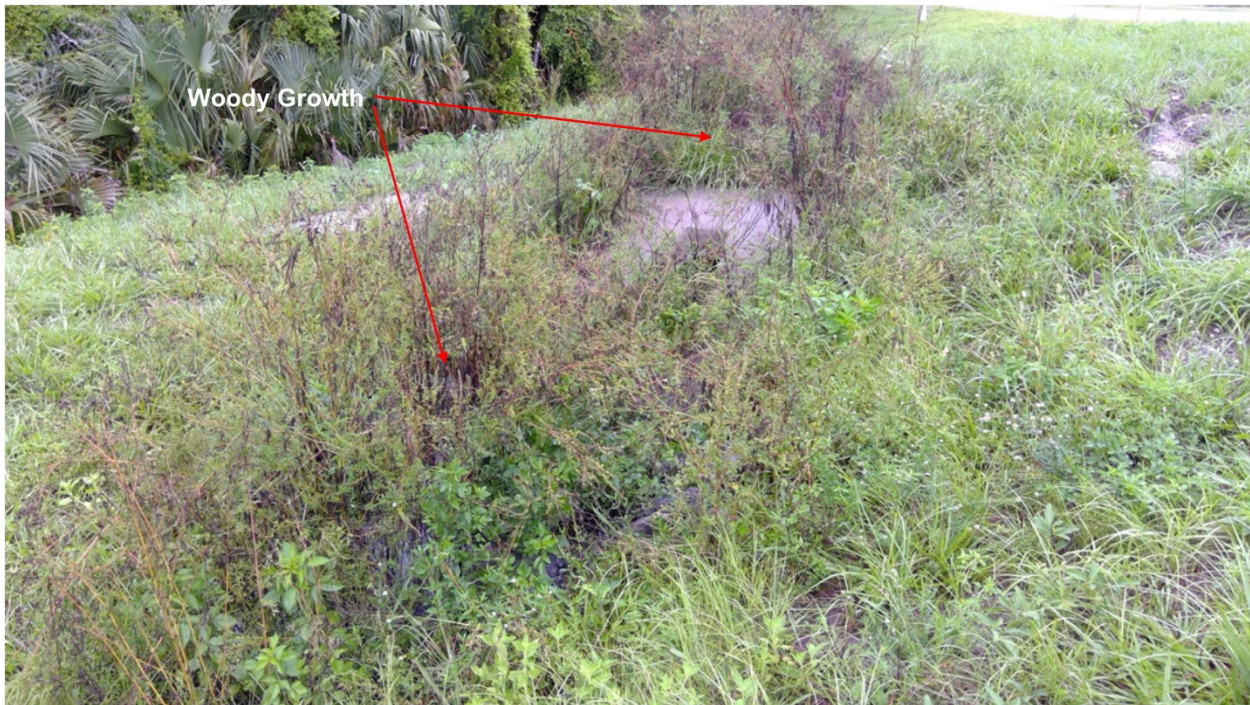
A-40

- Inflow and Outflow Pipes – Poor
 - Woody vegetation growth with more than 40 percent of pipe obstructed
 - No significant cracks or undermining observed
- Vegetation Condition – Poor
 - Excess vegetation present in and around inflow pipe

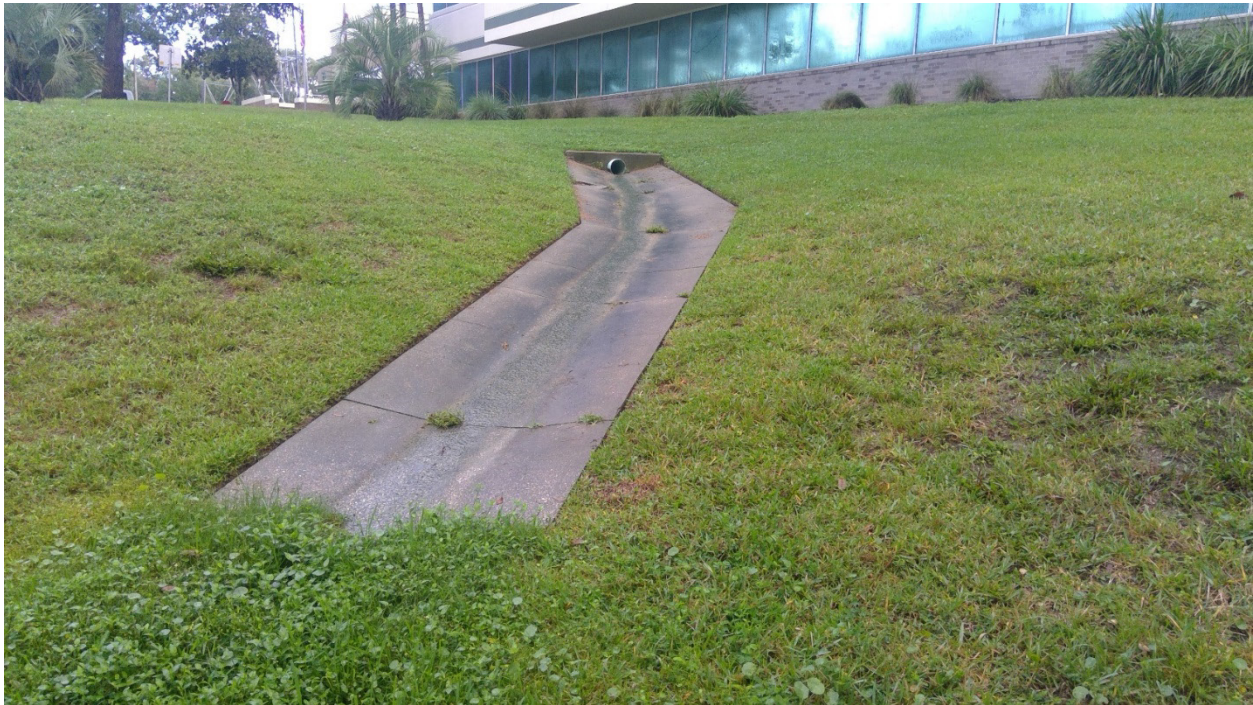
A-43

- Inflow and Outflow Pipes – Good
 - Like-new condition
 - No significant cracks or undermining observed
 - Pipe is open and no obstructions observed
 - Pipe appears to be functioning as designed
- Aesthetic Condition – Good
 - Side slopes are well maintained and regularly mowed
 - No trash and debris present
- Vegetation Condition – Good
 - Vegetative cover is in good condition and well maintained

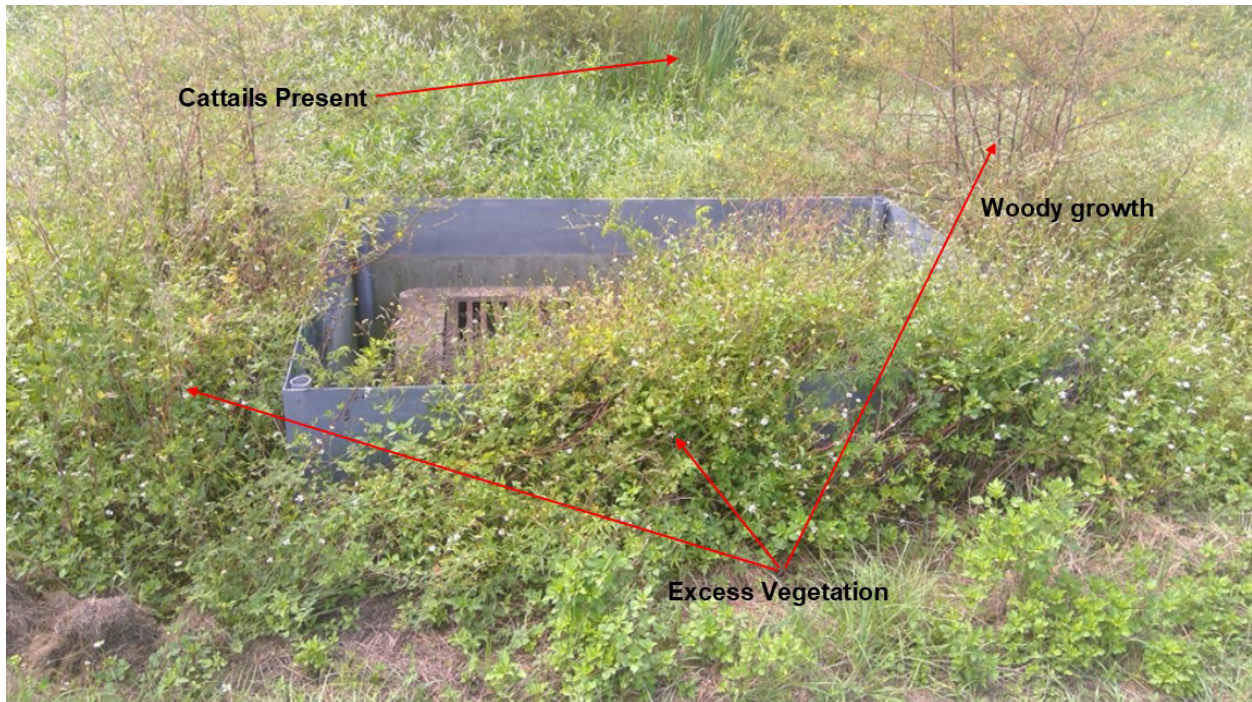
A-47

- Control Structure – Good
 - Skimmer present and intact
 - Grate is present
- Hydraulic Recovery – Fair
 - System mostly dry
 - Small amount of cattail present indicates the system may not be fully recovering its treatment volume
- Vegetation Condition – Poor
 - Excess vegetation growth present around control structure and within the pond bottom.

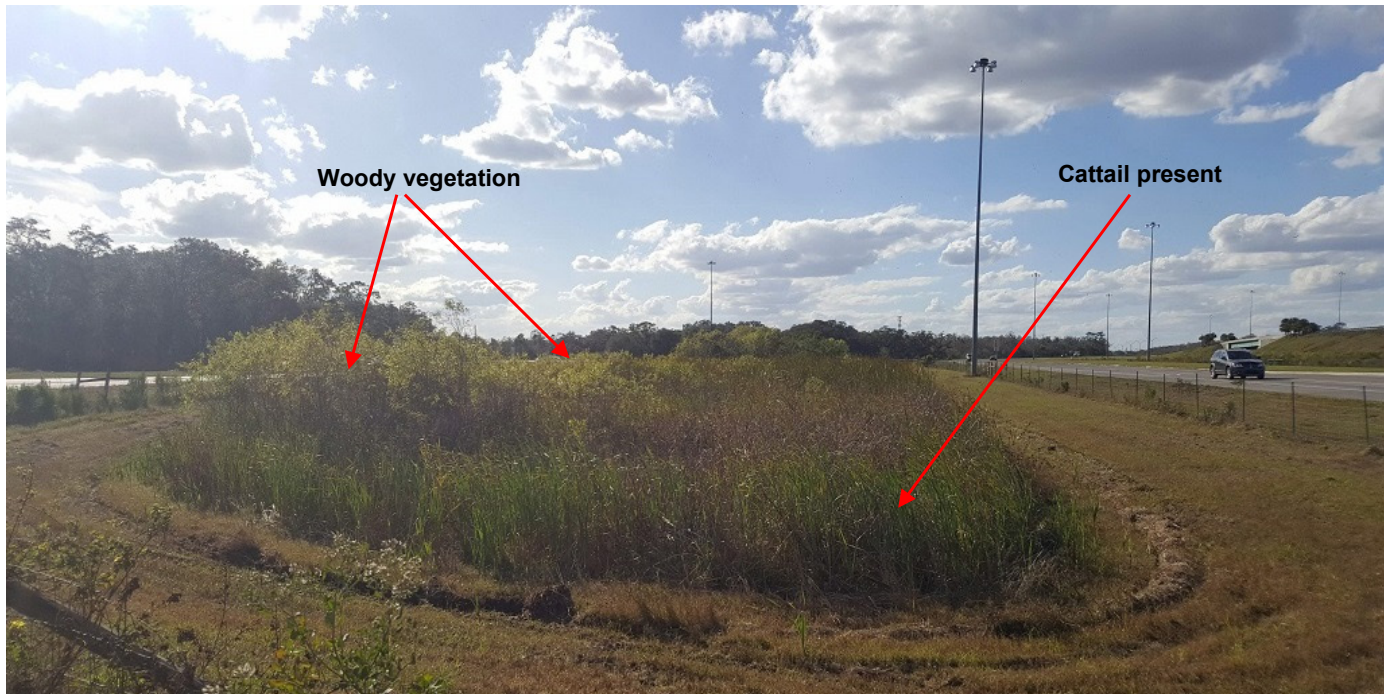
A-48

- Aesthetic Condition – Poor
 - Excess vegetation in pond
 - No debris or trash present
 - Side slopes are regularly mowed
 - Fence is in good condition
- Erosion Condition – Good
 - No slope erosion or rills observed
- Hydraulic Recovery – Poor
 - The presence of cattail throughout the pond bottom indicates the system may not be fully recovering its treatment volume
- Vegetation Condition – Poor
 - Woody vegetation present within the pond bottom.
 - Excess vegetation growth present within the pond bottom

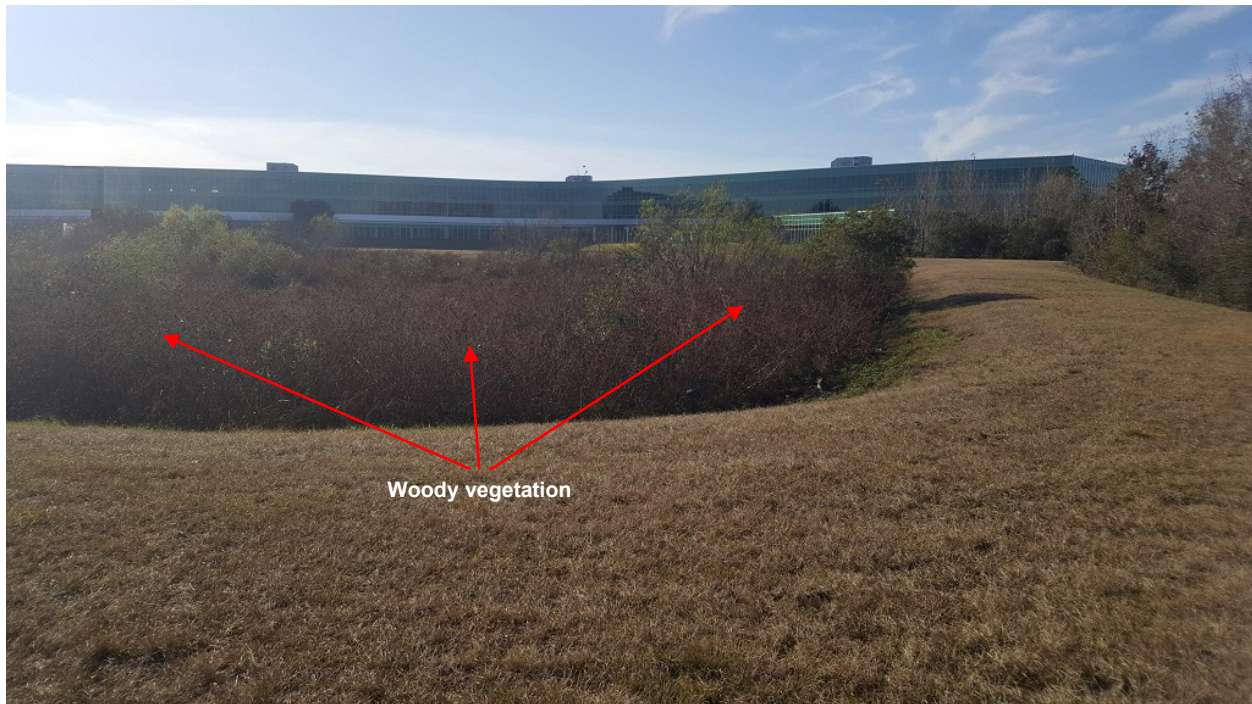
A-49

- Aesthetic Condition – Poor
 - Excess vegetation in pond
 - No debris or trash present
 - Side slopes are regularly mowed
- Erosion Condition – Good
 - No slope erosion or rills observed
- Hydraulic Recovery – Poor
 - Excess, woody vegetation inhibits recovery
- Vegetation Condition – Poor
 - Woody vegetation present within the pond bottom.
 - Excess vegetation growth present within the pond bottom

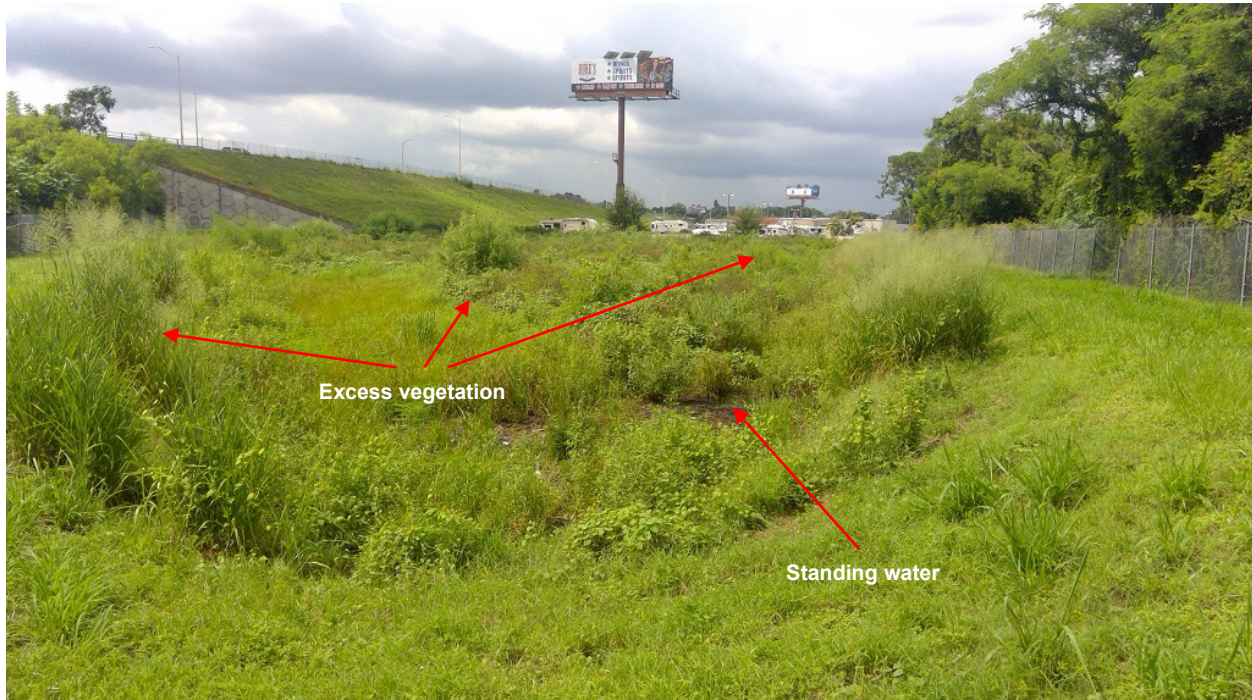
A-50

- Aesthetic Condition – Poor
 - Excess vegetation in pond
 - No debris or trash present
 - Side slopes need to be mowed
 - Fence is in good condition
- Erosion Condition – Good
 - No slope erosion or rills observed
- Hydraulic Condition – Poor
 - Standing water indicates the system is not fully recovering its treatment volume
- Vegetation Condition – Poor
 - Excess vegetation growth present within the pond bottom

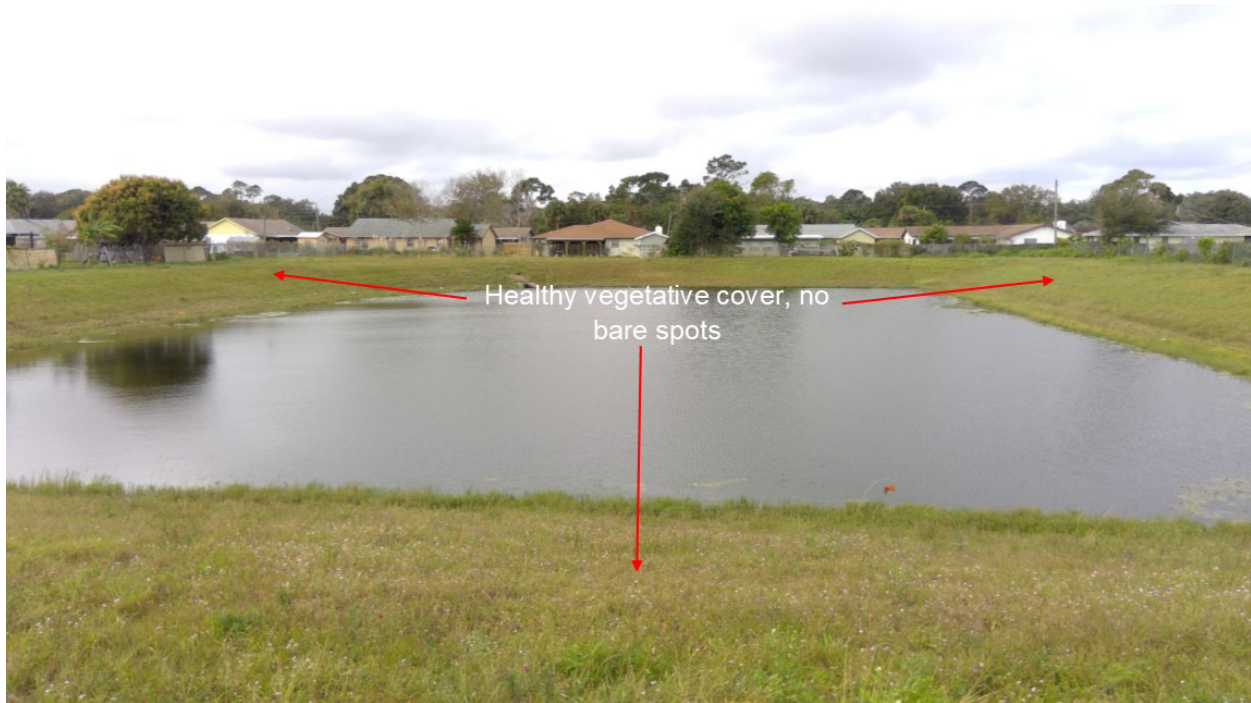
A-52

- Aesthetic Condition – Good
- Erosion Condition – Good
 - Healthy vegetative cover with no bare spots
- Water Condition – Good
 - Water is clear, free of trash, vegetation, and visible sheens
- Vegetation – Good
 - Vegetation is well maintained and recently mowed
 - Complete vegetative cover with no bare spots

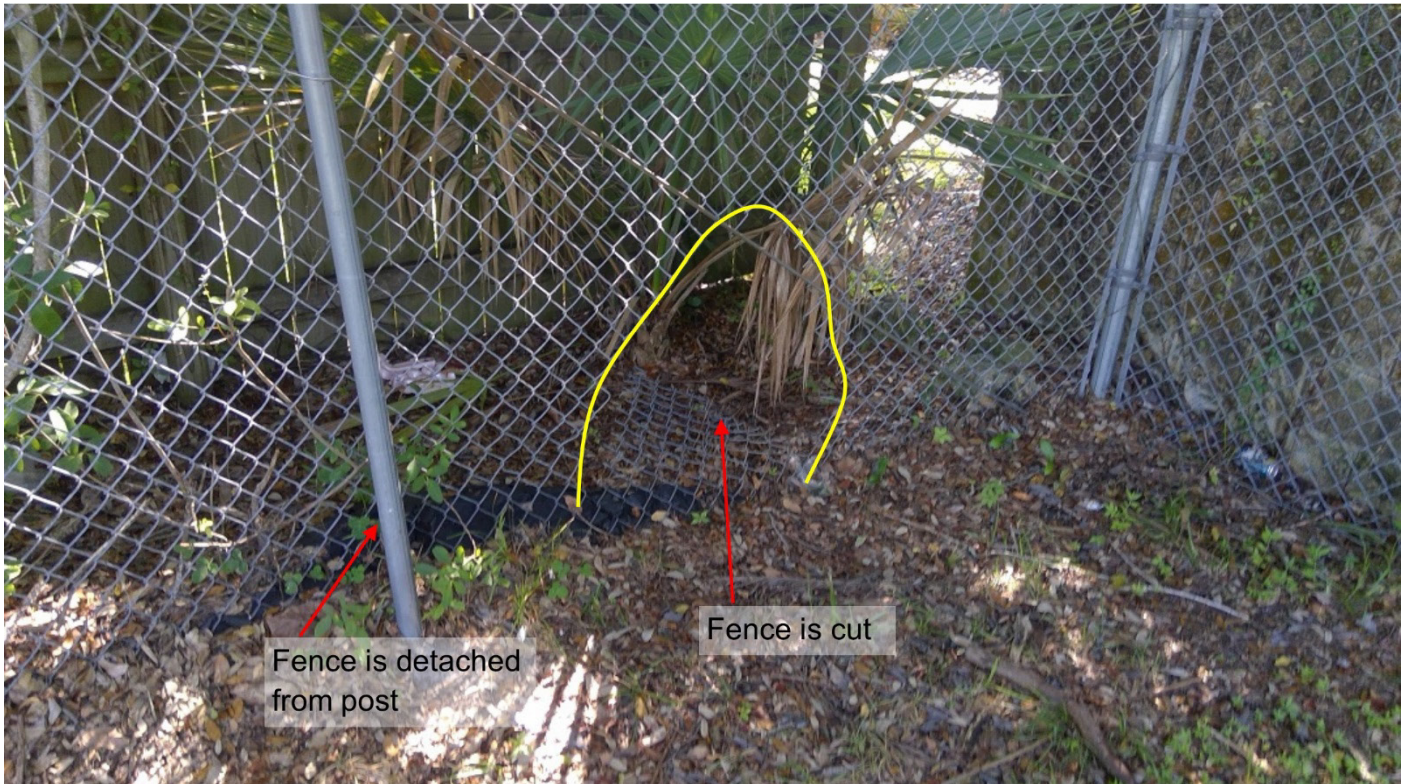
A-53

- Fence – Poor
 - Cut section is greater than 2 square feet
 - Fabric is detached from fence post
 - Site is no longer secure

- Secure site immediately
- Repair fence fabric
- Reattach fabric to fence post

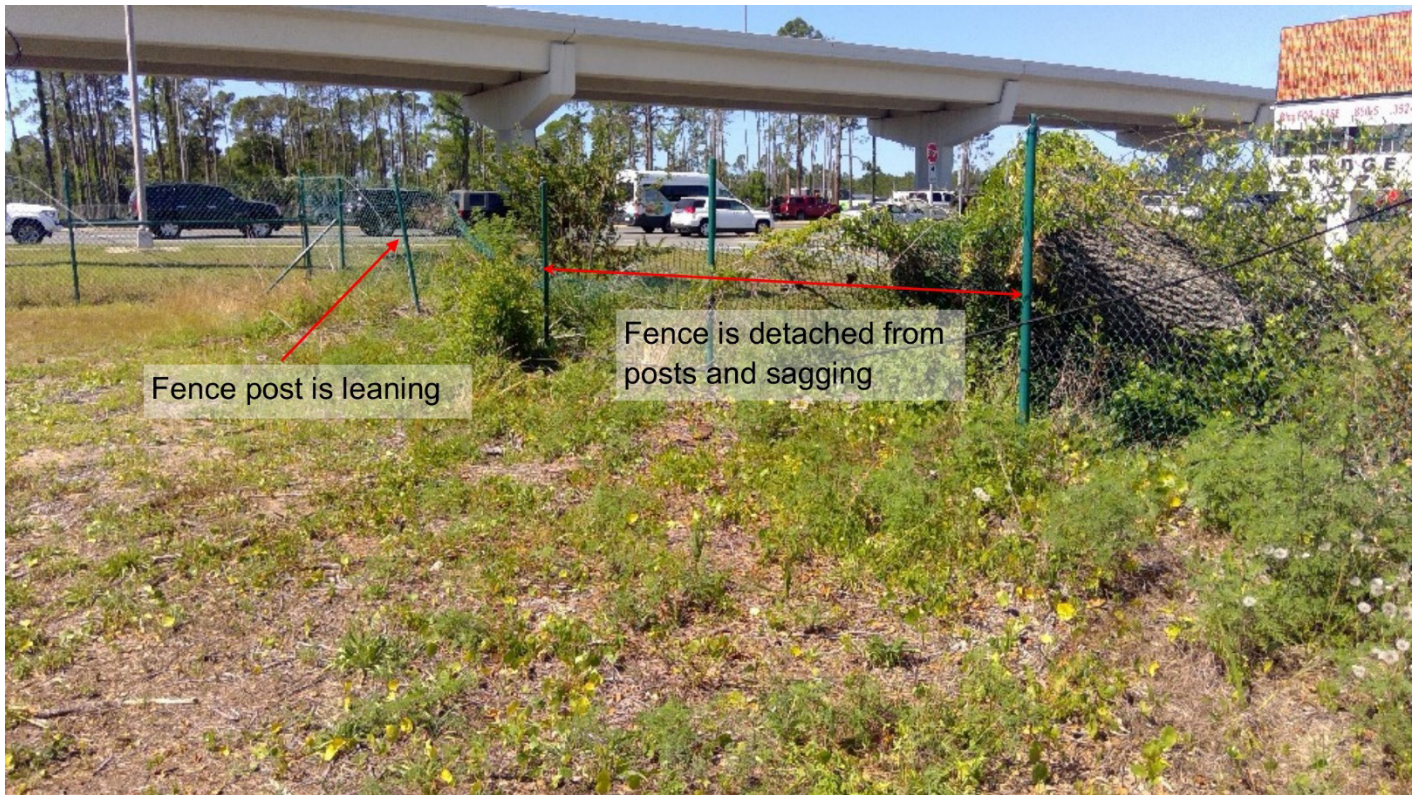
A-54

- Fence – Poor
 - Fence fabric is detached from consecutive fence posts
 - Opening at sagging fence section is greater than one-third original fence height
 - Site is not secure

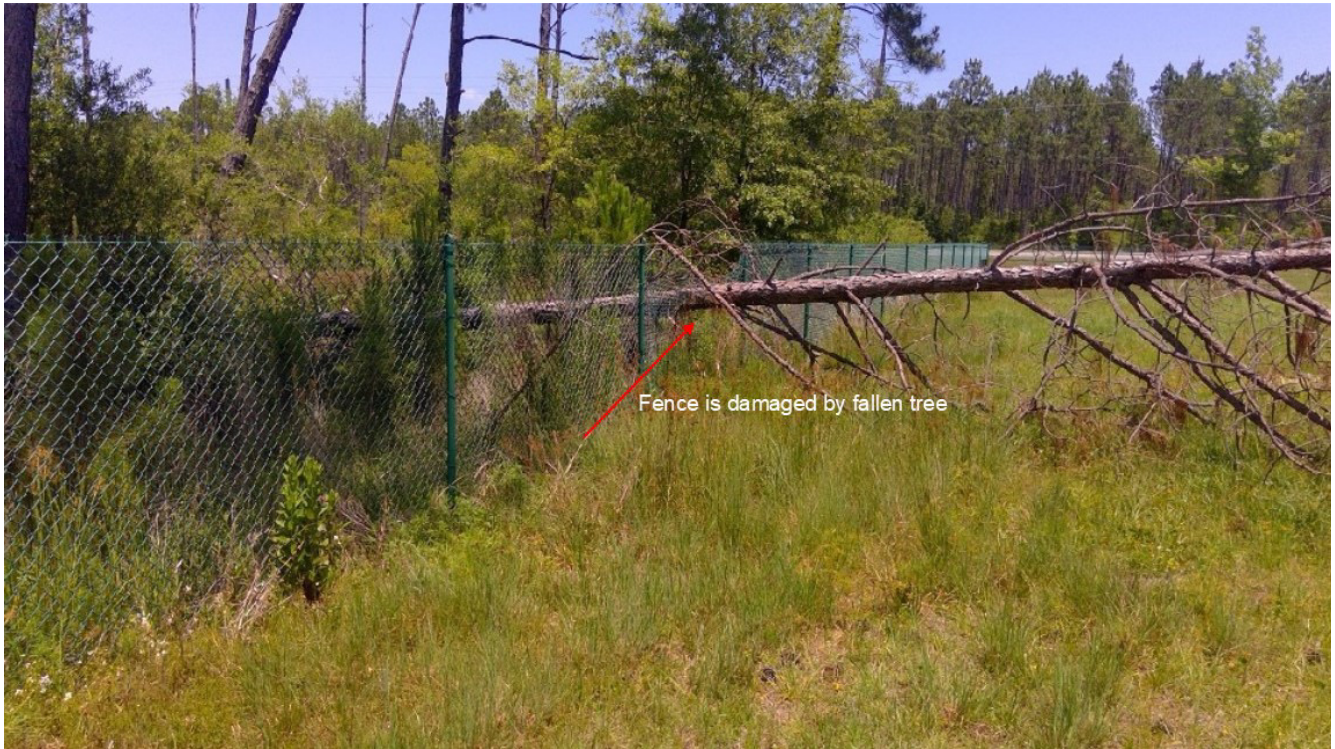
A-55

- Fence – Poor
 - Downed tree on fence
 - Cut section in fence is greater than 2 square feet
 - Opening at cut section is greater than one-third original fence height
 - Site is not secure

- Secure site immediately
- Remove tree
- Replace damaged fence section

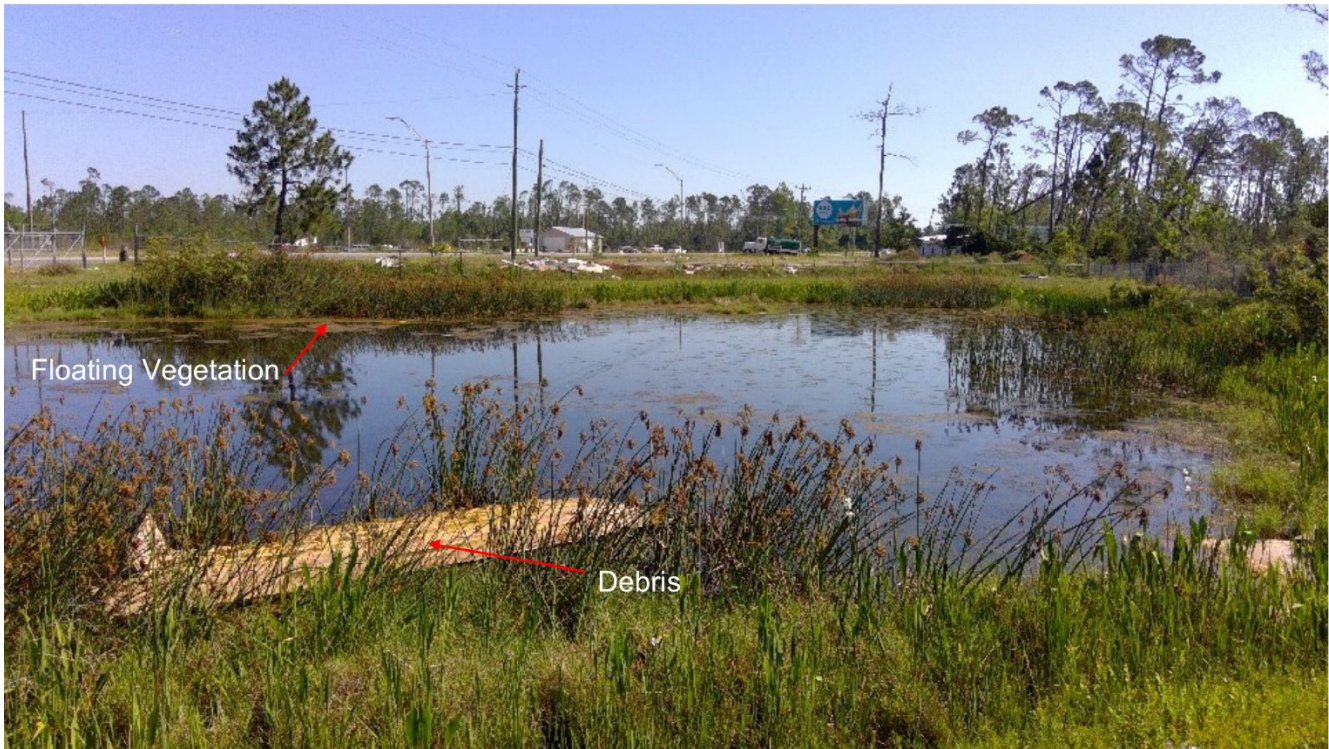
A-57

- Aesthetic Condition – Fair
 - Debris on slope
- Water Condition – Good
 - Minor amount of floating vegetation present

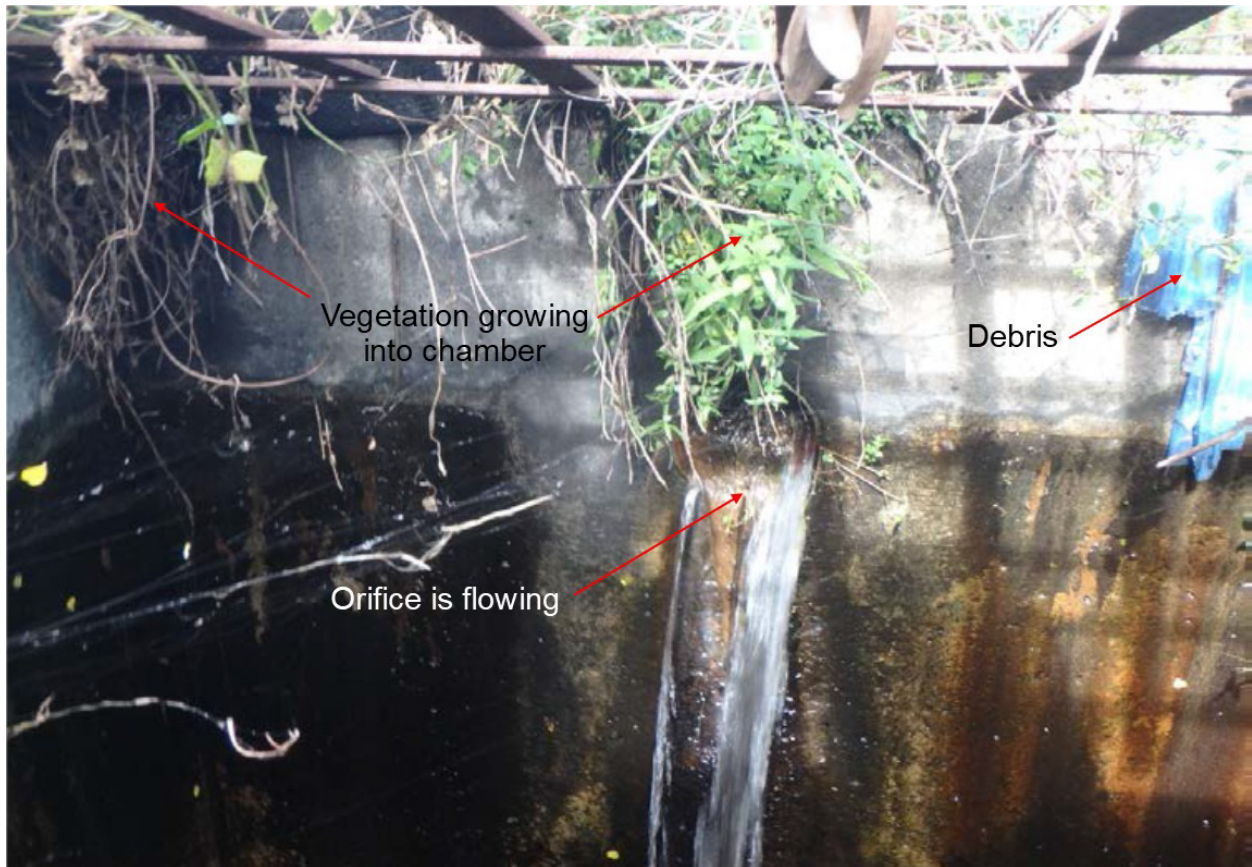
A-59

- Control Structure – Fair
 - Chamber – Fair – Grate partially blocked by vegetation and debris
 - Orifice – Fair – Discharging, but unclear if flowing at full capacity; vegetation growing in front of orifice

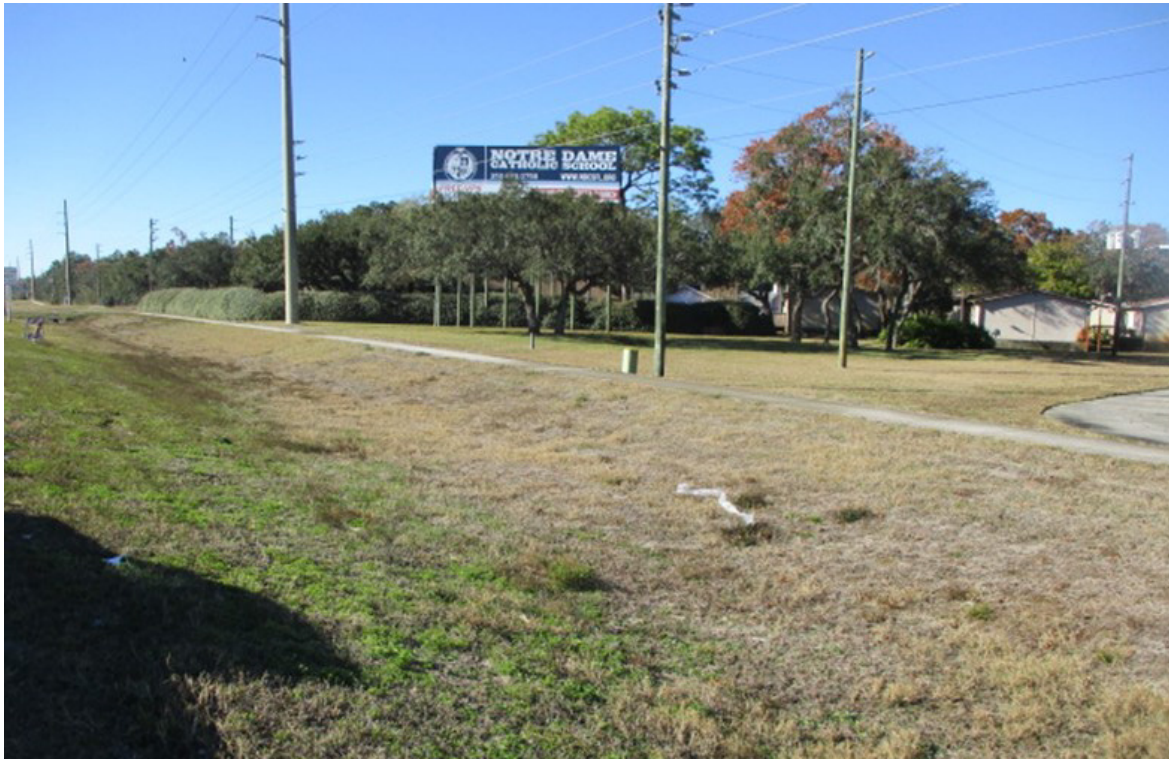
B-1

Treatment Swale

- Overall Appearance – Good
 - Minimal trash present
 - Slopes well maintained
- Hydraulic Recovery – Good
 - Swale dry, indicating system is recovering its treatment volume
- Sedimentation Condition - Good
 - No buildup of sediment
- Vegetation Condition – Good
 - Vegetation cover intact with no bare areas
 - Slopes mowed regularly
 - Brown turf indicates dormancy, not lack of maintenance
- Erosion Condition – Good
 - No erosion, slope appears stable

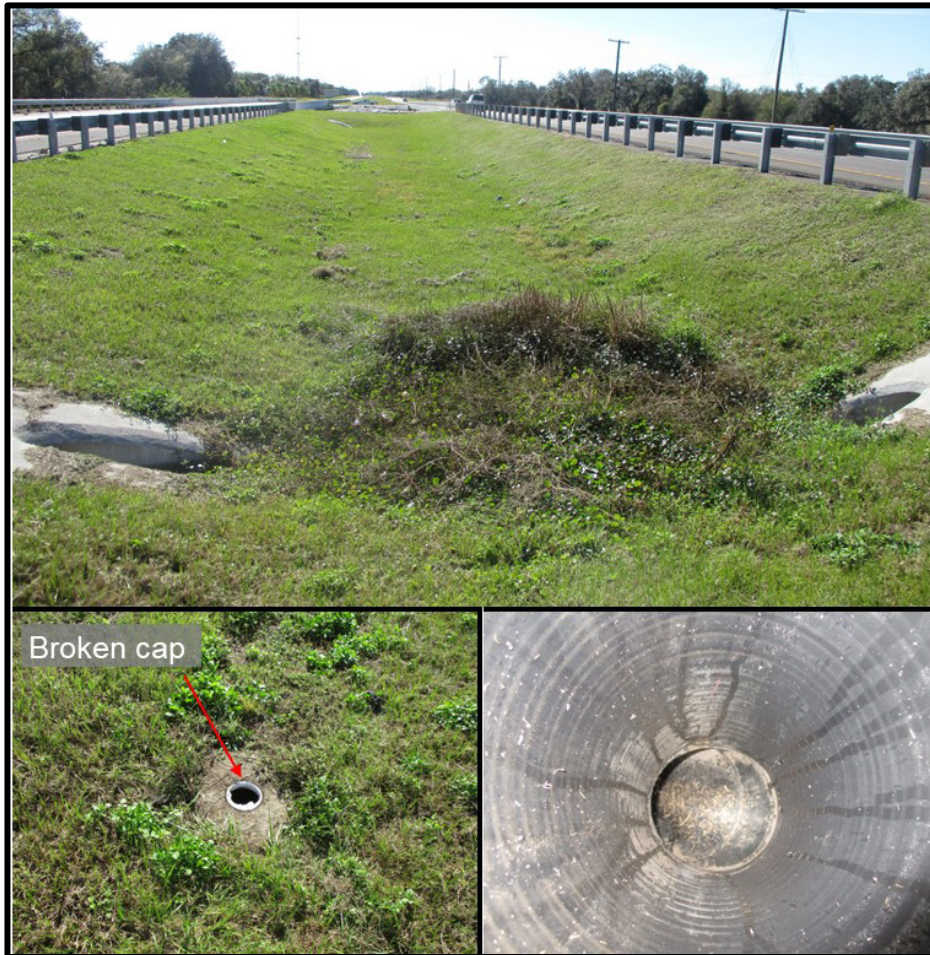
B-2

Treatment Swale with Underdrain

- Overall Appearance – Good
 - Free of trash and debris
- Hydraulic Recovery – Good
 - No standing water observed
- Sedimentation Condition – Good
 - No sediment accumulation observed
- Vegetation Condition – Good
 - Slopes are mowed and well maintained
- Structural Condition – Fair
 - Underdrain cleanout cap is broken
 - Inflow pipes undamaged and free of obstruction
- Erosion Condition – Good
 - No erosion present

- Replace underdrain cap

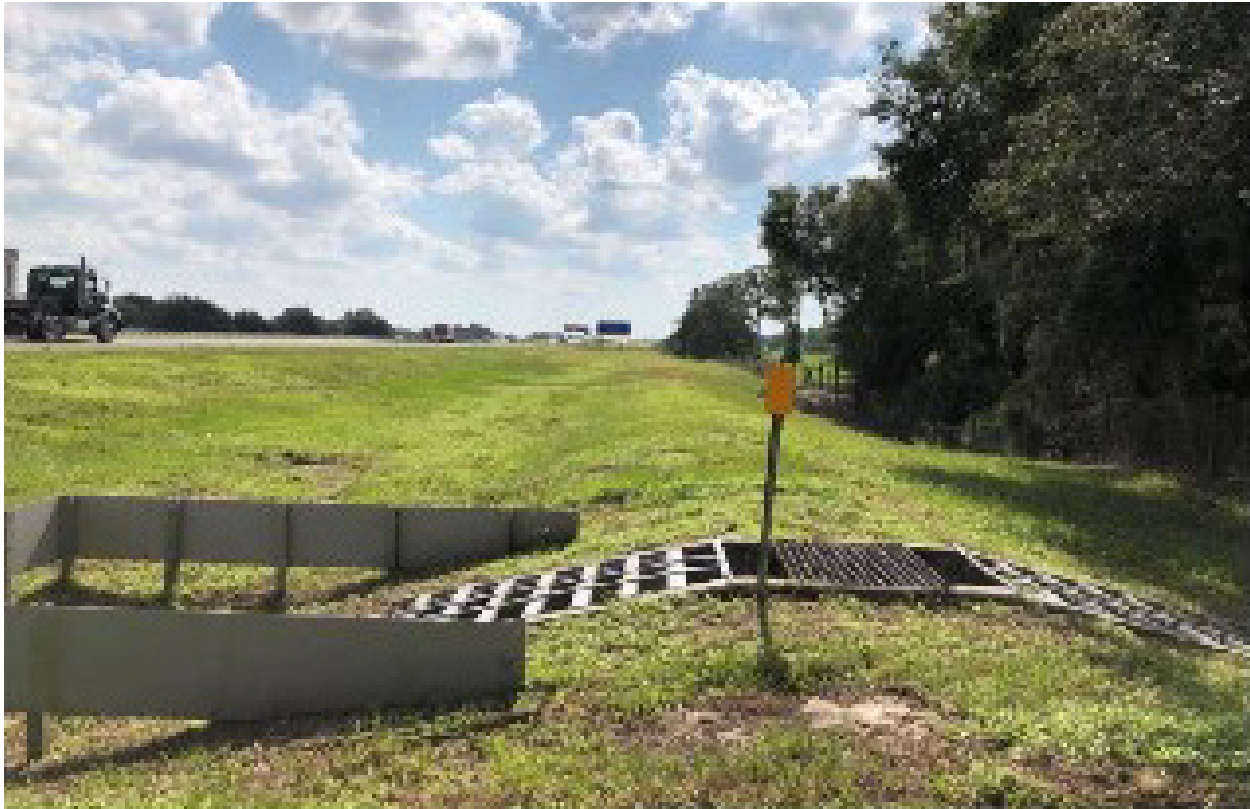
B-3

Treatment Swale

- Overall Appearance – Good
 - Free of trash and debris
- Hydraulic Recovery – Good
 - System appears to be recovering as designed
- Sedimentation Condition – Good
 - System is free of accumulated sediment
- Vegetation Condition - Good
 - Vegetative cover in good condition and well maintained
- Control Structure – Good
 - Skimmer fully attached and undamaged
 - Grates in place and undamaged
- Erosion Condition – Good
 - No erosion noted

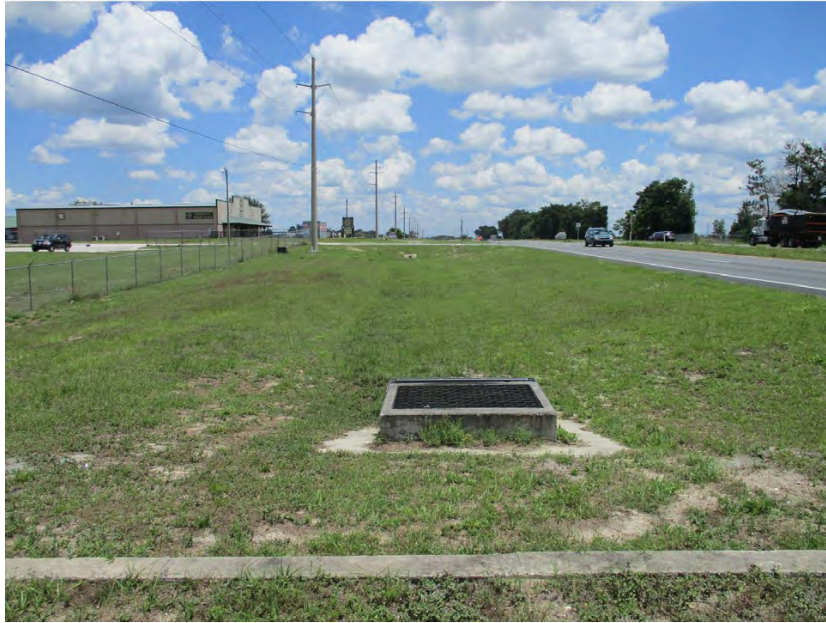
B-4

Concrete Core Ditch Block with Overflow Control Structure

- Aesthetic Condition – Good
 - No trash or debris
- Hydraulic Recovery - Good
 - No standing water
 - No accumulated sediment
- Vegetation Condition – Fair
 - Patchy vegetative cover
 - Recently mowed
- Structural Condition - Good
 - No damage to overflow structure
 - No damage to concrete core
- Erosion Condition – Good
 - No erosion noted

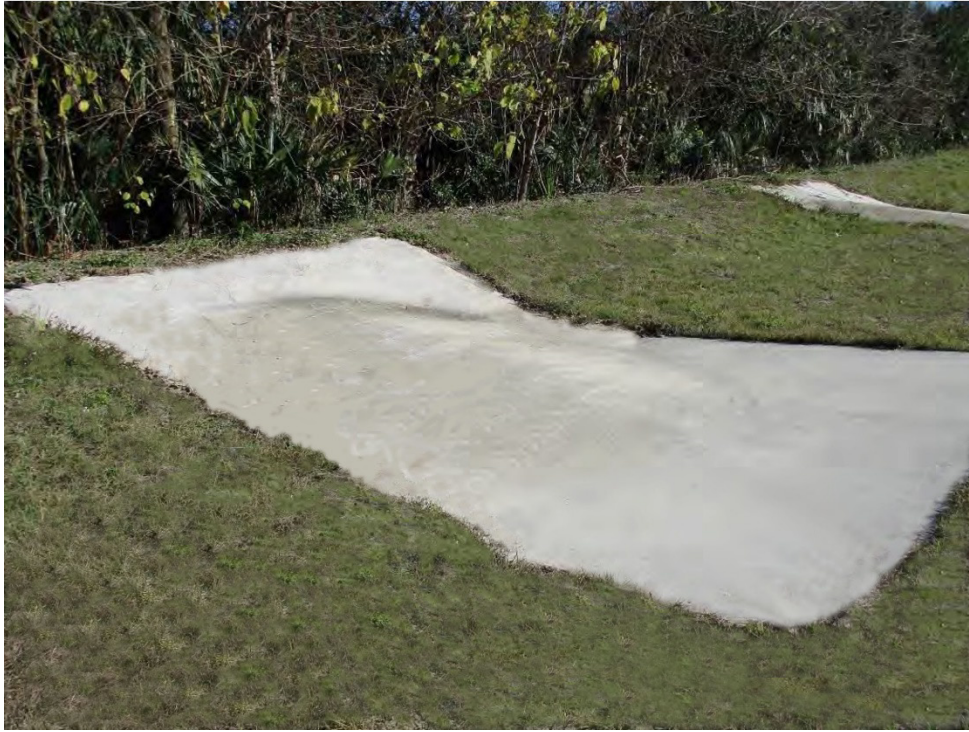
B-5

Concrete Ditch Block

- Aesthetic Condition – Good
 - Free of debris and litter
- Hydraulic Recovery - Good
 - No standing water
 - No accumulated sediment
- Vegetation Condition – Good
 - Recently mowed
- Structural Condition - Good
 - No damage to concrete; like new
- Erosion Condition – Good
 - No erosion noted

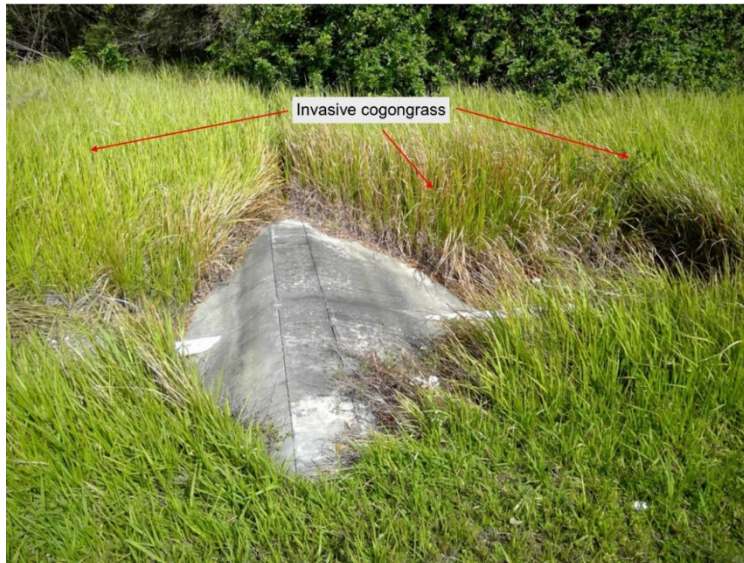
B-6

Concrete Ditch Block with Orifice

- Aesthetic Condition – Fair
 - Overgrown, invasive vegetation on slopes
 - Free of debris and litter
- Hydraulic Recovery - Poor
 - Excess vegetation and sediment in sump impacting system recovery
- Vegetation Condition – Poor
 - Invasive vegetation covering more than 25% of area
 - Excess vegetation affecting system recovery
 - Vegetation blocking orifice
- Structural Condition - Poor
 - Excess sedimentation in sump as evidenced by vegetative overgrowth
 - No damage to concrete berm
 - Orifice appears to be intact
- Erosion Condition – Good
 - No erosion noted

- Remove sediment accumulation in sump
- Check orifice for blockages
- Mow swale
- Control for invasive vegetation

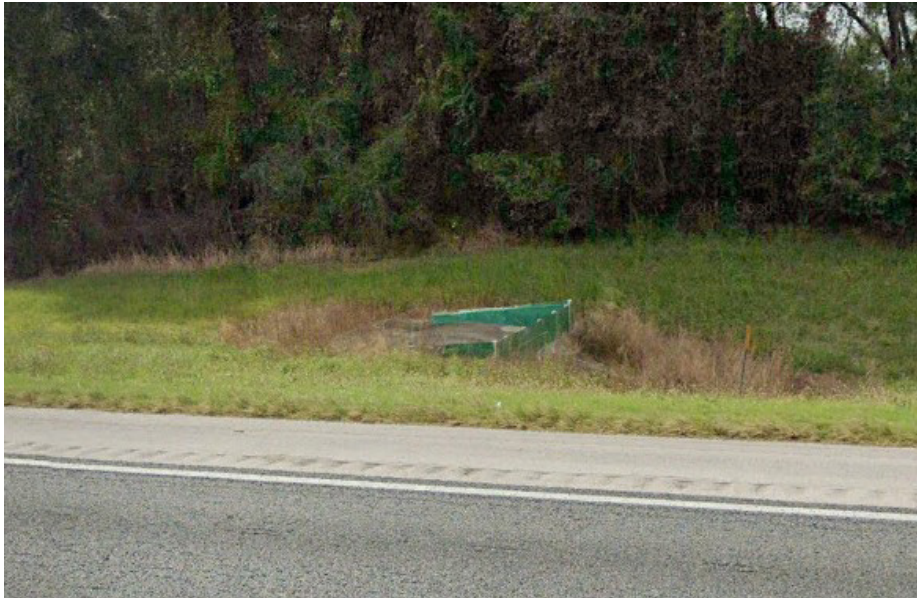
B-7

Concrete Ditch Block with Skimmer

- Aesthetic Condition – Poor
 - Overgrown vegetation in swale and blocking skimmer
- Hydraulic Recovery - Fair
 - Excess vegetation inhibiting system recovery
 - No standing water
 - No accumulated sediment
- Vegetation Condition – Poor
 - Vegetation not being maintained
- Structural Condition - Poor
 - More than 50% of skimmer opening is obstructed
 - No damage to concrete berm
 - No damage to skimmer
- Erosion Condition – Good
 - No erosion noted

- Address excess vegetation so skimmer function is restored

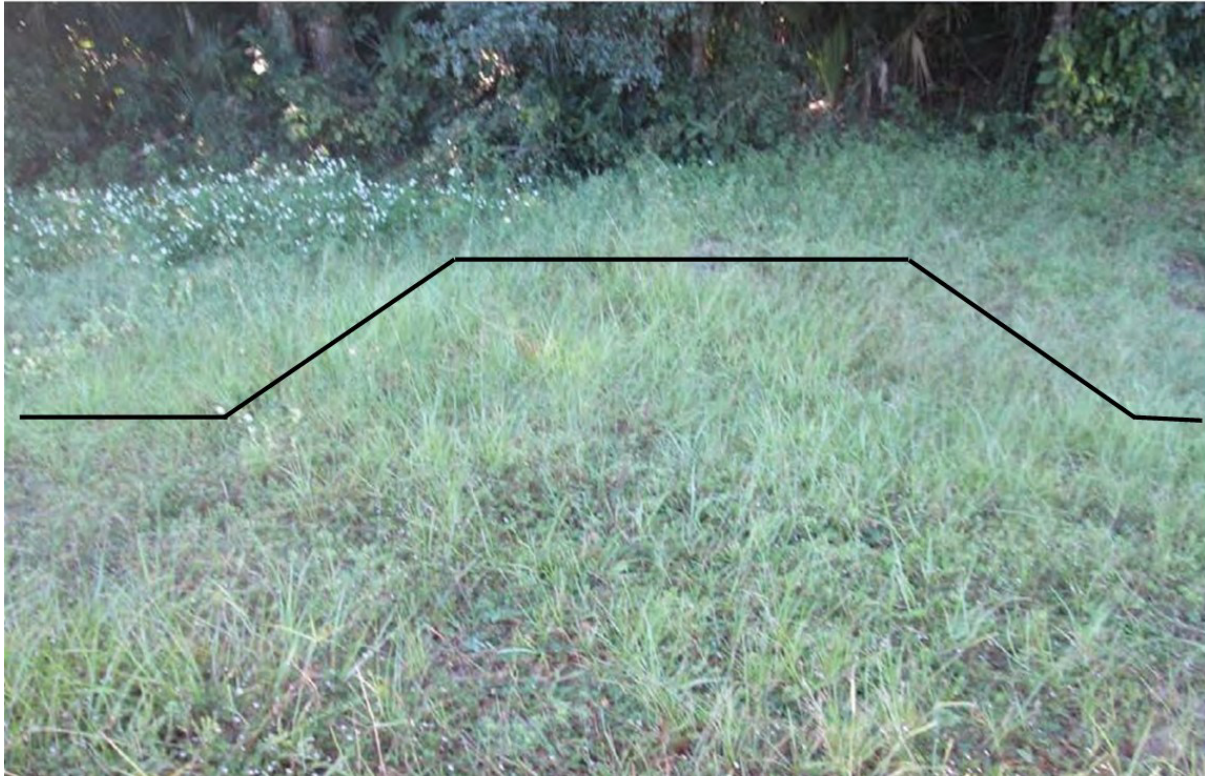
B-8

Earthen Ditch Block

- Aesthetic Condition – Good
 - Free of debris and litter
- Hydraulic Recovery - Good
 - No standing water
 - No accumulated sediment
- Vegetation Condition – Fair
 - Needs to be mowed
- Structural Condition - Good
 - No erosion or scour
- Erosion Condition - Good

- Mow ditch block and swale

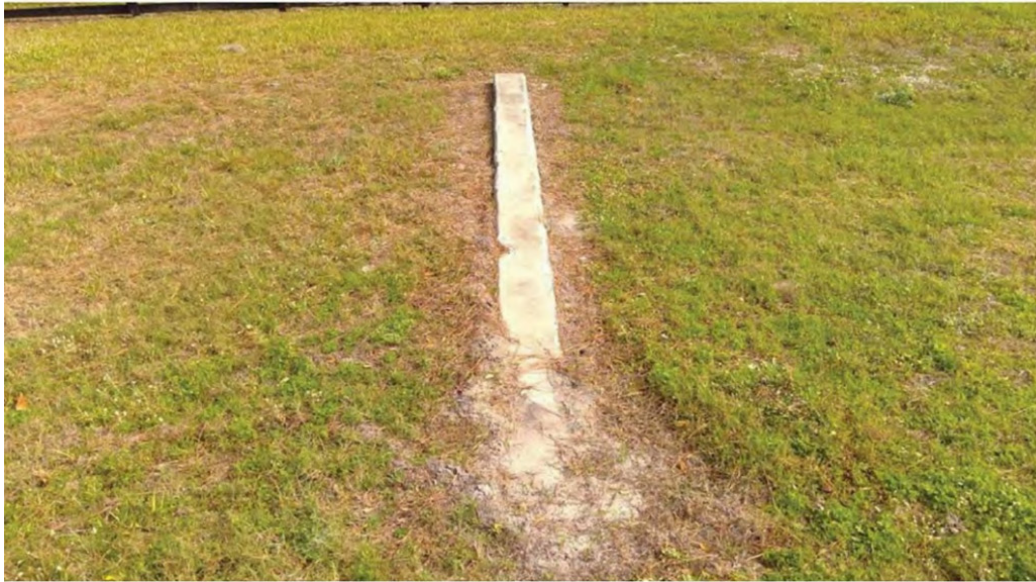
B-9

Concrete Core Ditch Block

- Aesthetic Condition – Good
 - Free of debris and litter
- Hydraulic Recovery - Good
 - No standing water
 - No accumulated sediment
- Vegetation Condition – Good
 - Recently mowed
- Structural Condition - Fair
 - Minor damage to concrete
- Erosion Condition – Fair
 - Minor scour/erosion on one end

- Monitor scour, and add fill and sod as needed

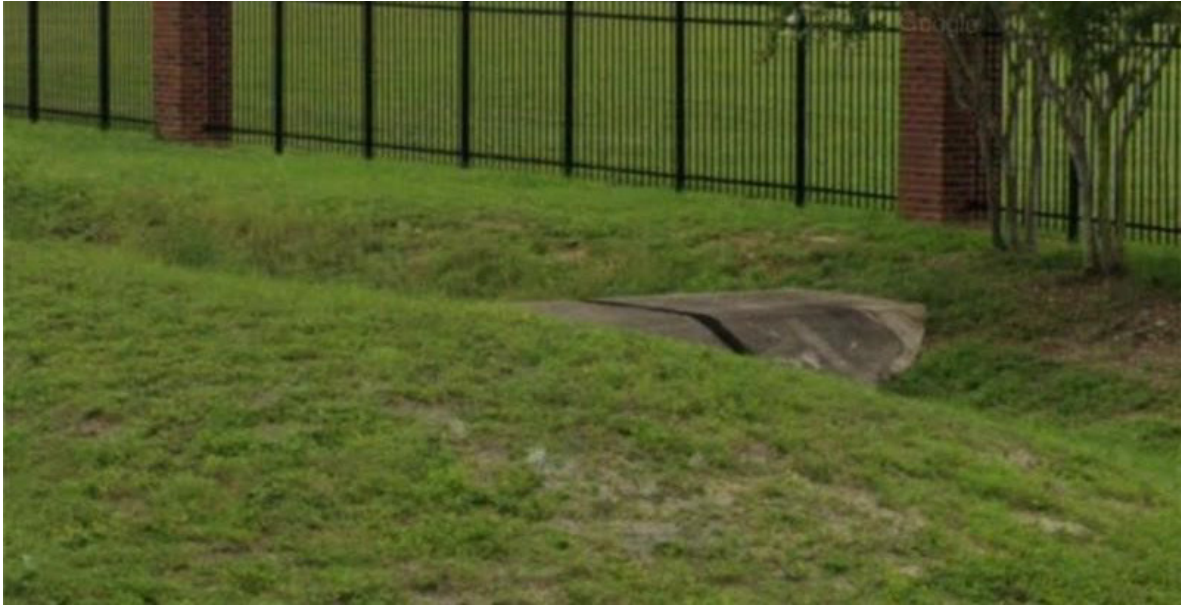
B-10

Concrete or Earthen Ditch Block with Weir

- Aesthetic Condition – Good
 - No trash or debris
- Hydraulic Recovery - Good
 - No standing water
 - No accumulated sediment
- Vegetation Condition – Good
 - Recently mowed
- Structural Condition - Good
 - No damage to concrete; like new
- Erosion Condition – Good
 - No erosion noted

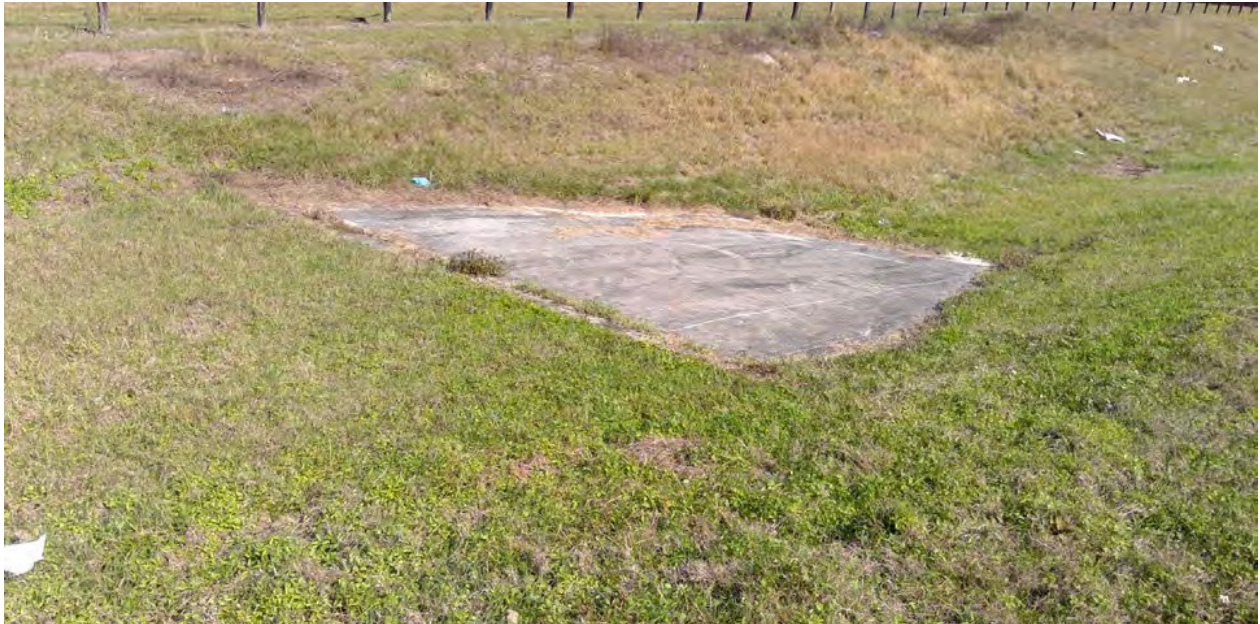
B-11

Earthen Berm/Concrete Discharge Ditch Block

- Aesthetic Condition – Good
 - No trash or debris
- Hydraulic Recovery - Good
 - No standing water
 - No accumulated sediment
- Vegetation Condition – Good
 - Vegetation intact and recently mowed
- Structural Condition - Good
 - No damage to concrete
- Erosion Condition – Good
 - No erosion noted
