Maintenance Guide for Stormwater Assets

May 2023

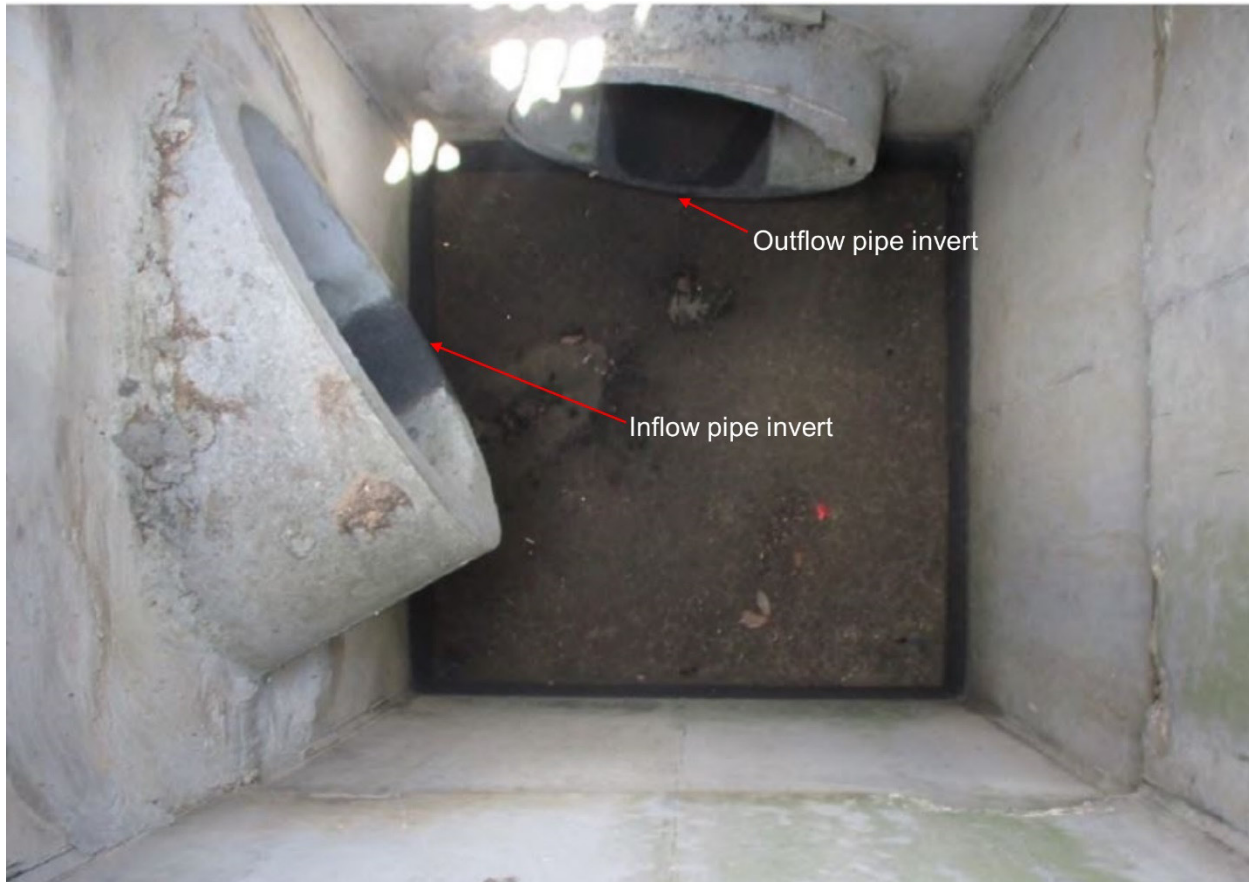
C-1

Horizontal French Drain System

- Sump – Good
 - Free of trash and debris
 - No cracks or damage
 - No sign of groundwater intrusion
- Pipes – Good
 - No cracks or obstructions
- Hydraulic Recovery – Good
 - Sump is dry, indicating proper drainage and recovery
- Sedimentation - Good
 - No sediment observed

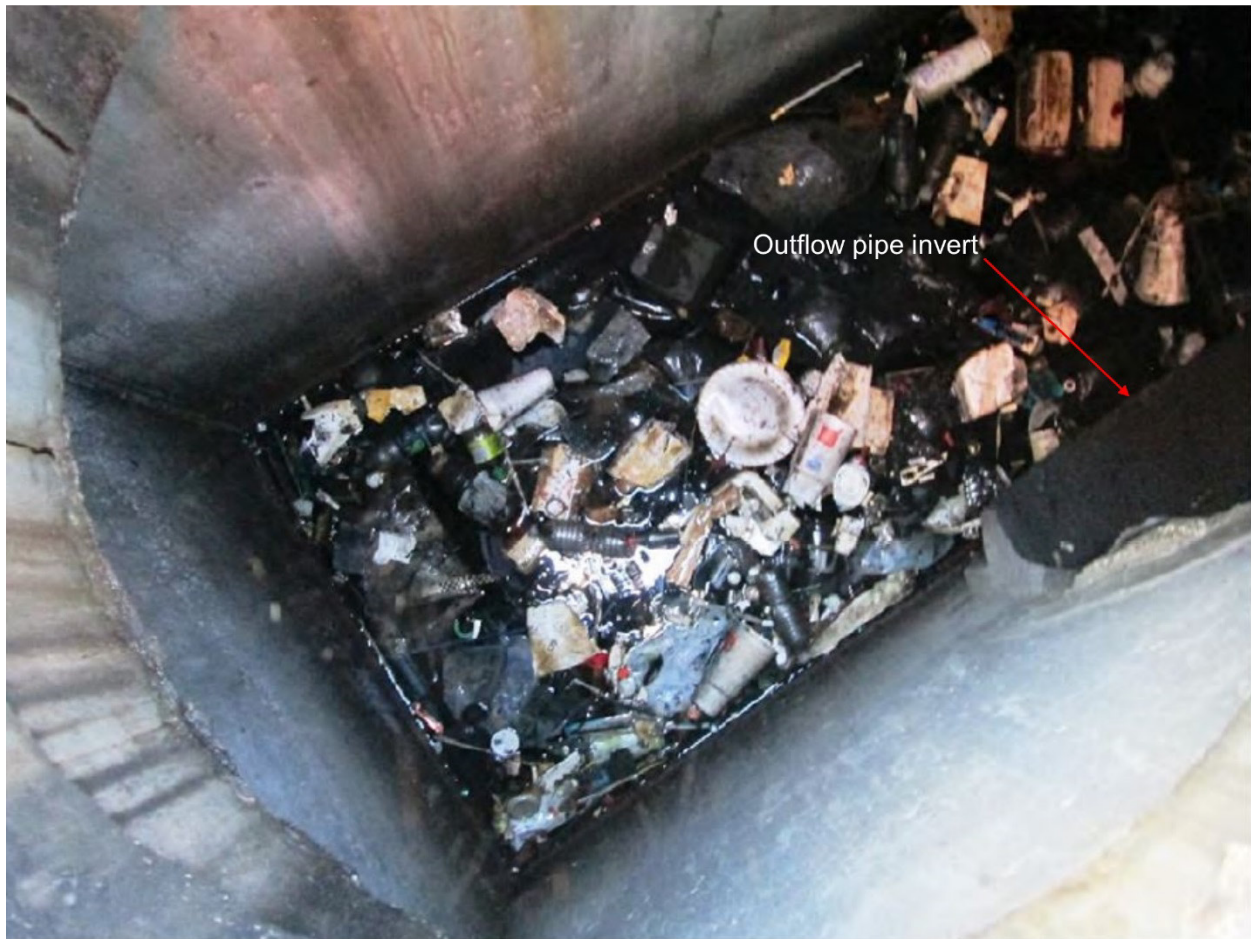
C-2

Horizontal French Drain System

- Sump – Poor
 - More than one-third of sump is covered with trash
 - Top of trash accumulation is less than one foot below pipe invert
 - No cracks or damage
 - No sign of groundwater intrusion
- Pipes – Good
 - No cracks or obstructions
- Hydraulic Recovery – Good
 - Water level is below outflow pipe invert

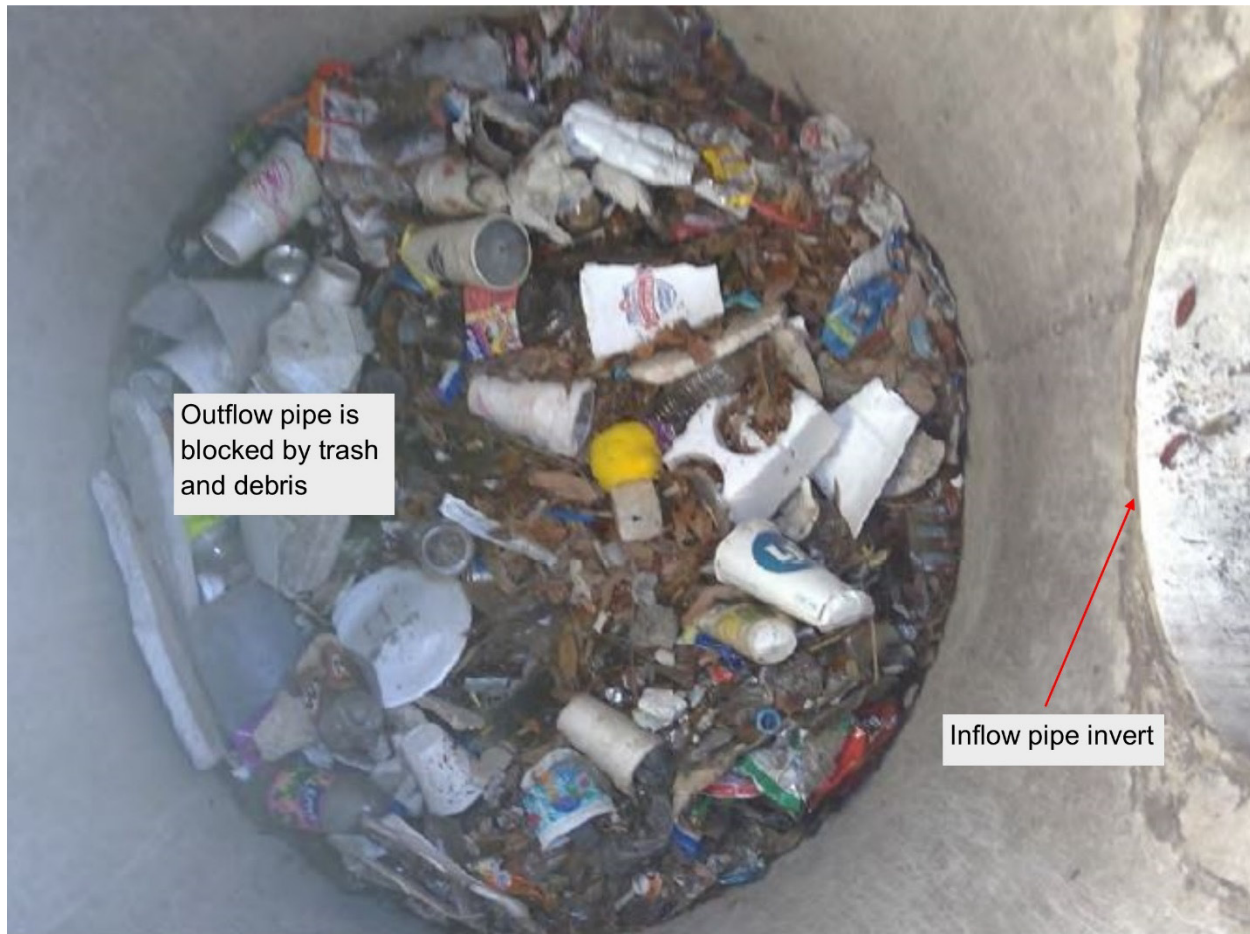
C-3

Horizontal French Drain System

- Sump – Poor
 - Trash and debris are covering outflow pipe
- Pipes – Poor
 - Outflow pipe is 100 percent obstructed
- Hydraulic Recovery – Poor
 - Obstruction of outflow pipe is affecting system recovery

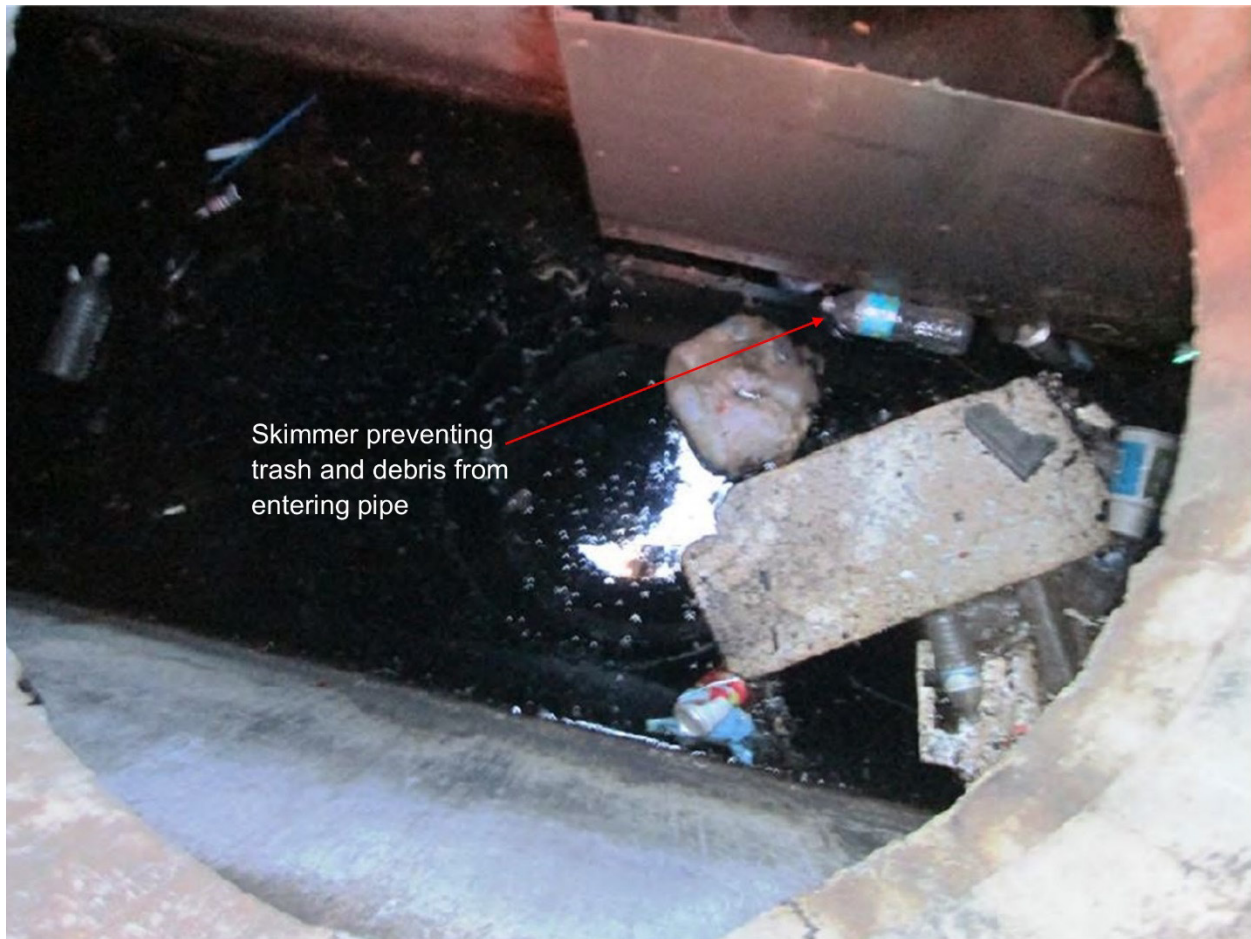
C-4

Horizontal French Drain System

- Sump – Fair
 - Some trash and debris are present
 - No visible cracks or indication of groundwater intrusion
- Skimmer – Good
 - No damage to skimmer
 - Skimmer is effectively preventing trash from entering pipe
- Hydraulic Recovery – Fair
 - Partial blockage of skimmer is slowing system recovery
