DRAINAGE COMPLAINT

S.R. 29 From North of S.R. 78 to Chaparral Slough (M.P. 4.709 – 6.877)

Reference No. 05090-1

January 2010

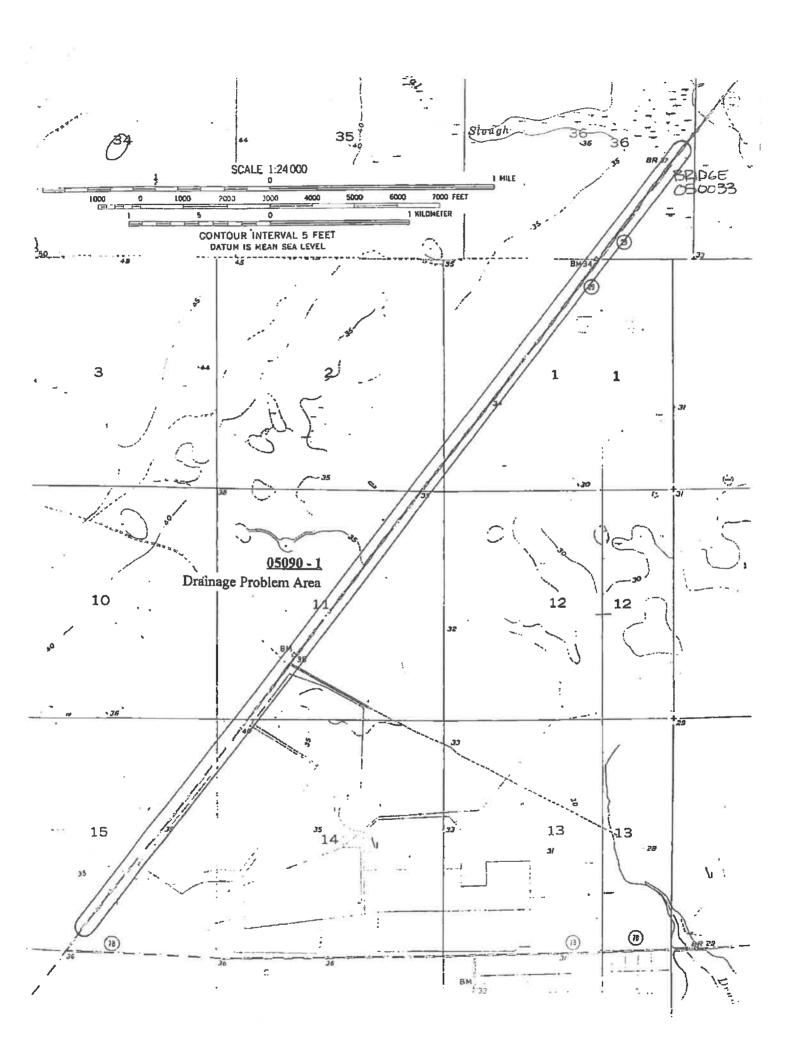
SR 29 - Between Bridge 050033 and SR 78 on June 29, 1992 - wet season.

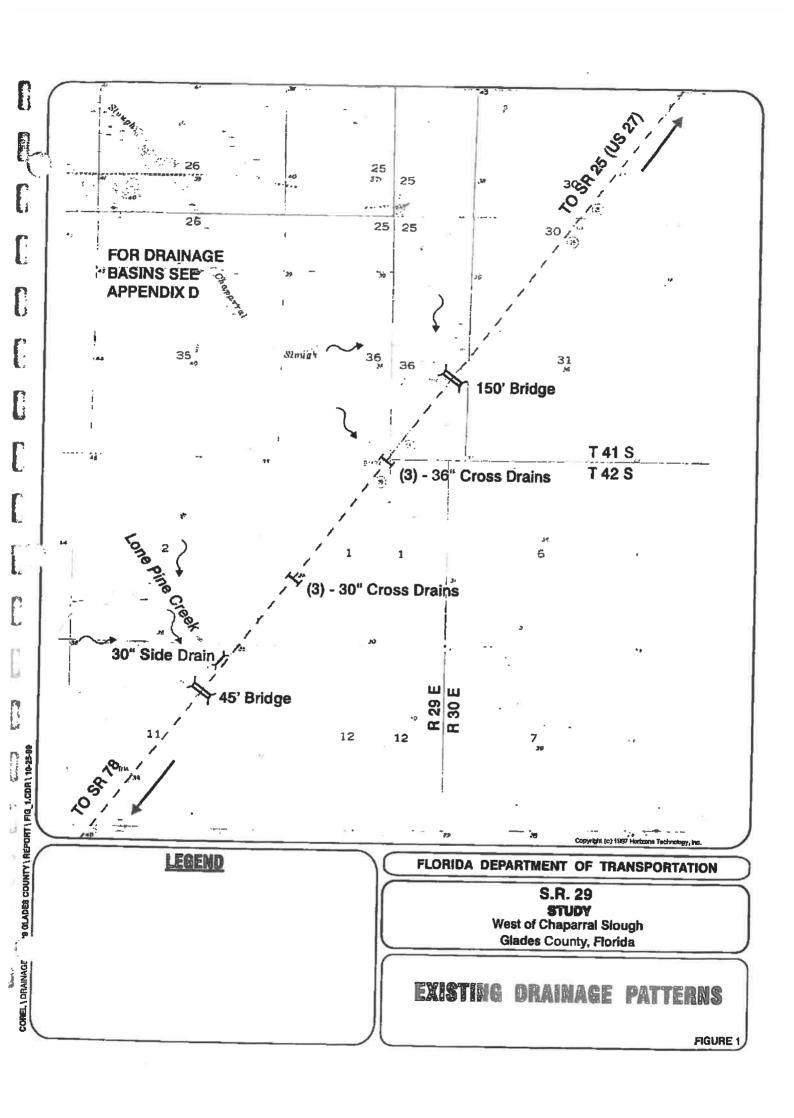
The original roadway project provided a large R/W ditch on the northwest side of SR 29 between Lone Pine Creek Bridge and a slough approximately 1500 ft northeast of the bridge. It connected the slough, which drains a 2618 acre basin (see original project drainage map), with Lone Pine Creek Bridge. The old plans show the R/W ditch begins at station 315+70.50 and ends at approximately 325+00. The ditch has a 20 ft bottom width and a 0.15% profile grade (Elv 28.65 @ Sta 316+00 to Elv 30.00 @ Sta 325+00).

During flood conditions, a large area northwest of SR 29 stores runoff and rises to elevation 35.4 before overtopping occurs. There is a slight gradient on the pool due to its movement toward the southwest.
