DRAINAGE COMPLAINT

S.R. 29

**From North of S.R. 78 to Chaparral Slough
(M.P. 4.709 – 6.877)**

Reference No. 05090-1

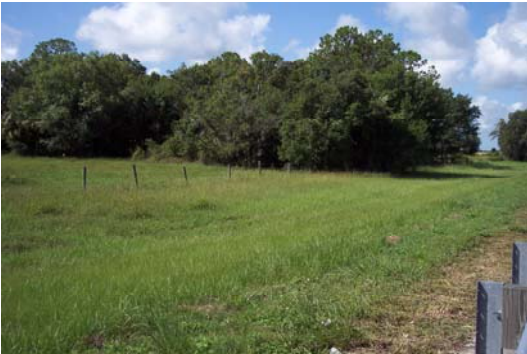
Ditch on southeast side of bridge.

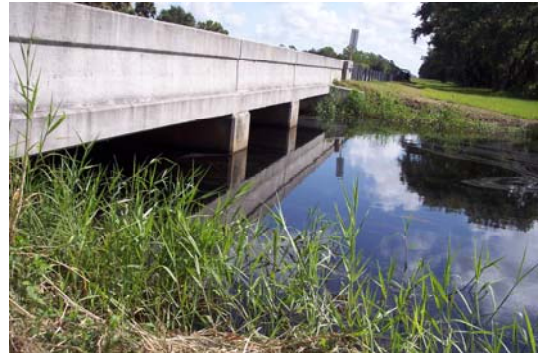
East side of bridge.

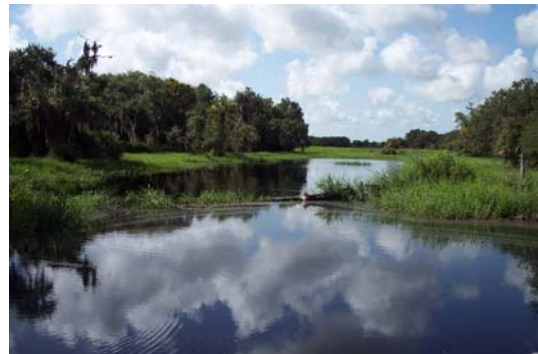
Looking east from east side of bridge.

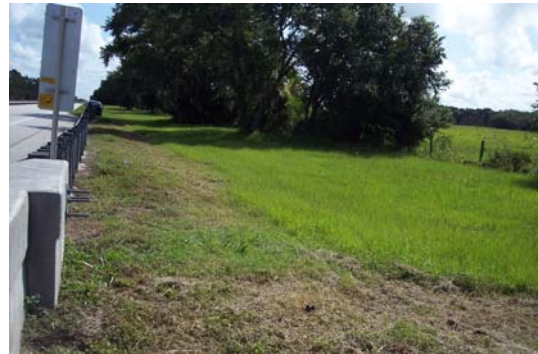
Ditch on northeast side of bridge.

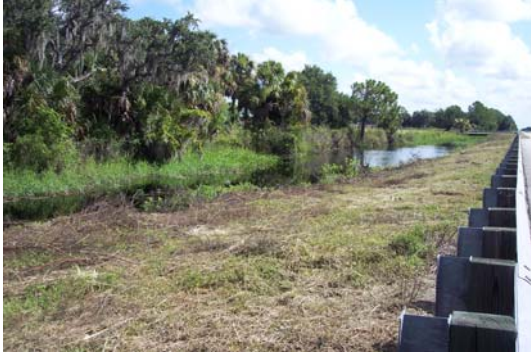
Ditch on northwest side of bridge.

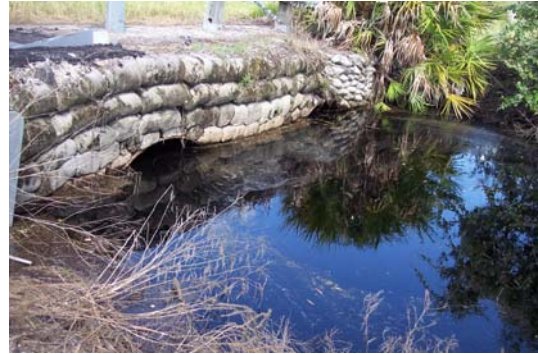
The existing double 54" side drain north of Lone Pine Creek was also analyzed. This pipe was originally a single 30" pipe according to the *Analysis of Flooding Problem for S.R. 29 West of Chaparral Slough*, PBS&J, October 1999. It is unknown when the pipe was replaced. The report, however, recommended double 72" pipes in this area. The double 54" pipes are undersized. They have the capacity for 135.04 cfs, however the runoff generated by the offsite area coming to the cross drain is 202.3 cfs for the 10 year design flood. A minimum of 2-66" pipes or pipes of equal capacity are needed to intercept this runoff.

Sidedrain at cow pens, just north of bridge on S.R. 29. Ditch almost at capacity.

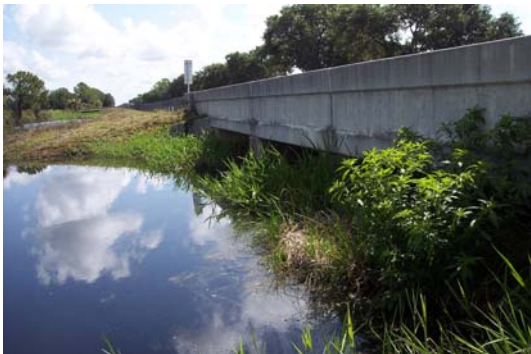
West side of bridge.

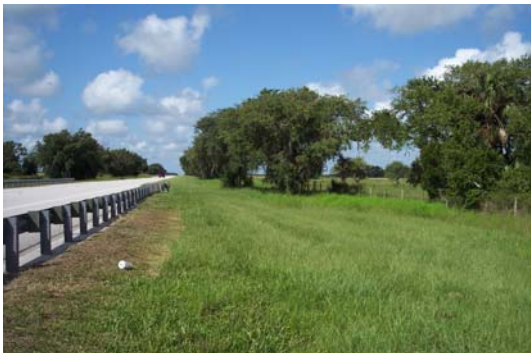
Ditch on southwest side of bridge.

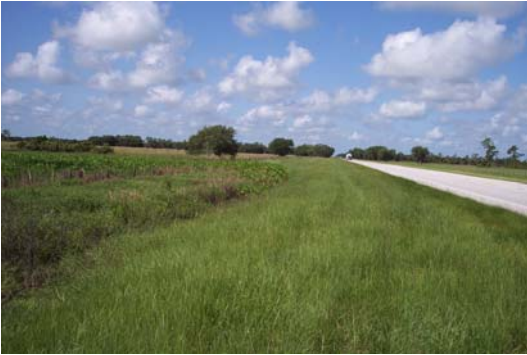
Looking south along S.R. 29 from cross drain.

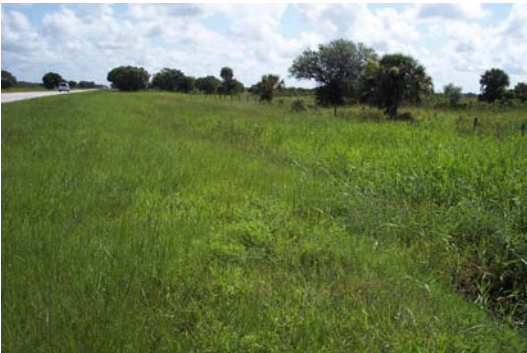
Ditch on northeast side of cross drain.

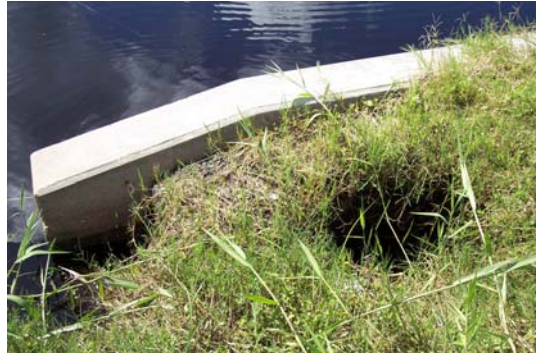
Erosion at headwall on east side of cross drain.

Therefore, the recommended temporary improvements to this area includes de-silting of the existing pipes and ditches, replacing the existing triple 30" pipes with quadruple 48" pipes at the first cross drain and replacement of the existing triple 36" pipes to the north due to failing joints.

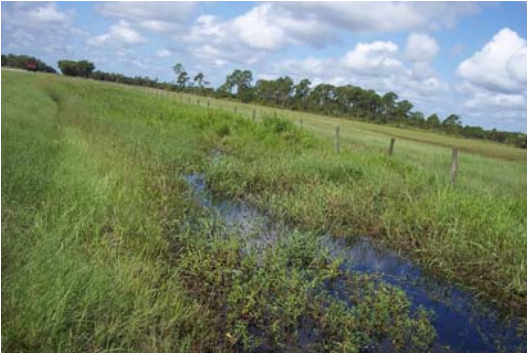
Ditch on southwest side of cross drain.

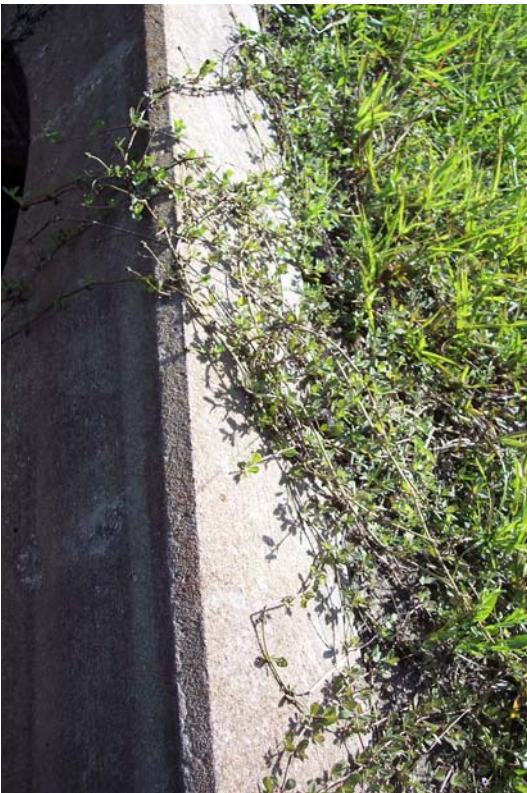
Headwall on west side of cross drain.

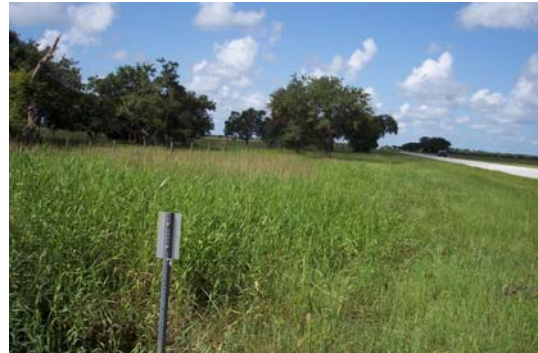
Ditch on southeast side of cross drain.

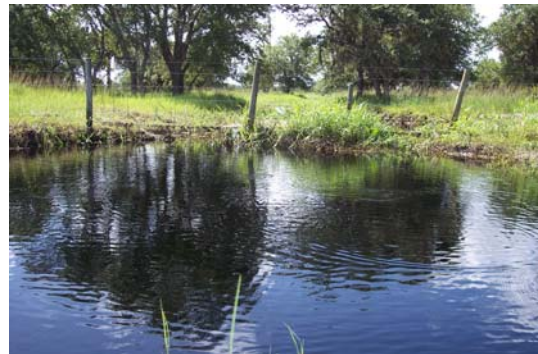
Looking east from east side of cross drain.

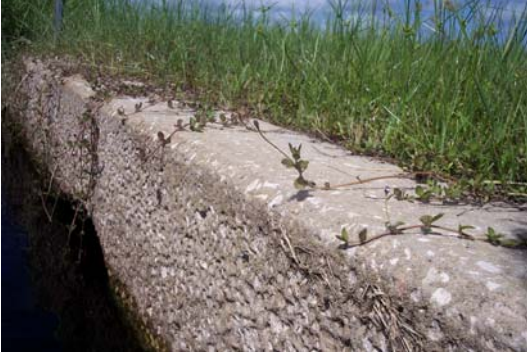
Headwall on east side of cross drain.

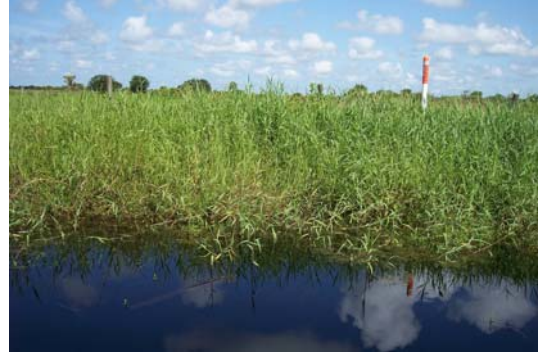
Looking west from west side of cross drain.

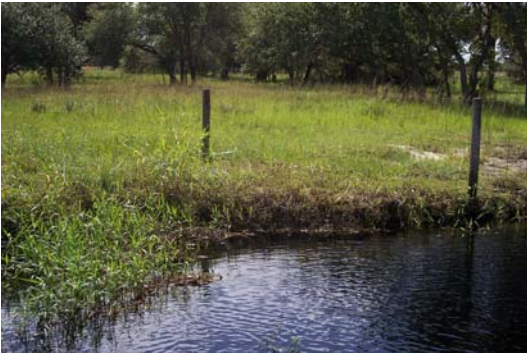
Looking northeast from east side of cross drain.

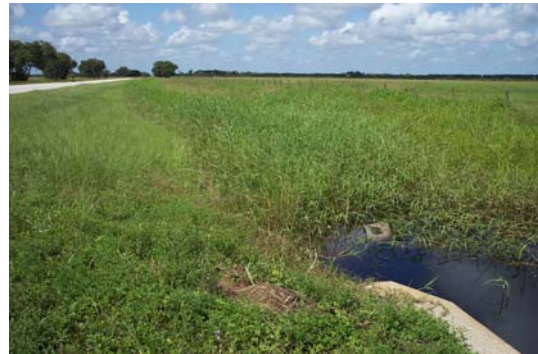
Ditch on southwest side of cross drain.

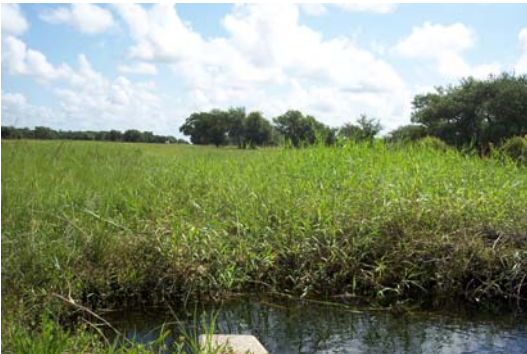
Ditch on northeast side of cross drain.

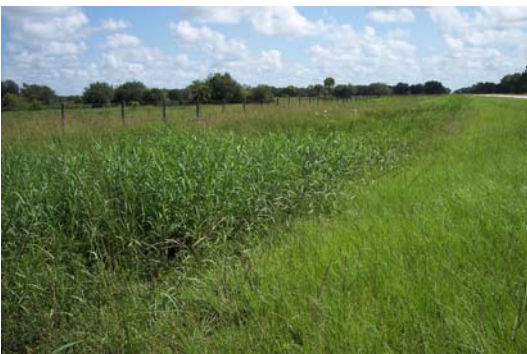
Ditch on northwest side of cross drain.

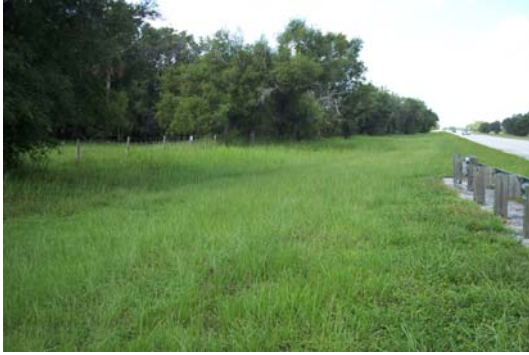
Ditch on southeast side of bridge.

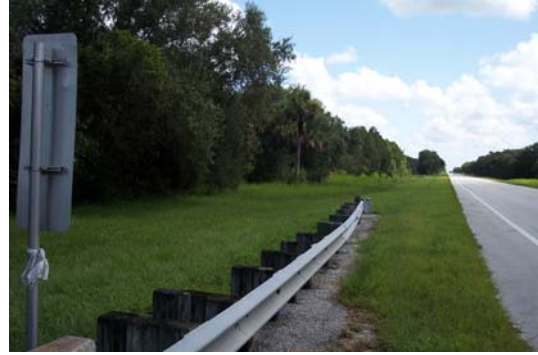
Ditch on northwest side of bridge.

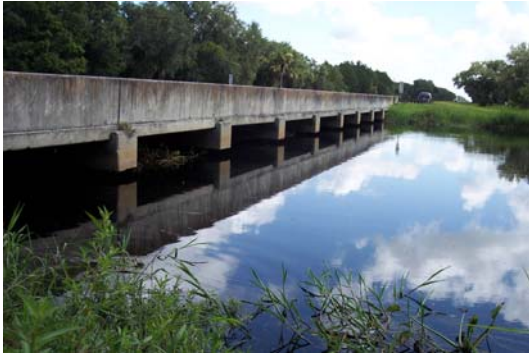
East side of bridge.

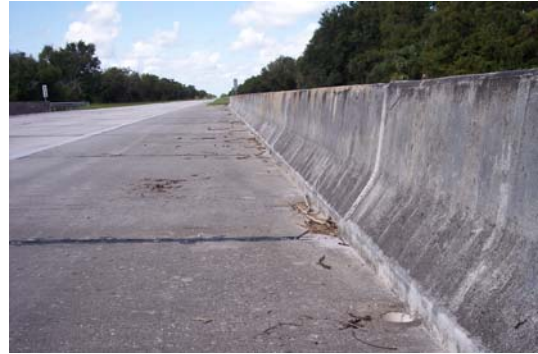
Facing south along shoulder, west side of bridge.

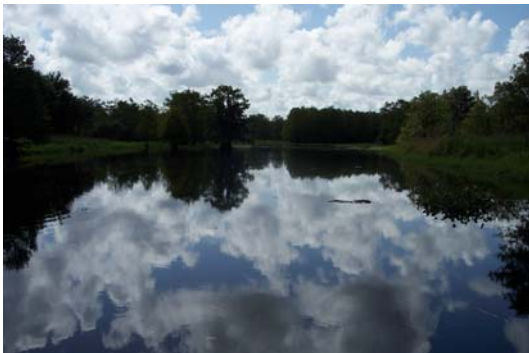
Looking east from east side of bridge.

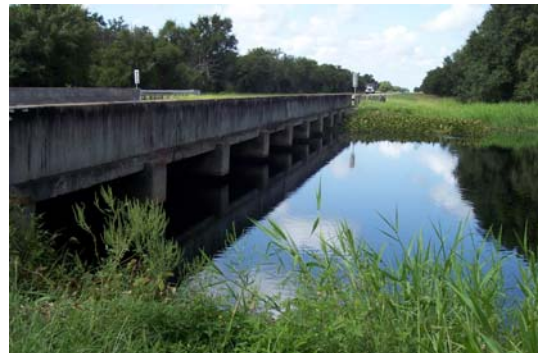
West side of bridge.

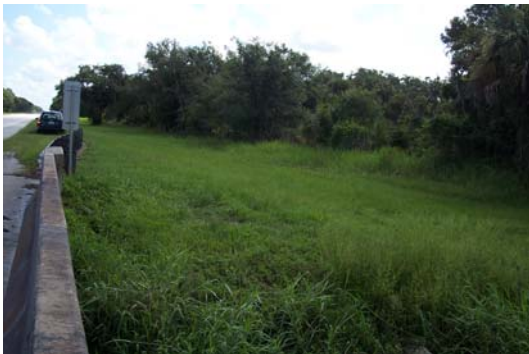
Ditch on northeast side of bridge.

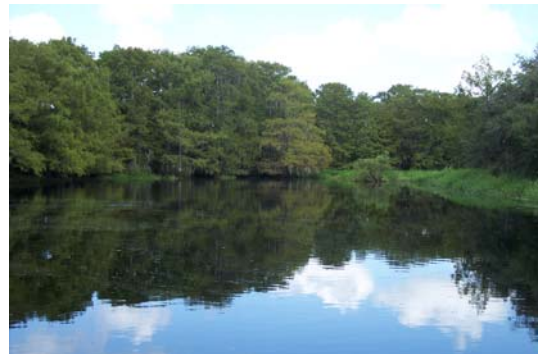
Facing west from west side of bridge.
