US 29 from W. Burgess Road to Old Chemstrand Road

PRELIMINARY FREIGHT CORRIDOR SCREENING US 29 (W. Burgess Road to CR 297 (Old Chemstrand Road))

N. Palafox Street (SR 95) from W. Leonard Street to Brent Lane

US 90 from Avalon Boulevard to SR 87 South

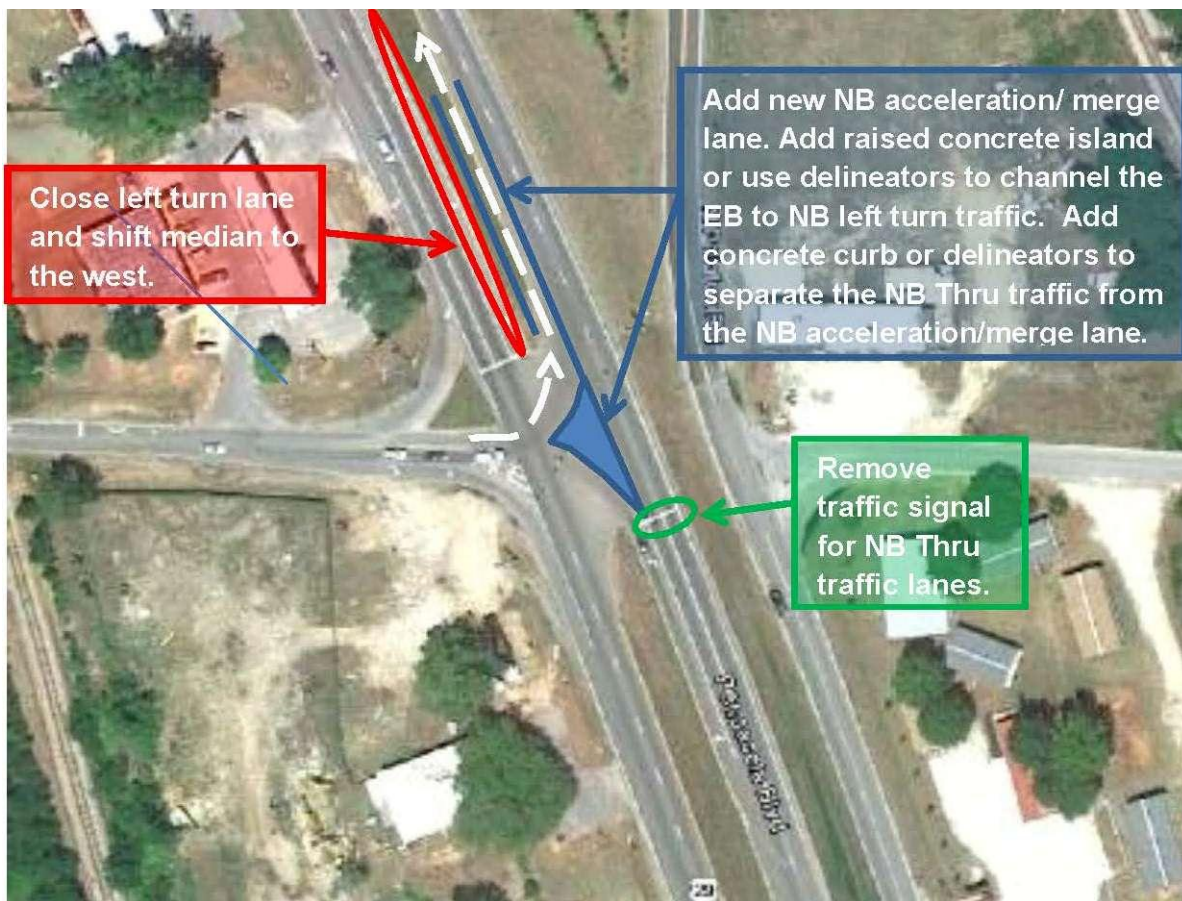
**FIGURE 2
RECOMMENDED INTERSECTION MODIFICATION AT W. ROBERTS ROAD TO PERMIT
FREE-FLOW NORTHBOUND THROUGH TRAFFIC**

There is an unnecessary short delay (20 seconds) to the northbound through traffic at W. Roberts Road resulting from the eastbound to northbound left-turn cycle. Because of the operational characteristics of trucks (especially loaded trucks) from a stop condition, unnecessary stops should be eliminated as much as possible. This intersection is followed by another signalized intersection 0.5 miles to the north. The probability is good that a truck that begins from a stop at W. Roberts Road would be required to stop again at E. Kingsfield Road, thus reducing efficiency. There are two options for this intersection. First, W. Roberts Road can be cut through to N. Palafox Street forming a continuous east west corridor and a fully signalized intersection. This option will result in a continued northbound stop condition on US 29 and the cycle will more than likely be lengthened increasing the delay. This option also presents other issues due to the short (40 feet) distance between US 29 and N. Palafox Street which would also require a signal. The second option would be to close the southbound U-turn lane, shift the median to the west to replace it, and create a new dedicated northbound acceleration/merge lane separated from the northbound through lanes by a narrow concrete median or delineators (see **Figure 2**). A concrete or delineated painted island within the median opening would channel the eastbound to northbound left turn traffic up the acceleration lane until a safe merger can be made. The signal for the northbound lanes would be removed allowing continuous travel through the intersection and provide a non-stop northbound flow for 1.6 miles between W. 10 Mile Road and E. Kingsfield Road.

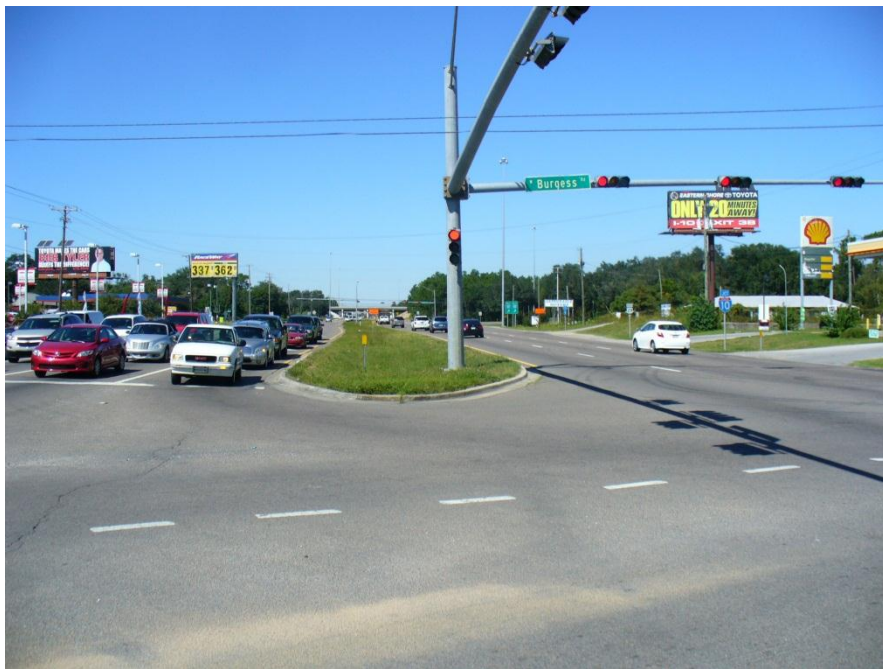
Traffic signals at W. Burgess Road are mounted on mast arms (see Photo 2 in Appendix 3). At Diamond Dairy Road, the signals are strain pole mounted. The curb at the southbound inside left-turn lane has been damaged by off-tracking at W. Burgess Road. There is similar off-tracking damage at the southeast quadrant (see Photo 3 in Appendix 3).

Traffic signals at W. Burgess Road are mounted on mast arms

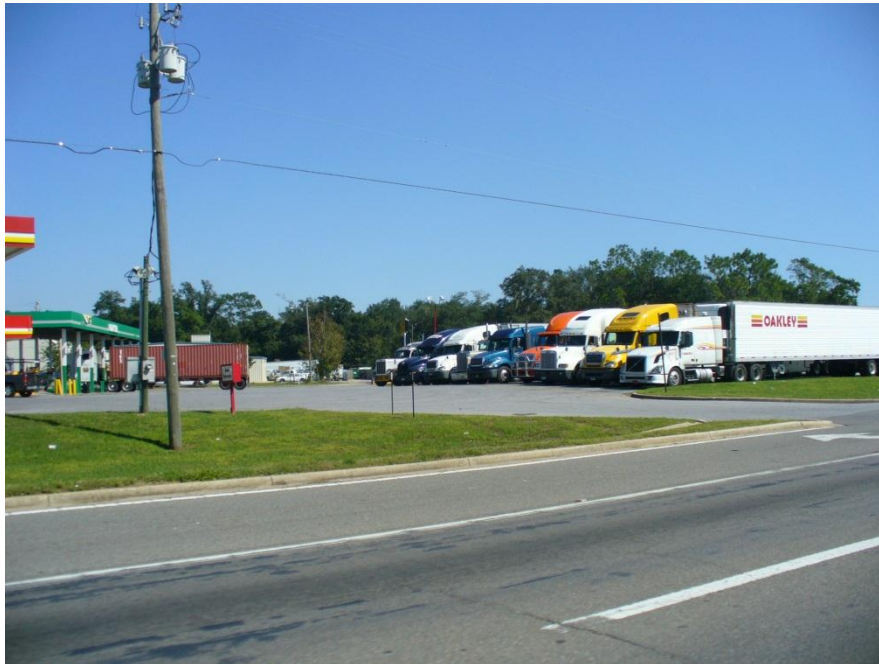
Photo 11
Large truck stop at the southeast corner of Broad Street

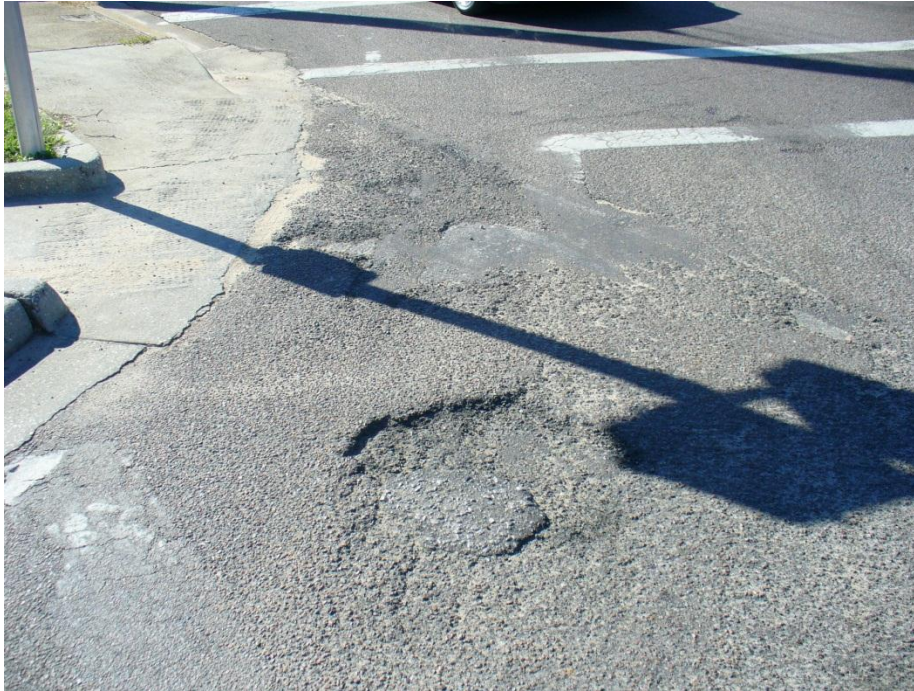
Photo 1
Rough pavement and pothole southeast quadrant at W. Texar Drive

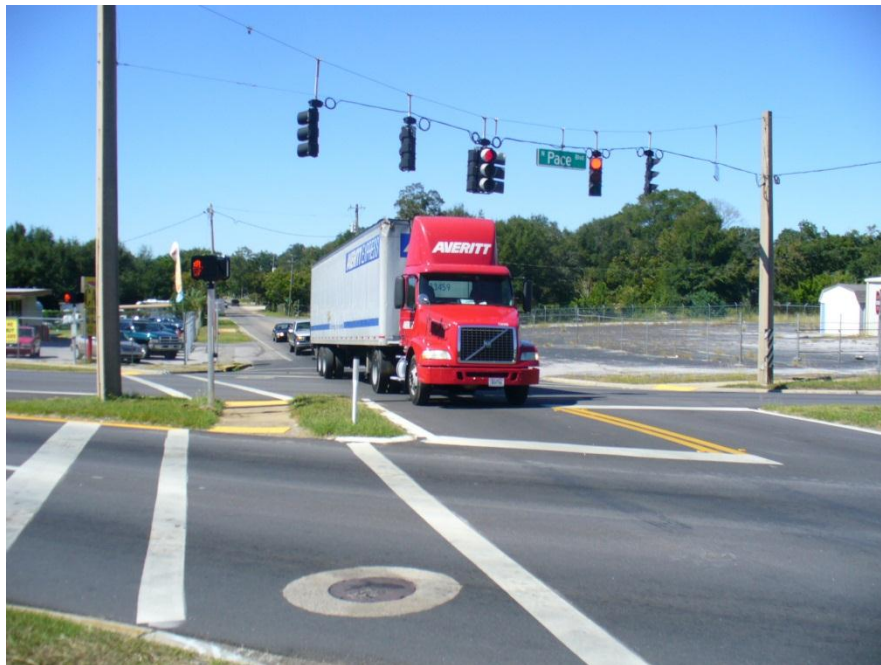
Photo 6
Truck northbound on N. Pace Boulevard at intersection of Massachusetts Avenue and N. Palafox Street

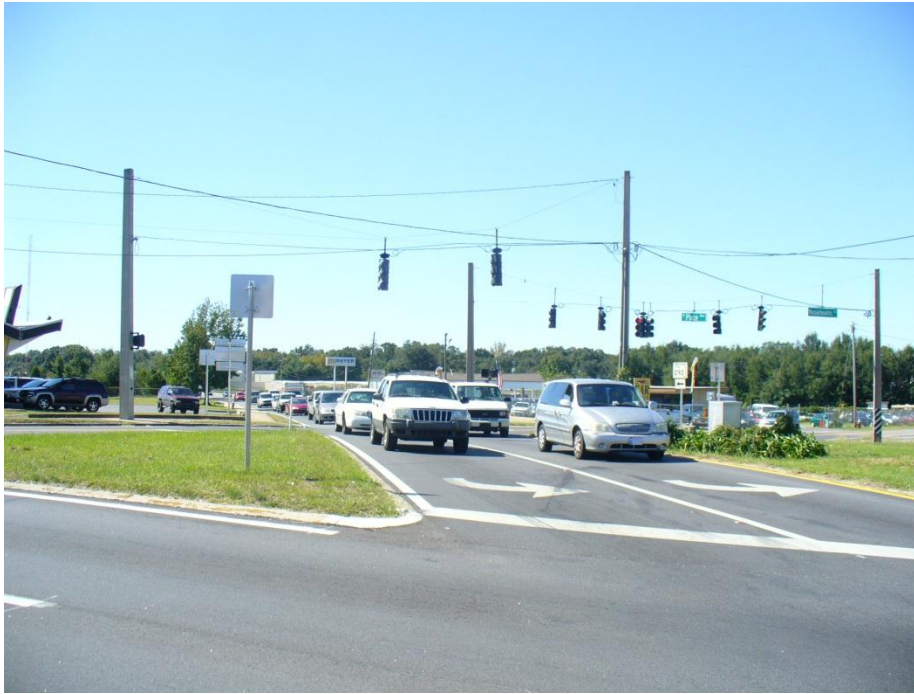
Photo 7
Eastbound left turn traffic on Massachusetts Avenue, crossing southbound N. Pace Boulevard and approaching turn at northbound N. Pace Boulevard

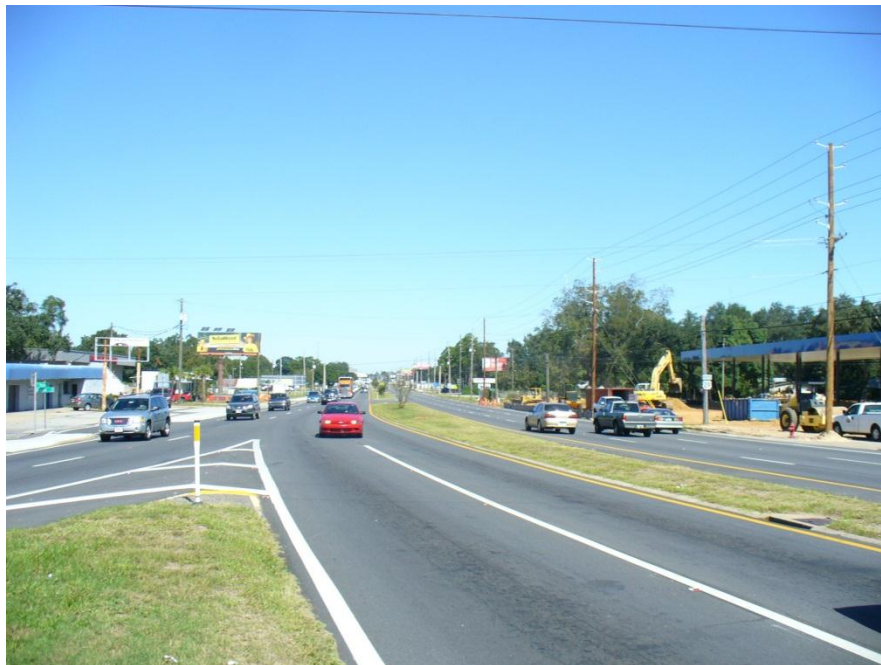
Photo 8
Southbound split of N. Palafox Street (center) to N. Pace Boulevard (left) northbound (N. Palafox Street at right)

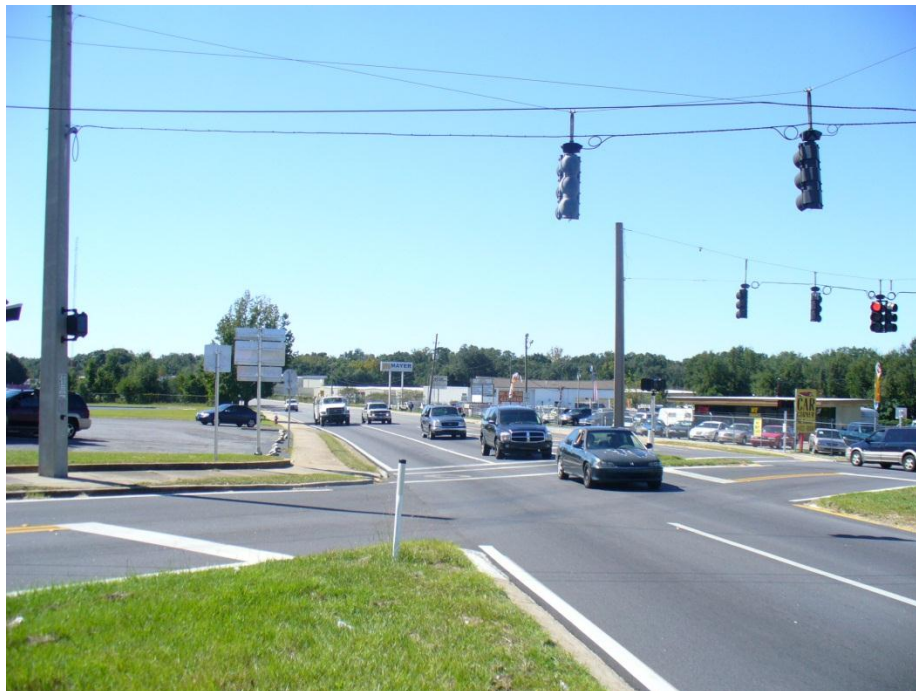
Photo 9
Northbound N. Pace Boulevard

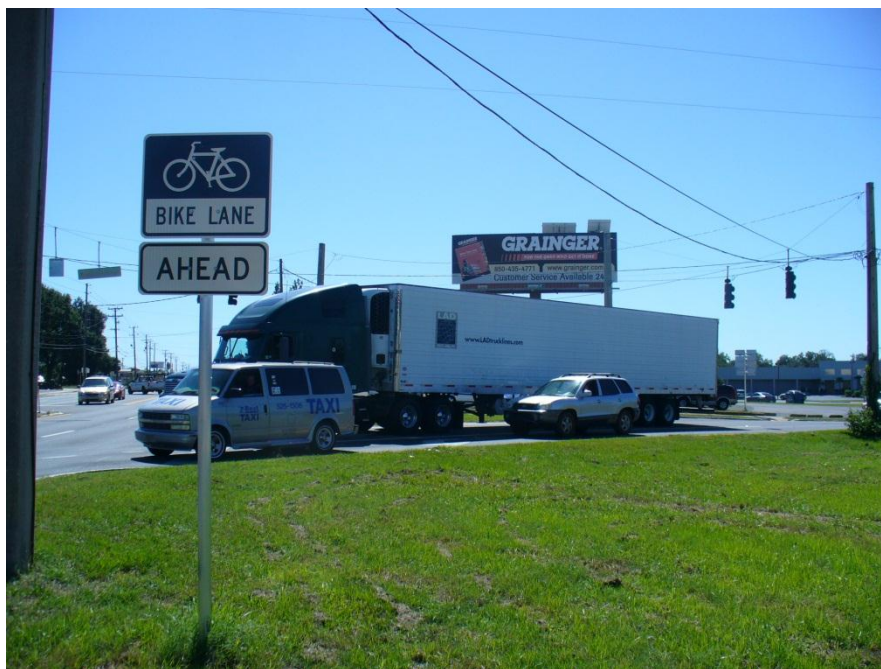
Photo 10
Truck on northbound N. Pace Boulevard merging with northbound N. Palafox Street

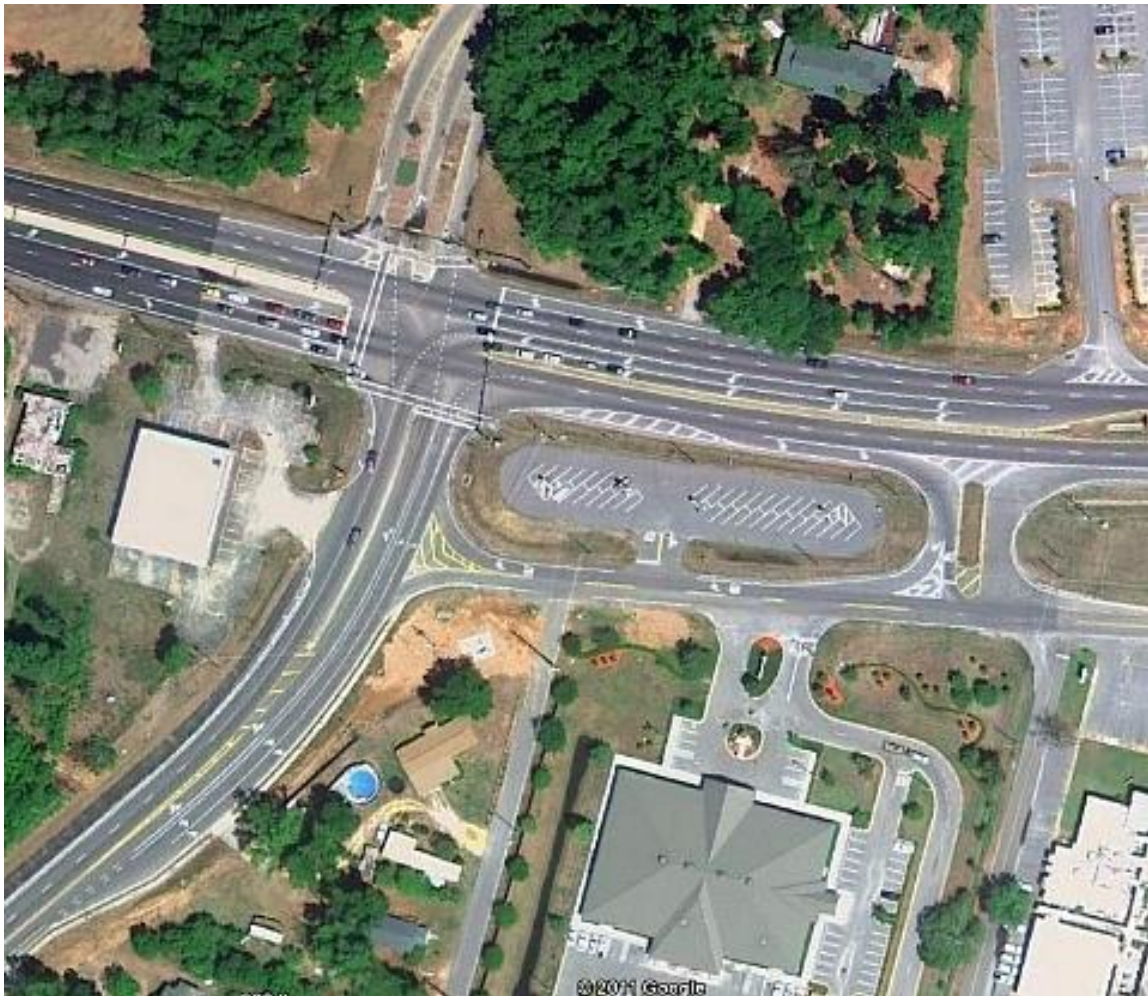
Aerial 9
SR 281 (Avalon Boulevard) and Old Bagdad Road at US 90

SR 281 (Avalon Boulevard) forms an off-set intersection with the entrance to Pensacola State College on the north side of the corridor (see Aerial 9 in Appendix 1). US 90, at this intersection, includes two through lanes in each direction, as well as dual westbound left-turn lanes and a single eastbound left-turn lane. This off-set will be corrected as part of the reconstruction that includes a realignment of the lanes on the north side of the intersection (see Photo 7 in Appendix 3). SR 281 (Avalon Boulevard) includes

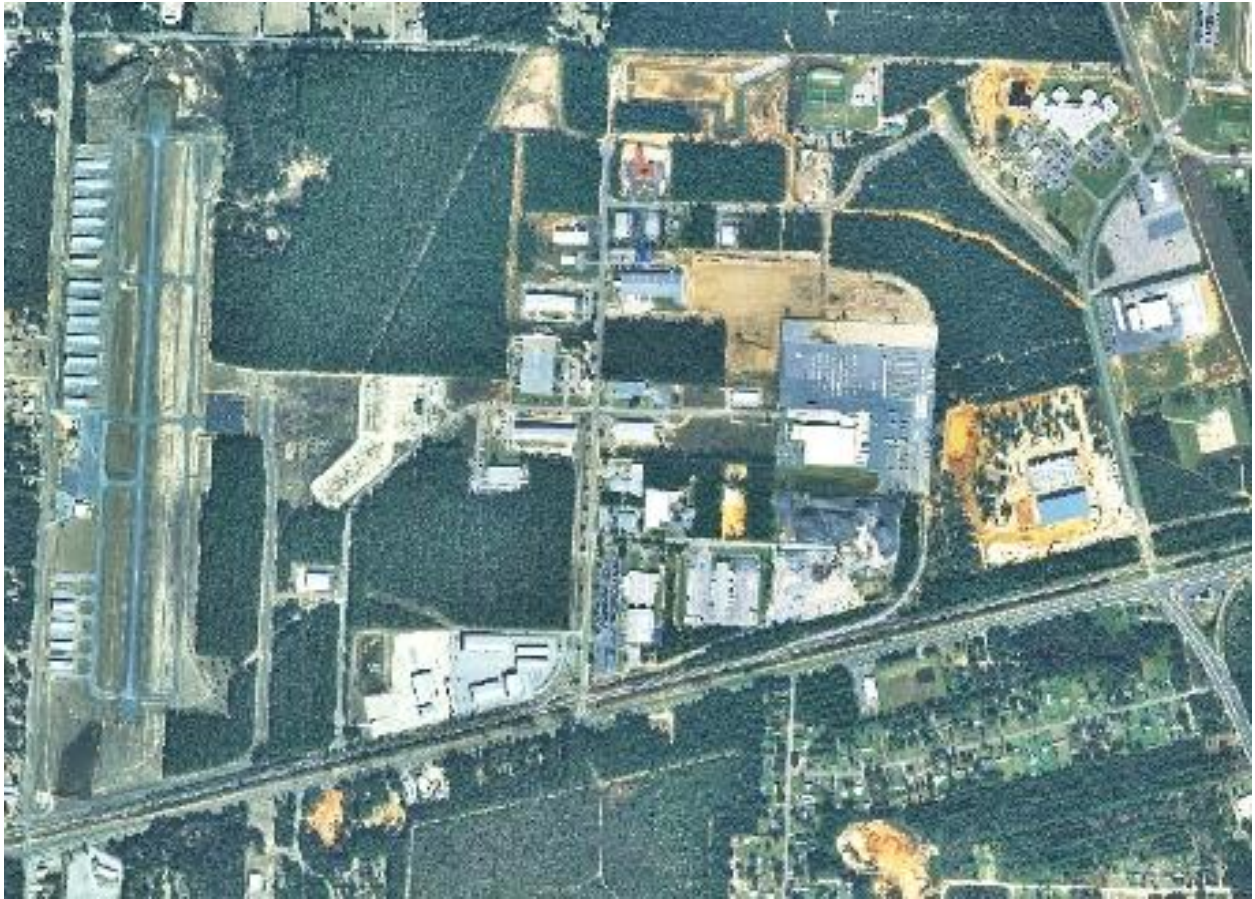
**Aerial 10
Airport Industrial Area**

From SR 87 to N. Airport Road the north side of the corridor is industrial (see Photo 14 in Appendix 3) and includes a prison facility (see Aerial 10 in Appendix 1). The south side of the corridor is rural residential, which continues westward to Milton on both sides of the corridor. The remainder of the corridor is developed as intense commercial and is lined with various businesses and shopping plazas, as well as government facilities and a college campus. No change is expected from the current uses in the future.

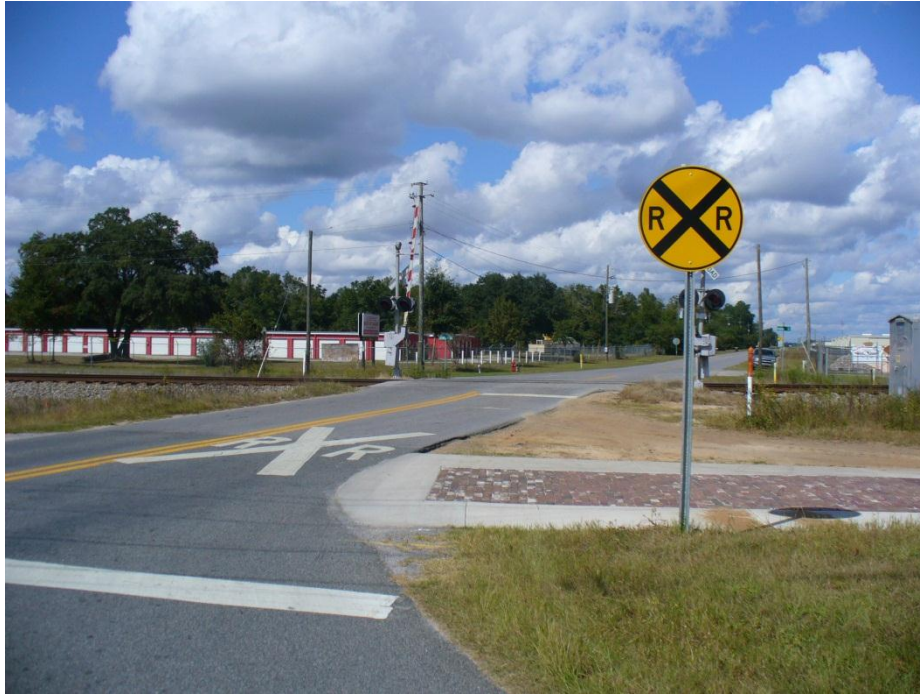
Photo 1
Airport Road at US 90 showing brick paver trail and railroad crossing

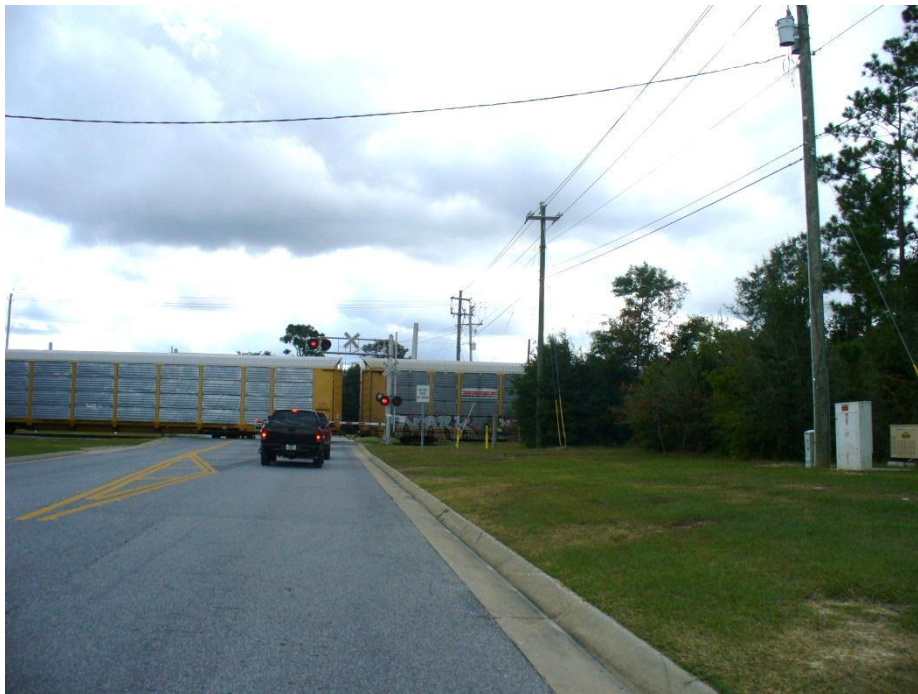
Photo 2
Train crossing Industrial Boulevard, south view

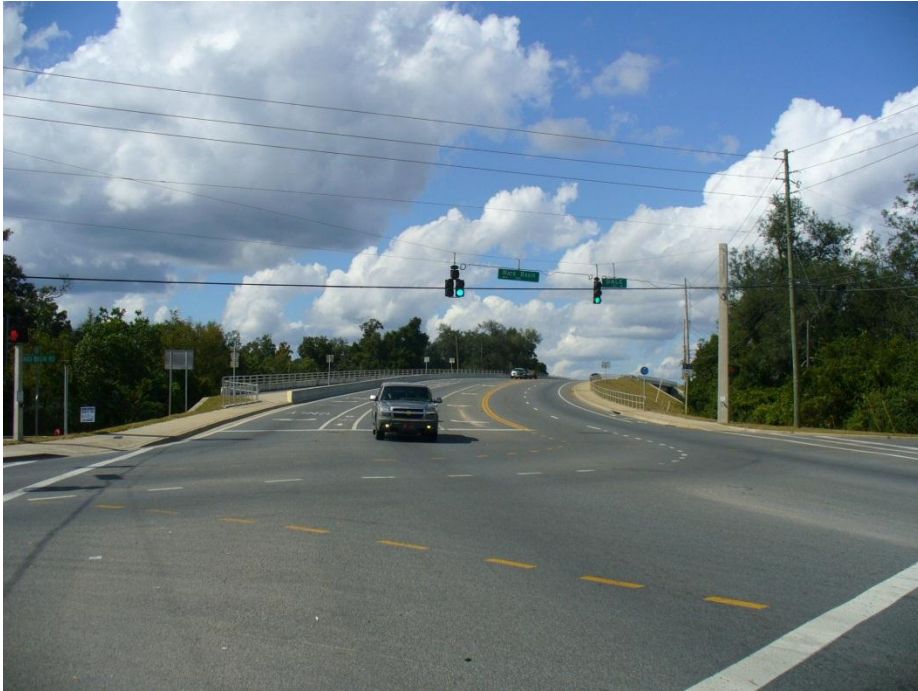
Photo 3
Approach to grade-separated railroad bridge west of Ward Basin Road

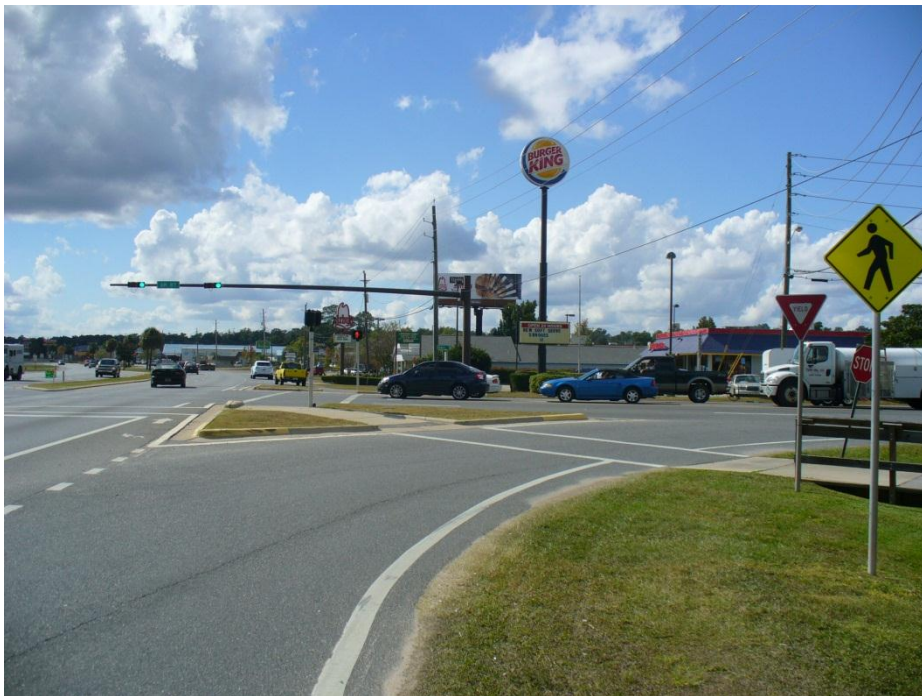
Photo 4
US 90 at SR 87 (Stewart Street) channelized right turn with grass island

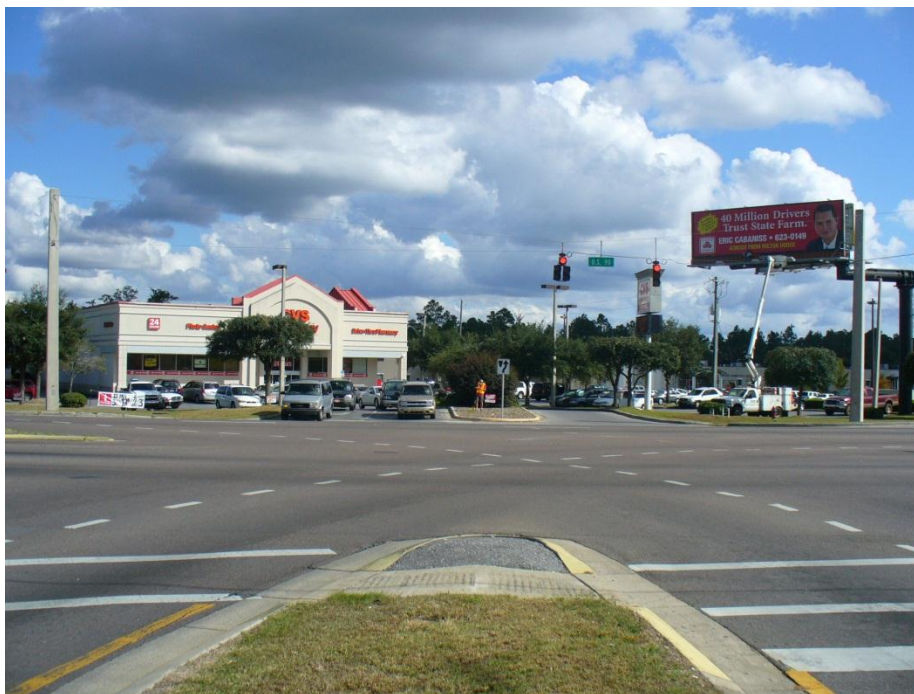
Photo 5

View south from SR 89 toward signalized driveway to CVS pharmacy. Driveway also provides alternate access to the County Center.

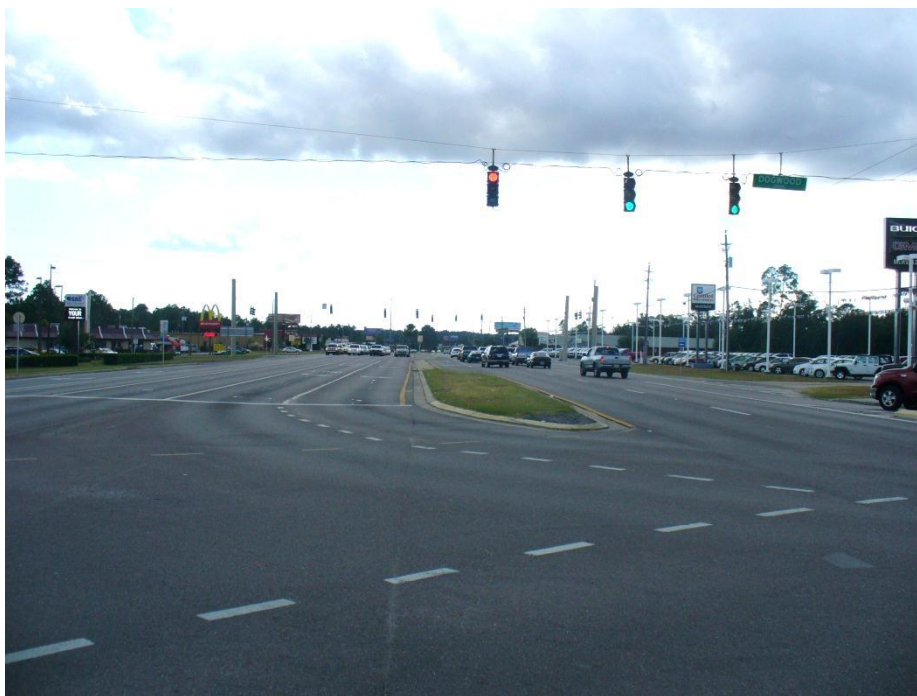
From SR 89 (Dogwood Drive) to SR 281 (Avalon Boulevard) the typical section continues as a rural four-lane divided facility with 25-foot grassed medians (no curbs) (see Photo 6 in Appendix 3), 4-foot paved shoulders, no sidewalks, and open drainage. There are signalized intersections at Glover Lane and at Parkmore Plaza Drive/Jamiee Leigh Drive and the entrance to the K-Mart shopping plaza.

SR 90 looking west from SR 89 showing typical section and grass median

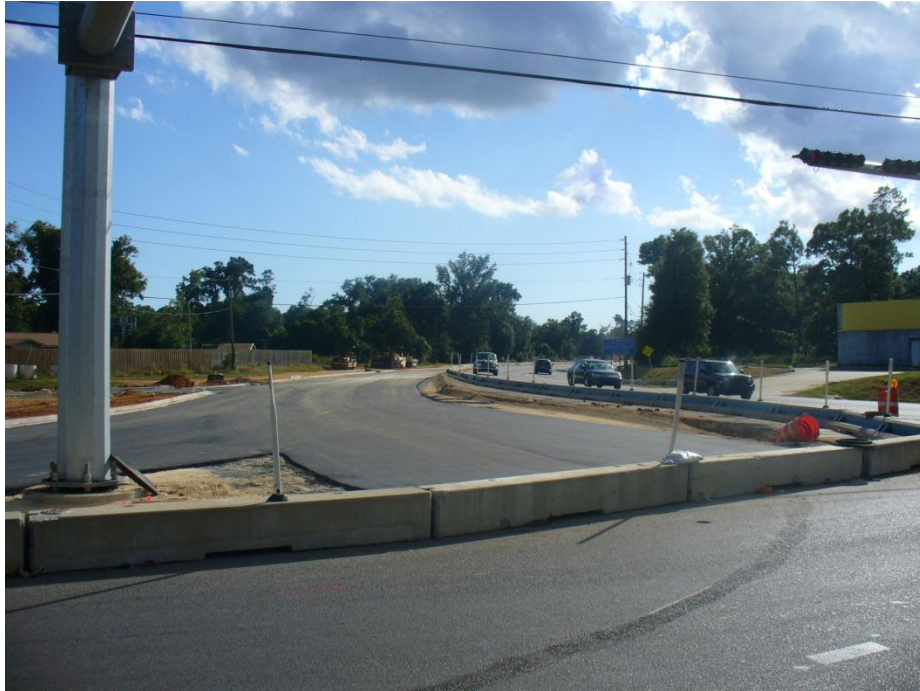
Photo 7
New construction at Avalon Boulevard

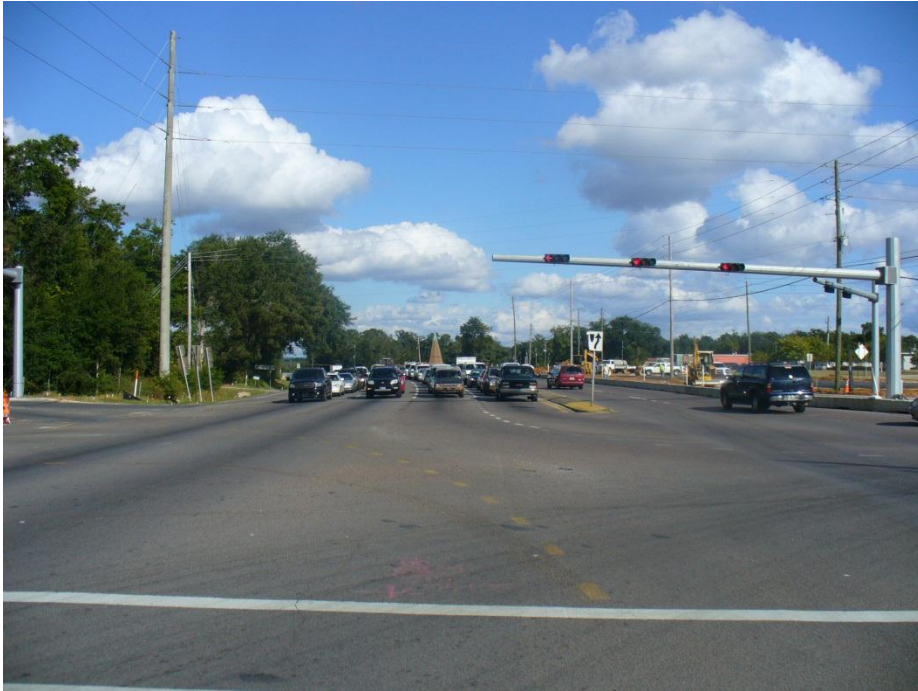
The pavement is in generally good condition throughout the corridor with some minor rutting on the through lanes and the left-turn lanes at the approaches to the intersections on US 90. The pavement condition on Industrial Boulevard at the intersection of US 90 is in poor condition with patches at the corners and cracking in the intersection. Additionally, a brick paver multi-use trail that crosses Industrial Boulevard between US 90 and the parallel railroad crossing is in bad condition and in need of repair at both Industrial Boulevard and N. Airport Road. Industrial Boulevard leads into a developing regional industrial center that will become a major truck generator in the area (see Photo 8 in Appendix 3). There is minor rutting in the eastbound and westbound through lanes west of N. Airport Road. The downtown area was recently repaved from Willing Street to Bruner Street and is in excellent condition. The intersection at SR 281 (Avalon Boulevard) was under construction (see Photo 9 in Appendix 3) at the time of the field study, which will result in new pavement in this area.

Photo 9
US 90 looking east from Avalon Boulevard

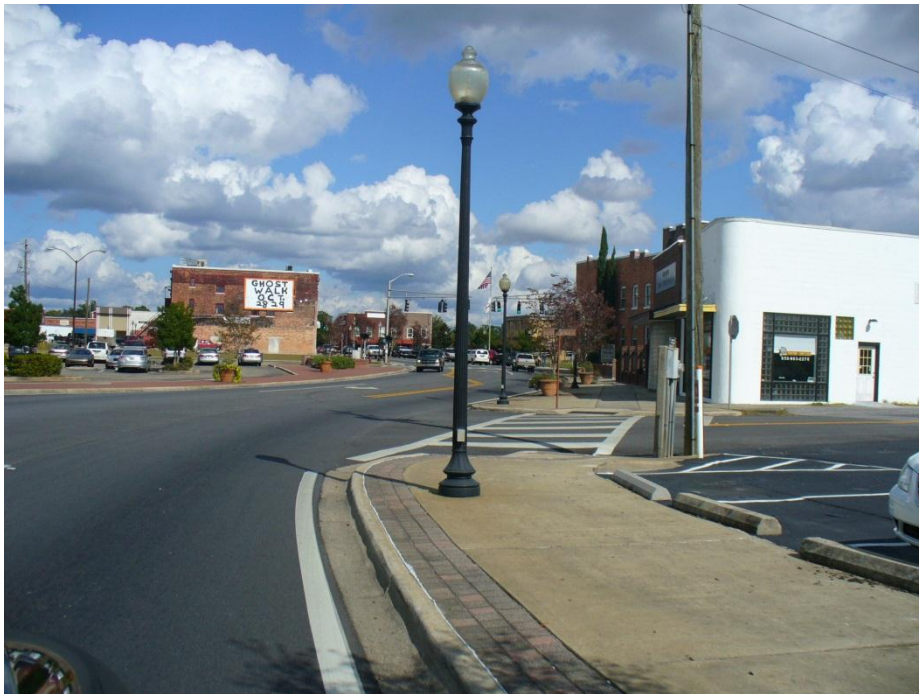
Photo 10
US 90 looking downtown from east of Stewart Street (east view) showing sidewalks and antique looking fixtures

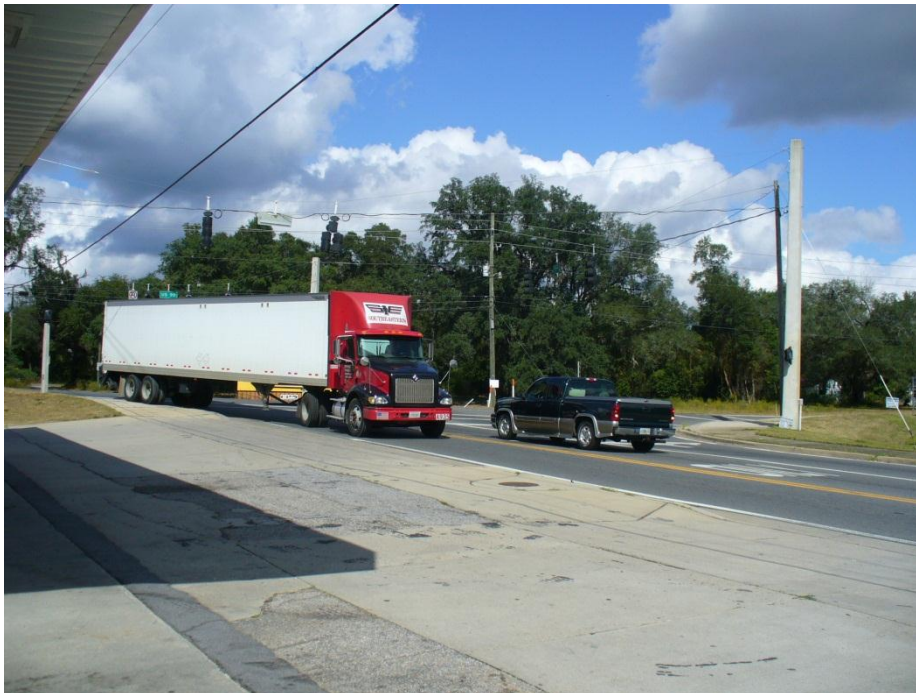
At the intersection of Ward Basin Road, the southeast and southwest corners show signs of off-tracking by trucks. The northbound to eastbound right turn is acute, causing trucks to off-track in order to make the right turn due to the single receiving lane (see Photo 10 in Appendix 3). At the southeast corner, damage may be caused by gasoline and delivery trucks turning into the gas station driveway immediately south of the corner (see Photo 11 in Appendix 3).

Photo 12
Truck making right turn from eastbound US 90/SR 87 at Ward Basin Road. Gas Station is located on the left.

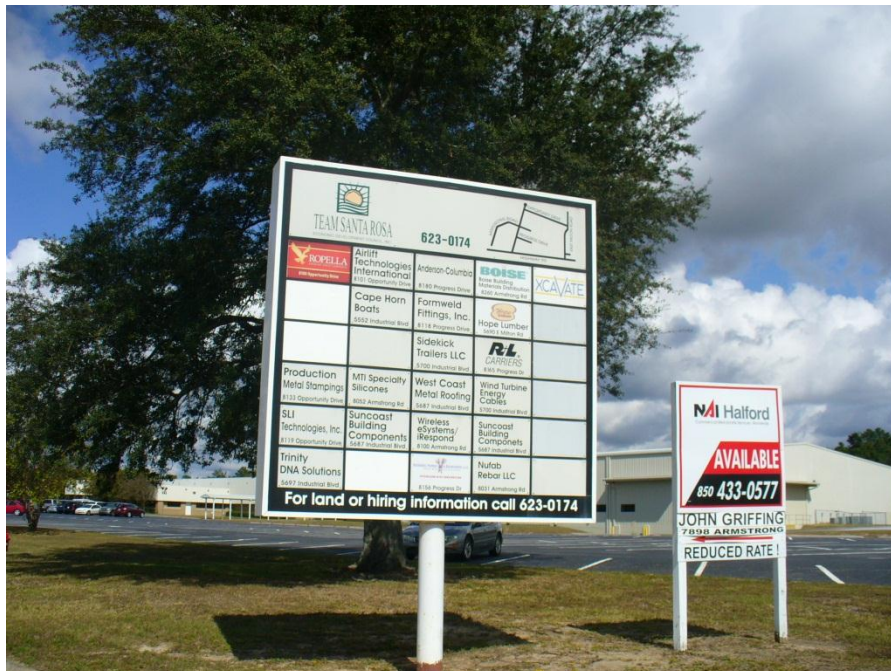
The Airport Industrial Park is primary freight generator along US 90 (see Photo 14 in Appendix 3). It is located between SR 87 and Ward Basin Road. The area is characterized as emerging with lots of room for future expansion and the addition of new facilities within its boundaries.

Marquee to the Santa Rosa Industrial Park
