SR 85 from John King Road to Airport Road

PRELIMINARY FREIGHT CORRIDOR SCREENING SR 85 (John King Road to Airport Road)

PRELIMINARY FREIGHT CORRIDOR SCREENING US 98 (Destin Bridge to Walton County Line)

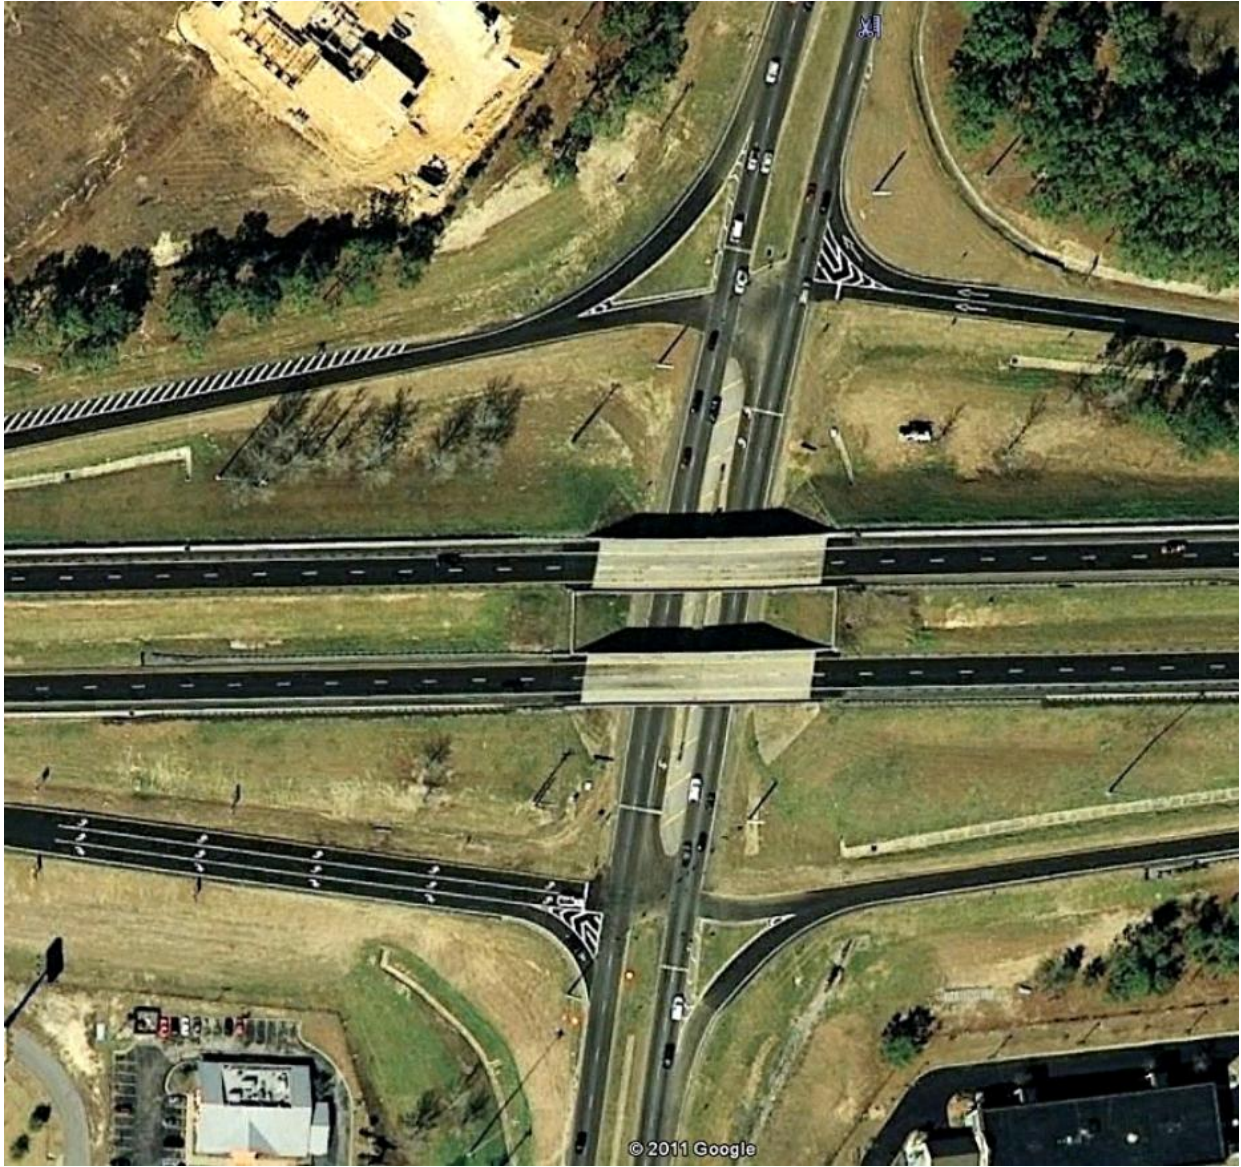
Aerial 2
I-10 at SR 85

At the I-10 ramps, there are dedicated left- and right-turn lanes, as well as two through lanes in each direction (see Aerial 2 in Appendix 1). The exit ramp from eastbound I-10 includes signal controlled double left-turn lanes and a dedicated unsignalized continuous right-turn lane. The westbound I-10 exit ramp includes a signal controlled left-turn lane and an unsignalized continuous right-turn lane.

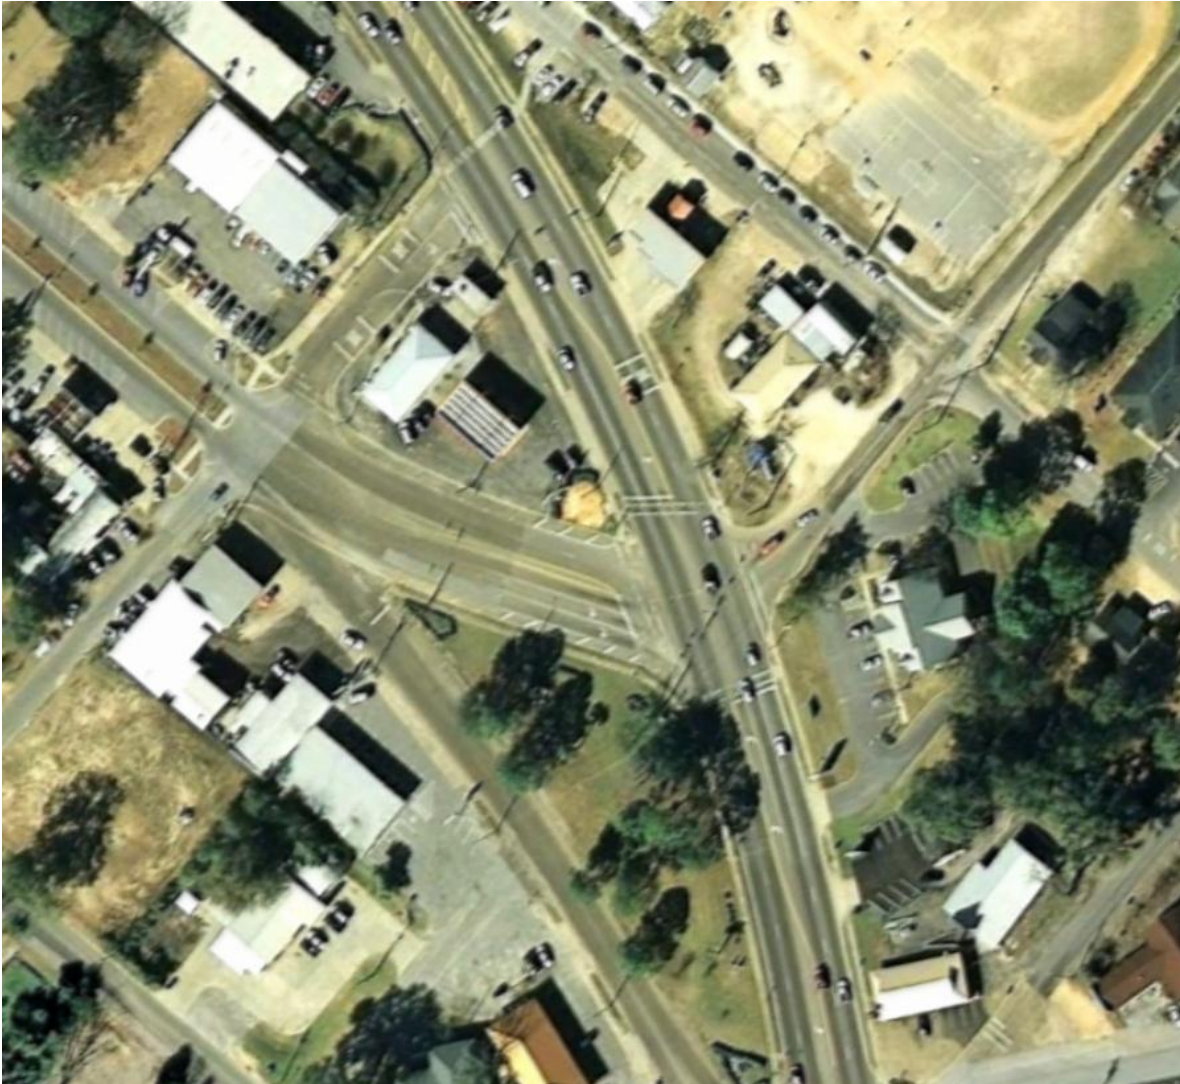
Aerial 6
S. Main Street at SR 85

S. Main Street forms an acute angle with southbound SR 85 (see Aerial 6 in Appendix 1); however, S. Main Street has been designed as a pedestrian-friendly facility that is not conducive to truck movements so there is little chance that trucks would be making routine turns at this signalized intersection and the infrastructure at all four quadrants is in good condition. Traffic signals are mounted from concrete strain pole located at the northeast and southwest quadrants.

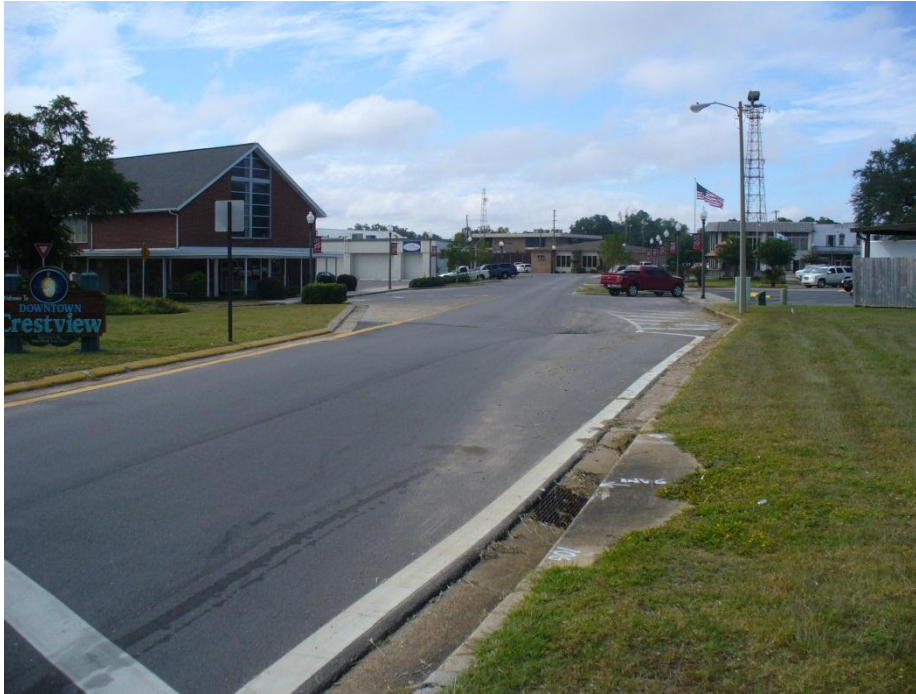
Photo 3
Courthouse Terrace, right in only intersection at southwest corner of US 90 and SR 85

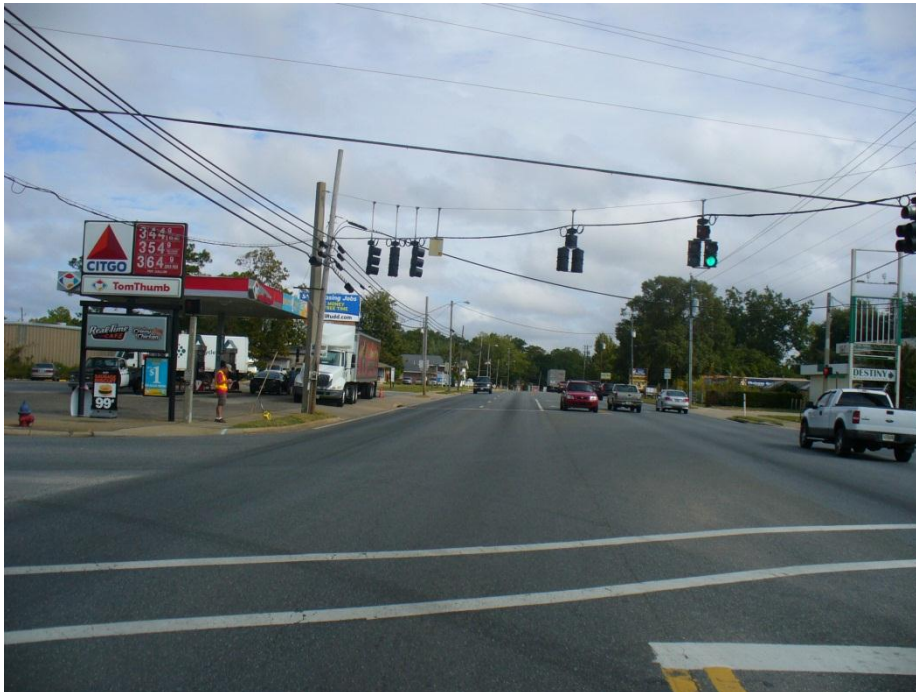
Photo 6
Stillwell Boulevard has pedestrian controls at all four quadrants but only one crosswalk on the south side of the intersection

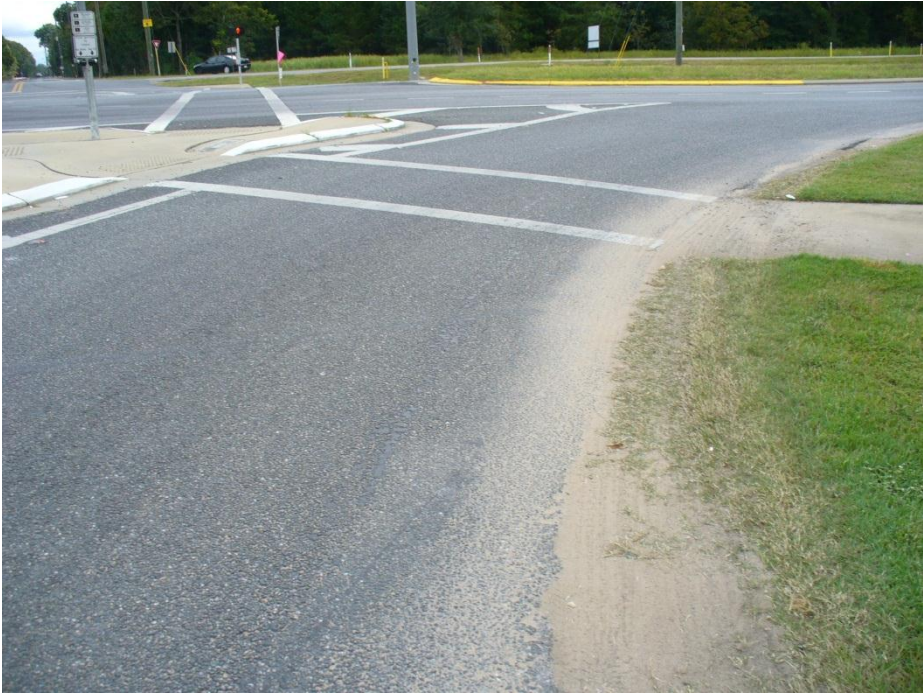
Photo 9
Channelized right-turn lane and raised concrete island at the northeast corner of Airport Road

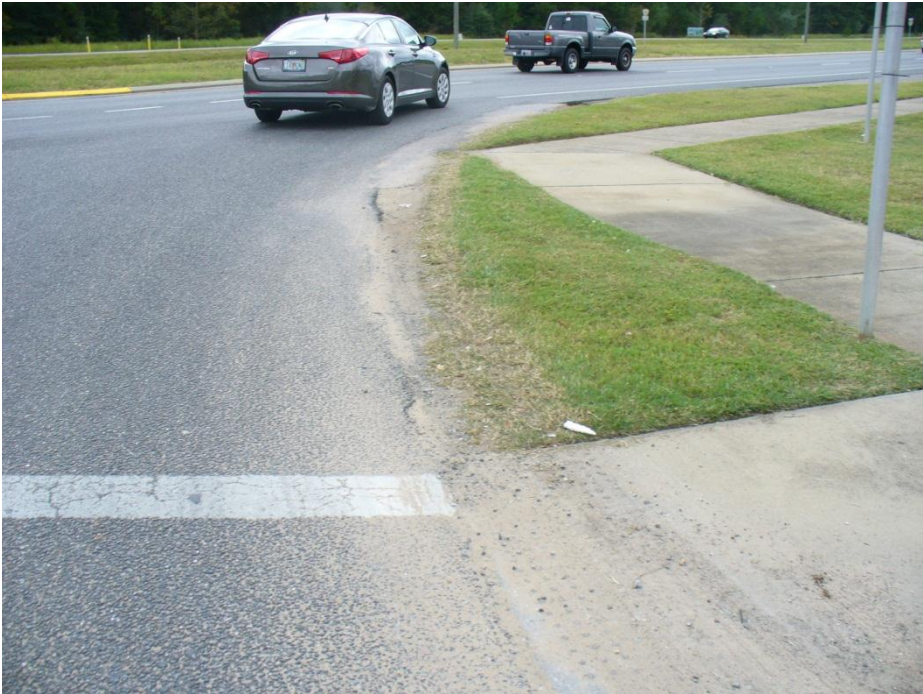
Photo 10
Sidewalk from southwest corner of Airport Road extending south on west side of SR 85

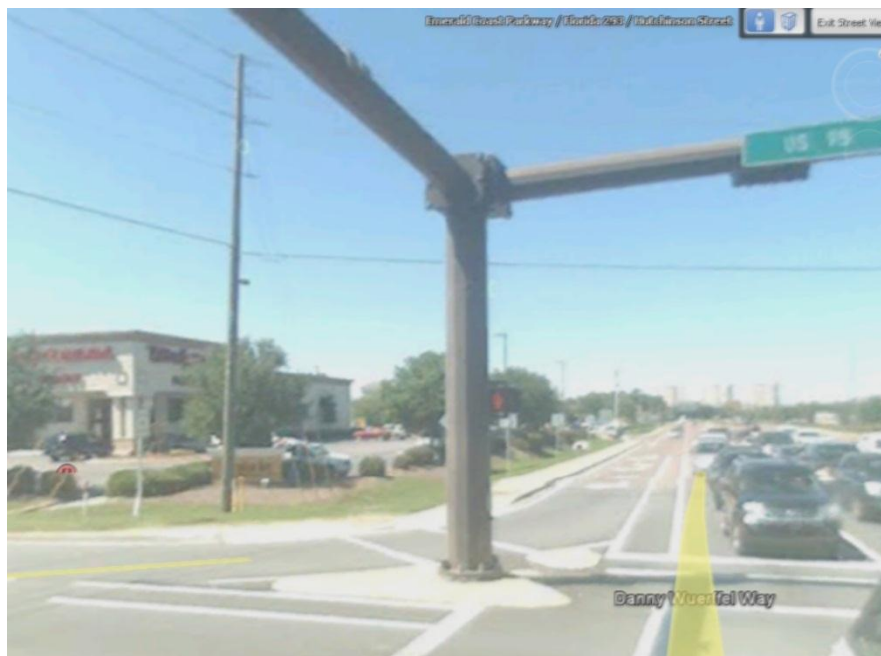
Photo 10

Wide view of mast arm at the northwest corner of Danny Wuerffel Way

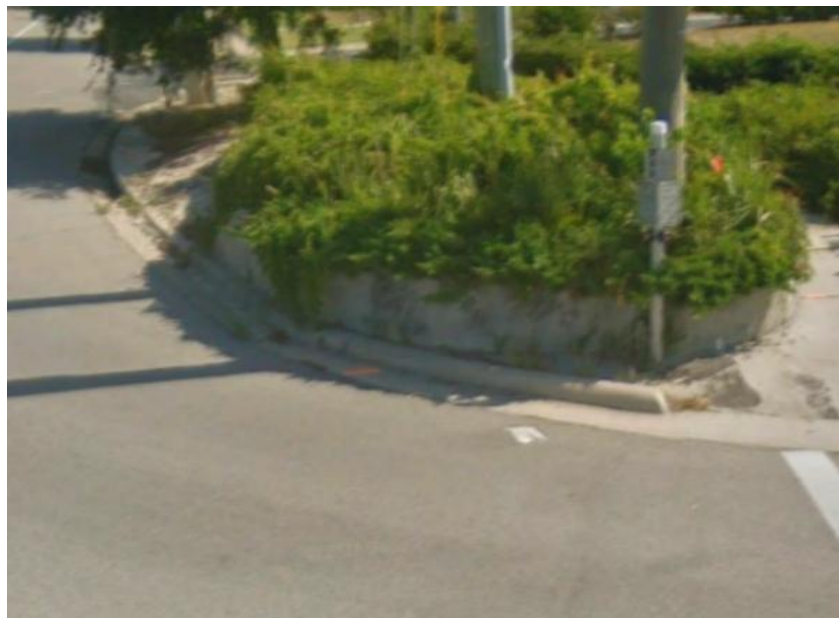
Photo 12

Raised concrete structure at the northeast corner of Gulf Shore Drive

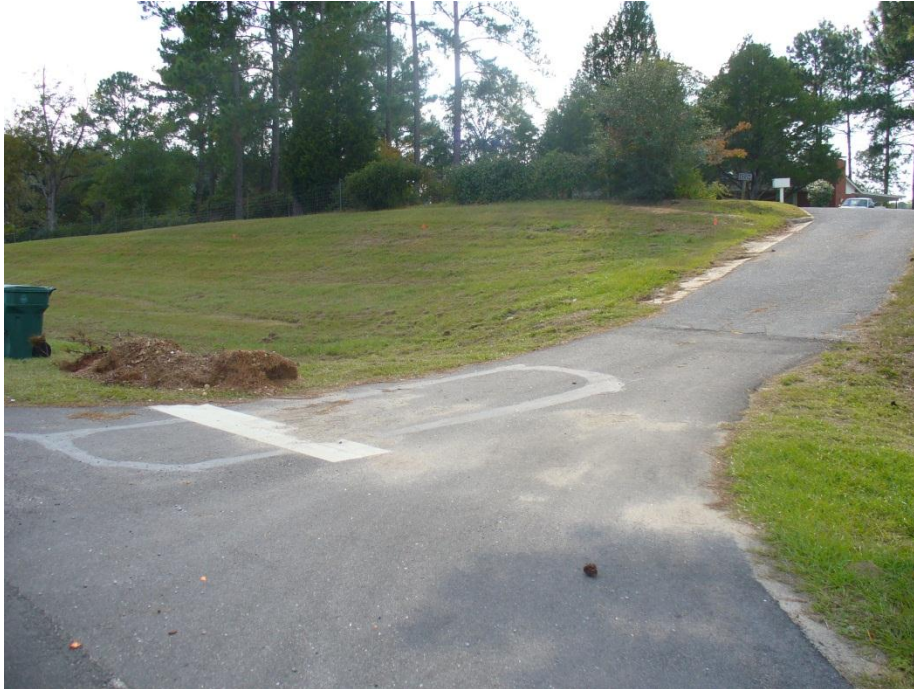
Business Park Road (see Aerial 3 in Appendix 1) is a newly signalized intersection (not shown on Aerial 3) with a southbound left-turn lane, a northbound right-turn lane, and key-hole bike lane. Opposite of Business Park Road is a private residential driveway with signal activation (see Photo 1 in Appendix 3). This signal serves no other parcel except the residential parcel.

Photo 1
Signalized private driveway opposite Business Park Road (note the loop detector and stop bar)

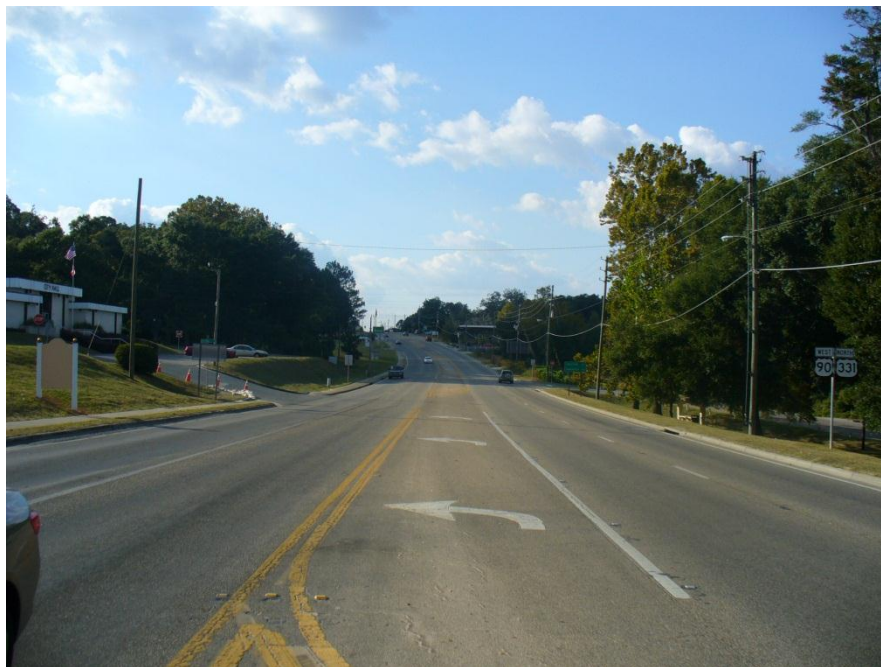
This portion of the corridor lies along US 90 for 1.9 miles to the west of the US 331 South intersection. The typical section on US 90/US 331 is a suburban, five-lane (see Photo 2 in Appendix 3) with a continuous center left-turn lane, outside curbs, open drainage, and a sidewalk along the north side. West of Country Club Drive (see Aerial 9 in Appendix 1), the typical changes to a rural, four-lane divided

Photo 2
Five-lane typical section on US 90/US 331

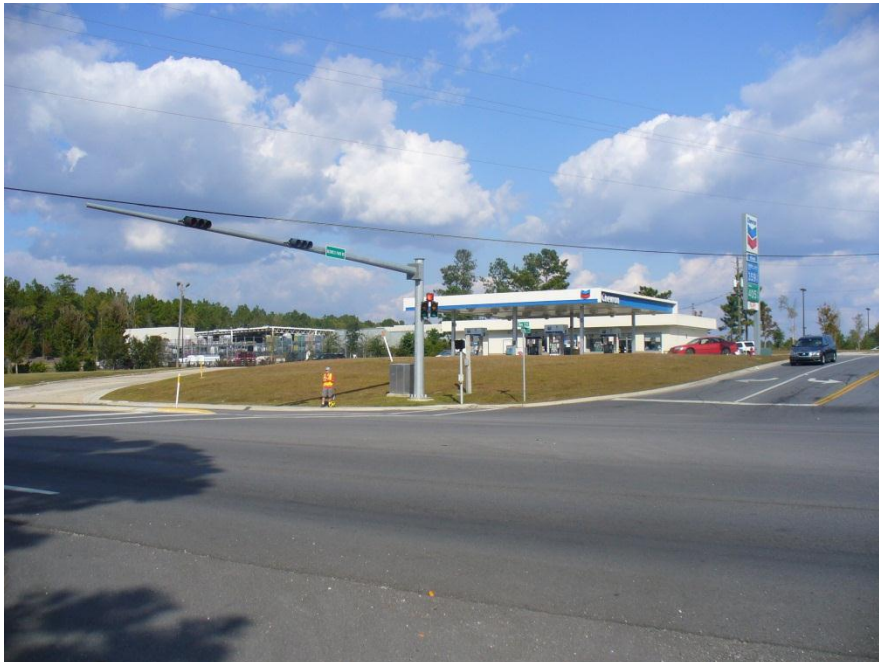
Business Park Road has been recently signalized and includes mast arms (see Photo 6 in Appendix 3) at the northeast and the north and south sides of the driveway opposite Business Park Road, as well as a single-mounted signal on a single pole at the southeast corner that serves the driveway. A new, short sidewalk has been added to the northeast quadrant and there is a concrete pedestrian corner ramp on the west side of the roadway.

Photo 6
New signal at Business Park Road (looking northeast)

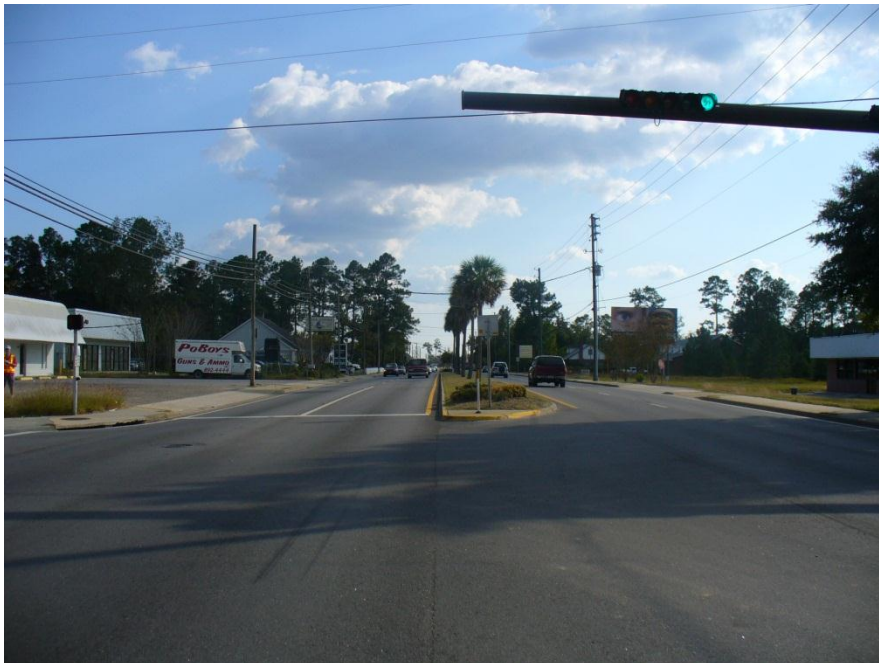
Photo 8

New mast arm signal at Bruce Avenue, which was previously un-signalized

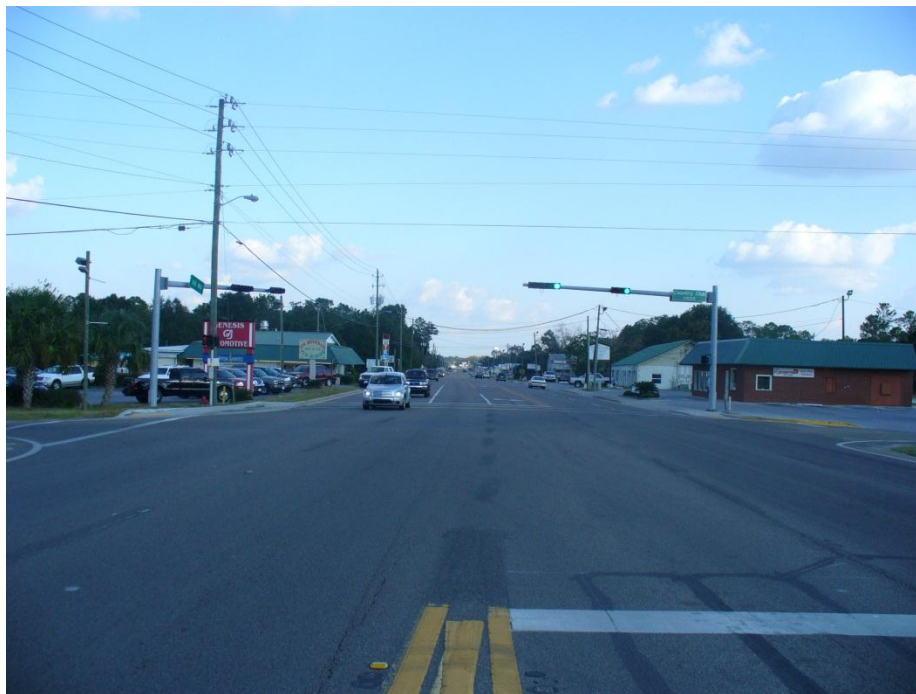
There are also new, mast arm-mounted traffic signals located on US 90/US 331 at Country Club Drive/Shoemaker Drive (see Photo 9 in Appendix 3). The mast arm poles are located at all four quadrants of the intersection and there are pedestrian activation buttons located at all quadrants. In addition, there is a railroad crossing located approximately 50 feet to the south of the intersection with crossing gates that extend across the entire roadway to prevent vehicles from circumventing the gates. Since this road leads to a private country club, it is unlikely that trucks would be accessing this road on a routine basis. At US 331 North signals are hung from concrete strain poles located at the southeast and northwest quadrants. Significant shoulder rutting was noted at the northwest quadrant from off-tracking trucks; however, this intersection is scheduled for improvements as part of a paving project in 2014.

New mast arm signals at Country Club Drive/Shoemaker Drive and US 90, which was previously un-signalized

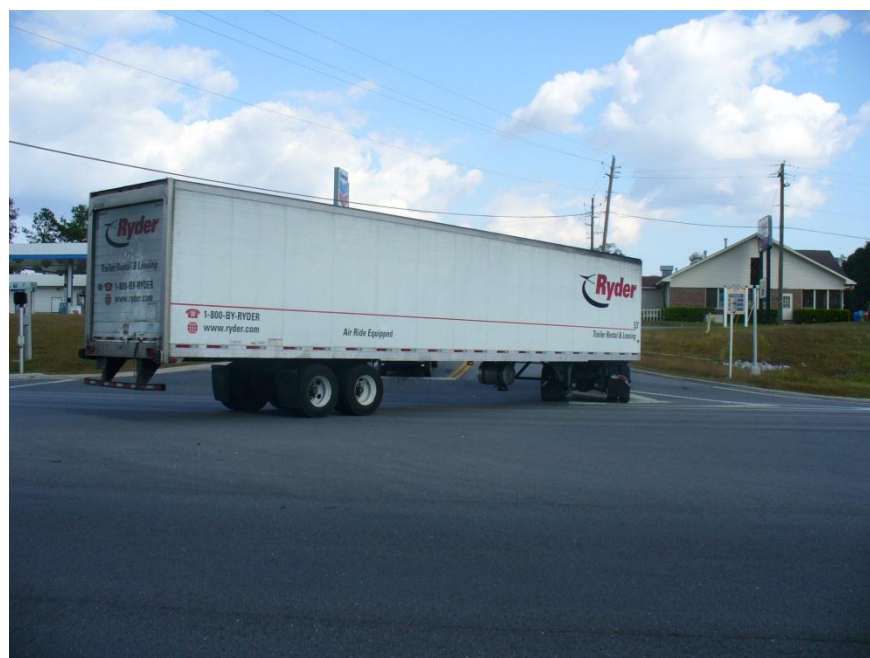
The right turn into Business Park Road is a truck-friendly compound curve that should prevent serious off-tracking of large trucks; however, some encroachment into the westbound left-turn lane is likely and consideration should be given evaluating the location of the left-turn lane stop bar (see Photo 10 in Appendix 3). Also, Hugh Adams Road intersects with Business Park Road 80 feet east of US 331. In the future, traffic from the commercial properties to the east as well as from the small industrial area to the east will make it difficult for vehicles to make left turns from this intersection. Although not necessary

Trucks turning left into Business Park Road (note that 53-foot-long trailers are now commonly used for deliveries to large businesses, as well as to smaller sites such as fast food restaurants and convenience stores)
