**SR 22 (Wewa Highway) from Star Avenue to US 98 Business**

# PRELIMINARY FREIGHT CORRIDOR SCREENING SR 22 (Wewa Highway) from Star Avenue to US 98 Business

# PRELIMINARY FREIGHT CORRIDOR SCREENING SR 368 (23<sup>rd</sup> Street) and SR 390 (St. Andrews Boulevard/Beck Avenue)

# **PRELIMINARY FREIGHT CORRIDOR SCREENING US 98 (15th Street) and Jenks Avenue, US 98 and Harrison Avenue, and US 231 and Harrison Avenue**

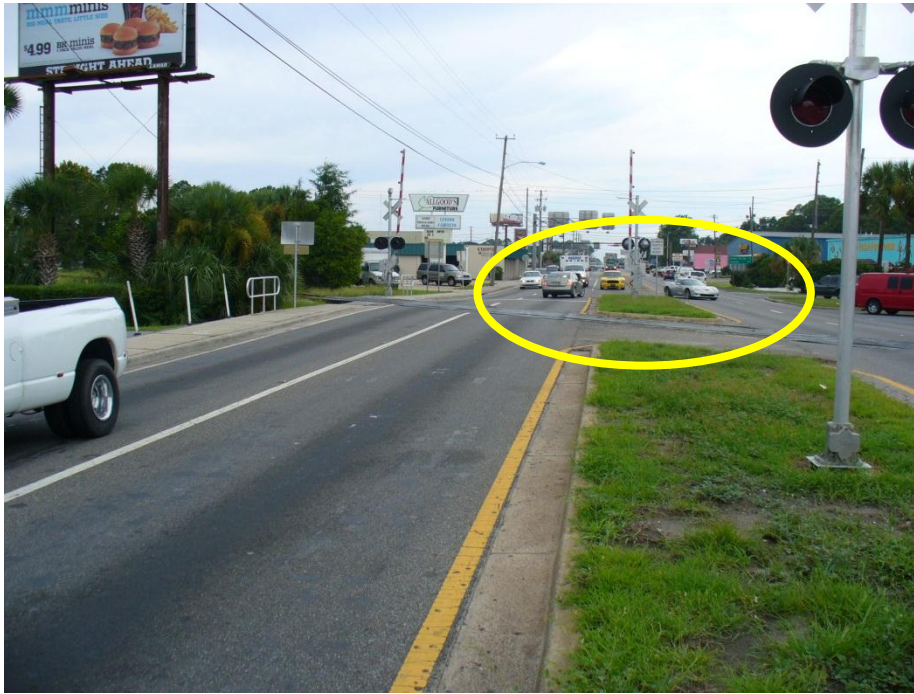
**Photo 1A**  
**Railroad crossing on US 98, west of Harrison Avenue.**  
**Note the unsignaled left-turn lane to US 231)**

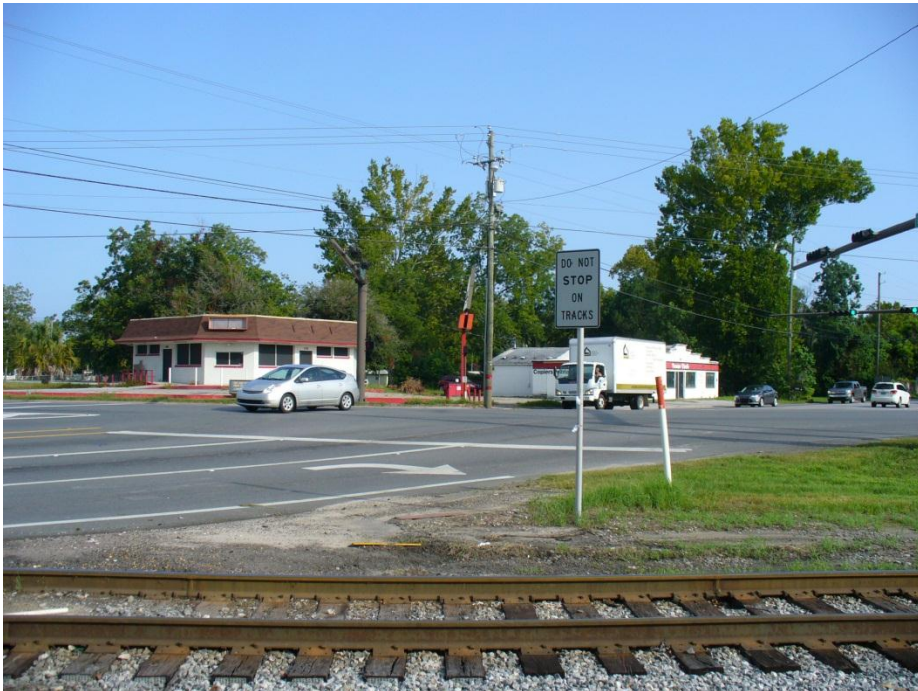
**Photo 2**  
Bay Line Railroad main line crosses N. East Avenue approximately 75 feet south of US 231 right-of-way

The intersection of US 231 and N. East Avenue has skewed geometry, as shown in Figure 2. To further complicate this intersection the main line of the Bay Line Railroad crosses N. East Avenue less than 75 feet from the northbound lanes of US 231. Additionally, the Bay Line Railroad has a multi-track yard located immediately south of the intersection. Also, Lafayette Road intersects with N. East Avenue immediately south of the railroad tracks between the tracks and the crossing gate on N. East Avenue.

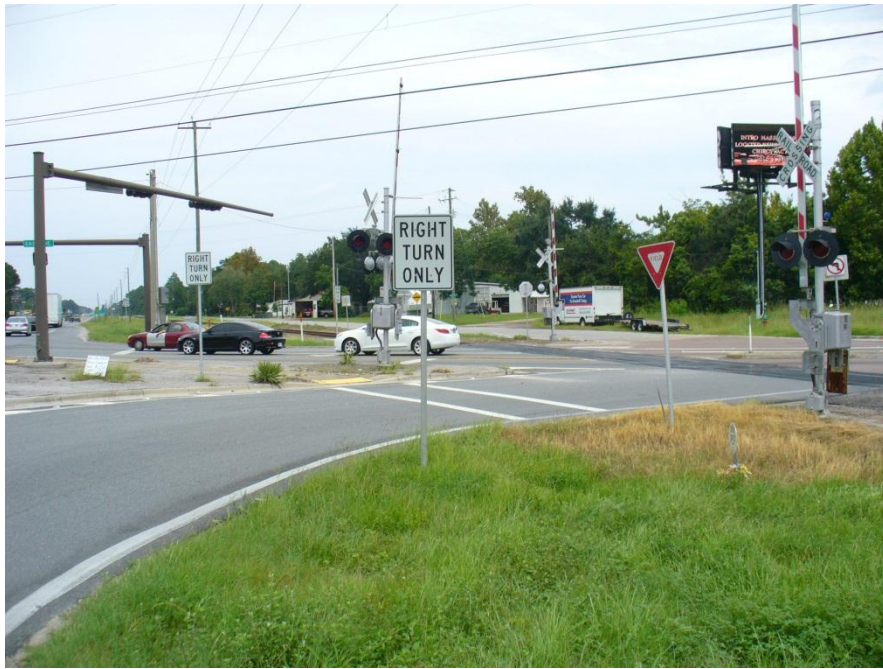
**Photo 3**

**Right-turn lane is separated from the southbound lane of N. East Avenue by a raised concrete island. Note the railroad crossing gates on this turn lane.**

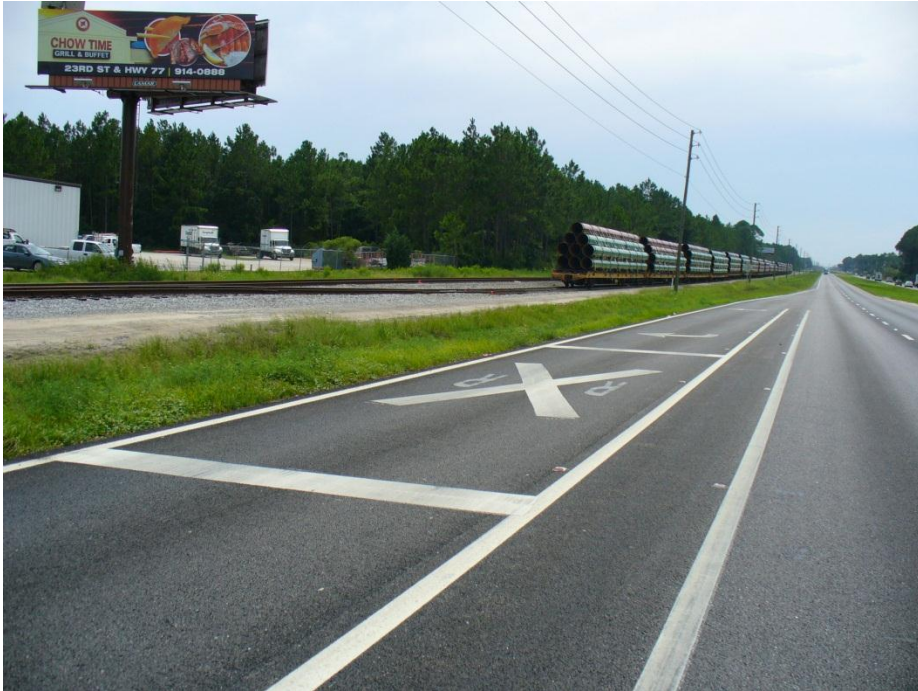
**Photo 1**  
**Right-turn only lane on US 231 with railroad warning pavement markings.**

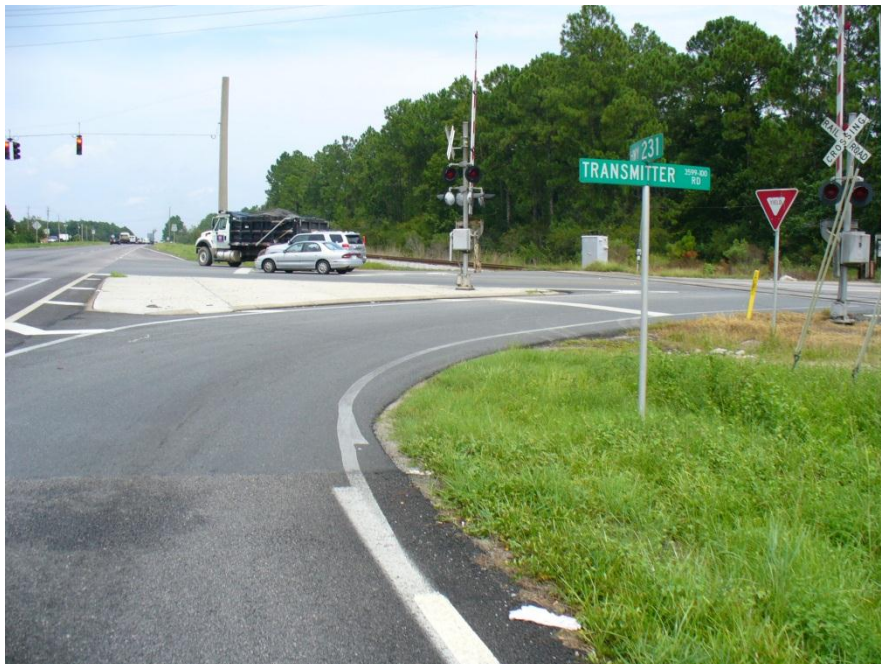
**Photo 2**  
**Railroad crossing gates on right-turn lane. Gate mounted on the raised island is for the southbound through traffic.**

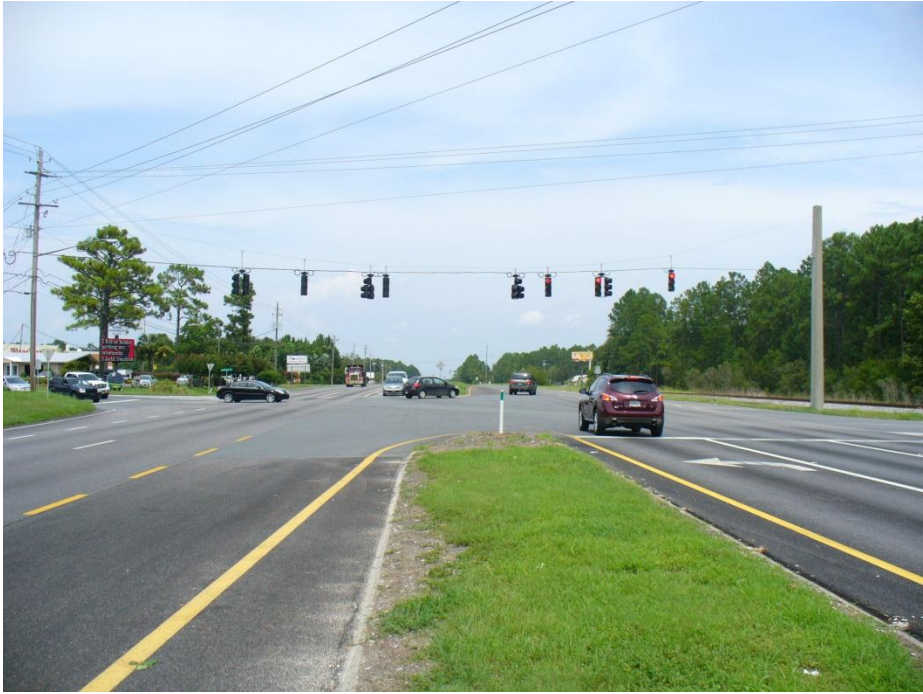
**Photo 3**  
**Inside merge lane on US 231 and northbound dedicated right-turn lane.**

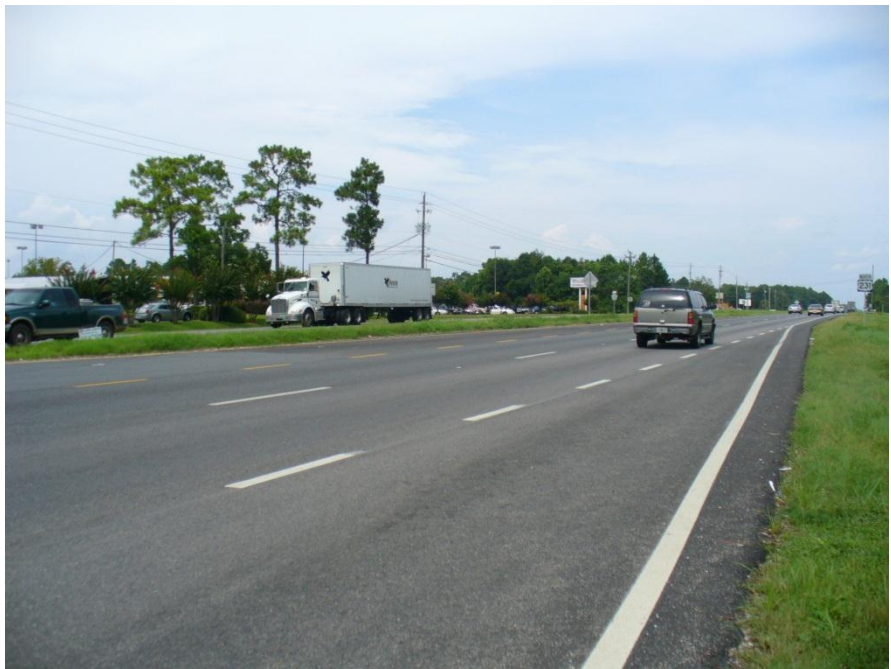
**Photo 4**  
**Outside merge lane on US 231.**
