**CORROSION PERFORMANCE OF
CONCRETE CYLINDER PILES
Contract No. BC353 RPWO#10
Final Report to Florida Department of Transportation**

**A. A. Sagüés
Principal Investigator
Department of Civil and Environmental Engineering**

University of South Florida
Tampa, FL, 33620
February 28, 2005

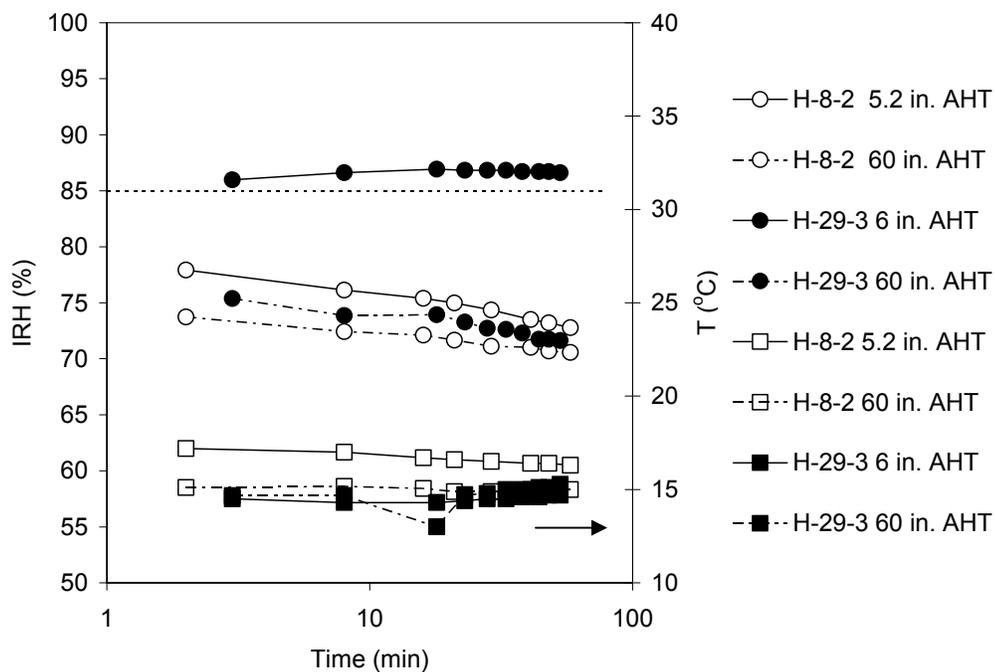
Concrete internal relative humidity measurements were taken from the same two piles (H-8-2 and H-29-3). Measurements were taken at elevations within the tidal/splash zone and atmospheric exposure zone as listed in Appendix III Table A7. IRH measurements were made approximately 18 hours after the test fittings, described in Section 2.2.1, were installed and sealed. IRH measurements were made for approximately 1 hour after inserting the Vaisala probe into the fitting. Figure 3.2 shows the measured IRH as function of time upon insertion of the Vaisala probe into the fitting. These tests show that concrete IRH was generally higher at the tidal/splash zone (expected to have a higher water content) than at higher elevations. Ambient conditions upon completion of testing were ~85% RH and ~15°C

Figure 3.2 Hathaway Bridge concrete internal relative humidity. Measurement readings as function of time after probe insertion, 18h after fitting installation. ○ ● IRH. □ ■ Temperature.

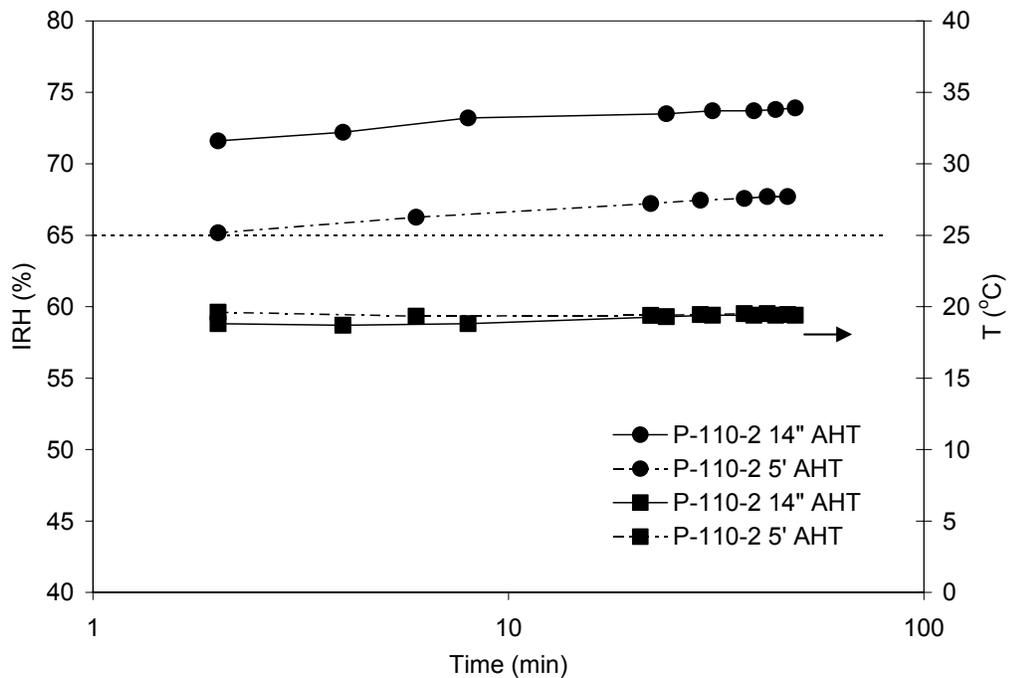
Concrete internal relative humidity measurements were made for P-110-2 at 14 in (35.6 cm) and 5 feet (1.5 m) AHT. IRH measurements were made starting approximately 22 hours after the fittings had been installed, and monitored for approximately 1 hour. Consistent with measurements from the Hathaway Bridge, the IRH is higher within the splash zone than that measured in the atmospheric exposure zone. This is likely due to the higher degree of water saturation near the surface of the tidal zone. Ambient conditions were ~ 65% RH and ~ 18°C.

Figure 3.6 Pensacola Bay Bridge concrete internal relative humidity as function of time since probe insertion, 22 hrs after test fitting installation. ● IRH. ■ Temperature. Horizontal line represents ambient humidity.

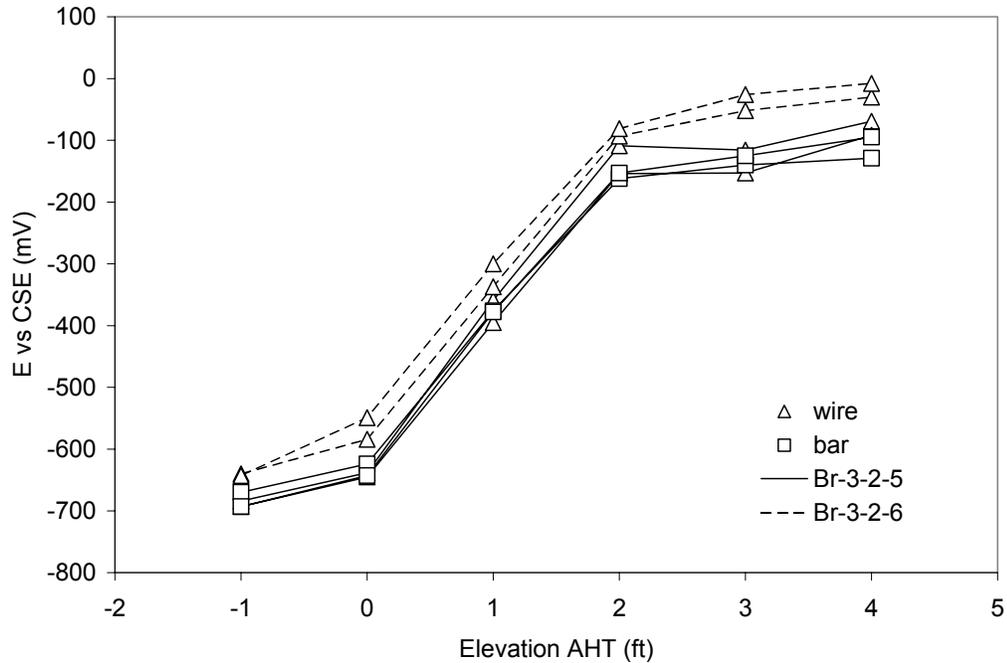
Half-cell potential measurements were made at elevations from high tide to 4 ft (1.2 m) AHT as well as below the waterline on piles Br-3-2-5 and Br-3-2-6. Potential measurements were taken for reinforcements exposed by coring from a crack line and the companion core hole 6 in (15.2 cm) horizontally apart on center. Potential mapping of the LC-rated wire and rebar in Br-3-2-5 showed highly negative values characteristic of corrosion activity. Continuity measurements are not available for this spot, but the reinforcements from the cracked concrete location had close potential values indicative of electrical continuity between hoop reinforcements and spacing rebar.

Figure 3.7 Brooks Bridge half-cell potential measurements as function of elevation.

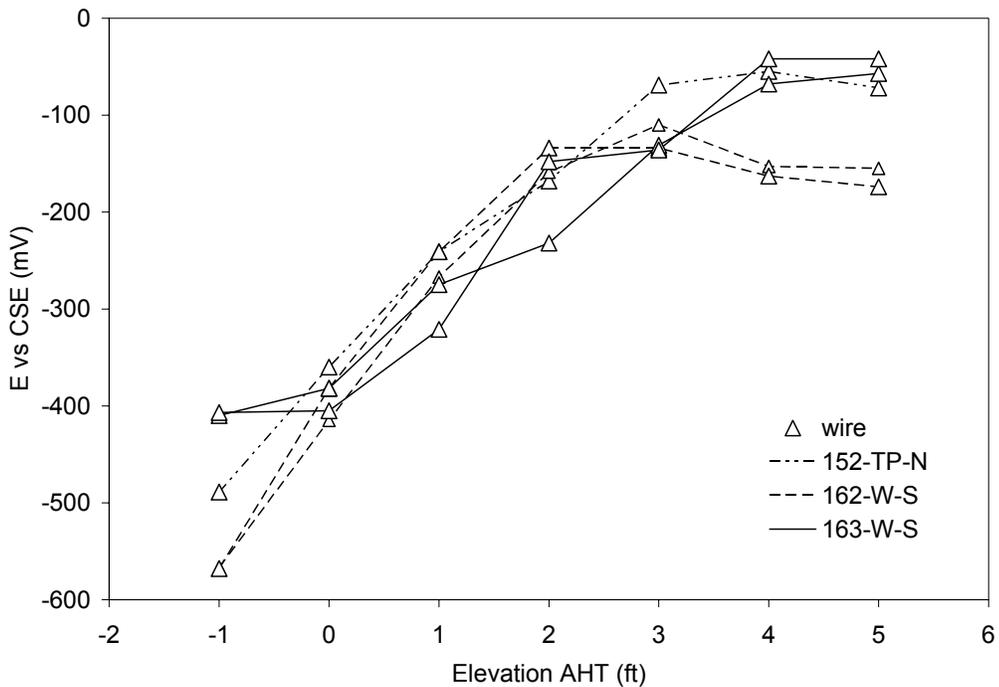
Core samples were extracted to hoop reinforcement depth, which was found at ~ 2.8 – 3.5 in (~ 7.2 -8.9 cm) (see Figure A2), consistent with design specifications. Hoop reinforcement exposed at the bottom of the cores was in all cases in the NC condition. Strand was not exposed during coring. As expected, the exposed hoop reinforcements were electrically continuous. Half cell potential measurements results for the exposed spiral wire are shown in Figure 3.9. It is noted that the core samples extracted from the test pile did not show any physical signs of concrete distress, yet the potential values were generally similar to those on the piles with longitudinal cracks.

Figure 3.8 St. George Island Bridge half-cell potential measurements.

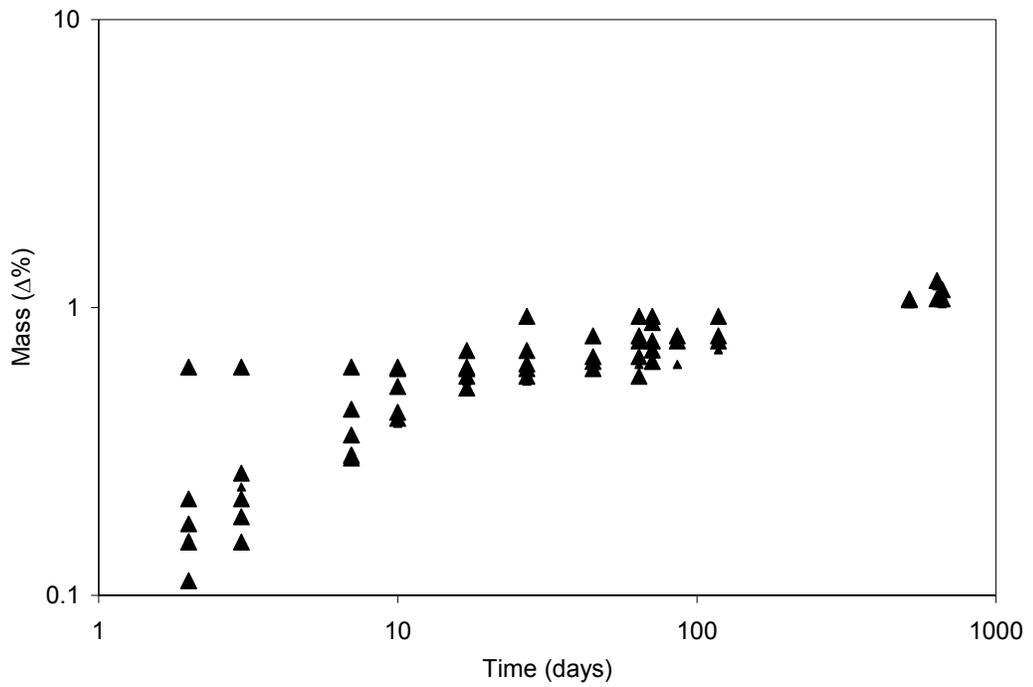
Figure 4.1 Hathaway Bridge core mass change as function of exposure time to 100% RH.

Hathaway Bridge specimens developed wet resistivity in the order of ~ 100 – 200 k Ω -cm after ~ 70 days and ~ 60 – 100 k Ω -cm after extended exposure of 635 days. Those are high values, characteristic of highly impermeable concrete. Water mass pickup and resistivity varied in inverse proportion as exposure time increased (Figure 4.1 and 4.3), as expected. The moisture mass gain was only 1% after ~600 days of conditioning in 100% RH which is also indicative of low pore connectivity.

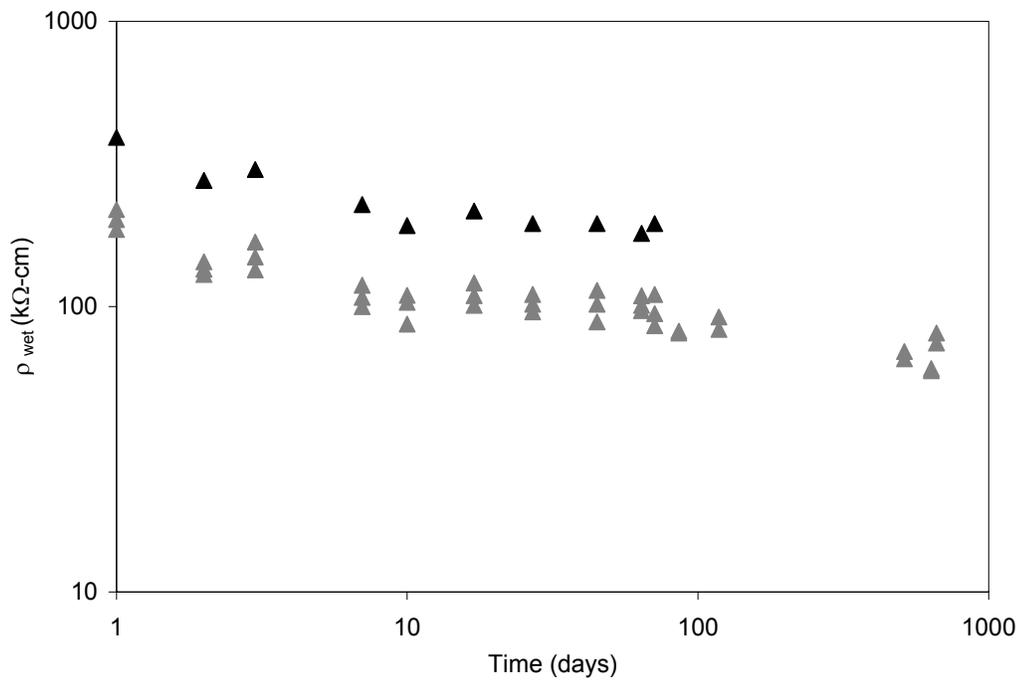
Figure 4.2 Hathaway Bridge core resistivity measurements as function of exposure time to 100%RH. ■ Cores > 1.75 inch (4.45 cm). ■ Cores < 1.5 inch (3.81 cm).

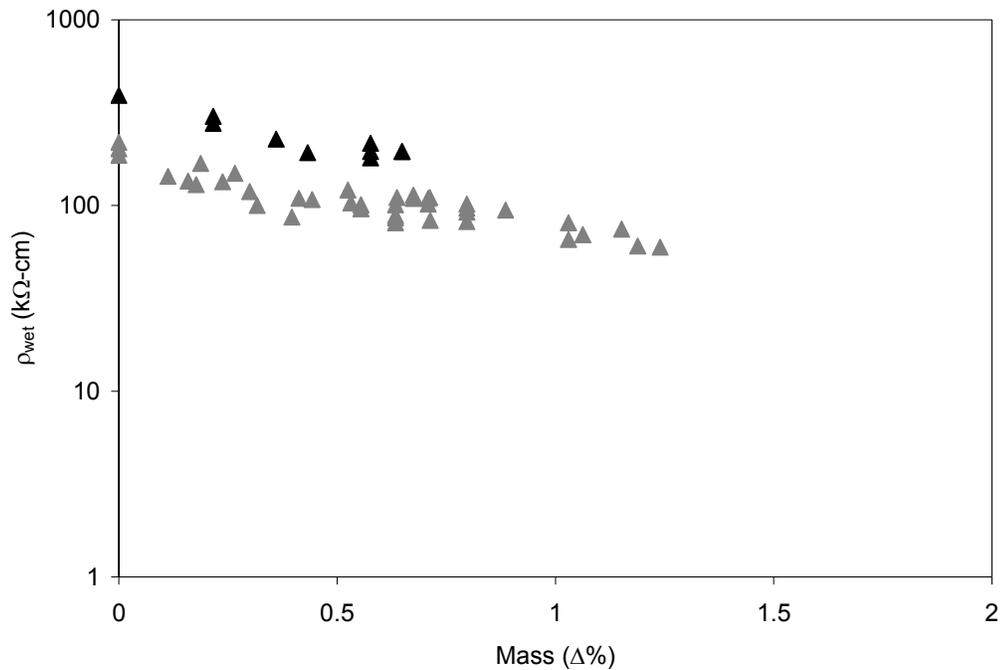
Figure 4.3 Hathaway Bridge core apparent wet resistivity as function of mass increase due to water absorption. ■ Cores > 1.75 inch (4.45 cm). ■ Cores < 1.5 inch (3.81 cm).

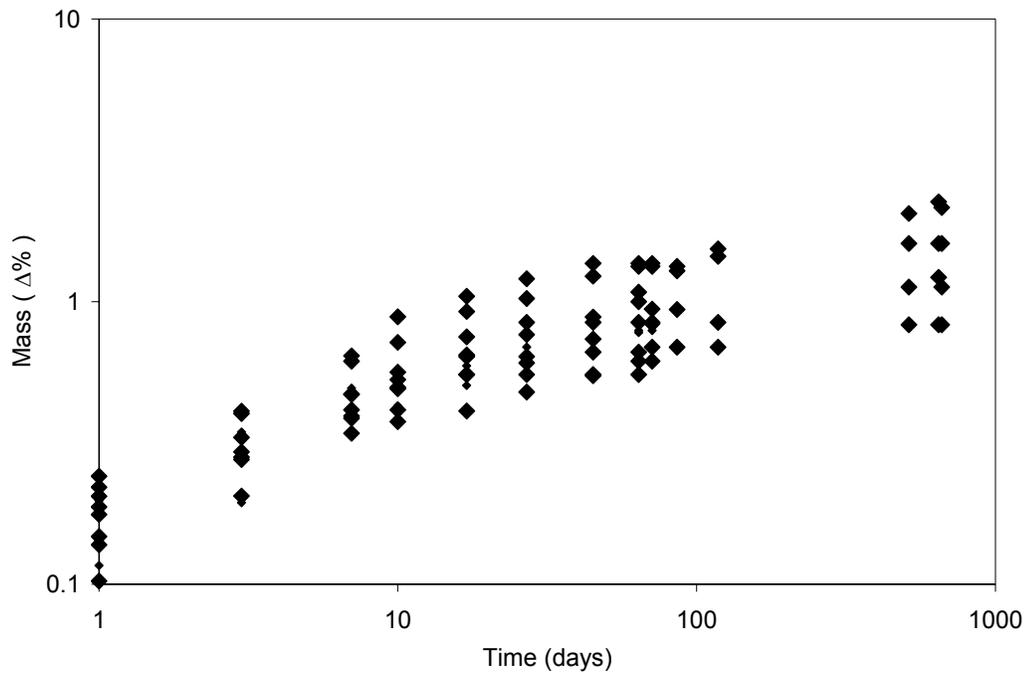
Figure 4.4 Pensacola Bay Bridge core mass change as function to exposure time to 100% RH.

The resistivity of some of the Pensacola Bay Bridge (Figure 4.5) cores reached values at ~70 days (~ 70 – 100 kΩ-cm) that were comparable to those of the Hathaway Bridge. Five other Pensacola Bay cores show a measured wet resistivity of only ~ 25 -50 kΩ-cm after ~ 70 days. Four of those cores were short and possibly subject to the test artifacts indicated earlier. Nevertheless, these resistivity values are still quite high for wet concrete and indicative of low permeability. The long term moisture mass gain was only 0.8% - 2%, also suggestive of low interconnected porosity. Mutual water pickup and resistivity trends were as expected (Figures 4.4 – 4.6).

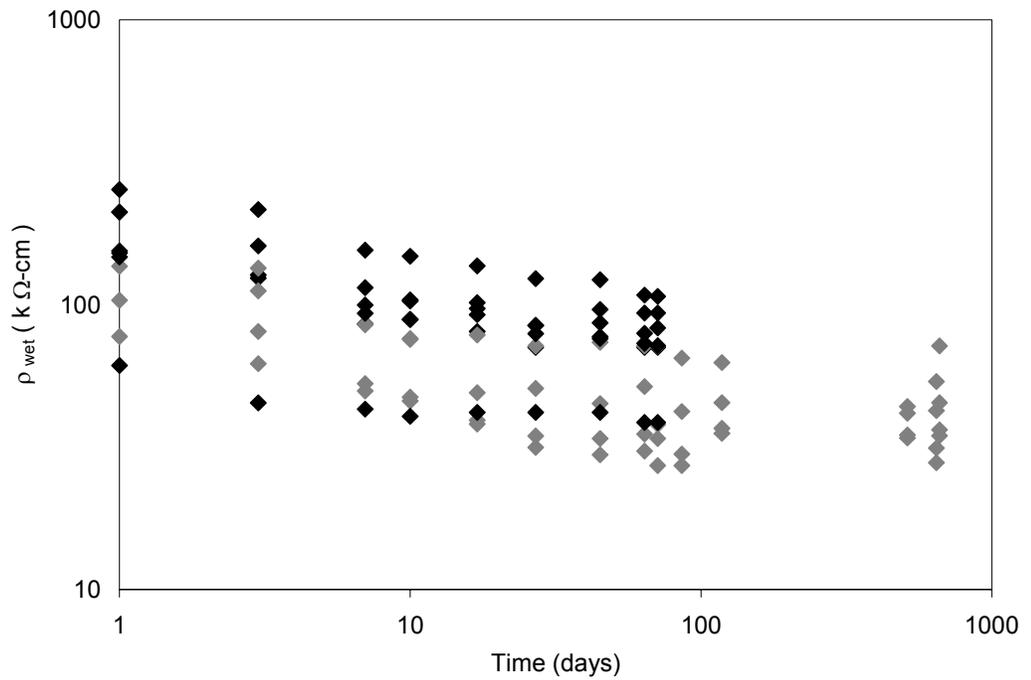
Figure 4.5 Pensacola Bay Bridge core wet resistivity measurements as function to exposure time to 100% RH. ■ Cores > 1.75 inch (4.45 cm). ■ Cores < 1.5 inch (3.81 cm).

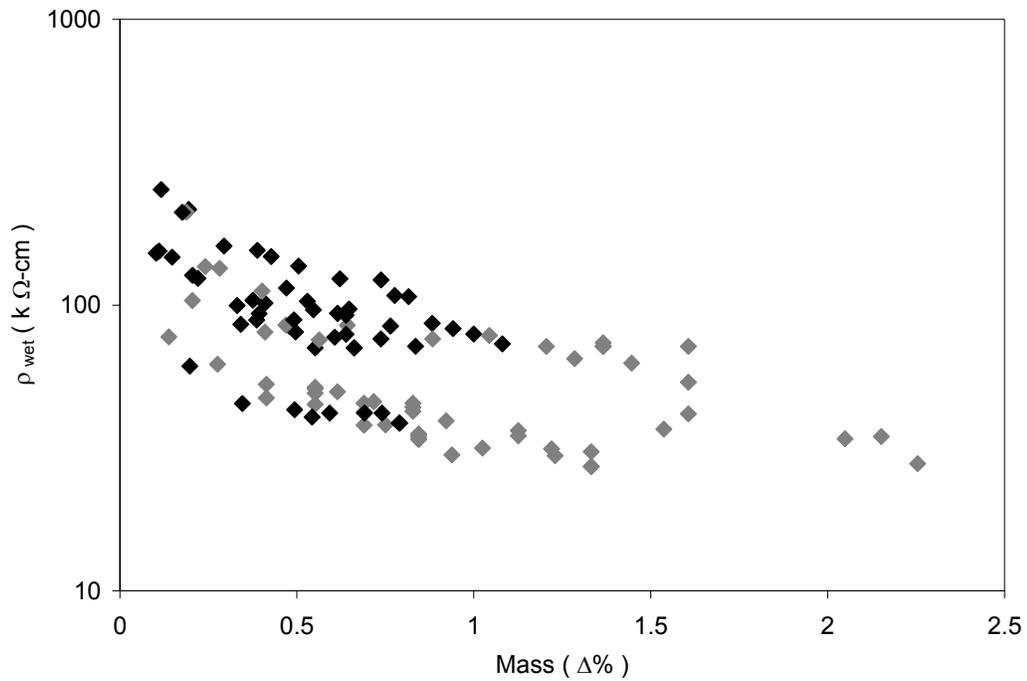
Figure 4.6 Pensacola Bay Bridge core apparent wet resistivity as function of mass increase due to water absorption. ■ Cores > 1.75 inch (4.45 cm). ■ Cores < 1.5 inch (3.81 cm).

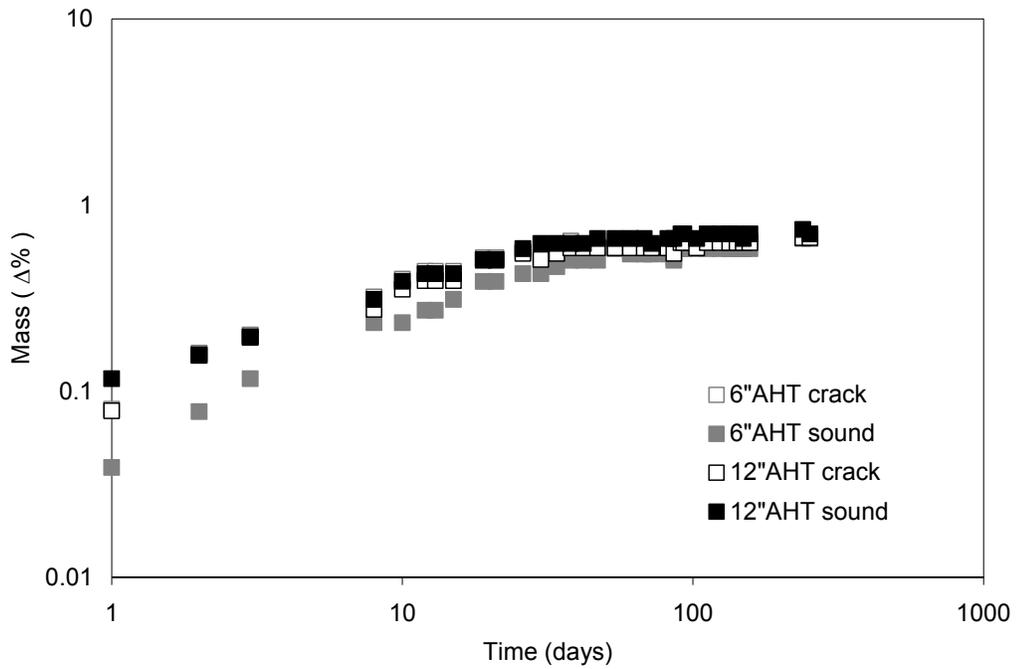
Figure 4.7 St. George Island Bridge (Pile 162) core mass change as function of exposure time to 100% RH.

The SGI Bridge cores from the two in-service piles evaluated showed the highest long term resistivity levels of the bridges in the study (~50 to ~200 kΩ-cm) and low mass gain (Figures 4.7- 4.11). These trends are to be expected from the concrete formulation that included pozzolanic additions intended to further reduce permeability. It is noted that resistivity tended to be higher in specimens for Pile 162 than in those of Pile 163. As it will be shown later the apparent chloride diffusivities for concrete cores from pile 162 were significantly lower than for those from Pile 163, which is as expected as wet resistivity and ion diffusivity are opposite indicators of concrete permeability [29]. Moisture-resistivity trends were as expected and seen for the other bridges (Figure 4.11).

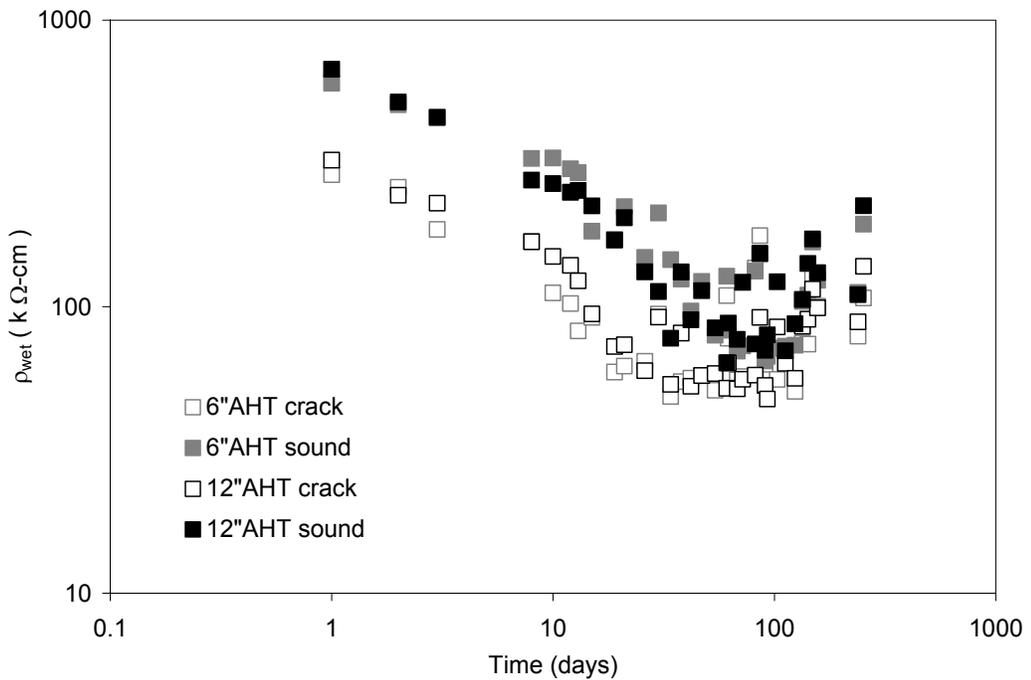
Figure 4.8 St. George Island Bridge (Pile 162) core wet resistivity measurements as function of exposure time to 100% RH.

For both piles the resistivity of the core drilled on a crack was noticeably smaller than that of the core on sound concrete (Figure 4.8, Figure 4.10). This behavior indicates enhanced ionic transport through the crack region. It should be noticed that similar enhanced transport may be present in cracks in cores from the other bridges.

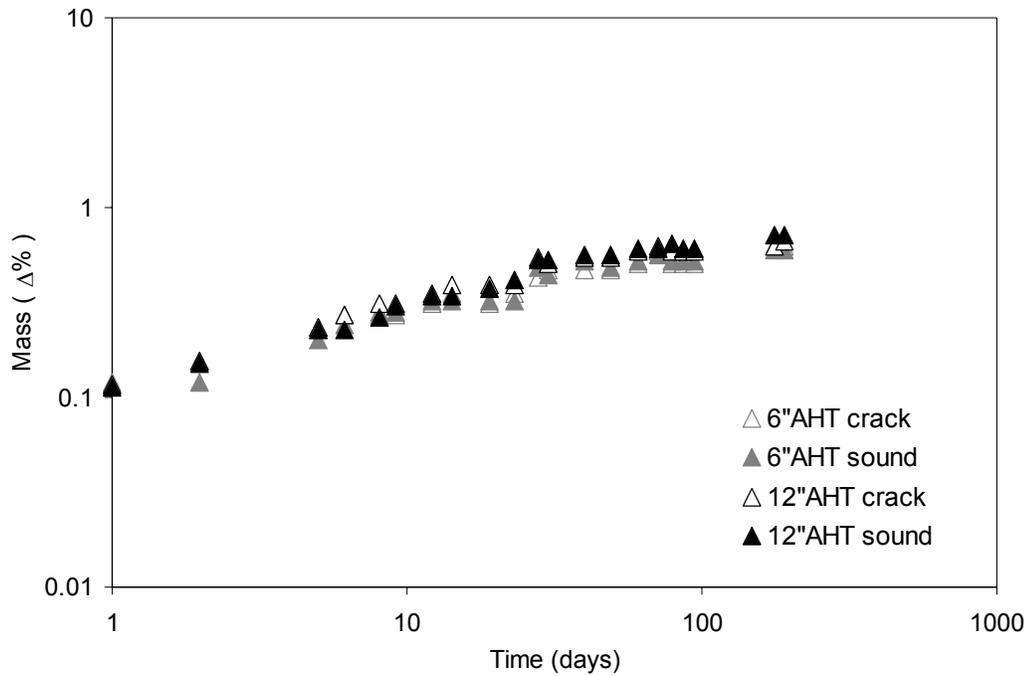
Figure 4.9 St. George Island Bridge (Pile 163) core mass change as function of exposure time to 100% RH.

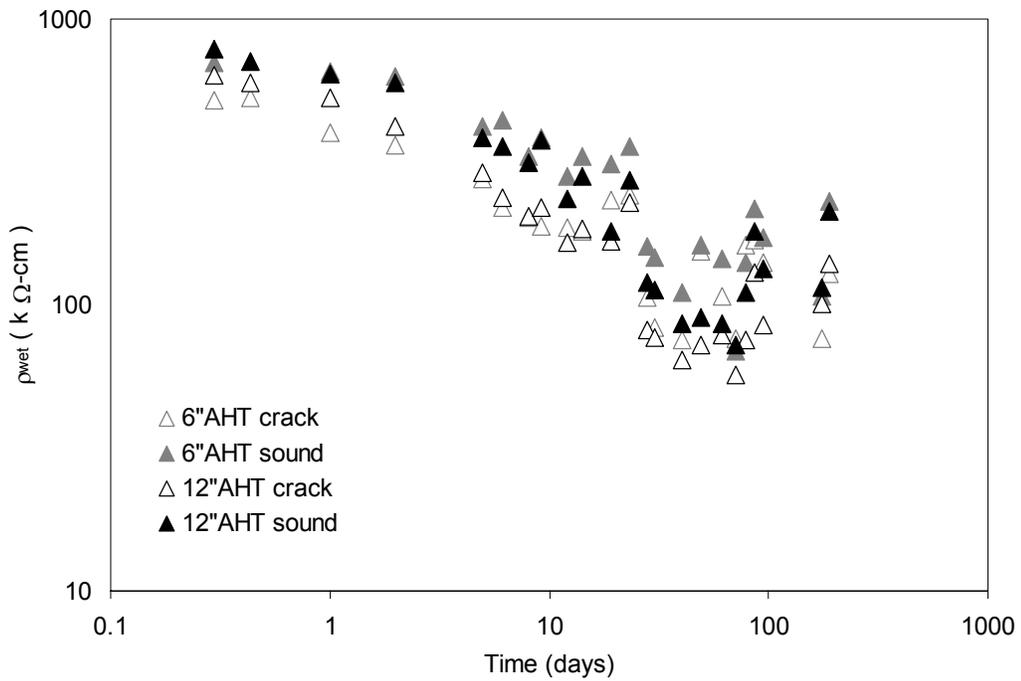
Figure 4.10 St. George Island Bridge (Pile 163) core wet resistivity measurements as function of exposure time to 100% RH.

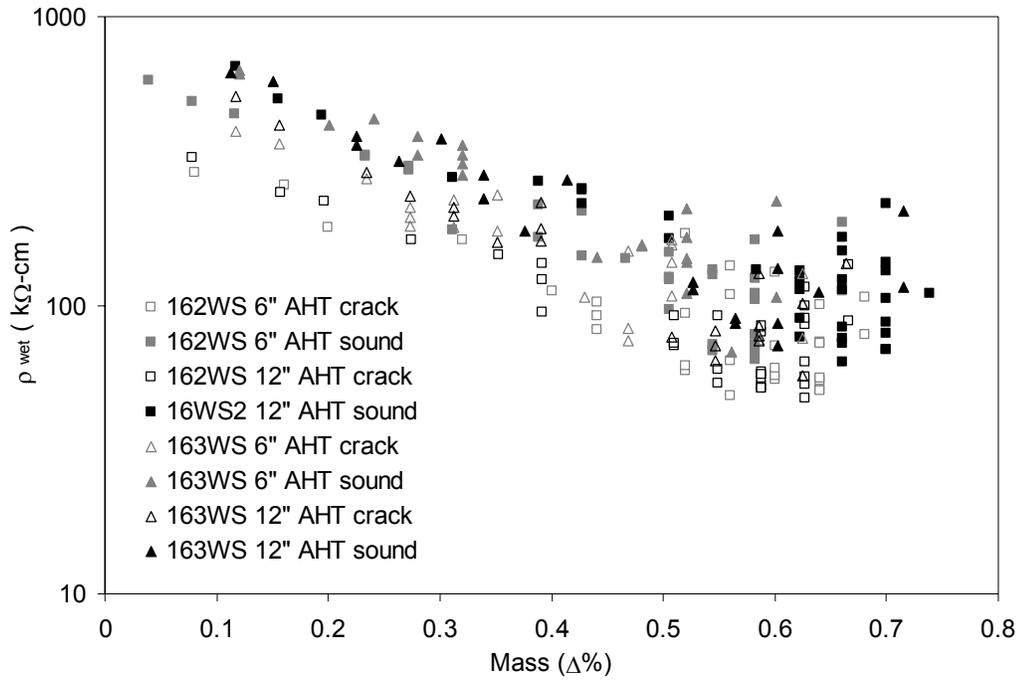
Figure 4.11 St. George Island Bridge core apparent wet resistivity as function of mass increase due to water absorption.

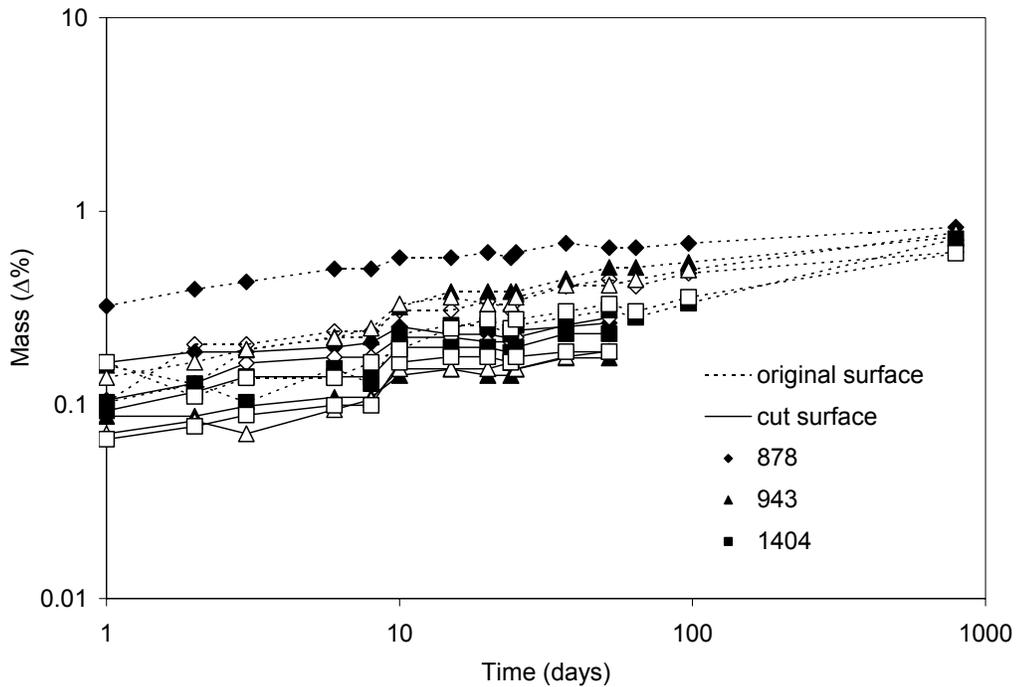
Figure 4.13 St. George Island Bridge pile cutoff mass change as function of exposure time to 100%RH.

Upon testing, the uncut original concrete surface did not appear to have affected significantly water absorption or wet resistivity, but it should be noted that the perimeter and opposite face of the specimen were cut surfaces. Similar to other bridge core samples conditioned in high humidity, water absorption appears to continue upon extended exposure. Resistivity values were high, consistent with the expected high concrete quality, but as seen in figures 4.13 and 4.14 the 878 mix with river rock had not as high wet resistivity (~ 100 kΩ-cm) as the 943 and 1404 mixes (~ 200 kΩ-cm). The 878 mix also showed faster water absorption that compared to the other mixes.

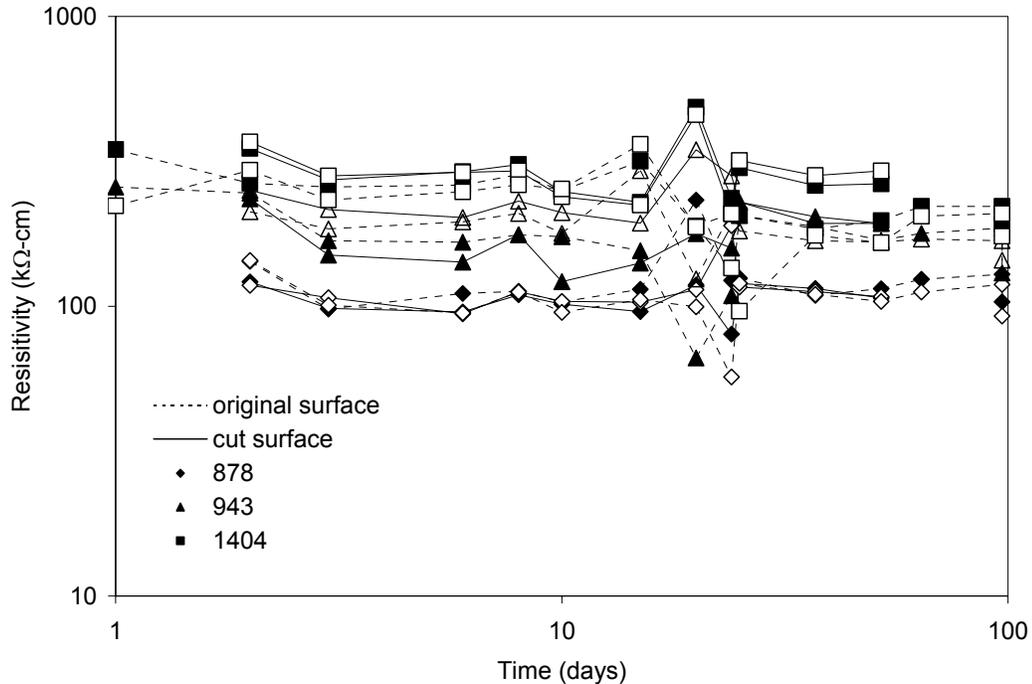
Figure 4.14 St. George Island Bridge pile cutoff wet resistivity measurements as function of exposure time to 100%RH.

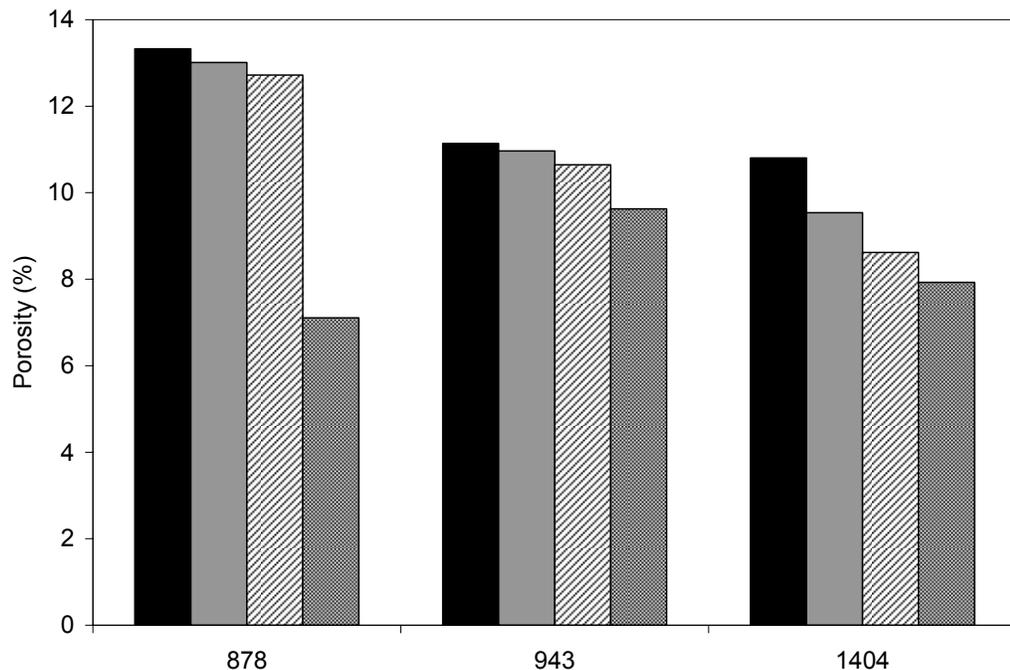
Volumetric porosity measurements generally following ASTM C642-97 were made for samples from the concrete cores extracted from SGI Bridge pile cutoffs. Concrete mix 943 and 1404 had similar results (~ 8 – 11%); concrete mix 878 showed high porosity in three out of four tests (~ 13%) as shown in Figure 4.15. As mentioned in Section 4.1, mix 878 (limestone-river rock mix) had markedly lower wet resistivity than mixes 943 and 1404 which would be in agreement with the observed higher porosity. It is noted that the effectiveness of soaking and boiling methods used in ASTM C-642 to saturate high quality concrete has been questioned in the literature [30]. One porosity test result for concrete mix 878 was significantly lower than those of replicate measurements. It is noted that the river rock was intended in the SGI Bridge for concrete mixes for pile sections to be placed below tidal zone.

Figure 4.15 St.. George Island Bridge pile cutoff porosity. Four replicate measurements, as shown by the bars, were made for each sample: 878, 943, and 1404

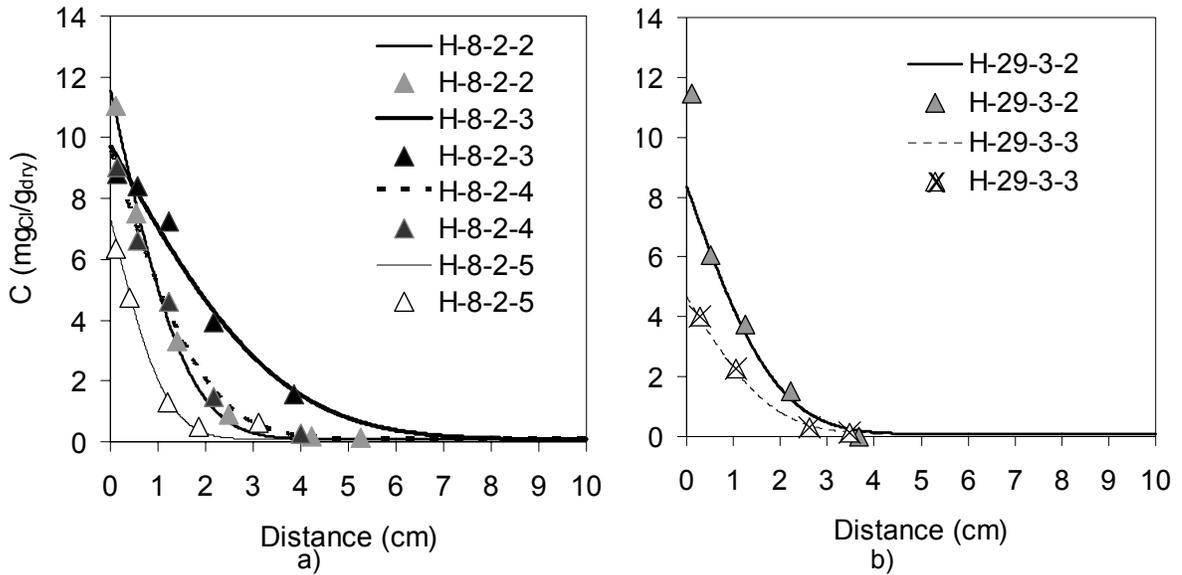
In agreement with a commonly observed trend in marine substructure [2], the apparent diffusivity tended to decrease with increasing elevation AHT. This behavior is visible in the example of Figure 4.16a where the profiles are significantly wider for cores extracted from below tide than for cores in the atmospheric exposure zone. The composite graph in Figure 4.22 shows diffusivity as function of elevation for all of the core locations in this survey as well as those from the Escambia Bay bridges. Although there is significant local scatter, there is a clearly decreasing trend in D as elevation increases. The decrease is expected as the water content of the concrete decreases with

Figure 4.16 Hathaway Bridge chloride ion penetration profile. a) H-8-2. b) H-29-3. ■ Below high tide. ▀ Splash/ tidal zone. □ Atmospheric exposure zone. X Cracked concrete. Lines represent chloride penetration profiles predicted by Eq. 1.

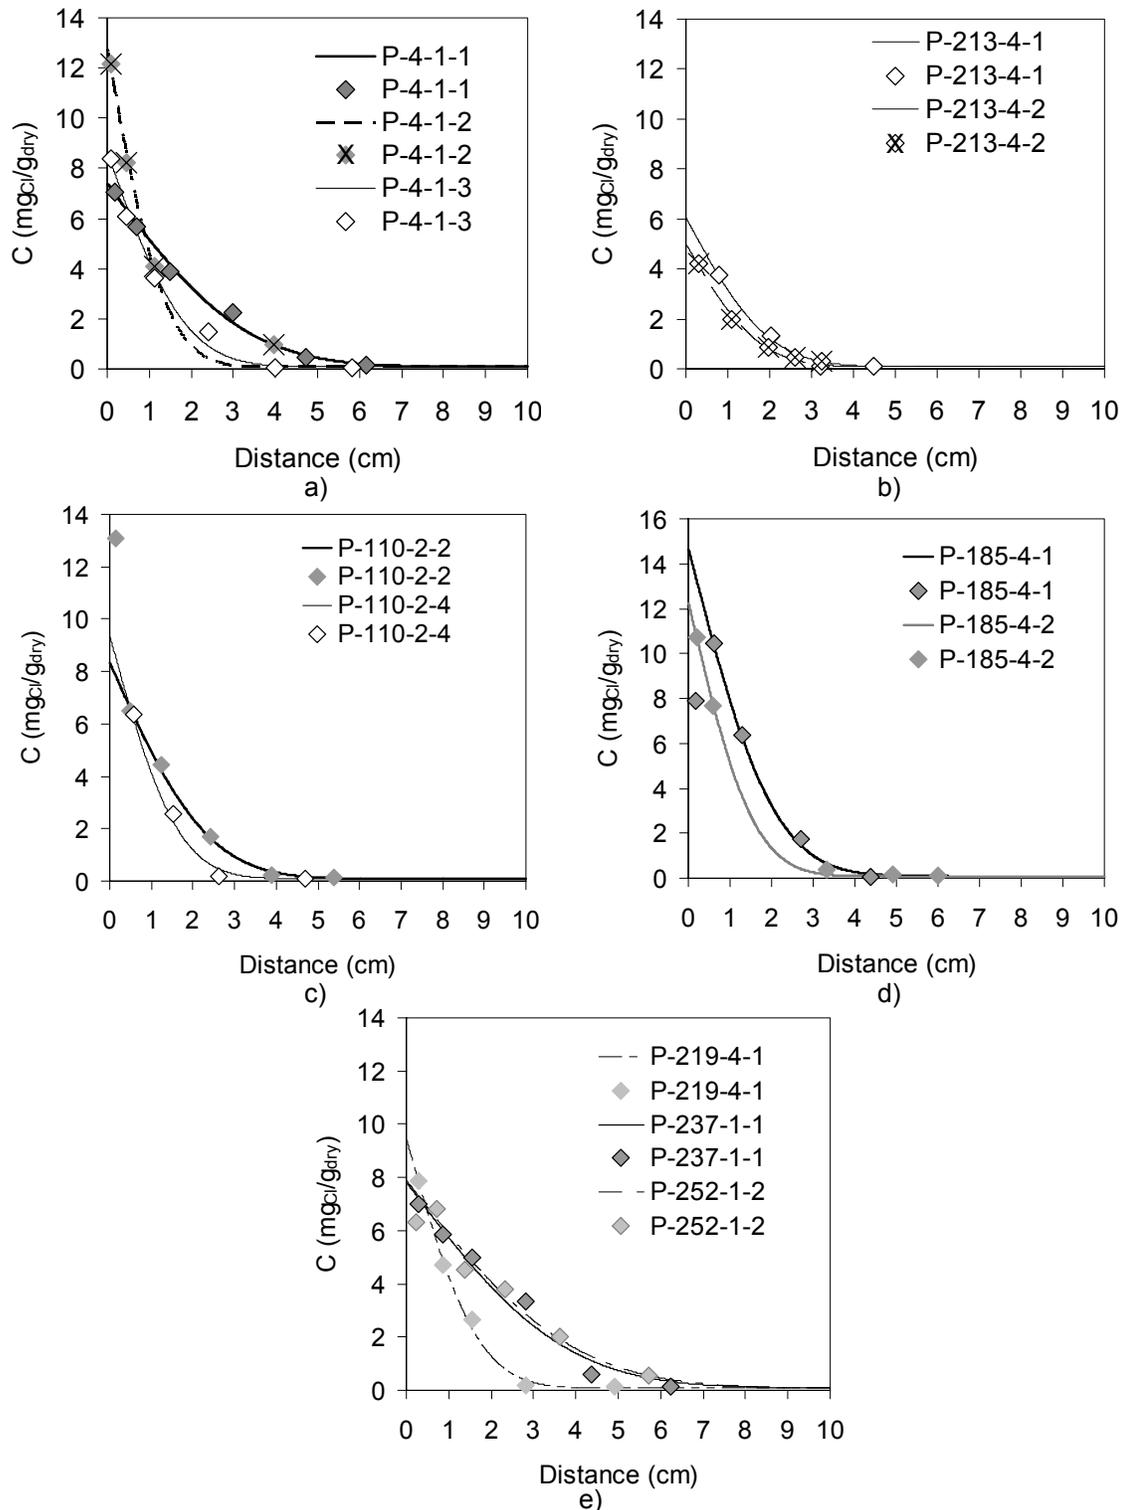
Figure 4.17 Pensacola Bay Bridge chloride ion penetration profile. a) P-4-1. b) P-213-4 c) P-110-2 d) P-185-4 e) P-219-4, P-237-1, and P-252-1 ■ Splash/ tidal zone. □ Atmospheric exposure zone. X Cracked concrete. Lines are chloride penetration profiles predicted by Eq. 1.

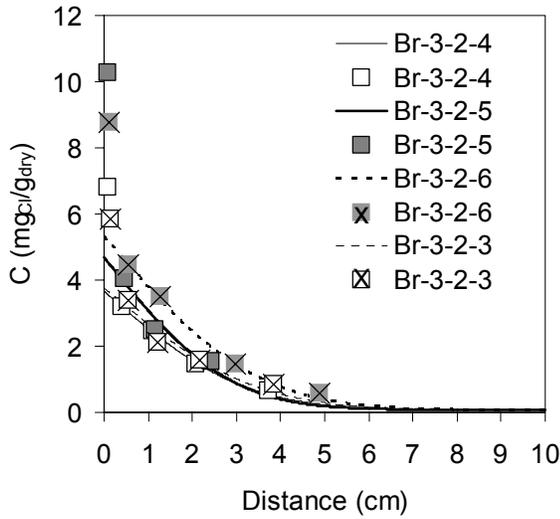
Figure 4.18 Brooks Bridge chloride ion penetration profile. ■ Splash/ tidal zone. □ Atmospheric exposure zone. X Cracked concrete. Lines represent chloride penetration profiles predicted by Eq. 1.

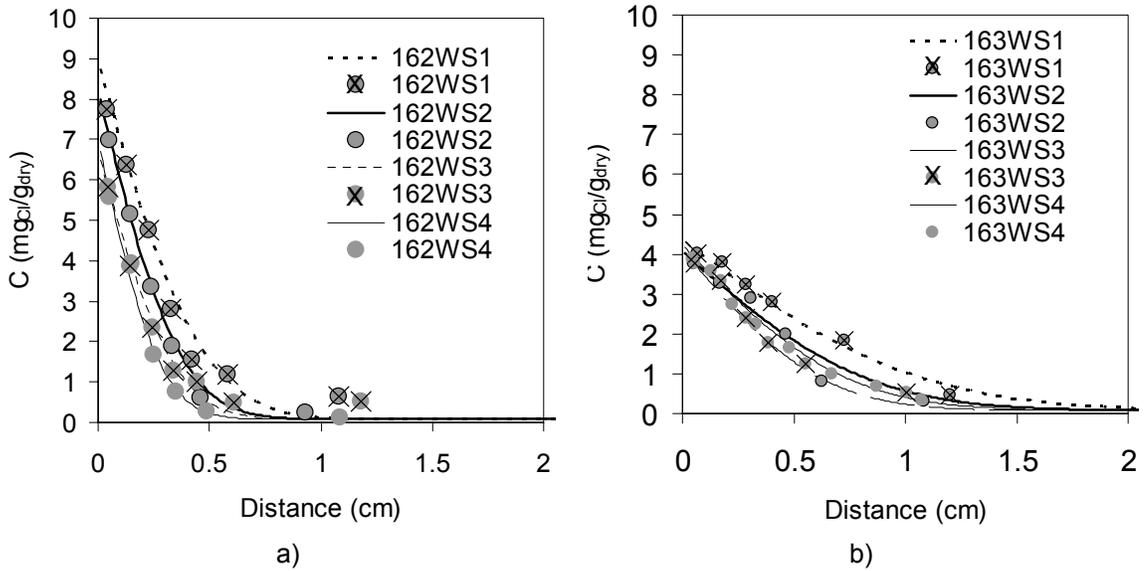
Figure 4.19 St. George Island Bridge chloride ion penetration profile. a) 162WS. b) 163WS. ■ Splash/ tidal zone. X Cracked concrete. Lines represent chloride penetration profiles predicted by Eq. 1.

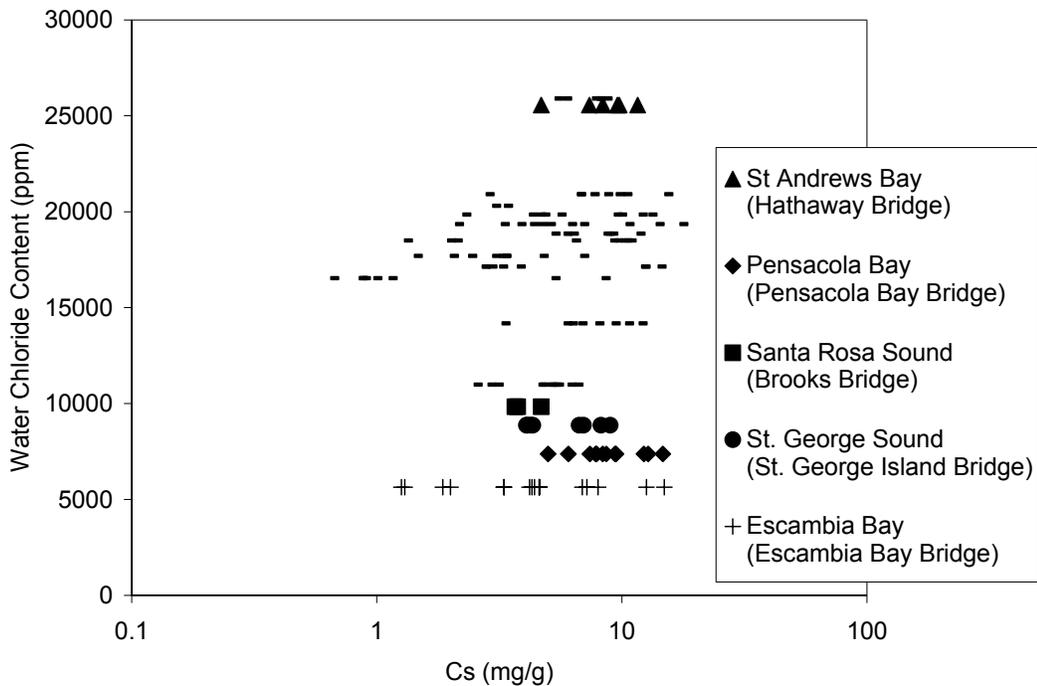
Figure 4.21 shows that the ranges of C_s values observed in the various bridges investigated generally overlap, roughly independent of the chloride content of the water in the span of salinity encountered. The similarly overlapping data from an additional statewide sampling of Florida bridge [2] substructures made with conventional concrete is also shown. This behavior has been noted elsewhere [34] and it reflects the development of nearly salt-saturation conditions (and hence approximately equal concentration independent of salinity of the source) on much of the surface of the concrete by evaporative concentration of marine or estuary water.

Figure 4.21 Comparison of water chloride content and concrete chloride surface concentration Cs at elevations -0.14 to 1.52 m AHT (-0.5 to 5 ft AHT). (-) data from [2] for various FDOT bridges built with conventional modern concrete.

As shown in Figure 4.21, the range of surface chloride concentrations observed in the cylinder pile surfaces were similar to those encountered in other marine and estuarial Florida bridges built with conventional concrete. Thus the driving force for chloride penetration in the older cylinder piles was not unusually high or low. The observed chloride diffusivities were however extremely small (typically about 10^{-13} m²/s) which caused chloride penetration to be greatly retarded in the bulk of the concrete. Furthermore, in contrast to observations in conventional FDOT substructures [2], rapid chloride transport through thin cracks was not strongly apparent in the older cylinder piles. Thus, even though thin cracks were frequently observed, inward chloride ion penetration appeared to be ruled mostly by bulk parameters.

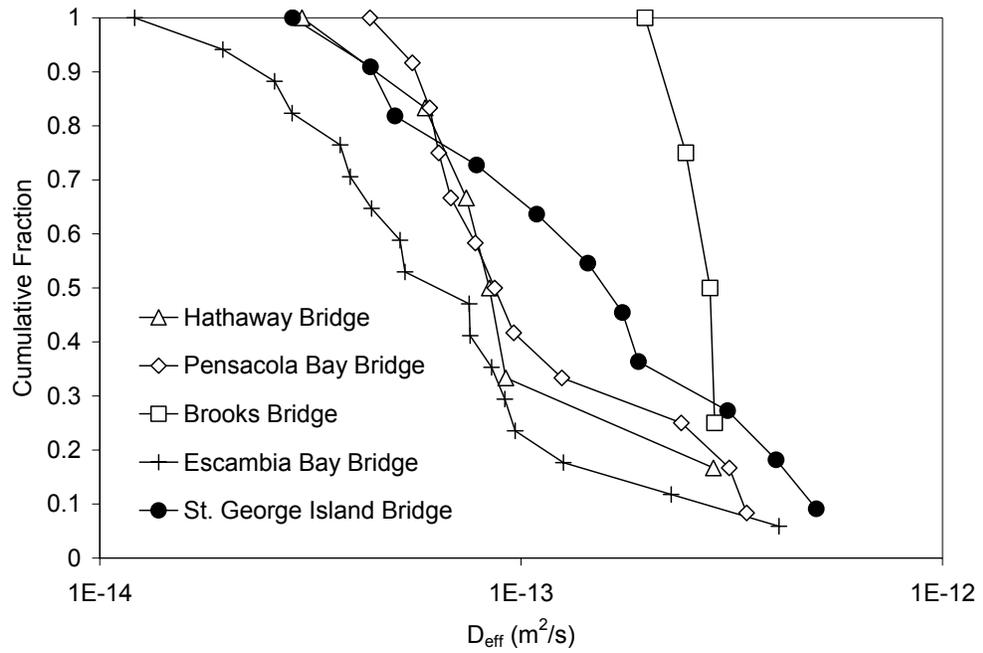
The most notable feature of the chloride concentration data from piles in service in all four bridges was the very low resulting values of the apparent chloride ion diffusion coefficient. Figure 4.24 shows cumulative distributions of the values obtained for each of the structures assessed as well as for the previous assessment of the Escambia Bay bridges. The overall median value for the four bridges was only $\sim 1 \times 10^{-13}$ m²/s (~ 0.005 in²/y), which is less than the median value recently obtained for the best performing structures built with modern FDOT class V concretes for aggressive marine service, $\sim 4 \times 10^{-13}$ m²/s (0.02 in²/y) [2]. The range of diffusivity values observed in this study are also in the same class as those obtained for cylinder piles at the Escambia Bay bridges [1], underscoring the overall low permeability of the concrete in these components.

Measurement and model uncertainty are inherent to the process of evaluation of the apparent diffusion parameters obtained here [31]. In addition, there is large actual variability of transport parameters with factors such as elevation, as shown below. Consequently, the differences in the diffusivity cumulative distribution curves (Figure 4.24) of the Escambia Bay, Pensacola and

Figure 4.24 Cumulative Fraction of D_{eff} values for cylinder piles in study and Escambia Bay Bridge study [1]

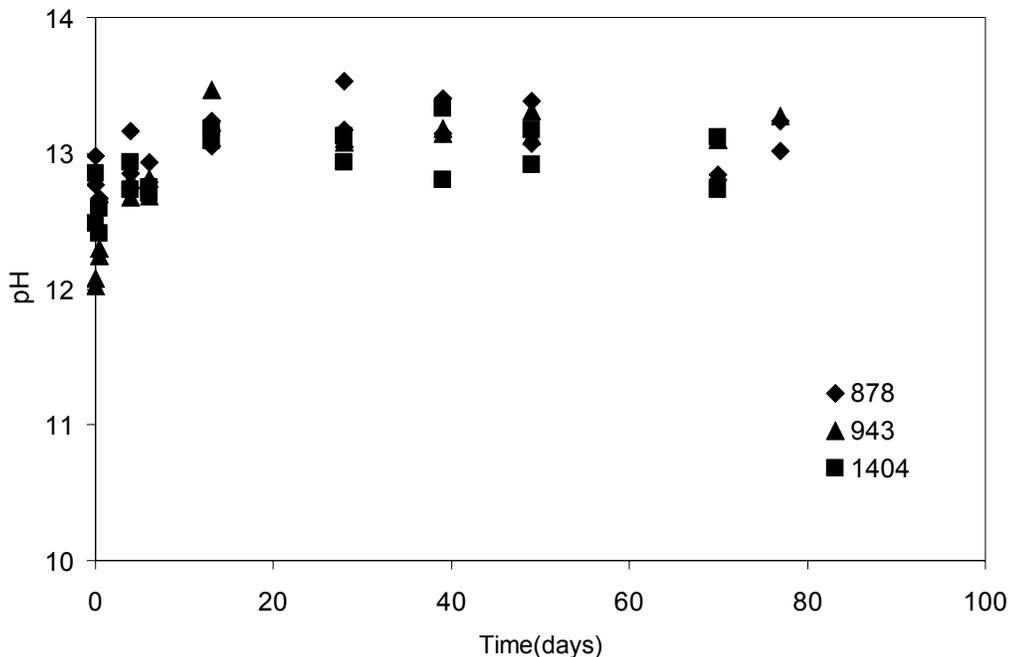
ISL measurements of pore water pH were made for samples of in-service piles from the Hathaway and Pensacola bridges, as well as samples from SGI Bridge pile cutoffs that were not in service. Results are shown in Figures 4.26 and 4.27. Terminal pH values for the SGI Bridge cutoffs ranged from 12.8 to 13.5. Those values are within the commonly observed range for present day concretes [36], so it appears that the pozzolanic additions used in the SGI Bridge concrete formulation did not result in a pronounced pore water pH drop. Some of the samples the older bridges had also terminal pH values of ~ 13, but most of the cores yielded values between 12 and 13 (and in one instance as low as ~ 11). Experimental artifacts, likely when using small cored specimens of highly impermeable concrete, may account for some of the lowest values observed. The overall modest pH values observed in the older bridge samples are nevertheless intriguing, considering that these older piles were expected to be made using unblended cement, and that pH lowering processes such as carbonation do not penetrate deeply in lower marine substructure elements [18]. It is possible however that the cements used in the older piles had lower alkali content than modern cements. Further assessment of this issue is recommended.

Figure 4.26 Pore water pH of St. George Island Bridge pile cutoffs by ISL technique.
