**CORROSION PERFORMANCE OF
CONCRETE CYLINDER PILES
Contract No. BC353 RPWO#10
Final Report to Florida Department of Transportation**

**A. A. Sagüés
Principal Investigator
Department of Civil and Environmental Engineering**

University of South Florida
Tampa, FL, 33620
February 28, 2005

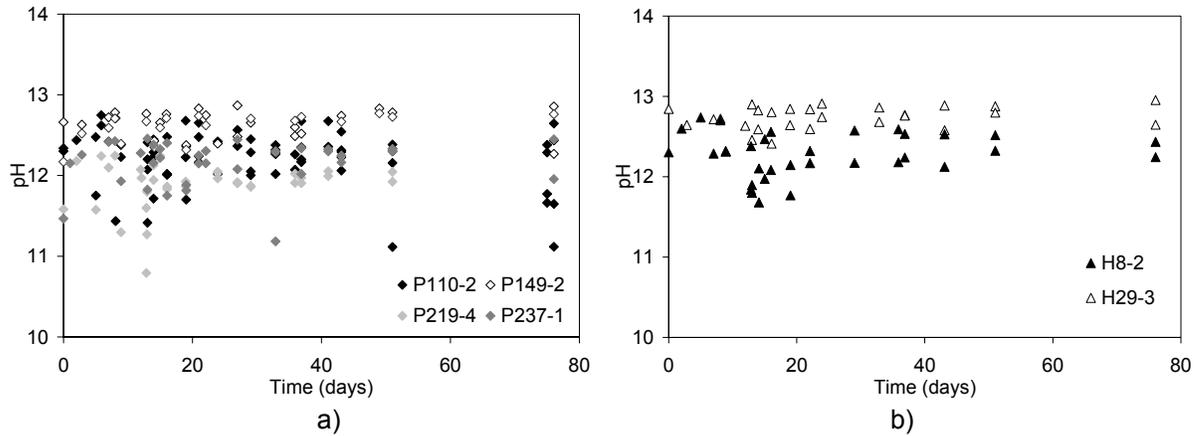
ISL measurements of pore water pH were made for samples of in-service piles from the Hathaway and Pensacola bridges, as well as samples from SGI Bridge pile cutoffs that were not in service. Results are shown in Figures 4.26 and 4.27. Terminal pH values for the SGI Bridge cutoffs ranged from 12.8 to 13.5. Those values are within the commonly observed range for present day concretes [36], so it appears that the pozzolanic additions used in the SGI Bridge concrete formulation did not result in a pronounced pore water pH drop. Some of the samples the older bridges had also terminal pH values of ~ 13, but most of the cores yielded values between 12 and 13 (and in one instance as low as ~ 11). Experimental artifacts, likely when using small cored specimens of highly impermeable concrete, may account for some of the lowest values observed. The overall modest pH values observed in the older bridge samples are nevertheless intriguing, considering that these older piles were expected to be made using unblended cement, and that pH lowering processes such as carbonation do not penetrate deeply in lower marine substructure elements [18]. It is possible however that the cements used in the older piles had lower alkali content than modern cements. Further assessment of this issue is recommended.

Figure 4.27 Pore water pH by ISL technique. a) Pensacola Bay Bridge. b) Hathaway Bridge

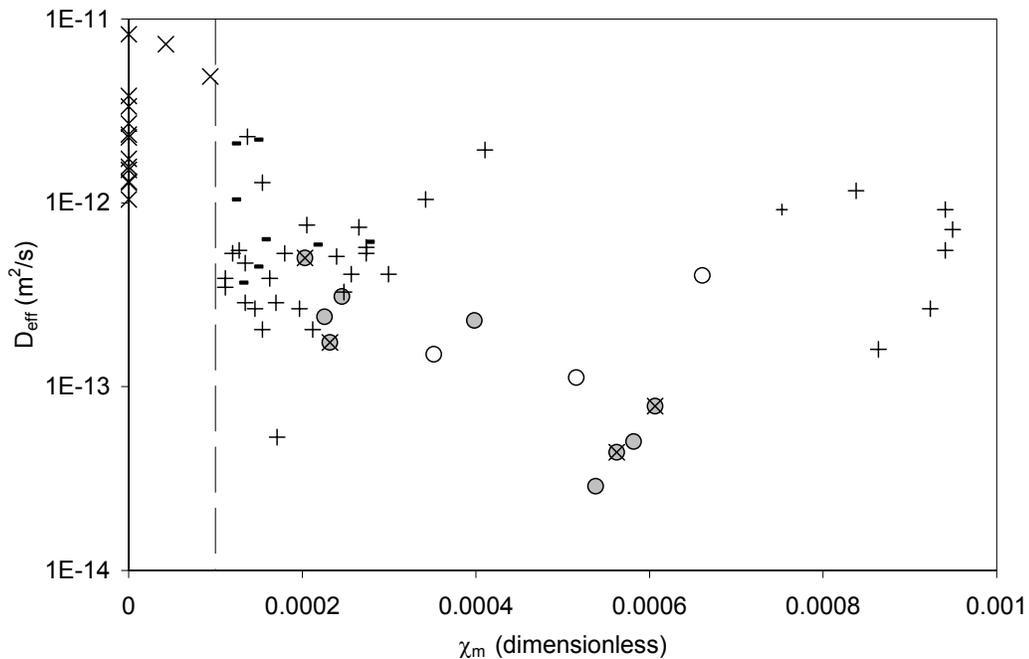
These tests were performed in the SGI Bridge samples as an indirect means to detect presence of fly ash as an admixture, and reveal possible pozzolanic addition shortage in the samples from P-162 which had shown relatively fast chloride penetration. Figure 4.28 shows that the magnetic susceptibility of all the SGI Bridge samples tested (with no clear trend differences between samples from both in-service piles) is of the same order or greater than the typical values encountered for other concretes known to have fly ash addition [2]. Therefore, all the SGI Bridge samples show a positive fly ash indication per this method. In Figure 4.28 the apparent diffusivity measured in the same or in the companion cores is used as a plotting parameter. Interestingly, for the SGI Bridge samples the apparent diffusivity tended to be smaller for the samples with the greatest magnetic susceptibility. However, susceptibility is only qualitatively representative of fly ash content and the observed trend may only be fortuitous.

Figure 4.28 Magnetic susceptibility indication of fly ash presence and apparent chloride ion diffusivity. ● St. George Island Bridge samples. ○ Laboratory ponded samples. ✕ Cracked concrete. + Concrete samples with known fly ash [2]. X Concrete samples without fly ash [2]. – Concrete samples with unknown presence of fly ash [2]. Vertical line represents susceptibility detection limit.

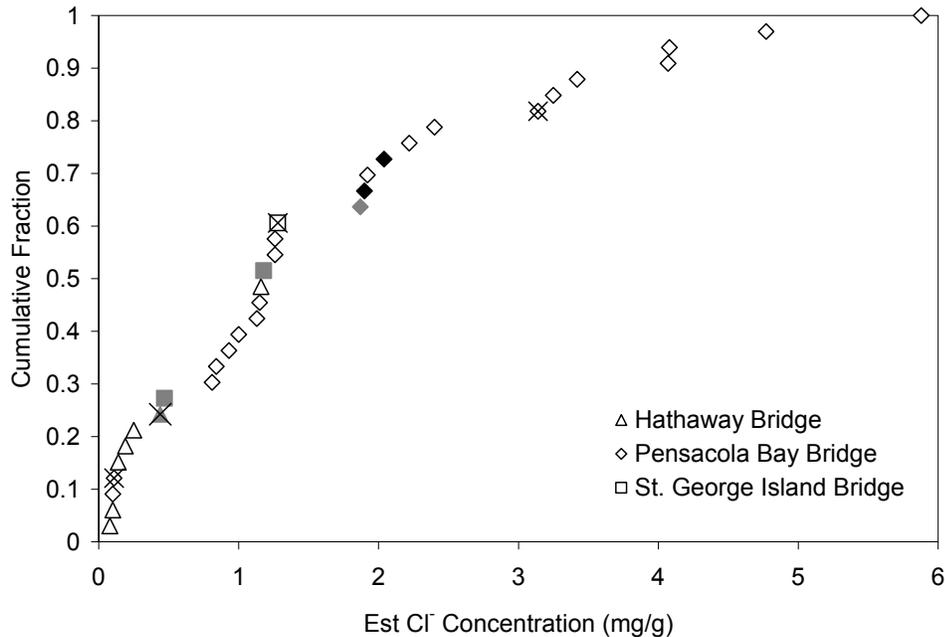
The trend in Figure 5.1 (although affected by large uncertainty from the many assumptions made) suggests that no corrosion initiation took place at concentrations below ~ 0.5 mg/g (or ~ 2 pcy (~ 1.2 kg/m³) for typical 4000 pcy (2400 kg/m³) concrete), and that in many instances the chloride content was higher and not even incipient signs of corrosion took place. Thus a value of 0.5 mg/g may be suggested as a conservative lower bound for the critical chloride threshold of reinforcing steel in these piles, recognizing that the actual effective threshold value (or range of values⁵) is likely to be significantly greater. It is worthwhile noting that corrosion thresholds reported in the literature for steel in conventional concrete but with high cement content similar to that present in the circular piles are in the order of ~ 1 mg/g [40]. Factors such as better concrete compaction in the cylinder piles may result in higher threshold values compared with that in conventional cast concrete.

The trend in Figure 5.1 suggests that corrosion initiation was just beginning to affect a small fraction of the pile inventory in these bridges at the

Figure 5.1 Cumulative fraction of estimated chloride concentration at steel depth determined for locations where spiral or spacing bar steel was exposed by coring in the Hathaway, Pensacola, and Brooks bridges. See Table A3, Appendix III for details and assumptions. Solid symbols- SC. Grey symbols- LC. Open symbols- NC. X- core drilled on crack.

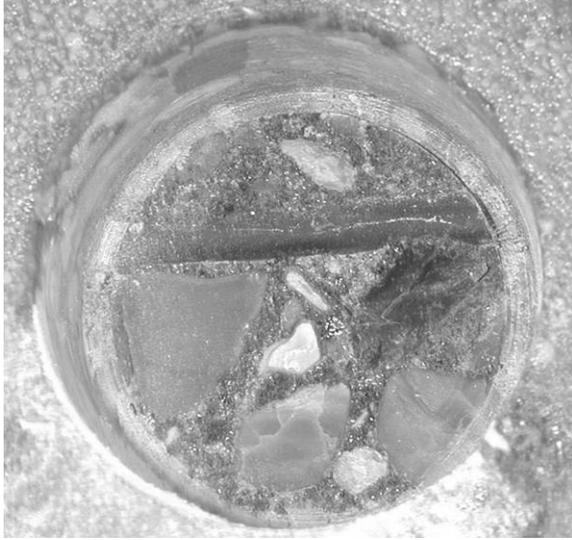
Figure A4 Examples of corrosion ratings. a) Example of spiral wire with No Corrosion (NC) rating. Hathaway Bridge, bottom of core hole, Pile H29-3. b) Example of spiral wire with Light Corrosion (LC) rating. Arrow indicates spot showing minor rust discoloration. Pensacola Bay Bridge, bottom of core hole, Pile P110-2. c) Example of severe corrosion (SC) of $\frac{1}{4}$ in (0.64 cm) diameter spiral wire from Pensacola Bay Bridge (P149-2) showing appreciable localized loss of cross section at the right end of the wire segment cut out by coring.
