Final Report

June 2006

UF Project No. 00051711  
Contract No. BD545, RPWO #27

## ST. GEORGE ISLAND BRIDGE PILE TESTING

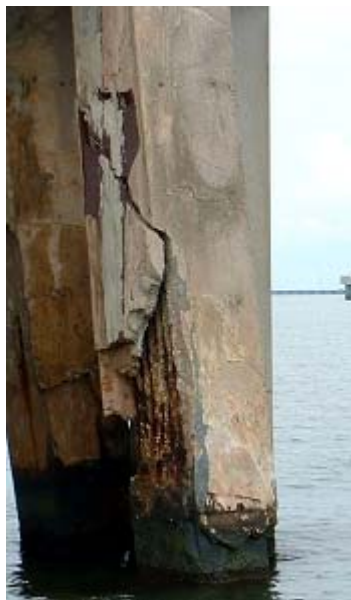
Figure 1 – Corrosion Damaged Pile

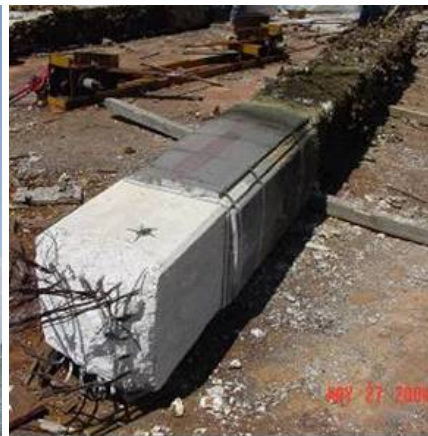
There was concern that the results of the structural testing would be adversely effected by the damage caused during pile removal. The cutting process, however, affected a relatively isolated area near the pile ends. Cracking and spalling of the concrete usually extended into the pile no more than 20-in. (Figure 5e).

Figure 5 – (a) Prestressed pile bents after cap removal; (b) Pile “beaver” used to cut the piles at the mud line; (c) Pile being lifted from the water after being cut; (d) Pile Recovery; (e) pile immediately after recovery. Note damage at end of pile from cutting.

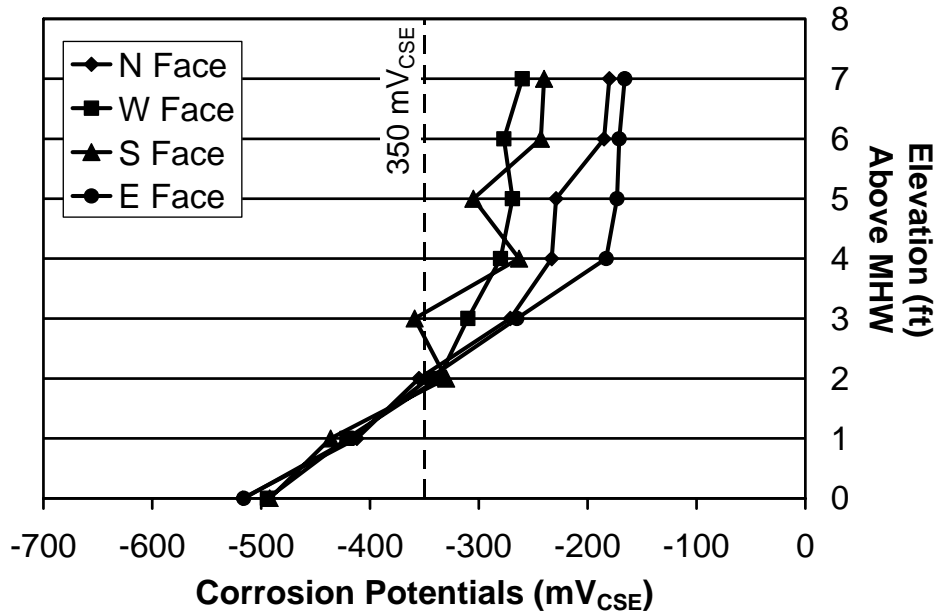
The  $-350\text{mV}_{\text{CSE}}$  demarcation on the plots provides an elevation below which corrosion activity was likely. Piles 39-2 and 40-3J have potentials more negative than  $-350\text{mV}_{\text{CSE}}$  over most of the seven feet above MHW. Piles 40-4, 29-2, and 44-2 have potentials less negative than  $-350\text{mV}_{\text{CSE}}$  over the height where measurements were taken, while pile 32-3J is split nearly evenly. These results will be related to the flexural capacities later in this report.

(a) Corrosion potentials at various heights of Pile 29-2

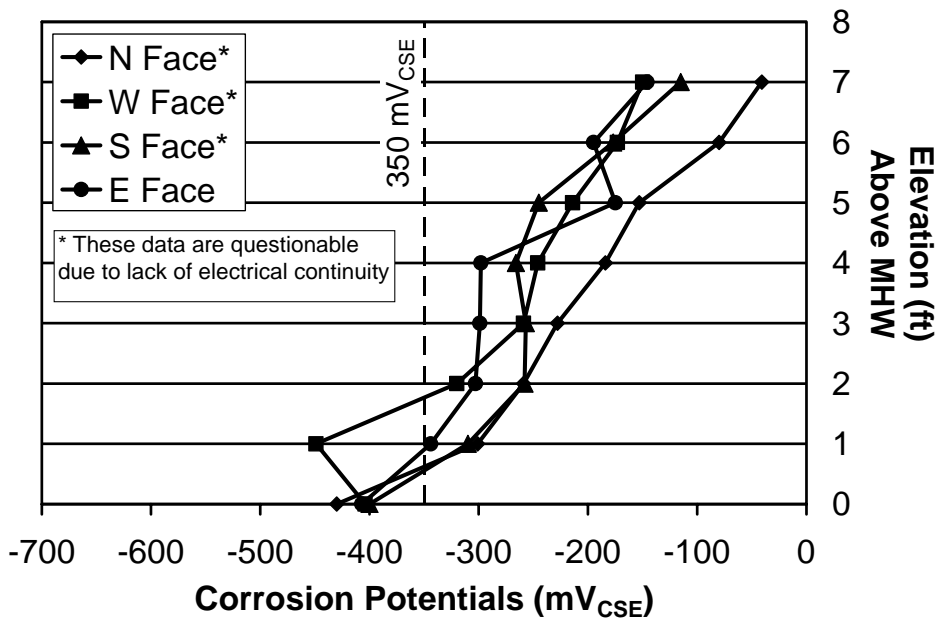
continuity of the strands was checked against the strand used for the ground. Some of the noted data from piles 44-2, 32-3J, 40-3J were questionable due to lack of continuity.

(b) Corrosion potentials at various heights of Pile 44-2

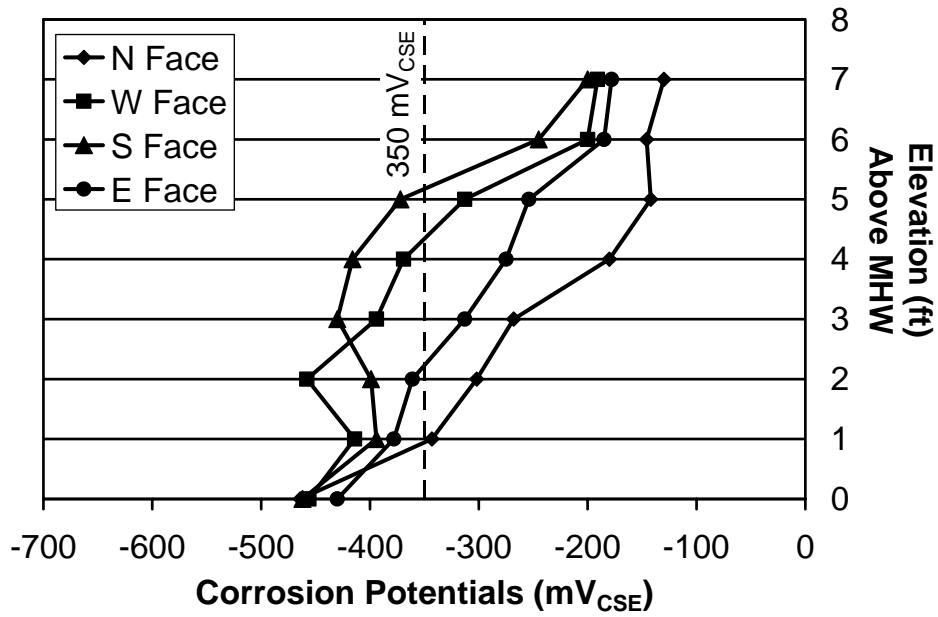
(c) Corrosion potentials at various heights of Pile 39-2

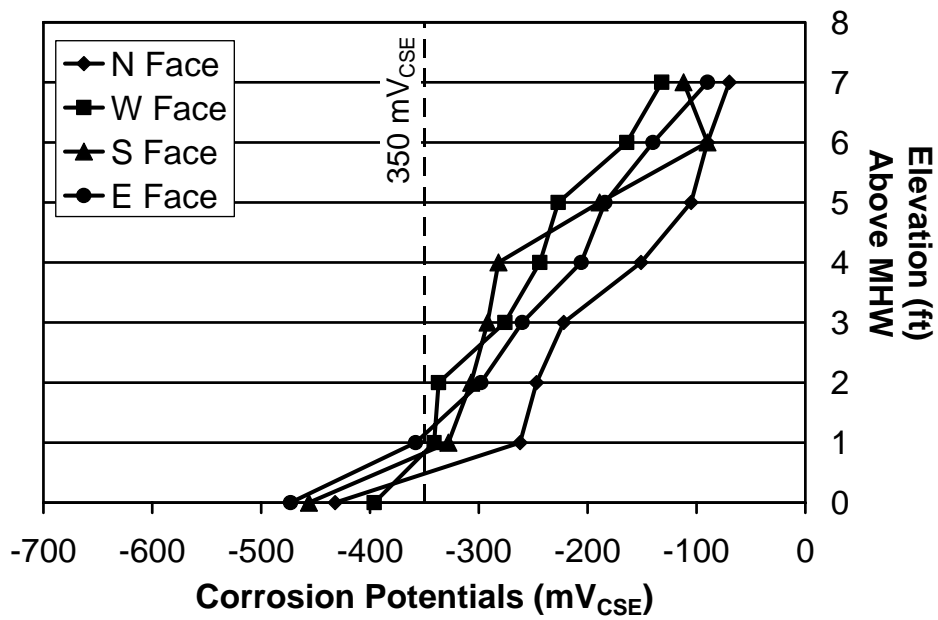
(d) Corrosion potentials at various heights of Pile 40-4

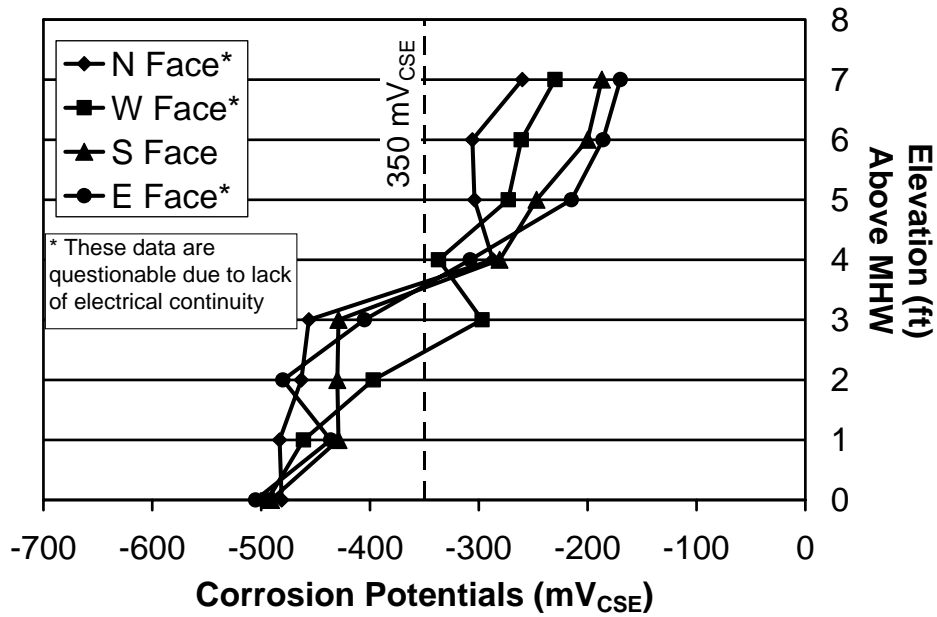
(e) Corrosion potentials at various heights of Pile 32-3J

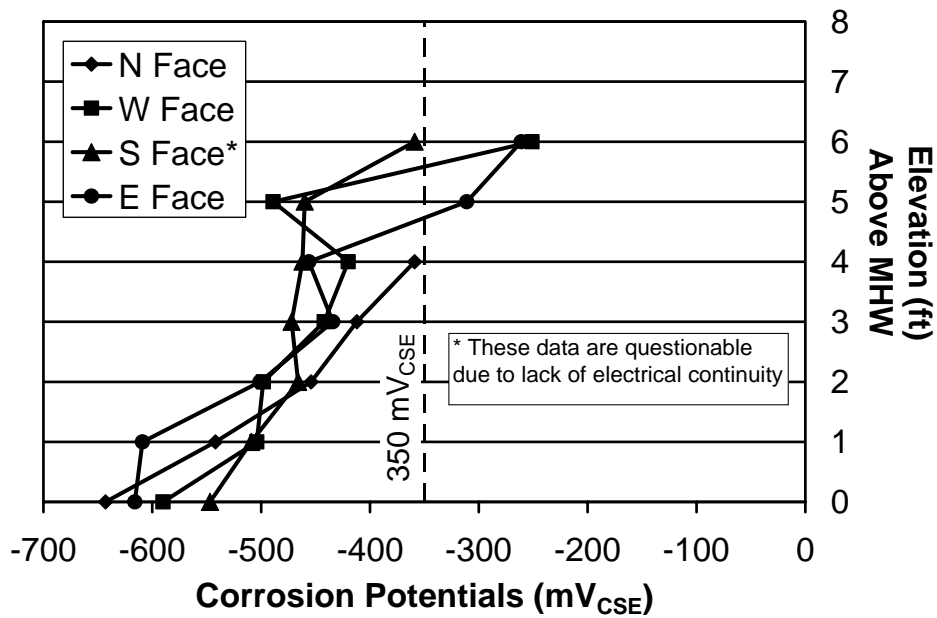
(f) Corrosion potentials at various heights of Pile 40-3J

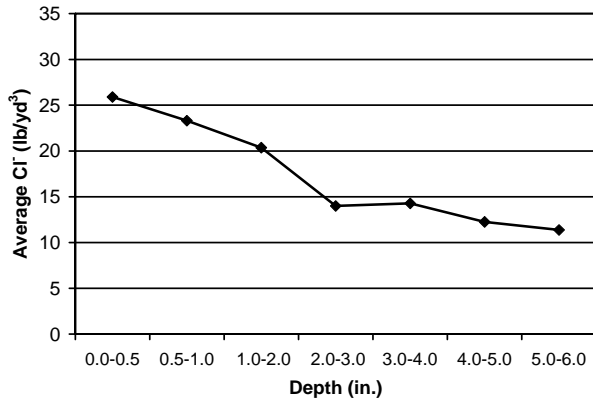
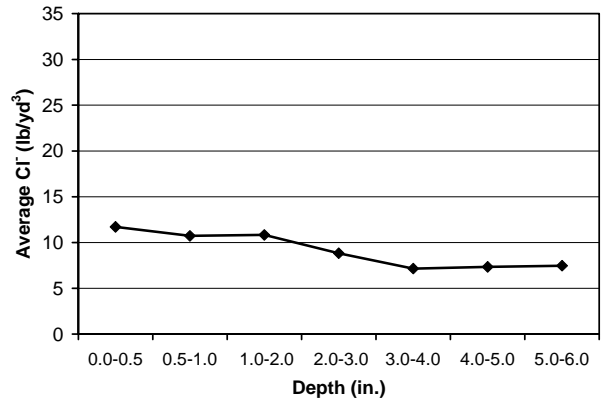
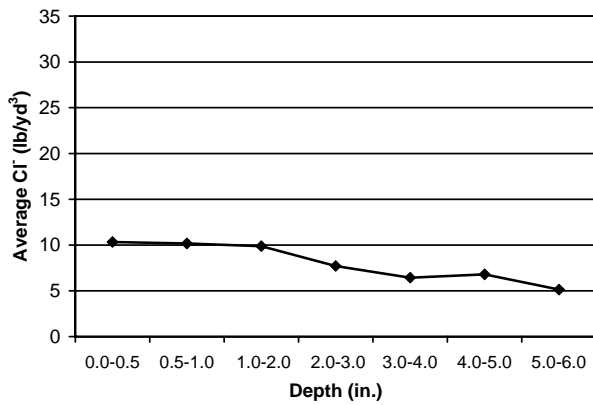
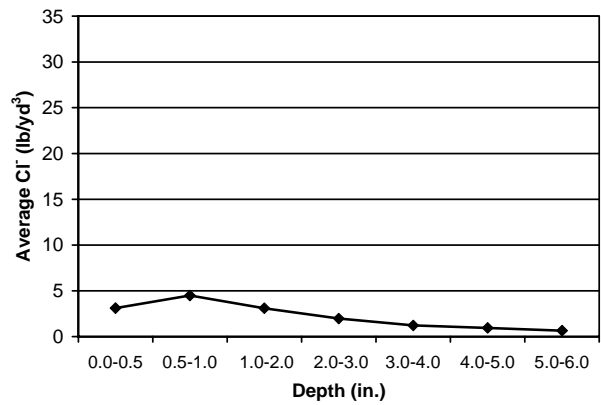
Figure 8 – Chloride content, Pile 32-3J

The chloride profiles show that the greatest contamination occurs in the submerged portion of the pile where the concrete is continuously exposed to the salt water. The location of next greatest contamination is that of the tidal zone where the concrete is repeatedly submerged by the tidal fluctuation, followed by the splash zone and then the dry zone. Corrosion generally occurs in the splash zones due to the combination of chloride contamination and oxygen availability to support the corrosion reactions.

percent. Clearly, the chloride ion concentration in these piles is unsurprisingly high considering the relatively low cement content, lack of pozzolan use, and long-term exposure to a severe environment. Visual inspection of the two piles and subsequent flexural testing, however, indicated that pile 44-2 was in better condition than that of 32-3J, even though the chloride contents were comparable. A jacket was installed on pile 32-3J in 1983, which perhaps contributed to the lower chloride levels at the 2 to 3-in. depth and the better visual rating.

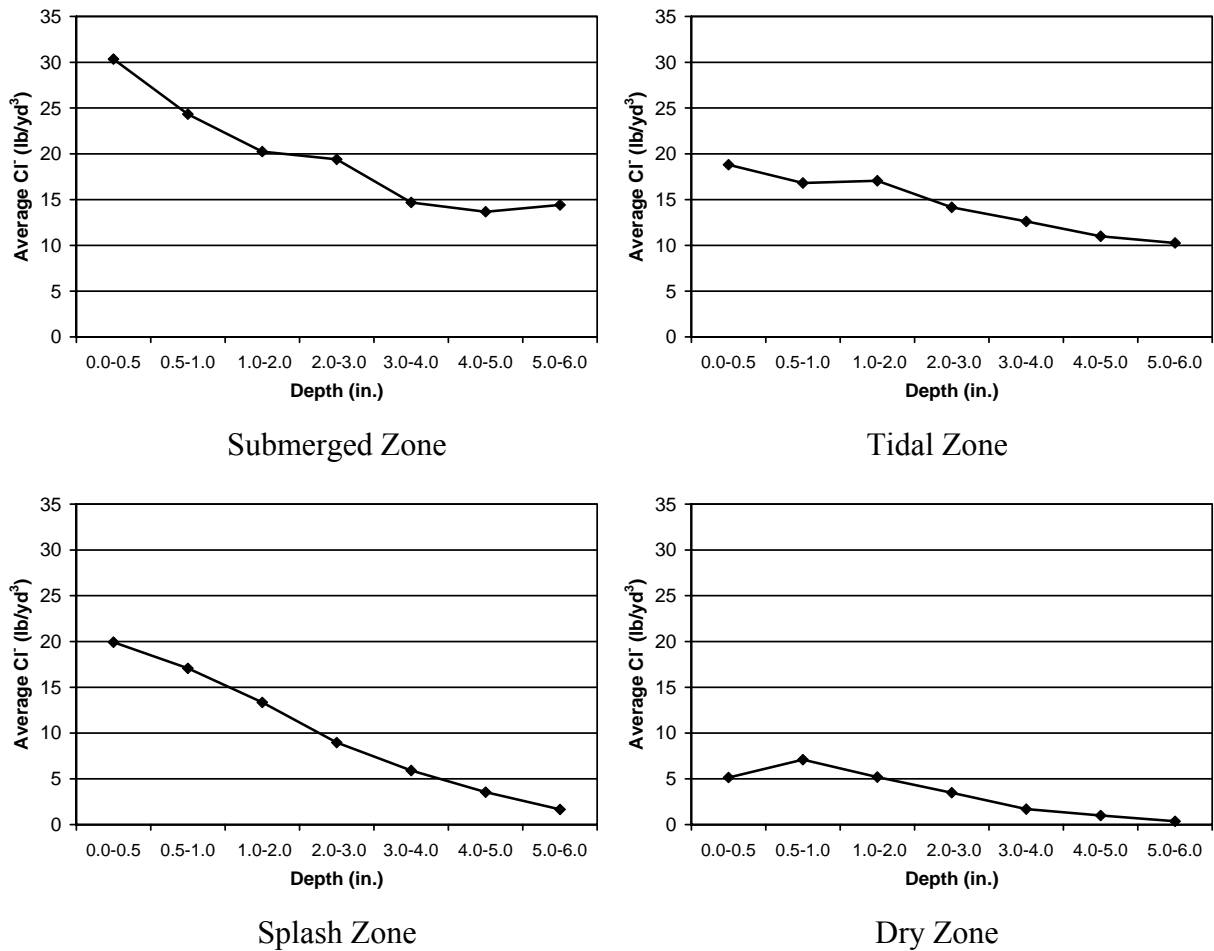
Figure 9 – Chloride content, Pile 44-2

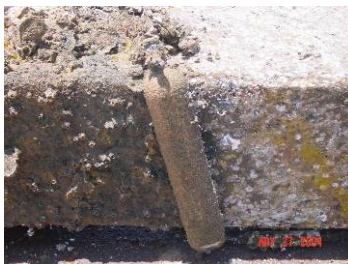
The first pile sampled was 21-4, which was cut and pulled from the bay on May 27, 2004. The pile was placed on the demolition barge to allow samples of the prestressing strand to be taken for hydrogen testing. Although potentials were not taken following extraction of 21-4, inspection of the bulk anode indicated that the anode was still electrically connected to the strand and likely providing protection. The second pile was 44-2, which was sampled at the FDOT Structures Research Center after it had been tested in flexure. This pile did not have a cathodic protection system installed. Accordingly sampling of this pile was intended to provide background data on the dissolved hydrogen.

Figure 10 – Bulk zinc anode on pile 21-4

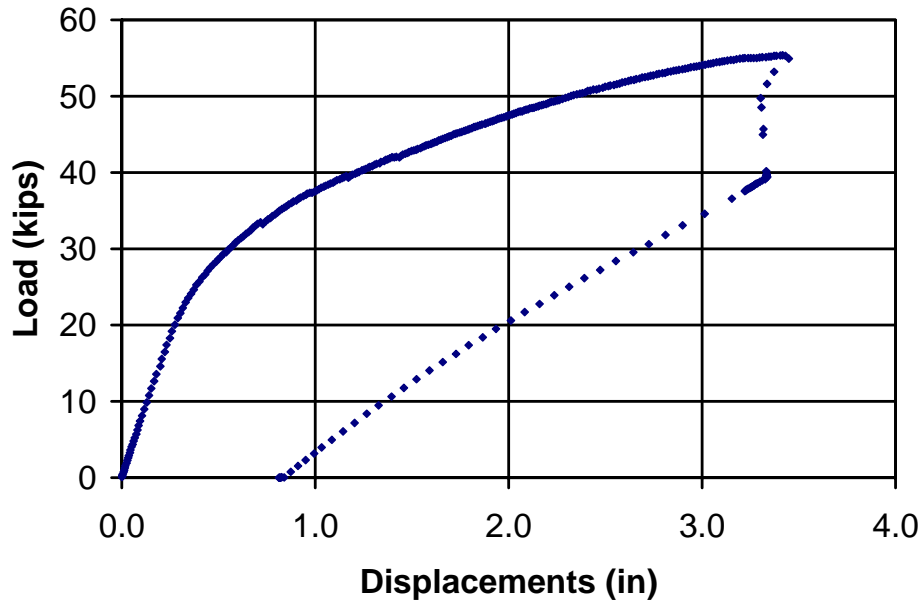
flexural capacity comparable to that measured in the shear test. No strands ruptured during this test as indicated by the smooth and continuous load deflection response.

Figure 23 – Pile 40-4 load displacement response

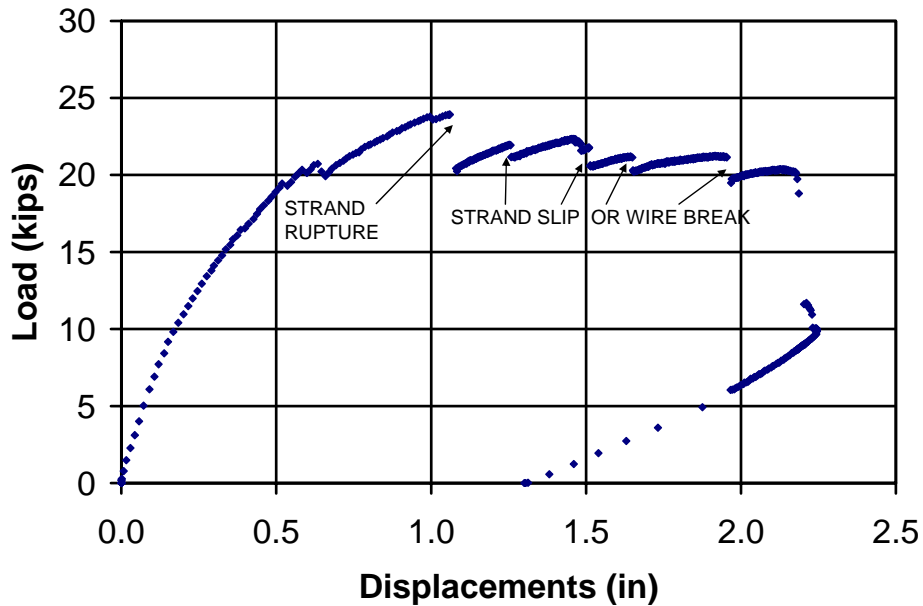
In many of the tests, the pile capacity was controlled by strand rupture or slip or both. Figure 24 shows the load-displacement behavior for pile 32-3J. Denoted on the plot are the locations where drops in load corresponded to audible sounds video-recorded during testing. These sounds are attributed to either strand rupture or slip since they are associated with a sharp reduction of load. Video recordings of each test were reviewed to determine the number of breaks or slips noted in each test. These are presented along with the failure mode in Table 13.

Figure 24 – Pile 32-3J load-displacement response

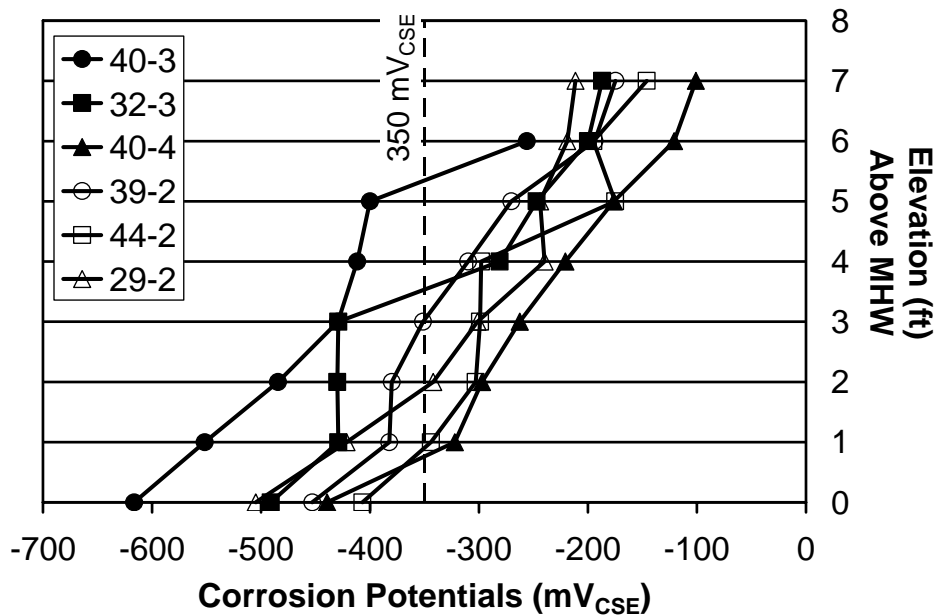
elevation including only those data in which electrical continuity of the ground connection was confirmed. The plot clearly indicates that some of the piles have very negative potentials over most of their height. Pile 40-3J, for example, has readings more negative than -350 mV up to nearly 6 ft. above MHW. This pile retained only 31% of its calculated capacity. Conversely, pile 44-2 has only one reading more negative than -350mV near the MHW line and retained more than 100% of its calculated capacity. As the length of pile in the splash zone that has very negative readings increases it appears that the flexural capacity decreases.

Figure 25 – Compilation of the average corrosion potential of the tested piles.

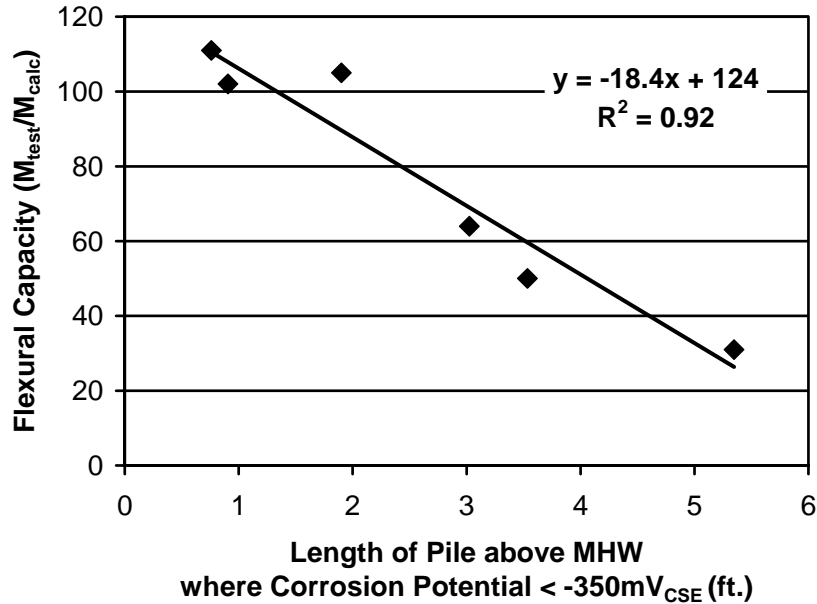
Figure 26 illustrates this trend. The normalized moment capacities are shown on the vertical axis and the horizontal axis shows the length of pile above the mean high water over which the measured corrosion potentials are less than -350 mV<sub>CSE</sub>. There appears to be a linear relationship between the measured corrosion potential and flexural capacity that is quite strong ( $R^2 = 0.92$ ). Visual inspection of the strand after the flexural test indicated that corrosion was most severe at the base of the splash zone (just above the MHW) and would taper in intensity as the distance from the MHW was increased. Field observations also confirm that the corrosion tends to migrate upward on the pile through the splash zone, which supports the behavior illustrated by the plot. The plot can be summarized as follows. When the average corrosion potential was less than -350 mV<sub>CSE</sub> over an approximate height of:

- 1 ft. above the MHW, then 100% of the pile capacity remained.
- 3 ft. above the MHW, then approximately 68% of the pile capacity remained.
- 5 ft. above the MHW, then approximately 32% of the pile capacity remained.

Figure 26 – Relationship between flexural capacity and corrosion potential

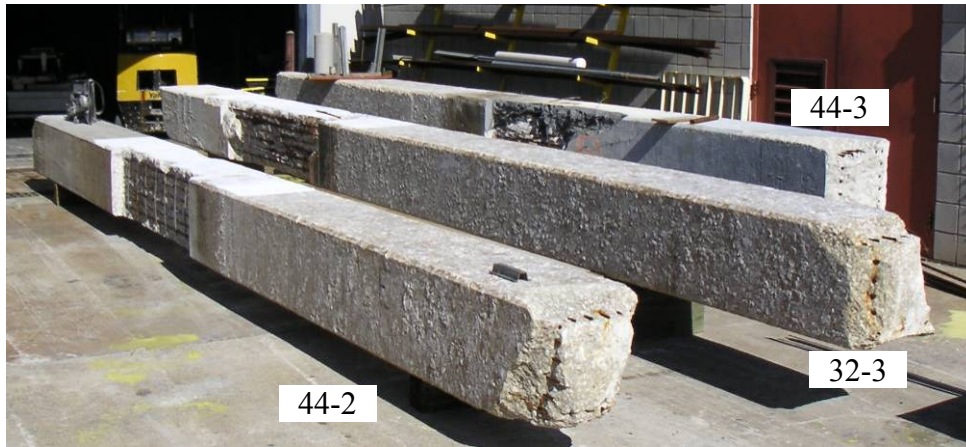
Following flexural testing, piles 44-3CP (cathodically protected), 32-3J (concrete jacket), and 44-2 were excavated to inspect the strands in the splash zone. Figure 27 shows the piles after excavation. Concrete was removed from the face that carried the extreme flexural tension during flexural testing, which was oriented to coincide with the splash zone. Strands were examined for corrosion and wire breaks. Generally, moderate to severe corrosion was noted on the prestressing strands. In some cases the prestressing strands were completely consumed by corrosion as can be seen in the top two strands in Figure 28. Figure 29 shows a range of corrosion. The top two strands are severely corroded while the bottom four strands have corrosion ranging from light to severe as the strands enter the splash zone. The portion of the pile above the splash zone when it was in service is to the left of the figure.

Figure 27 – Piles being excavated to examine corroded strand.

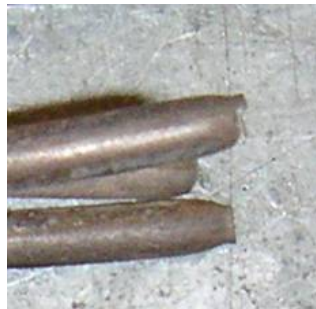
Figure 33 shows the behavior of a severely corroded strand when loaded to rupture. The wires generally ruptured at varying locations along the length of the strand. In contrast, Figure 34 shows the rupture pattern of an uncorroded strand taken from the piles in which the individual wire ruptures occur in very close proximity to each other. Furthermore, each wire exhibits the ductile necking and cup/cone fracture surface.

Figure 34 – Failure mode of uncorroded prestressing strand sample taken from pile 44-2. Ductile necking of the cross section and cup/cone fracture surface are shown.

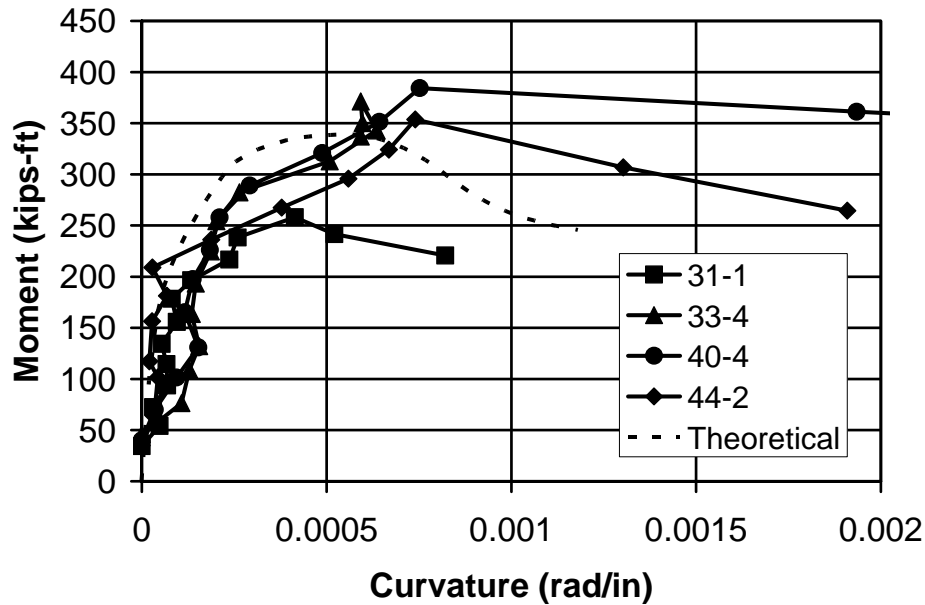
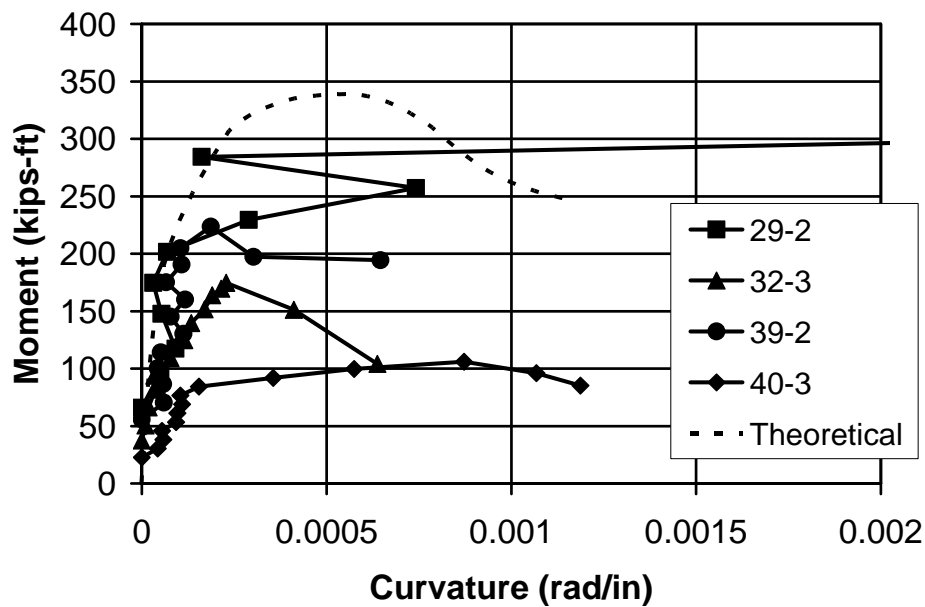
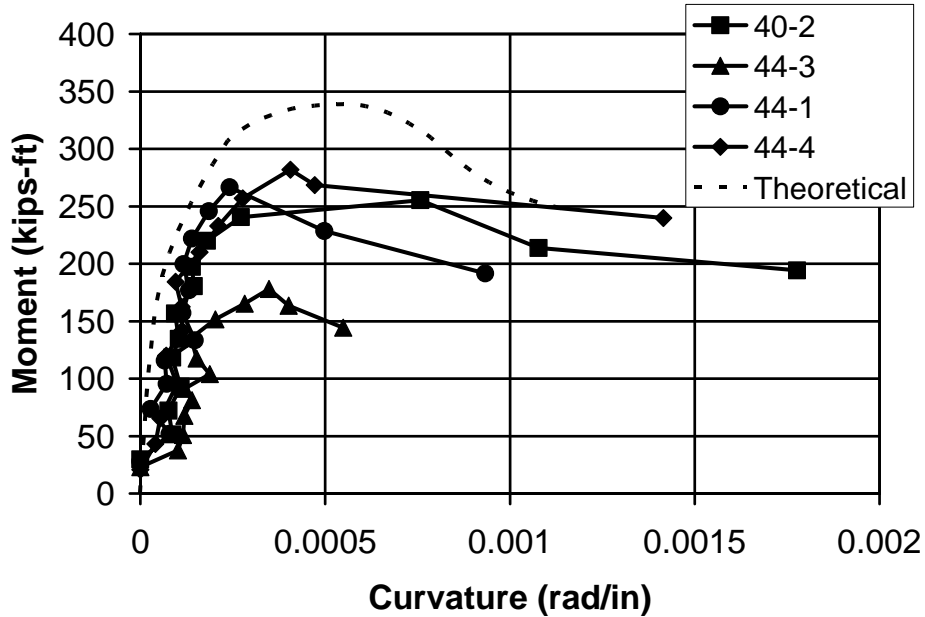
curvatures at or adjacent to that location were used in all other points for a particular pile. Figure 35 shows the results of the moment-curvature analysis. Although this method compounds error and results in somewhat distorted curvature profiles, the results are still insightful. Individual plots are included in Appendix D.

Each plot in Figure 35 also shows a theoretical moment curvature, which was calculated using strain compatibility along with the material properties obtained from tests on concrete cores and prestressing strand coupons pulled from the piles following the structural tests. Table 15 shows the properties used to calculate the moment curvature relationship. The average compressive strength of the two cores taken from pile 31-1 was used along with an average effective depth of 17.19 in. Average mechanical properties of the strands were also used to derive the moment curvature.

Figure 35 – Actual vs. theoretical moment-curvatures

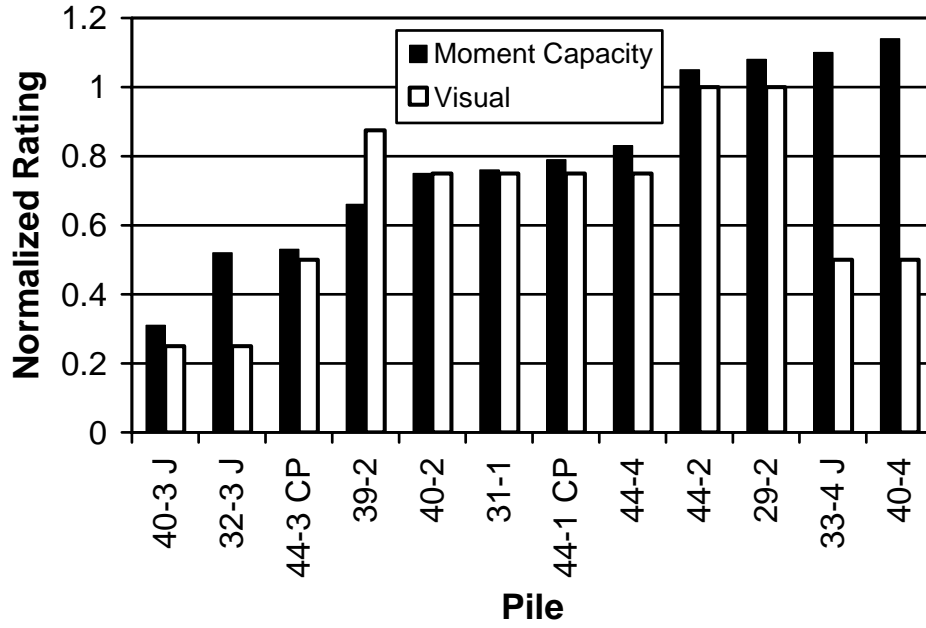
Figure 36 shows the data plotted in order of increasing moment capacity to give a visual impression of the distribution of capacity loss that these piles experienced. Several of the piles retained their full capacity while the most damaged pile lost nearly 70% of its capacity.

Both cathodically protected piles, 44-3CP and 44-1CP, had visual ratings that were comparable to the rated capacity. Based on limited exploratory excavations of the cathodically protected piles it is unclear how much protection was provided to the piles since the system was installed in 1994. The excavations did indicate, however, that on at least one of the piles, the corrosion prior to the installation of the CP system was severe. Based on this observation and that there was little outward signs of continued corrosion, it is likely that most of the corrosion occurred before repair and installation of the cathodic protection system.

Figure 36 – Comparison of visual rating with experimental moment capacities

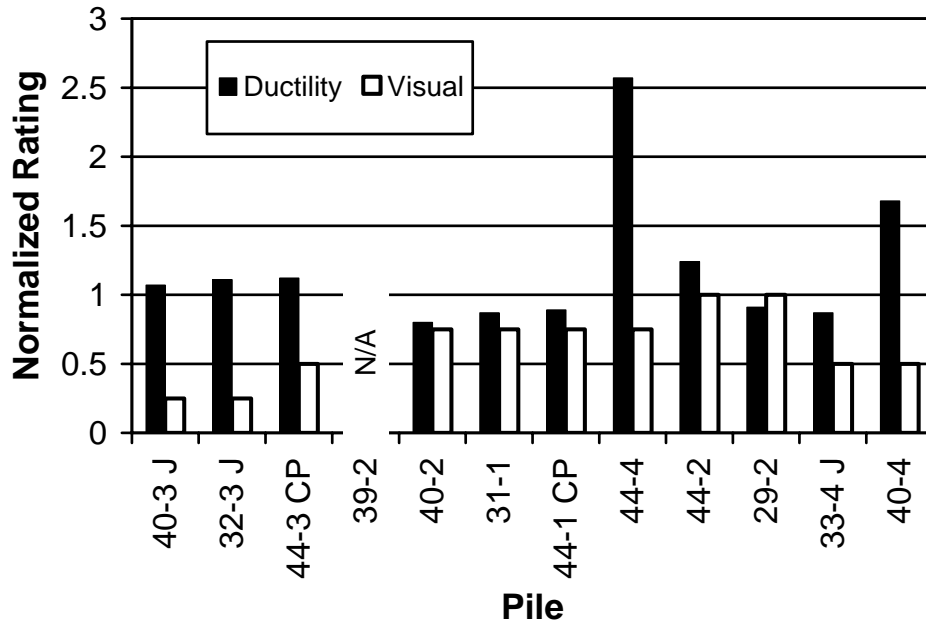
Figure 37 shows a comparison of the visual ratings and the ductility factors calculated from the experimental data. Ductility appears to be relatively constant with the exception of 44-4 and 40-4. Consequently, no clear relationship between visual ratings used in this research and the ductility factors was found.

Figure 37 – Comparison of visual rating with experimental ductility

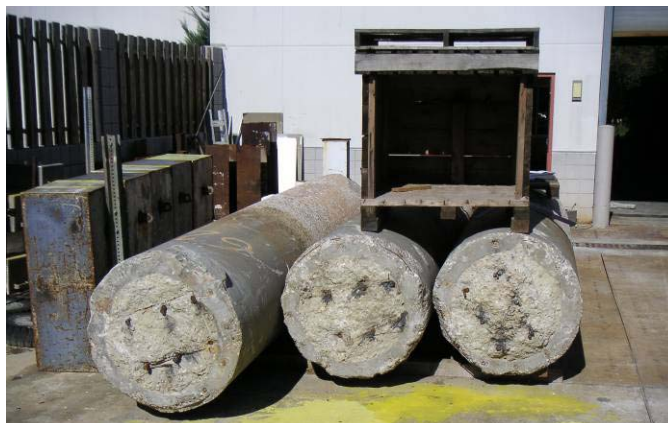
Precast post-tensioned cylinder piles from the Escambia Bay bridge carrying route I-10 were tested to determine flexural capacity. The piles were taken from the piers that were damaged by Hurricane Ivan in 2004. The bridge was constructed in 1964. Figure 38 shows the piles as recovered from the bay. The photo shows the top end of the pile, which has been filled with concrete to connect to the cap beam. The connection was made by six mild steel reinforcing bars. Figure 39 shows the opposite end of the piles. The cylinder piles were approximately 36-in. diameter with a 5-in. thick wall. Twelve post-tensioning tendons were evenly spaced around the perimeter at the mid-thickness of the cylinder wall. Each tendon had 10 0.192-in. diameter parallel prestressing wires surrounded by prestressing grout (Figure 40). The number of wires in the tendons was increased to twelve in the region near the connection to the cap beam. It appears that the tendon passages were cast into the cylinder piles without the use of a conduit.

Figure 38 – Three piles prior to testing, view of filled end of pile.

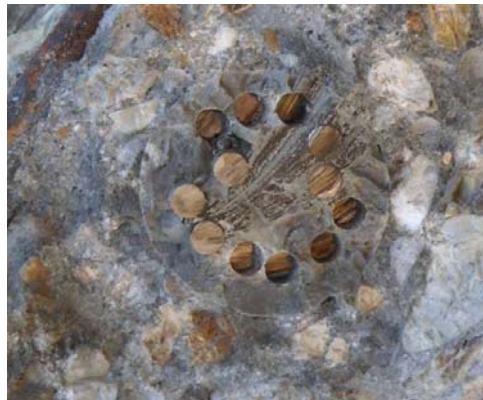
Figure 40 – Prestressing tendon from cylinder pile. Note grout surrounding wire with no evidence of conduit.

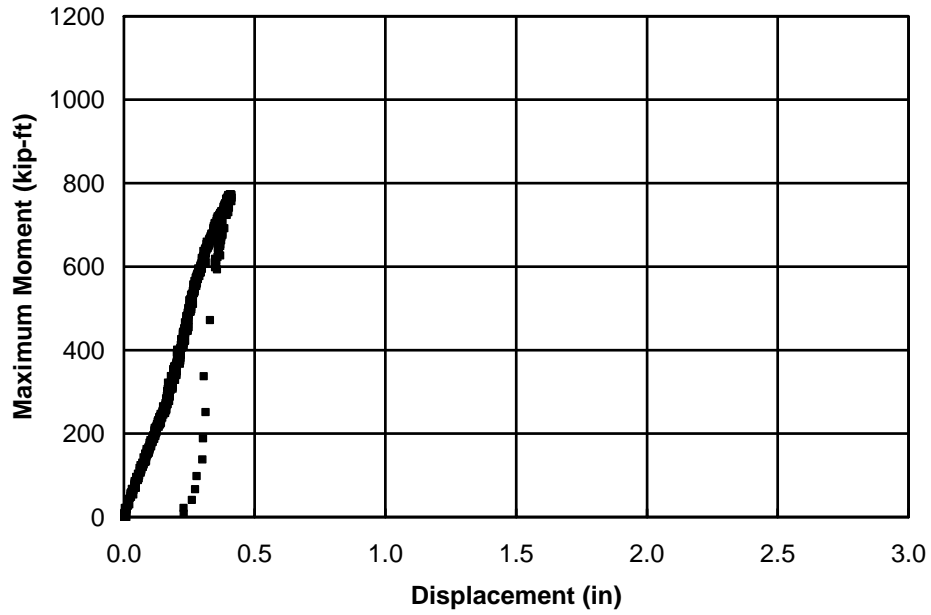
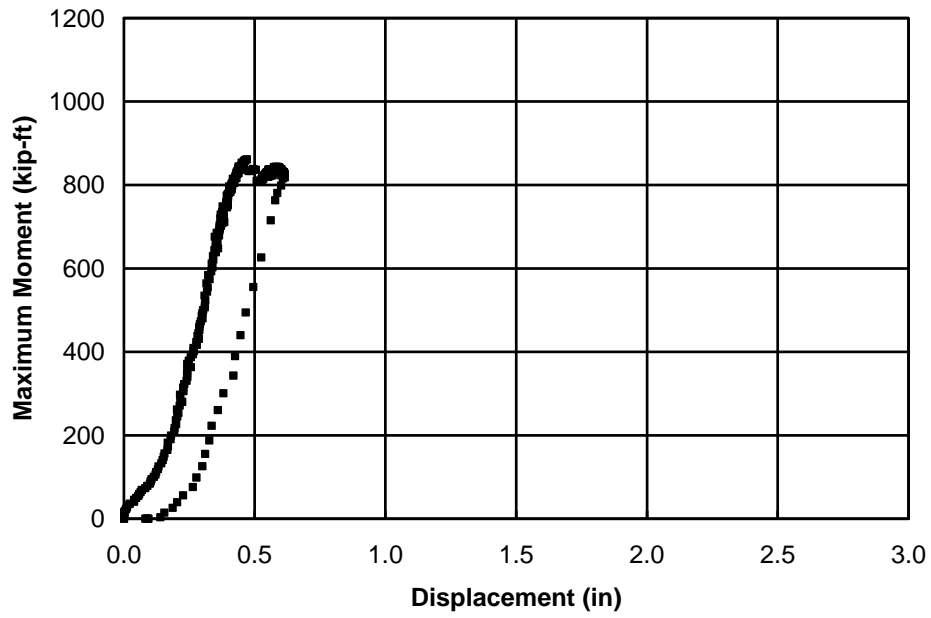
The moment displacement plots are shown in Figure 42 through Figure 44. The plots were generated from the displacement of deflection gage at the outer most point on the cantilever. Movement in the fixture, which contributed to the tip displacement was removed by subtracting the rigid body motion measured by the displacement transducers mounted over the support. Difficulty with the fixture on the first test required that the specimen be unloaded. The second loading then was taken to the pile capacity. Behavior of the three piles was similar in that the wires of the tendons slipped, giving the “saw-tooth” shape to the plots after capacity had been reached. Wires may have also been yielding, but is unconfirmed because they were not instrumented.

Figure 42 – Load deflection response of CP1

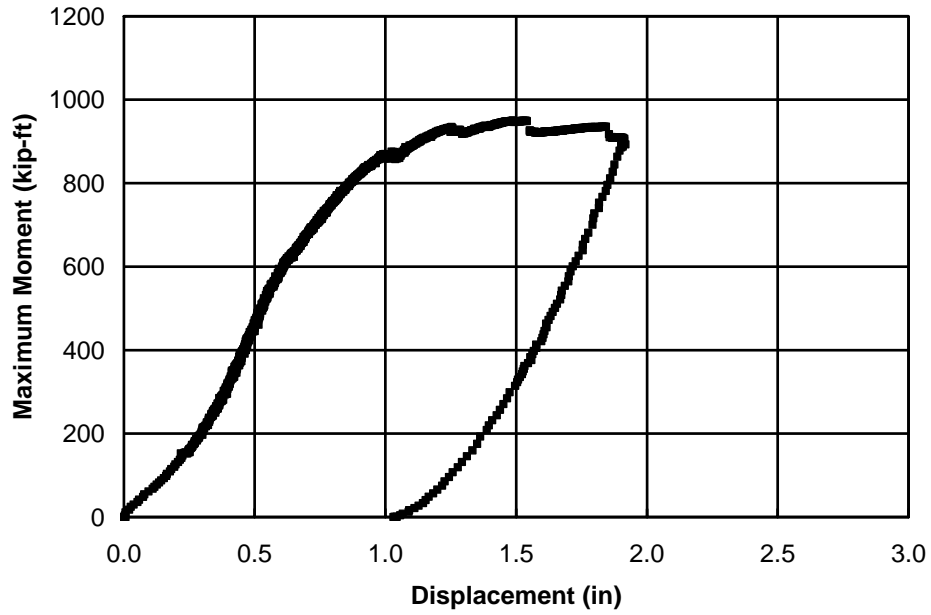
Figure 43 – Load deflection response CP2

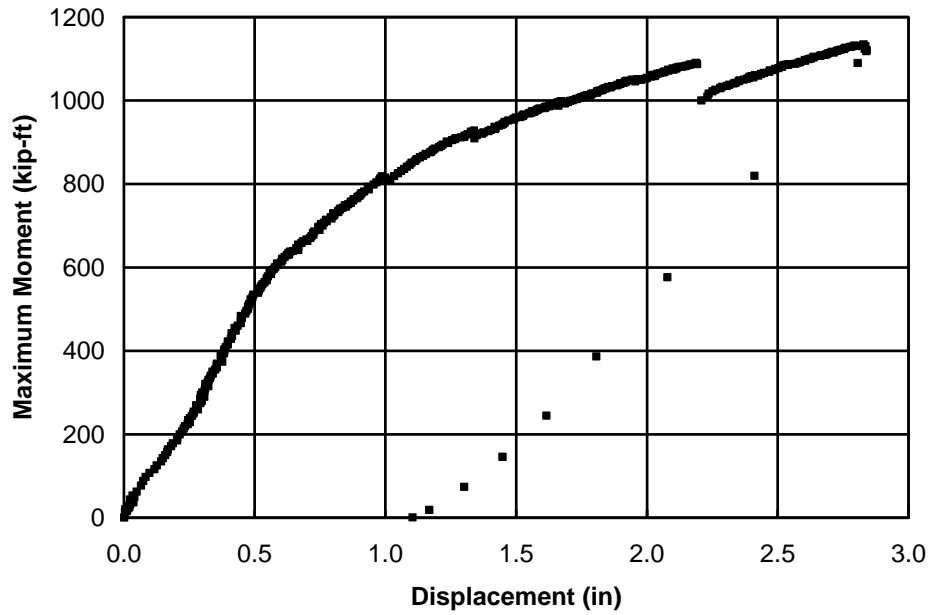
Figure 44 – Pile deflection response CP3

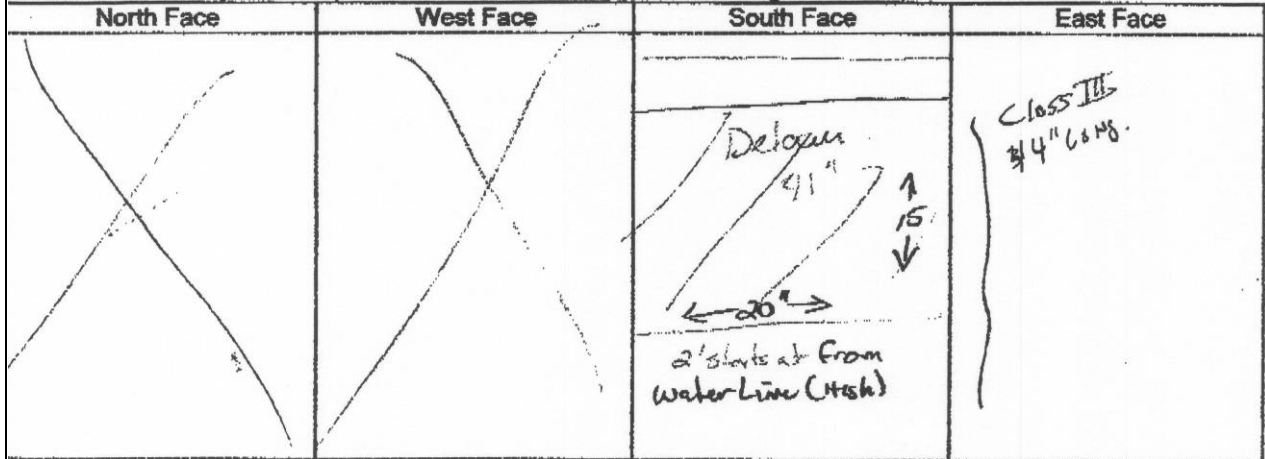
Piling 39-2

NDT Concrete Cover Measurements: 2.5", 2.95", 2.9", 2.65", 3.1", 3.3"  
 Original Cover on Exposed Steel: 2.5"

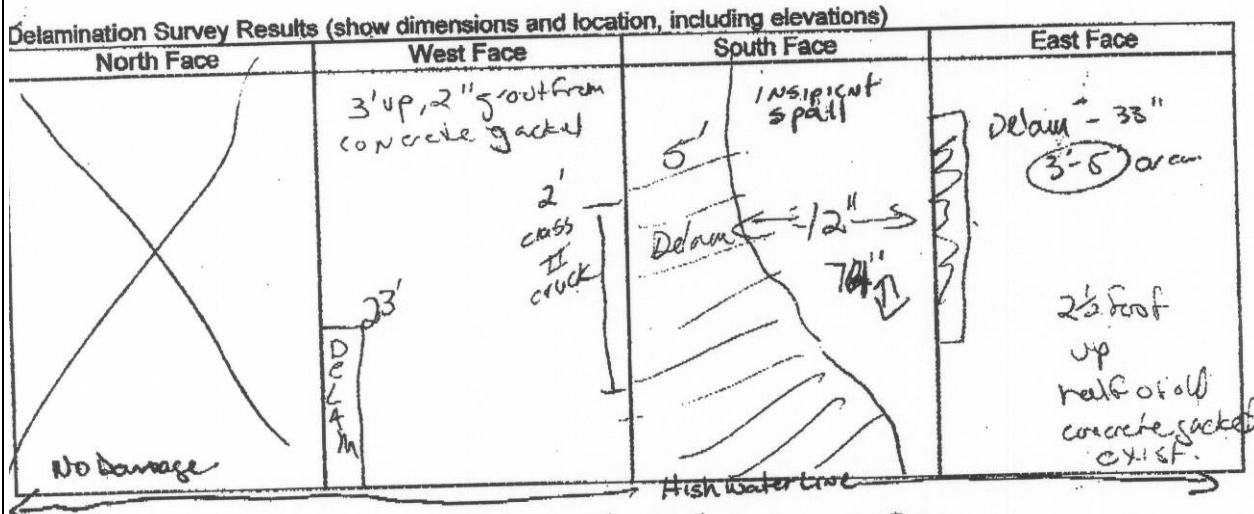
Piling 32-3J

NDT Concrete Cover Measurements: 2.7", 2.9", 2.95", 2.8", 2.5", 3.0"  
 Original Cover on Exposed Steel: 3.0", 3.0", 2.75"

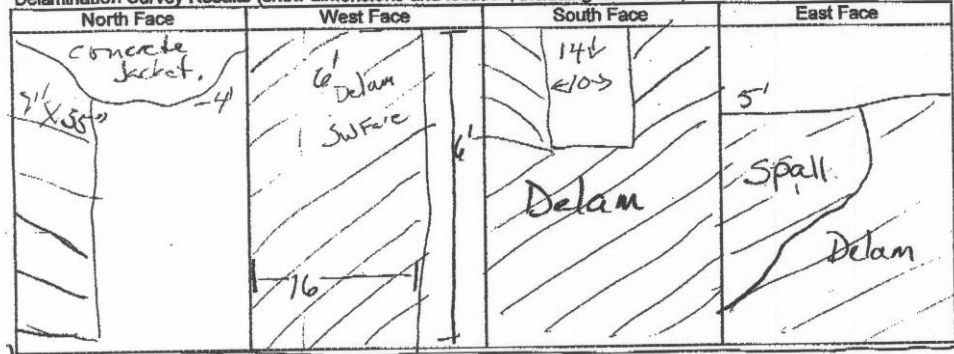
NDT Concrete Cover Measurements: 2.45", 2.5", 2.25", 2.6", 2.7", 2.65"  
 Original Cover on Exposed Steel: 2-7/8", (2-3/4", 3.00") Exposed bars

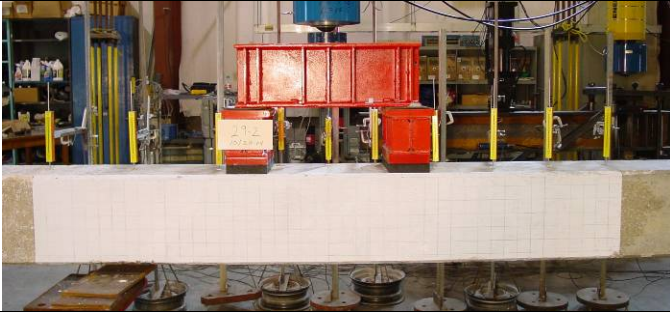
### 29-2

<b>Pre-Test Condition</b>	
Minimal to no damage was visible on this pile.	
<b>Pre-Test Photos</b>

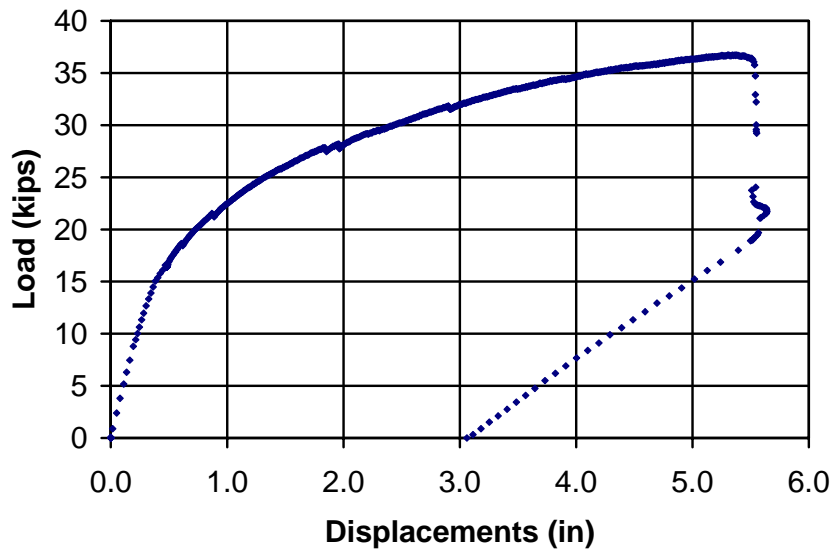
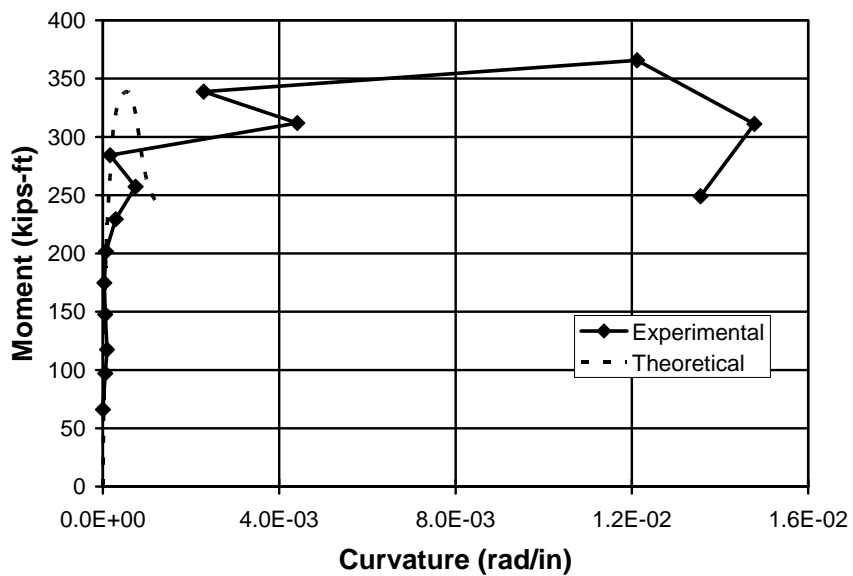
<b>Post-Test Condition</b>	
First crack appeared at 14 kips. Concrete 6 in below the top face of the pile just north of the north load point was crushed severely. Flexural cracks were present after unloading	
<b>Post-Test Photos</b>

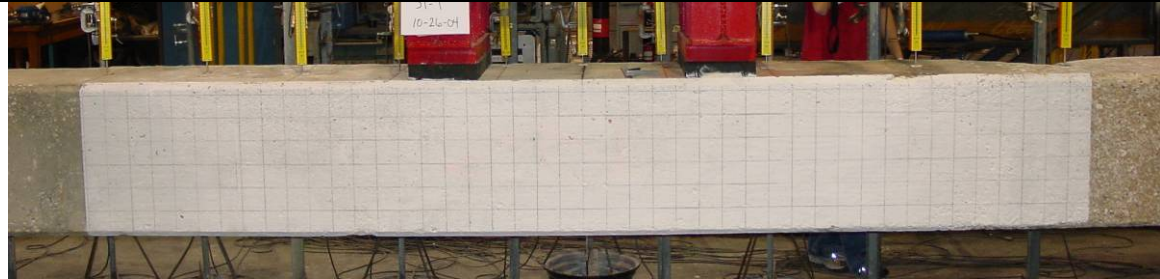
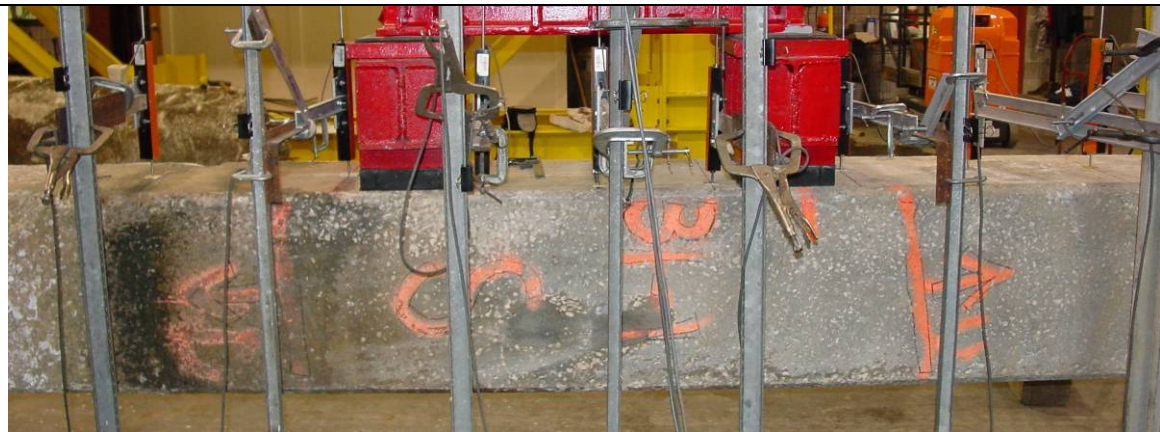
## 31-1

Minimal damage was visible on the pile.

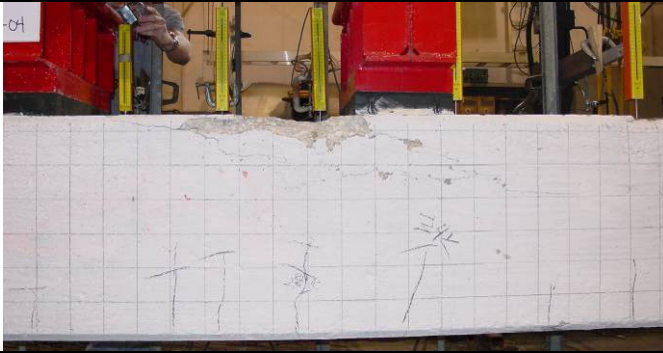
First crack appeared at 28 kips. The compression zone concrete was only slightly crushed. The pile showed compression zone crushing to a limited extent. The flexural cracks mostly closed after unloading.

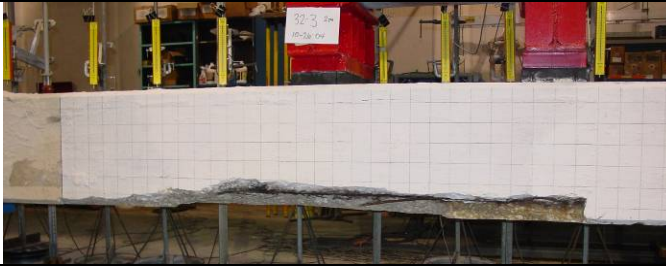
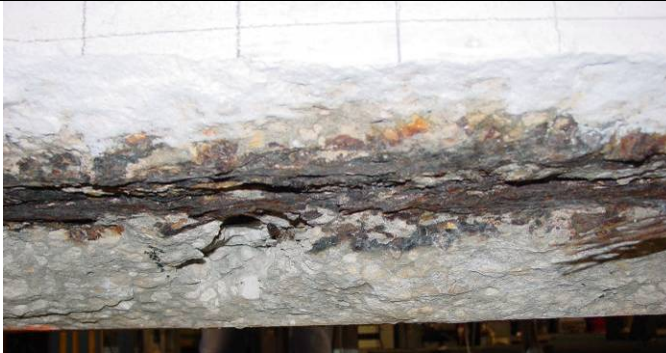
### 32-3J

Severe spalling, corrosion and strand damage were visible. Under the northern load application point, the bottom west corner had spalled off to expose the steel strands which were completely rusted through and had debonded from the concrete.

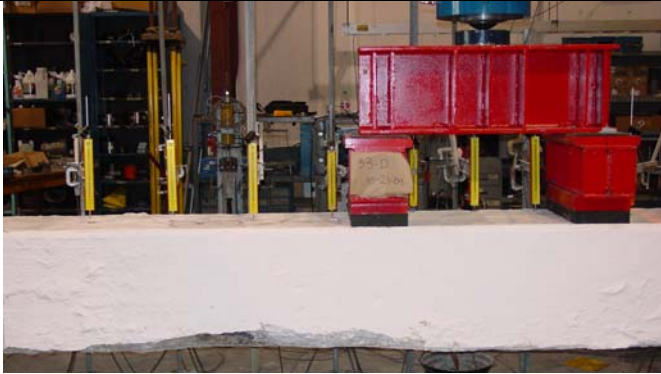
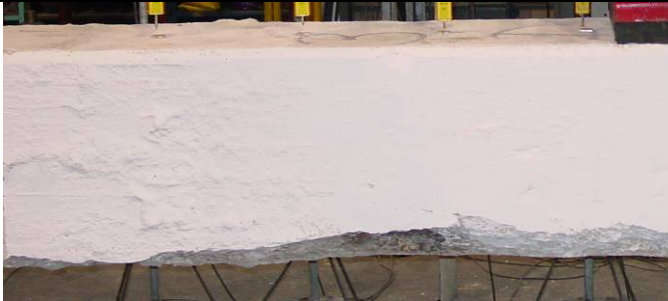
### 33-4J

Concrete had spalled off from the bottom west corner of the cross section under the north loading point. Strands were exposed and rust was visible.
