Final Report

June 2006

UF Project No. 00051711  
Contract No. BD545, RPWO #27

## ST. GEORGE ISLAND BRIDGE PILE TESTING

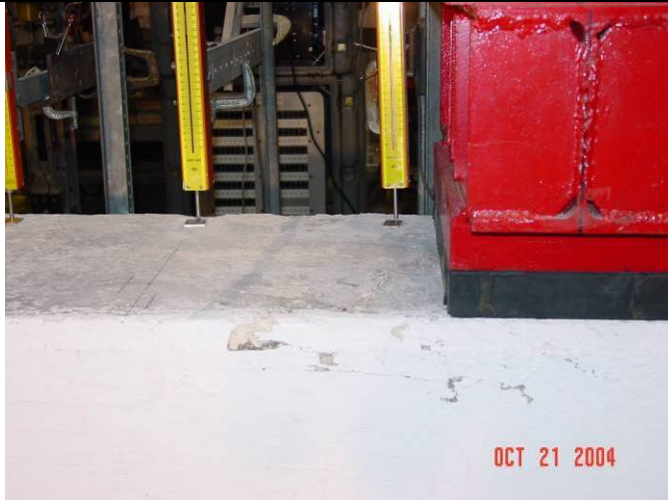
### 33-4J

There were flexural cracks visible on the pile. The concrete in the compression zone was only slightly crushed at the completion of the test.

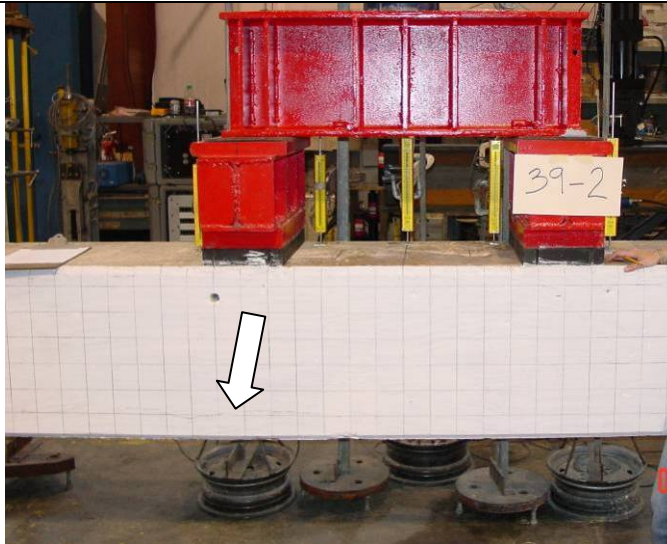
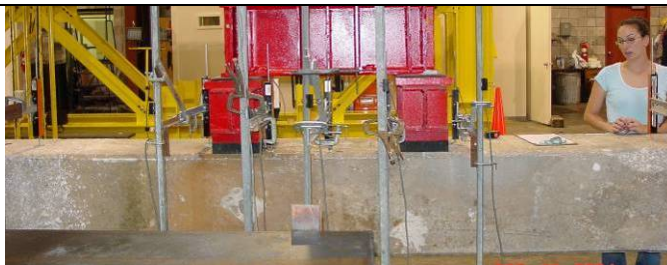
## 39-2

Minimal damage was visible on the majority of the pile. However, one crack was visible at the bottom of the west face of the pile, under the northern load point. The crack was approximately 30" long, running parallel with the bottom layer of steel at approximately 3" from the bottom edge.

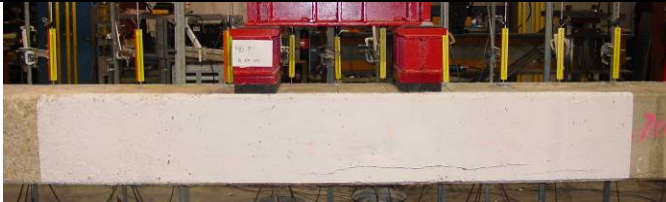
## 40-2

Cracks up to eight feet long were visible at the bottom side of the pile on both east and west faces. The crack was approximately 3" to 4" above the bottom edge of the pile. Rust staining was visible through the crack on the east face of the pile.

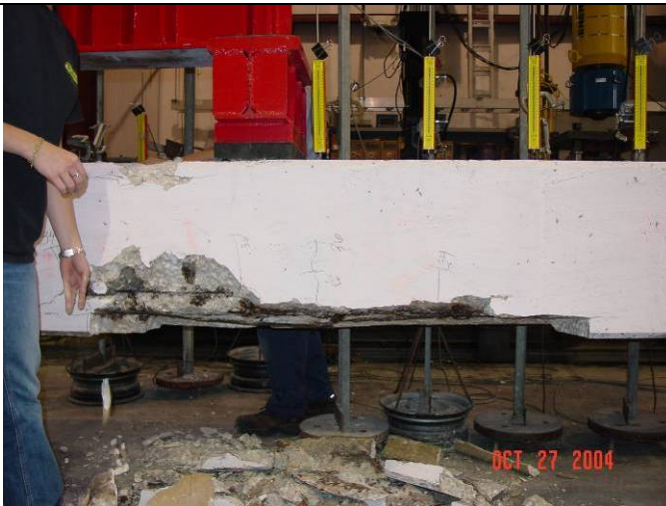
Cracking first appeared on this pile at 15 kips. Many flexural cracks were emanating off of the horizontal crack. Eventually all of the concrete below the horizontal crack fell off. This revealed that all of the strands were severely corroded and all the strands were broken. Crushing of the compression zone occurred between the load points. A dip in the load-deflection plot between 1" and 1.5" deflection may relate to the concrete falling off.

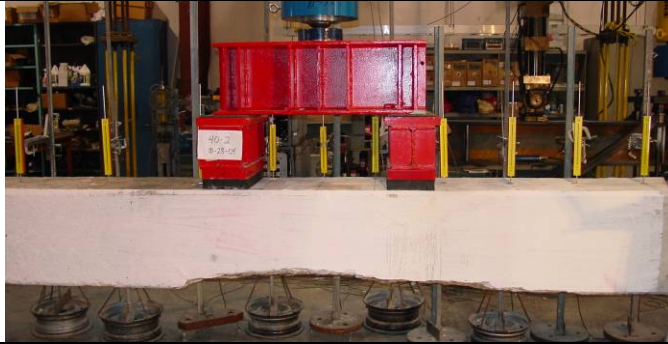
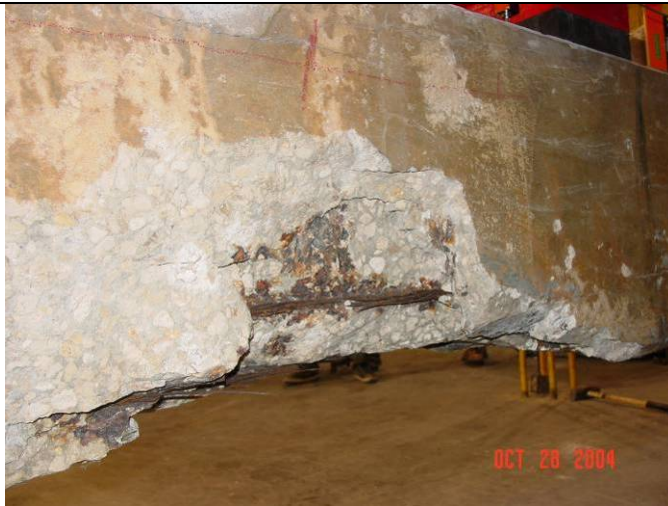
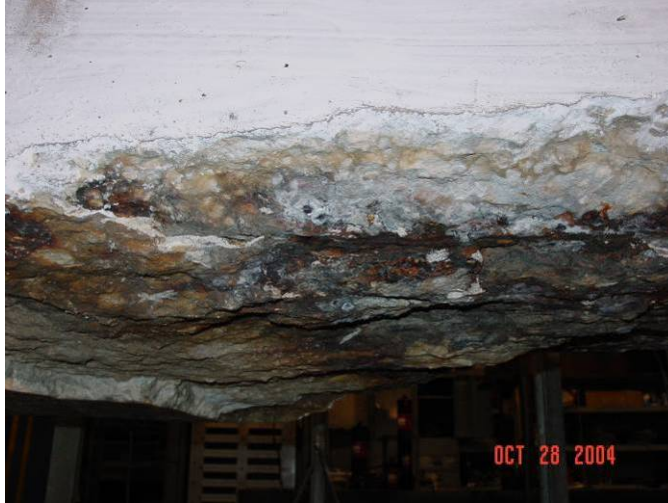
### 40-3J

Severe damage and spalling was evident on this pile. The bottom face of the cross section was missing prior to testing. Each strand on the bottom face of the pile was completely rusted through, had debonded and some were no longer intact. On the east face of the pile, a gap of approximately 12 in. wide and 12 in. high exposed another strand, which was also rusted and had debonded. Spalling and rust staining were extensive.

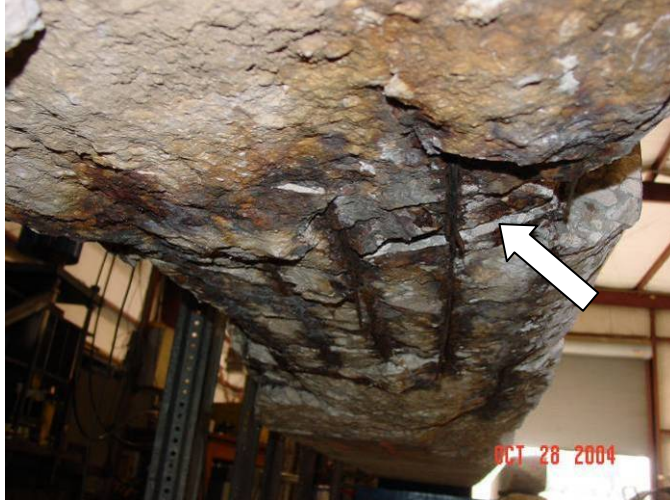
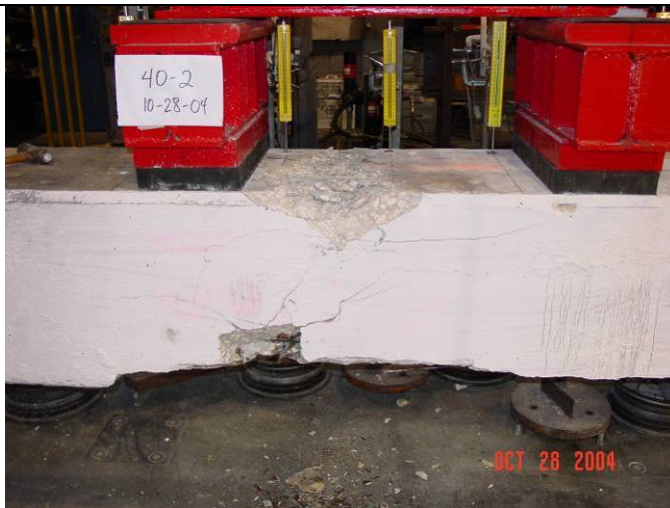
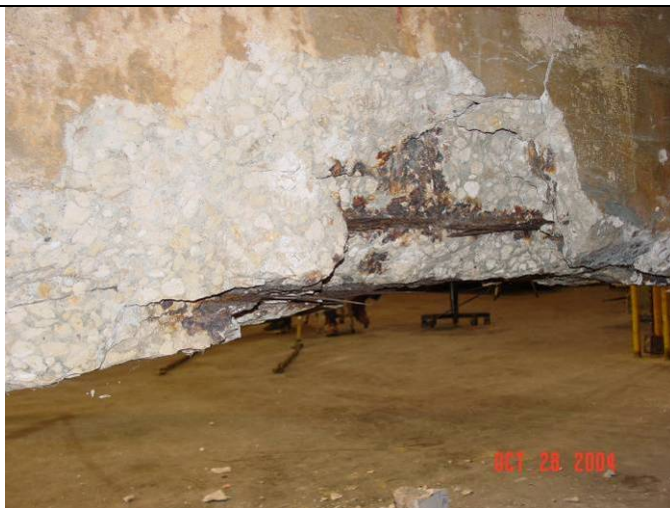
First crack appeared at 12 kips. Flexural cracks appeared mostly under the North load point. The concrete of the top face began to crush. Large pieces of concrete spalled off on the east side of the pile exposing more corroded strands.

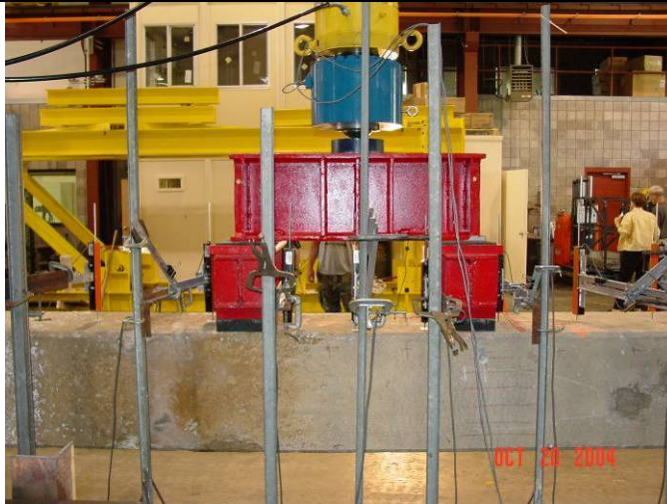
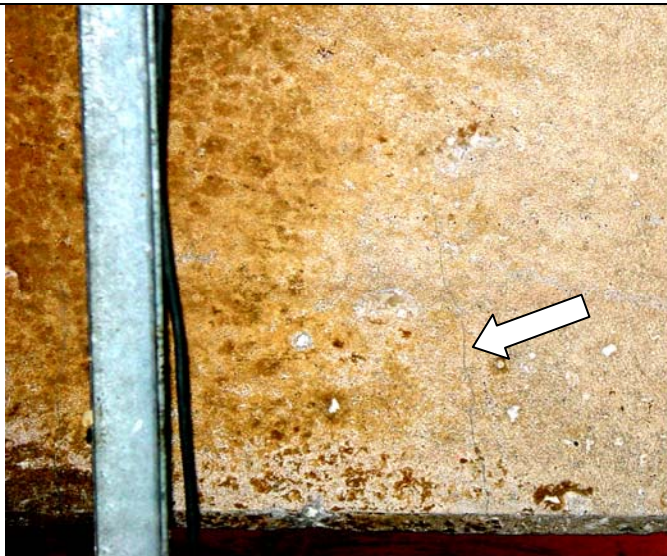
## 40-4

Some damage was evident on this pile. One vertical crack was visible on the west face of the pile in the middle of the splash zone. Some concrete spalling and subsequent patching was also evident.

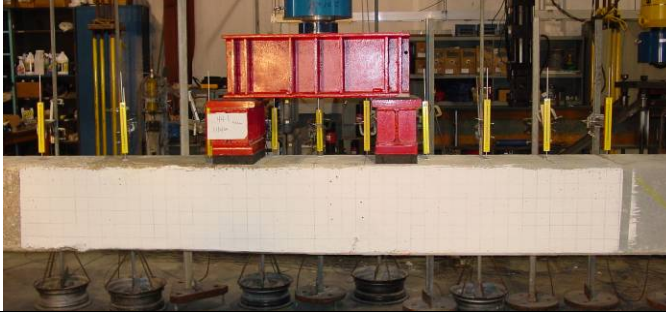
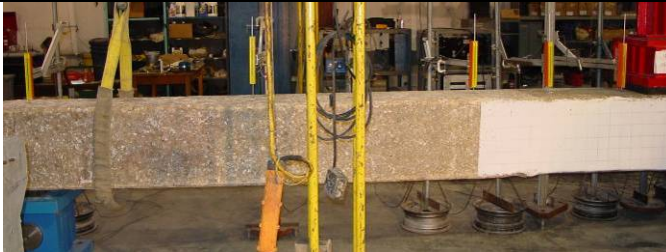
**44-1CP**

There were some small holes visible on the exterior of the pile, and minimal damage aside from one area on the bottom west corner approximately 2 ft. north of the north load point where a piece of concrete had chipped off.

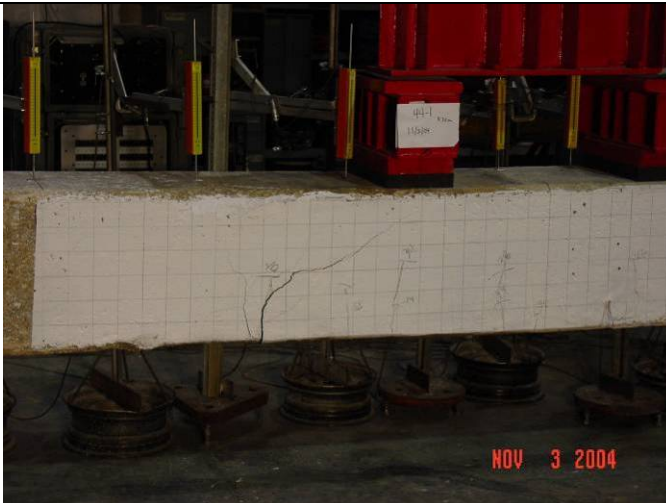
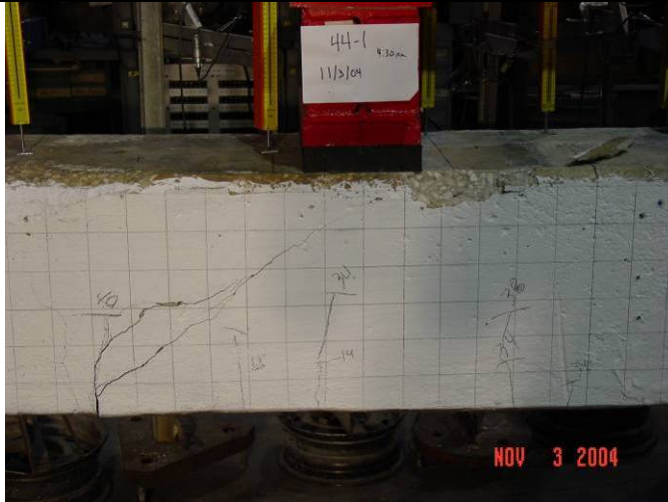
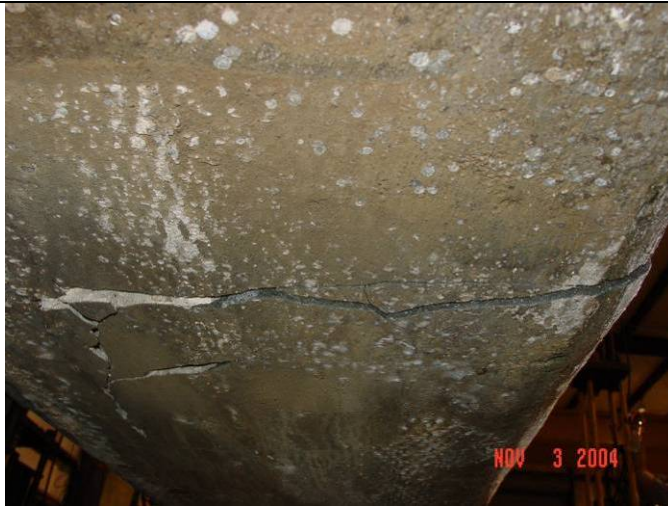
Underside of pile (bottom face of cross section)

First crack appeared at 14 kips. The pile had multiple flexural cracks. One large flexural crack extended up from just under the north load point. The concrete on the top face was not crushed.

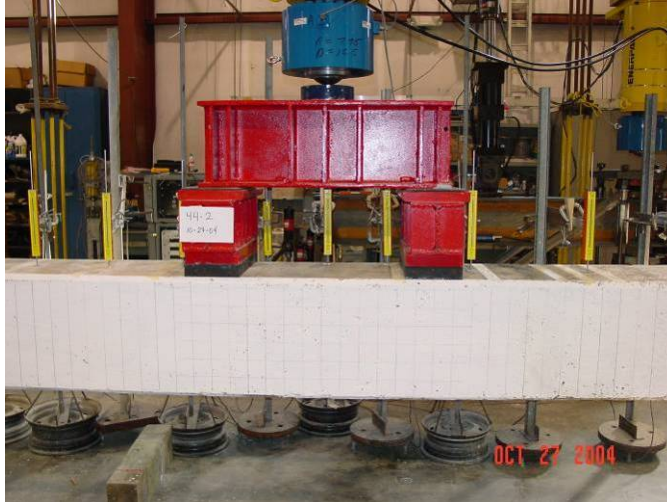
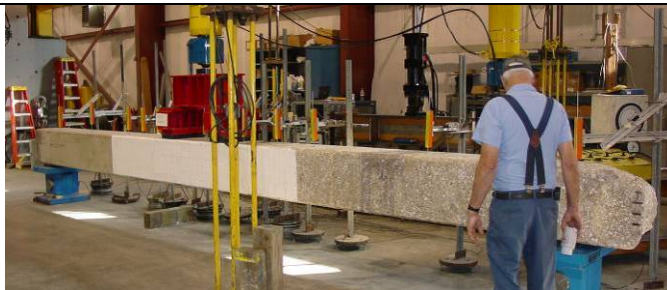
## 44-2

Minimal damage was visible in the splash zone of the pile.

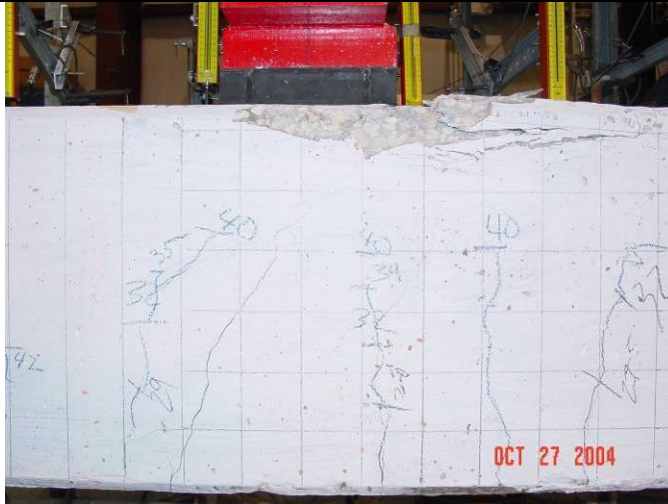
The first crack appeared at 24 kips. This pile had multiple flexural cracks within the splash zone. The concrete under the north support crushed. After testing, the cover was taken off the bottom face (tension zone) strands. There were a few broken wires but none of them were corroded very badly.

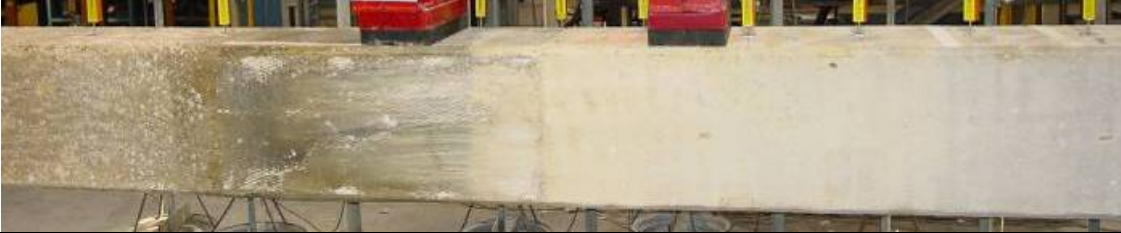
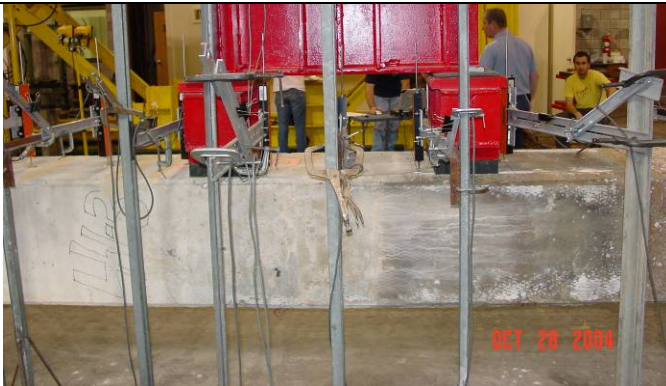
**44-3CP**

Minimal to no damage was visible on this pile.

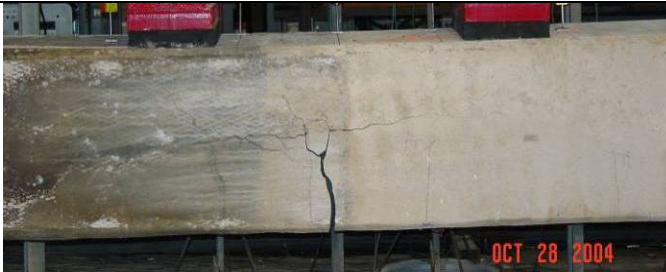
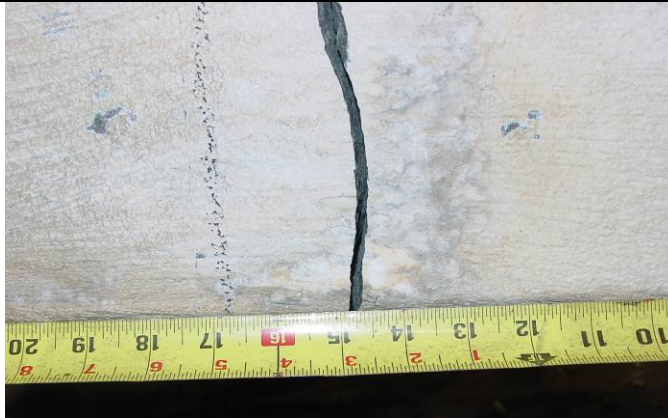
First crack appeared at 10 kips. A very large flexural crack opened up about midway between the north and south load points. This was the only crack visible and was approximately 1/4 in wide after the load was removed. The crack extended through the bottom face of the pile to the east face. Removal of the tension face concrete revealed that this pile had been patched. The strands in this pile were also severely corroded. Many of the strands were completely corroded.
