Final Report

June 2006

UF Project No. 00051711  
Contract No. BD545, RPWO #27

## ST. GEORGE ISLAND BRIDGE PILE TESTING

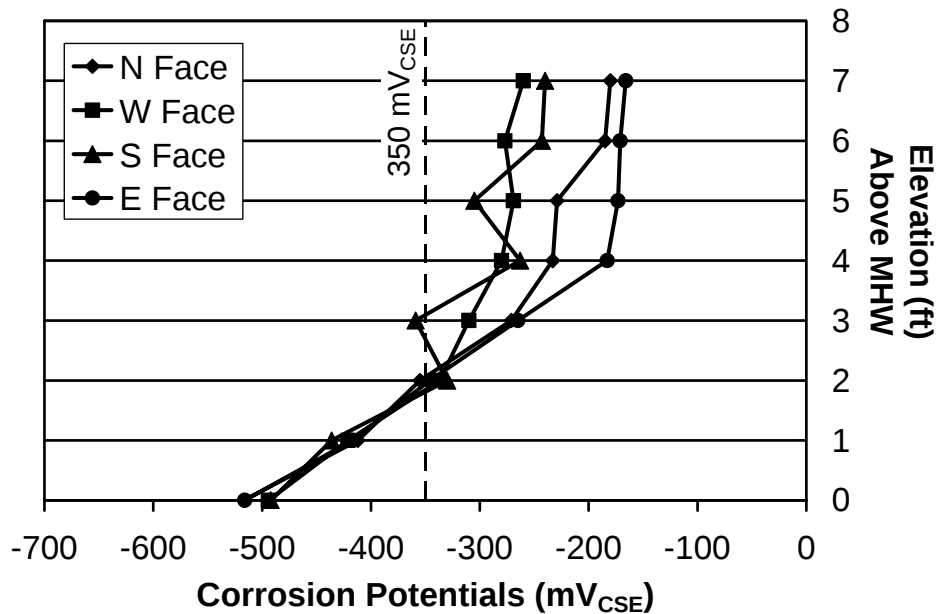
The  $-350\text{mV}_{\text{CSE}}$  demarcation on the plots provides an elevation below which corrosion activity was likely. Piles 39-2 and 40-3J have potentials more negative than  $-350\text{mV}_{\text{CSE}}$  over most of the seven feet above MHW. Piles 40-4, 29-2, and 44-2 have potentials less negative than  $-350\text{mV}_{\text{CSE}}$  over the height where measurements were taken, while pile 32-3J is split nearly evenly. These results will be related to the flexural capacities later in this report.

(a) Corrosion potentials at various heights of Pile 29-2

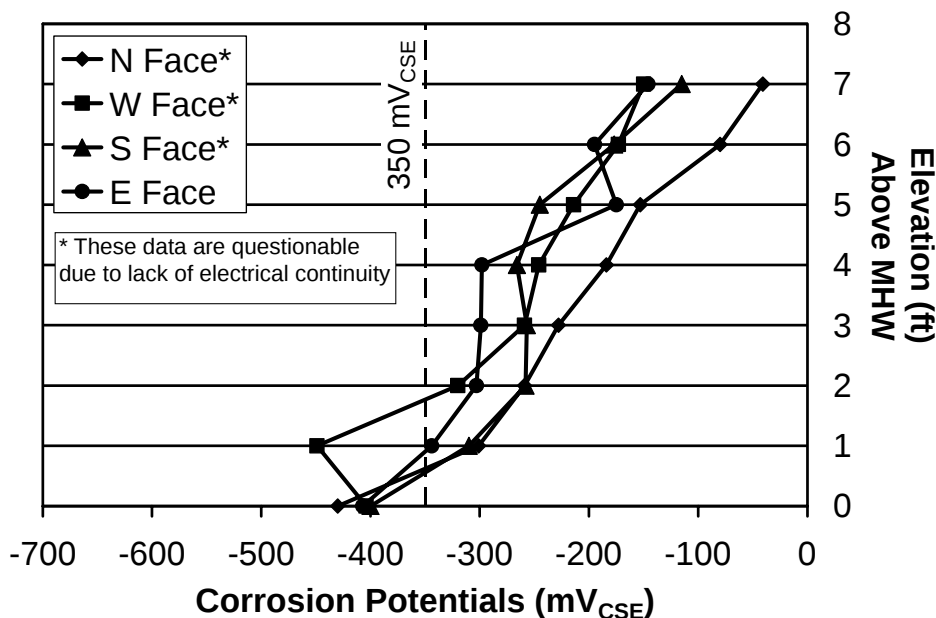
continuity of the strands was checked against the strand used for the ground. Some of the noted data from piles 44-2, 32-3J, 40-3J were questionable due to lack of continuity.

(b) Corrosion potentials at various heights of Pile 44-2

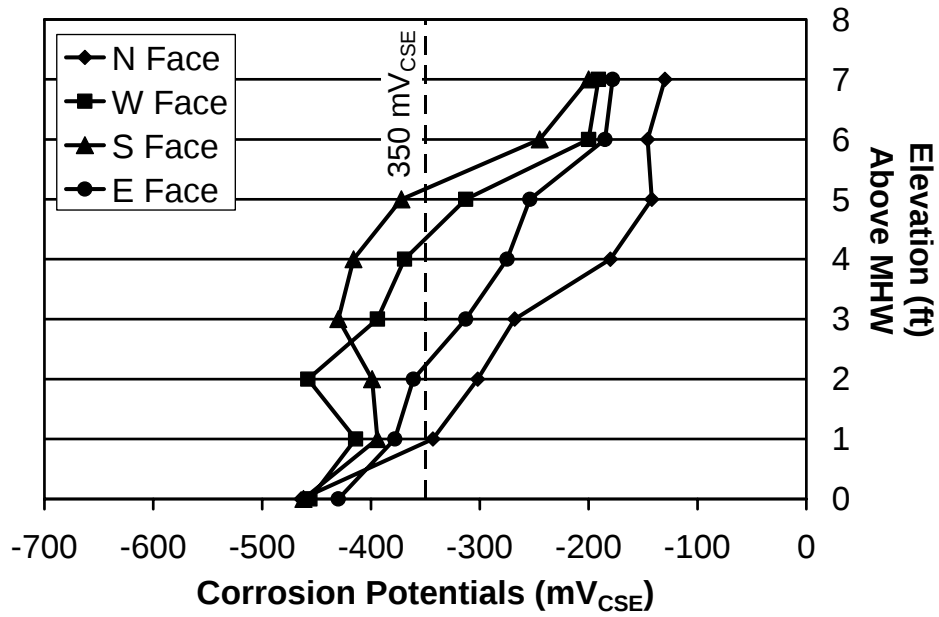
(c) Corrosion potentials at various heights of Pile 39-2

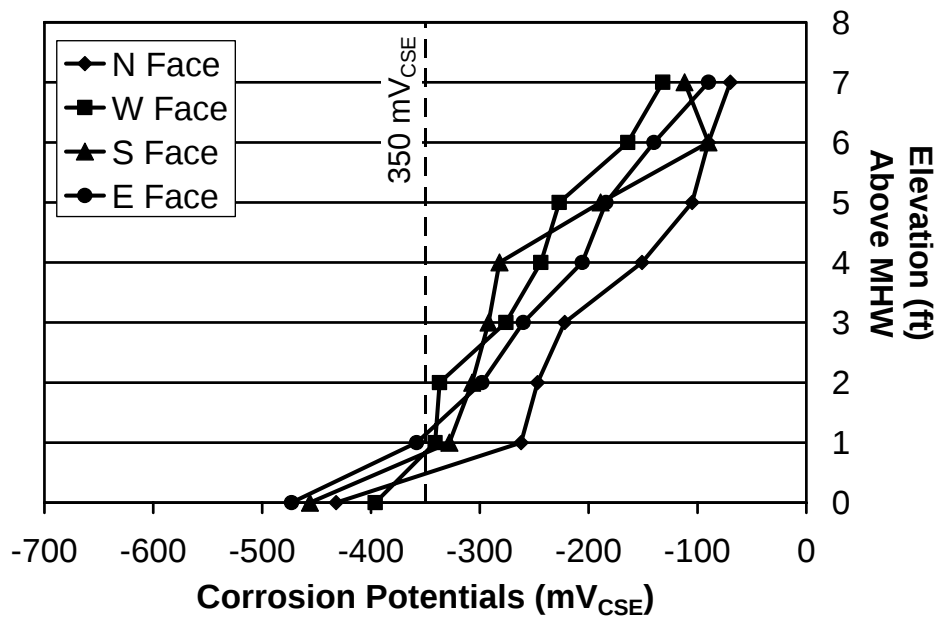
(d) Corrosion potentials at various heights of Pile 40-4

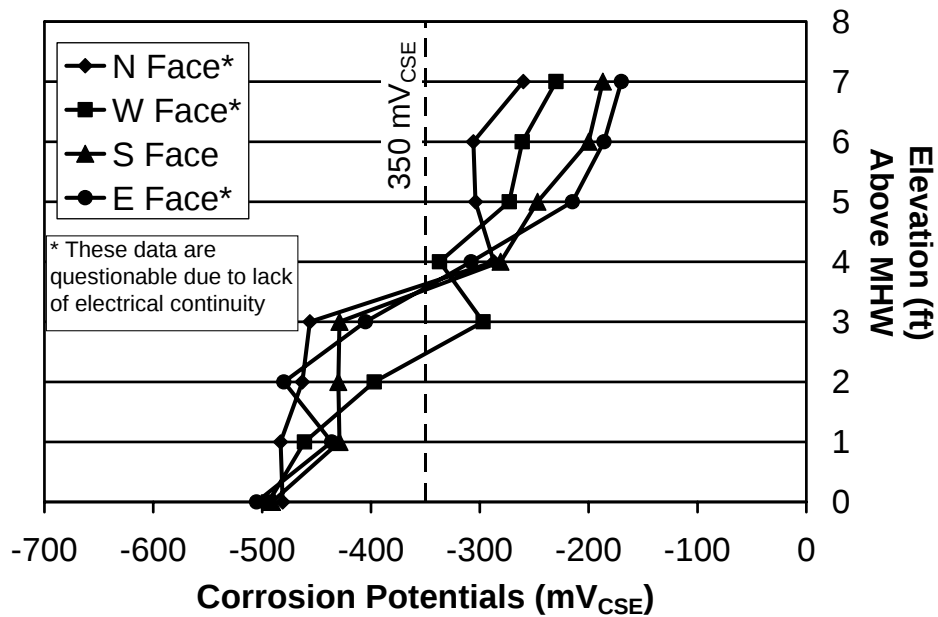
(e) Corrosion potentials at various heights of Pile 32-3J

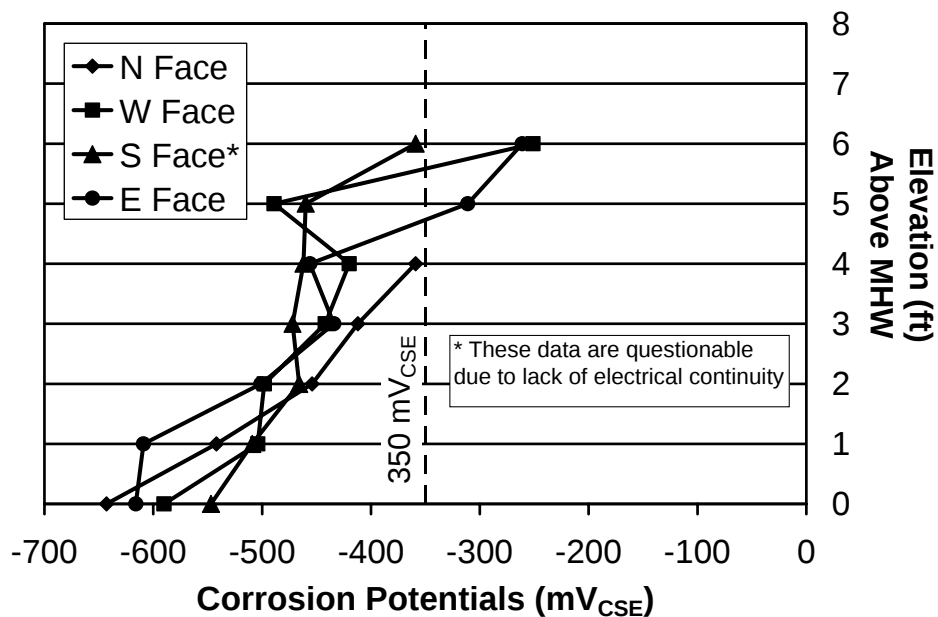
(f) Corrosion potentials at various heights of Pile 40-3J

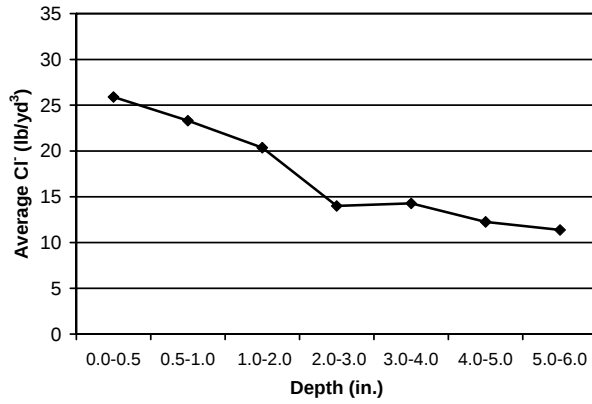
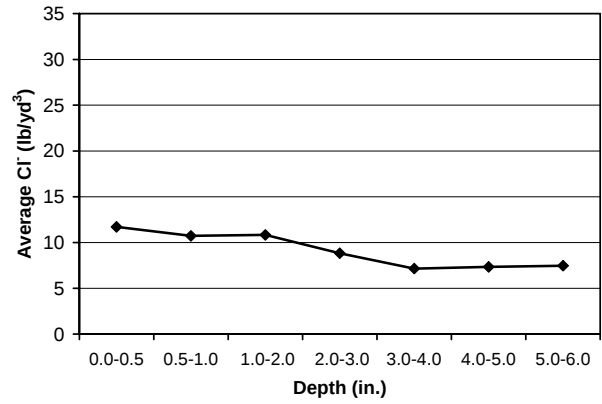
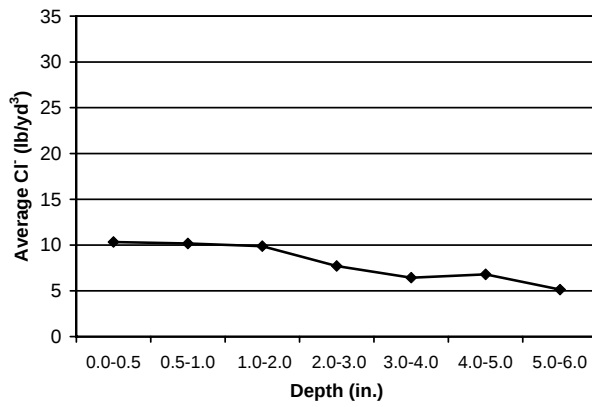
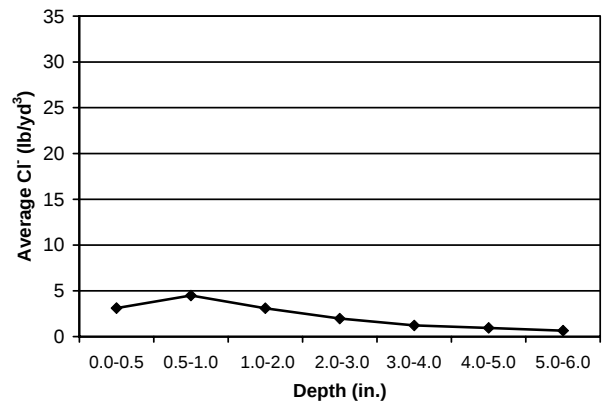
Figure 8 – Chloride content, Pile 32-3J

The chloride profiles show that the greatest contamination occurs in the submerged portion of the pile where the concrete is continuously exposed to the salt water. The location of next greatest contamination is that of the tidal zone where the concrete is repeatedly submerged by the tidal fluctuation, followed by the splash zone and then the dry zone. Corrosion generally occurs in the splash zones due to the combination of chloride contamination and oxygen availability to support the corrosion reactions.

percent. Clearly, the chloride ion concentration in these piles is unsurprisingly high considering the relatively low cement content, lack of pozzolan use, and long-term exposure to a severe environment. Visual inspection of the two piles and subsequent flexural testing, however, indicated that pile 44-2 was in better condition than that of 32-3J, even though the chloride contents were comparable. A jacket was installed on pile 32-3J in 1983, which perhaps contributed to the lower chloride levels at the 2 to 3-in. depth and the better visual rating.

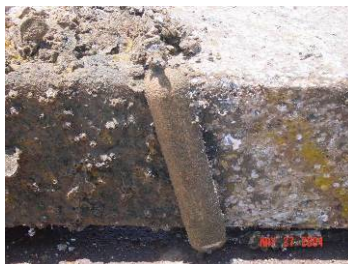
The first pile sampled was 21-4, which was cut and pulled from the bay on May 27, 2004. The pile was placed on the demolition barge to allow samples of the prestressing strand to be taken for hydrogen testing. Although potentials were not taken following extraction of 21-4, inspection of the bulk anode indicated that the anode was still electrically connected to the strand and likely providing protection. The second pile was 44-2, which was sampled at the FDOT Structures Research Center after it had been tested in flexure. This pile did not have a cathodic protection system installed. Accordingly sampling of this pile was intended to provide background data on the dissolved hydrogen.

Figure 10 – Bulk zinc anode on pile 21-4

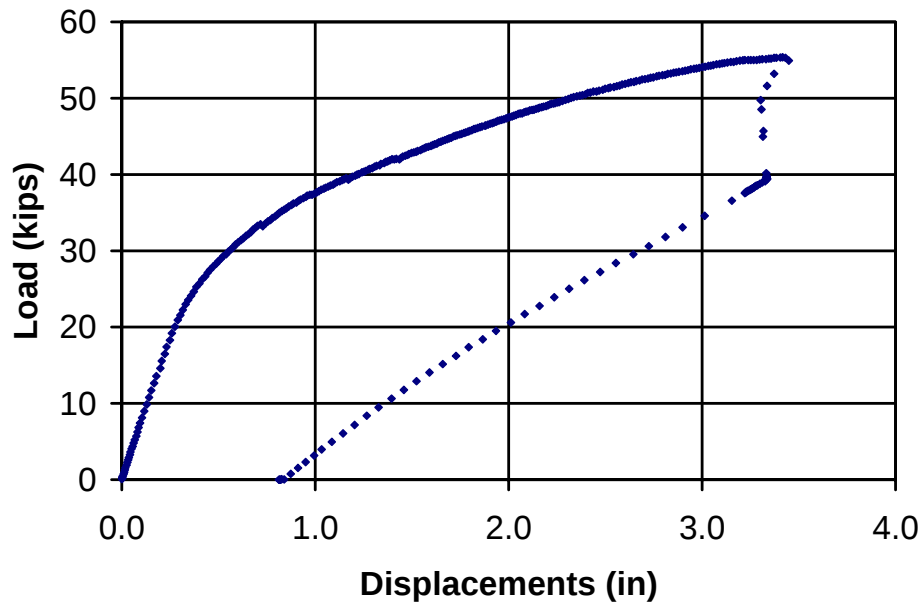
Relative comparison of the load-displacement plots is of little value since each pile was tested with a different span. They do, however, provide an indication of the general aspects of the behavior of the piles under load. Figure 23 shows the load-deflection response for pile 40-4, and is what would be expected from an undamaged pile. The pile initially responded in a linear manner until cracking and strand yielding caused a reduction in stiffness. Load continued to increase up to the ultimate capacity when the compression zone failed. This pile reached a

flexural capacity comparable to that measured in the shear test. No strands ruptured during this test as indicated by the smooth and continuous load deflection response.

Figure 23 – Pile 40-4 load displacement response

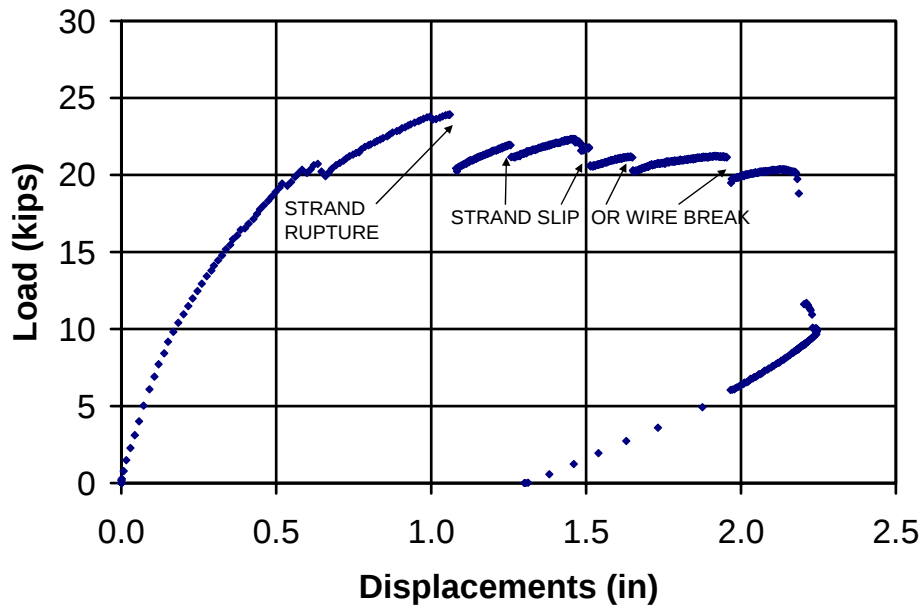
In many of the tests, the pile capacity was controlled by strand rupture or slip or both. Figure 24 shows the load-displacement behavior for pile 32-3J. Denoted on the plot are the locations where drops in load corresponded to audible sounds video-recorded during testing. These sounds are attributed to either strand rupture or slip since they are associated with a sharp reduction of load. Video recordings of each test were reviewed to determine the number of breaks or slips noted in each test. These are presented along with the failure mode in Table 13.

Figure 24 – Pile 32-3J load-displacement response

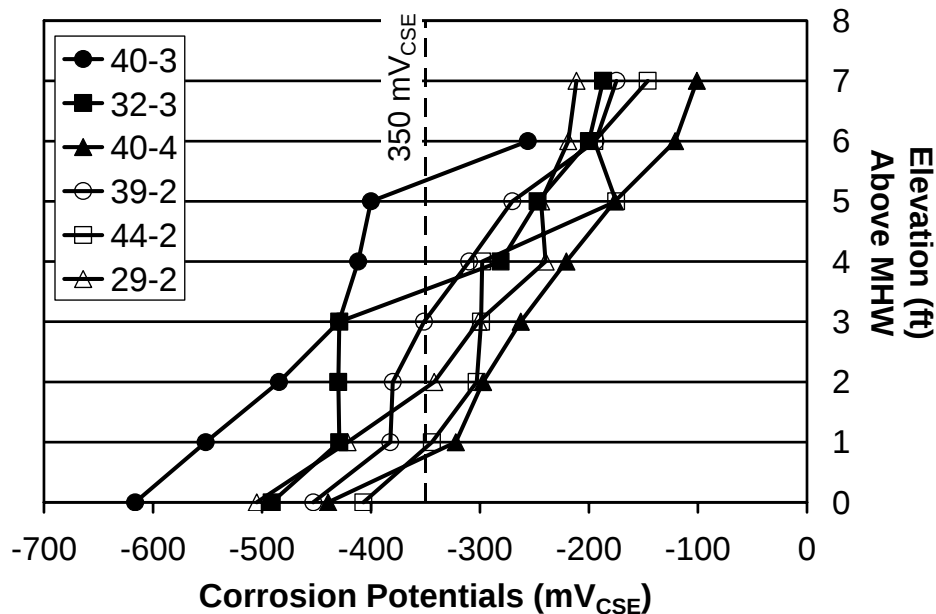
Figure 25 shows a compilation of the average corrosion potentials from all tested piles. Each plot represents the average of the corrosion potentials on all four faces for a particular

elevation including only those data in which electrical continuity of the ground connection was confirmed. The plot clearly indicates that some of the piles have very negative potentials over most of their height. Pile 40-3J, for example, has readings more negative than  $-350$  mV up to nearly 6 ft. above MHW. This pile retained only 31% of its calculated capacity. Conversely, pile 44-2 has only one reading more negative than  $-350$  mV near the MHW line and retained more than 100% of its calculated capacity. As the length of pile in the splash zone that has very negative readings increases it appears that the flexural capacity decreases.

Figure 25 – Compilation of the average corrosion potential of the tested piles.

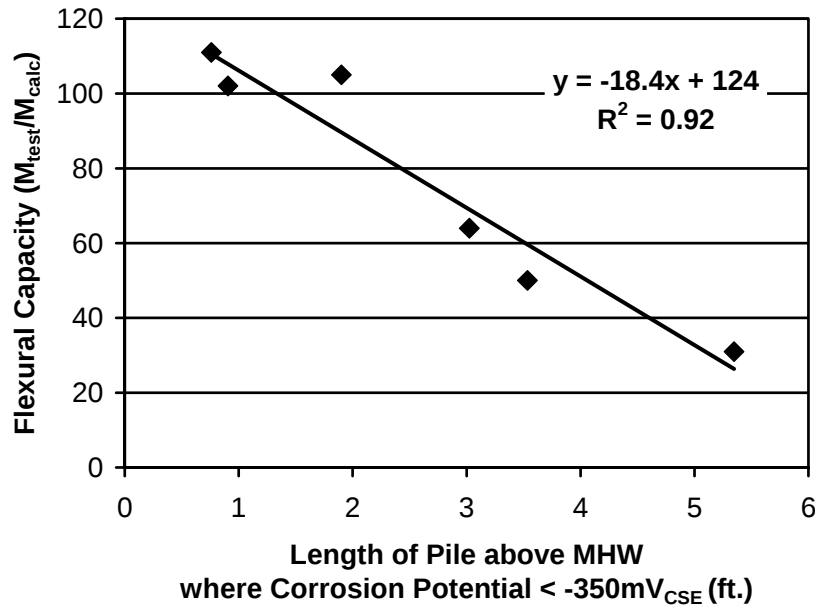
Figure 26 illustrates this trend. The normalized moment capacities are shown on the vertical axis and the horizontal axis shows the length of pile above the mean high water over which the measured corrosion potentials are less than  $-350$  mV<sub>CSE</sub>. There appears to be a linear relationship between the measured corrosion potential and flexural capacity that is quite strong ( $R^2 = 0.92$ ). Visual inspection of the strand after the flexural test indicated that corrosion was most severe at the base of the splash zone (just above the MHW) and would taper in intensity as the distance from the MHW was increased. Field observations also confirm that the corrosion tends to migrate upward on the pile through the splash zone, which supports the behavior illustrated by the plot. The plot can be summarized as follows. When the average corrosion potential was less than  $-350$  mV<sub>CSE</sub> over an approximate height of:

- 1 ft. above the MHW, then 100% of the pile capacity remained.
- 3 ft. above the MHW, then approximately 68% of the pile capacity remained.
- 5 ft. above the MHW, then approximately 32% of the pile capacity remained.

Figure 26 – Relationship between flexural capacity and corrosion potential

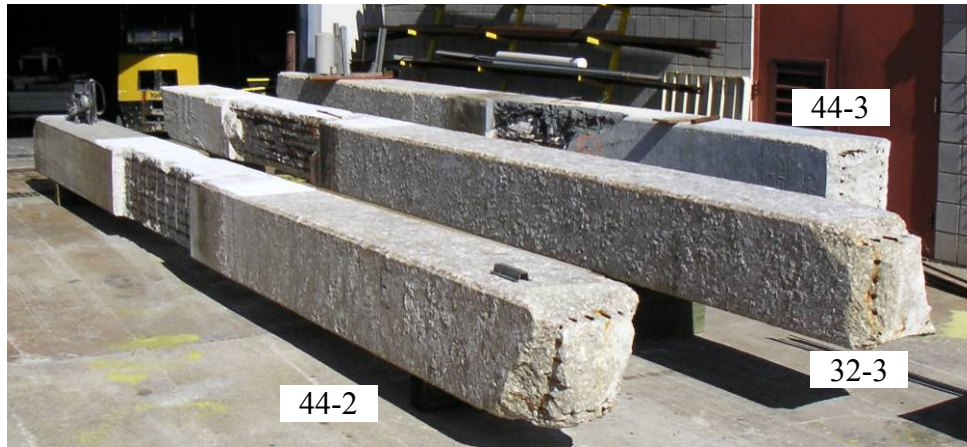
Figure 27 – Piles being excavated to examine corroded strand.

Following flexural testing, piles 44-3CP (cathodically protected), 32-3J (concrete jacket), and 44-2 were excavated to inspect the strands in the splash zone. Figure 27 shows the piles after excavation. Concrete was removed from the face that carried the extreme flexural tension during flexural testing, which was oriented to coincide with the splash zone. Strands were examined for corrosion and wire breaks. Generally, moderate to severe corrosion was noted on the prestressing strands. In some cases the prestressing strands were completely consumed by corrosion as can be seen in the top two strands in Figure 28. Figure 29 shows a range of corrosion. The top two strands are severely corroded while the bottom four strands have corrosion ranging from light to severe as the strands enter the splash zone. The portion of the pile above the splash zone when it was in service is to the left of the figure.

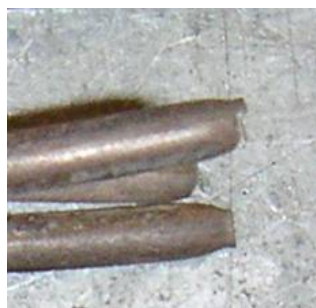
Figure 33 shows the behavior of a severely corroded strand when loaded to rupture. The wires generally ruptured at varying locations along the length of the strand. In contrast, Figure 34 shows the rupture pattern of an uncorroded strand taken from the piles in which the individual wire ruptures occur in very close proximity to each other. Furthermore, each wire exhibits the ductile necking and cup/cone fracture surface.

Figure 34 – Failure mode of uncorroded prestressing strand sample taken from pile 44-2. Ductile necking of the cross section and cup/cone fracture surface are shown.

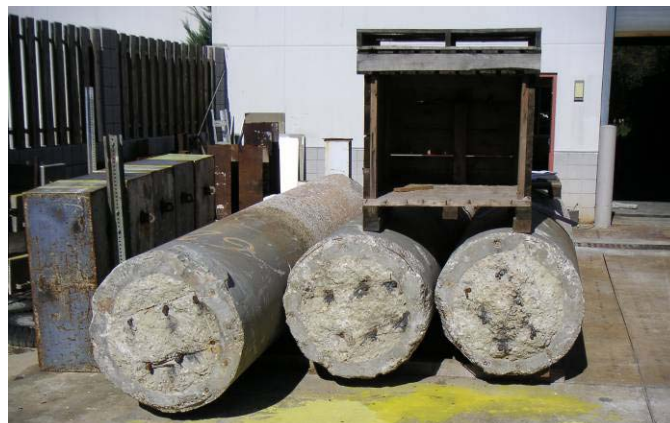
Precast post-tensioned cylinder piles from the Escambia Bay bridge carrying route I-10 were tested to determine flexural capacity. The piles were taken from the piers that were damaged by Hurricane Ivan in 2004. The bridge was constructed in 1964. Figure 38 shows the piles as recovered from the bay. The photo shows the top end of the pile, which has been filled with concrete to connect to the cap beam. The connection was made by six mild steel reinforcing bars. Figure 39 shows the opposite end of the piles. The cylinder piles were approximately 36-in. diameter with a 5-in. thick wall. Twelve post-tensioning tendons were evenly spaced around the perimeter at the mid-thickness of the cylinder wall. Each tendon had 10 0.192-in. diameter parallel prestressing wires surrounded by prestressing grout (Figure 40). The number of wires in the tendons was increased to twelve in the region near the connection to the cap beam. It appears that the tendon passages were cast into the cylinder piles without the use of a conduit.

Figure 38 – Three piles prior to testing, view of filled end of pile.

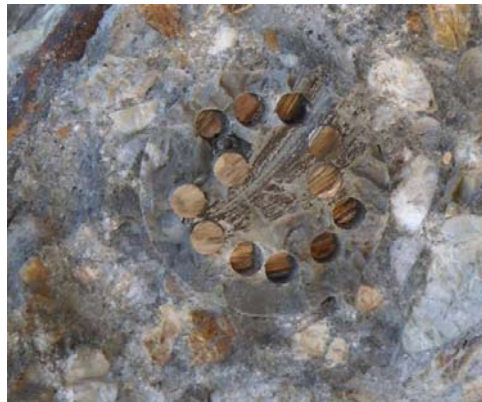
Figure 40 – Prestressing tendon from cylinder pile. Note grout surrounding wire with no evidence of conduit.

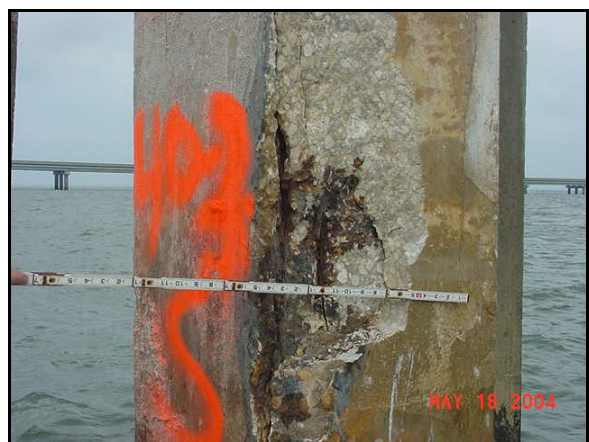
SOUTH FACE PILE 40-2

| PILE | FACE / CORNER | DIMENSIONS | REMARKS |
|---|---|---|---|
| 40-2 | Northwest | | Minor spall |
| | Northeast | 37" x 7" | Incipient spall w/CBO above tidal zone |
| | Southeast | 38" x 8 1/2" | Incipient spall w/CBO above tidal zone |
| | South | 7' x 3/8" | Vertical crack w/CBO |

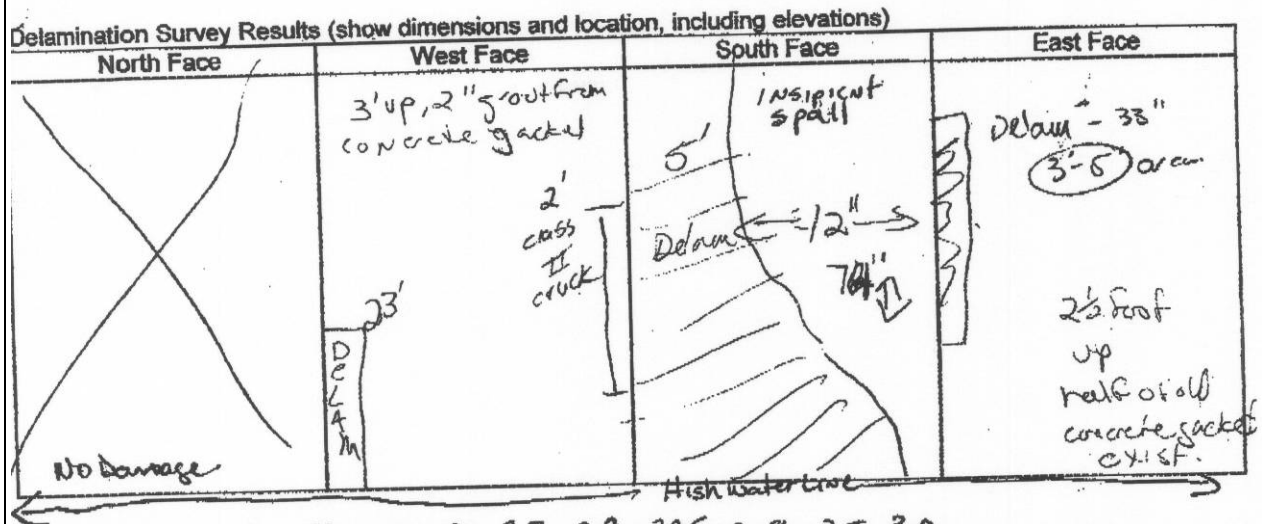
# Piling 32-3J

NDT Concrete Cover Measurements: 2.7", 2.9", 2.95", 2.8", 2.5", 3.0"  
 Original Cover on Exposed Steel: 3.0", 3.0", 2.75"

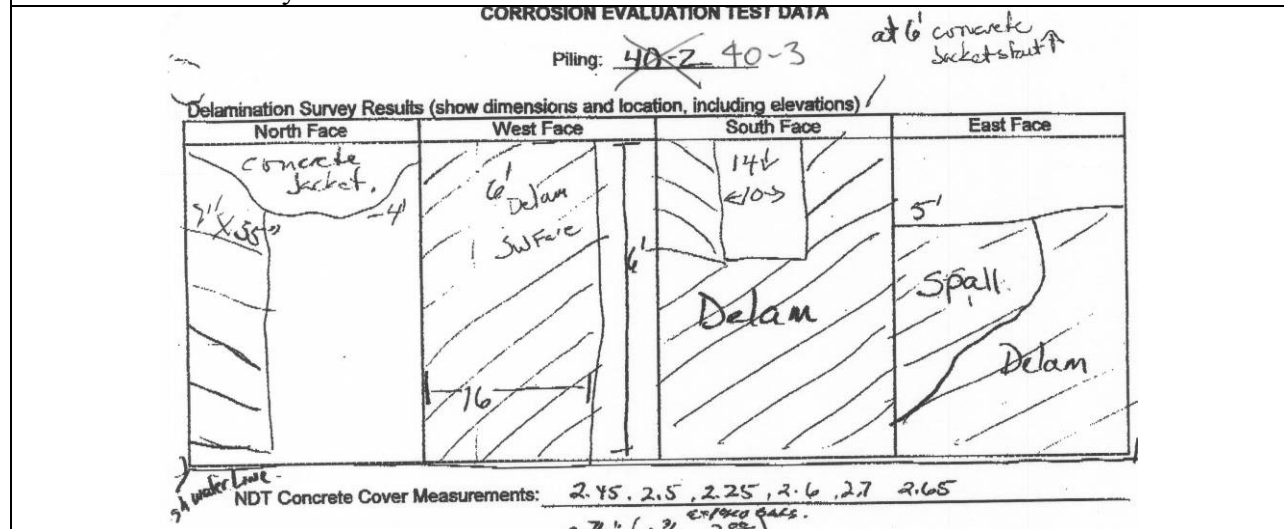
# Piling 40-3J

NDT Concrete Cover Measurements: 2.45", 2.5", 2.25", 2.6", 2.7", 2.65"

Original Cover on Exposed Steel: 2-7/8", (2-3/4", 3.00") Exposed bars

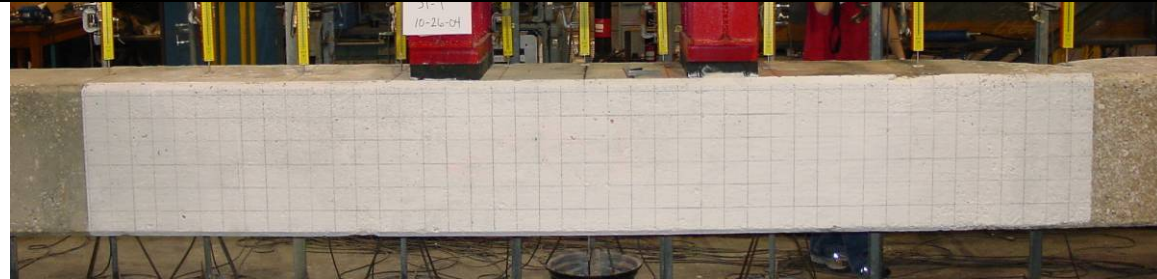
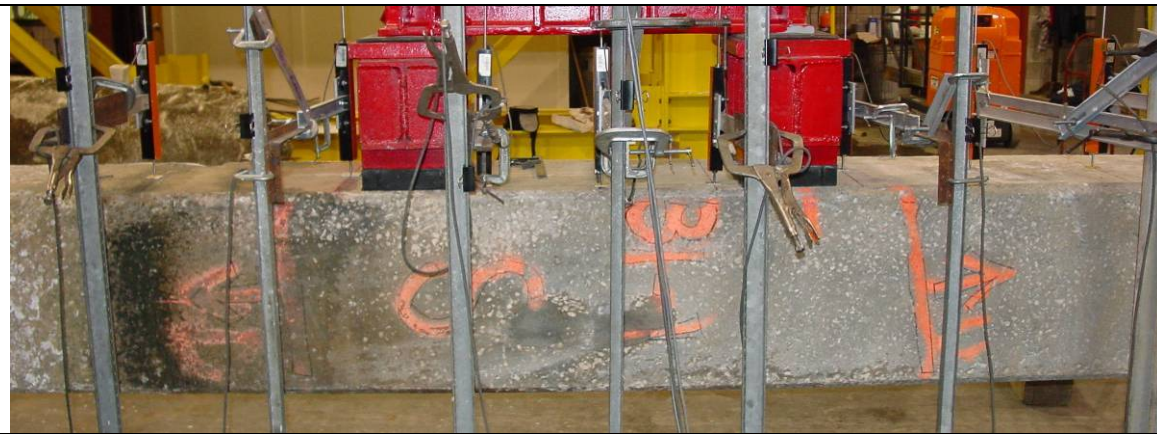
### 31-1

Minimal damage was visible on the pile.

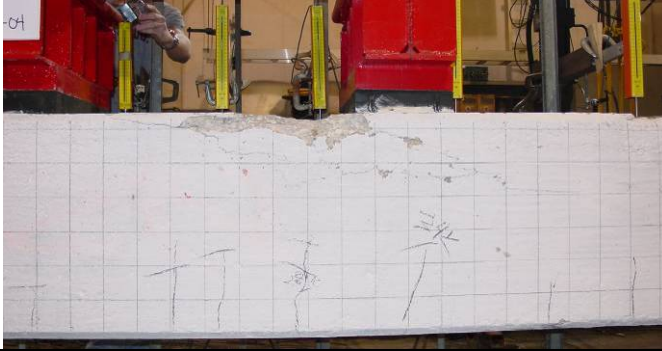
First crack appeared at 28 kips. The compression zone concrete was only slightly crushed. The pile showed compression zone crushing to a limited extent. The flexural cracks mostly closed after unloading.

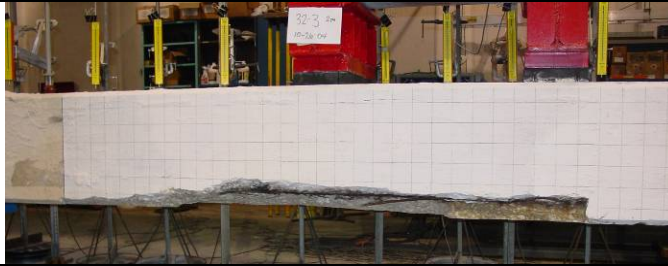
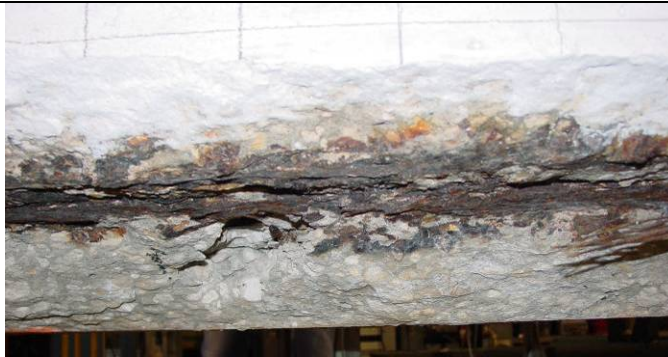
### 32-3J

| PILE | FACE / CORNER | DIMENSIONS | REMARKS |
|---|---|---|---|
| 32-3J | Southeast | 6'6" x 12" x 2" | Spall with one heavily deteriorated exposed strand 24" long extending to grout of partially removed jacket |

Severe spalling, corrosion and strand damage were visible. Under the northern load application point, the bottom west corner had spalled off to expose the steel strands which were completely rusted through and had debonded from the concrete.

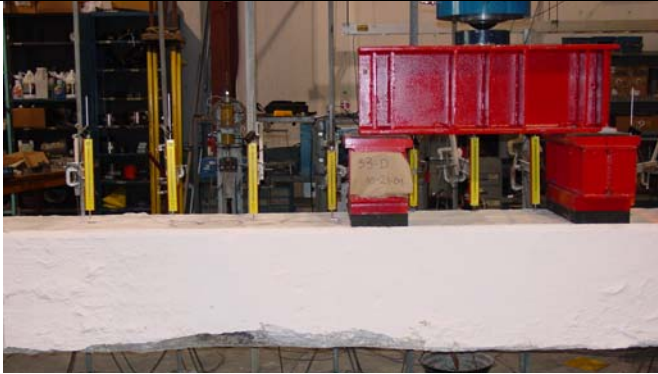
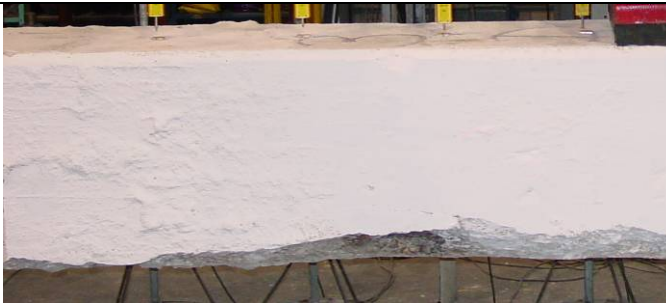
### 33-4J

| PILE | FACE / CORNER | DIMENSIONS | REMARKS |
|---|---|---|---|
| 33-4J | | | Remaining grout of partially removed jacket has multiple cracks and spalls |

Concrete had spalled off from the bottom west corner of the cross section under the north loading point. Strands were exposed and rust was visible.

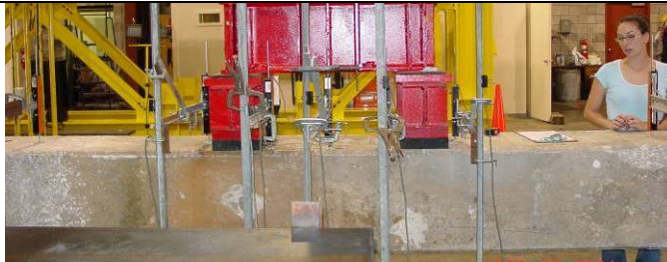
## 39-2

Minimal damage was visible on the majority of the pile. However, one crack was visible at the bottom of the west face of the pile, under the northern load point. The crack was approximately 30" long, running parallel with the bottom layer of steel at approximately 3" from the bottom edge.

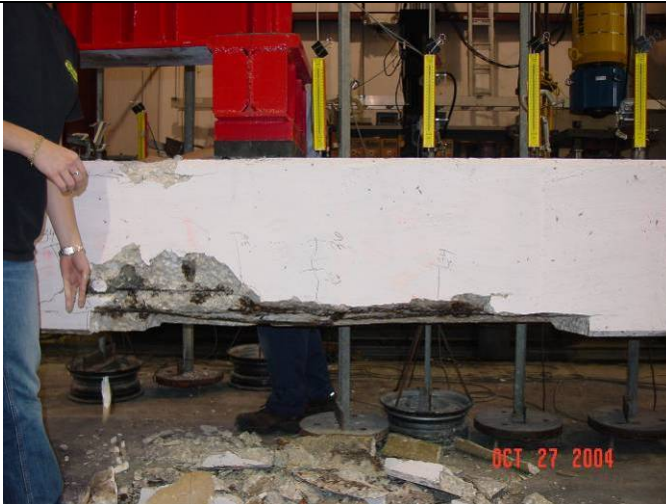
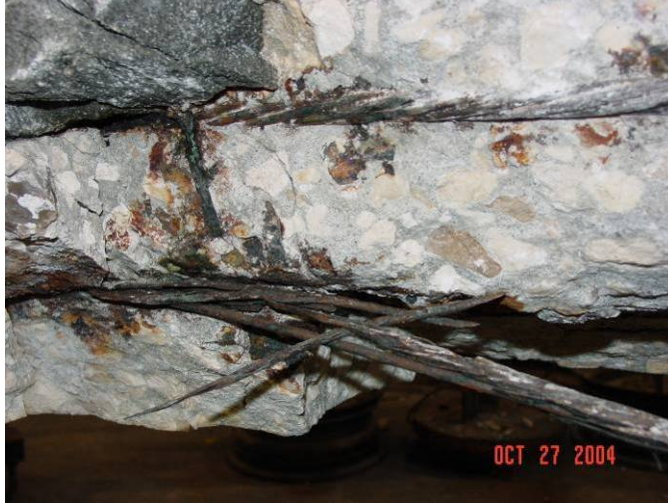
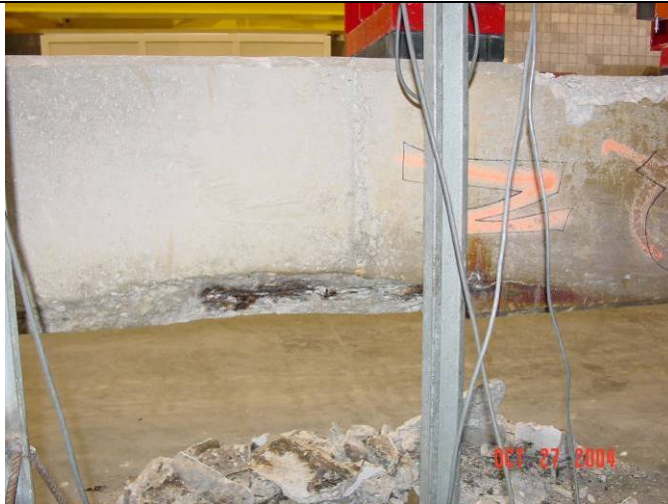
## 40-2

Cracking first appeared on this pile at 15 kips. Many flexural cracks were emanating off of the horizontal crack. Eventually all of the concrete below the horizontal crack fell off. This revealed that all of the strands were severely corroded and all the strands were broken. Crushing of the compression zone occurred between the load points. A dip in the load-deflection plot between 1" and 1.5" deflection may relate to the concrete falling off.

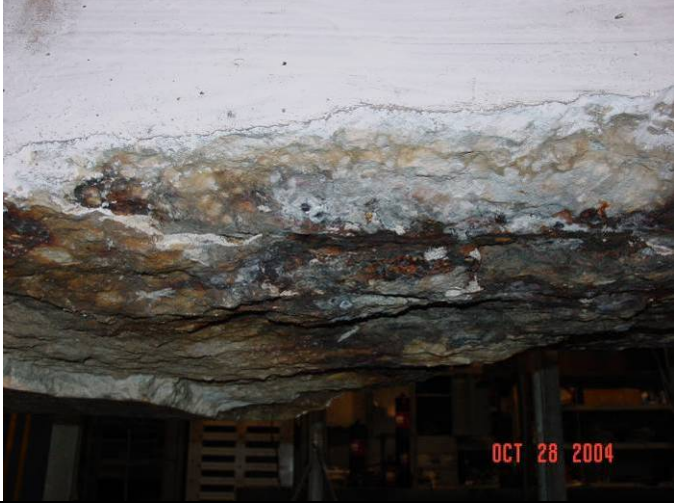
#### 40-3J

Severe damage and spalling was evident on this pile. The bottom face of the cross section was missing prior to testing. Each strand on the bottom face of the pile was completely rusted through, had debonded and some were no longer intact. On the east face of the pile, a gap of approximately 12 in. wide and 12 in. high exposed another strand, which was also rusted and had debonded. Spalling and rust staining were extensive.

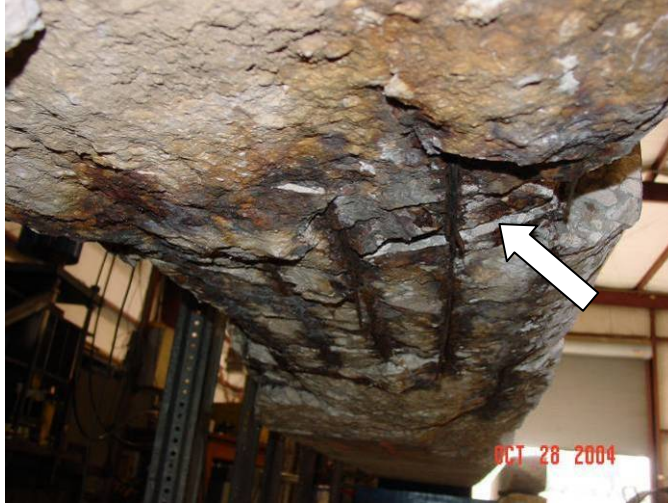
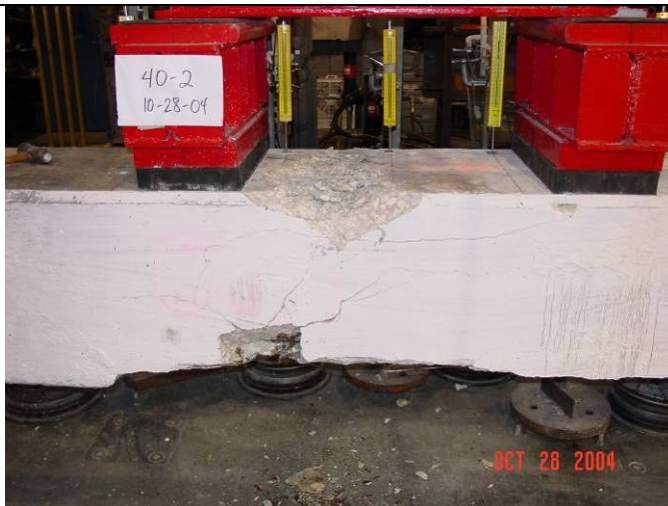
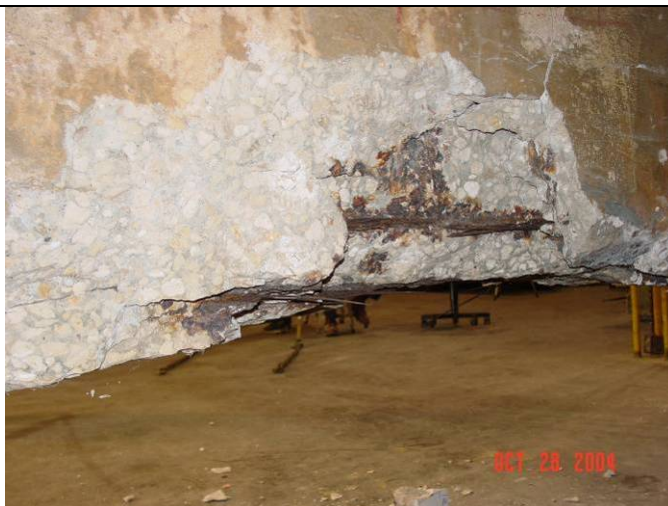
| <p>First crack appeared at 12 kips. Flexural cracks appeared mostly under the North load point. The concrete of the top face began to crush. Large pieces of concrete spalled off on the east side of the pile exposing more corroded strands.</p> | | |

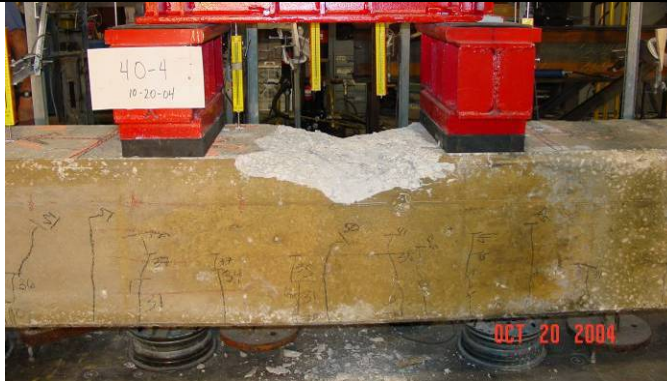
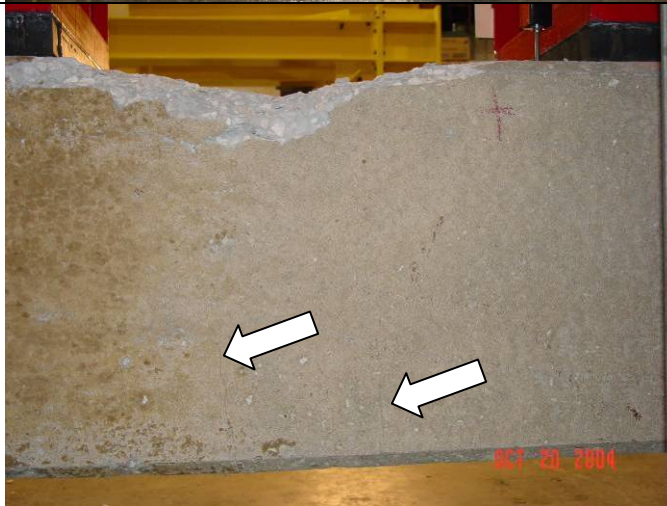
#### 40-4

First crack appeared at 10 kips. Concrete on the top face of the pile, in between the load points was crushed. Flexural cracks were present but were not very large.

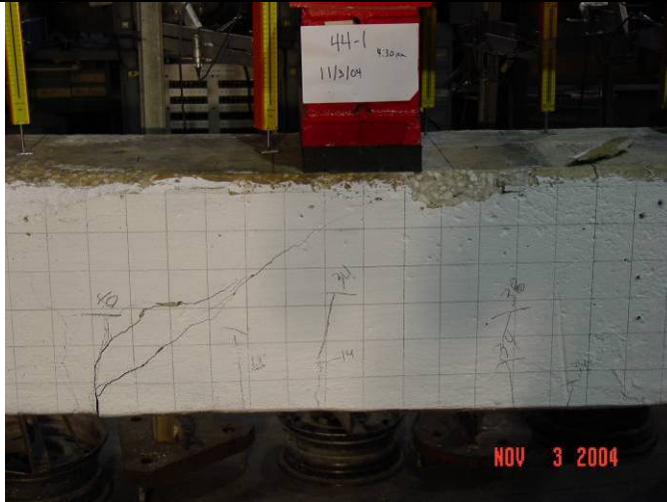
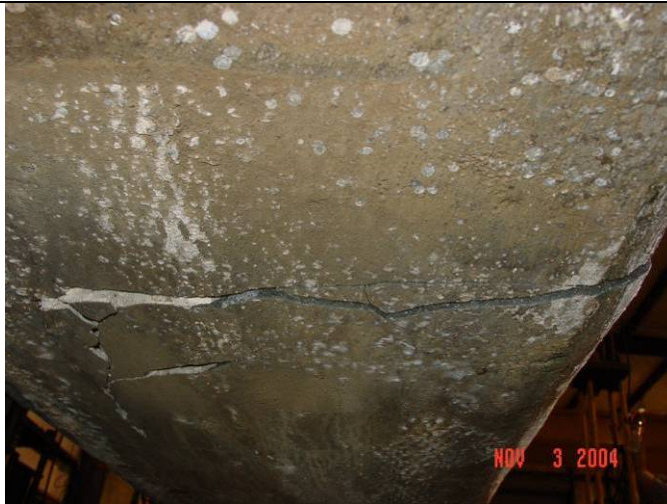
#### 44-1CP

First crack appeared at 14 kips. The pile had multiple flexural cracks. One large flexural crack extended up from just under the north load point. The concrete on the top face was not crushed.

Underside of pile (bottom face of cross section)

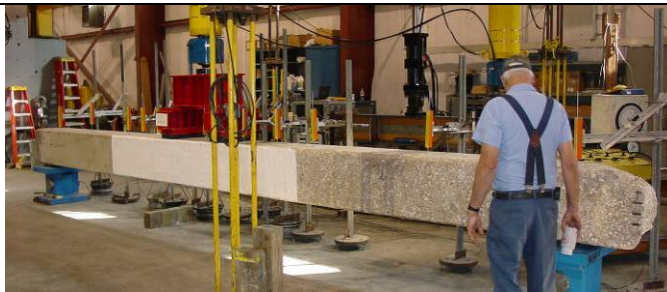
## 44-2

Minimal damage was visible in the splash zone of the pile.

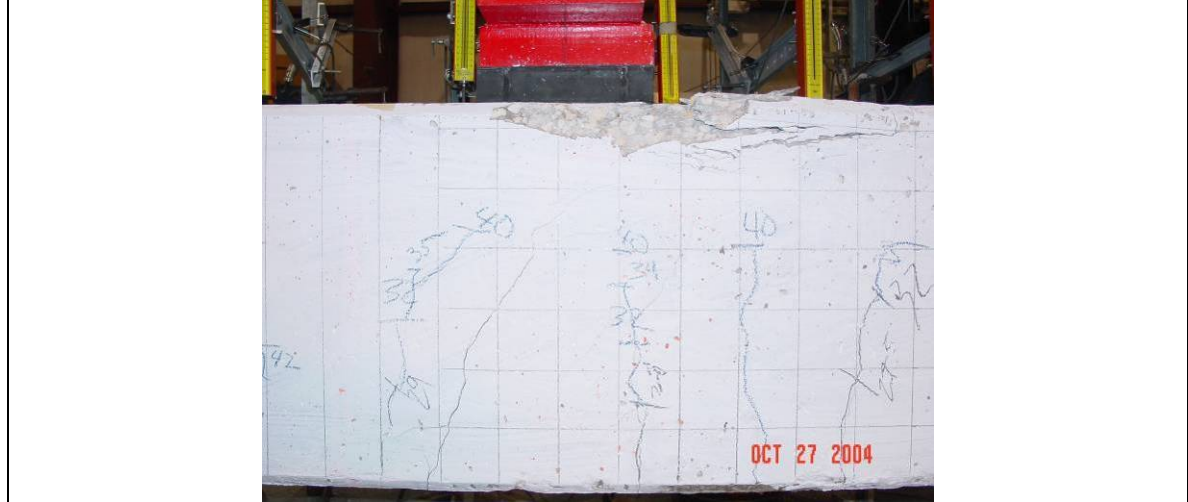
The first crack appeared at 24 kips. This pile had multiple flexural cracks within the splash zone. The concrete under the north support crushed. After testing, the cover was taken off the bottom face (tension zone) strands. There were a few broken wires but none of them were corroded very badly.

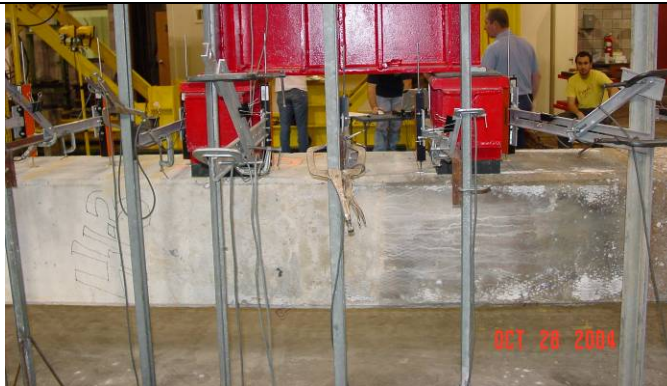
#### 44-3CP

Minimal to no damage was visible on this pile.

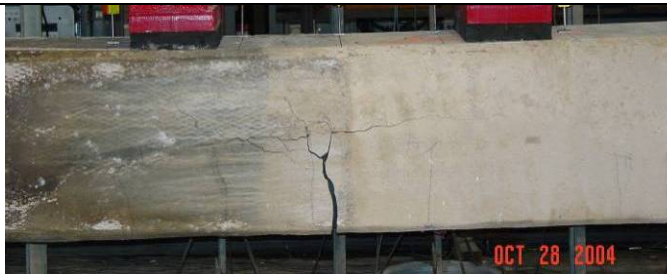
First crack appeared at 10 kips. A very large flexural crack opened up about midway between the north and south load points. This was the only crack visible and was approximately  $\frac{1}{4}$  in wide after the load was removed. The crack extended through the bottom face of the pile to the east face. Removal of the tension face concrete revealed that this pile had been patched. The strands in this pile were also severely corroded. Many of the strands were completely corroded.
