Florida LTAP Safety Circuit Rider Program

Final Report

FDOT Project BD545-52
UF52349

September 2009

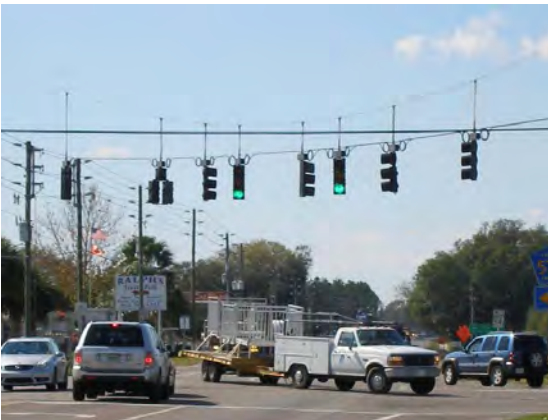
307 - Pasco County, SR 54 at Morris Bridge Road / Eiland Boulevard (CR 579, blocked drain around intersection
