## **Appendix C–SR-72 Tests**

## 1 Introduction

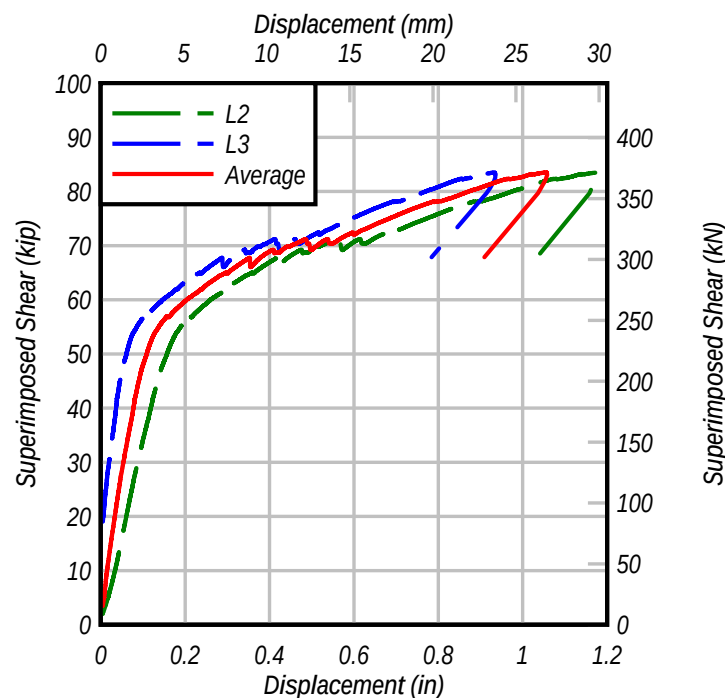
Figure 12–X7 shear vs. vertical displacement

Girder X7 was load tested at an  $a/d$  ratio of 3.4. Shear-displacement behavior of X7 is shown in Figure 12. As load was applied the girder displaced vertically and laterally, and rotated about its longitudinal axis. Lateral displacement is presented in Figure 13. The maximum rotation was approximately 0.14 degrees, as determined from LVDTs L2 and L3 which were placed on either side of the load point. The rotation and lateral movement are attribute in-part to the asymmetric cross-section and load location which was not through the section's shear-center. Uneven bearing pad deformation may also have contributed to the rotation. As previously discussed, and as presented in Figure 9, multiple bearing points were placed at the far end of X7 to prevent instabilities due to asymmetry of the cross-section and load.

The girder behaved linear-elastically until the formation of cracks. Visible cracking was first observed in the web at a superimposed shear load of approximately 51kip (Figure 14). Although cracks were not visible prior to 51kip, data from rosette R7 indicates that the crack first formed at a shear of 41kip (Figure 15). At 58kip of shear, the initial crack in the web was observed to have joined with a flexural crack in the bottom flange. This load corresponds to the change in slope on the shear-displacement plot; the change in stiffness being attributed to cracking.

Referring to Figure 12, the abrupt changes in the shear-displacement curve between 65kip and 70kip correspond to the formation of additional cracks. Cracks formed farther from the load point and at shallower angles as the load increased. Comparing the final crack pattern with the location the transverse reinforcement (Figure 14), it is noted that with only one exception, the cracks did not cross transverse reinforcement. Thus, after cracking the load could not have transferred through truss action, but rather was carried through arch action. Girder X7 supported a maximum superimposed shear of 84kip. At this load a punching shear failure occurred in the slab and curb. Figure 16 is a photo of the curb side of X7 showing the location of the punching failure. The red strap in the picture is from the crane which was lifting the girder as the photo was taken.

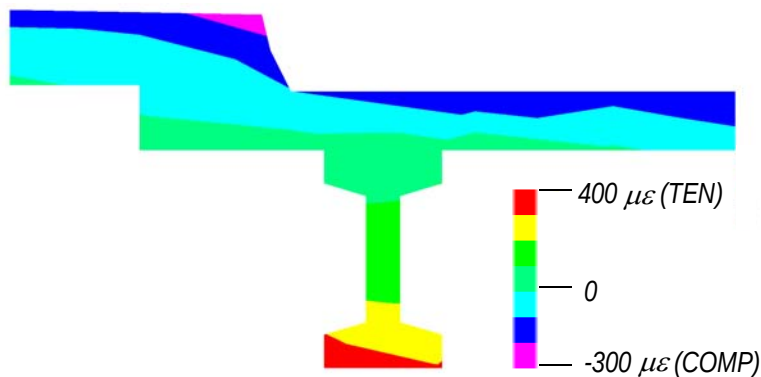
Figure 17–X7 Strain contour at shear of 45 kip at section below load point

Strain gages were placed around the cross-section at three sections along the length of the girder. Data from these gages were combined via linear interpolation to approximate the strain contour of the section during loading. Figure 17 shows the strain contour at the section below the load point at a shear of 45 kip. The maximum compressive strain occurred at the top corner of the curb. Because the section experienced biaxial bending, the strain contours were inclined.

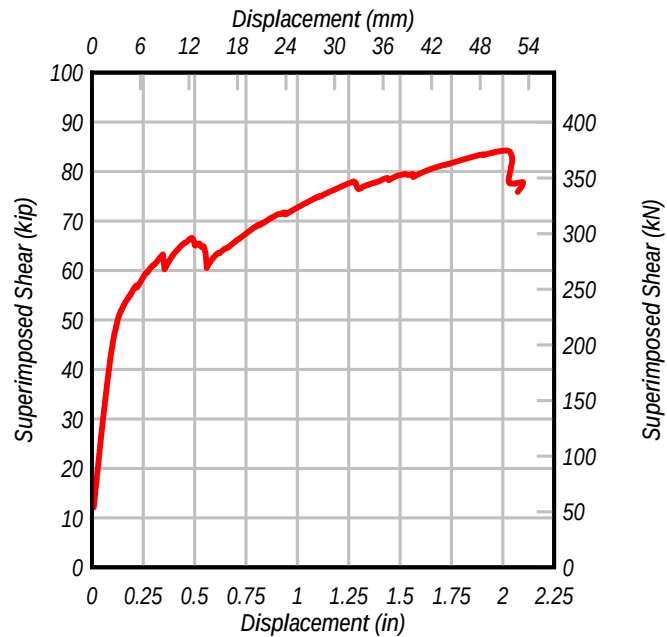
Figure 18–X4 shear vs. displacement

Referring to Figure 18, girder X4 behaved linear-elastically until a superimposed shear of about 45kip. The transition from linear-elastic behavior corresponded to the formation of flexural cracks at the bottom of the girder below the load point (Figure 20). Data from gage S25 (Figure 21) indicate that cracking initiated at a shear of 44kip. Initial cracks were first visually observed at a shear of 56kip.

The abrupt changes in the shear-displacement plot at 62kip and 66kip correspond to the formation of incline cracks in the web. Cracks continued to form farther from the load point and at shallower angles as the load increased. At the final stages of the load test incline cracks had a maximum width of 1 in. As shown in Figure 20 vertical reinforcement was not engaged by the inclined cracks. The relatively large crack widths and absence of engaged vertical reinforcement suggest that the girder supported load by arch-action.

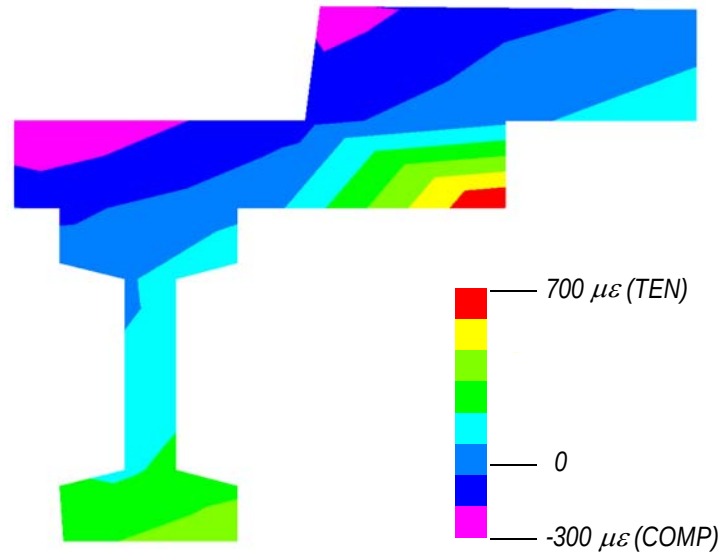
Figure 22–X4 strain field at load location at a superimposed shear of 46 kip

Strain gages were placed around the cross section to evaluate the flexural strain field during load testing. Figure 22 shows the strain field at the section below the load point at a superimposed shear load of 46k. Contours indicate biaxial bending with the neutral axis inclined at approximately 20 degrees from horizontal. The largest compressive strains occurred in the upper corner of the curb and slab. Formation of the initial flexural cracks on the curb side is consistent with the measured strain field which recorded the largest tensile strains at the location of cracking.

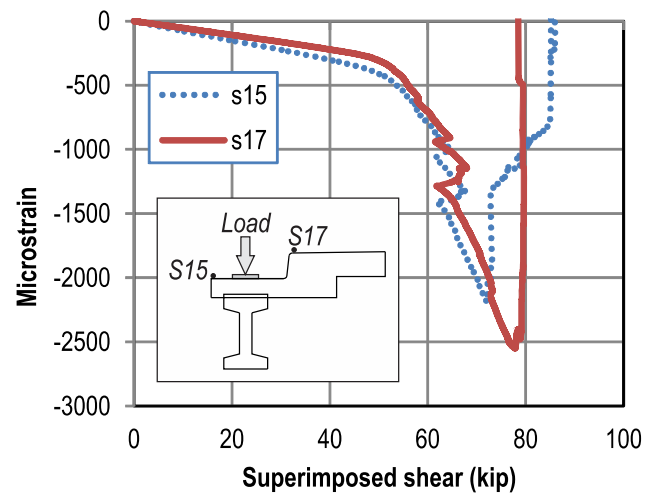
Figure 23–X4 shear vs. compressive strain

Crushing of the compression zone in the slab near gage S15 began at a shear of 71kip. Examining data from S15, the compressive strain reached 2200 microstrain prior to crushing (Figure 23). Crushing is attributed to the superposition of bearing strain from the load point and the flexural strain. The corner of the slab near S15 continued to crush and spall as the shear increased beyond 71kip. The corner of the curb near gage S17 began to crush at a shear of 76 kip. According to gage S17, the strain at the corner of the curb reached 2550 microstrain immediately prior to crushing (Figure 23). Girder X4 supported additional load after the initial crushing at the corners of the slab and curb, reaching a maximum superimposed shear of 84kip. As previously noted, the girder behaved as a tied-arch in the final stages of loading. The failure mode of Girder X4 was flexural compression failure of the concrete. The moment at failure was 95% of the calculated nominal moment capacity. Details of nominal capacity calculations are presented in a later section.

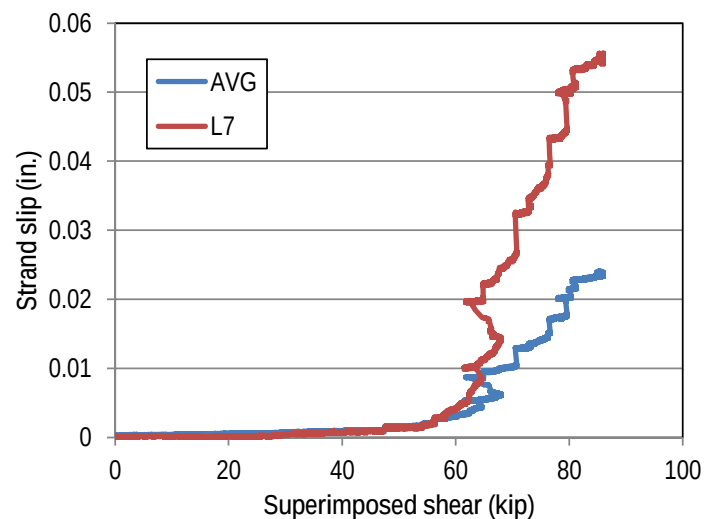
Figure 24–X4 strand slip vs. shear

Girder X4 was the only test in which the strands exhibited significant slip (Figure 24). The strand monitored by LVDT L7 was located the curb side in the bottom row. This strand was in the region of highest tension in the bottom flange (Figure 22). Slipping of the strands in X4

contributed to the rotation about the load point and crushing of the compression zone. Because X4 failed in flexural the strands in this girder likely supported higher loads than in other girders, making slip more likely. Slip was also augmented by the asymmetric bending as demonstrated by the slip L7.

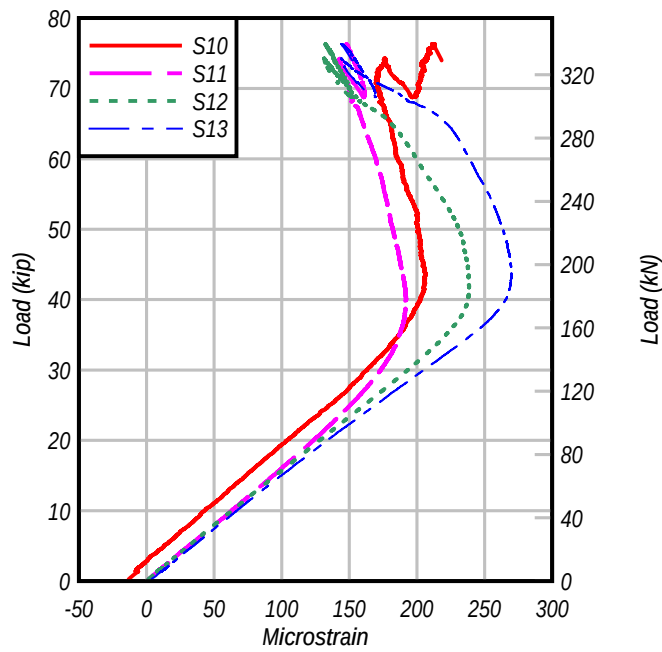
Figure 26–I2A load vs. decompression strain (crack opening)

Girder I2A was loaded to failure after the initial cracks were marked and strain gages were installed. Figure 26 shows applied load vs. strain data from each strain gage placed adjacent to the flexural cracks. Theoretically, as load is increased, the cracks should open when the tension the tension due to bending equals the precompression from the effective prestress force. This behavior is indicated by a bilinear shape in the load-strain plots shown in Figure 26. At a load of 40kip (22kip shear) the load-strain relationship became nonlinear due to reopening of the flexural cracks. Knowing this load at which the cracks reopened (i.e. precompression force was overcome), the effective prestress force in the girder was calculated using flexural theory. Specified initial prestress force, effective prestress force and total losses are shown in Table 2. Note that calculation of the experimental prestress force utilized flexural stiffness properties derived from the experimental load-displacement data.

An effective prestress force of 112kips was calculated from the experimental data. Assuming an initial prestress force of 210kip as per the construction drawings, the experimental data indicate a 47% loss in prestress force. This value of prestress loss is unusually high suggesting that the initial prestress force may have been less than specified. This would not be unreasonable considering other inconsistencies between the girders and plans, such as placement of vertical reinforcement. It is not known if the experimentally evaluated prestress force from I2A was representative of all test girders.

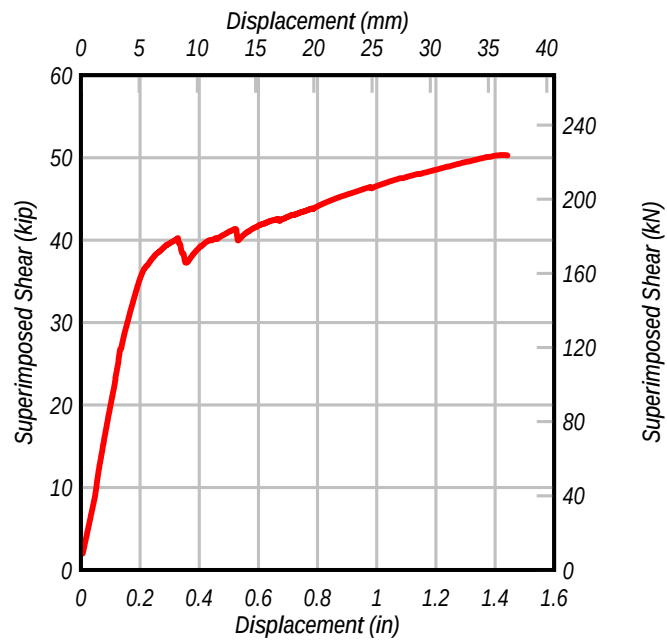
Figure 27-I2A shear vs. displacement

After evaluating I2A for effective prestress, the specimen was loaded to ultimate load. Load was applied at an a/d ratio of 4.5. Shear-displacement data from the ultimate load test is presented in Figure 27. Contrary to X4 and X7, girder I2A did not rotate about its long axis during loading. Flexural cracks reopened at a load 40 kip, corresponding to 22 kip superimposed shear. According to the shear-displacement plot, significant deviation from linear-elastic behavior did not occur until the shear reached 36k. Softening of the girder corresponded to the propagation of flexural cracks. The abrupt changes in the shear-displaced data at shear forces near 40 kip were due to the formation of inclined cracks in the web. As the load increased, additional cracks formed farther from the load point and at shallower angles. Cracking in the web between the load point and the near support was particularly severe, as noted by the shaded area in Figure 28 and shown in Figure 29.

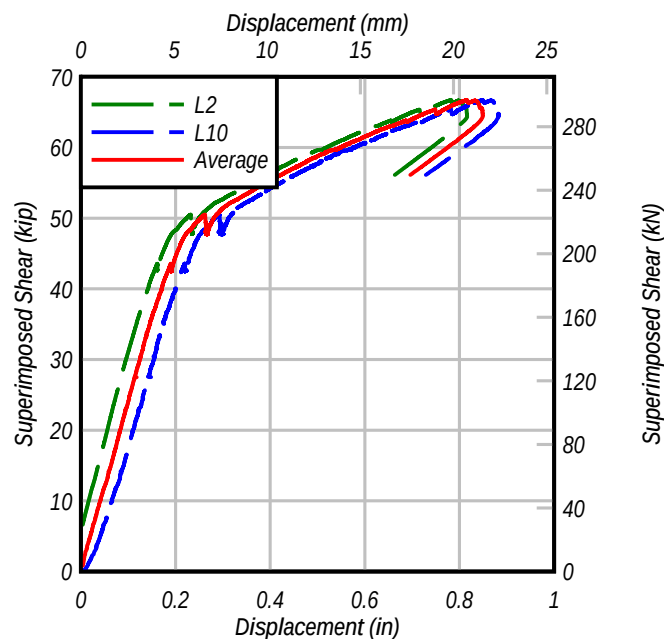
Figure 32–I2B superimposed shear vs. displacement

Girder I2B was loaded at an a/d ratio of 3.3. Figure 32 shows the superimposed shear vs. load point displacement. I2B rotated 0.22 degrees about its long axis as the shear increased from 0kip to 5kip. The girder maintained this rotated orientation for the remainder of the test. Girder I2B behaved linear-elastically until the shear reached about 43kip, at which point flexural cracks formed below the load point (Figure 33). After formation of the initial cracks, load was held constant and the cracks were marked. After loading was resumed, inclined cracks formed in the web and additional flexural cracks formed in the bottom flange. Loading was stopped again to mark the cracks at 50kip of shear. The abrupt change in the shear-deflection plot at 50kip was due to relaxation of the load while cracks were being marked. Loading was again resumed, and additional shallower cracks formed farther from the load point towards the far support. One of these cracks formed at the peak load of 67kip. The load supported by the girder dropped after the formation of the crack at 67kip, and the load was held to mark cracks for the final time. After loading resumed, the inclined cracks near the far support continued to open and propagate,

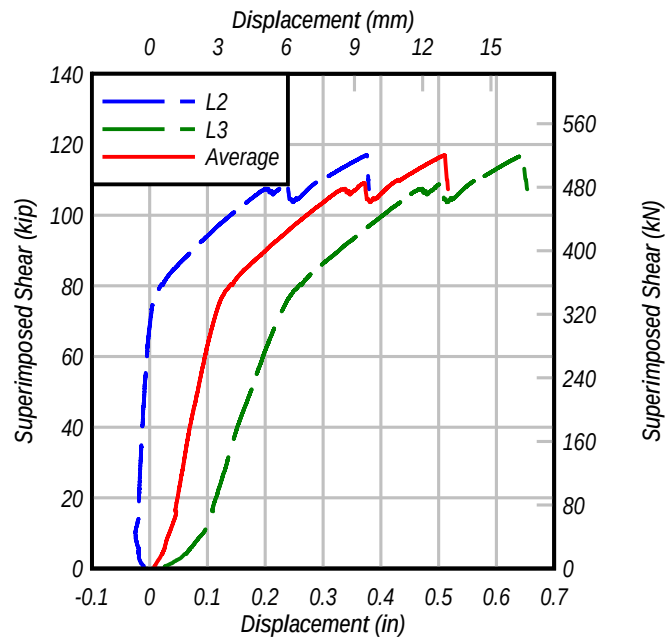
Figure 34-I4 shear vs. displacement

Girder I4 was loaded at an  $a/d$  ratio of 2.1. Figure 34 shows the superimposed shear vs. load point displacement. I4 began rotating about its long axis as soon as load was applied. The angle of rotation increased with increasing load, reaching a maximum of 0.57 degrees just before failure.

As the load was increased additional cracks formed in the web on the far support side. The cracks formed farther from the load point and at shallower angles at higher loads. The abrupt changes in the shear-displacement plot near 112 kip and 118 kip correspond with formation of inclined cracks towards the far support. During the final stages of loading cracks in the web were wide approximately 0.5in wide. As shear could not transfer across the cracks, and as the cracks did not engage transverse reinforcement, it is believed that the end of the girder towards the far support behaved as a tied arch during the final stages of loading. The peak superimposed shear supported by girder I4 was 118k.

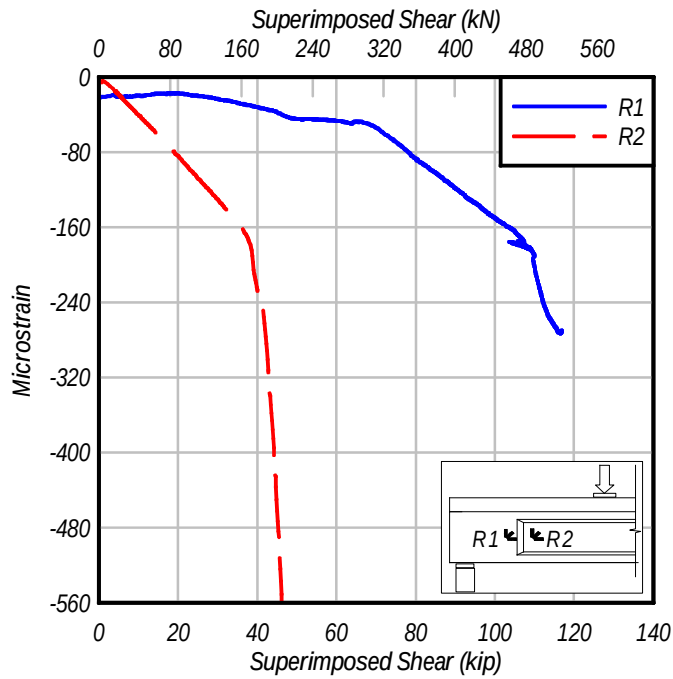
Figure 35-I4 principal strain vs. shear

The first crack formed at a shear of 38 kip as reported by rosette R2 on the web (Figure 35). The initial crack was an incline crack in the web (Figure 36), and appears to have had little effect on the girder stiffness as measured by the shear-displacement relationship. Stiffness of the girder changed at a shear of 75 kip. This is the same load at which the inclined crack near gage R2 was first visually observed.

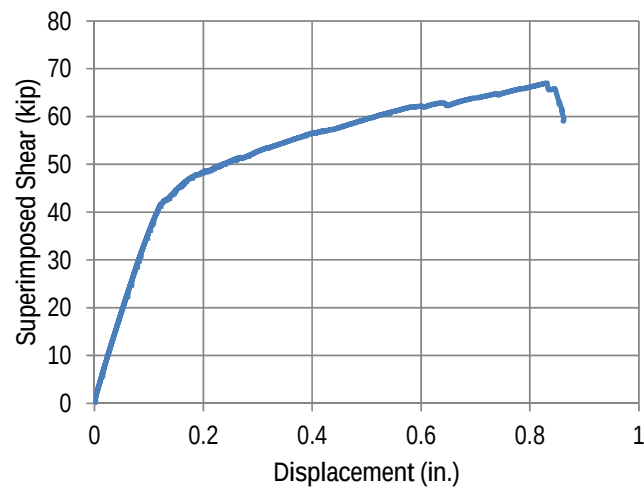
Figure 37–I6 shear vs. displacement.

Girder I6 was loaded at an a/d ratio of 3.5. Figure 37 shows the superimposed-shear versus load-point displacement. The girder behaved linear elastically until the first crack formed at a shear of 43kip. Load at cracking was determined by data from gage S29 (Figure 38). The initial crack was a flexural crack below the load point (Figure 39). Inclined cracks formed in the web toward the near support at a shear of 48kip. Shallower cracks formed farther from the load point as the load was increased. The load test was terminated after a sudden drop in load caused by the formation of an incline crack at the far end of the girder. The maximum superimposed shear was 68kip. Girder I6 did not rotate as load was applied.

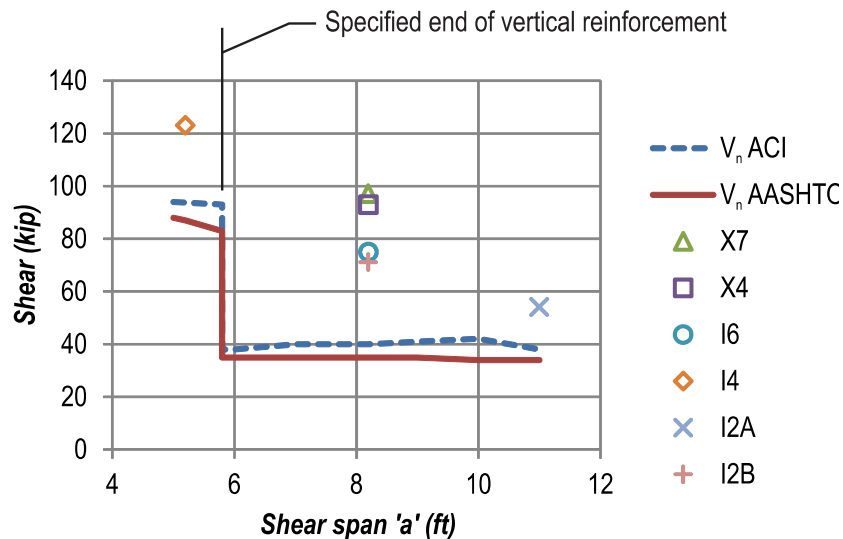
Figure 40—Experimental and theoretical shear capacities.

Based on the girders for which concrete compressive strength and effective prestress were tested, it is assumed that the specified properties are unconservative relative to the physical properties. Thus the approach used for shear calculations resulted in nominal capacities larger than the capacities calculated using the available tested properties. This effect of the approach is inconsequential considering that the experimental capacities were significantly higher than the nominal capacities as shown in Figure 40 and Table 3.

Figure 40 shows the code calculated nominal capacities plotted against the shear span length ( $a$ ). The discontinuity at  $a = 5.7$  occurs due to the specified termination of transverse reinforcement at that location. Point data on the figure represent the experiment shear capacity of the test girders. The experimental capacity of the girders was taken as the maximum superimposed shear plus the dead load shear. In each case, the experimental capacities of the girders were greater than the theoretical capacities predicted by ACI and AASHTO codes. Also note that the exterior girders exhibited 30% greater shear capacity than the interior girders tested at the same shear span.

Data from Figure 40 are tabulated in Table 3. The average experimental shear capacities were 1.96 and 2.10 times larger than the capacity of the standard girder predicted by ACI and AASHTO, respectively. The average experimental-to-nominal capacity ratio for the exterior girders was 2.56 (ACI) and 2.71 (AASHTO), compared to 1.66 (ACI) and 1.79 (AASHTO) for the interior girders. This increased capacity of the exterior girders is attributed to the shear capacity of the curb. As the test girders tended to behave as tied-arches prior to failure, the presence of the curb contributed to the strength of the arch and thus to the shear capacity of the girder.

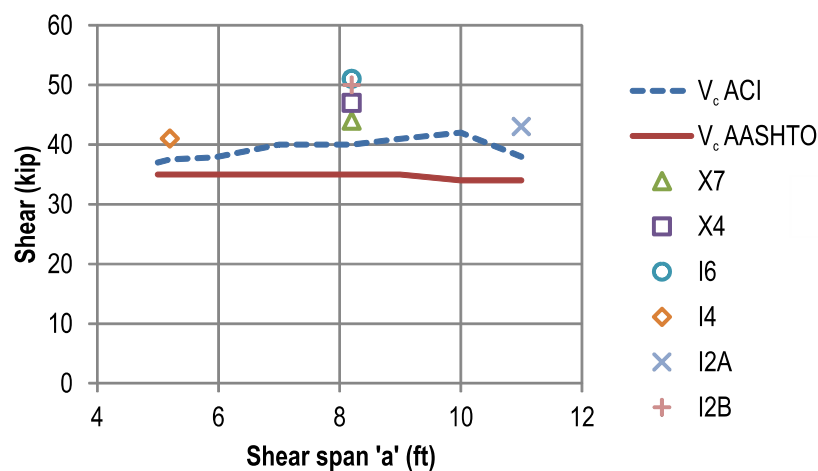
Figure 41–Shear at initial cracking and theoretical concrete contribution.

Experimental loads at the initiation of cracking provide another means of comparison with the theoretically calculated capacities. This comparison is useful for evaluating service behavior and cracking for similar in service girders. Figure 41 shows the theoretical concrete contribution as calculated by the ACI and AASHTO provisions. The theoretical concrete contribution represents the nominal strength of the standard section without shear reinforcement. The point data on this figure mark the total (dead plus superimposed) shear load of the first inclined cracking in the web. Load at first web cracking was determined from the strain gage data. Cracking load indicated by the strain gages was lower than the load at which cracking was visually observed. Data from Figure 41 are tabulated in Table 5. The average ratio of the experimental shear at cracking to the concrete contribution was 1.17 and 1.32 for the ACI and AASHTO procedures, respectively.
