*Final Report*

## **Durability of In-situ Pipe Repair**

**Developed for the Florida Department of Transportation**  
Larry Ritchie, P.E., Project Manager

November 2011

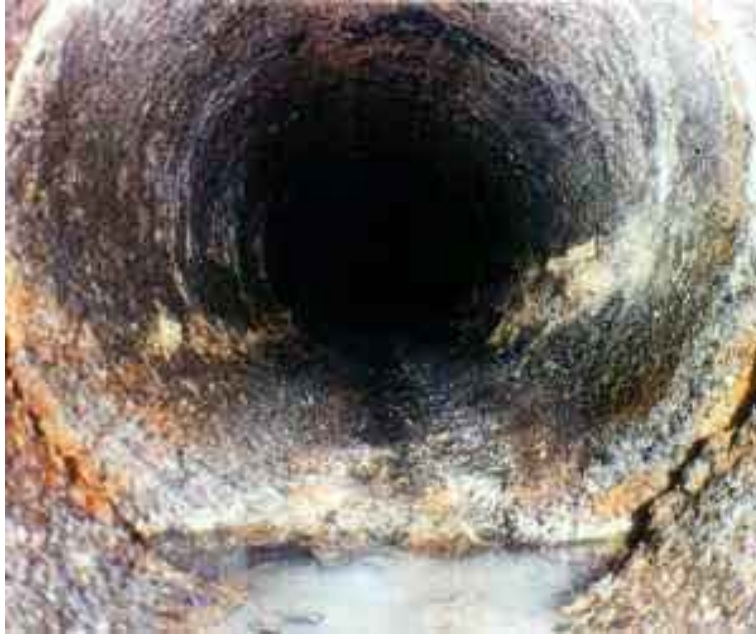
The most common durability problems associated with concrete culverts are abrasion, corrosion, cracks, spalling, invert deterioration, joint defects and misalignment (in precast concrete culverts), and footing problems (in arch-type cast-in-place culverts). Figure 2-2 is an example of a corroded concrete pipe (Oberdorfer AG 2010).

Figure 2-2. Corrosion of concrete pipe at a joint (Oberdorfer AG 2010).

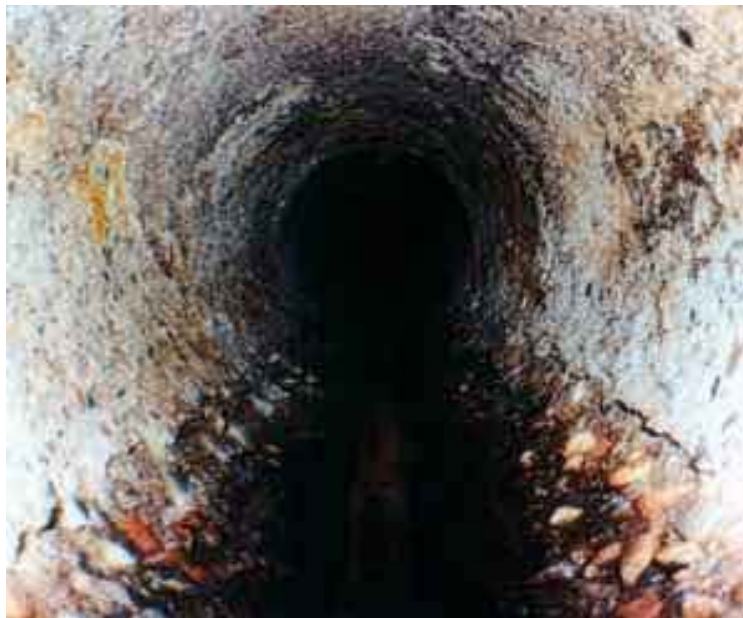
Concrete culverts usually exhibit high resistance to corrosive environments; however, invert deteriorations are also a common type of problem faced with concrete culverts. Deteriorated parts of the inverts should be repaired by paving the invert or applying proper coating materials, such as vitrified clay tiles. If abrasion is an important factor causing the deterioration of the invert, installing a neutralization basin would be a proper method of repair (Najafi et al. 2008). Figure 2-3 shows the damage that an abrasive flow can have on the inside of a concrete pipe (Oberdorfer AG 2010).

Figure 2-3. Damage from abrasive flow (Oberdorfer AG).

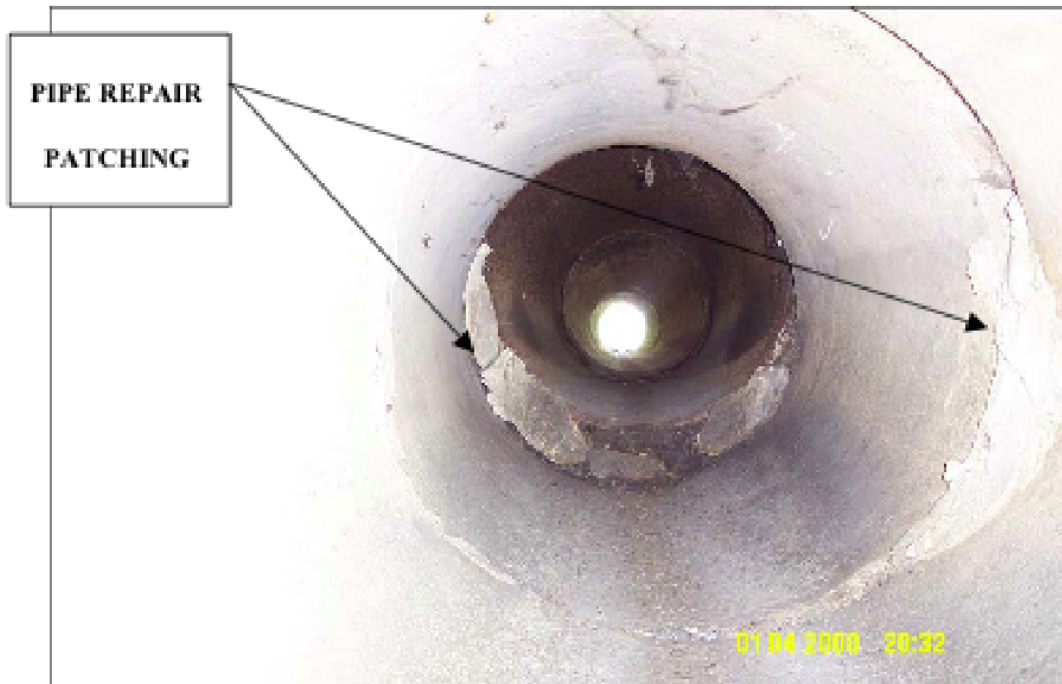
Figures 2-6 and 2-7 show examples of various pipe repair defects detected by CCTV inspection. The assessment of the durability of in-situ pipe repairs is more accurately determined by CCTV inspection of the actual repair point using available advanced technologies such as sonar, laser scanning, and sewer scanning evaluation technology (SSET). Figure 2-8 is a form developed by the DelDOT for calibrating and measuring pipe defects as viewed from CCTV video logs.

Original pipe section(s) repaired by patching.

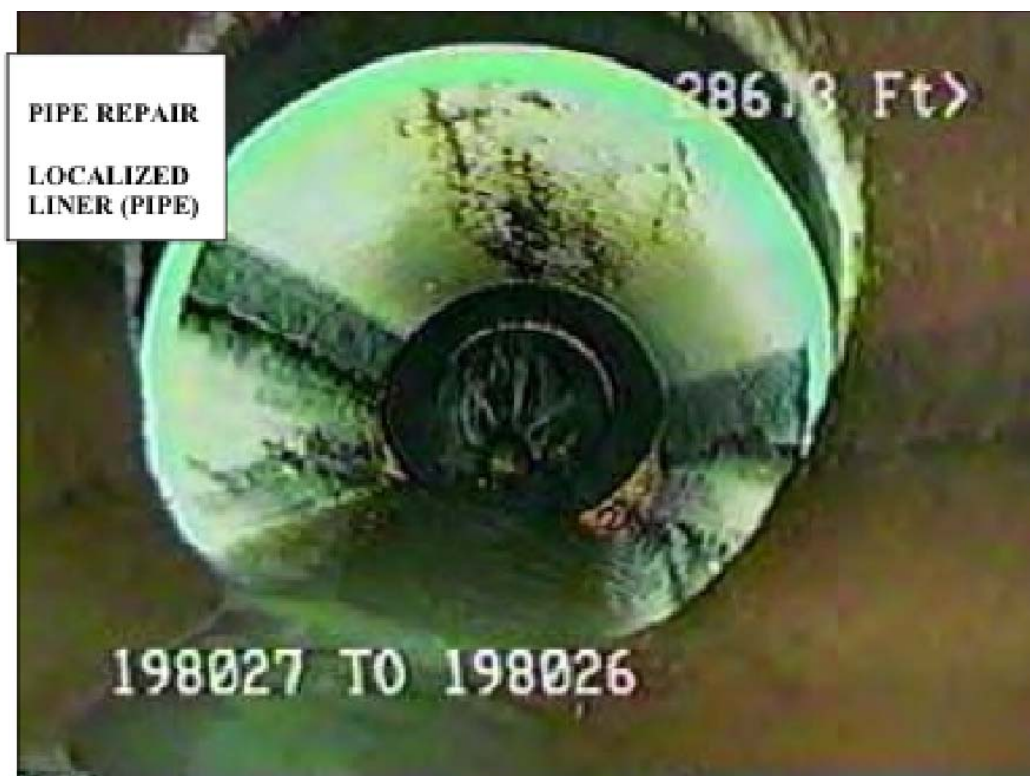
Original pipe section(s) repaired using localized liner.

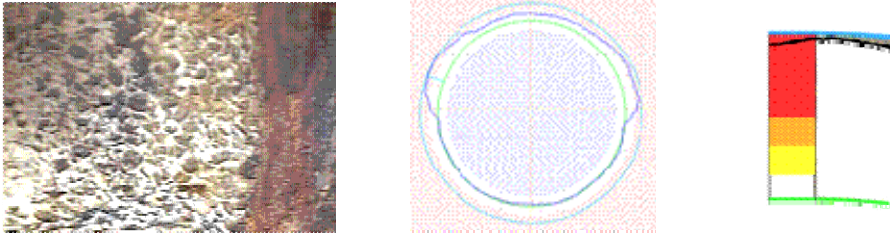
Figure 2-27. Laser profiling image above shows corrosion to 41 mm on original pipe wall (Atlas Inspection Technologies, Inc. 2010).

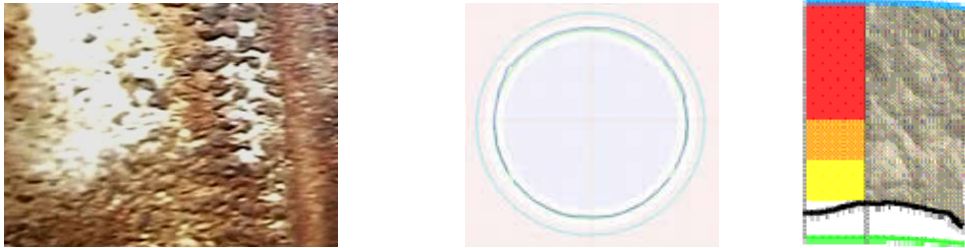
Figure 2-28. Laser profiling image above shows corrosion to 7 mm on pipe wall (Atlas Inspection Technologies, Inc. 2010).

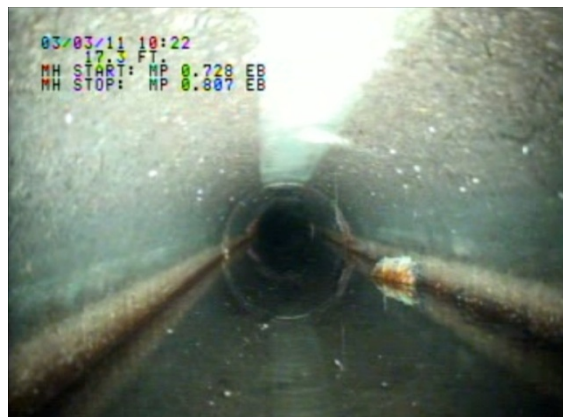
This site is located in Duval County off of SR 115 (see Figure 4-1). The drainage system utilized a curb and gutter system and a 15"-diameter pipe running along the roadway. Soil samples were obtained near the pipe location. The repair utilized at this location was chemical grouting. There was a small amount of standing water in the pipes, probably 1" to 2". All joints along the pipes were supposed to be grouted, but the grout was not apparent (see Figures 4-2 through 4-4). We could not determine with complete accuracy whether the grout was completely eroded or never actually installed, however there were certain joints that may have shown some minute remnants of grout, leading us to believe the grouting was completed and the repair had failed at this point. The appearance of the host pipe was good, with no signs of cracking caused by the installation of the repair. All of the standing water could not be attributed to infiltration, but the repairs showed slight infiltration in certain joints. Some joints were holding up better than others.

Figure 4-3. Screenshot from pipe inspection video of Site #000, showing inside of the pipe.

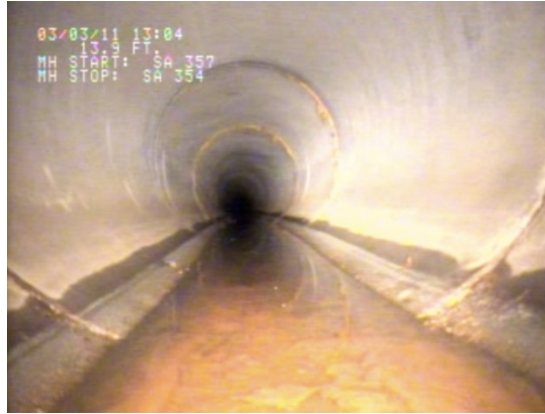
This site is located in Duval County off of SR 115 (see Figure 4-9). The drainage system utilized a curb and gutter system and a 36"-diameter pipe running along the roadway. Soil samples were obtained near the pipe location. The repair utilized at this location was chemical grouting due to infiltration in the joints repaired. There was no staining, water, or sediment due to infiltration as the repair showed no infiltration. However, there was mild staining at the bottom of the host pipe due to the chemical grouting (see Figure 4-10). Only the joints that had separation or other causes of infiltration were grouted. The appearance of both the host pipe and the repairs was very good and the host pipes showed no cracking caused by the installation of the repair. The repair installation had no apparent defects. Chemical grouting appears to be a good solution to small gaps and slight infiltrations at joints of the host pipe, such as shown in Figure 4-11 from Site #000.

Figure 4-10. Screenshot from pipe inspection video of Site #002, showing the inside of the pipe.

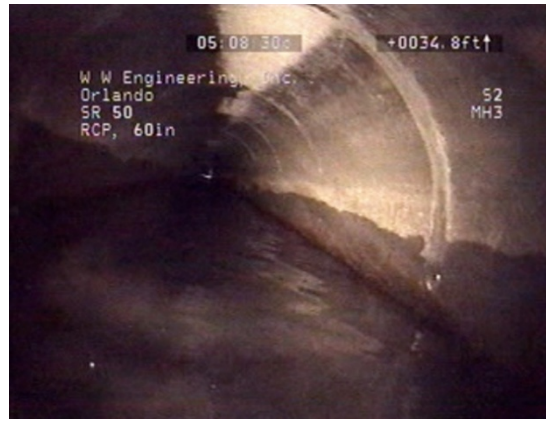
rover through the pipe, so the contractor walked the camera through the pipe. All joints along the pipes were grouted, but the grout seemed to be fading and slightly deteriorating. The appearance of the host pipe was good and the host pipes showed no cracking caused by the installation of the repair. All of the standing water could not be attributed to infiltration, but a small number of the repaired joints showed very light infiltration, according to the contractor. Some joints were holding up better than others. These failures appeared to be caused by the effect of time rather than by poor installation or implementation.

Figure 4-14. Screenshot from pipe inspection video of Site #003, showing the inside of the pipe.

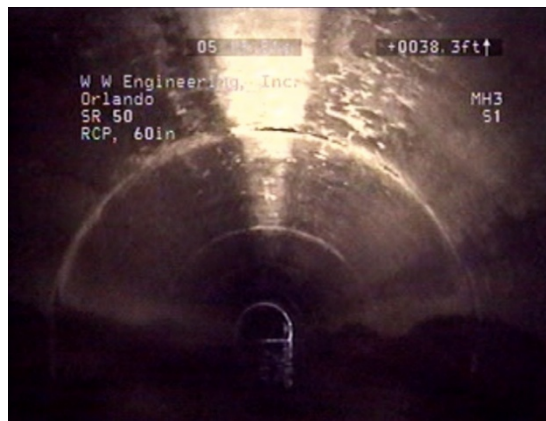
Figure 4-15. Screenshot from pipe inspection video of Site #004, showing the inside of the pipe.

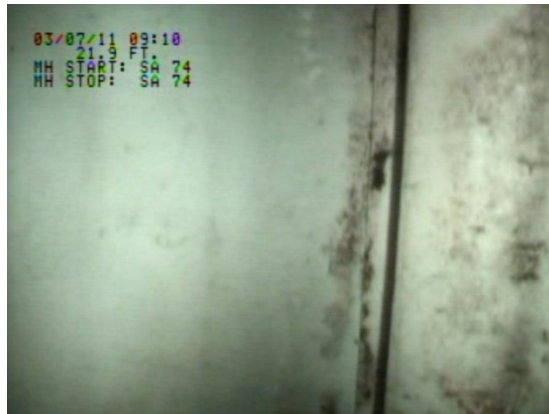
This site is located in Clay County off of SR 224 (see Figure 4-18). The drainage system utilized a curb and gutter system and a 15"-diameter pipe running across the roadway. Soil samples were obtained near the pipe location. The repair utilized at this location was a pipe liner (see Figure 4-19). There was no staining or water or sediment due to infiltration as the repair showed no infiltration. The liner was placed in the entire run of the pipe. The appearance of the repair was very good; it showed no cracking caused by the installation of the repair. The repair installation had no apparent defects. See Figures 4-20 and 4-21.

Figure 4-19. Screenshot from pipe inspection video of Site #005, showing a joint of the pipe liner.

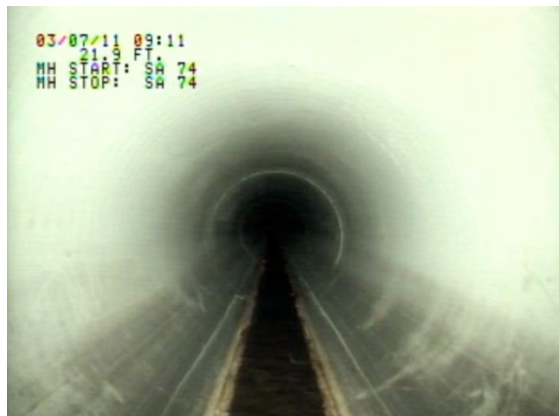
Figure 4-20. Screenshot from pipe inspection video of Site #005, showing the inside of the pipe.

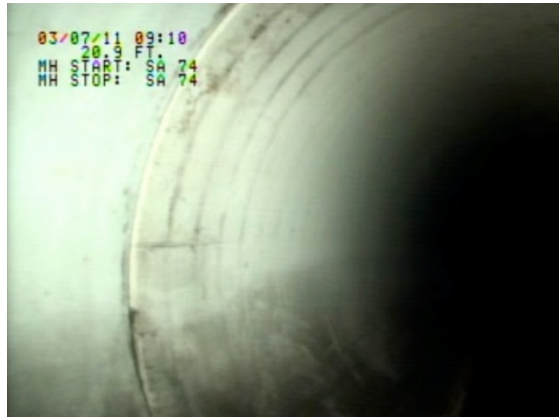
Figure 4-21. Screenshot from pipe inspection video of Site #005, showing a joint of the pipe liner.

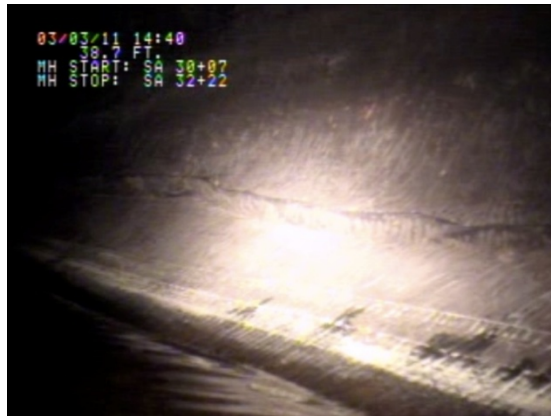
This site is located in Duval County off of SR 128 (see Figure 4-22). The drainage system utilized a curb and gutter system and a 48"-diameter pipe running across the roadway. Soil samples were obtained near the pipe location and directly on top of the pipe. The repair utilized at this location was a pipe liner to seal a large portion of the pipe (see Figures 4-23 through 4-25). There was no staining or water or sediment due to infiltration as the repair showed no infiltration. The liner was placed in the entire run of the pipe. The appearance of both the host pipe and the repairs was very good and the host pipes showed no cracking caused by the installation of the repair. There was a small section of the liner which showed a wrinkle in the felt tube, but it appeared this was done for a purpose unknown to us, rather than due to poor installation.

Figure 4-23. Screenshot from pipe inspection video of Site #005, showing the pipe liner.

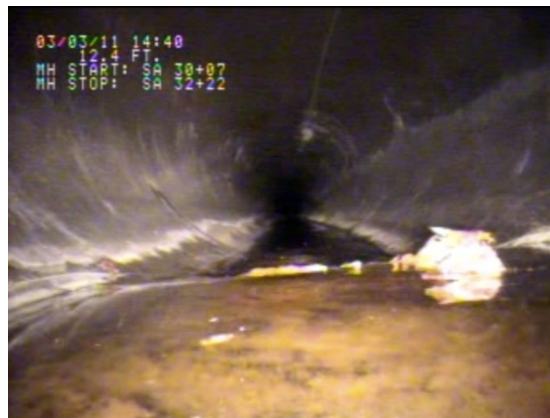
Figure 4-24. Screenshot from pipe inspection video of Site #006, showing the inside of the pipe.

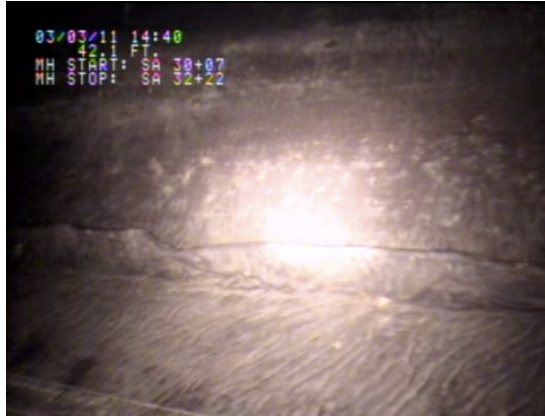
Figure 4-25. Screenshot from pipe inspection video of Site #005, showing the pipe liner and the wrinkle.

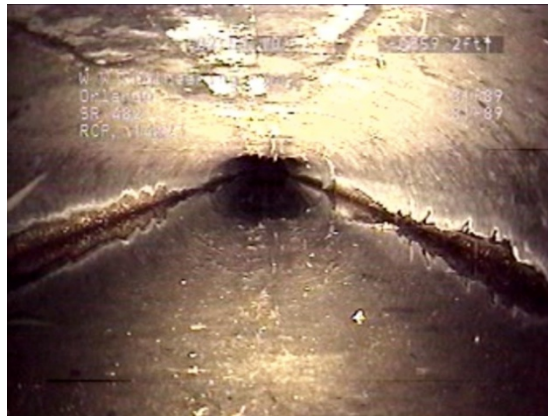
This site is located in Orange County off of SR 482 (see Figure 4-26). The drainage system was directly off the highway and utilized dual 13" × 24" elliptical pipe running across the highway. Soil samples were obtained directly on top of the pipe. The repair utilized at this location was a pipe liner (see Figure 4-27). There was a small amount of standing water, probably 1" to 2"; however, there did not appear to be much, if any, infiltration. The repair installation appeared to be proper; however, it did show a large amount of erosion. The liner was placed along the entire run of the pipe where there appeared to have been cracking, and separation of the host pipe. The appearance of the repair was not great and the host pipe was in poor shape; however, this appeared to have been the reason for the repair not a result of it. There was a small amount of debris in the pipe which possibly restricted drainage, resulting in the small amount of standing water observed.

Figure 4-27. Screenshot from pipe inspection video of Site #008, showing the inside of the pipe and the pipe liner.

*Orange County Site #008* – The pipe had standing water from five o'clock to seven o'clock and there appeared to be some light corrosion below the water line. Along the left side of the pipe, there was a wrinkle in the felt tube, however this did not seem to cause any issues.

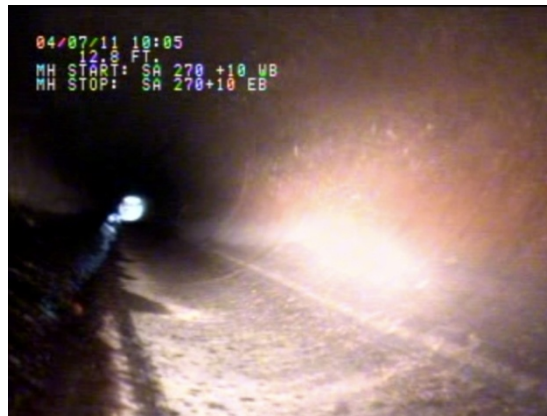
This site is located in Alachua County off of SR 24 (see Figure 4-28). The drainage system utilized a curb and gutter system connecting to a pipe running across the roadway. Soil samples were obtained near the pipe location. The repair utilized at this location was a cured in place impermeable fiberglass pipe liner to seal the entire run of the pipe (see Figure 4-29). There was no staining or water or sediment due to infiltration since the repair showed no infiltration. The liner was placed in the entire run of the pipe. The appearance of both the host pipe and the

repair was very good and the host pipes showed no cracking caused by the installation of the repair.

Figure 4-29. Screenshot from pipe inspection video of Site #009, showing the inside of the pipe and the pipe liner placed along the entire run of the pipe.

*Alachua County Site #009* – The pipe had a small amount of water but showed no visible structural issues and zero corrosion on the surface of the pipe.

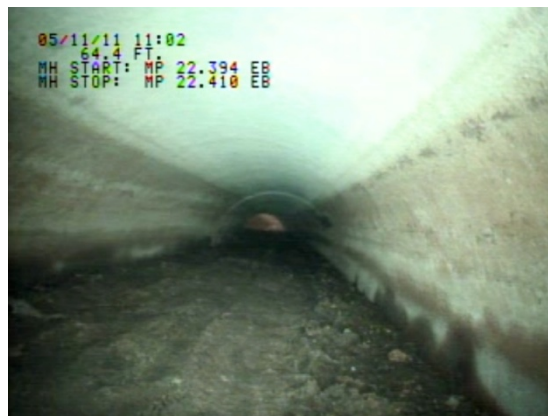
Figure 4-34. Screenshot from pipe inspection video of Site #010, showing the inside of the pipe.

*Putnam County Site #010* – The pipe had no standing water and there were no visible structural issues. There appeared to be a very light amount of corrosion along some of the joints.

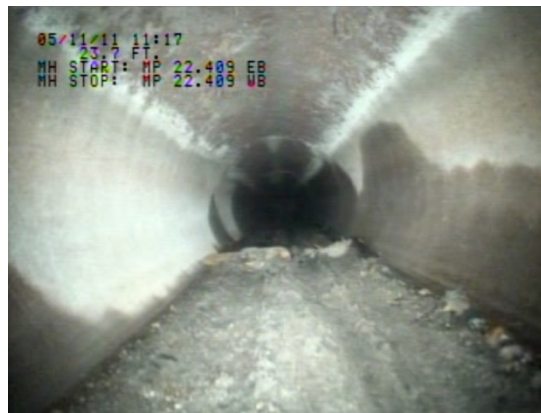
Figure 4-37. Screenshot from pipe inspection video of Site #011, showing the inside of the pipe.

*Putnam County Site #011* – The pipe had some debris along the bottom of the pipe, but had no visible structural issues. There appeared to be some corrosion along some of the joints.

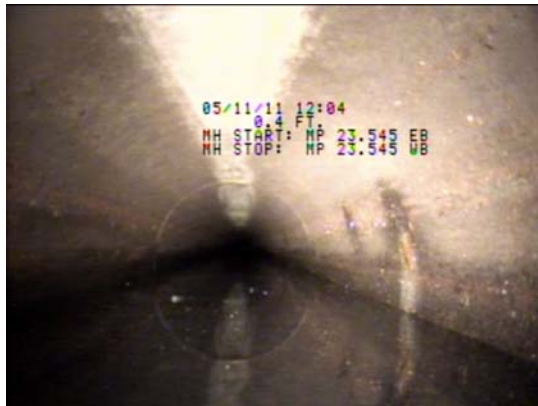
Figure 4-40. Screenshot from pipe inspection video of Site #012, showing the inside of the pipe.

*Putnam County Site #012* – The pipe had standing water from five o'clock to seven o'clock. There were no visible structural issues and there appeared to be some corrosion along some of the joints.

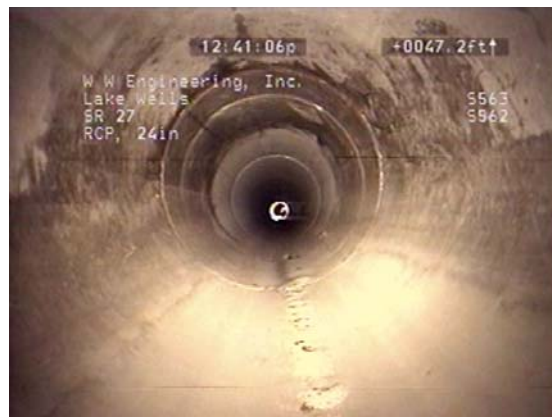
This site is located in Polk County off of SR 25 and US 27 (see Figure 4-42). The drainage system utilized a curb and gutter system and a 24"-pipe running along the highway. Soil samples were obtained near the pipe location. The repair utilized at this location was a repair sleeve (see Figures 4-43 and 4-44). There was no staining or water or sediment due to infiltration as the repair showed no infiltration. The repair installation appeared to have no defects and to be of high quality. The sleeve was placed along the middle section of the pipe where the host pipe showed some cracking; other joints which showed no such issues were not included in the sleeve. The appearance of both the repairs and the host pipe was good and the host pipe showed no cracking caused by the installation of the repair. There was no debris in the host pipe.

Figure 4-44. Screenshot from pipe inspection video of Site #015, showing the inside of the pipe.

*Polk County Site #015* – The pipe had no standing water and no visible structural issues. There appeared to be some light corrosion along the very bottom of the pipe and along some of the joints.

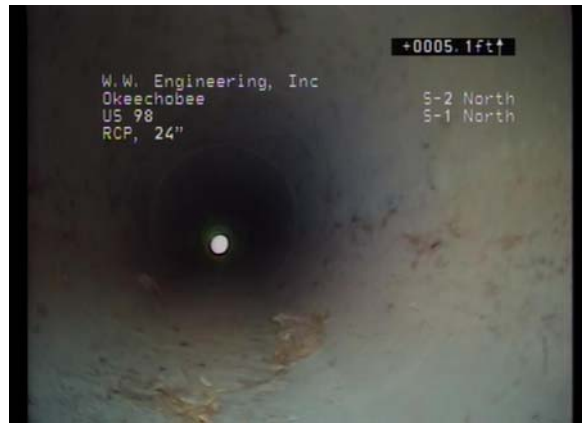
This site is located in Okeechobee County off of SR 700 and US 98 (see Figure 4-45). The drainage system was directly off the highway and utilized dual 24"-pipe running across the highway. Soil samples were obtained directly on top of the pipes. The repair utilized at this location was NPC internal joint seals (see Figure 4-46). There was no staining or water or sediment due to infiltration as the repair showed no infiltration. The repair installation appeared

to have no defects and to be of high quality. The seals were placed only at joints that had significant separation; other joints which had acceptable separation were not repaired. The appearance of both the repairs and the host pipes was good, and the host pipes showed no cracking caused by the installation of the repair (see Figure 4-47). There was minimal debris in the host pipes; the small amount of debris was probably due to the location of the pipes (the pipes were directly exposed to the outside environment).

Figure 4-47. Screenshot from pipe inspection video of Site #013, showing the inside of the pipe.

*Okeechobee County Site #013* – The pipe had no standing water and no visible structural issues. There appeared to be some corrosion along the joints which had not been banded.

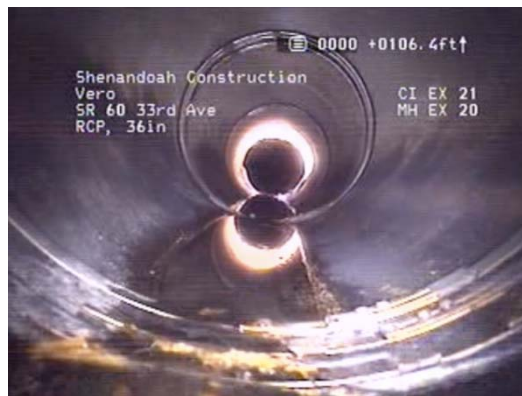
This site is located in Indian River County off of SR 60 (see Figure 4-48). The drainage system utilized a curb and gutter system and a 36"-pipe which ran along the roadway. Soil samples were obtained directly on top of the pipes via boring through the pavement. The repair utilized at this location was a set of band seals (see Figure 4-49). There was no staining or water or sediment due to infiltration as the repair showed no infiltration. The repair installation appeared to have no defects and to be of high quality. The seals were placed on all joints along the run of the pipe. The appearance of both the repairs and the host pipes was good and the host pipes showed no cracking caused by the installation of the repair (see Figure 4-50). There was minimal debris in the host pipes.

Figure 4-50. Screenshot from pipe inspection video of Site #014, showing the inside of the pipe.

*Indian River County Site #014* – The pipe had standing water along the bottom of the pipe. There were no visible structural issues, but the pipe appeared to have some light corrosion along the length of the pipe from 3 o'clock to 6 o'clock.
