## **FINAL REPORT**

### **Effects of Service Life of Aluminized Steel Corrugated Pipe with Visible and Not Visible Coating Deficiencies within the Lock System**

FDOT Contract Number: BDV25-977-62

PI: Christopher L. Alexander, University of South Florida, Tampa, FL.

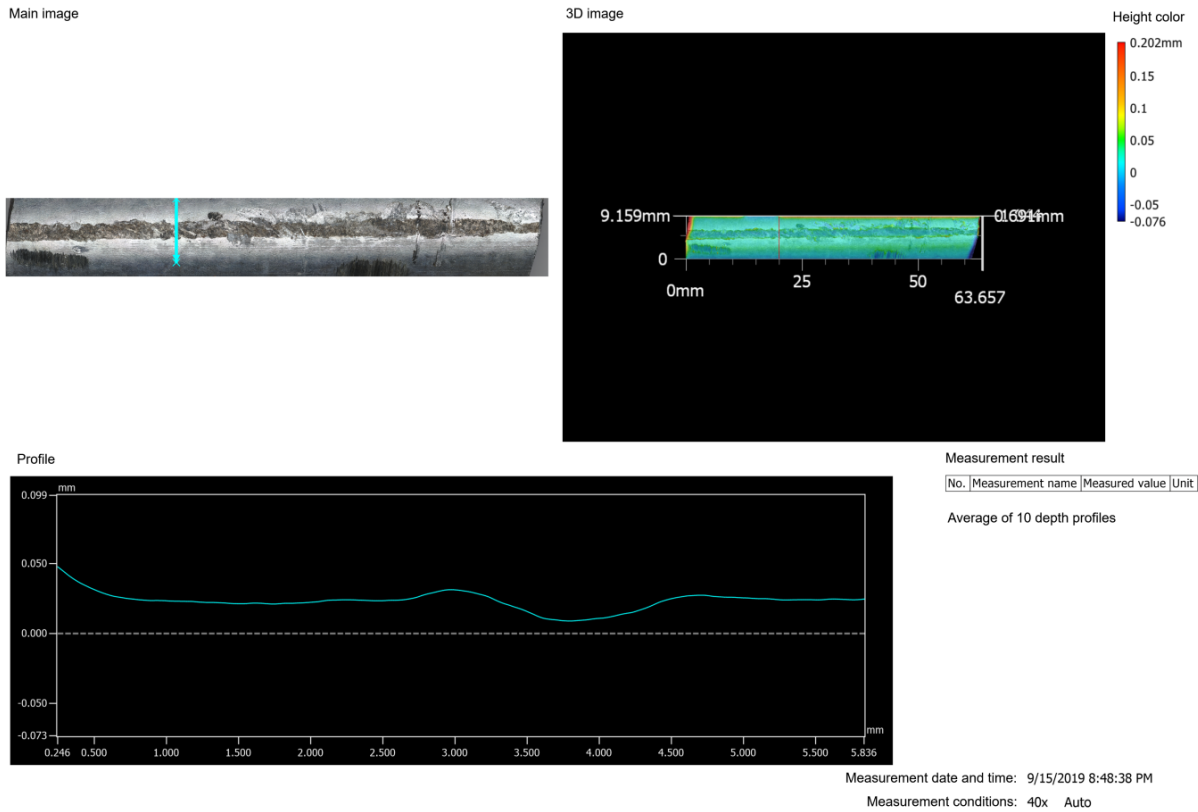
Figure 3.2. Surface analysis results of a coating scrape along the corrugation of an aluminized pipe.

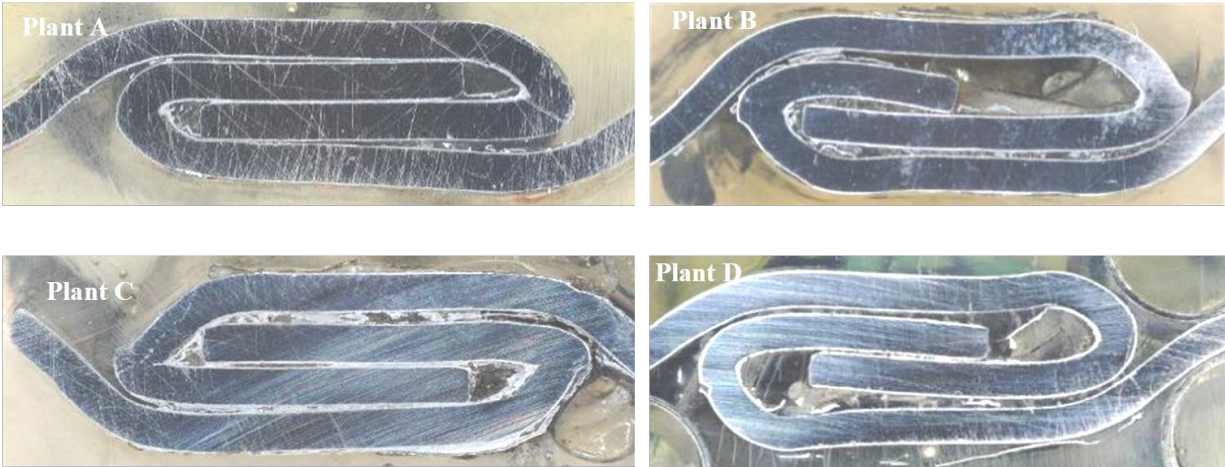
Even though each plant followed the same standard to form drainage pipes, the lock-seams from each plant differed in terms of the way that the two sheets locked together. For some plants the lock-seam was looser than others. Figure 3.8 and Figure 3.9 show the different shapes and looseness of the lock-seams from each plant for both the aluminized and galvanized steel pipes, respectively.

*Figure 3.8. Aluminized steel pipe lock-seams from four different manufacturers.*

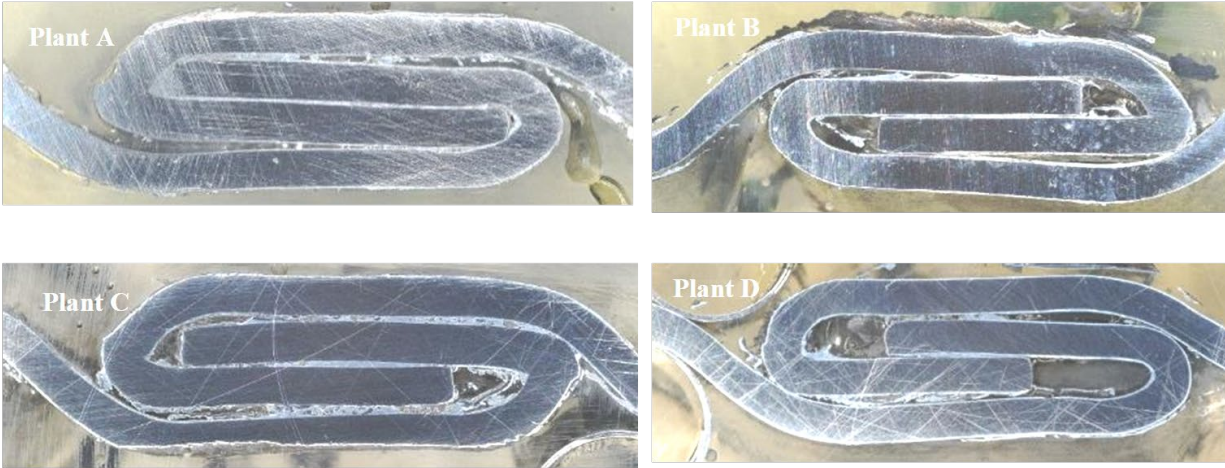
*Figure 3.9. Galvanized steel pipe lock-seams from four different manufacturers.*

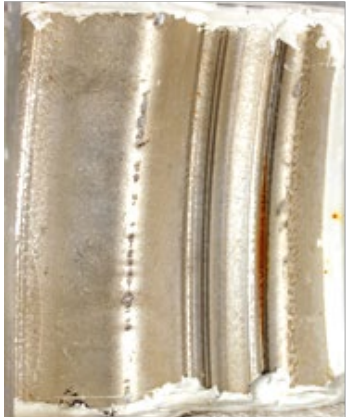
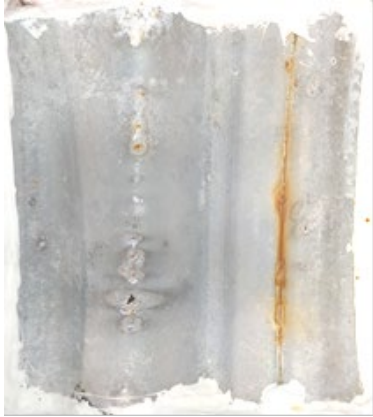
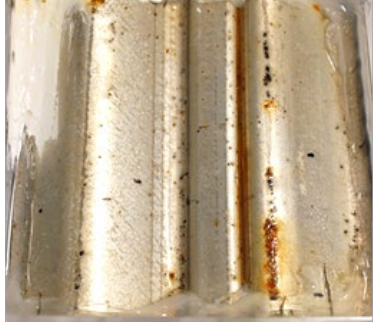
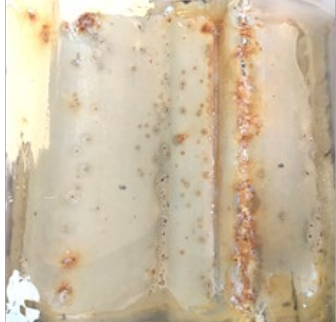
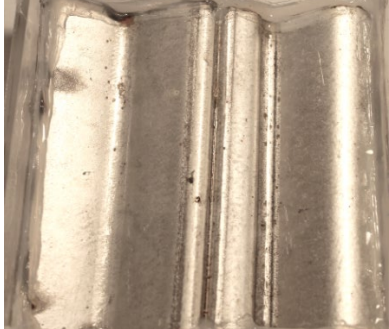
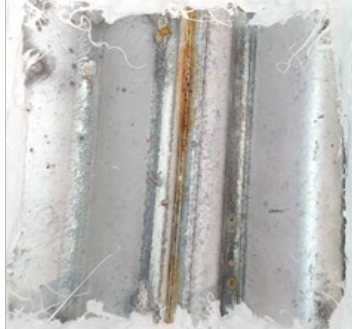
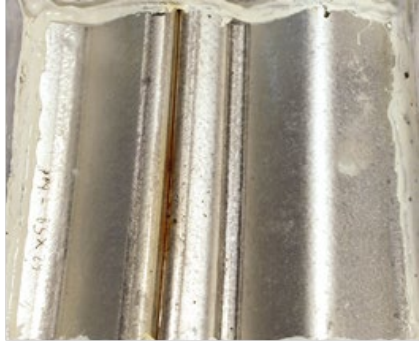
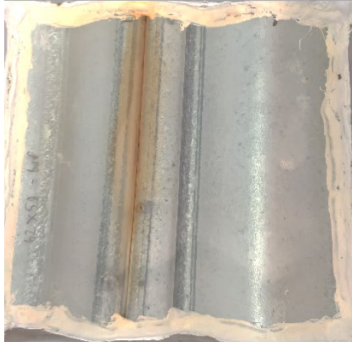
Aluminized steel samples cut from plant A and B pipes are presented in Figure 4.3 and those of plant C and D are presented in Figure 4.4. After 51 days of immersion, the plant A specimens show clear signs of steel corrosion products at the mouth of the lock-seams, and this occurs more in the mild case. There are no signs of aluminum corrosion products at this stage of exposure indicating that the aluminum does not seem to provide any protection to exposed steel defects as was the case with the galvanized steel specimens. However, at the end of the exposure period (227 days), there is clear presence of general aluminum corrosion and in some cases aluminum corrosion around defects suggesting some protection ability after a certain exposure period. Similar results were observed for plants B, C, and D. This agrees with prior work which showed that initially the aluminum remains passive in natural waters until there is either a brief period where the bulk solution pH or local cathodic activity at the coating surface results in alkalinization. Additionally, there were also some cases in which the aluminum corrosion products were localized and surrounded small defects.

*Figure 4.3. Aluminized steel long-term immersion samples at 51 days (left column) and after 227 days (right column) of immersion in aggressive and mild solutions for Plants A and B.*

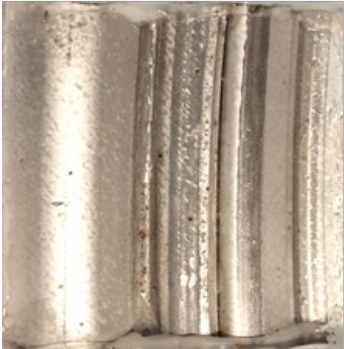
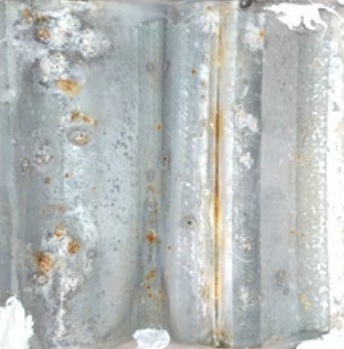
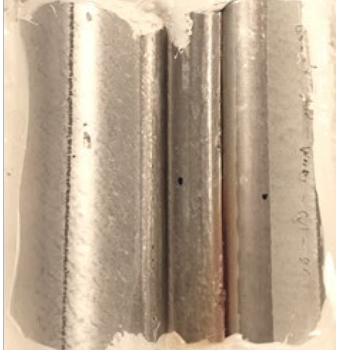
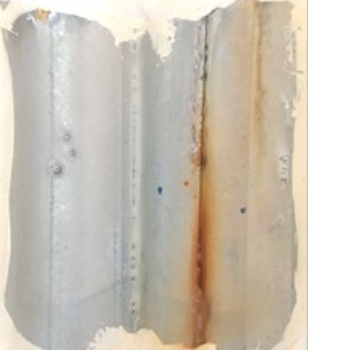
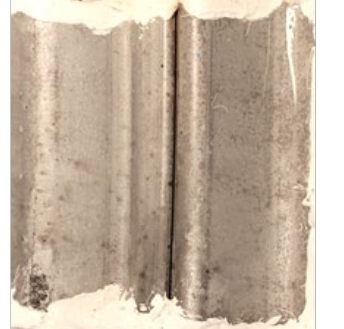
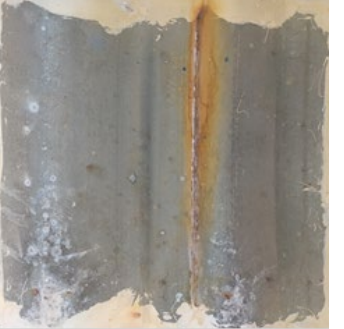
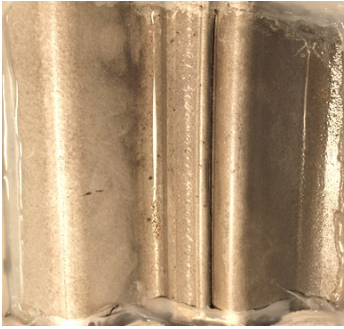
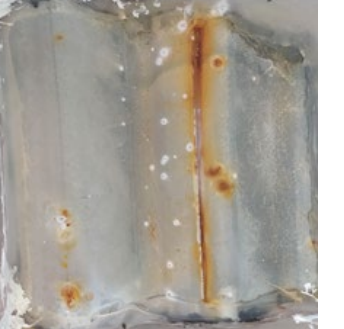
*Figure 4.4. Aluminized steel long-term immersion samples at 51 days (left column) and after 227 days (right column) of immersion in aggressive and mild solutions for Plants C and D.*
