**FINAL REPORT (Project BDV25-977-69)**

**Identification of the Mechanisms that Produce Hydrogen Embrittlement on  
Post-Tensioning Members and the Effects of Galvanic Coupling on Bridge  
Tendons**

**Final Report to Florida Department of Transportation**

April 2022

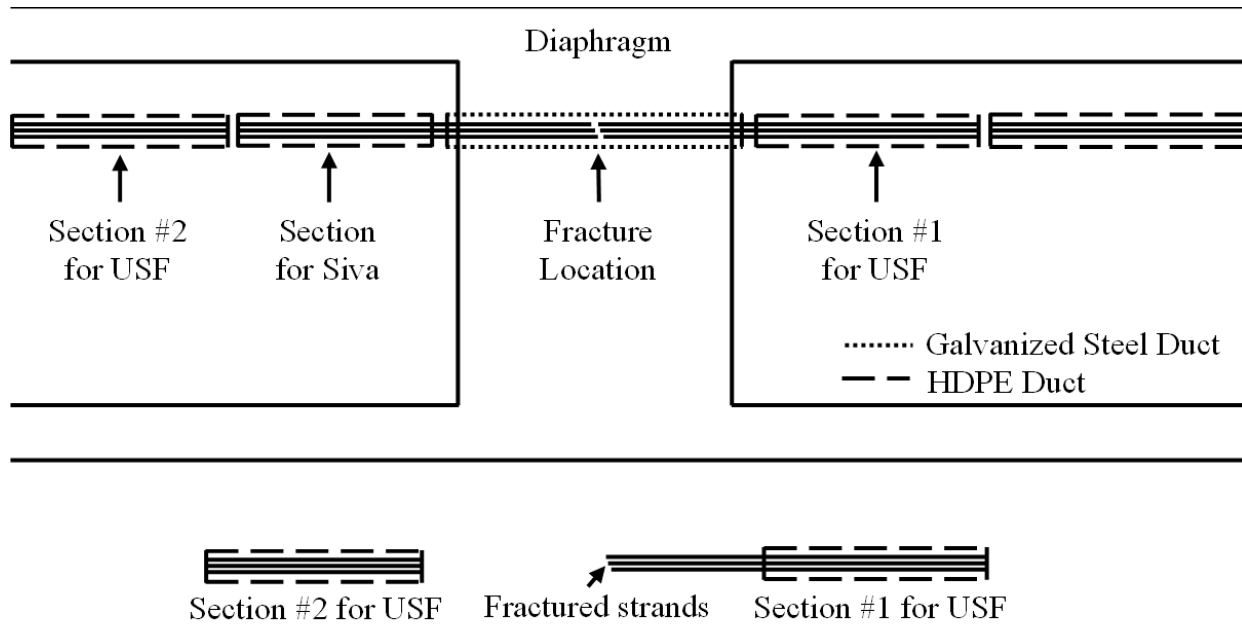
Figure 3-1. Failed tendon cut scheme.

Two sections of the failed tendon were obtained from the South Carolina DOT according to the diagram presented in Figure 3-1. One of the sections included one end of the failed or broken strands that were contained within the galvanized duct of the pier diaphragm and the other section was taken from the external portion of the tendon. The focus of this report is the analysis of the failed section.

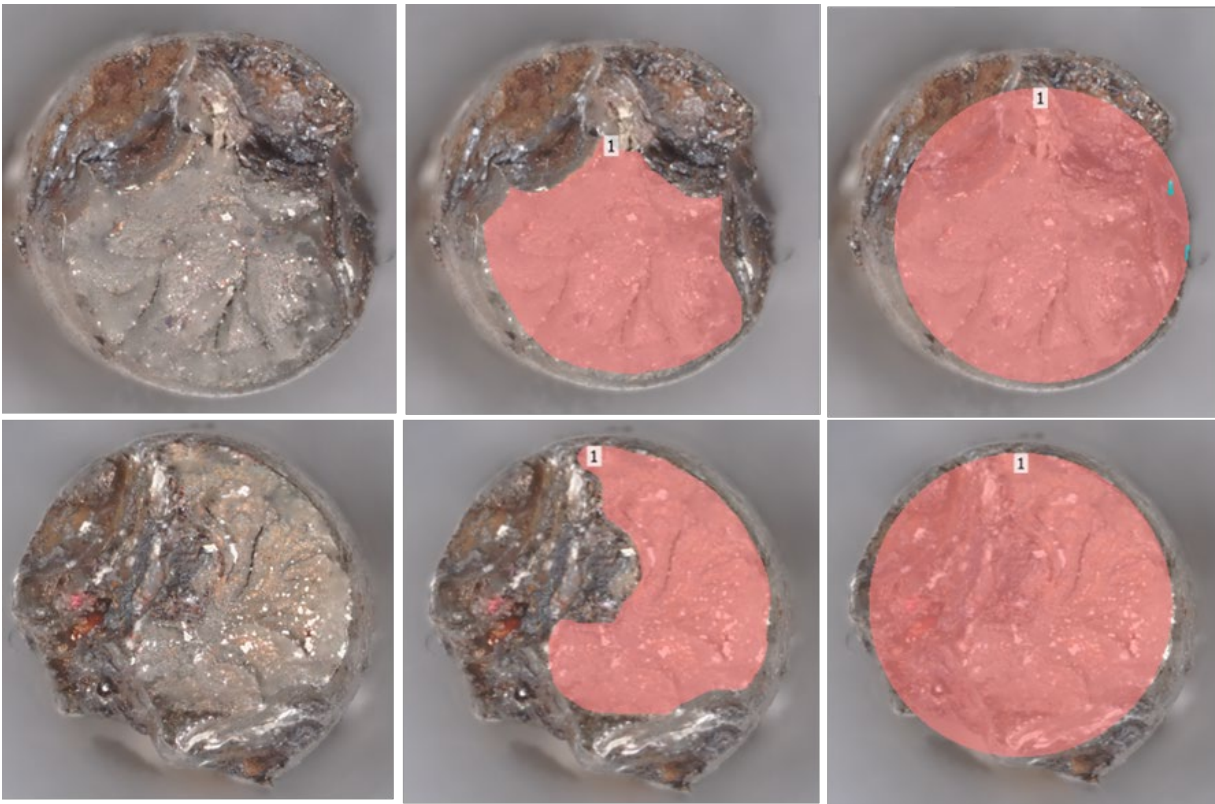
Figure 3-2. Cross-sectional view of selected samples (left), measured non-corroded area (center) and reduced necking area (right).

The corrosion morphology near the fractured ends was assessed using a high resolution 3-D surface scanner. The objective was to quantify the loss in cross sectional area due to corrosion. To do this, any reduction in area due to plastic deformation (necking) had to be accounted for. The average reduced necking area was determined by fitting a circle to the partial necking that was visible in the cross-sectional view as seen in Figure 3-2 right. After identifying the reduced area due to necking,  $A_n$ , the uncorroded fracture surface area,  $A_r$ , was identified as shown in Figure 3-2 middle. The degree of corrosion is then calculated as

While it can be expected that necking results in an observably reduced fracture surface area, it is assumed that the percentage of cross section loss due to corrosion is the same whether necking was present or not.

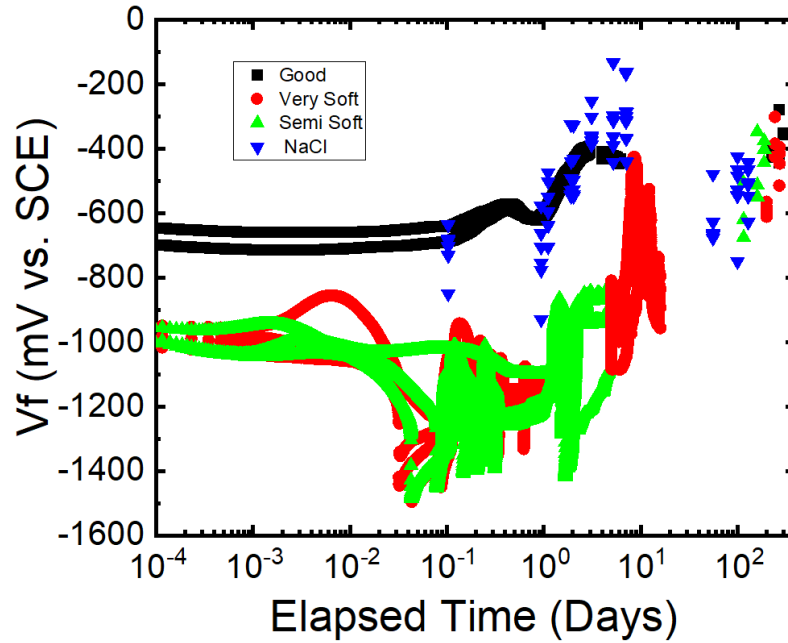
Figure 4-3. Galvanic potential as a function of time in log-scale with grout water-to-cement ratio as a parameter.

According to the results, tendons cast with the recommended water to cement ratio resulted in the most positive cell potential indicating minimal galvanic activity. The tendons cast with intermediate water to cement ratio grout yielded cell potentials ( $< -900 \text{ mV}_{\text{SCE}}$ ) that may suggest hydrogen evolution is likely.

The tendons cast with the high water to cement ratio resulted in cell potentials that were well below the  $-900 \text{ mV}_{\text{SCE}}$  threshold [8] and multiple current density peaks.

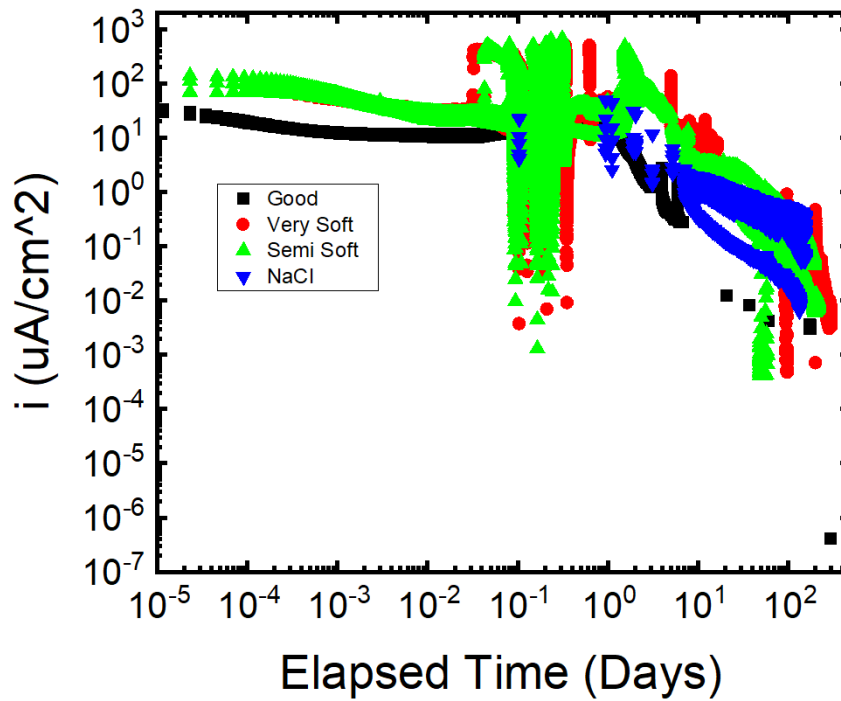
Figure 4-4. Galvanic current density in log-scale as a function of time in log-scale with grout water-to-cement ratio as a parameter.

The results of the galvanic coupling experiments are shown below for the first week following casting. Figures 4-3 and 4-4 respectfully show the potential of the steel wire and the galvanic current density of these three batches plotted as a function of time in log-scale. For ease of interpretation of the general trends, all the results of each tendon were grouped by their water to cement ratio and set to the same color. Since zinc has a more negative corrosion potential than the prestressing steel, the galvanized duct polarizes the prestressing steel to more negative values than its corrosion potential while the duct is polarized to more positive (anodic) potentials than its corrosion potential. The cell potential reported is the amount of polarization applied to each material and should be a value between the two corrosion potentials of each material. The cell resistance or the resistance between the duct and the steel wire in some cases controls the amount of galvanic coupling possible. As the resistance between the two materials decreases, the galvanic couple strengthens, and the steel wire is increasing cathodically polarized. If the steel is overly polarized to more negative values, hydrogen evolution will occur which may lead to embrittlement of the prestressing steel. The galvanic current density is the total current scaled by the surface area of the strand. Therefore, the ideal scenario is for a minimal galvanic couple to form with a weak galvanic potential drop and low galvanic current density.

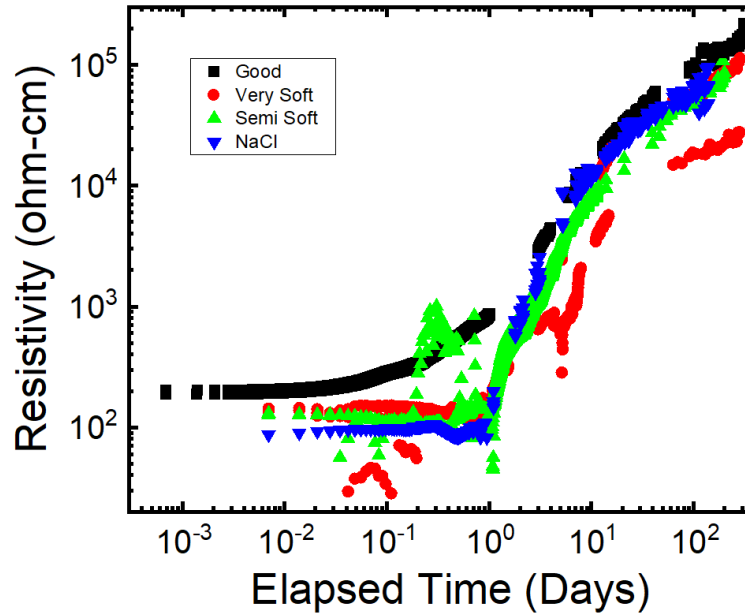
Figure 4-5. Grout resistivity in log-scale as a function of time in log-scale with grout water-to-cement ratio as a parameter.

Based on this data, the resistivity of each of the grout mixtures remained low initially after casting, while the grout was still workable, and began to increase after the first day regardless of the water to cement ratio. As expected, the increased water content in the higher water to cement ratio grouts increased the conductivity of the initial mixture and therefore decreased the resistivity of the initial mixtures. Because of this lower initial grout resistivity for the higher water to cement ratio grouts, any galvanic polarization of the steel strand would be strengthened. Additionally, the higher conductivity grout allows for increased galvanic current to flow in between the strand and the duct.

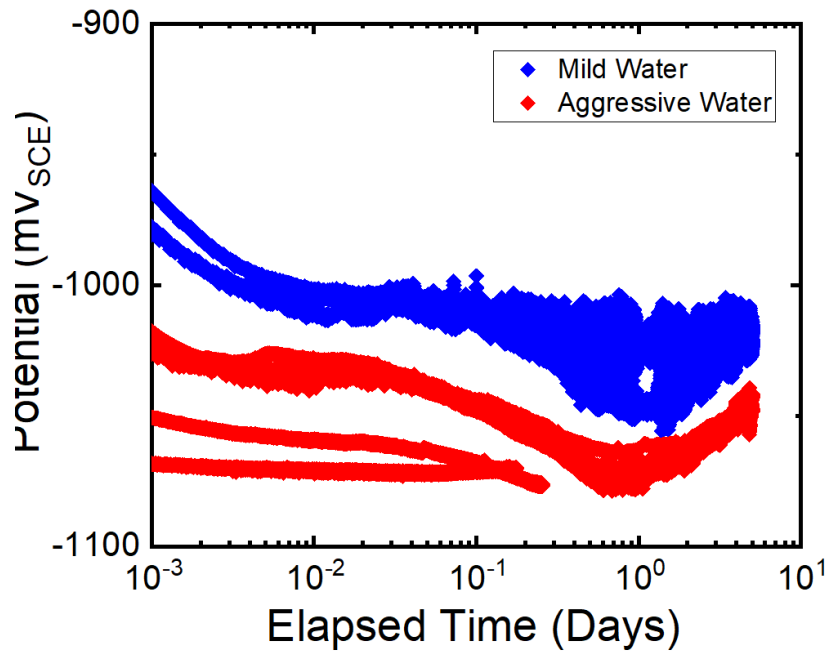
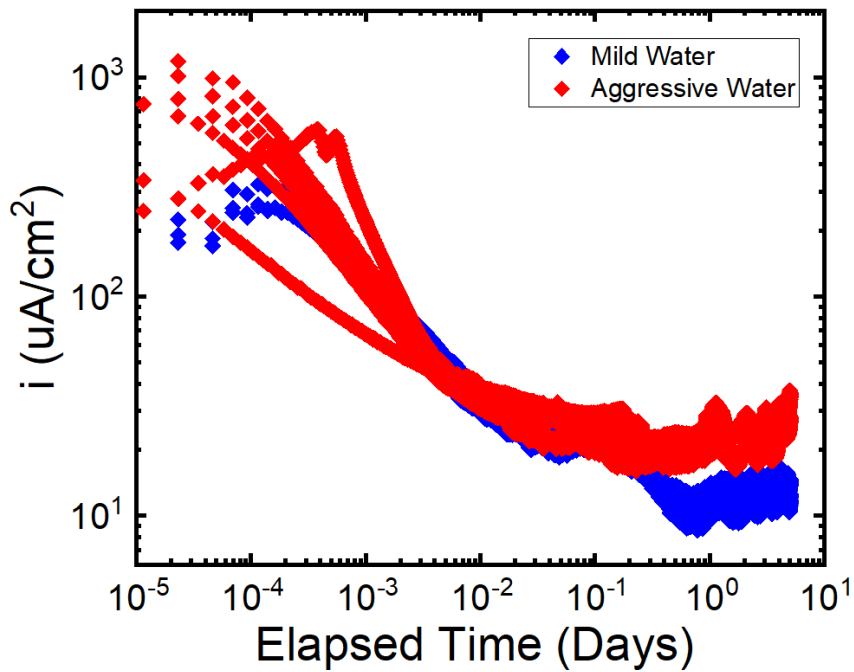
Figure 4-6. Galvanic potential of tendons as a function of time in log-scale with mild or aggressive water solution as a parameter.

Figure 4-7. Galvanic current density in log-scale as a function of time in log-scale with mild or aggressive water solution as a parameter.

Based on Figure 4-6 to Figure 4-8, the elevated current densities of the voided tendons filled with mild and aggressive water show that the hydrogen evolution reaction was likely occurring throughout the duration of those experiments. Further evidence of the hydrogen evolution reaction can be seen in Figure 4-9. This figure shows a photo of one of the solution-filled mock tendons at the end of the experiment where small bubbles were visible at the steel solution interface likely resulting from their formation due to hydrogen evolution at the steel strand surface.

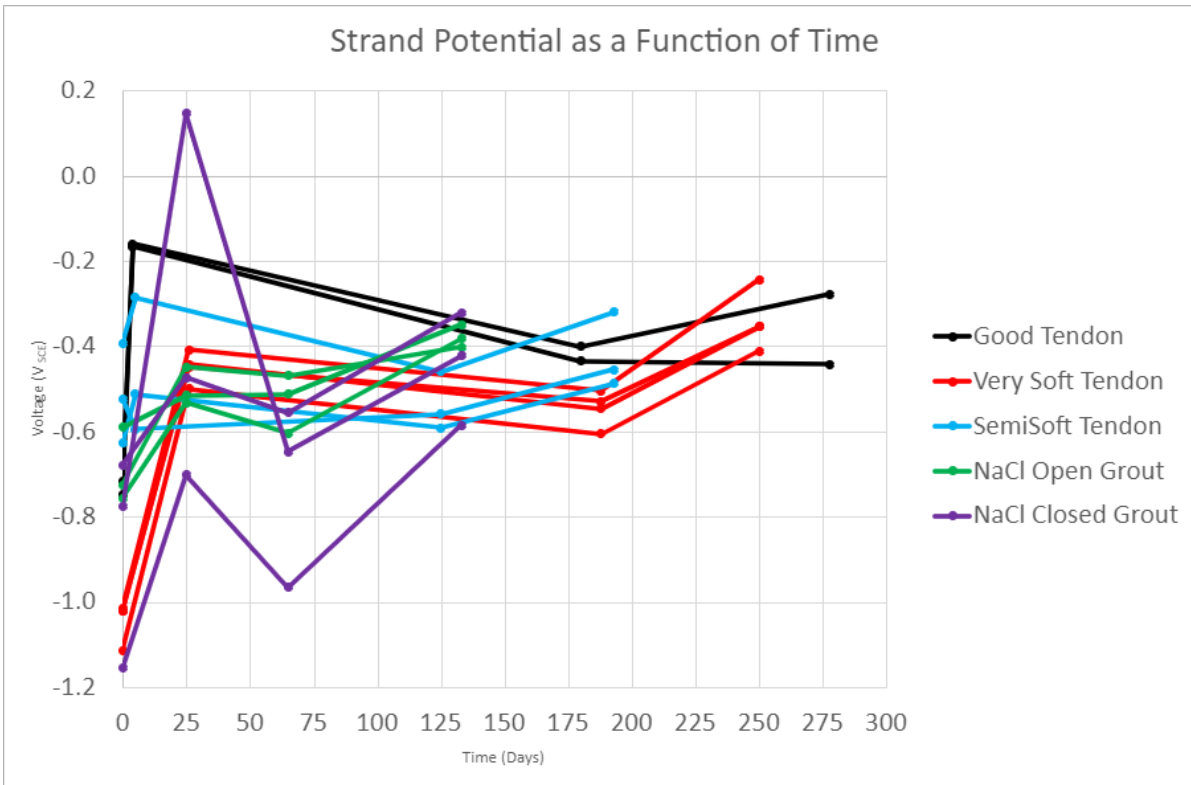
Figure 4-10. Strand corrosion potential vs. SCE over time for each grout condition.

Figure 4-10 shows the the measured corrosion potential of the steel wire as a function of time with the grout condition as a parameter. The most negative value ( $\sim -1.18 \text{ V}_{\text{SCE}}$ ) was measured immediately after casting of the chloride-contaminated grout condition. After approximately 100 days the corrosion potential reached values between  $-0.6$  and  $-0.3 \text{ V}_{\text{SCE}}$ . A similar behavior was observed for the very soft grout condition with the most negative potential measured of  $-1.1 \text{ V}_{\text{SCE}}$  and reaching values between  $-0.4$  and  $-0.25 \text{ V}_{\text{SCE}}$  after 250 days of exposure.

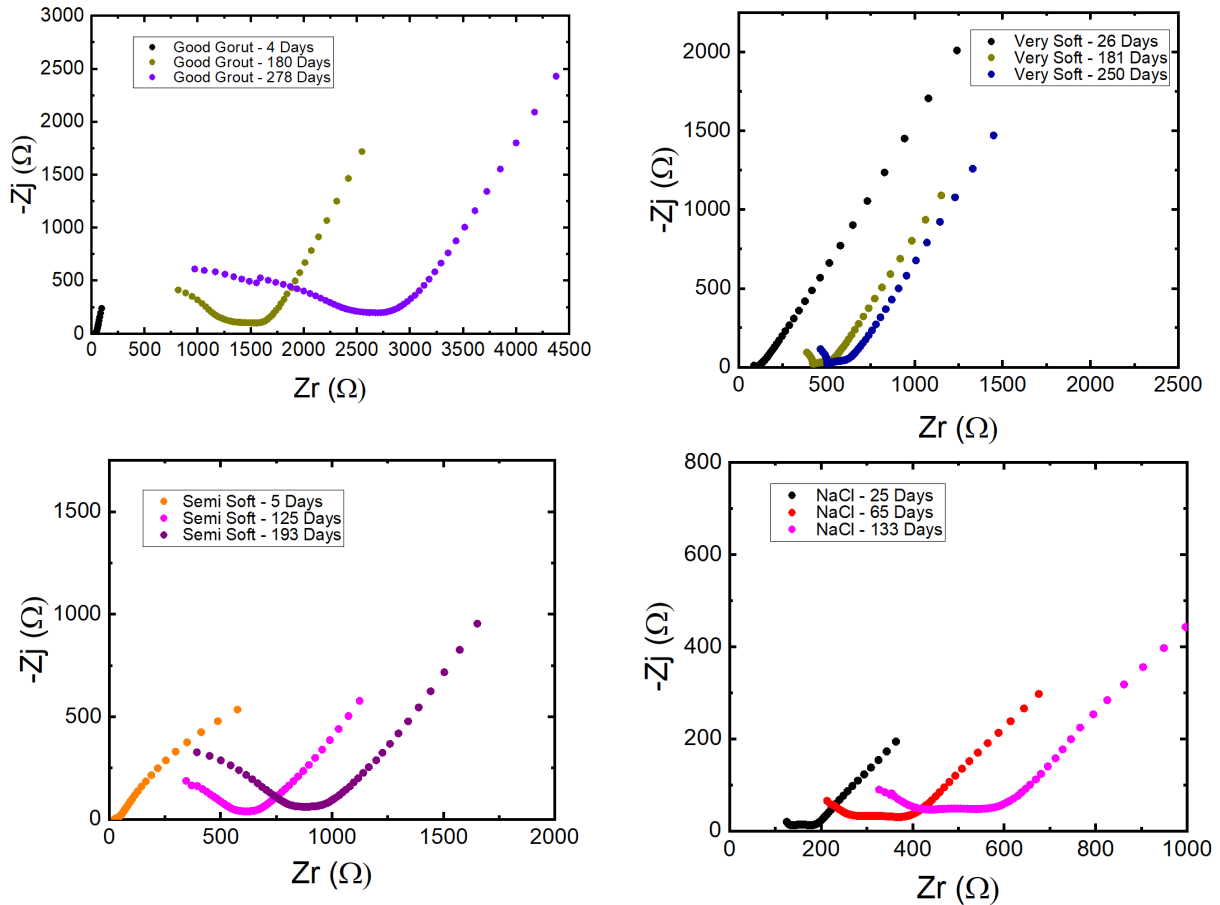
Figure 4-11. Steel wire impedance for each grout condition at beginning and end of exposure.

The electrochemical impedance spectroscopy results are shown in Figure 4-11 for each grout condition with exposure time as a parameter. The greatest impedance was measured on the good grout tendons suggesting little corrosion activity. These results were used to calculate the corrosion current density as a function of time for each grout condition which will be incorporated into the simulations presented in section 4.3.
