# Durability Evaluation of Florida's Fiber-Reinforced Polymer (FRP) Composite Reinforcement for Concrete Structures

**Final Report**

**March 2017**

UF Project No. 106074 & 107174  
FDOT Contract No. BDV31-977-01

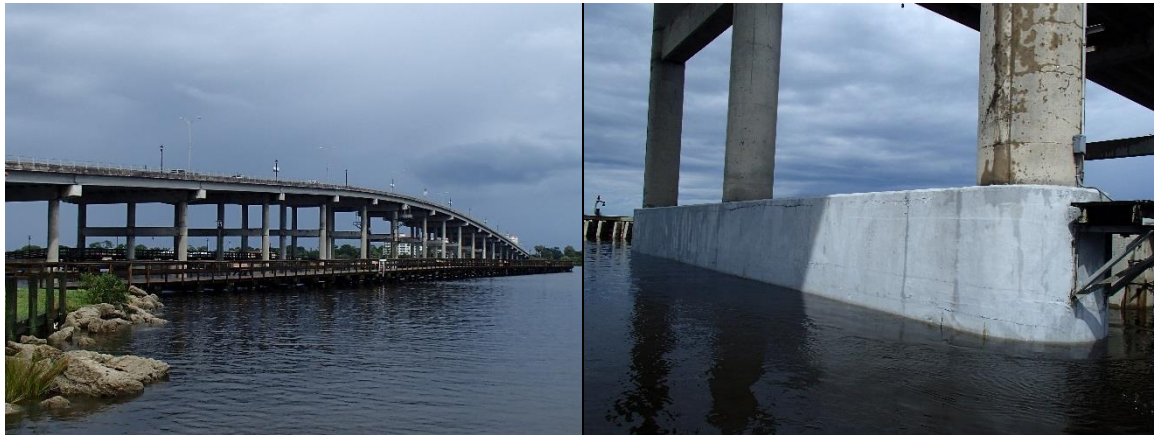
Figure 58—(a) Grenada Bridge (b) crash wall of Pier 8

Initial visit to Grenada Bridge in Ormond Beach, FL (Figure 58a) occurred on Monday, September 29, 2014 to observe FRP repairs on the crash wall of Pier 8. On Monday, November 3, 2014, an additional trip was taken by personnel from FDOT State Materials Office (SMO) Corrosion Lab and eUniversity of Florida to perform coring for chloride content testing and

direct-tension pull-off bond tests on the crash wall of Pier 8 (Figure 58b). Additionally, control core specimens were taken from the middle foundation of Pier 7 and crash wall of Pier 9.

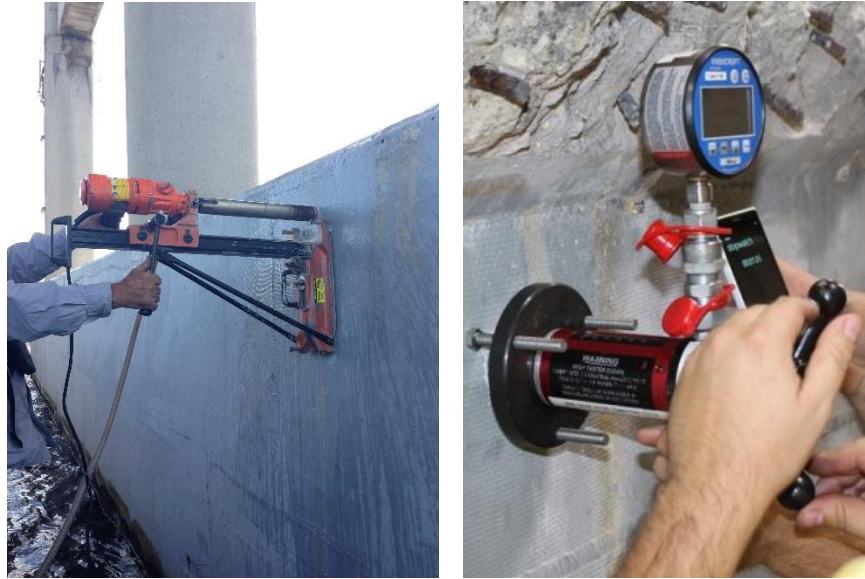
Figure 59—(a) Coring (b) direct tension pull-off test apparatus

Pull-off testing was performed in accordance with ASTM D7522 (Figure 59b) to assess the bond capacity of the bonded FRP composite. On Monday, November 3, 2014, pull-off locations were scored and test disks were attached. On the following day (November 4, 2014), pull-off tests were conducted.

FRP-concrete bond was evaluated by coin-tap method during the initial visit; based on the results it was concluded that the bond was in good condition. Pull-off testing, however, revealed that bond strength was less than 200 psi (Table 8), which is recommended by ACI 440.2R-08 and NCHRP (2010) specification. In addition, the failure modes (Figure 60) were typically adhesive and not cohesive; cohesive failure mode in which the failure plane passed through the concrete is preferred. The adhesive failure modes for the majority of the performed tests may indicate a degradation in bond over the service life or perhaps initial installation problems. This could only be confirmed if pull-off tests were conducted immediately following installation of the CFRP composite for comparison purposes. Exact locations of pull-off tests are included in Appendix B.

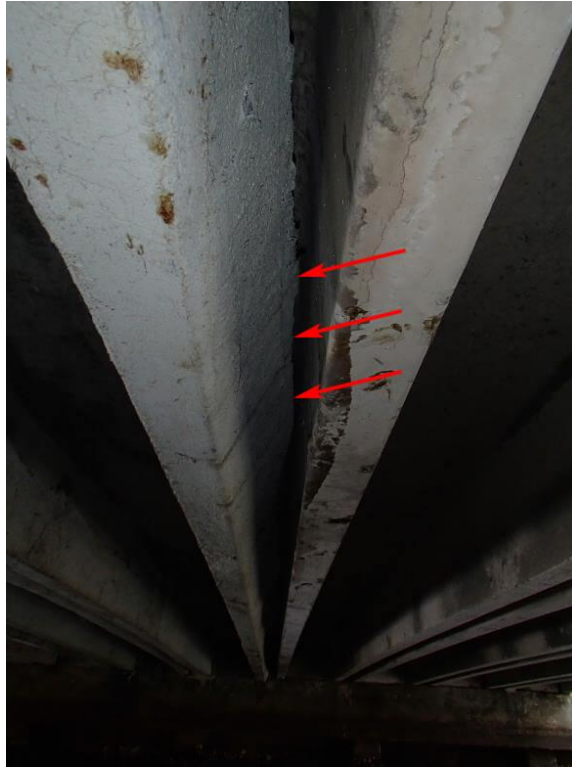
Figure 65—Debonded FRP wrap on a double tee girder

Phillips Lane bridge experienced significant corrosion damage (brackish water environment), and was repaired with CFRP wraps in 2001. No significant deterioration of the composite wrap was observed (Figure 64), with an exception of one girder where an entire side of the wrap was debonded as observed during the visual inspection (Figure 65) based on visual inspection. The debonded CFRP was located on one of the vertical faces of the concrete channel girder; close proximity of adjacent webs would have made accessing the concrete for surface preparation and CFRP installation difficult. Observation of multiple pull-off test locations (performed in the past) revealed rust staining and adhesive failure modes (Figure 66). The inspection was performed in 2015.

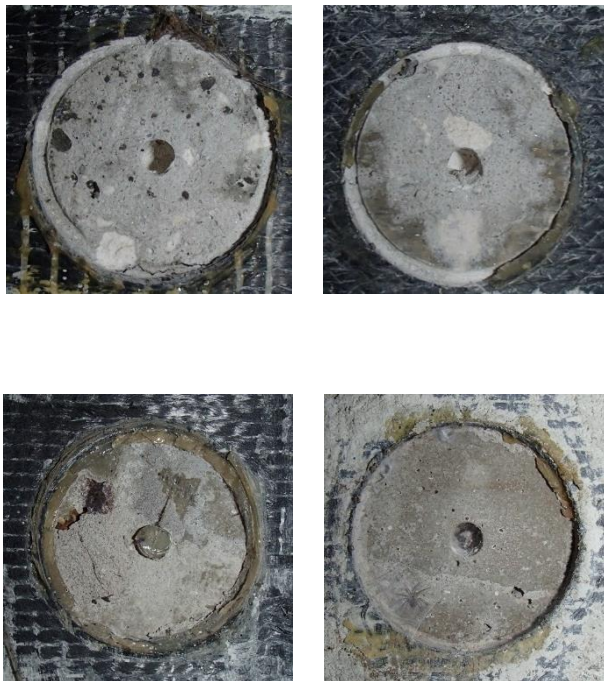
Figure 66—Pull-off test locations on Phillips Lane Bridge indicate adhesive failure modes. It is not known when these pull-off tests were conducted

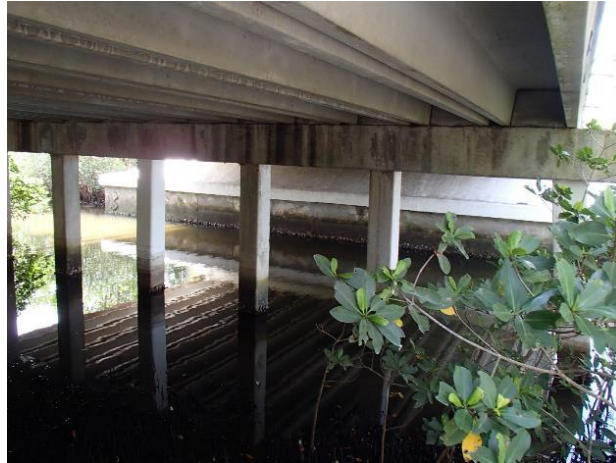
Figure 67—Repaired piles on Dickman Road Bridge

Two piles were repaired by wrapping with CFRP (Figure 67 and Figure 68). Coin tap sounding revealed minor debonding in both piles. Decay of the coating was apparent in the exterior pile, most likely due to exposure to sunshine.

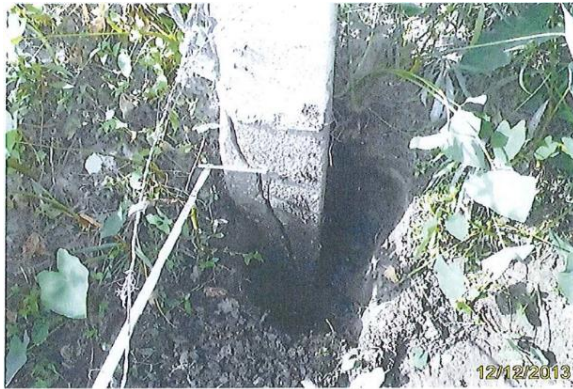
An impact damaged pile (Figure 69) on Durant Road Bridge was confined with CFRP. Coin tap sounding revealed two debonded regions shown in Figure 70. The middle section of the superstructure was also repaired with CFRP (Figure 71), presumably to offset the damage due to a longitudinal crack in the deck crossing multiple spans.

Photo #1 Element 204 - Pile 3-5 fracture in east face

Figure 69—Cracking at the base of pile due to impact

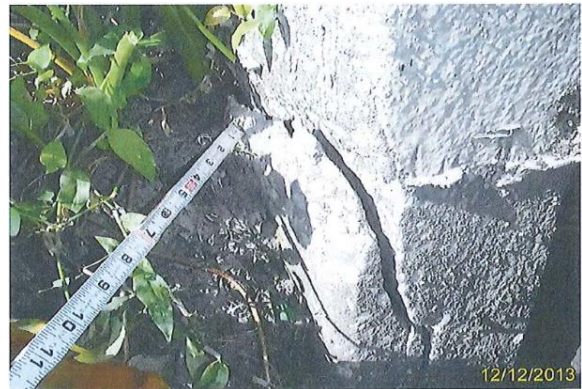
Photo #2 Element 204 - Pile 3-5 fracture in south face

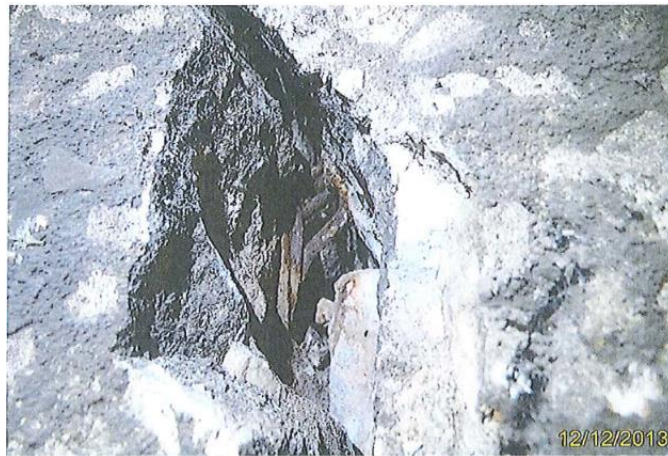
Photo #5 Element 204 - Pile 3-5 exposed and corroded prestress strand (visible through east face)

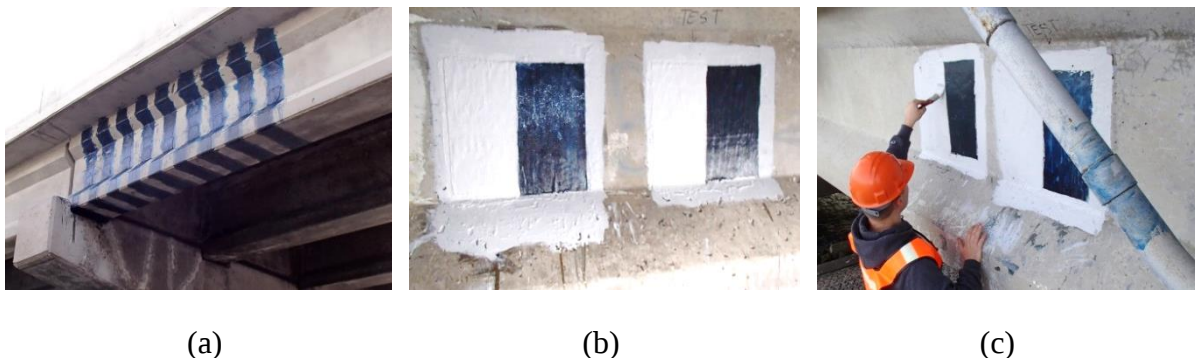
Figure 72—(a) Repair of Sunshine Skyway Bridge (b) interior girder test patches and (c) exterior girder test patches

Portions of the approach spans in the Sunshine Skyway Bridge, located in Tampa, FL, were recently repaired using a wet layup CFRP system. To alleviate the effects of cracking in shear-critical regions (near the supports), multiple locations were wrapped with CFRP composite strips (Figure 72a). At the time of the repair, researchers from University of Florida installed 4 test patches (24 in. × 24 in.) at the approach span girders of the north abutment of the bridge for the purpose of determining the durability of bond between the composite and concrete substrate by means of direct pull-off testing (ASTM D7522). Tests were performed after 6 and 18 months of exposure.

Test locations were first sandblasted by the contractor. Two patches installed on the interior girder and one patch on the exterior girder were installed as per manufacturer's instructions; all three components of the system were used (primer, putty, and CFRP). One patch on the exterior girder was installed without the putty layer to determine the effects of putty on bond durability. Twenty-four hours after installation one-half of each patch was coated with a UV protective coating. Patches were divided vertically for coating to account for possible effects of rainfall on the bond durability (Figure 72b, Figure 72c). Interior and exterior girder locations were chosen to minimize/maximize (respectively) influence of UV irradiance, rainfall, diurnal temperature fluctuations, etc. on the bonded system.

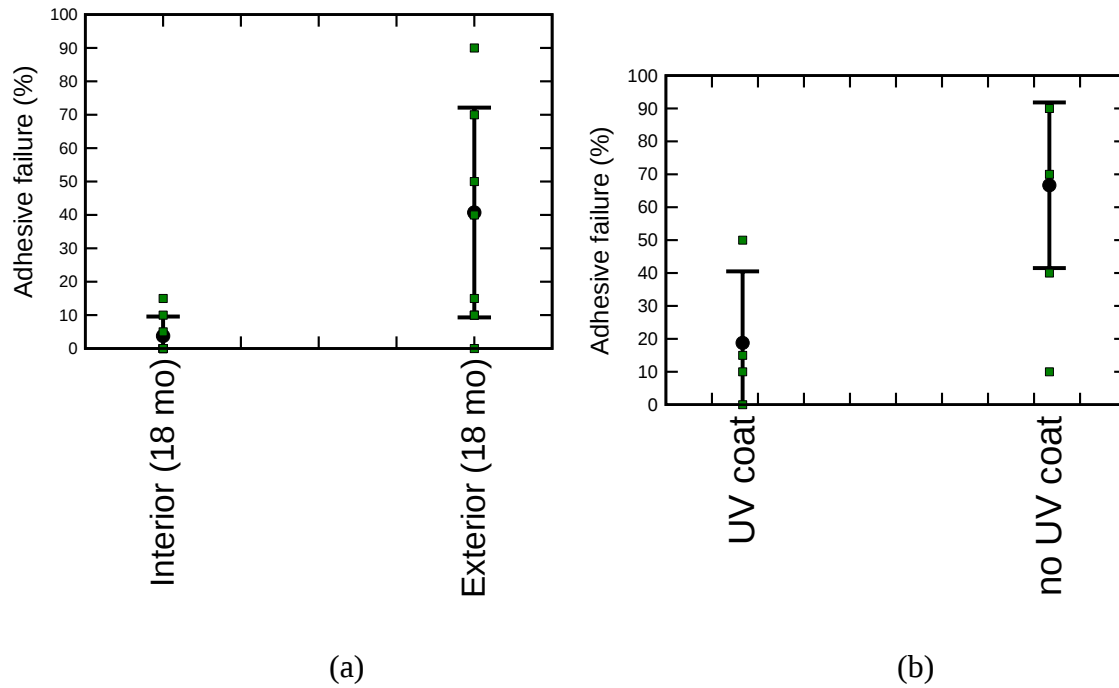
Figure 74—(a) Distribution of adhesive failure modes amongst the test groups (b) distribution of adhesive failure mode characteristics on exterior girder

A more compelling evidence of higher degradation of FRP-concrete bond in the exterior girder is observed when comparing the failure mode data between the two girders. The presented results in Figure 74a show an increase in adhesive failure mode characteristics from interior to exterior girder, with the difference being apparent for the 18-month tests; typical failure modes that were observed on the interior and exterior girder are shown in Figure 75 and Figure 76. A comparison of test data obtained from locations with UV coating to those without it, on the exterior girder (at 18 months of exposure), reveals the existence of correlation between the presence of UV coating and the failure mode. As shown in Figure 74b, adhesive failure mode characteristics increased at the location without the UV coating, indicating that UV radiation may be a significant contributing factor to the bond degradation. Effects of radiation were observed on the surface of CFRP composite without UV coating in the form of scaling and change in color of the saturating

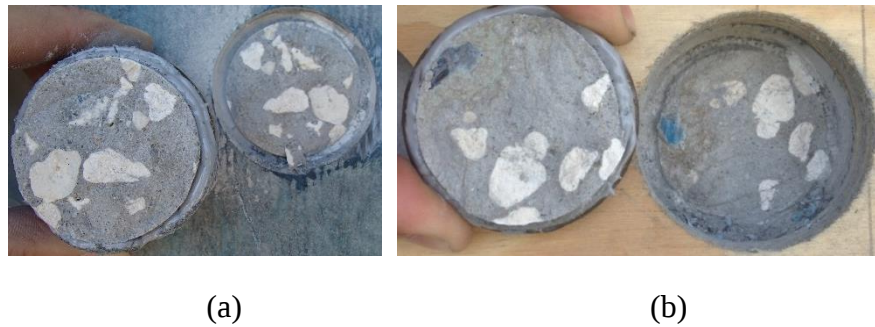
Figure 75—(a) Typical cohesive failure mode (b) typical mixed failure mode

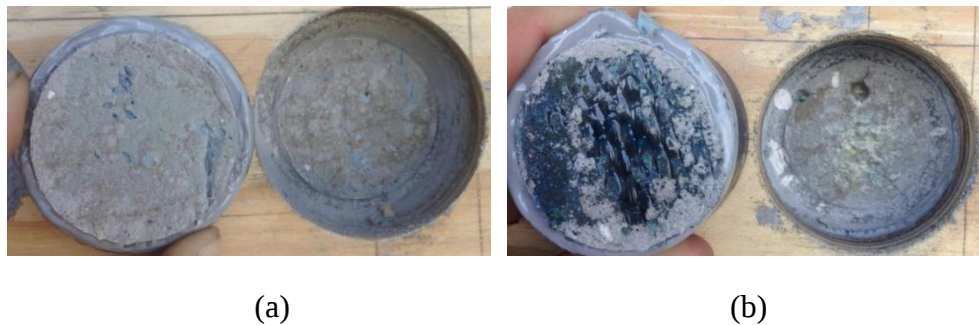
Figure 76—(a) Typical adhesive failure mode (system with putty) (b) typical adhesive failure mode (system without putty)

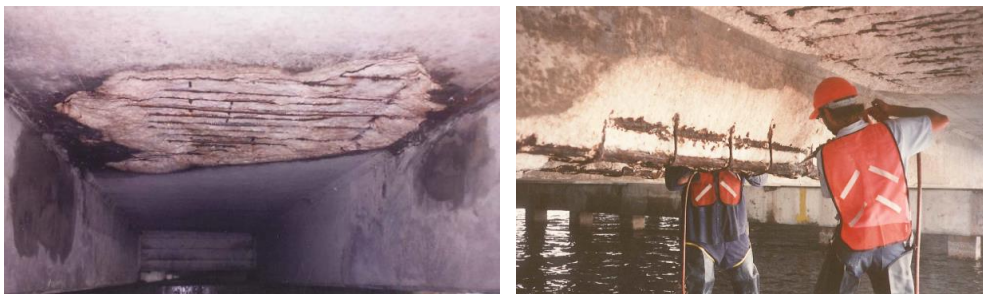
Figure 80—Indian River Bridge – corrosion damage

In the early 1990's, the girders had shown signs of corrosion, which was particularly severe in the span adjacent to the abutment (Figure 80). Tidal fluctuations put the water level within 3 to 5 ft (1 to 1.5 m) of the bottom of the girders. Near the abutment, wind-driven waves splashed salt water onto the underside of the girders and accelerated the corrosion. Little is known about the repair other than the system was a commercially available system. Florida Department of Transportation (FDOT) records indicate that both wet layup and precured laminate bonded reinforcement were applied to the girders. The repaired span was at the east end of the bridge with one end supported on the abutment (Figure 81). The first FRP repair on the bridge apparently had degraded and was reapplied in 1999. Neither the details of the first repair nor the characteristics of the degradation are known. The repair material was a wet layup CFRP system composed of bi-directional (0-90 deg.) carbon sheets (Figure 82).

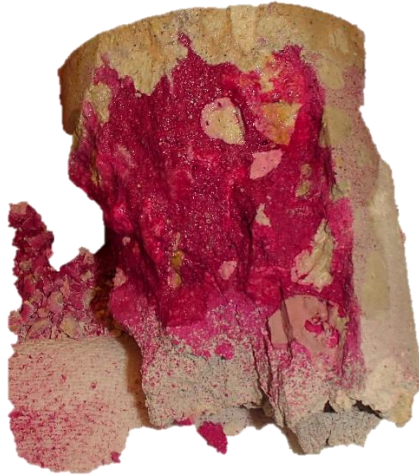
Figure 95—Concrete carbonation examined on a concrete cylinder following the compression test

Higher (on average) depths of carbonation were noted in specimens with no CFRP, or epoxy only on the exterior surface compared to specimens with bonded CFRP (Figure 95). At this point, however, no conclusive evidence exists regarding the possible correlation between the CFRP wrapping and progression of carbonation.

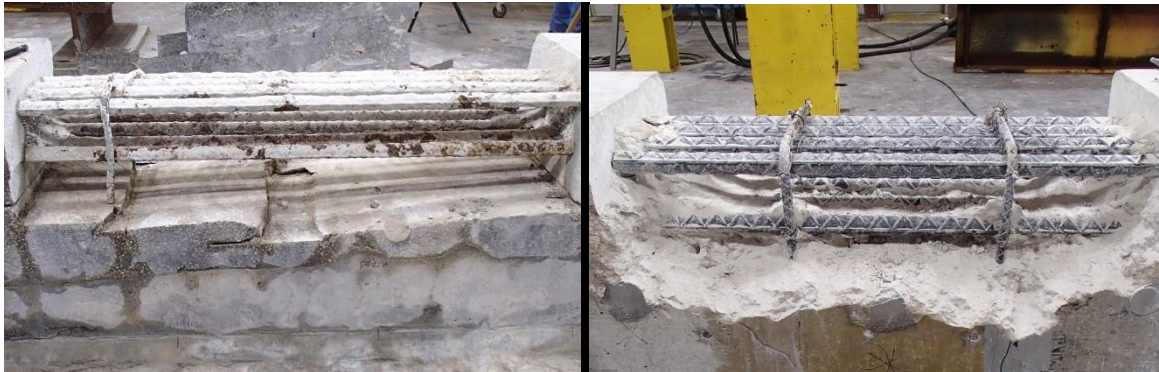
Figure 97—Steel reinforcement: (a) corroded (b) uncorroded

Steel reinforcement samples, for the purpose of tension testing, were taken from the corroded and uncorroded regions along the span (Figure 97). Steel reinforcement most severely affected by corrosion was located near the repaired portion of girder span, while uncorroded steel reinforcement was situated towards the west end of the girder in the area under old concrete. Less corrosion was observed in the repaired region of Girder #1 than in that of Girder #2. Steel bars measuring approximately 45 in. were collected using an acetylene torch (Figure 97). Four specimens were collected from repaired regions of both Girder #1 and #2, two of which were #11 bars and two #10 bars. Four bars (two #10 and two #11) were taken from the uncorroded region of Girder #2, in addition to two #11 bars from Girder #2.

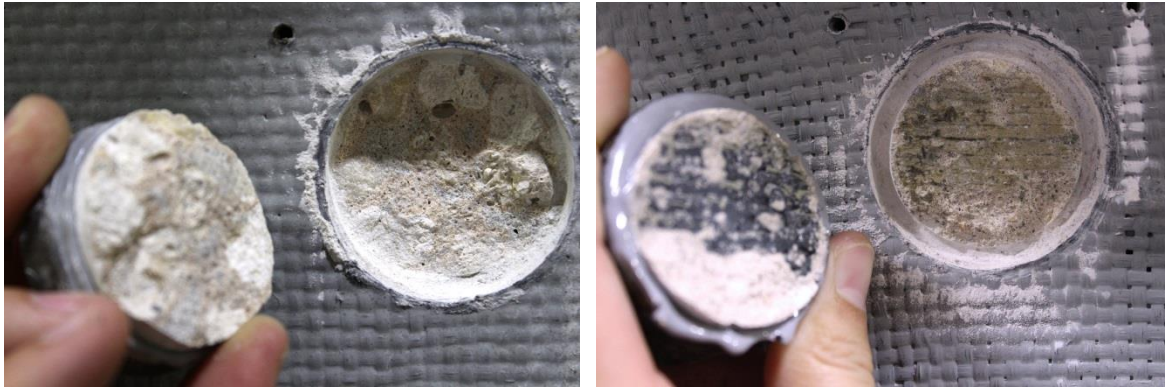
Figure 102—Failure mode: (a) cohesive and (b) adhesive

Direct pull-off test results are summarized in Table 16. All tests passed the tensile pull-off strength criterion. An adhesive and a mixed failure mode on each girder, however, were observed, which may signify bond degradation and/or inadequate surface preparation.

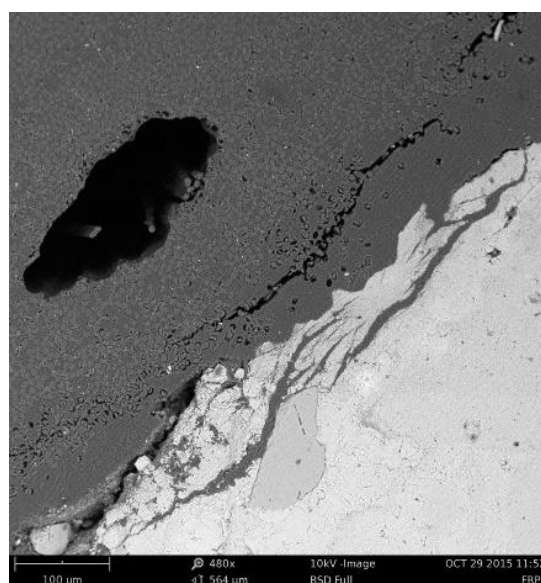
Figure 105—Large void and initiation of debonding of CFRP near CFRP-concrete interface

Collected images showed defects within the FRP composite (Figure 104). Voids within the matrix were likely a result of inadequate impregnation of dry carbon-fiber fabric in the field. At higher magnifications, microcracks located at the fiber-matrix interface were observed. These fibers could be due to manipulation of the samples during the extraction, or due to the environmental degradation. Larger microcracks were also present in the epoxy-concrete interfacial region, as shown in Figure 105. Sustained loading, combined with fatigue and environmental impacts could have been the cause of these microcracks. While further research is necessary to understand the source of cracking near the interface, these observed microcracks might result in early onset of debonding once they reach their critical length.

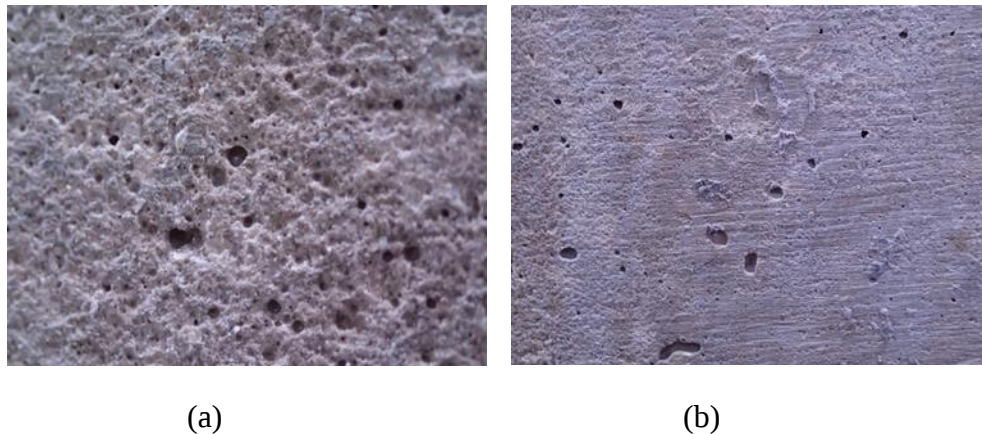
CFRP was removed by either pulling off by hand or using a scraping tool. This process revealed the variation in surface condition on each girder. Figure 120 shows marks from plywood grains on the surface indicating that the surface was not prepared. Such regions were observed intermittently on the sides of the girders. Approximately 30-40% of the total surface area of the sides on each girder did not appear to have been sandblasted.

Figure 120—Difference between: (a) sandblasted concrete surface and (b) concrete surface without surface preparation

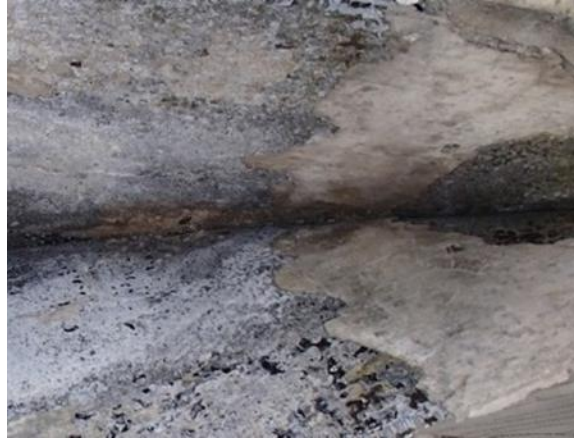
Removal of CFRP also revealed the presence of a cementitious material skim coat at multiple locations that pulled off with CFRP (Figure 121). This coat was most likely used to level the surface after the repair forms were removed.

Figure 121—Evidence of skim coat at the bond

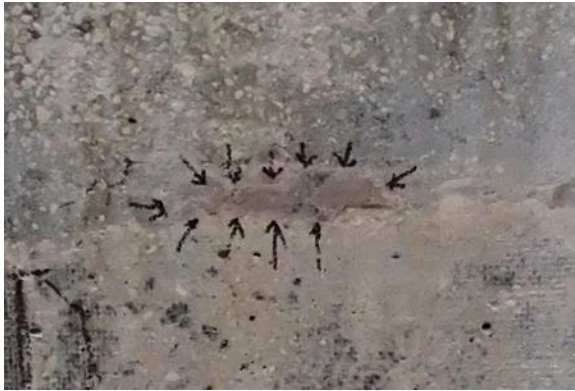
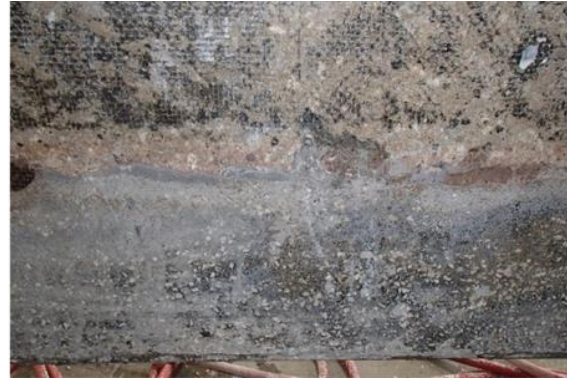
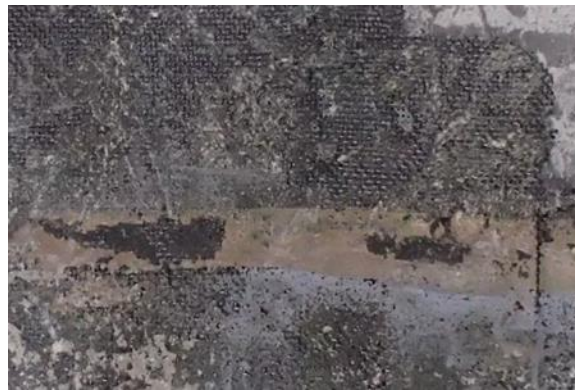
On both girders, a primer was used at the interface between old and new concrete. The primer was recognizable by a distinct light brown color that bled through (Figure 122). Marks from the primer were detected on the stripped CFRP.

Figure 122—Evidence of primer at the new–old concrete interface

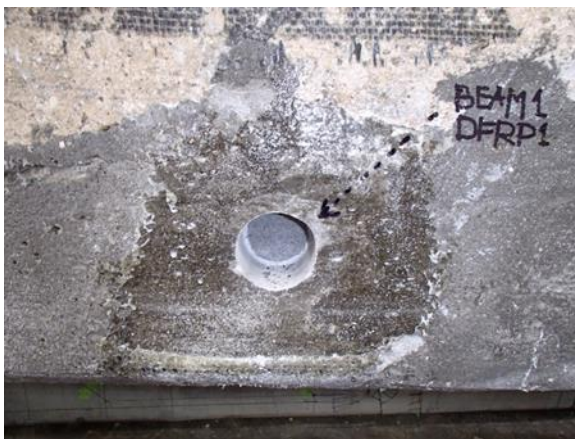
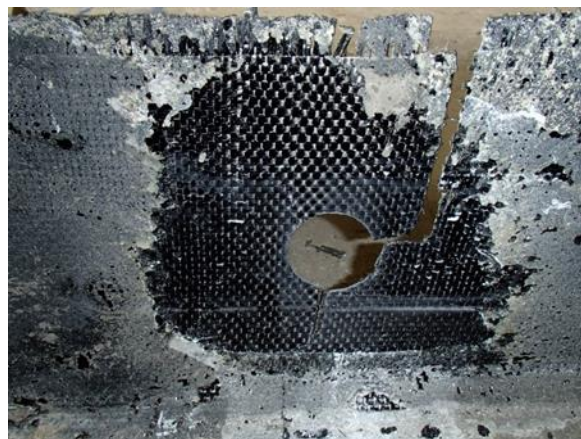
A few areas on each girder were found to be repaired with a cementitious repair material. Two such areas were identified on Girder #1, and were surrounded by severely debonded CFRP. The debonding occurred at the CFRP-epoxy interface (Figure 123), which is unusual; the most common type of debonding occurs at the concrete-epoxy interface.

Figure 123—Evidence of delaminated bond surface along the CFRP–epoxy interface on: (a) the girder and (b) CFRP wrap

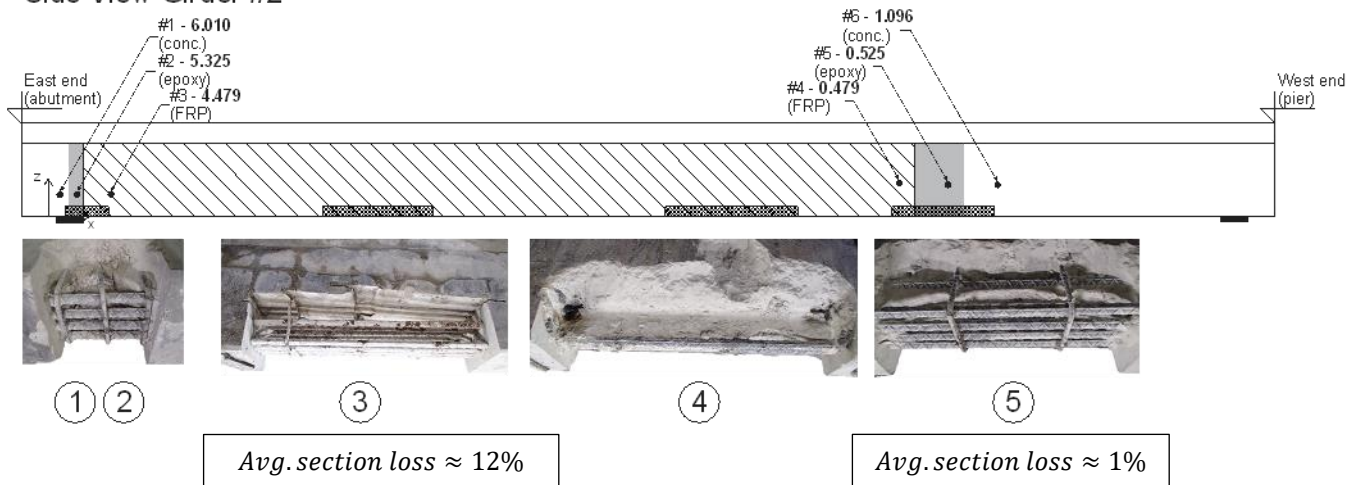
1. Splash zone at abutment: This region is thought to be the most affected by splash of brackish water. CFRP wrap starts in this region. Concrete was removed at the edge of the CFRP wrap to reveal the reinforcement on both sides of CFRP. No signs of corrosion were observed.

2. Old/new concrete interface (towards the abutment): An “anode-ring effect” takes place when new concrete is installed adjacent to chloride-contaminated concrete. The potential difference between the repair concrete and surrounding salt-contaminated concrete creates a corrosion cell where the anodic reaction occurs in the reinforcement adjacent to the repaired area; this reinforcement is also surrounded by chloride-contaminated concrete. No significant corrosion was observed on the reinforcement surrounding the repair, indicating that the anode ring effect did not strongly promote corrosion.

3. Repaired region: This region was initially the most severely damaged by corrosion, and consequently most of the repair efforts took place in this region. Corroded reinforcement was coated with a protective polymer coating. Average section losses of approximately 5% and 12% were observed in Girders #1 and #2, respectively; however, it is believed that no substantial corrosion processes have occurred following the CFRP repair. Close-up images of corroded reinforcement are shown in Figure 126.

most recent repair on the bridge. Moreover, steel reinforcement adjacent to the end of CFRP wrap was examined to determine what effect CFRP wrap had on corrosion of existing reinforcement. No significant signs of corrosion were observed.

Figure 125—State of reinforcement and chloride contents (pcy) at specified locations along the north face of Girders #1 and #2

Chloride ion ( $\text{Cl}^-$ ) concentrations vary on girders #1 and #2 (Figure 125). This variation is particularly acute in the splash zone (near the abutment support). Inconsistent exposure of each location to wind and wave action was likely the cause of the differences in  $\text{Cl}^-$  concentrations (Figure 129). Both girders were interior, with girder #1 situated further away from the exterior girder, thus placing it further away from the wind and wave action approaching from the North. Exposure to wave action was particularly severe at the east end of each girder, due to the configuration of abutment support and the diaphragm (Figure 130).

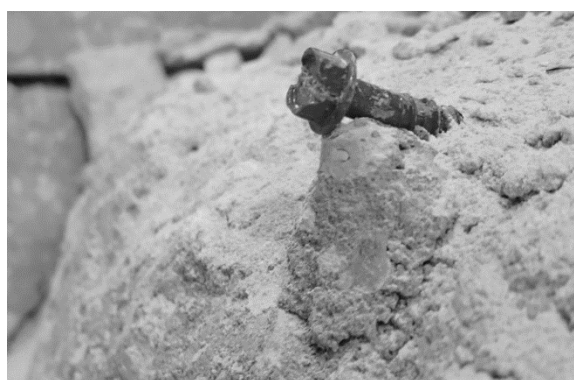
Concrete screws were observed at multiple locations during the concrete chiseling process (Figure 127). It was later confirmed from repair procedure photos that the screws served the purpose of enhancing the bond between the old and new repair concrete.

Figure 127—Concrete screw at the interface between new and old concrete

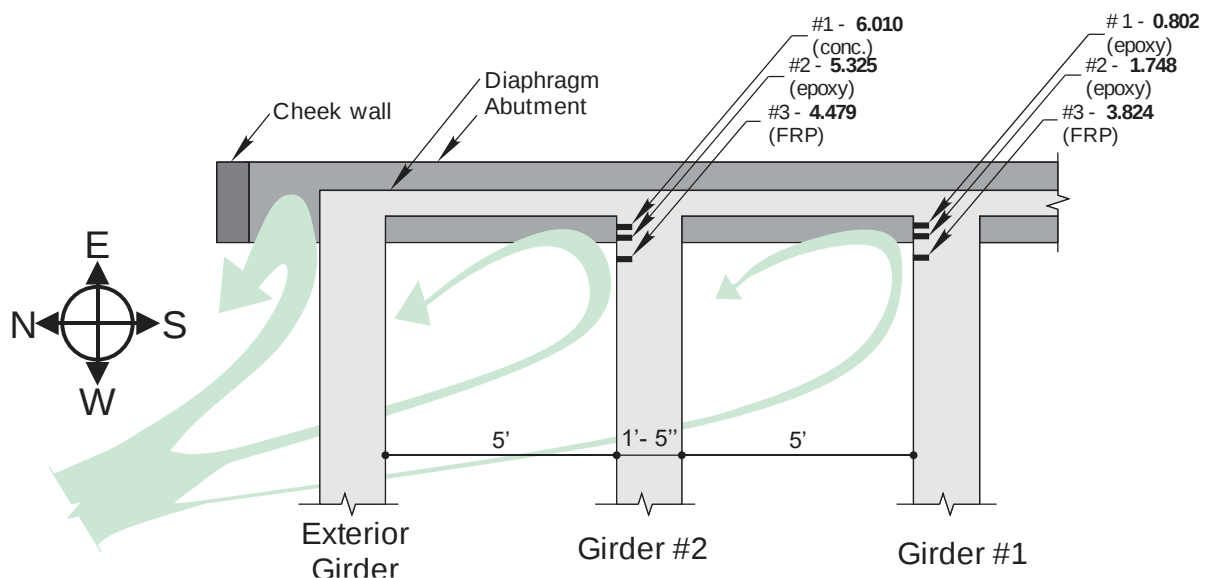
Figure 129—Wind and wave action on bridge girders near abutment (plan view)

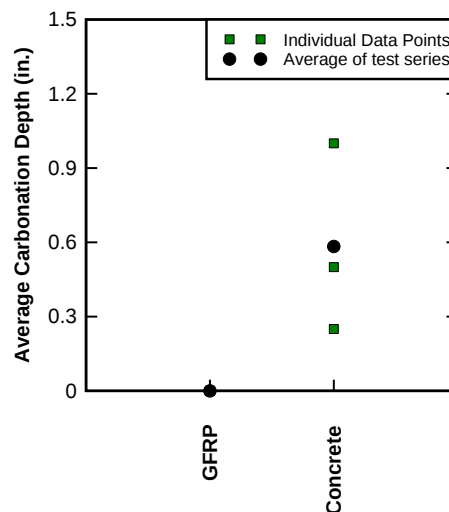
Higher depths of carbonation were noted in specimens with no GFRP on the exterior surface compared to specimens with GFRP (Table 22). The carbonation depths of the samples with and without externally bonded GFRP are compared in Figure 139.

Figure 139—Carbonation depth measurements

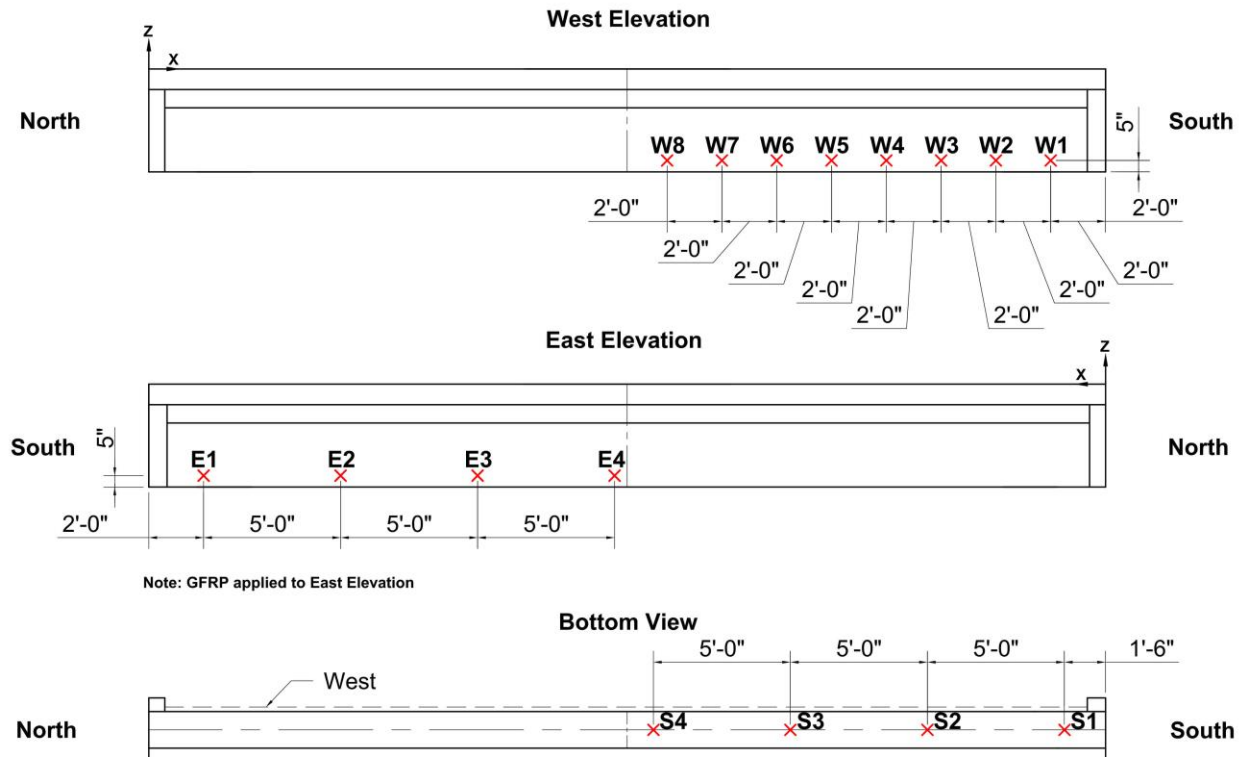
Figure 142—Potential testing locations for Girder 3-1

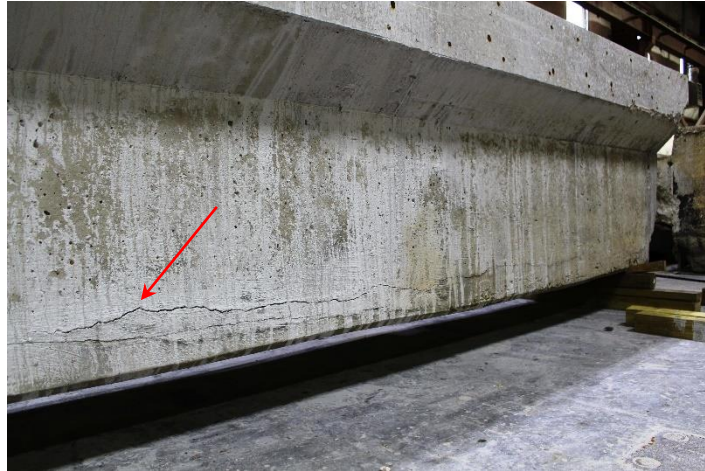
Girder 3-1 was predicted to have heavier levels of corrosion than the remaining tested girders because of its close proximity to the tidal fluctuations and due to a horizontal crack at approximately 5 in. from the bottom of the girder (Figure 143); girder 3-1 was not structurally tested due to this crack. This provided the opportunity to conduct additional material tests on Girder 3-1. All of the readings on the west elevation of 3-1 had a potential of -0.54V or lower, indicating a high probability of corrosion. Two of the voltmeter readings on the east elevation fall into the category where reinforcing steel in that area is uncertain. This may indicate that GFRP has some effect on the corrosion behavior of the steel reinforcement closest to the east elevation.

Figure 143—Horizontal crack on Girder 3-1 indicated by red arrow

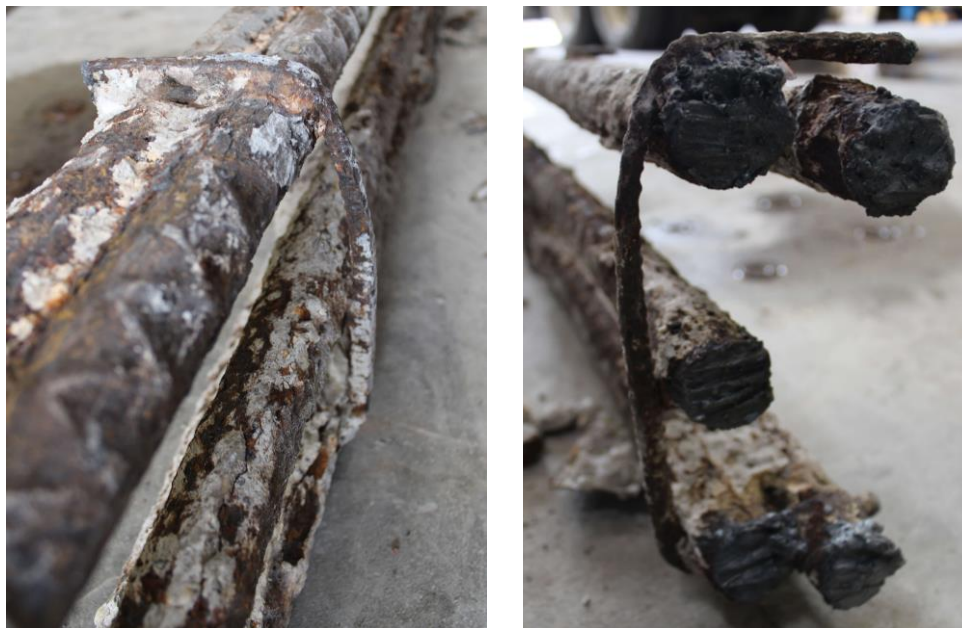
Samples were wire brushed to bare metal to avoid slipping in the grip during tension testing (Figure 144); grip length was 8 in. Wire brushed regions were also used to measure the cross-sectional dimensions so that section loss could be determined. After each sample was tested, approximately 6 in. of the steel reinforcement along the grip region was cut then weighed and measured with a caliper. The grip region was chosen because these regions had already been wire brushed for the corroded samples. Section loss was calculated by normalizing the cross-sectional area of corroded reinforcement to an average cross-sectional area of uncorroded reinforcement. The results from tensile testing the steel reinforcement can be found in Table 29. It was discovered during sampling that stirrups were welded to longitudinal reinforcement in some locations (Figure 145). These samples typically fractured at the spot weld (Figure 146).

Figure 145—Steel reinforcement welded together with stirrups

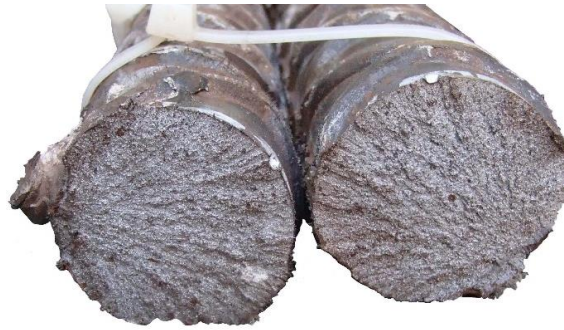
Figure 146—Typical hackle pattern pointing to the origin of fracture surface, which in this case is the spot weld

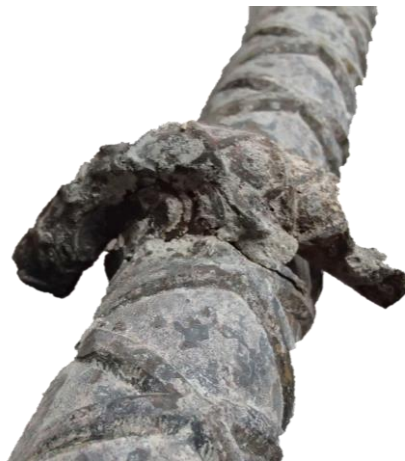
Figure 147—Stirrup remaining on steel reinforcement sample

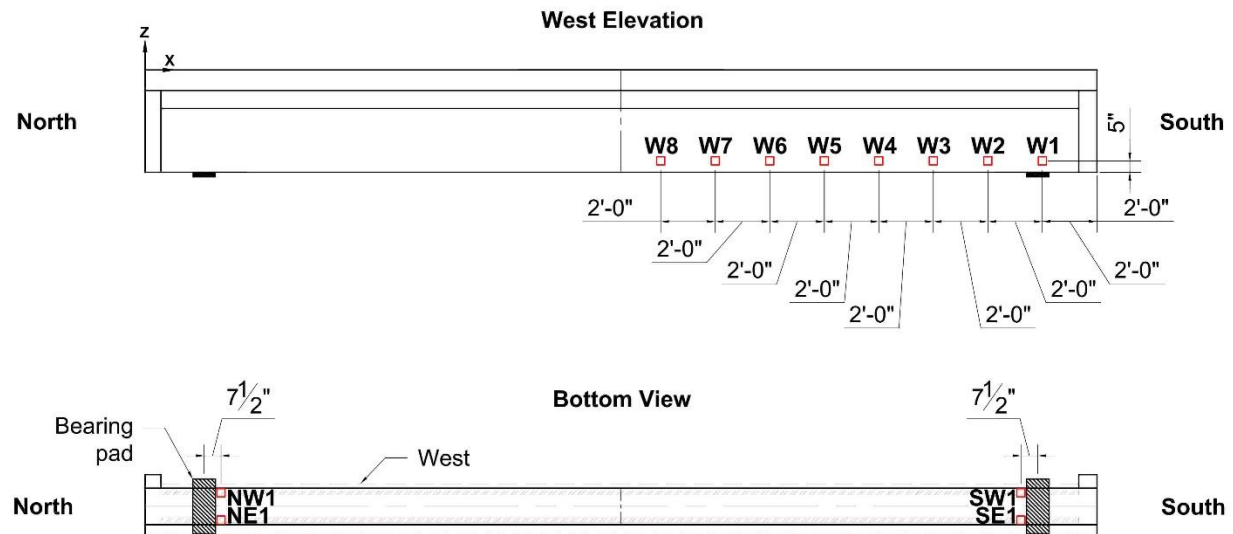
Figure 152—Direct pull-off testing locations for exterior girders

Figure 152 shows the locations of direct pull-off testing for exterior girders (3-1, 4-1, and 4-4). Direct pull-off test results for Girder 3-4 are summarized in Table 32. Approximately 83% of the pull-off tests passed the tensile pull-off strength criterion. One of the two samples that failed the tensile test had a crack in the testing location that most likely affected the tensile strength results. In addition, 50% of the samples failed cohesively; however, an adhesive and a mixed failure mode were also observed.

Direct pull-off test results for Girder 4-1 are summarized in Table 33. Approximately 83% of the pull-off tests passed the tensile pull-off strength criterion. One of the two samples, however, that did not exceed the strength criterion failed in mode A, which is considered neither an adhesive nor a cohesive failure mode. All but one sample failed cohesively; samples with failure mode A were not considered. The one sample that failed adhesively also failed at the interface between the loading fixture and the FRP, which may have had an effect on the failure mode.

Direct pull-off test results for Girder 4-4 are summarized in Table 34. All tests passed the tensile pull-off strength criterion. In addition, 33% of the samples failed cohesively; adhesive and mixed failure modes, however, were also observed. Some voids in the concrete were noted during testing (Figure 153).

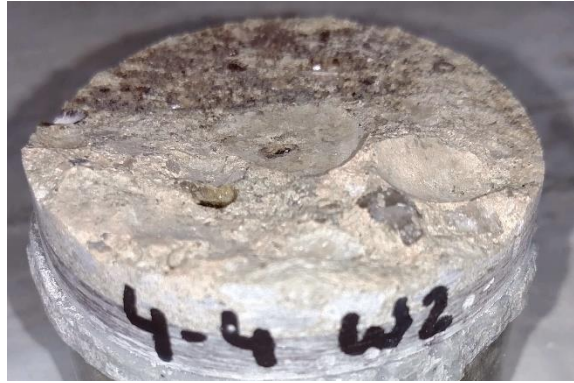
Figure 153—Pull-off testing sample from Girder 4-4 with multiple voids in concrete

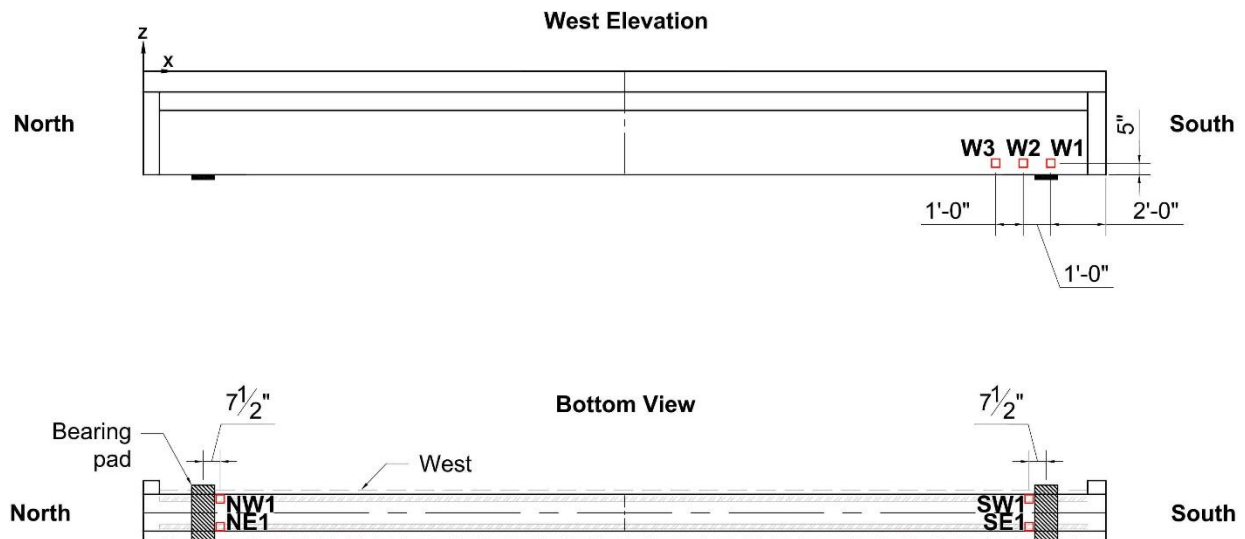
Figure 154 shows the locations of direct pull-off testing for interior girders (3-2, 4-2, and 4-3). Some of the pull-off tests failed at the dolly to FRP interface (Failure mode A), either from the adhesive not being completely cured or from the set of smooth dollies which were used on 11 pull-off testing locations (Figure 155). The same bond tester used in the Indian River report was used after these 11 locations to avoid more samples from failing in Failure mode A.

Direct pull-off test results for Girder 3-2 and 4-2 are summarized in Table 35 and Table 36, respectively. All tests passed the tensile pull-off strength criterion, and failed cohesively (excluding samples that had failure mode A). Direct pull-off test results for Girder 4-3 are summarized in Table 37. Six of nine tests passed the tensile pull-off strength criterion. Samples that failed the tensile test were noted to either have a crack or void in the testing area, which may have reduced the tensile strength results.

Figure 154—Direct pull-off testing locations for interior girders

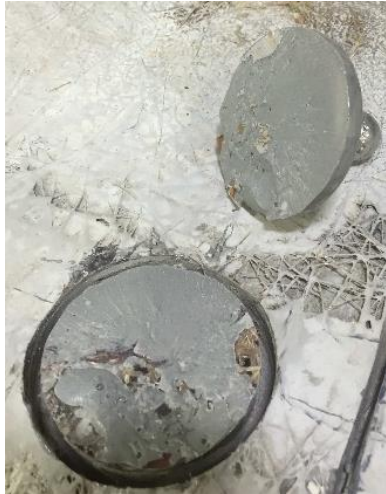
Figure 155—Smooth dolly that failed at the dolly-to-FRP interface

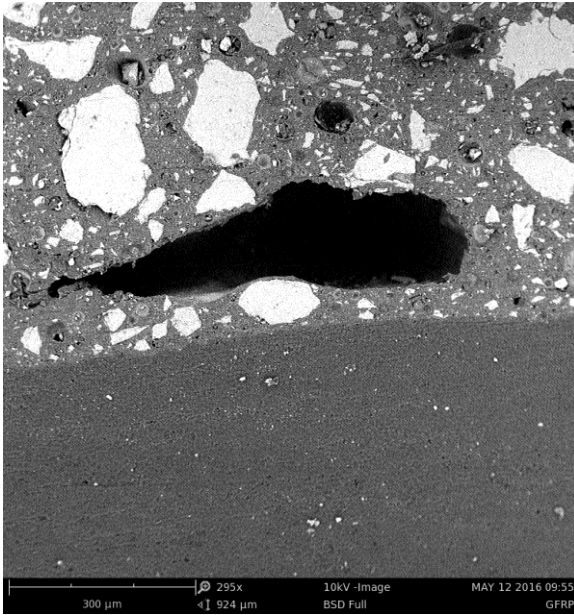
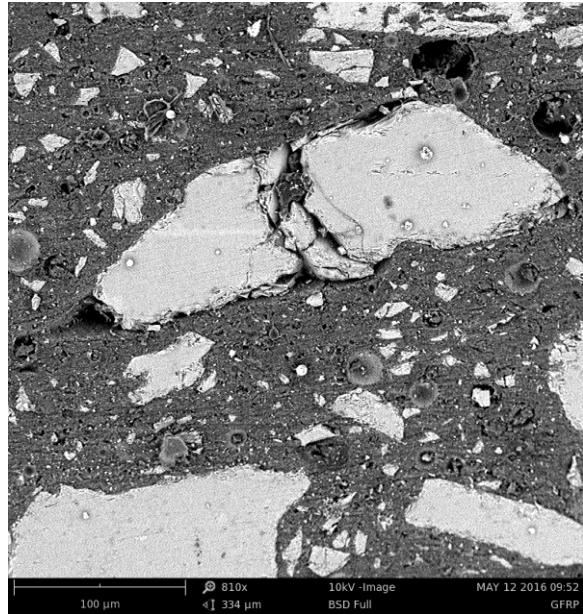
Due to its high viscosity and high silica sand content, the paste epoxy used to bond CFRP laminate to the girders had large number of voids present within its microstructure (Figure 159a). Additionally, possibly due to the environmental degradation, microcracks were observed at the interface between silica-sand filler particles and the epoxy adhesive (Figure 159b). No defects were observed at the CFRP-epoxy interface (Figure 159a). Many voids were found, however, along the interface between epoxy and concrete (Figure 160) which likely occurred during the installation of the composite. CFRP composite, similarly to the wet-layup system used in the Indian River Bridge, exhibited damage within the matrix and matrix-fiber interface (Figure 161). It is not clear whether the damage was due to the environmental degradation, specimen manipulation and handling, or the installation defects.

Figure 159—SEM images of: (a) interface between CFRP (bottom) and epoxy (top) (b) magnified image of a single silica sand grain in the epoxy matrix.

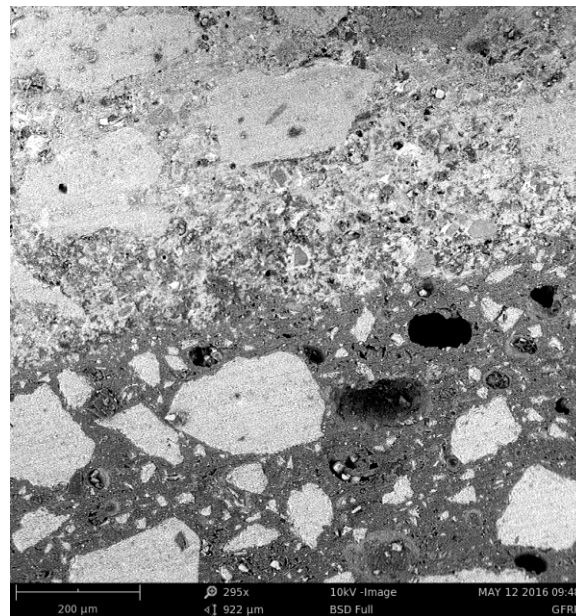
Figure 160—SEM image of interface between concrete (top) and epoxy (bottom).

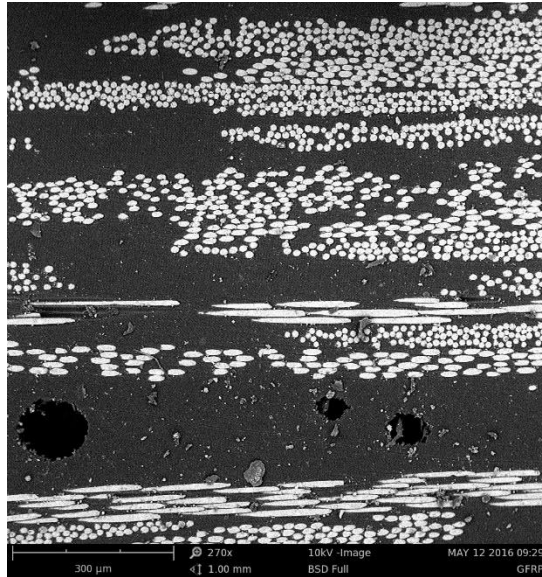
Inspection of the GFRP composite indicated that fibers were oriented in preferential directions. Additionally, it was apparent that fibers were also not uniformly distributed within the matrix. Regions with very high volume fractions of fibers were contrasted by the regions without any fiber content. Large defects (Figure 164) in the regions without fibers do not fully benefit from the fibers' crack-bridging effect, which can possibly improve the macroscale mechanical properties of the composite. Magnified images of the fibers embedded in the polyester matrix did not show any signs of matrix or interfacial damage (Figure 165); the fibers, however, appear to be packed very tightly, which could result in significant stress concentrations when stresses acting perpendicular to the fiber direction are applied.

Figure 164—SEM image showing non-uniform distribution and preferential orientation of fibers within the GFRP composite matrix

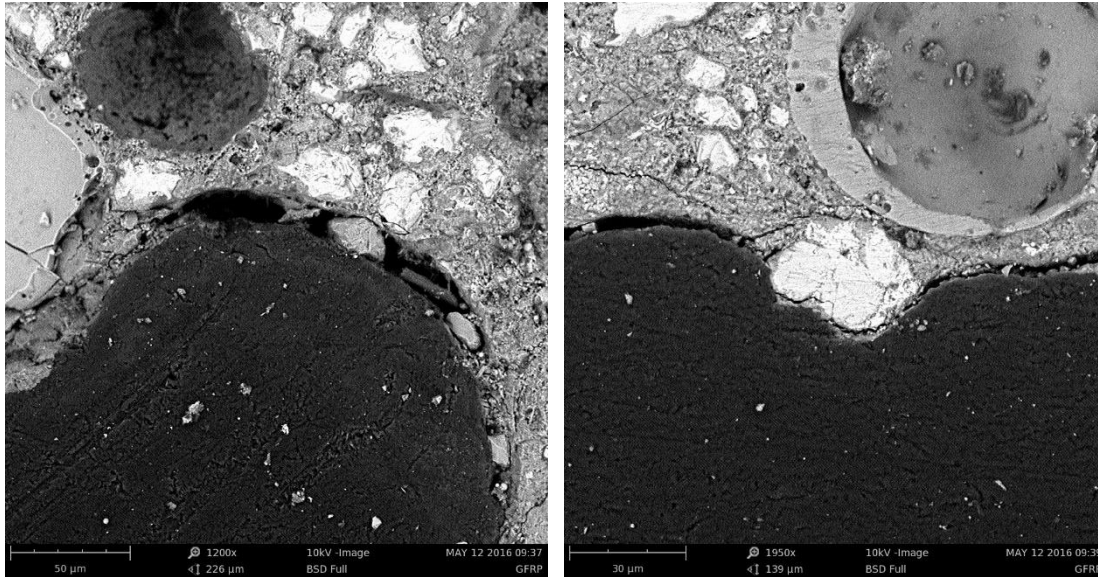
Figure 166 shows a backscatter electron image of the adhesive interface between GFRP and concrete. Dark regions in the image are representative of low average atomic number (low backscatter electron yield) and correspond to the adhesive; relatively brighter regions on the image represent concrete. Even though mechanical interlocking due to concrete surface irregularities is apparent, the collected SEM images reveal separation between the adhesive and concrete indicating potentially poor adhesion.

Figure 166—SEM image of interface between concrete (top) and GFRP composite (bottom)
